**EXAMINATION REPORT  
PHOTOGRAPHS OF STRUCTURE**

ELR: BAL Br. No.: 00

Mileage: 10 M 17 ch Sheet 23 of 29

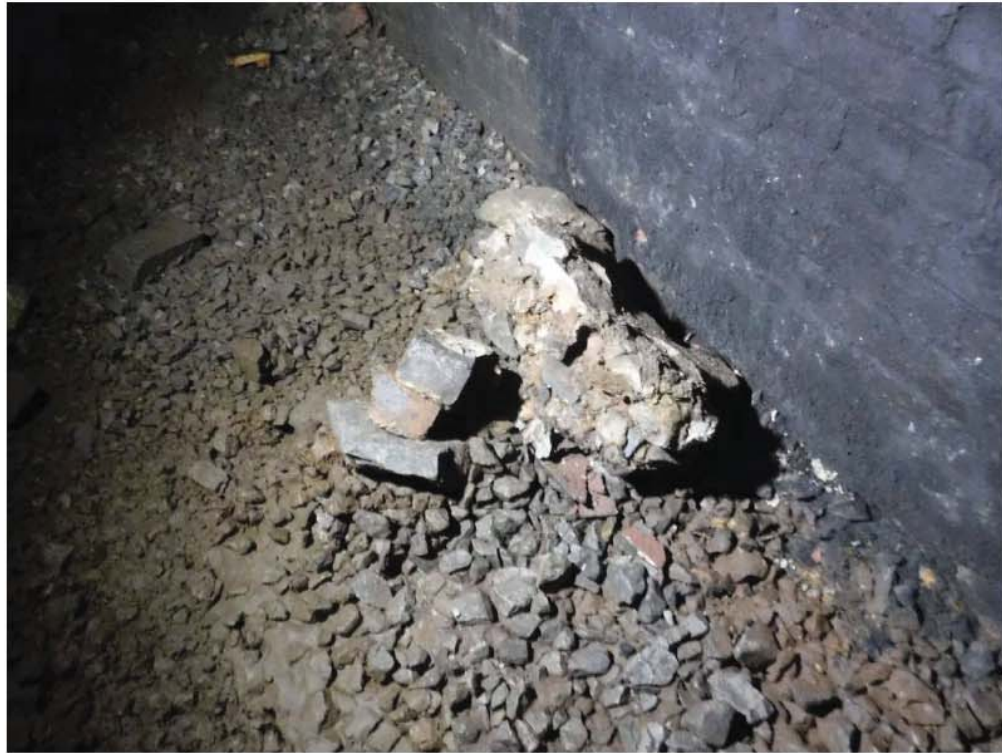
**Photo No.34:** 043+17 Solum Up, broken out catch-pit dumped in cess.

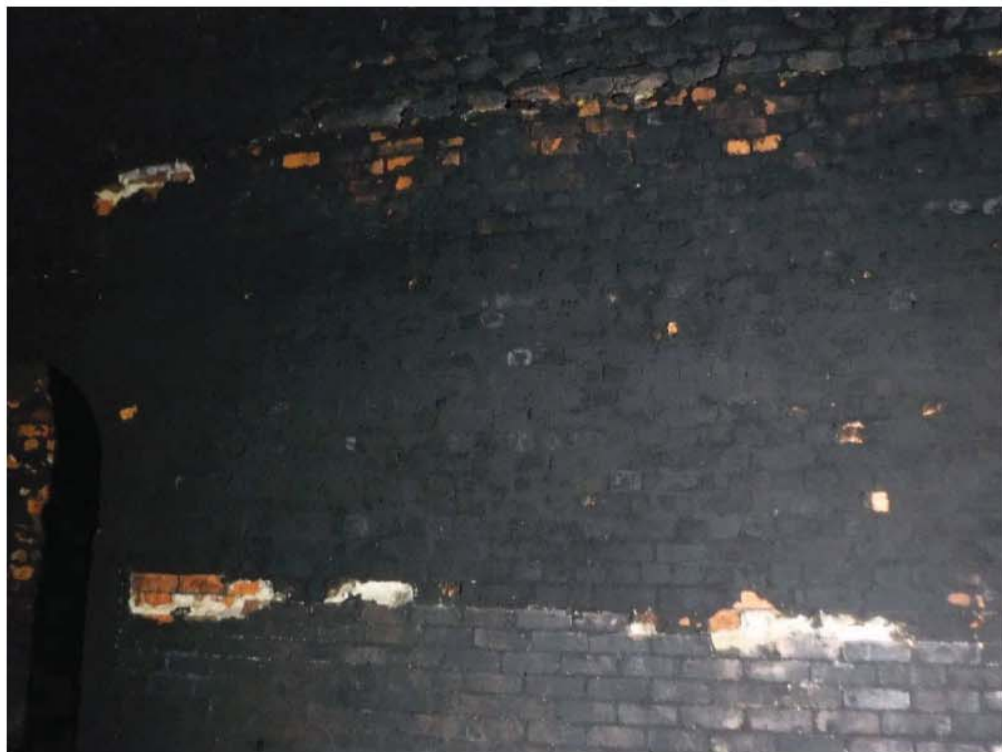
**Photo No.35:** 046+00 to 048+20 Sidewall & Haunches Up & Down, Brickwork, bulging 75mm with random vertical and longitudinal fractures, max. width 1mm, hollow, area 20sq.m.

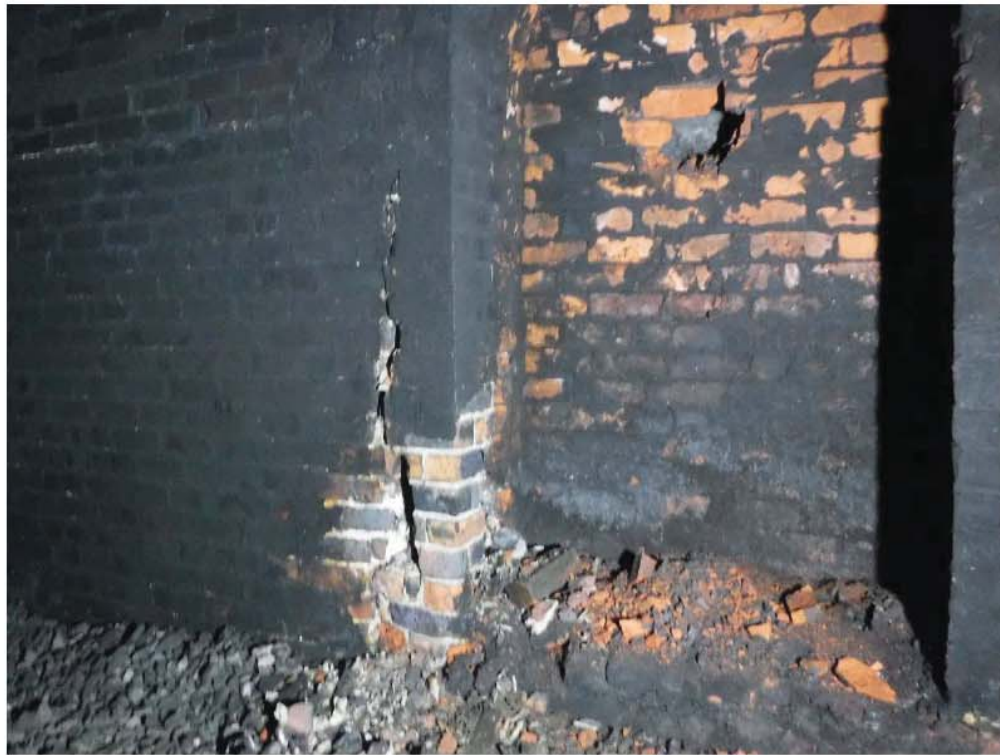
**Photo No.36:** 046+10 Refuge Down, Brickwork, spalling, depth 100mm, area 2sq.m., vertical fractures, length 1.6m to both Quoins, hollow.

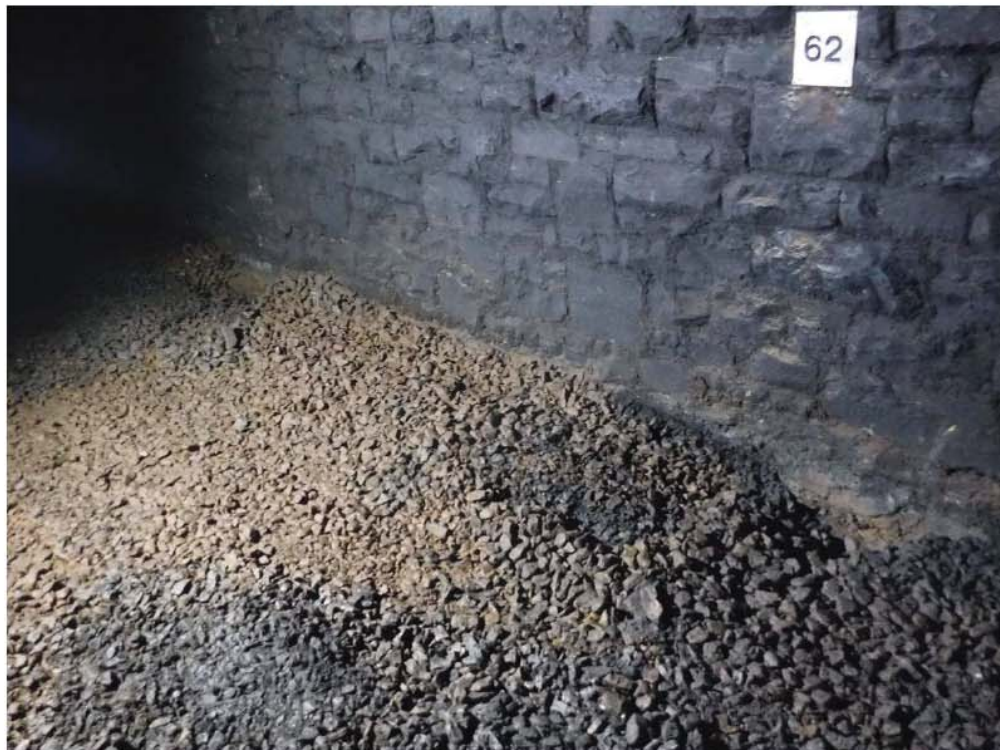
**Photo No.37:** 061+19 to 062+00 Solum Down, 2No. trial pits. Partially backfilled.

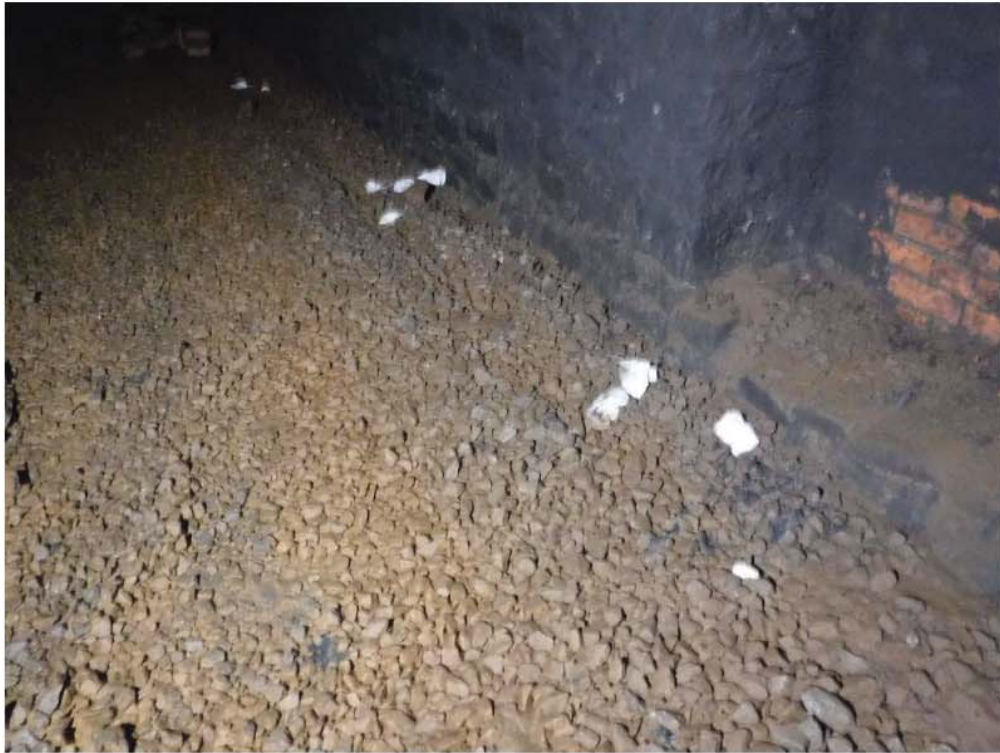
**Photo No.38:** 062+00 Solum Up, workman toilet waste, hazard.

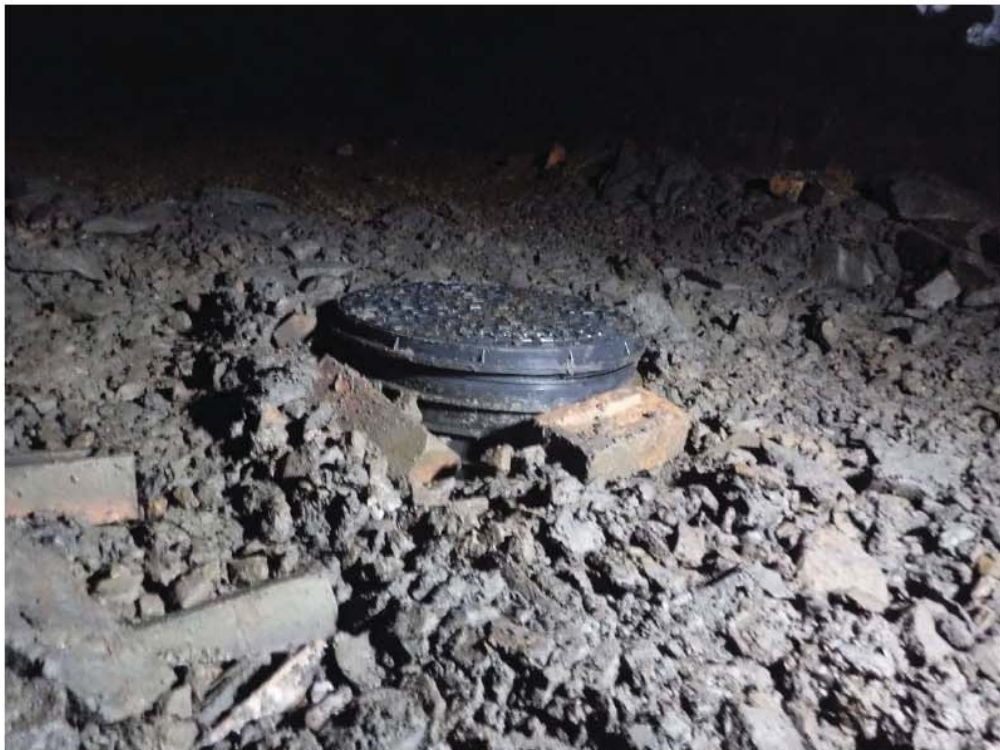
**Photo No.39:** 062+15 to 073+05 Solum Up & Down, drainage WIP, catch-pits and/or earthenware pipes broken out, new inspection chambers fitted proud on solum, hazard.

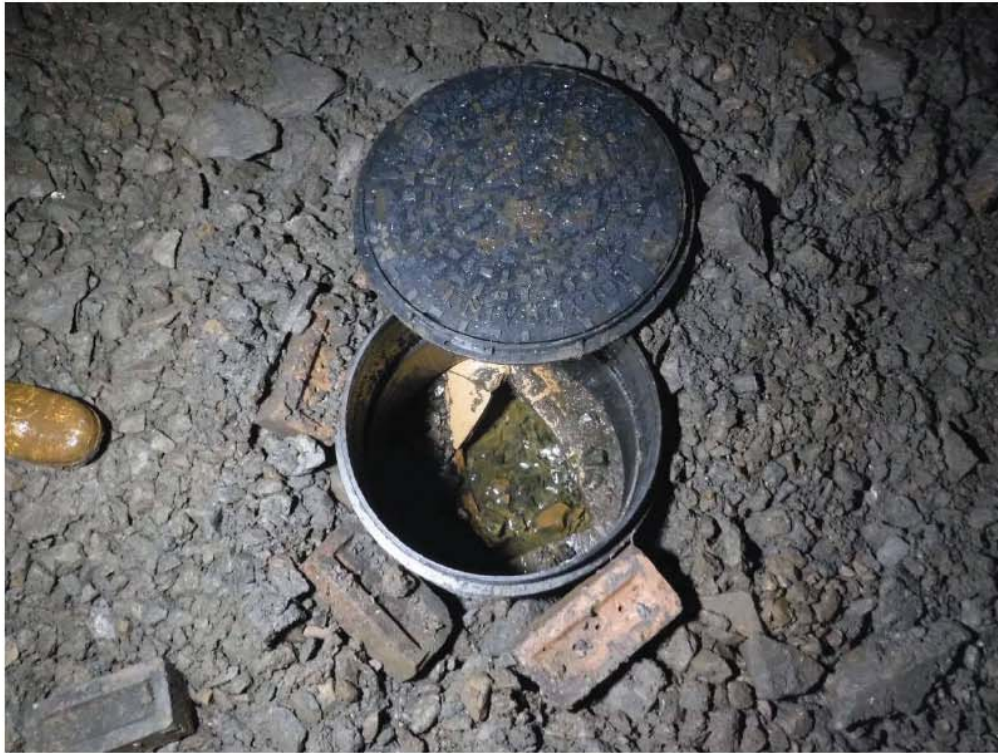
**Photo No.40:** 062+15 to 073+05 Solum Up & Down, drainage WIP, catch-pits and/or earthenware pipes broken out, new inspection chambers fitted proud on solum, hazard.

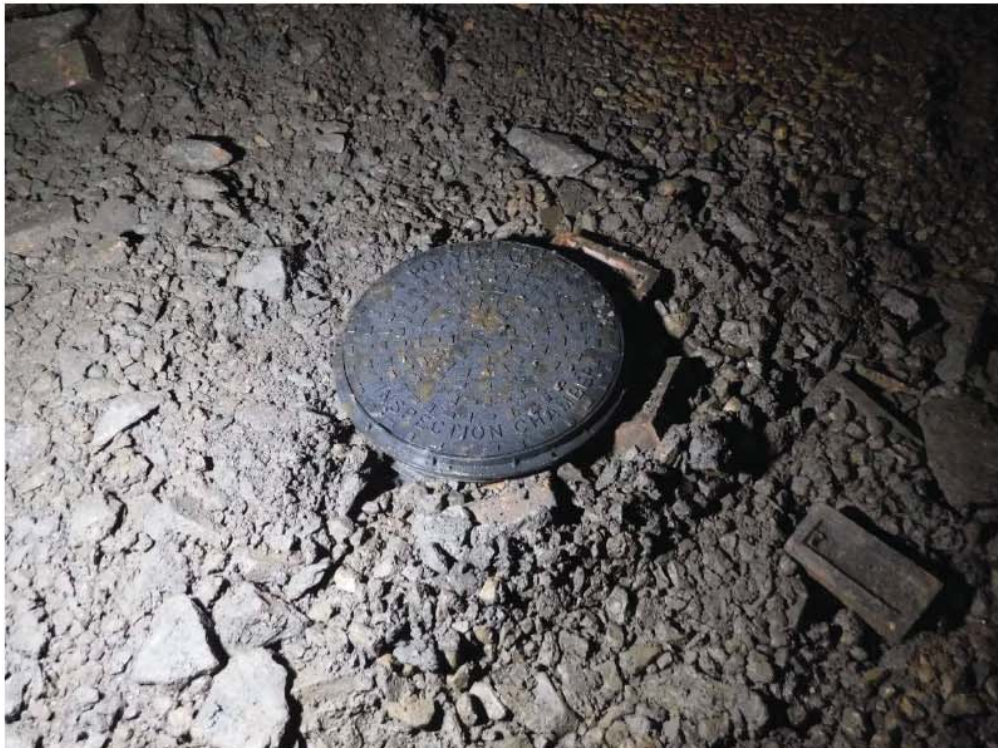
**Photo No.41:** 062+15 to 073+05 Solum Up & Down, drainage WIP, catch-pits and/or earthenware pipes broken out, new inspection chambers fitted proud on solum, hazard.

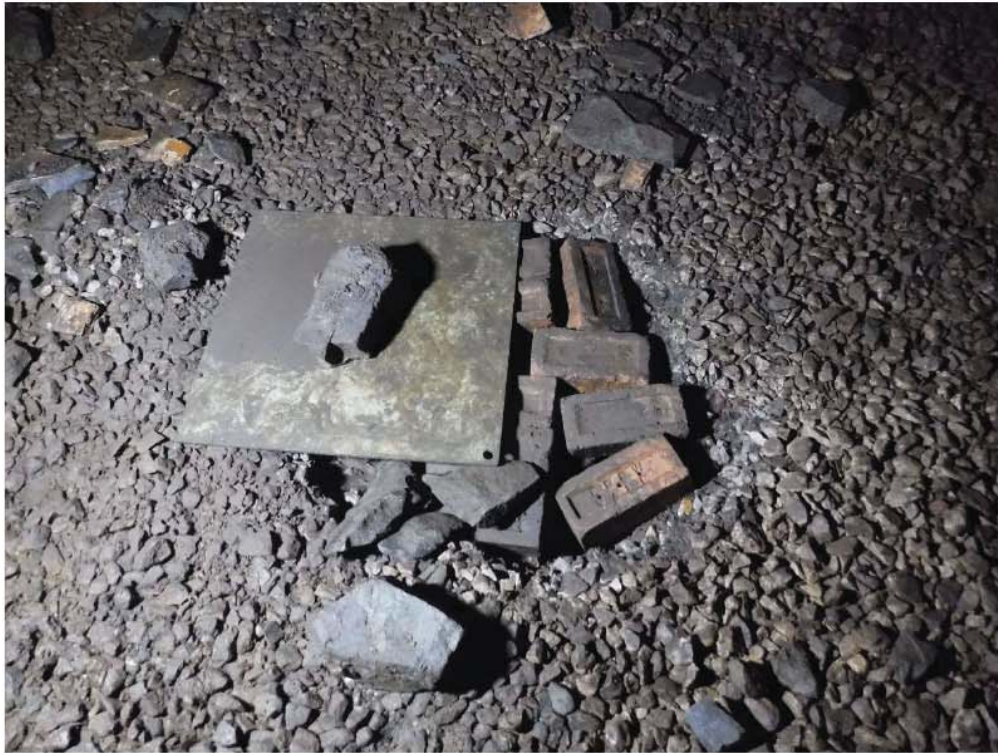
**Photo No.42:** 063+10 Solum Up & Down, Open catch-pit to six-foot with water welling up from inside. New cover fitted but displaced/ill-fitting. Now not surcharging.

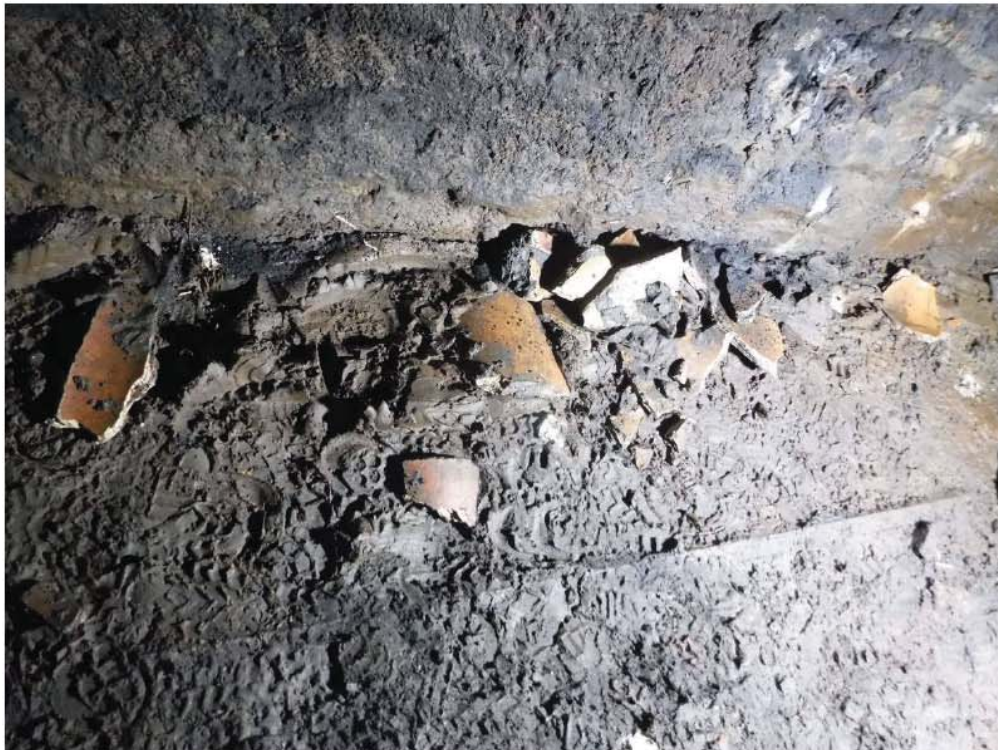
**Photo No.43:** Full length of tunnel, Solum Up & Down, drainage WIP, smashed track drainage pipes, poor underfoot conditions, hazard (typical example found at 071+11 cess down).

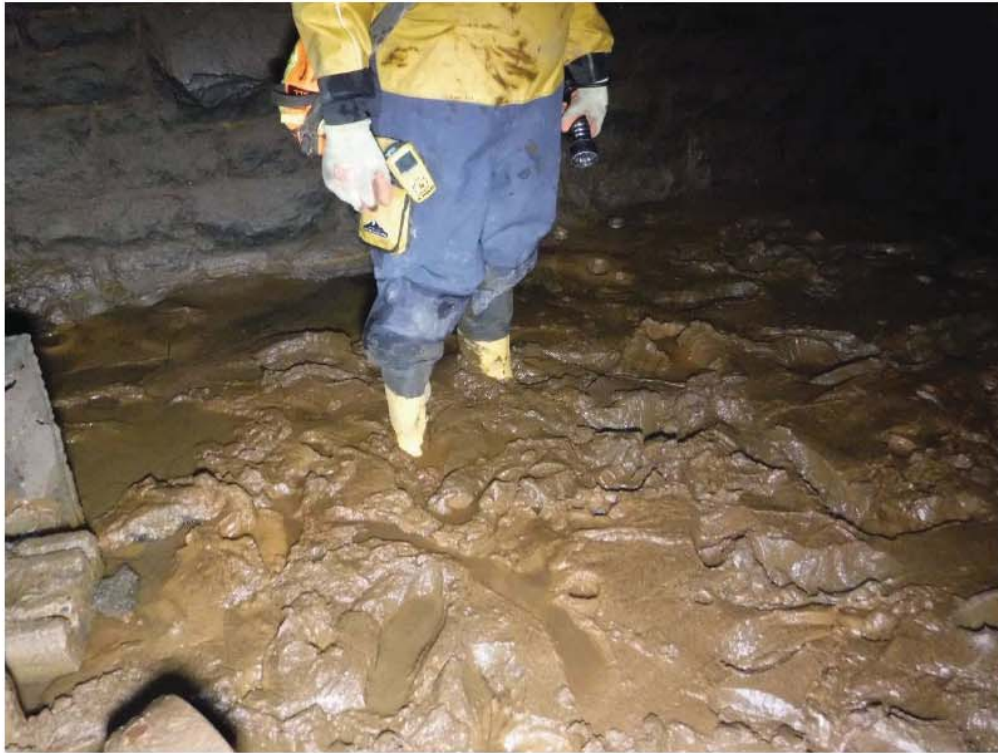
**Photo No.44:** 071+19 to 072+15 Solum Up & Down, Mud and flooding, depth 3".

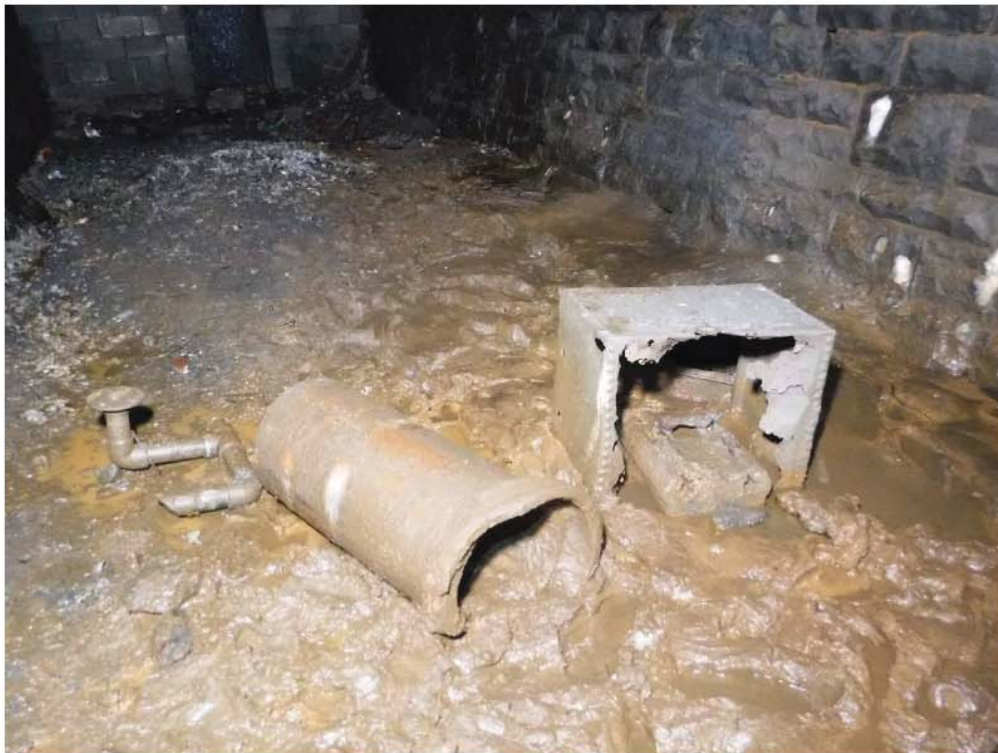
**Photo No.45:** 072+11 to 073+05 Solum Up & Down, Debris.

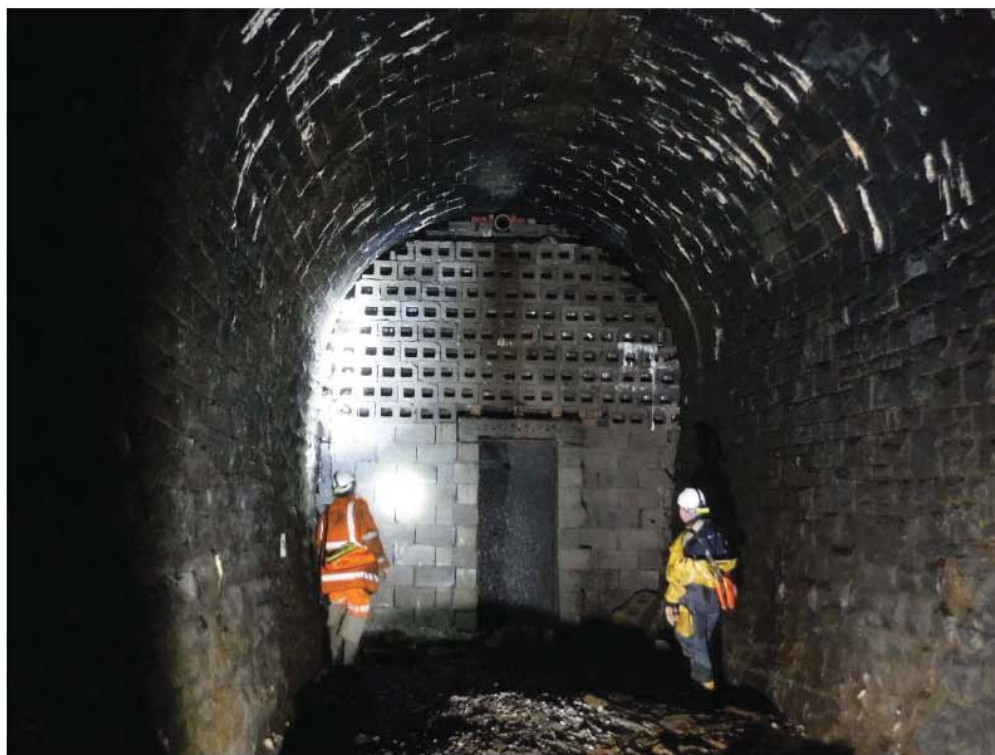
**Photo No.46:** 073+05 Portal Up & Down, View of blocked up Abergwynfi Portal from inside tunnel.
