# **Harbourside, NPT.**

## **Stage 3. Road Safety Audit**

*Design Completion of Works – “As Built.”*

*Report Reference No 000257*

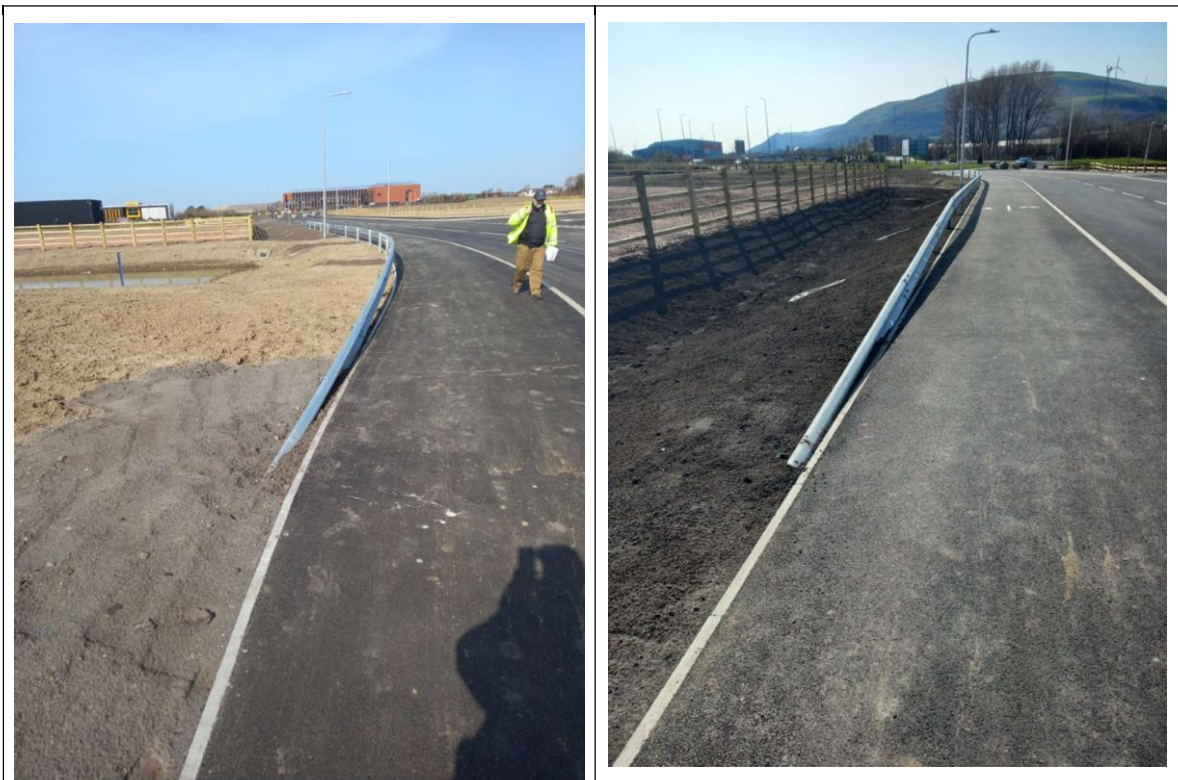
*Location of Problem*

#### 4.1.1 Problem 1 (Refer to Figure 6)

**Location:** Near side verge upon entry to the development.

**Summary:** Extent of and sloping end of safety fencing does not provide sufficient protection.

The extent of the safety fencing implemented is not sufficient to deter entry to the attenuation pond from the carriageway if a vehicle became errant off the entry radii, this is exacerbated by the sloping finish of the fencing detail provides a ramp effect for errant vehicles. Should a vehicle become errant at this point it could lead to serious or fatal type of injury.

It is recommended that The Designer re-examines the layout of the fencing detail to provide greater protection to the attenuation pond.

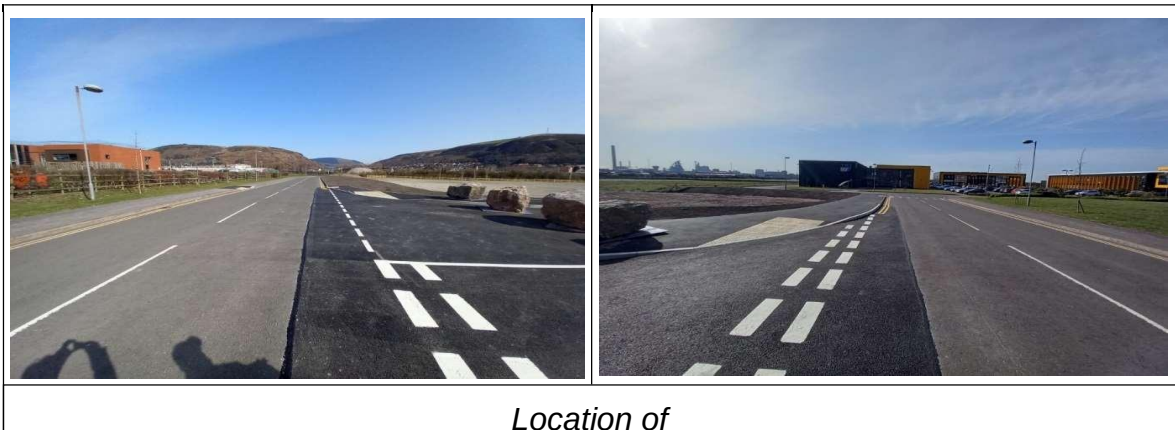
### 4.4.1 Problem 2 (Refer to Figure 6)

**Location:** T Junction between new access road and existing access road of industrial units.

**Summary:** *Lack of signing of cycle route.*

There is concern that the new shared route does not have any signage to provide continuity from the existing to the new route. Although the Audit Team have been made aware that it could be a year or more until occupation of the site is undertaken, if the route is to be utilised then it should be appropriately signed. If signing is not provided it could lead to vulnerable users taking an inappropriate direction to where no facilities are provided such as the peripheral distributor road to the south which could lead to collision with a vehicle resulting in serious or fatal injury.

It is recommended that – to address the problem without leading the designer and being too prescriptive. It is for the designers to address the problem raised.
