CYRCHFAN  
**WILDFOX**  
RESORTS

CWM AFAN  
AFAN VALLEY

# Arboricultural Impact Assessment

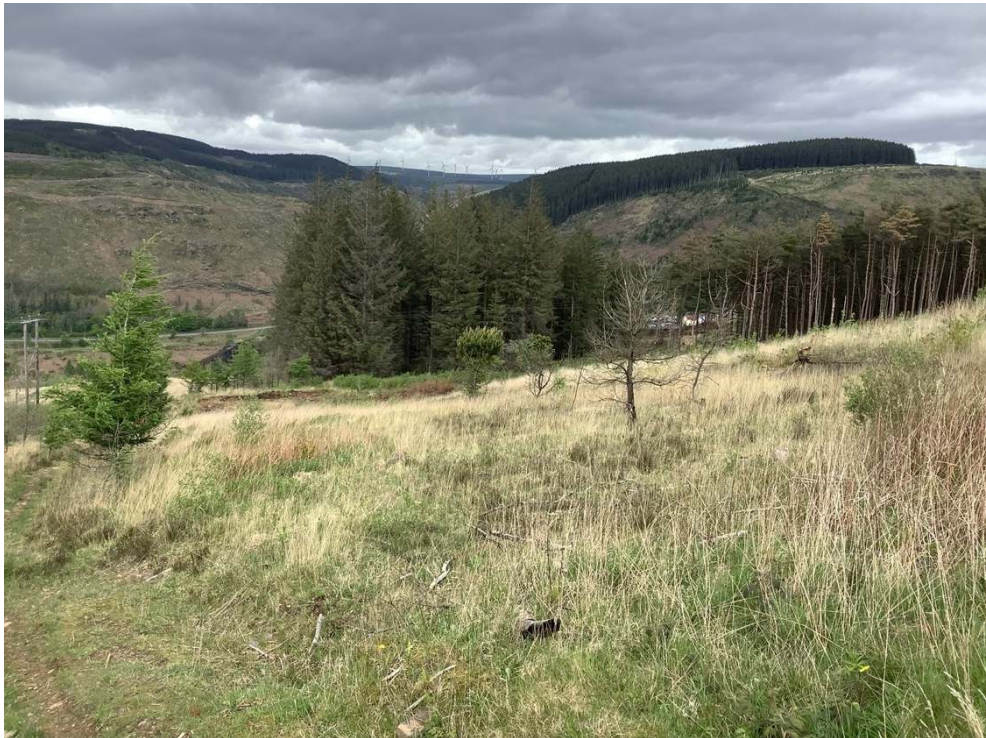
*Photograph 1:* Looking east towards woodland groups W2, W3 and W4 which were the major arboricultural features within the site.

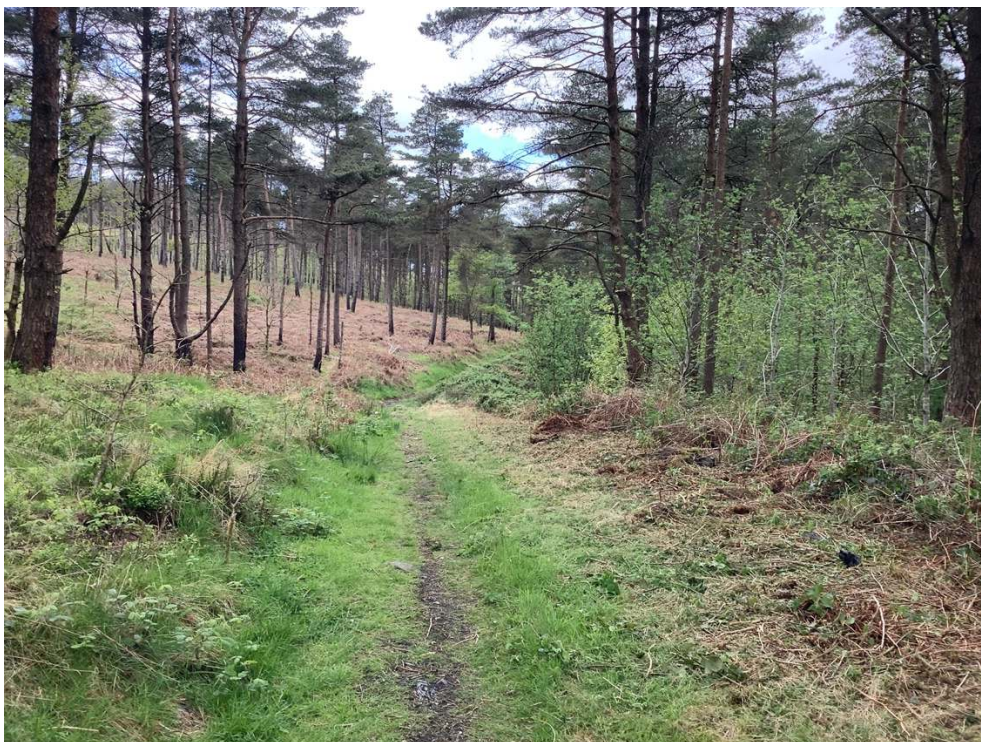
*Photograph 2:* Looking west along an existing forest track through wooded groups W2 and W3.

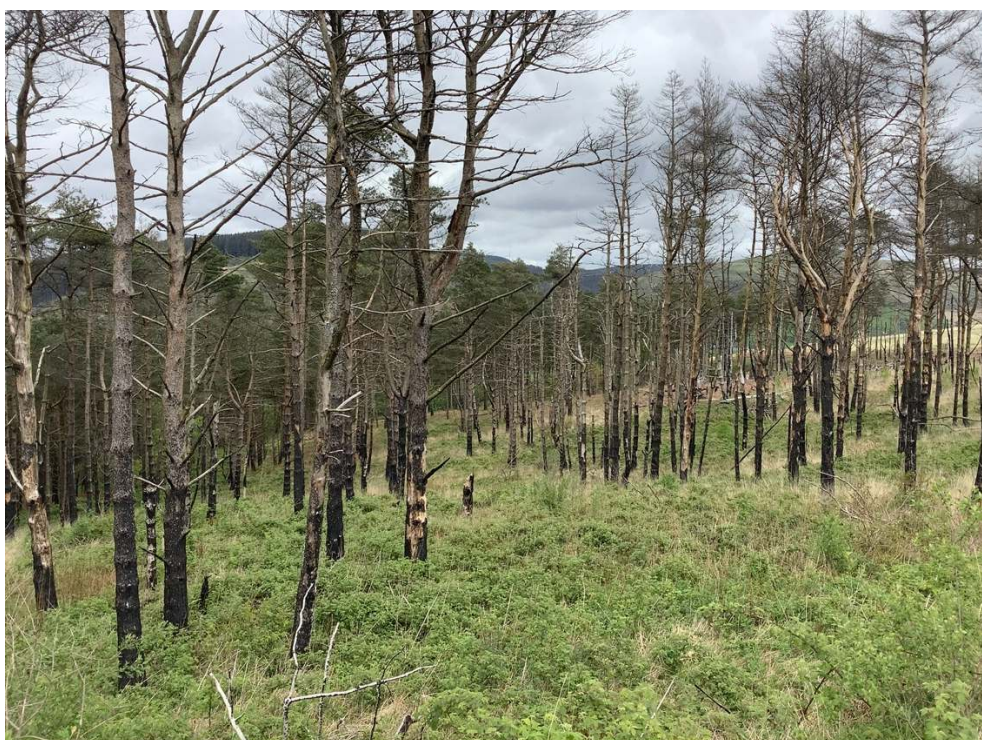
*Photograph 3:* Fire damaged woodland group W1 located to the south of moderate quality woodland W2. This group is recommended for removal.

| Woodland ID | Species | Height range in metres | Est | Est stem numbers | Max Stem dia in mm | Average radius in metres | Av canopy height in metres | Life stage | General observations | Preliminary Management Recommendations | Structural condition | Physiological condition | ULE | Quality grading | RPA radius in metres | RPA area in sqm |
|---|---|---|---|---|---|---|---|---|---|---|---|---|---|---|---|---|
| W1 | Scots pine, Willow, Oak | 5-16 | - | 100 | 450 | 3 | 10 | EM/M | Wooded area suffering from fire damage, many standing dead stems. | Remove dead standing stems and bolster with new woodland planting to increase species diversity. | Fair | Poor | <10 | U | 5.4 | 92 |

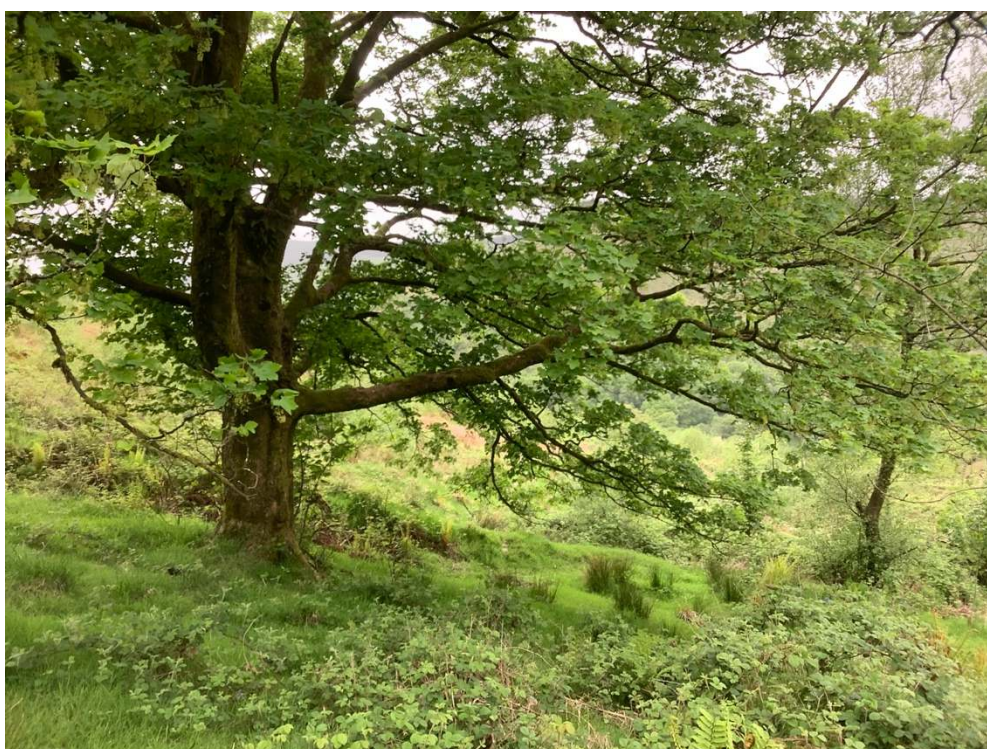
*Photograph 4:* Looking west towards moderate quality tree T21 located within the ‘plantation on ancient woodland’ area in the north of the site. This was located within a good collection of trees and is located away from the main construction area.
