# **ABBHEY PRIMARY SCHOOL, HEOL PENLAN, NEATH**

## **Stage 3 Road Safety Audit**

**JUNE 2022**

**DC-RDW-20-3061C-RSA3**

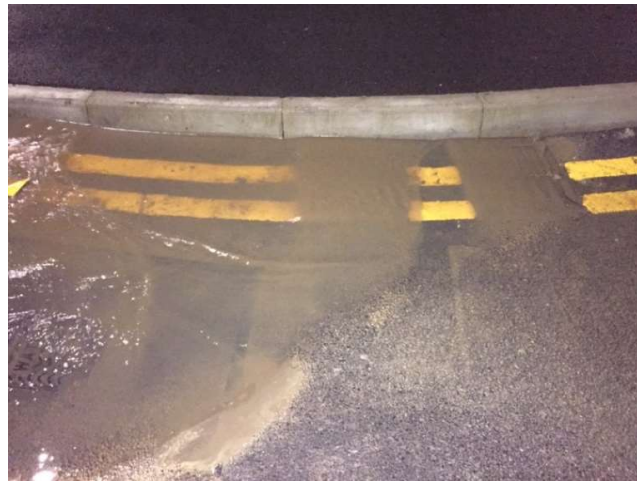
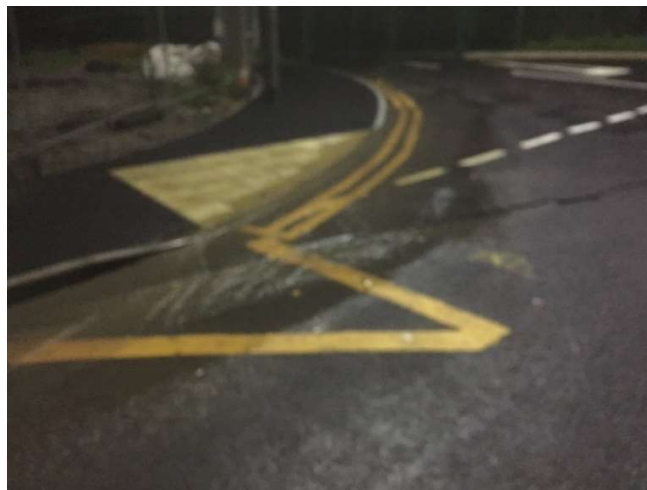
LOCATION: Vehicle access to school.

SUMMARY: Water discharging across and along the carriageway.

Due to earlier the heavy rain during the night time site visit, there was a lot of water which was escaping from either the twin gullies or from the chamber covers within the bell mouth, which may not be surface water sewers from examination of the drawing. This water could freeze and cause slip hazards or vehicles to lose control.

Prevent water from discharging from these chambers.
