## Tree Assessment 26/10/2022

9 PRINCESS DRIVE, BRYNCOCH - TTS/539

**Paul Hastings**

TENDERLEAF LTD | 19, HEOL Y NANT, RHOS, PONTARDAWE, SA8 3BX

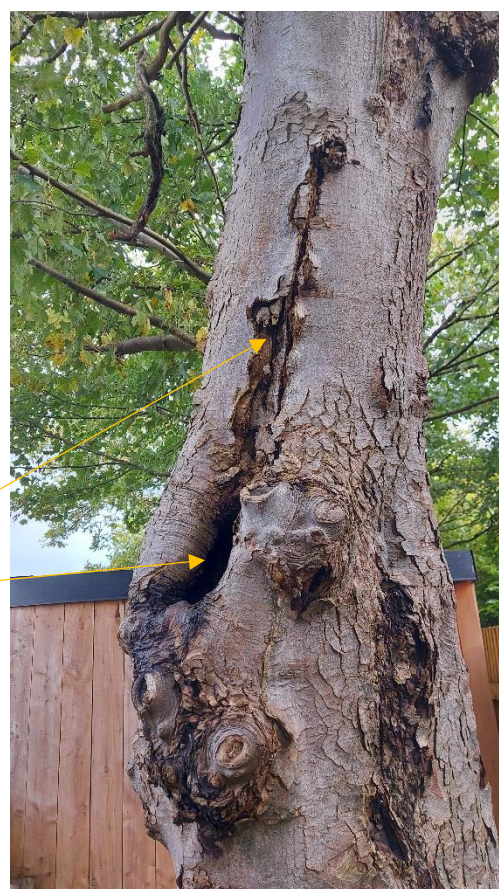
Photo 3 – Stem 2

There are multiple pruning points where epicormic growth has been pruned, and as a result infection seems to have entered. The largest pruning wound on the southern side of the main stem, has a formed a cavity with decay. The full extent of the decay is not clear however the addition of a vertical crack or line where the bark has submerged forming decay beneath, suggests the tree's compartmentalisation mechanism is failing.

Bark delamination stretches from approximately one metre and continues to around five metres. There are also several areas with an exudate bleeding from the bark as pictured below. The cause of this exudate is suspected to be bacteria based.

7.1 Using the information gathered above, including the risk analysis, it is clear to conclude that Stem 2 will require some intervention. Given the evidence it can be concluded that this tree's useful life expectancy has been significantly reduced by the onset of disease. Measures such as crown reduction or pruning would not sufficiently improve or mitigate the issues and so tree removal is recommended as the only viable option instead. This will enable the neighbouring stem to fill out and become more symmetrical over time.

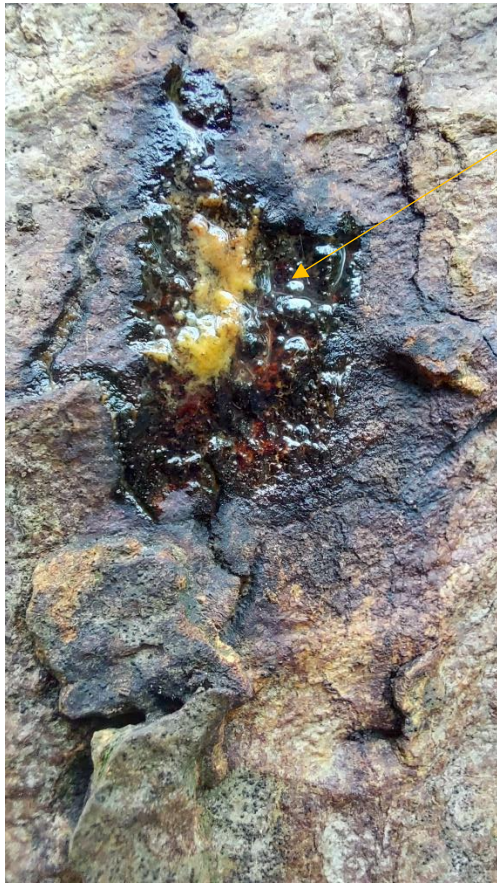
Many branch unions throughout the tree are affected by a cankerous growth. It is not clear to what degree this canker is affecting the stability of the unions.

Exudate

Cankrous growth around unions with further bark discolouration.

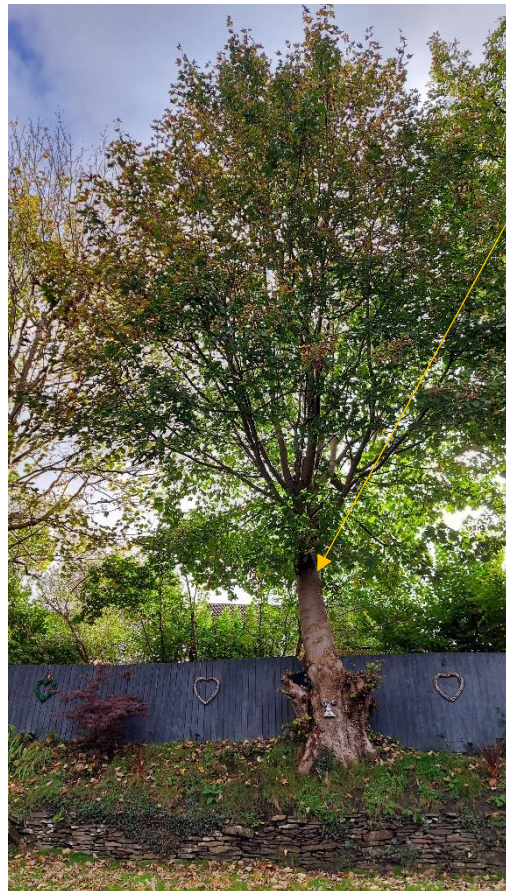
Photo 6

Larger diameter historic pruning points have developed decay that because of their location will decrease the strength of the union, reducing the development potential for retained branches.

Tree 2

Although Tree 2 is not requiring works urgently, there are indications of decay and reaction to historic pruning attempts. It would therefore be advantageous to carry out a crown thin of approximately 20%. This will allow the wind to pass through the crown with more ease thus relieving some of the wind sail effect. As well as reducing the windsail effect, crown thinning can also allow more sunlight to pass through, improving the association between the tree and its owner.

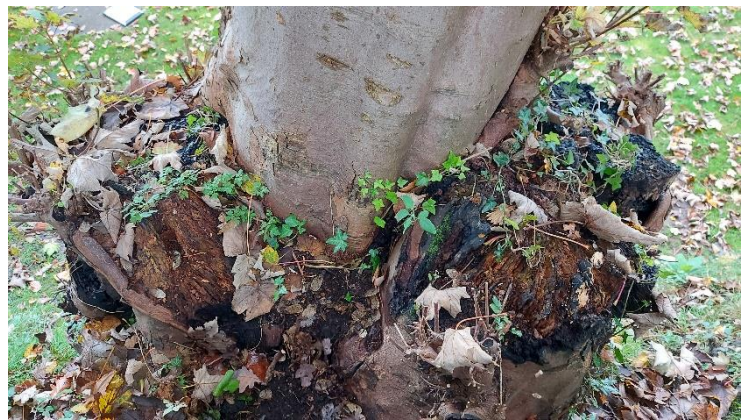
Approximately 4 rather significant stems have been removed from around the base of the retained tree. The stumps from these old stems are now decaying away.

The tree has undergone some significant management around 5-6 years ago. It appears the central, apical leader has been removed and the large wound as a result has developed quite significant decay. The replacement apical leader is now reliant upon the decayed union. Other pruning points have developed vigorous reaction growth, creating an overly dense crown.

Photo 7 – The pruning wound at the base of Tree 2
