## **BRE365 Infiltration Testing For:**

Y Boblen

24 Bryn Road,  
Cwmllynfell,  
Swansea,  
SA9 2FJ

**DATE:** 27.10.2021

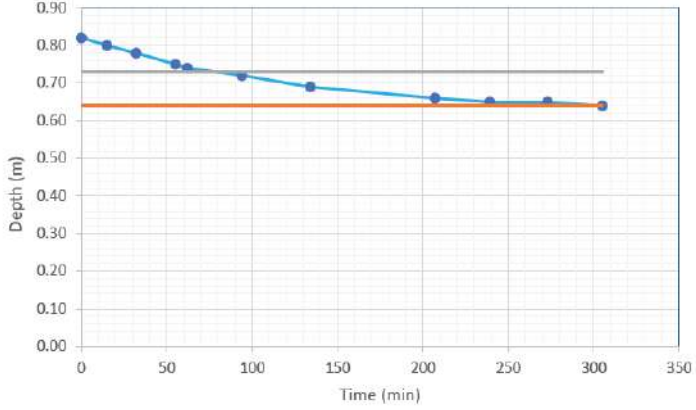
| <b>Effective depth</b> | 0.9 | <b>Comments:</b> | Water at bottom of pit before testing 30cm deep | |

| Test No. | Time (min) | Depth (m) | | |
|---|---|---|---|---|
| | | | f = | 4.93E-06 m/s |

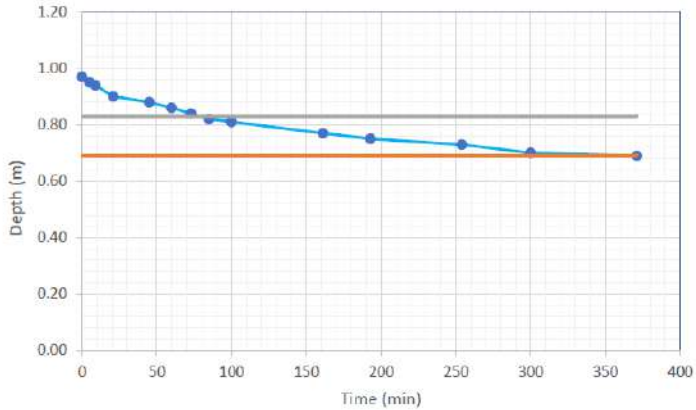
| <b>Effective depth</b> | 1.1 | <b>Comments:</b> | Water at bottom of pit before testing 32cm deep | |

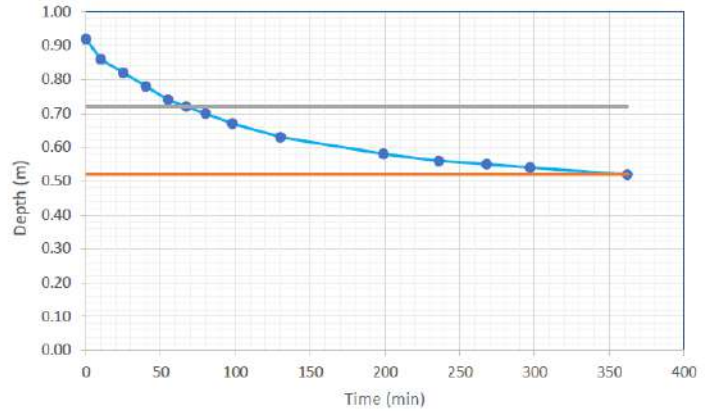
| <b>Total depth of hole</b> | 1.1 | <b>Comments:</b> | Water at bottom of pit before testing 32cm deep | |

| Test No. | Time (min) | Depth (m) | | |
|---|---|---|---|---|
| | 362 | 0.52 | f = | 6.46E-06 m/s |

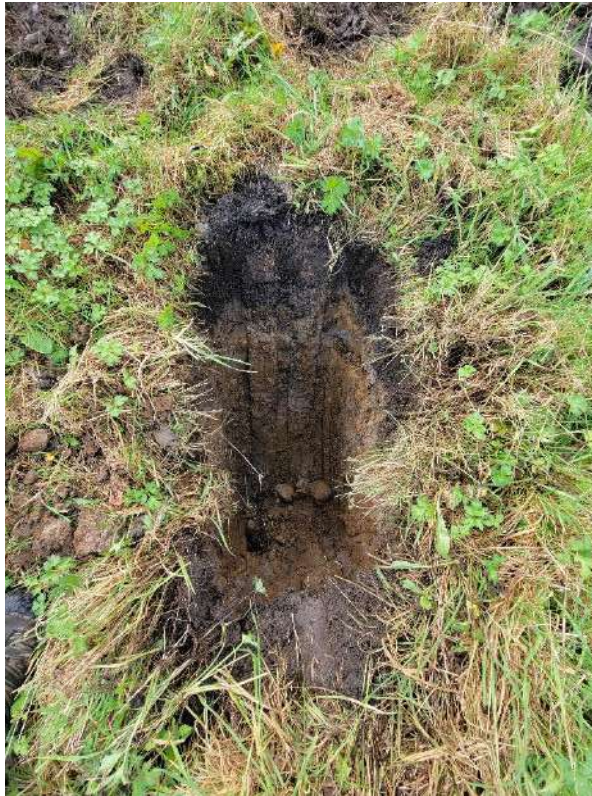
**Picture 1** – *Test Pit 1 Soil Strata. No water at base*

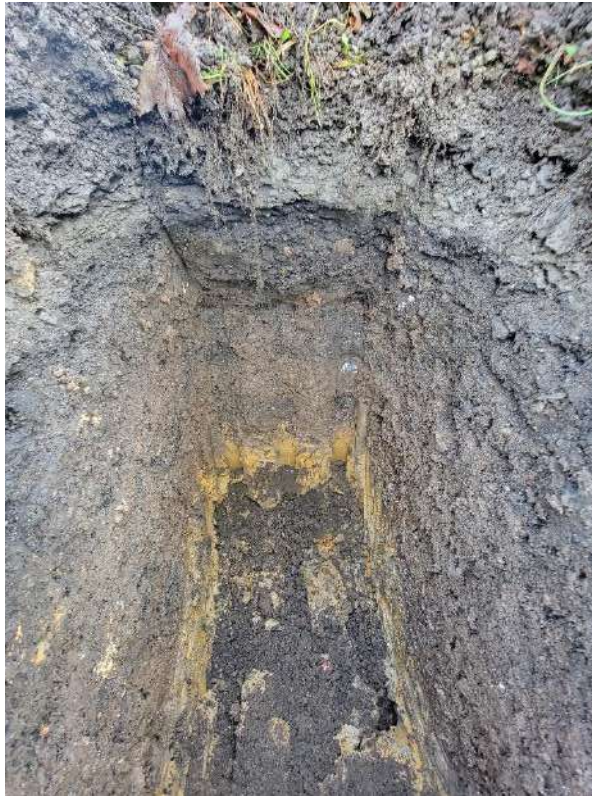
**Picture 5** – *Test Pit 2 Ground Strata's*

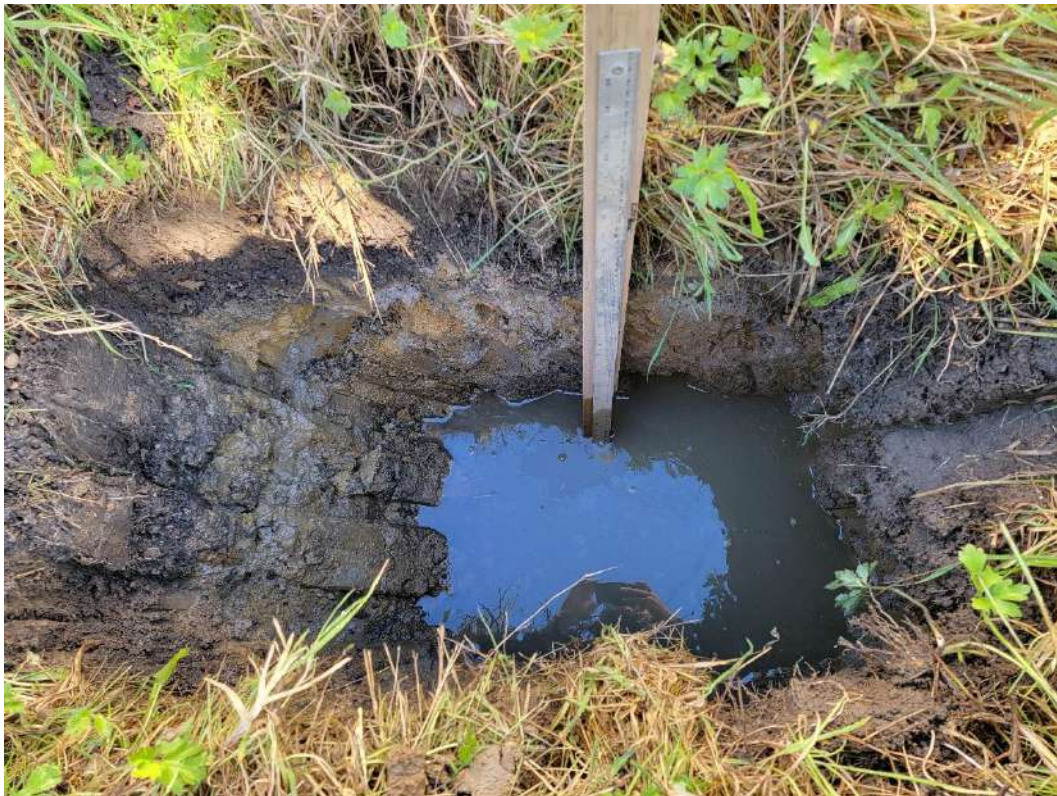
The ground was found to have a light red brown silty clay strata with build-up made ground along the eastern boundary. The test pits were dug on the 20<sup>th</sup> of October at which point ground water was not present. The following day when the pits were tested, approximately 30cm of water was found in the base of all 3 pits. Each pit was tested once and did not sufficiently drain in the day allowed to produce an accurate reading to the BRE 365 digest standards.

**Picture 6** – *Condition of Test pit 1 the morning of testing following heavy rain.*

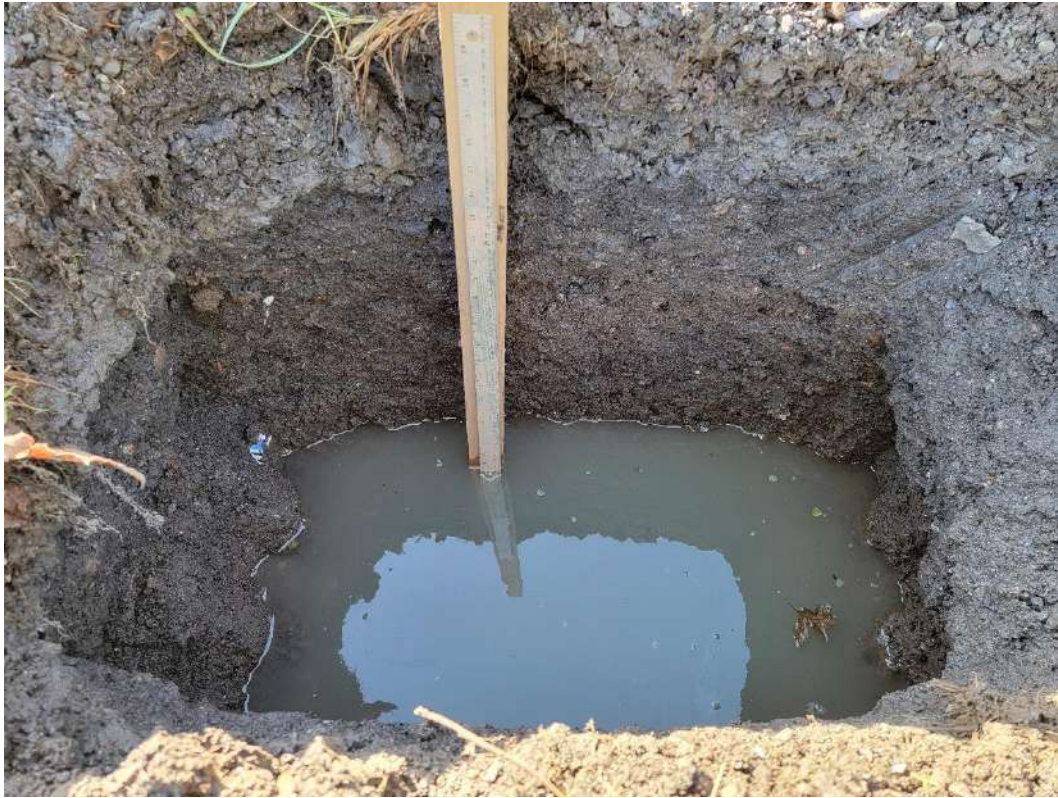
**Picture 7** – Condition of Test pit 1 the morning of testing following heavy rain.
