Land Adjacent Neath Abbey Road  
Abbey Road Industrial Estate,  
Neath.  
SA10 7BR

**Load Assessment on Existing Steel Framed Buildings**

For  
Huw Jenkins

| <b>Date:</b> | 14 <sup>th</sup> November 2022 |

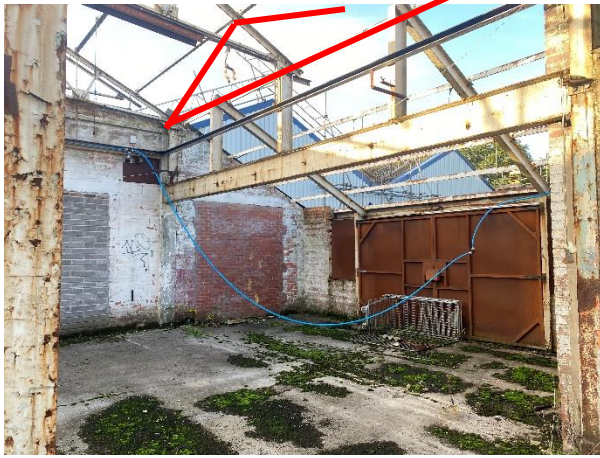
Photo B1- D1 – Bracing required

9. Additional roof bracing required between gridline 8 and 10 (restraint required)
10. Strengthen or replace purlins to valley with building 2
11. Lower cladding rail badly corroded and should be replaced

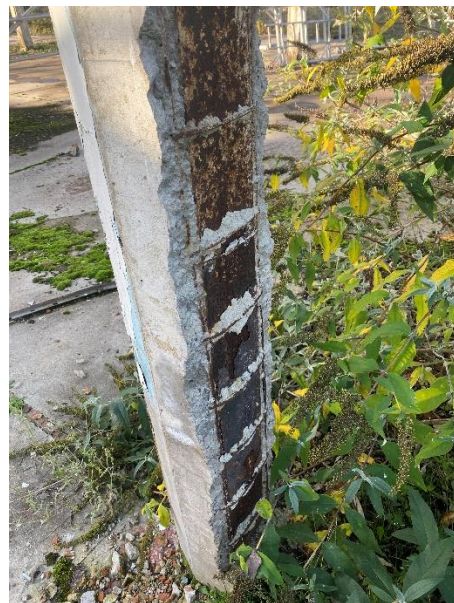
Photo B1- D2 – Concrete encasement spalled

1. Bent ends to truss rafters to be straightened
2. Concrete encasement to beams damaged (remove or repair)
3. Check steel beam connections to gable ends and provide cross bracing if necessary to replace masonry shear walls which are now removed.

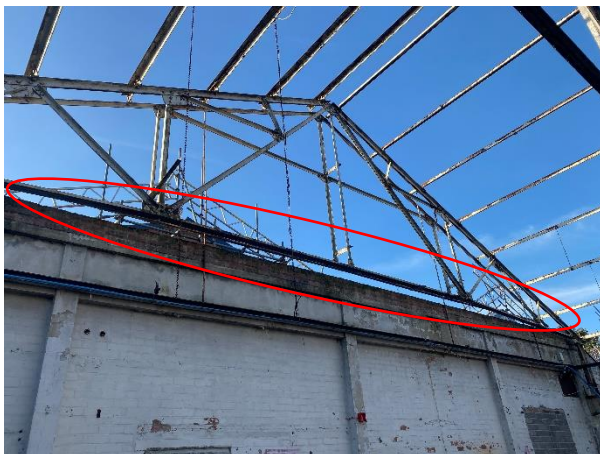
Photo B1- D3 – Unrestrained bottom edge of  
gable wall truss member

4. Paint flaking and light corrosion, requires blasting clean and repainting
5. Better restraint to gable truss bottom chord to resist wind loads in GL 10 (above neighbouring roof level)

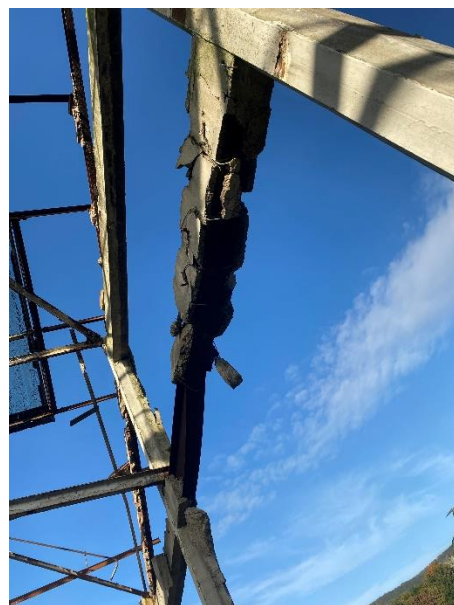
Photo B1- D4 – Damaged and missing concrete  
encasement

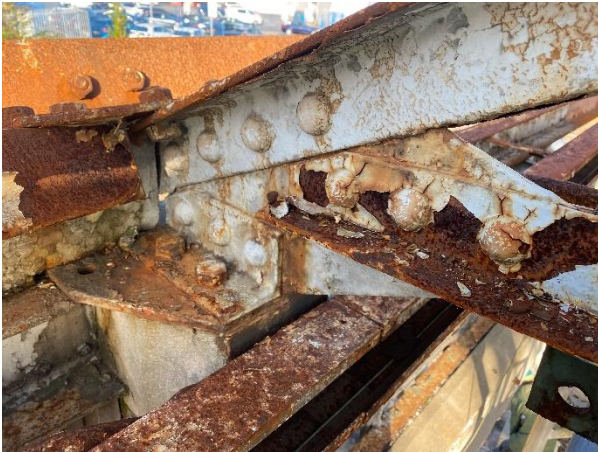
Photo B1- D5- Truss end connection – Typical spalling paint and light corrosion

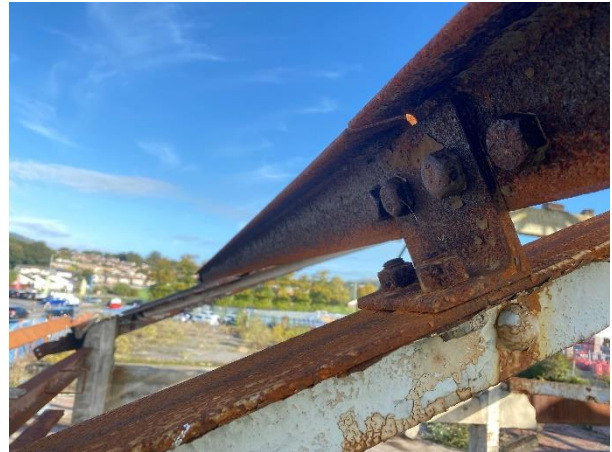
Photo B1- D6- Corrosion to purlins and truss

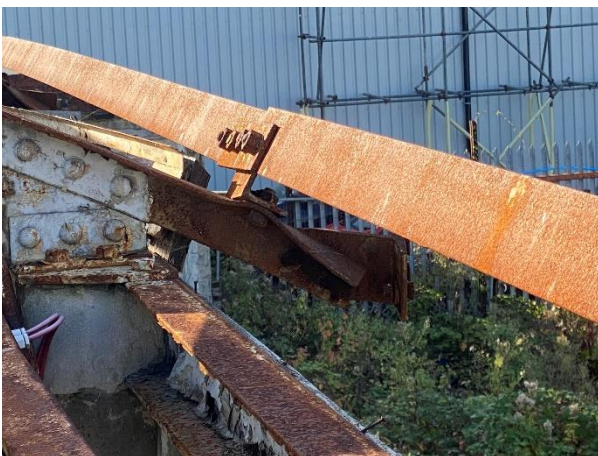
Photo B1- D7- Twisted end to truss

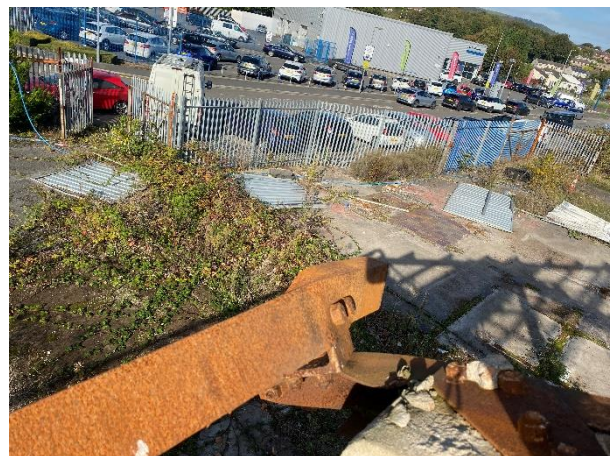
Photo B1- D8- Twisted end to purlin

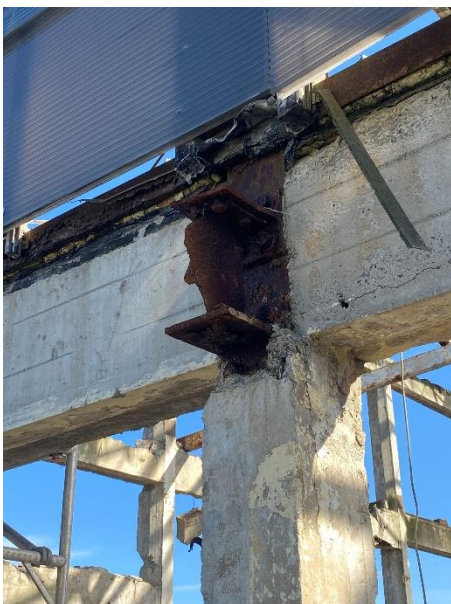
Photo B1- D9- Canopy member not fully removed

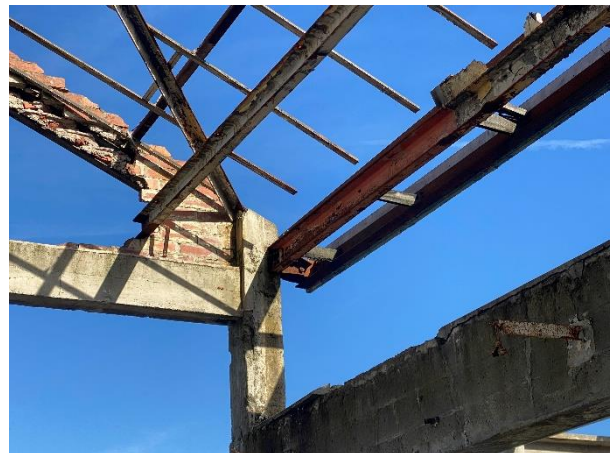
Photo B1- D10- Masonry infill still part in place

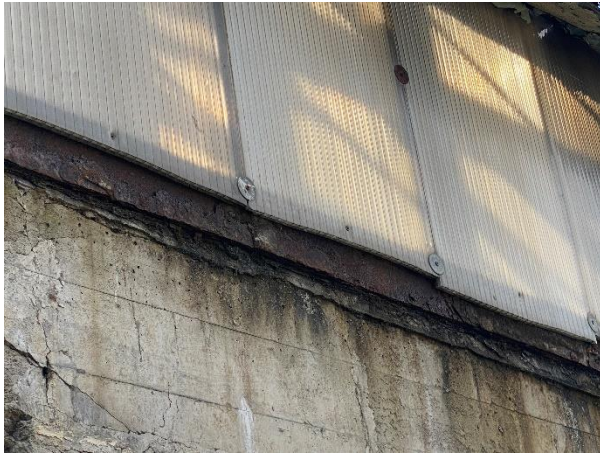
Photo B1- D11- Corroded bottom cladding rail

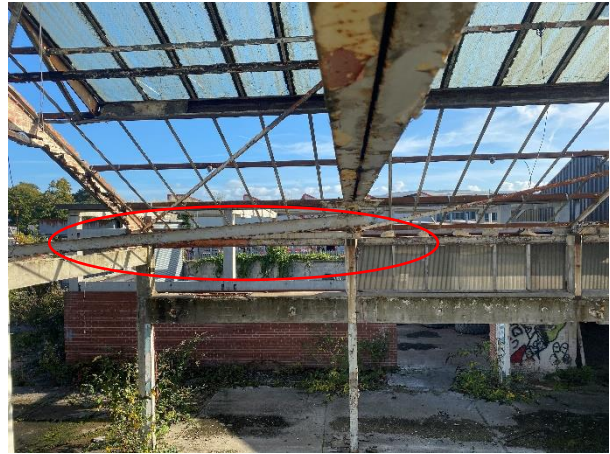
Photo B1- D10- Redundant steel beams to be removed circled in red

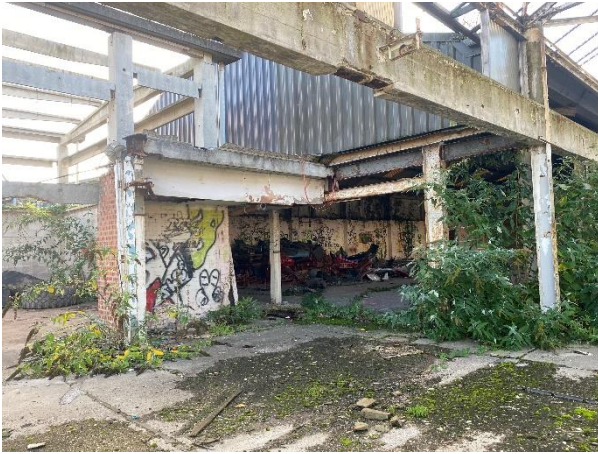
Photo B2- D1 – Redundant structure attached to frame

1. Roof sheeting outer face corrosions has started. Consider replacing or over cladding
2. Remove redundant structure attached to frame
3. Remove vegetation along boundary wall. Some vegetation appears to be Japanese Knot weed which will need continuous monitoring and treatment
4. Masonry repairs to boundary wall on gridline I
5. Replace the missing eaves beams
6. Consider a cross tie member between building 1 and 2 to improve lateral deflection and ensure the shared gutter does not pull away from building 1
7. Clean all previously painted steelwork and repaint as necessary

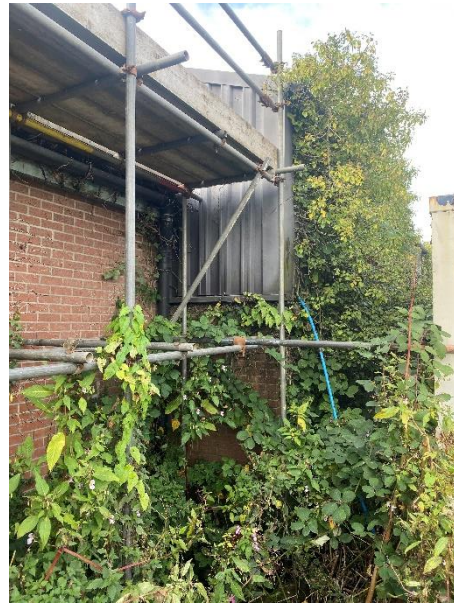
Photo B2- D2 – Heavy vegetation along boundary wall

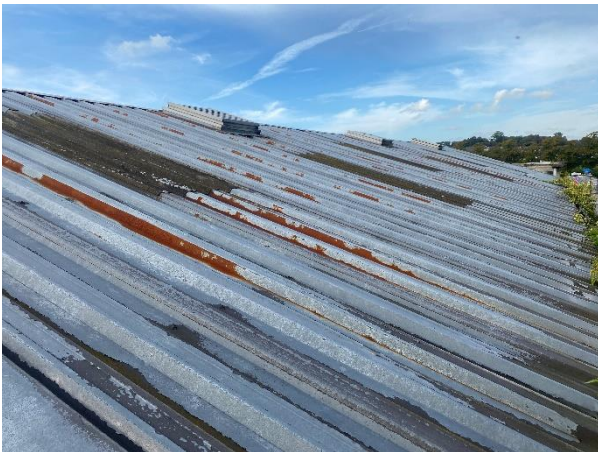
Photo B2- D3 – Corrosion to steel sheets. Paint system is failing

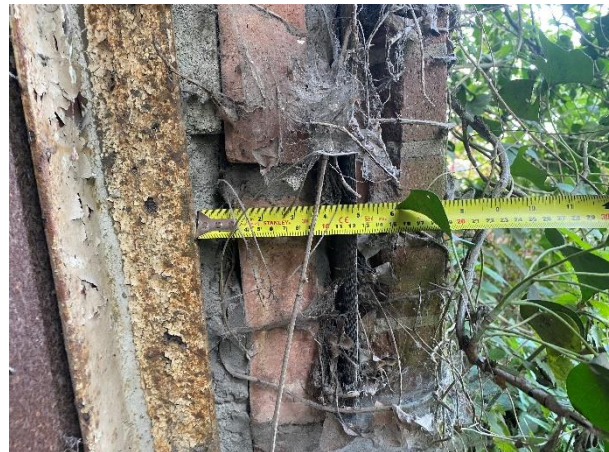
Photo B2- D3 – Masonry repairs to emergency exit on gridline I

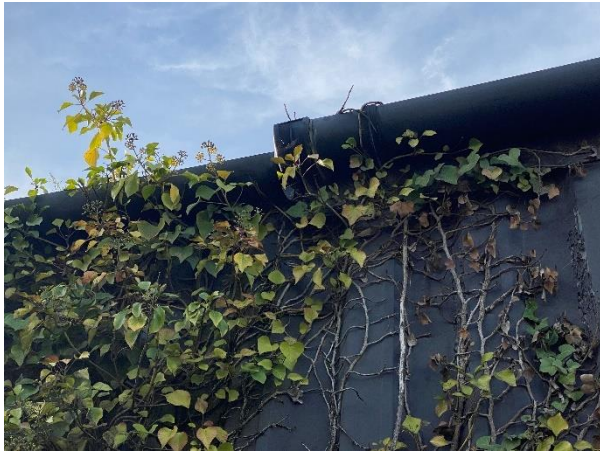
Photo B2- D4 – Gutters to be repaired on gridline I

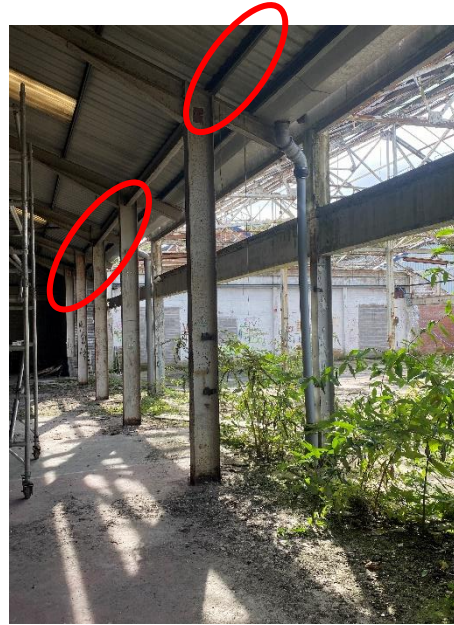
Photo B2- D5 – Missing eaves beams

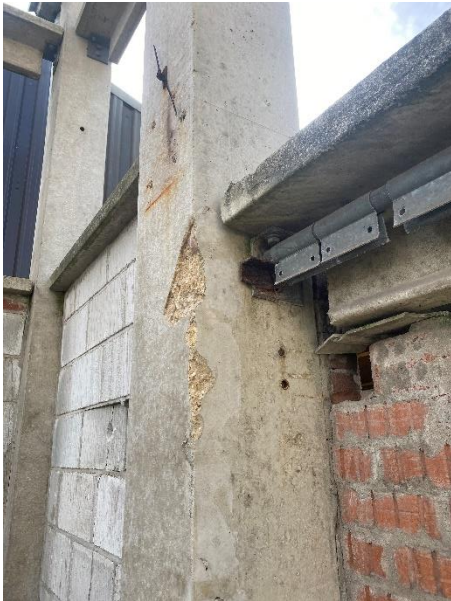
Photo B3- D1 – General minor damage to concrete elements

1. New cladding
2. Concrete repairs to columns and beams
3. Steel rail and cladding repairs to entrance canopy
4. Masonry repairs to inner leaf of wall
5. Perimeter drain to external wall areas where slab level externally is similar to internal levels
6. Replace lining to gutters and down pipes

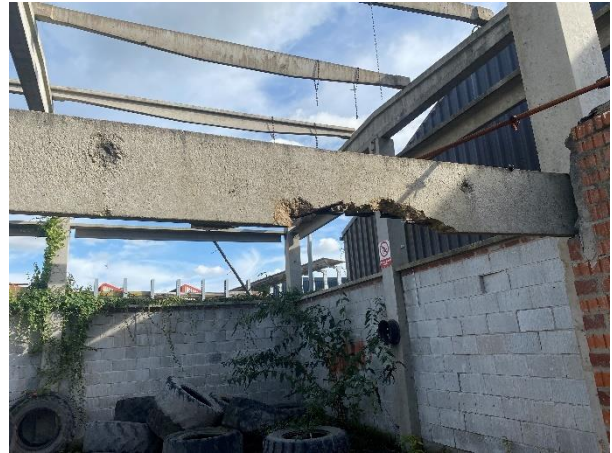
Photo B3- D2 – Impact damage to side entrance door head cladding rail on gridline J

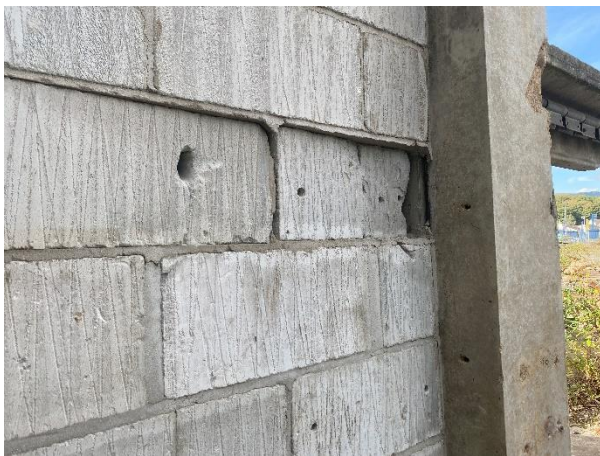
Photo B3- D3 – Impact damage to masonry infill panels

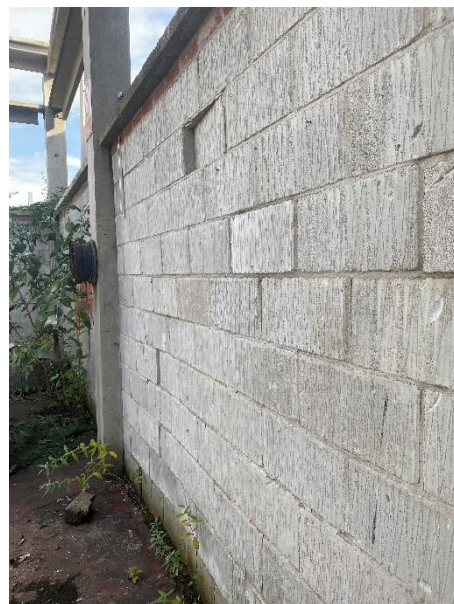
Photo B3- D4 – Further impact damage to masonry panel on GL 4

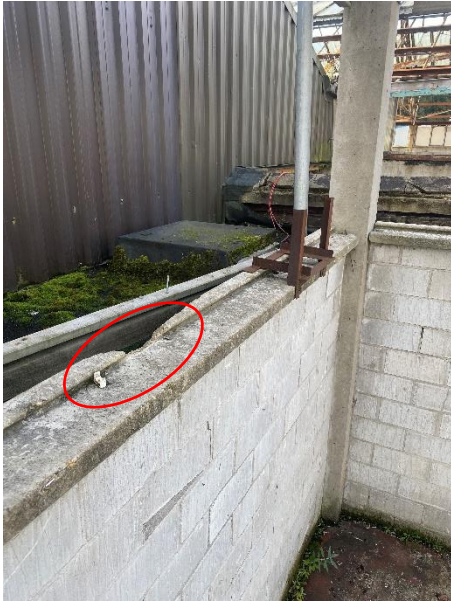
Photo B3- D5 – Spalled 'lip' to cladding rail

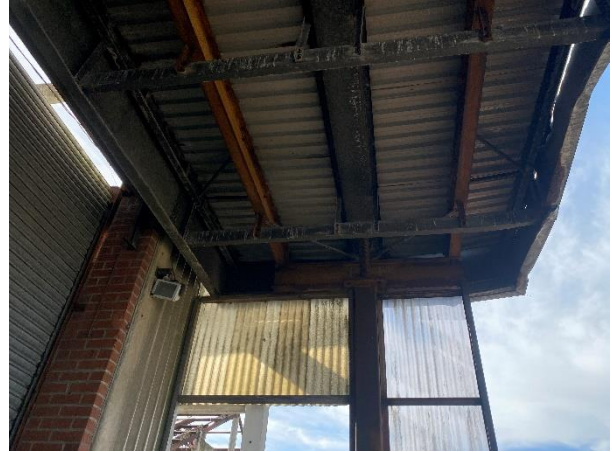
Photo B3- D6 – Impact damage to canopy
