ELR: VON

Contract Mileage: 035m 0468yds 21.27chs

Struc. Ref: 3521.25

Bridge Detailed Examination Report

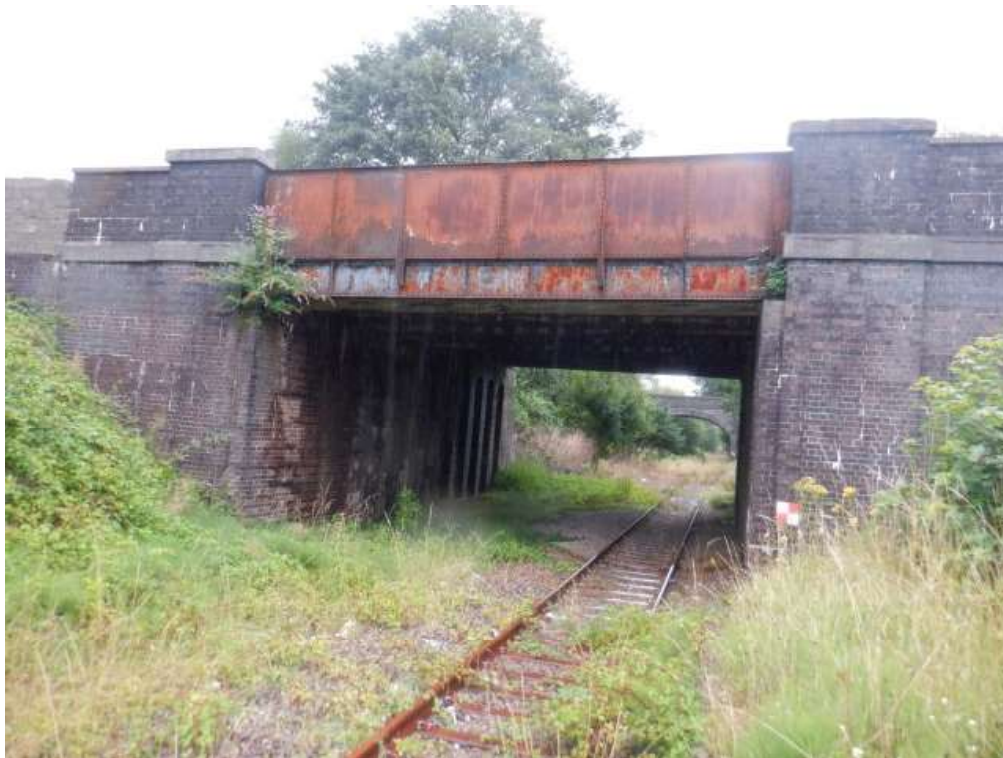
**Photo 2: High Mileage Elevation (07.08.21)**

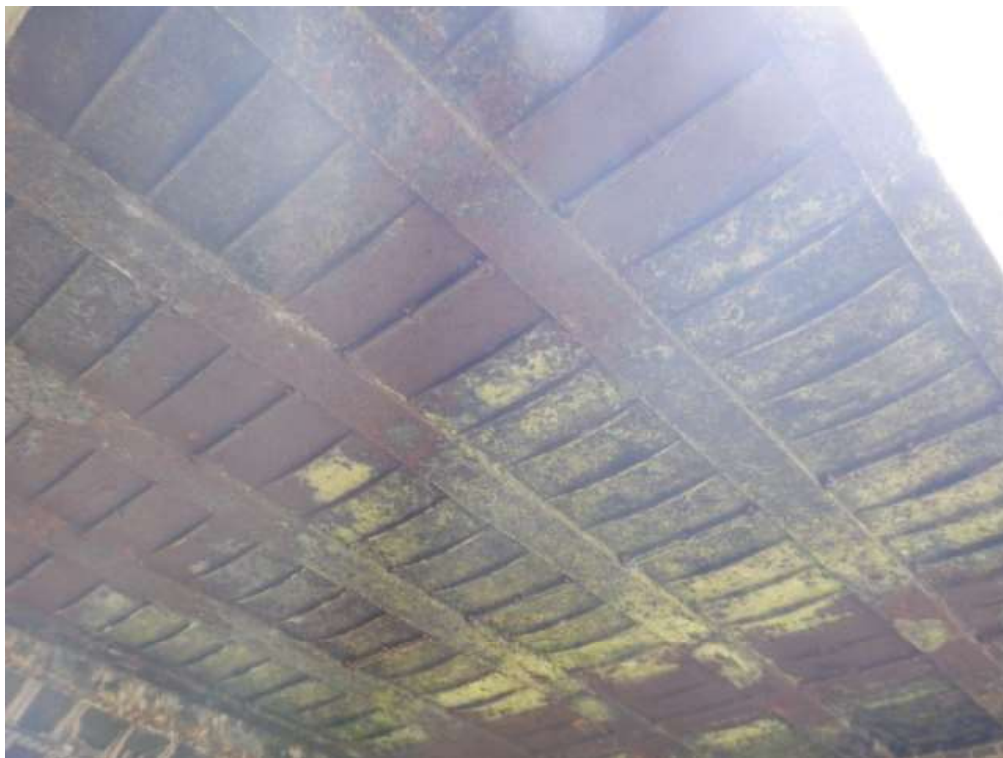
**Photo 3: Low Mileage Deck View (07.08.21)**

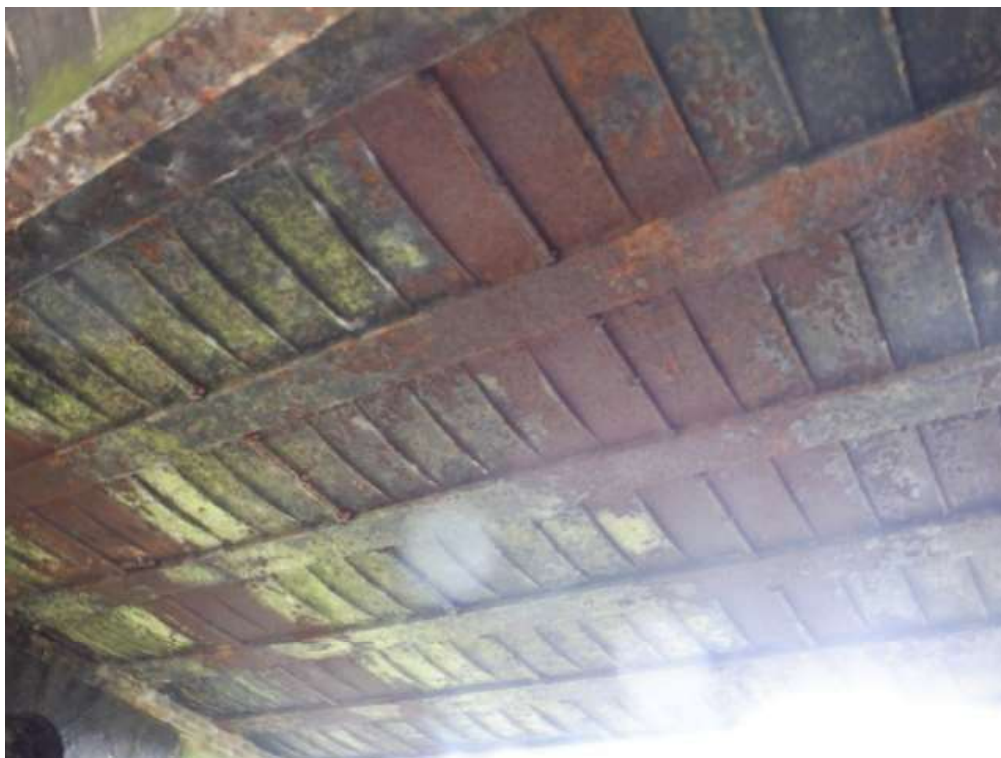
**Photo 4: High Mileage Deck View (07.08.21)**

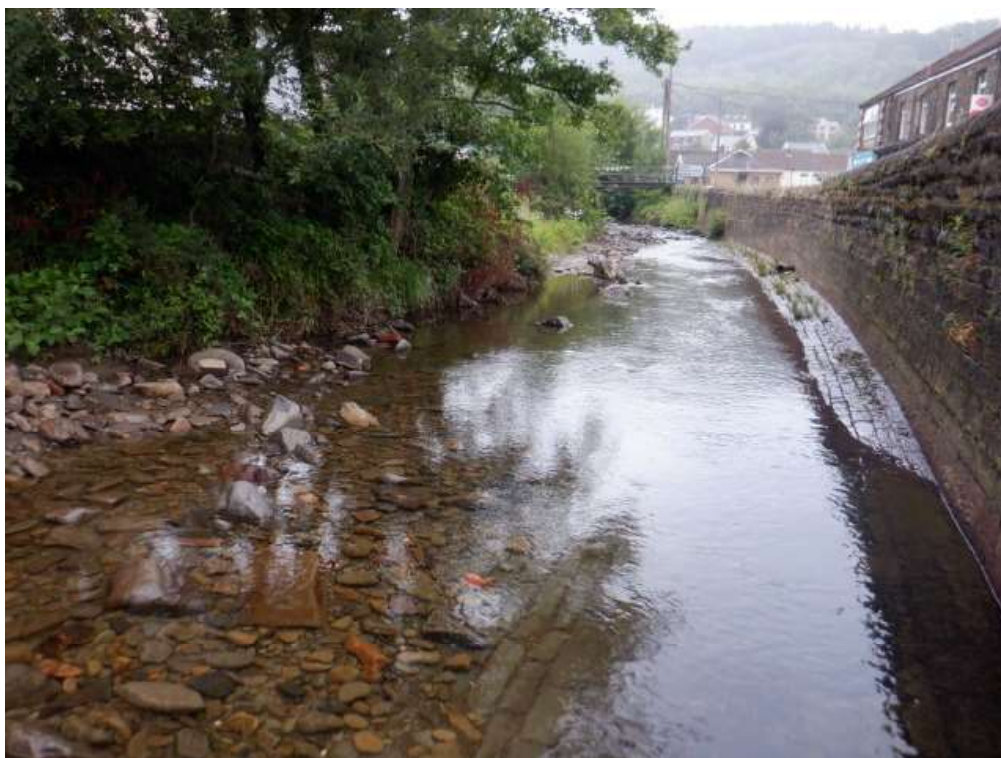
**Photo 5: Upstream View (07.08.21)**

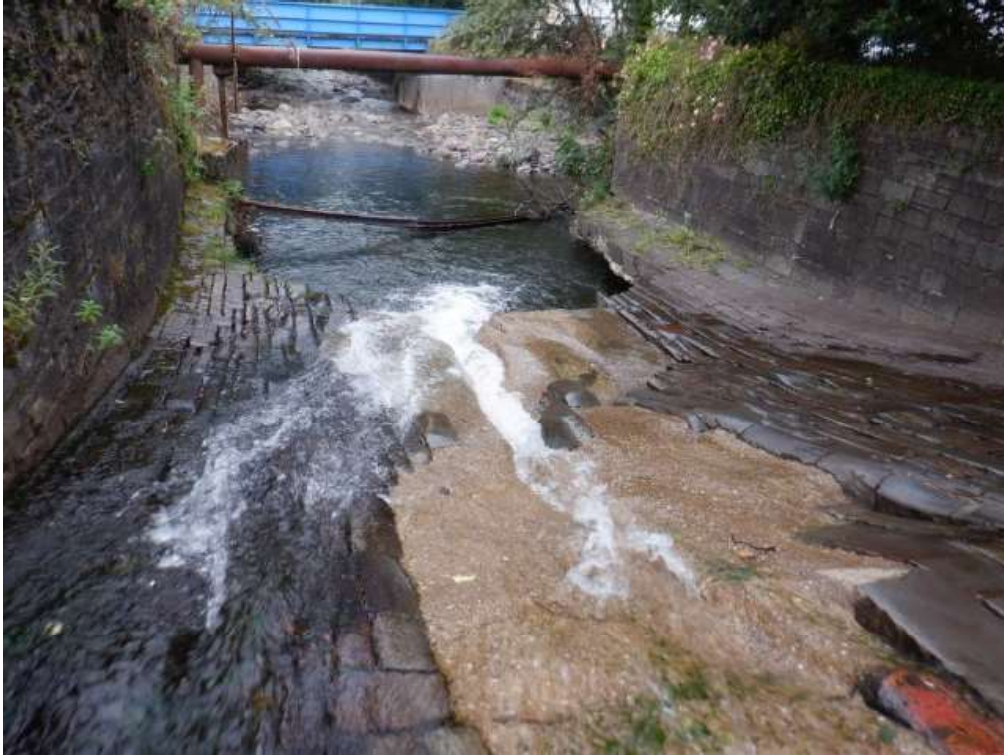
Photo 6: Downstream View (07.08.21)

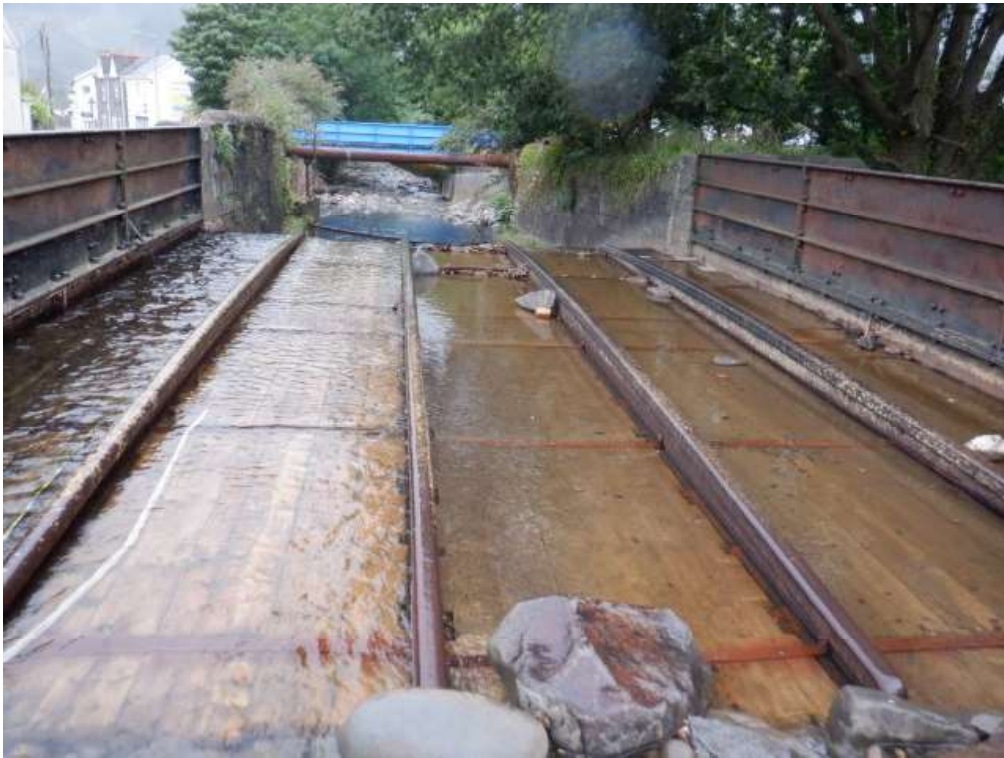
Photo 7: View Over Top (07.08.21)

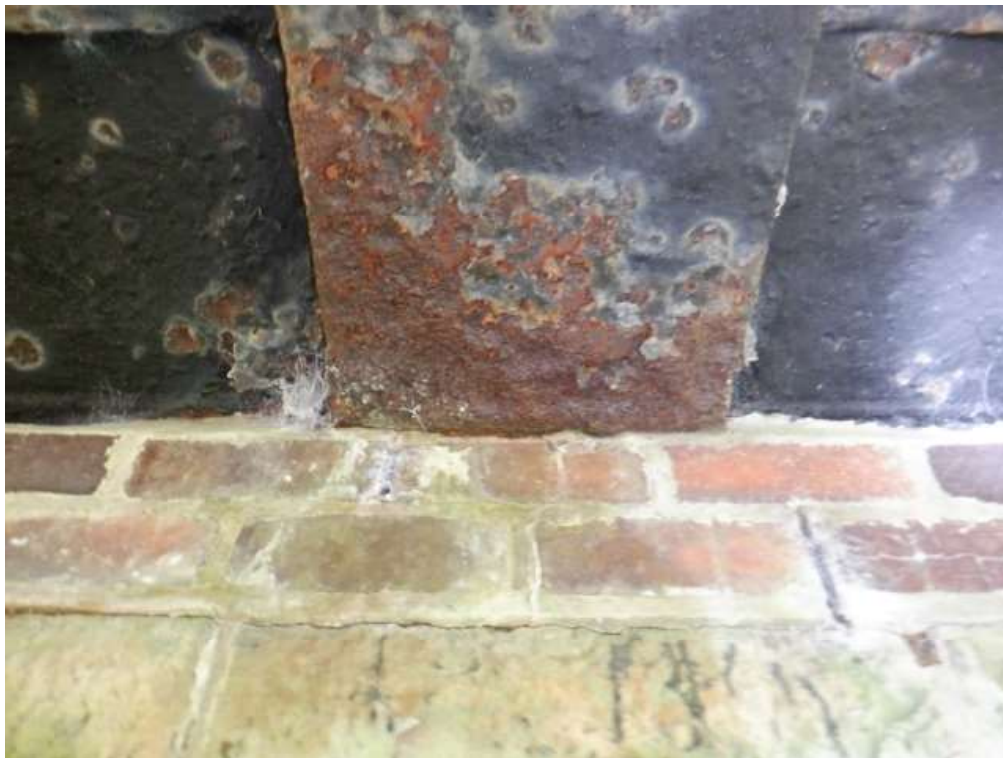
**Photo 8: Corrosion Loss to MGI's (07.08.21)**

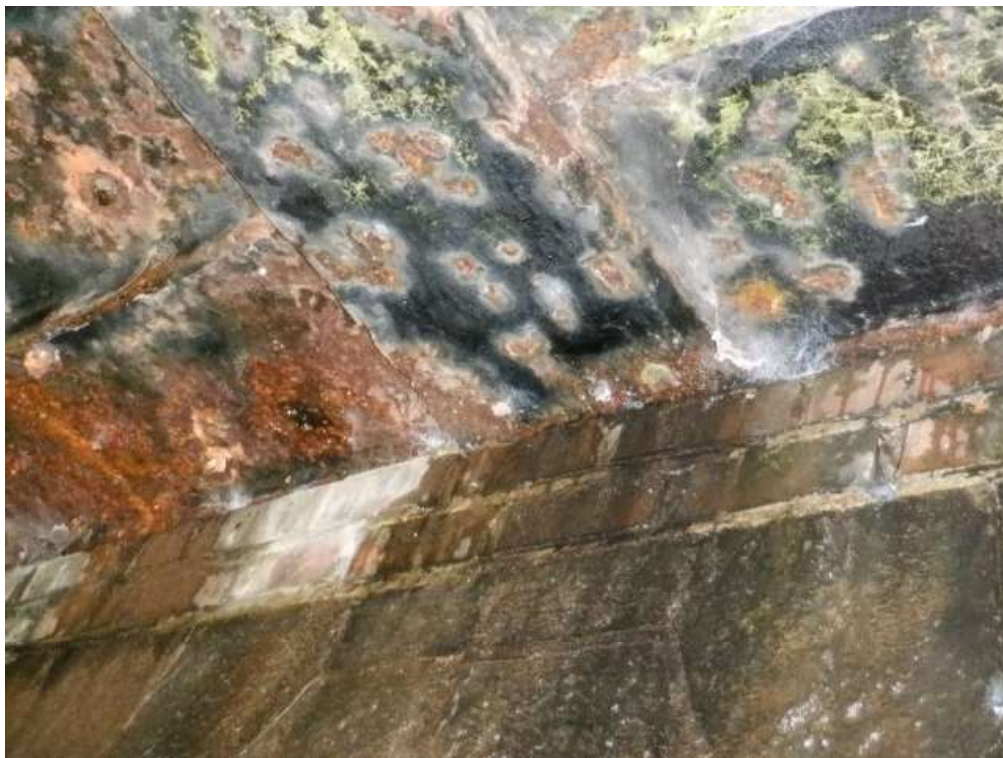
**Photo 9: Corrosion Loss to MGI's (07.08.21)**

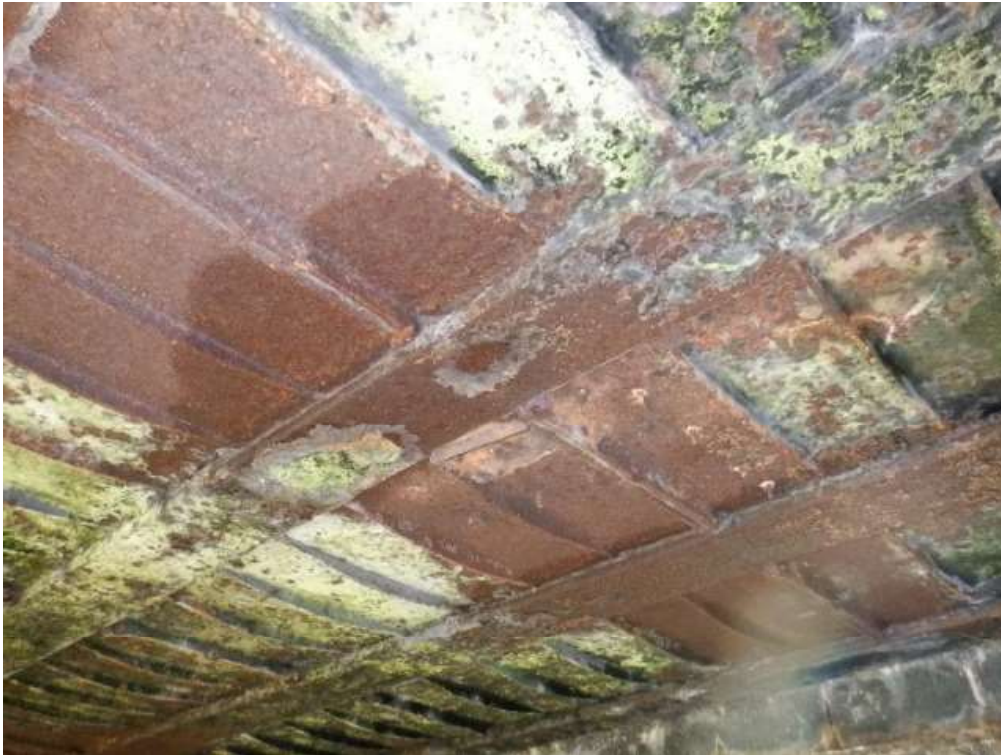
Photo 10: Corrosion Loss to MGI's (07.08.21)

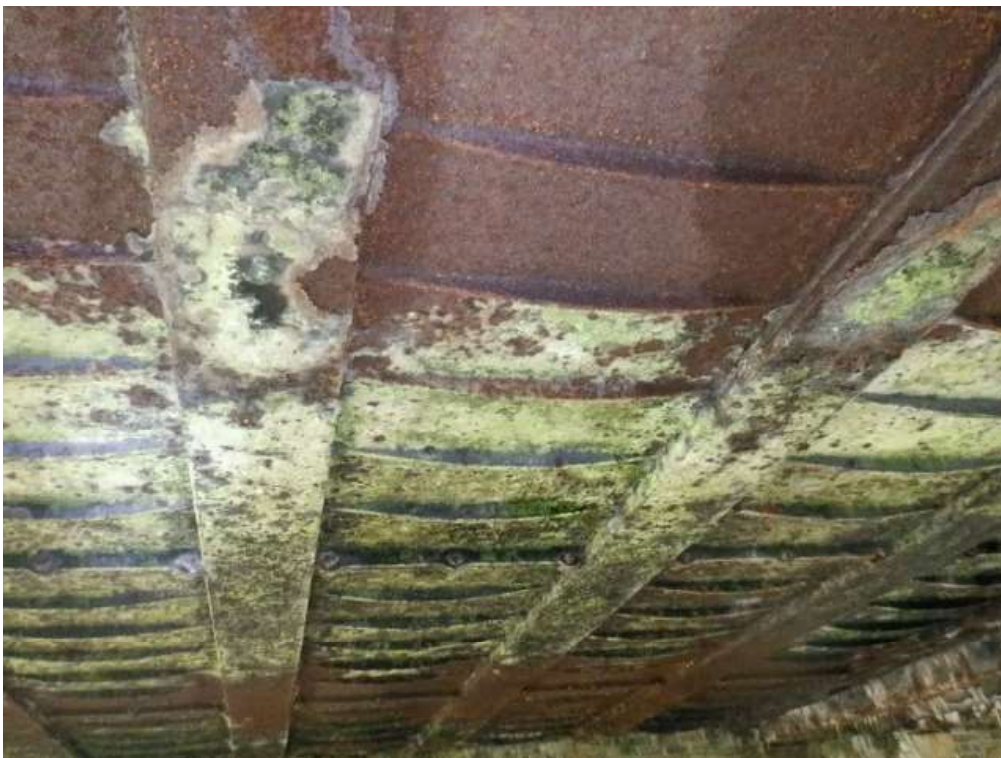
Photo 11: Corrosion to Deck Floor (07.08.21)

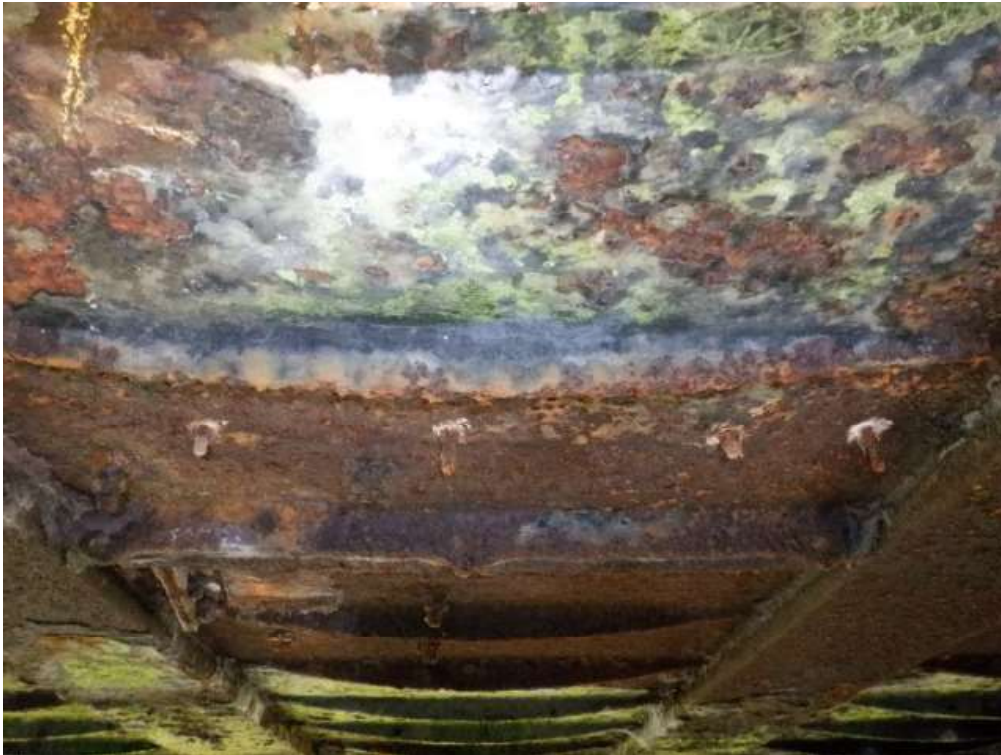
Photo 12: Loss to Ribbed Plate (07.08.21)

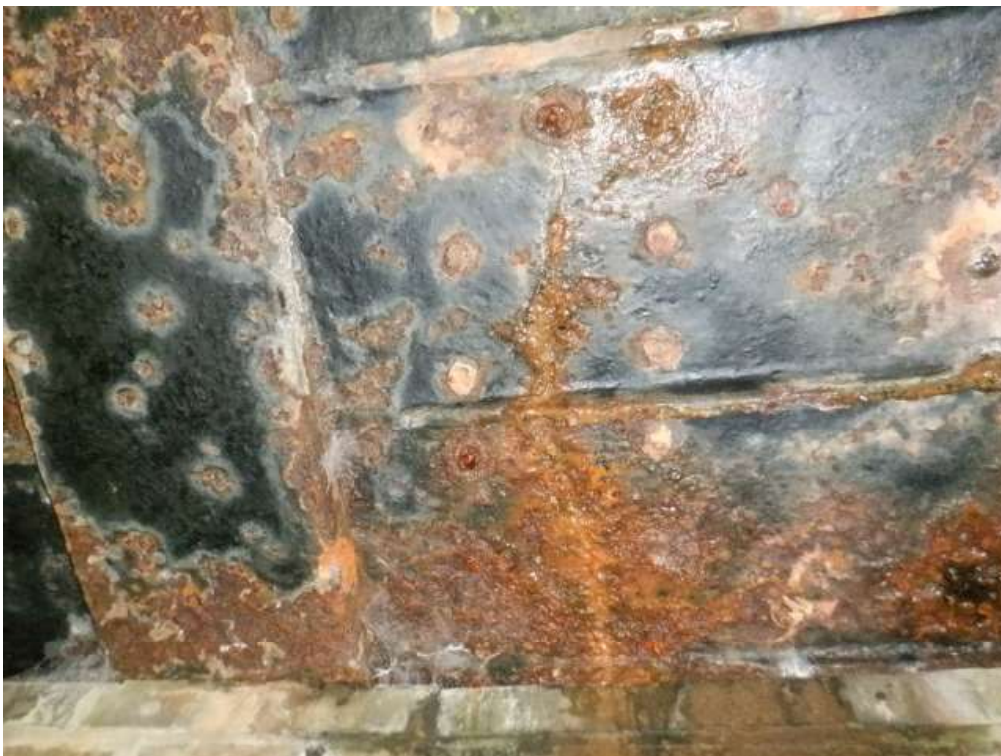
Photo 13: O/S Transverse Fracture to Upside End Panel (07.08.21)

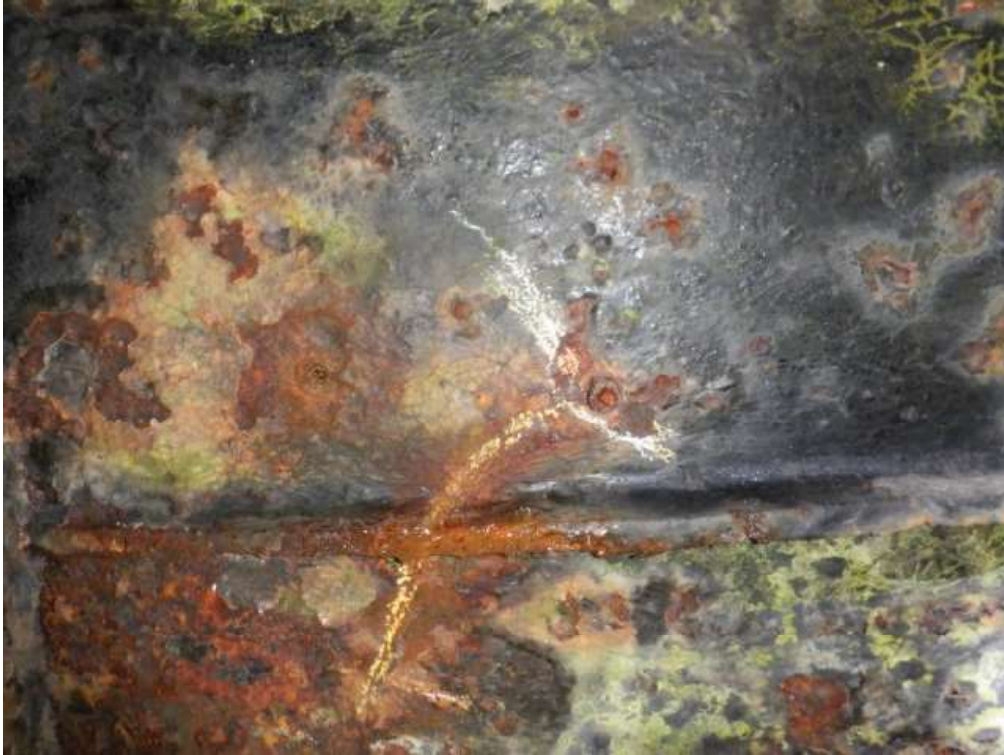
Photo 14: Diagonal Fracture to Upside Panel (07.08.21)

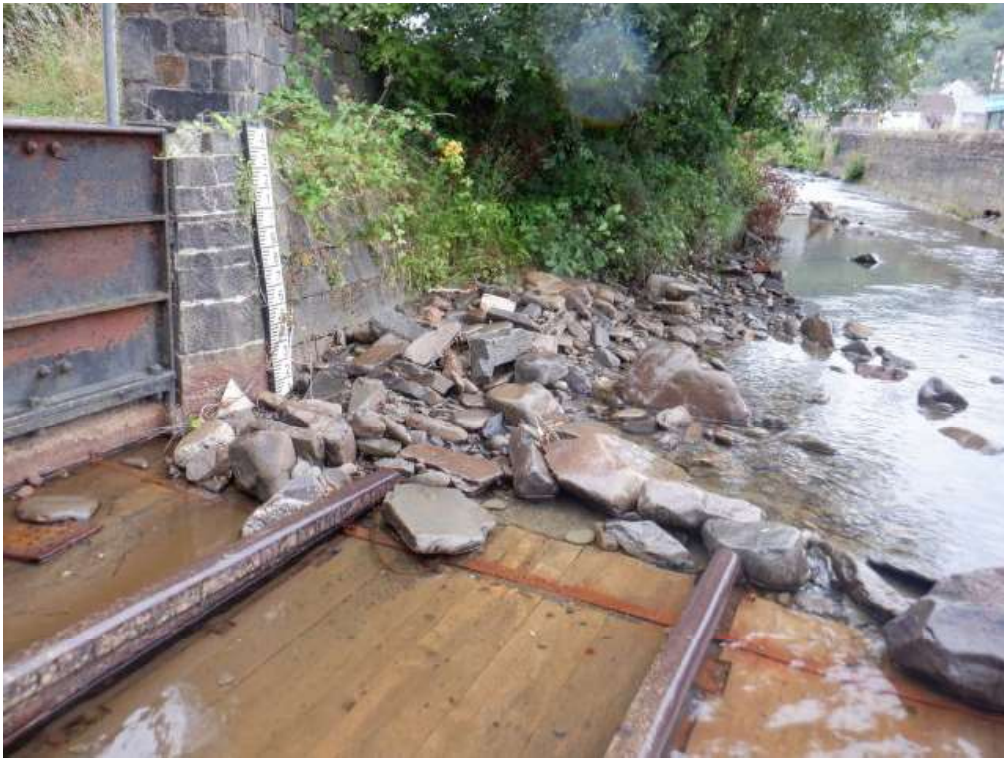
Photo 15: Large Stones Resting on Sacrificial Timbers (07.08.21)

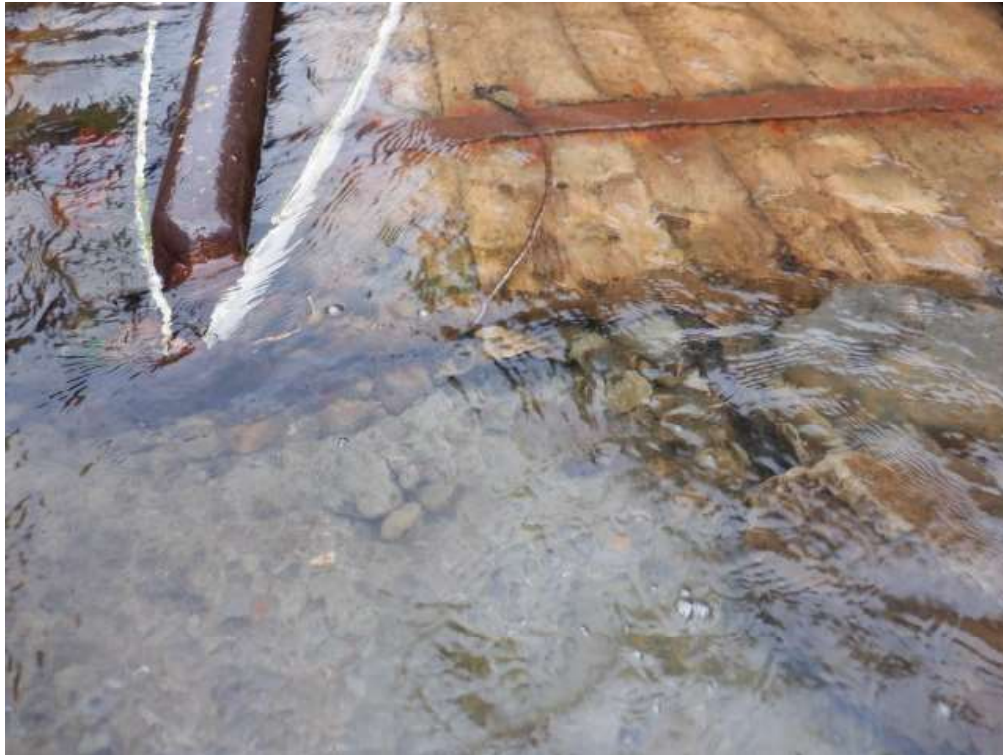
Photo 16: Debris Wedged at Timber Ends (07.08.21)

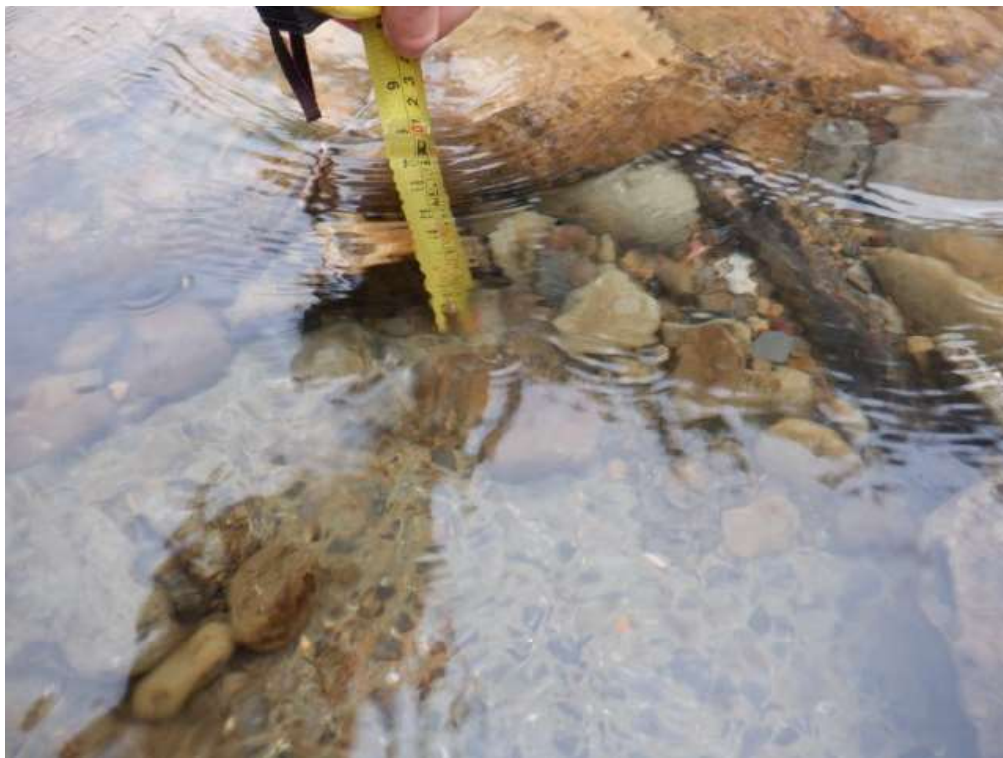
Photo 17: Raised Timbers (07.08.21)

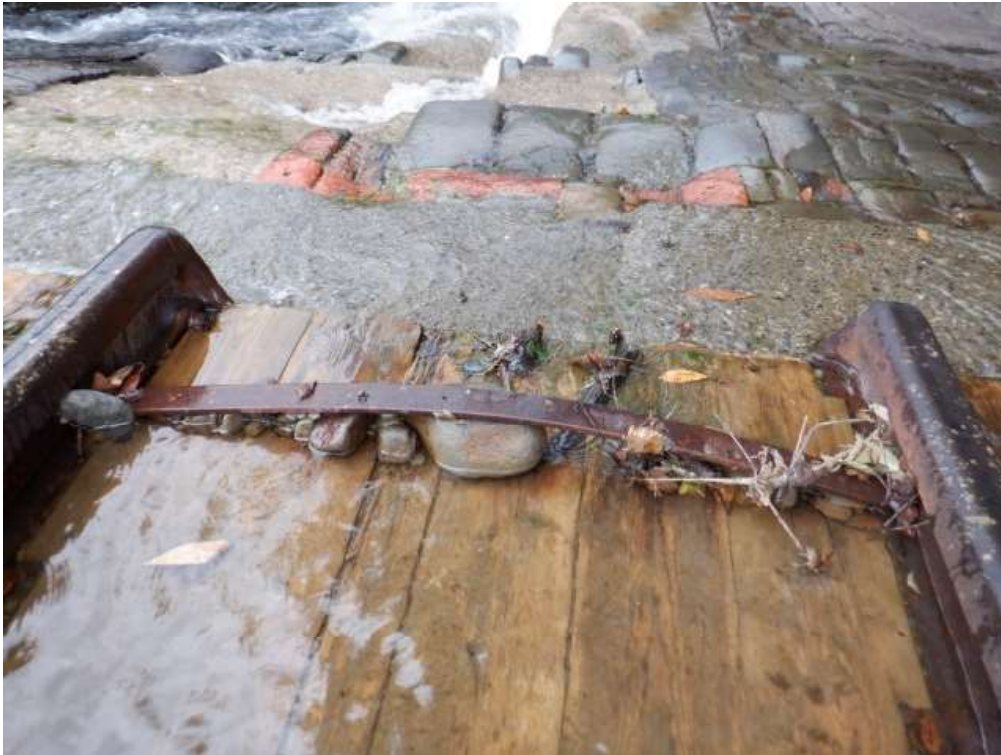
Photo 18: Raised Straps (07.08.21)

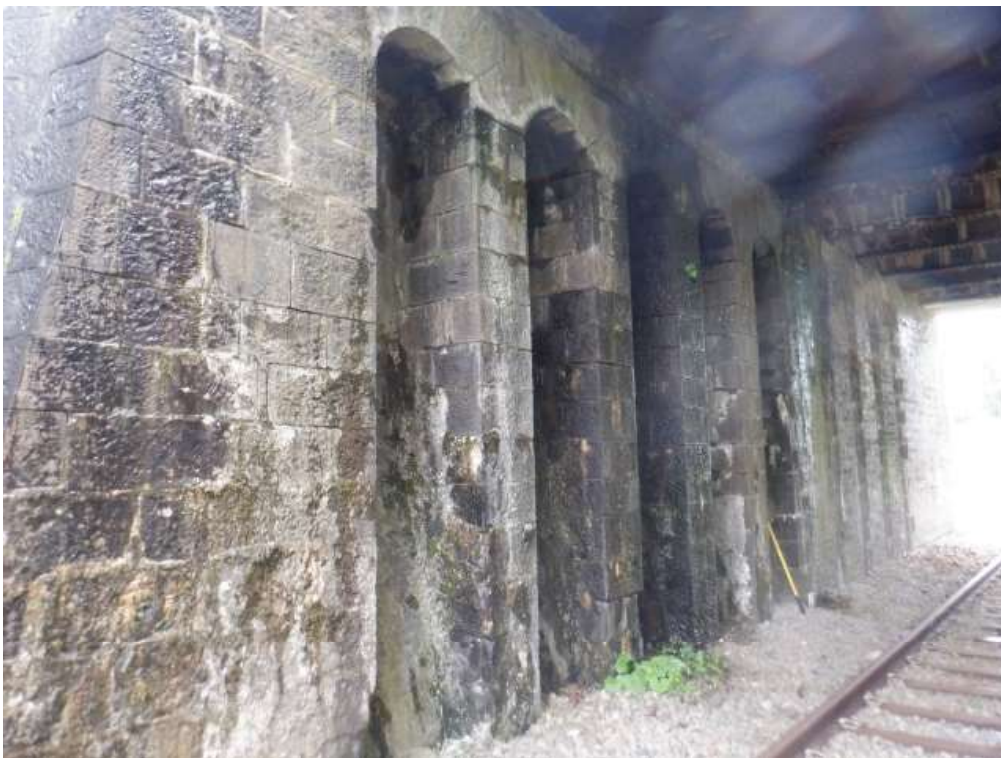
Photo 19: Downside Abutment (07.08.21)

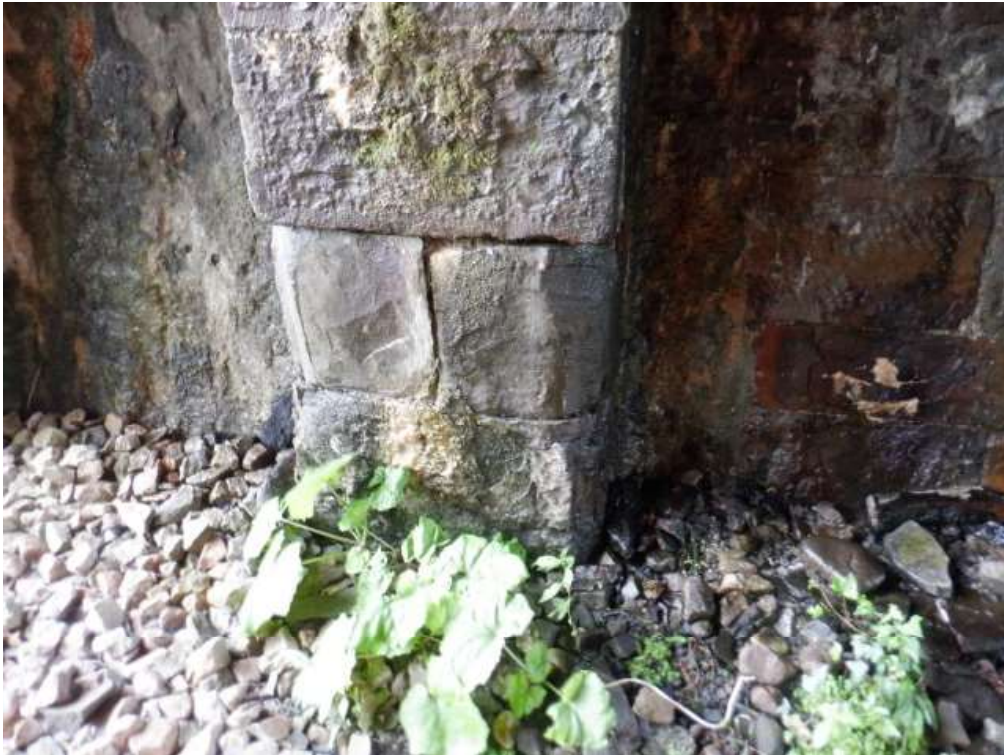
Photo 20: typical O/S Spalling to relieving Arches (07.08.21)

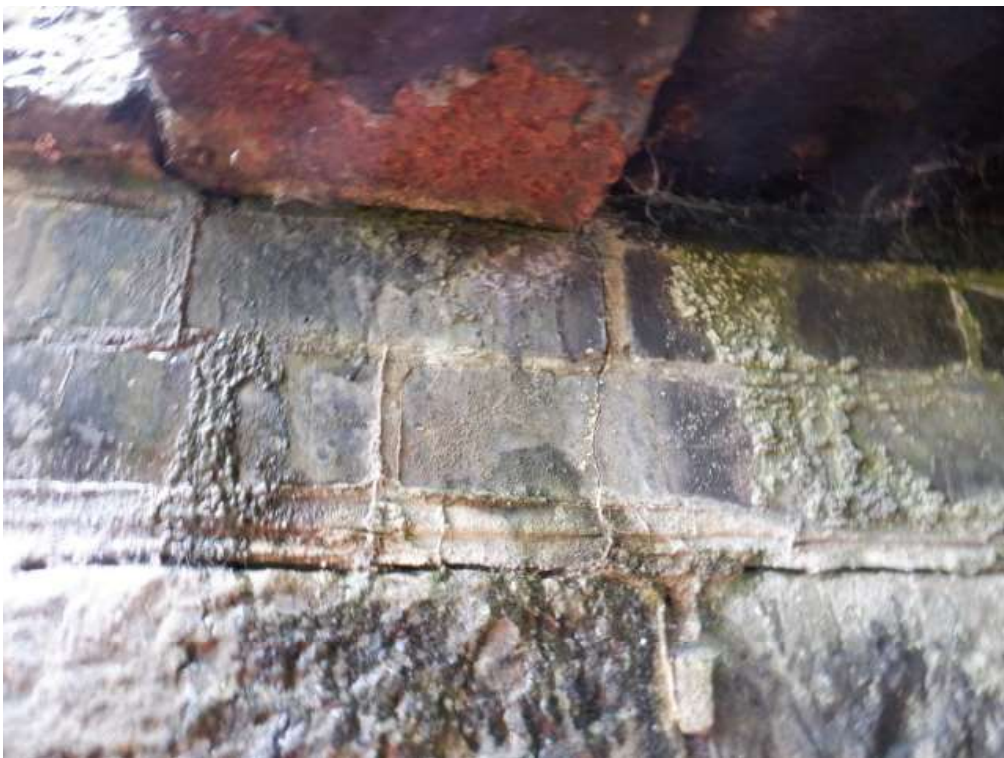
Photo 21: O/S Fracture to Downside Abutment (07.08.21)

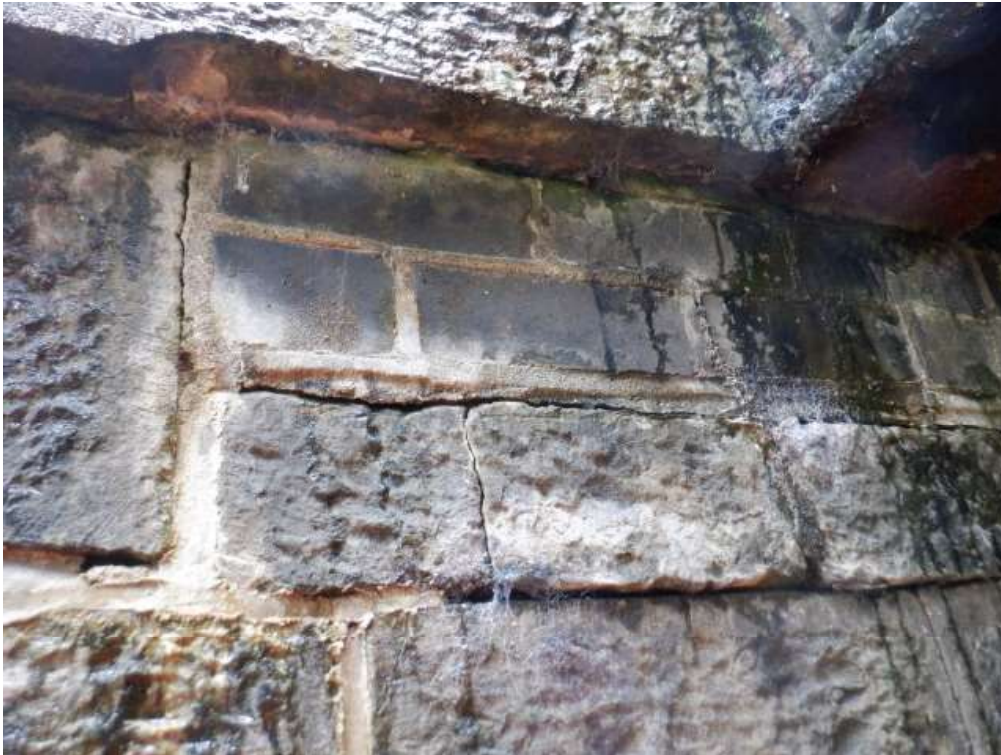
Photo 22: Horizontal Bed-Joint Fracture & LTH Stonework (07.08.21)

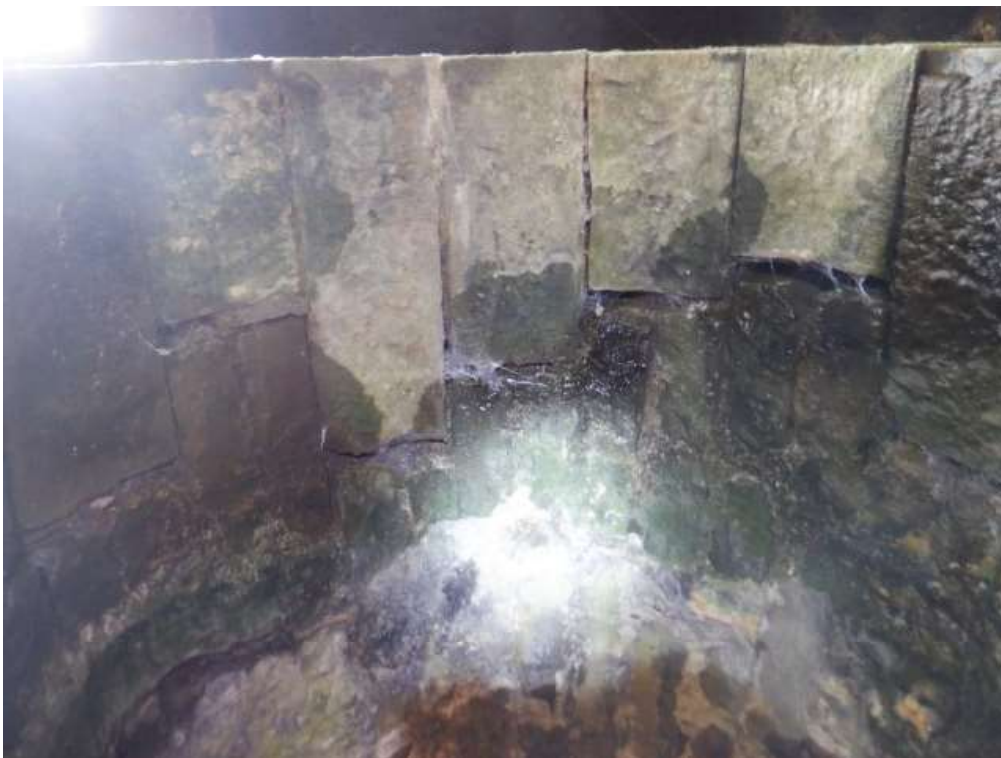
Photo 23: Typical View of Longitudinal Fractures to Relieving Arches (07.08.21)

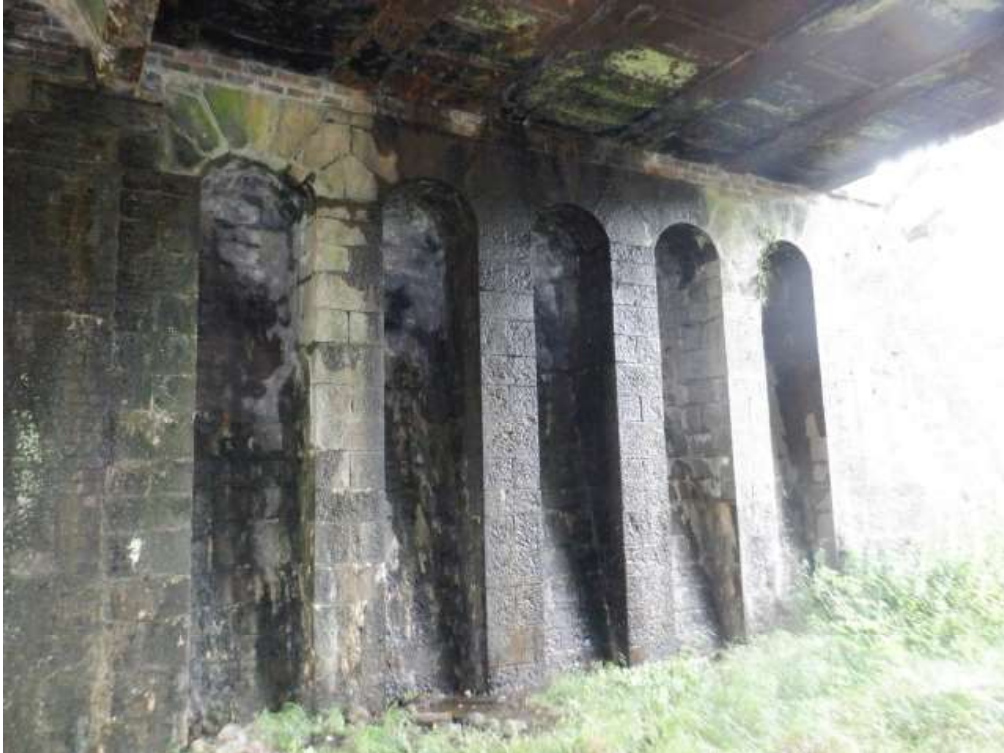
Photo 24: Upside Abutment (07.08.21)

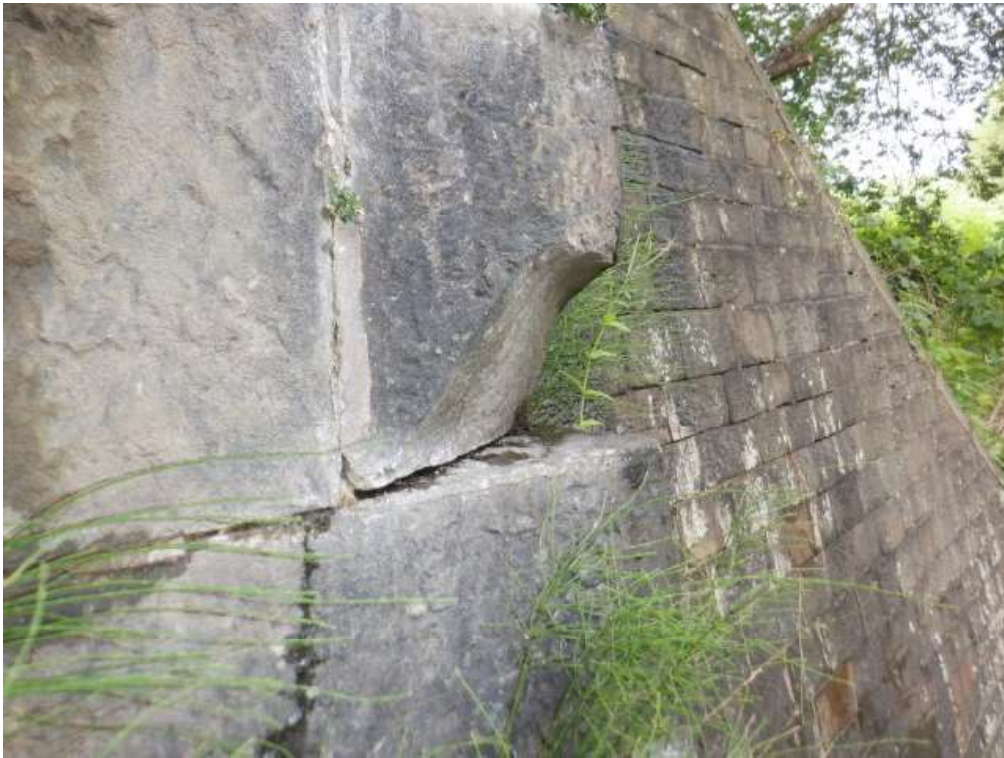
Photo 25: Spalling to Abutment Quoin (07.08.21)

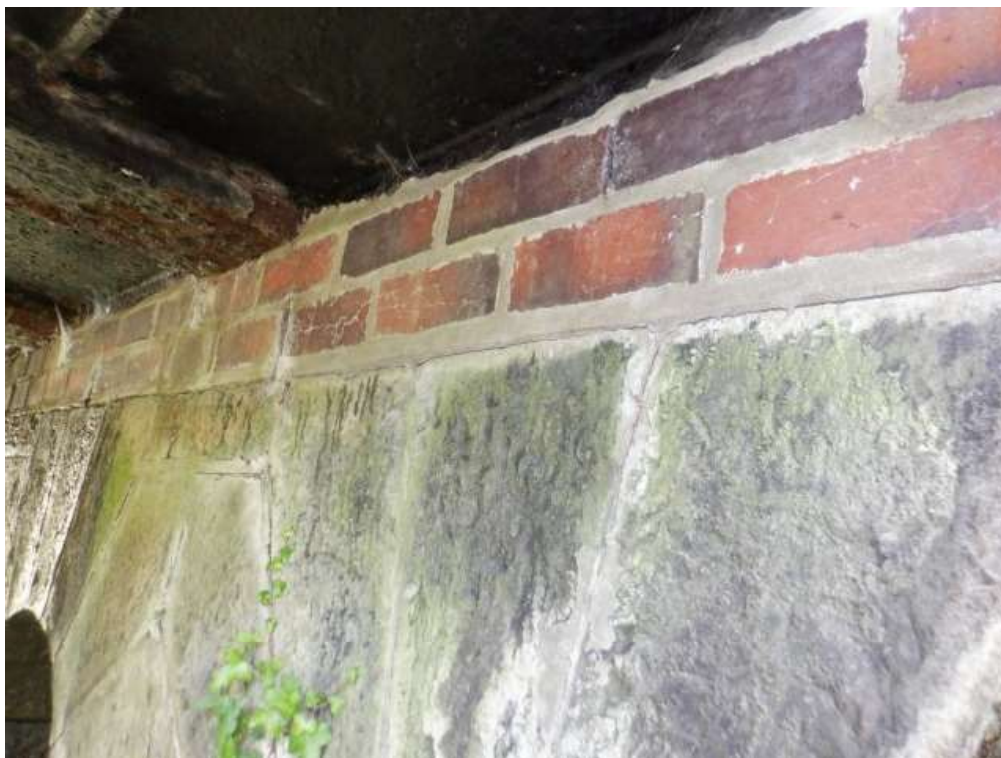
Photo 26: Horizontal Bed Joint Fracture (07.08.21)

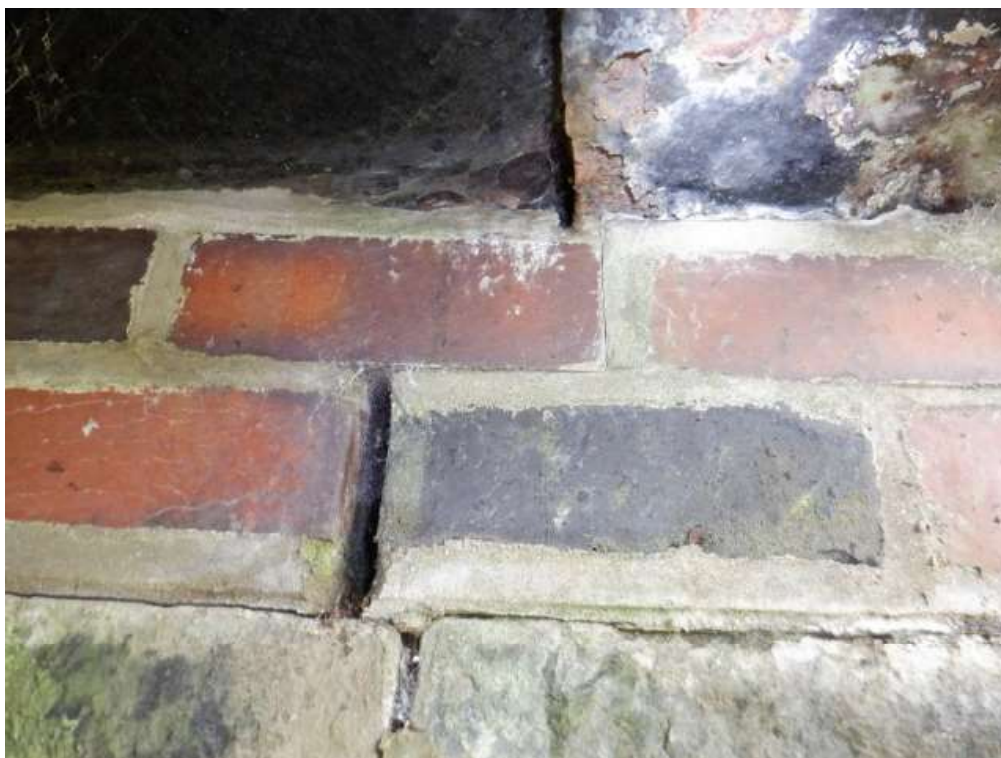
Photo 27: Vertical Fracture to Brickwork Below Low Mileage Girder (07.08.21)

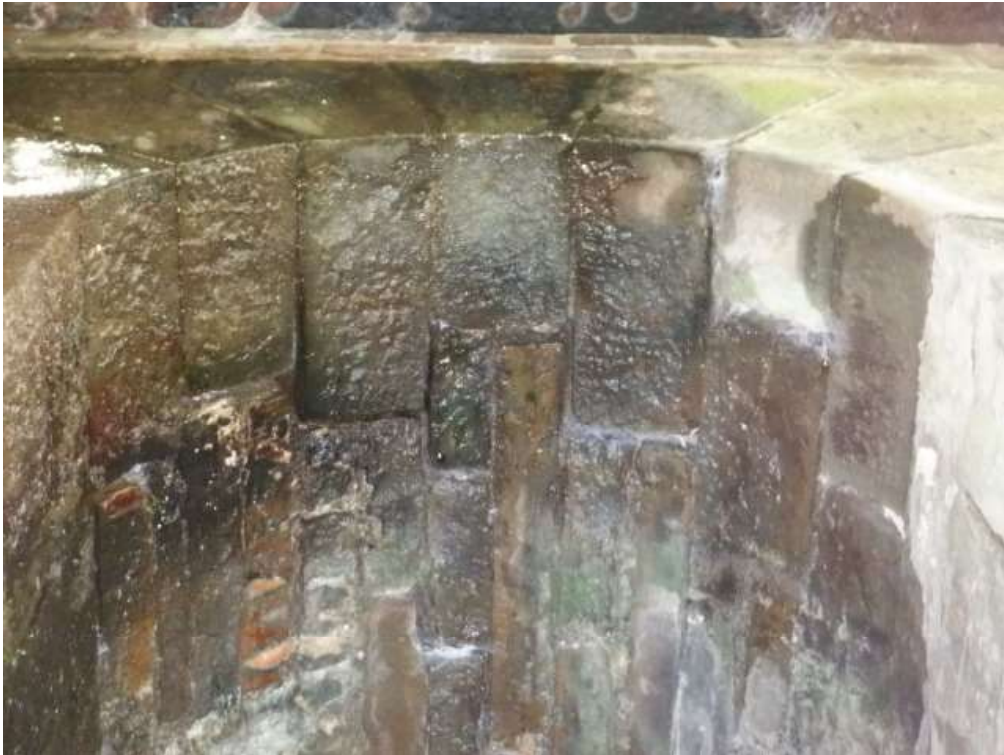
Photo 28: Typical View of Longitudinal Fracture to Relieving Arches (07.08.21)

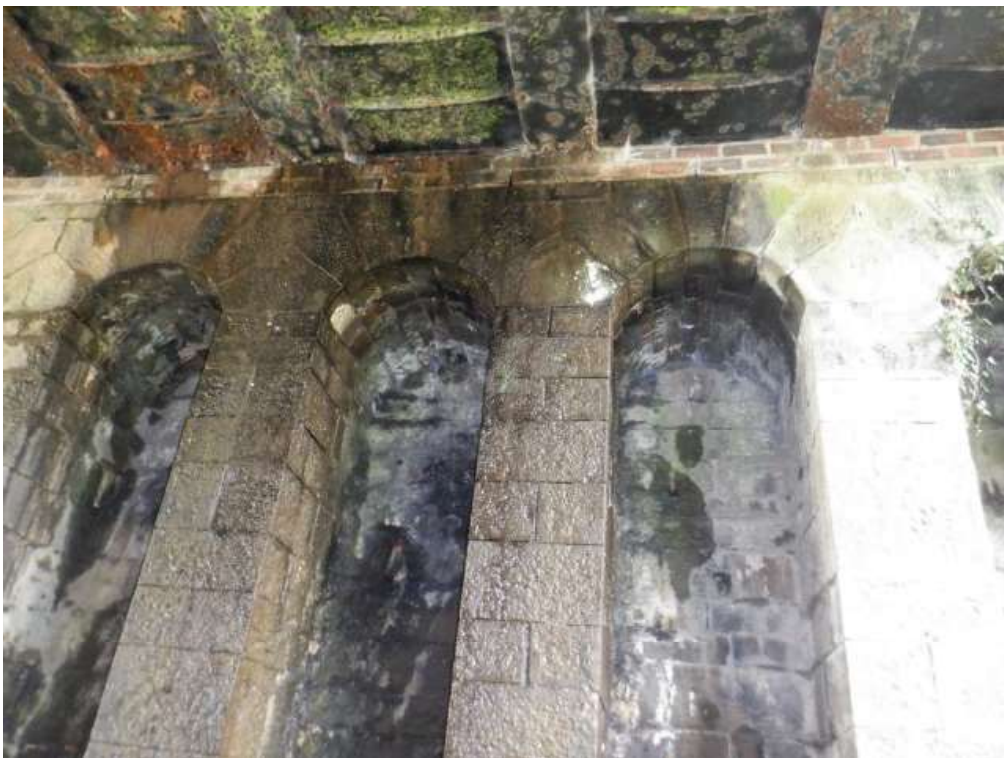
Photo 29: Water Flow Between 2nd & 3rd Relieving Arch (07.08.21)

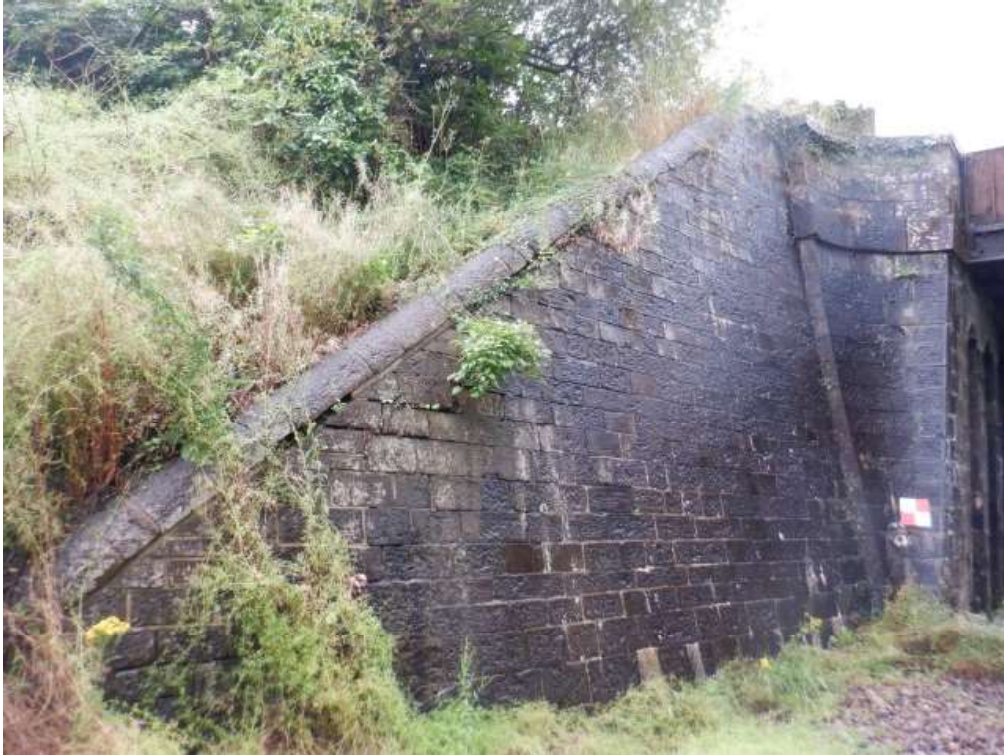
Photo 30: Downside Low Mileage Wingwall (07.08.21)

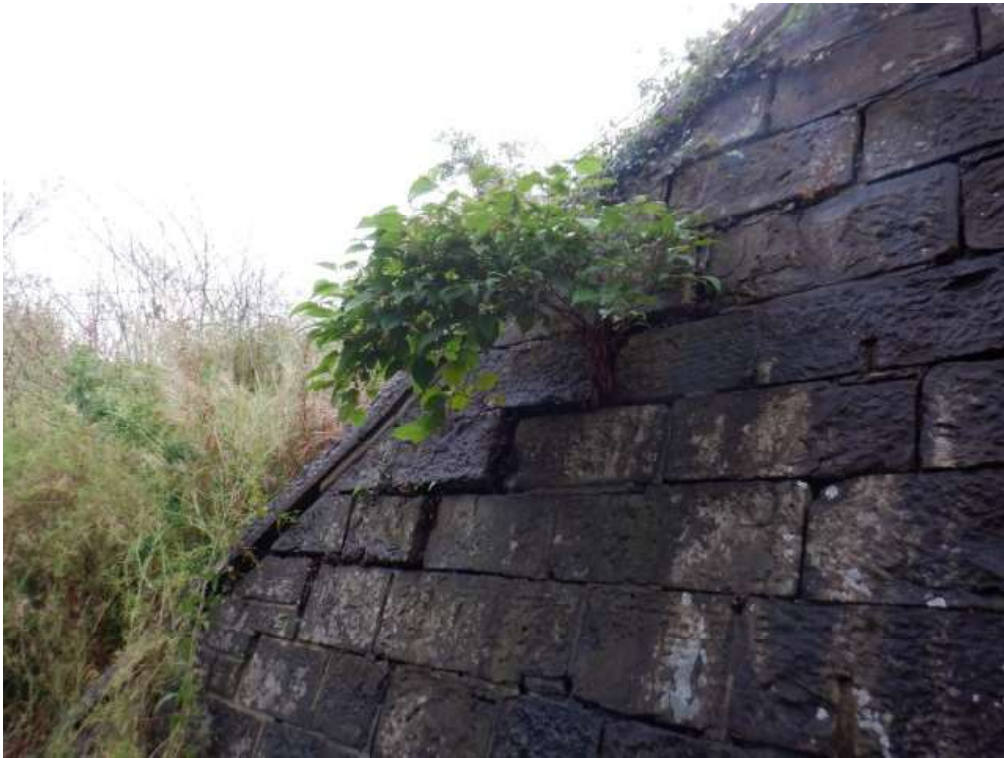
Photo 31: LTH & Displaced Stonework (07.08.21)
