ELR: VON

Contract Mileage: 035m 0468yds 21.27chs

Struc. Ref: 3521.25

Bridge Detailed Examination Report

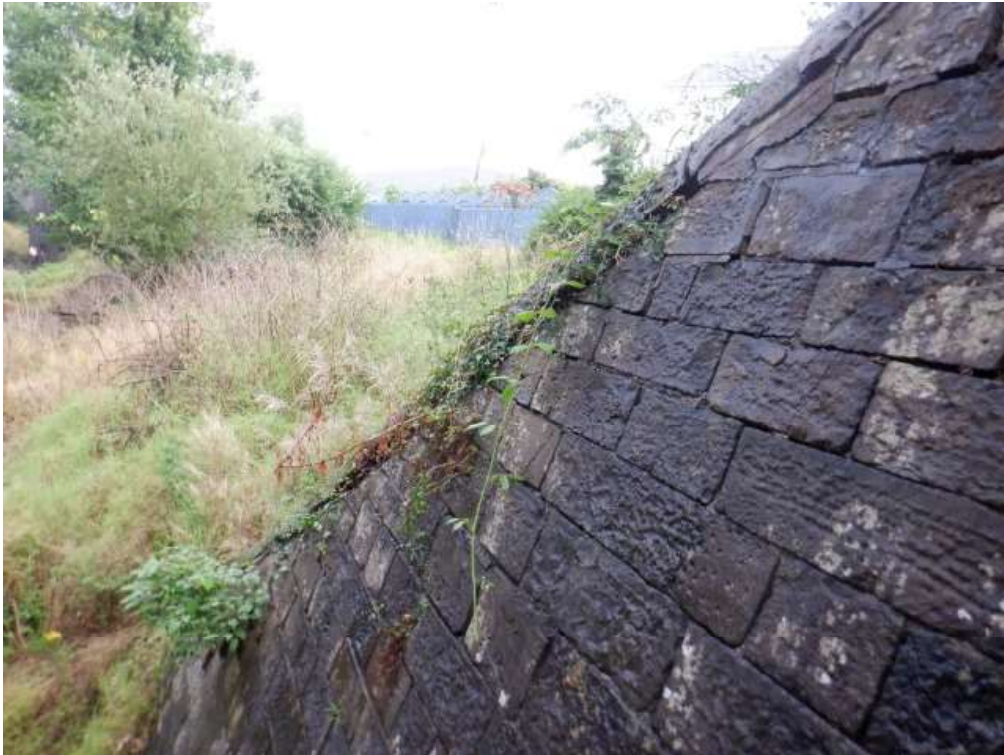
**Photo 32: Heaved Copings (07.08.21)**

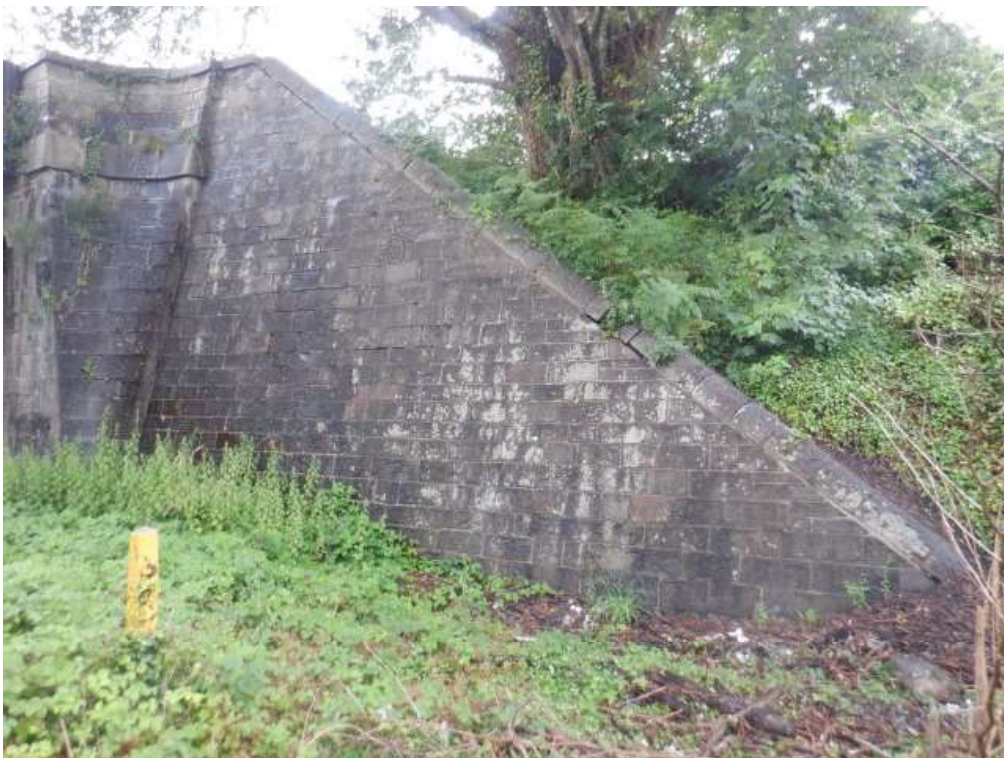
**Photo 33: Upside Low Mileage Wingwall (07.08.21)**

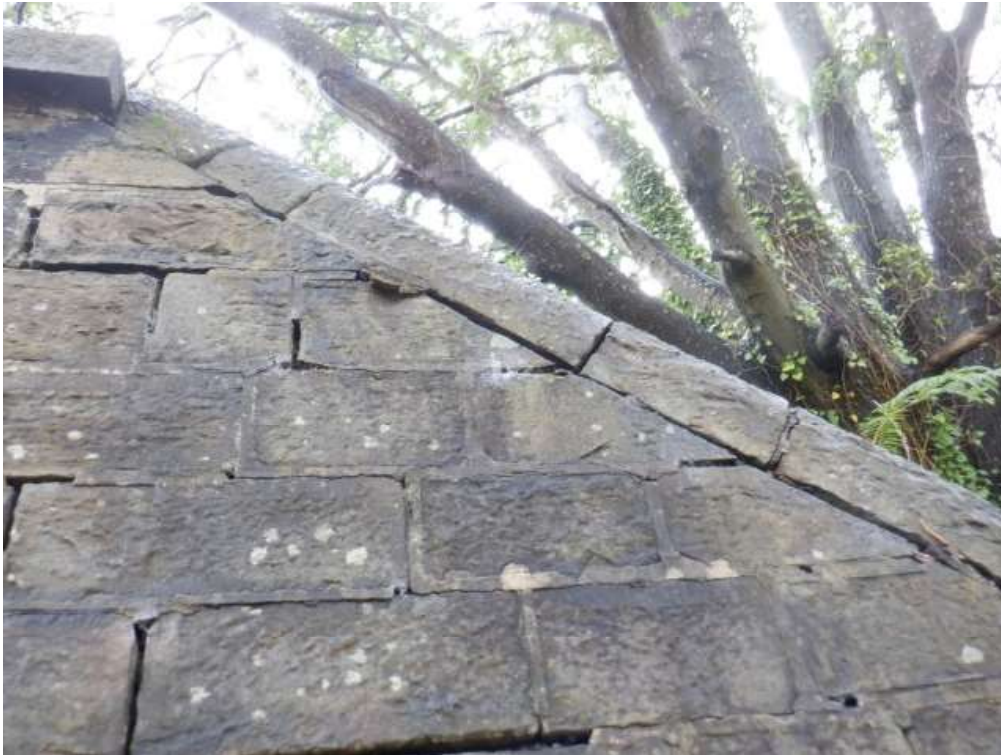
**Photo 34: Heaved Copings (07.08.21)**

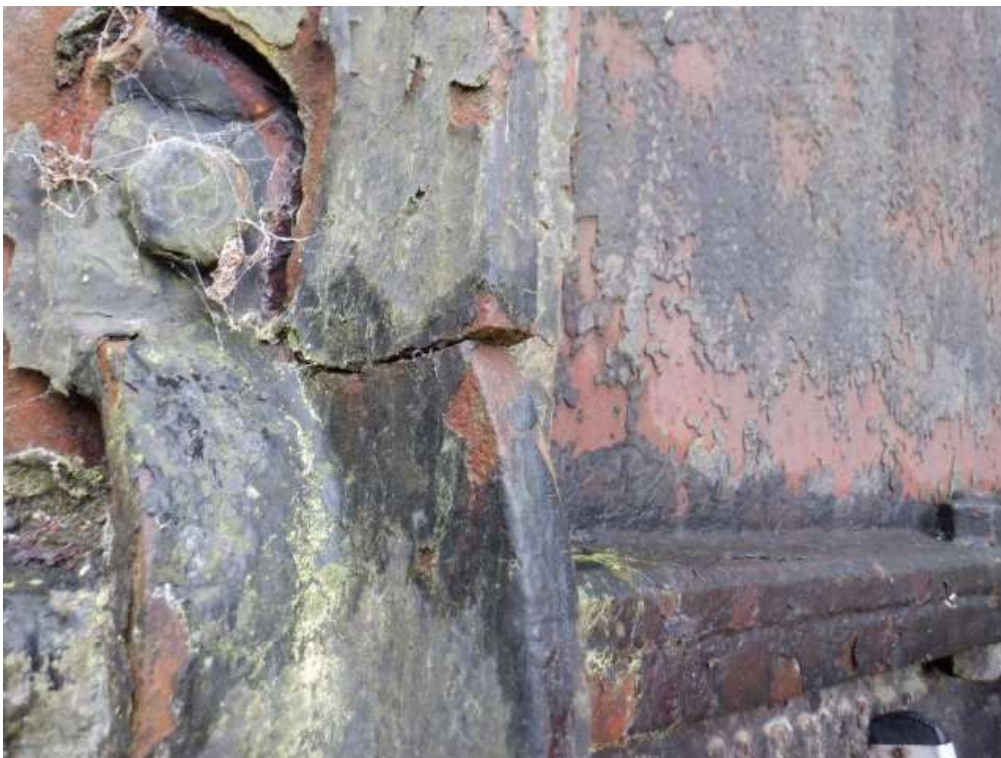
**Photo 35: Horizontal Fracture & Displacement to Lower cranking (07.08.21)**

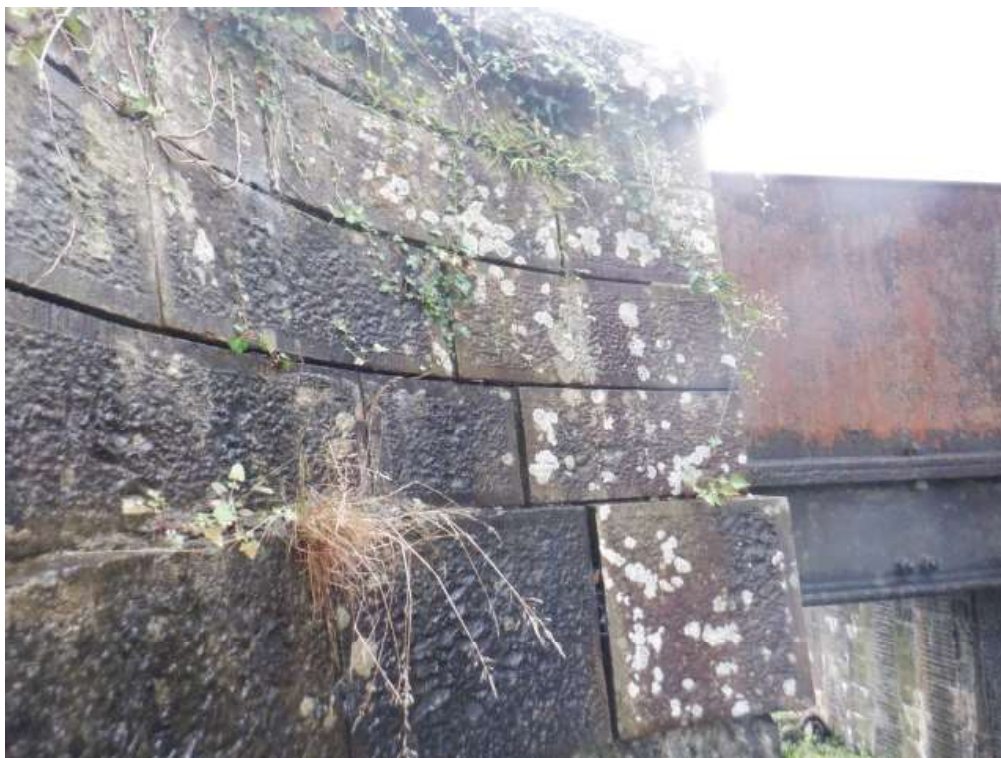
Photo 36: Displaced Stonework to Downside Pilaster (07.08.21)

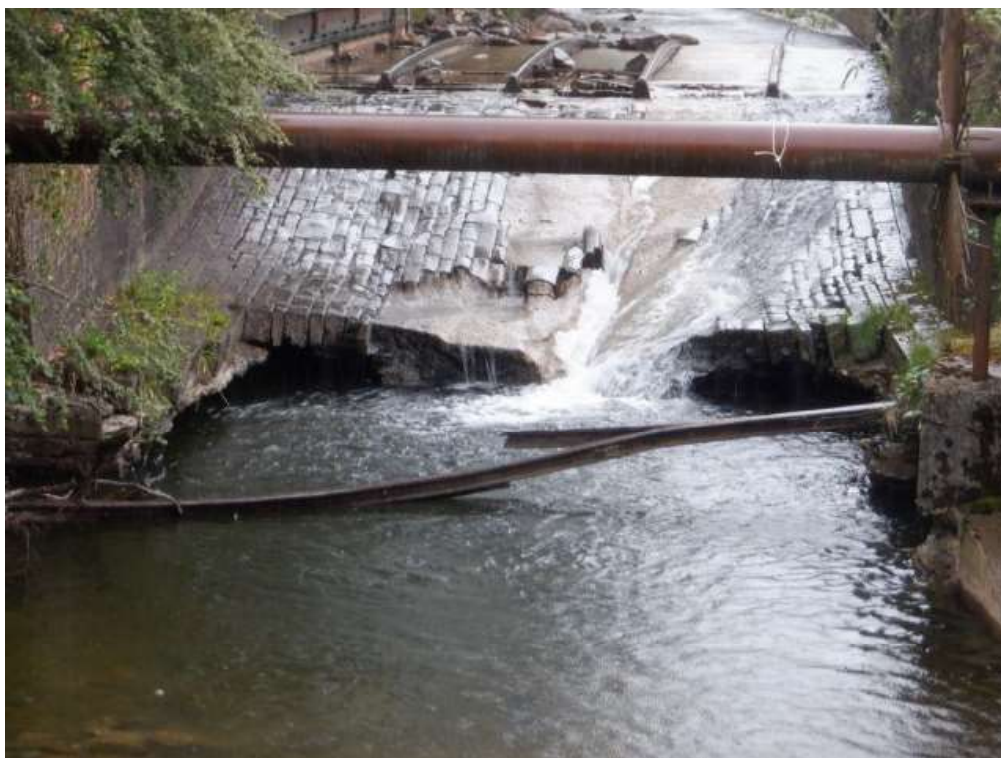
Photo 37: View of Weir (07.08.21)

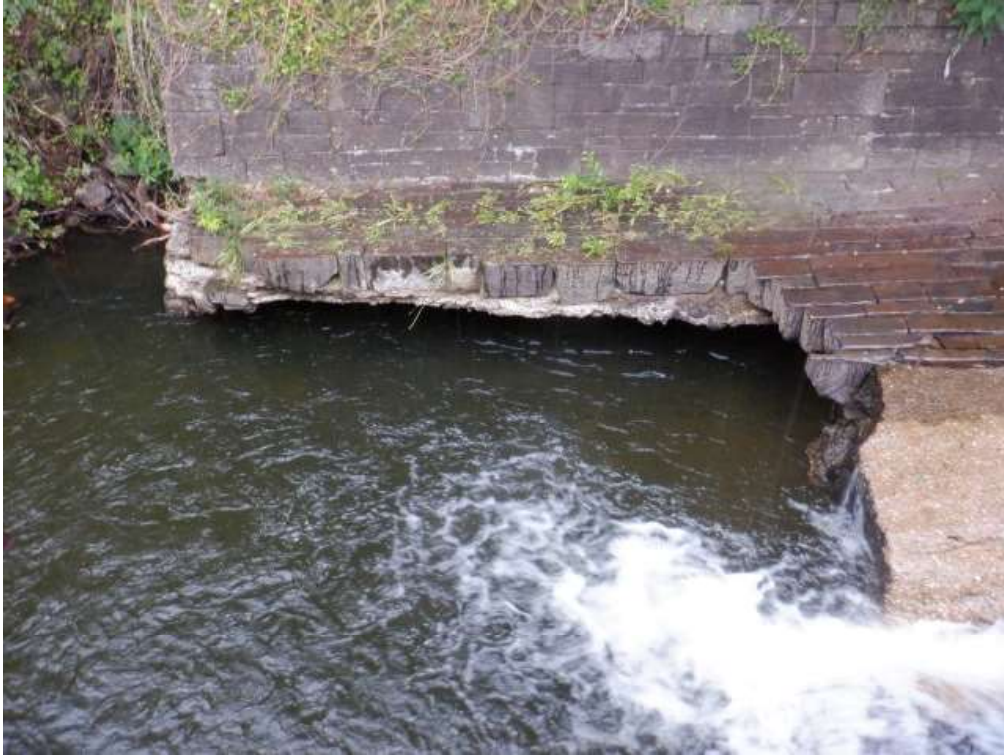
Photo 38: Undermining to Low Mileage End of Wier (07.08.21)

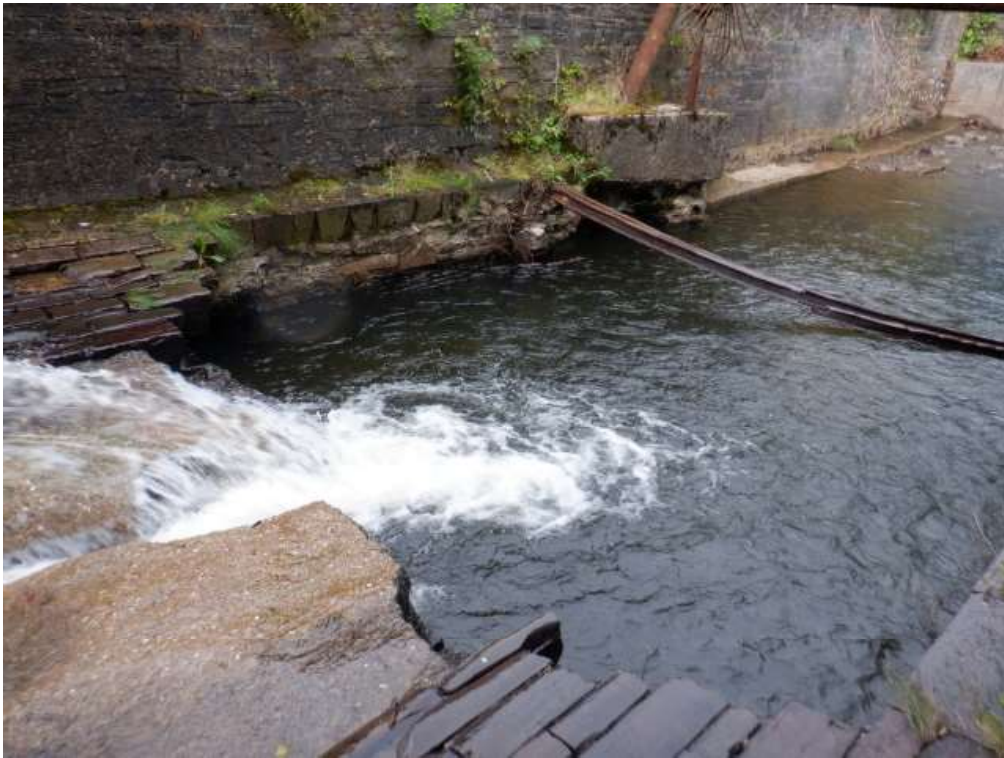
Photo 39: Undermining to High Mileage End of Weir (07.08.21)

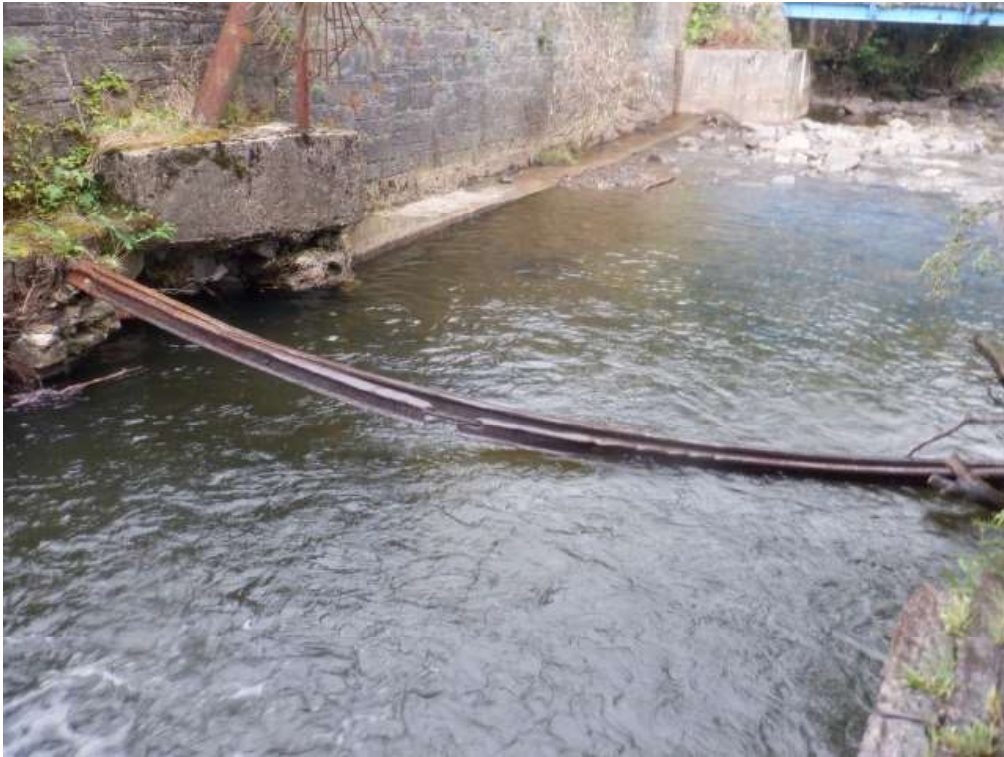
**Photo 40: Detached & Bent Rail Retainer (07.08.21)**

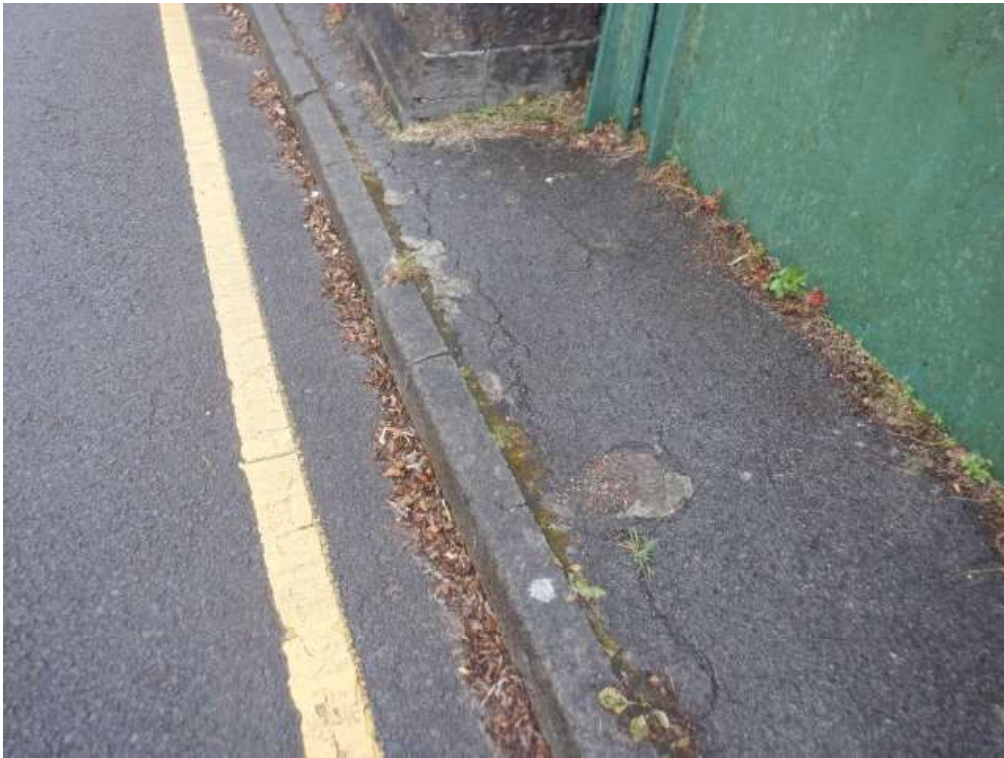
**Photo 41: Cracks Present to Road & Pavement(07.08.21)**

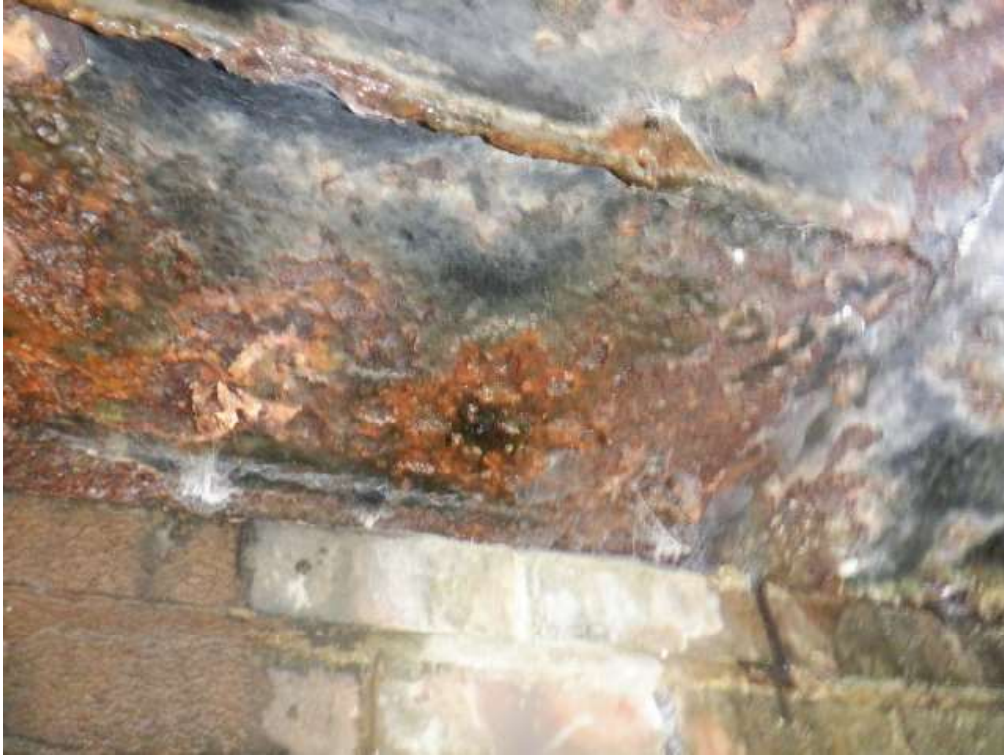
**Photo 42: View of Bolts (07.08.21)**
