## **Tree Condition report.**

**Land to the rear of 35, 36 and 37 Woodlands Park Drive,  
Cadoxton, Neath. SA10 8DE**

**Based on inspections carried out on  
21<sup>st</sup> January 2023**

**By Alan Webster, MArborA  
Our Ref: ARW 1141**

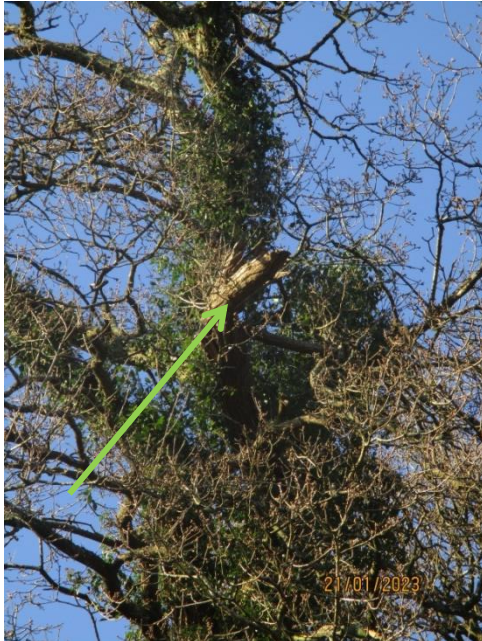
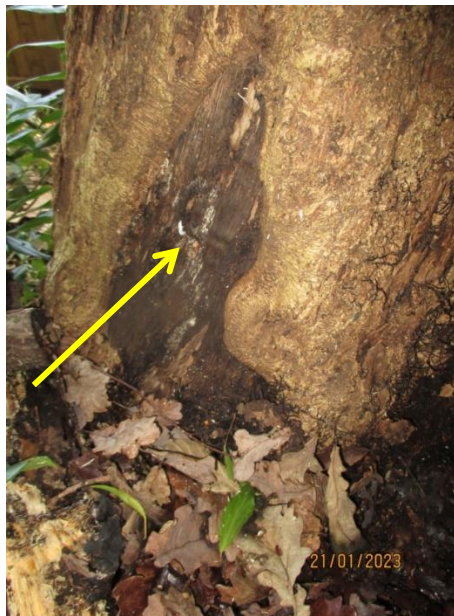
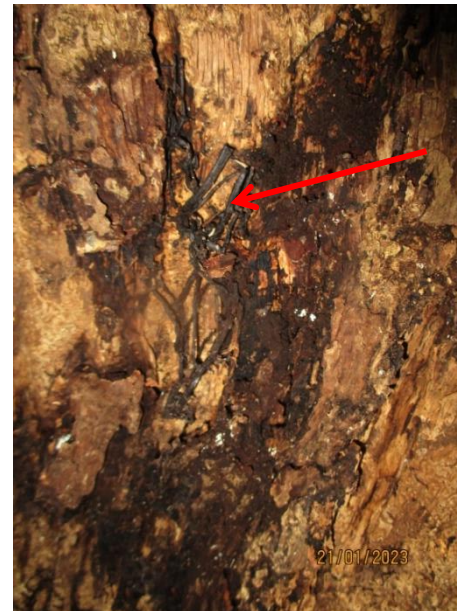
| Tree No. | Species | Height (m) | Spread (m) | Age class | Physiological and Structural condition | Recommendations | Work priority | Re-inspect |
|---|---|---|---|---|---|---|---|---|
| 658 | Oak ( <i>Quercus spp</i> ) | 22 | 8 | M | Ivy covering to 18m, normal bud density. Located on edge of woodland crown biased to south east.<br>Lean to SE. Minor surface wounds to buttress wounds on south. Large area of necrotic bark on west (yellow arrow) and black rhizomorphs (green arrow). Some rapid wood development at base.<br>Lost limb at 15m on eastern side leaving 2m long torn stump (green arrow) | 1. Fell | High | NA |

**Appraisal:** The crown does not indicate the fungal activity at the base. Black rhizomorphs are likely to be *Armillaria* spp which is consistent with the necrotic cambium area. Fungus is pathogenetic and will lead to a loss of structural strength and root function. Reaction wood indicates a loss of strength in the localised area. Whilst symptoms are not observed in the crown, this may be hidden by the time of year; considering the trees size and proximity to houses it should be felled to mitigate the level of risk.

| Tree tag | Recommendations | Priority |
|---|---|---|
| 658 | 1. Fell | High |

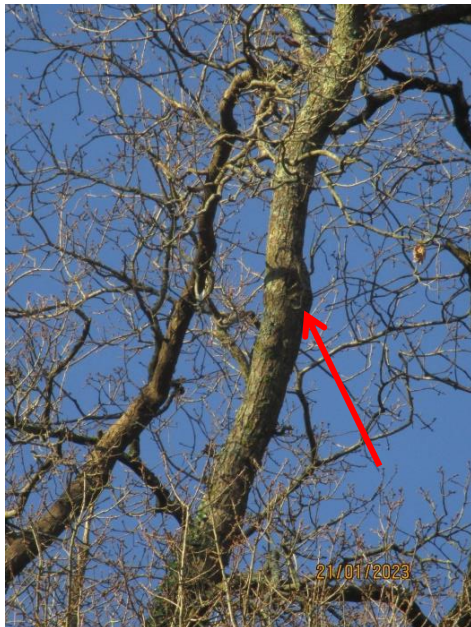
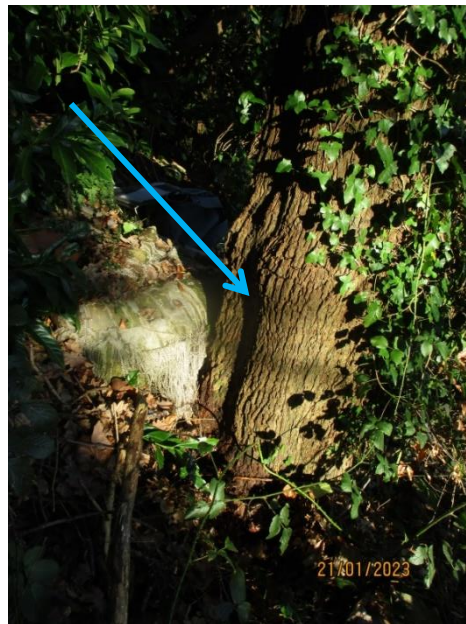
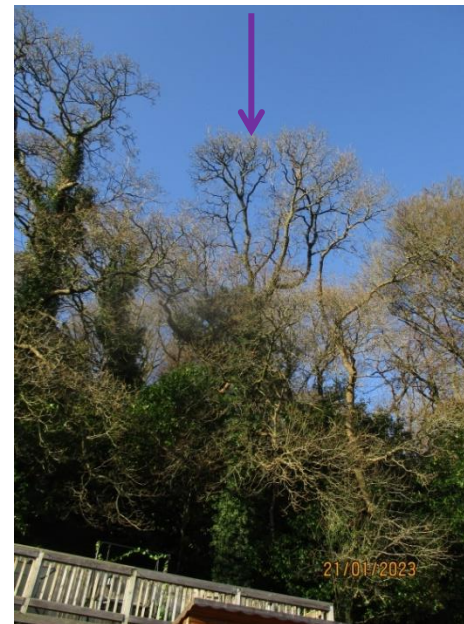
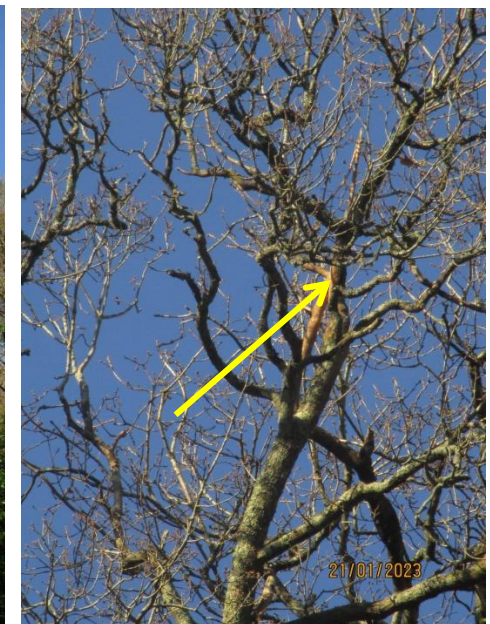
| 659 | Oak<br>( <i>Quercus spp</i> ) | 19 | 6 | M | Ivy covering to 12m. Fluting on lower stem (blue arrow), no decay detected through sounding. Socket cavity at 4m from ground on SW side, obscured by ivy. Stem forks at 12m; NE stem – thickening of stem at 3 to 4m from fork (red arrow). West stem no obvious defects. Both stems somewhat elongated with growth concentrated towards tips. Rubbing branch in top of NE stem (yellow arrow). | 2. Reduce to safe height of 12m (above main fork) | Medium | 2 years |

**Appraisal:** Fluting on lower stem may indicate dysfunction of associated buttress root. This is on the tension side of the tree i.e. the root doing most of the work to hold the tree up. No visual symptoms apart from this. Thickening of stem indicates internal decay in stem and a possible site of failure. No damage seen associated with rubbing branches but this is possible due to direct branch to branch contact. A reduction in height will mitigate the risk of all the defects observed whilst retaining some of the tree.

| Tree tag | Recommendations | Priority |
|---|---|---|
| 659 | 2. Reduce to safe height of 12m (above main fork) | Medium |

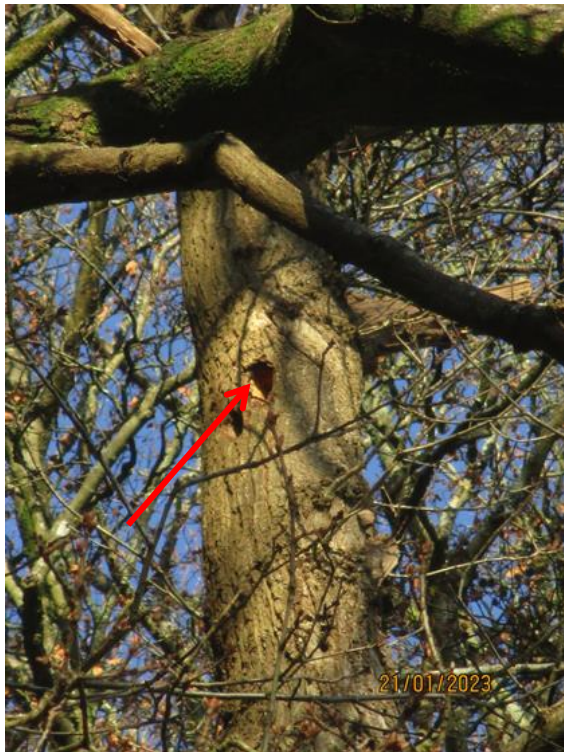
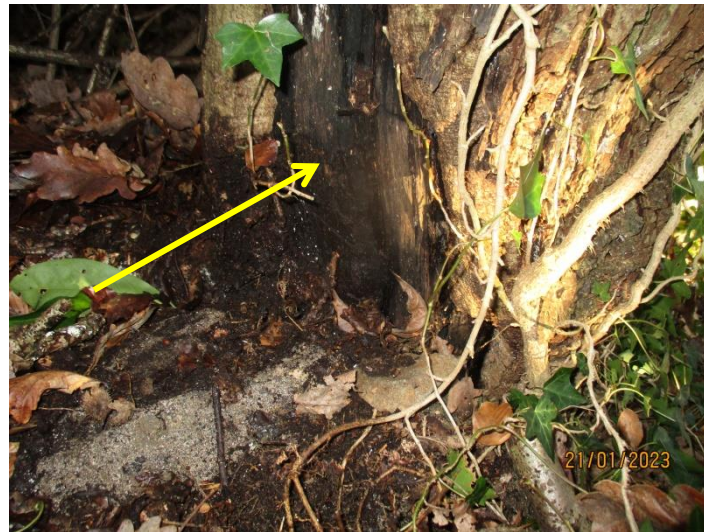
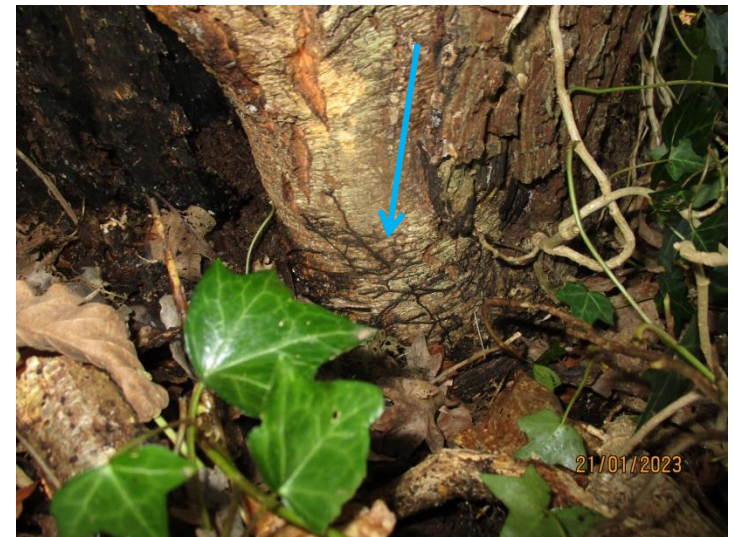
| 660 | Oak<br>( <i>Quercus</i> spp) | 16 | 7 | EM | Suppressed by larger trees weighted north east. Bulge in stem and woodpecker hole (red arrow) 600mm below main fork at 10 metres. Significant basal wound on western side (yellow arrow), concrete debris piled against stem. Black rhizomorphs (blue arrow); bark affected for more than 50% of circumference.<br>Tree forks at 10m both stems have poor taper. Bud density appears to be normal. Minor dead wood present. | 3. Fell | High | NA |

**Appraisal:** Woodpecker hole indicates internal decay and a potential site for failure. Basal damage and fungal activity of probable *Armillaria* spp makes root anchorage uncertain. Poor specimen all round and removal would mitigate risk posed to adjacent gardens.

| Tree tag | Recommendations | Priority |
|---|---|---|
| 660 | 3. Fell | High |

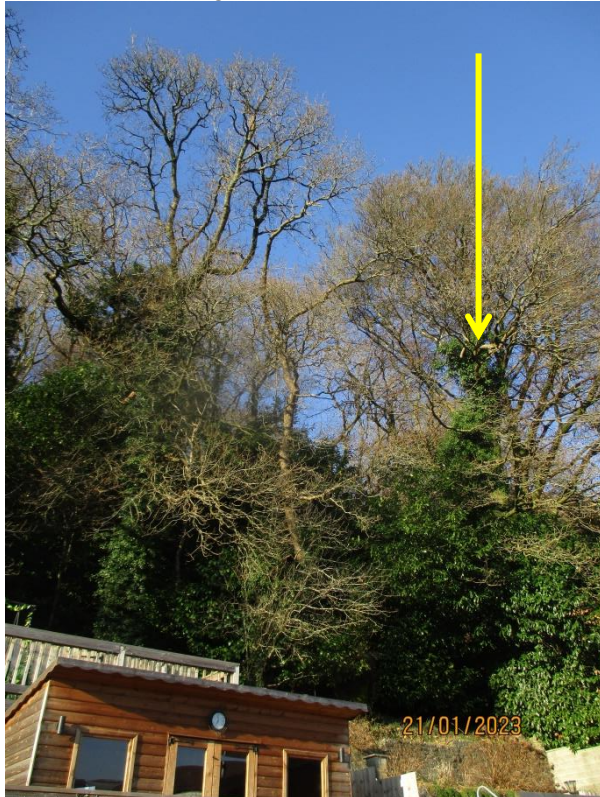
| 661 | Oak<br>( <i>Quercus spp</i> ) | 9 | 4 | EM | Short tree with dense rhododendron understory around base. Stem is ivy covered and tree is suppressed by neighbouring beech trees. Tree leans north east, some fluting on western side of lower stem. Live branches viewed through understory, buds appear to be normal. | 4. Clear understory and re inspect.<br>5. Sever ivy | Medium | 2 years |

**Appraisal:** Full inspection of this tree was not possible due to the dense undergrowth around it; this prevented any of the photographs taken being clear. What was observed did not indicate significant ill health or structural defect. Tree is small but should be looked at again after clearance of rhododendron.

| Tree tag | Recommendations | Priority |
|---|---|---|
| 661 | 4. Clear understory and re inspect.<br>5. Sever ivy | Medium |

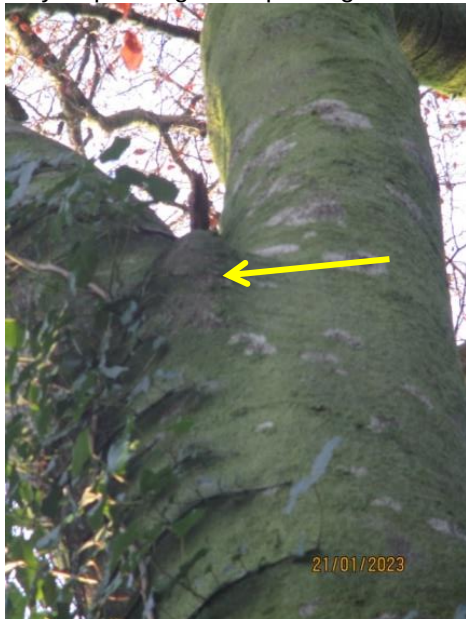
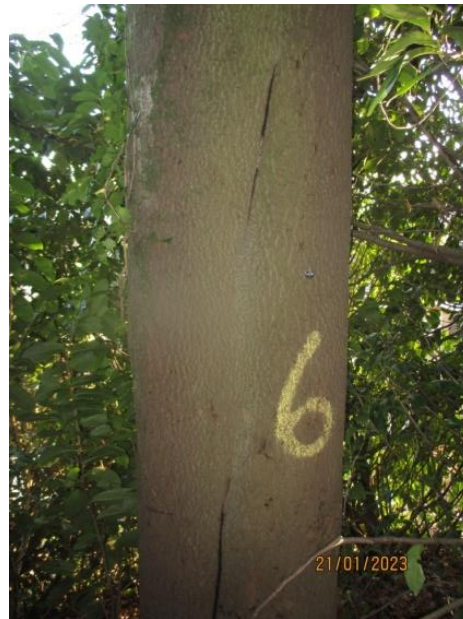
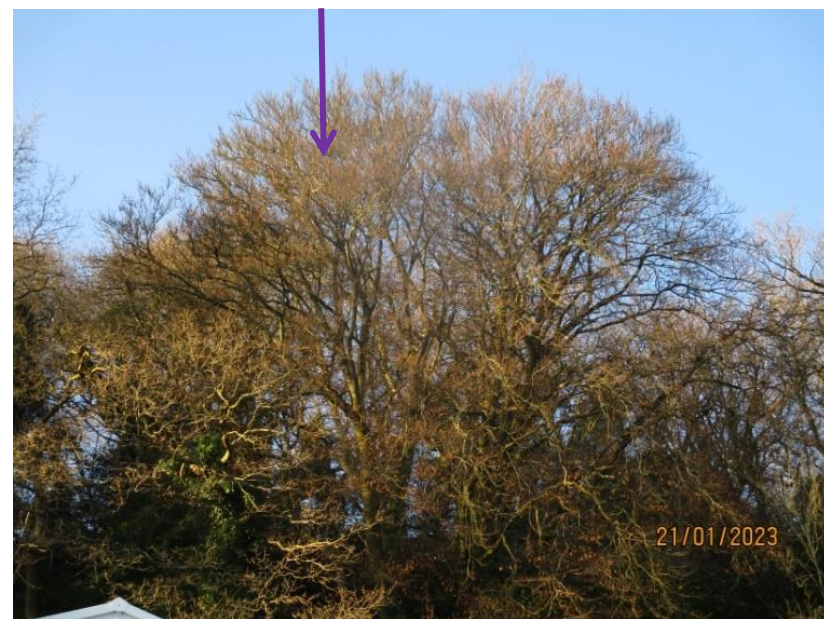
| 662 | Beech<br>( <i>Fagus sylvatica</i> ) | 26 | 10 | M | Tree leans south east, has mutual canopy with 663. Little to no western canopy. Insignificant ivy covering.<br>Forks at 8m, no signs of included bark, some adaptive growth on northern side (yellow arrow); some also shown on south side. No natural bracing observed.<br>Indication of fluting on western lower stem, no indication of decay from sounding. Good bud density; minor dead wood (<50mm in diameter and less than 1m in length) observed at 12m. | 6. Reduce by 4m<br>7. Aerial inspection of fork at 8m. | Medium | 2 years |

**Appraisal:** The fluting is probably due to the difference in growth rates caused by the affected side being under tension (tree leaning) this is not considered significant. The adaptive growth may indicate a certain amount of bark inclusion at the fork although the wood development is not advanced. This coupled with no natural bracing (Slater) does make further investigation of this fork advisable. In any case this tree is a significant height and causes some anxiety for the adjacent house holders; therefore a reduction would reduce any risk and provide some comfort for the residents. Whilst this work is carried out the fork could also have an aerial inspection to check for included bark which may require a greater pruning dose.

| Tree tag | Recommendations | Priority |
|---|---|---|
| 662 | 6. Crown reduce by 4m.<br>7. Aerial inspection of fork at 8m | Medium |

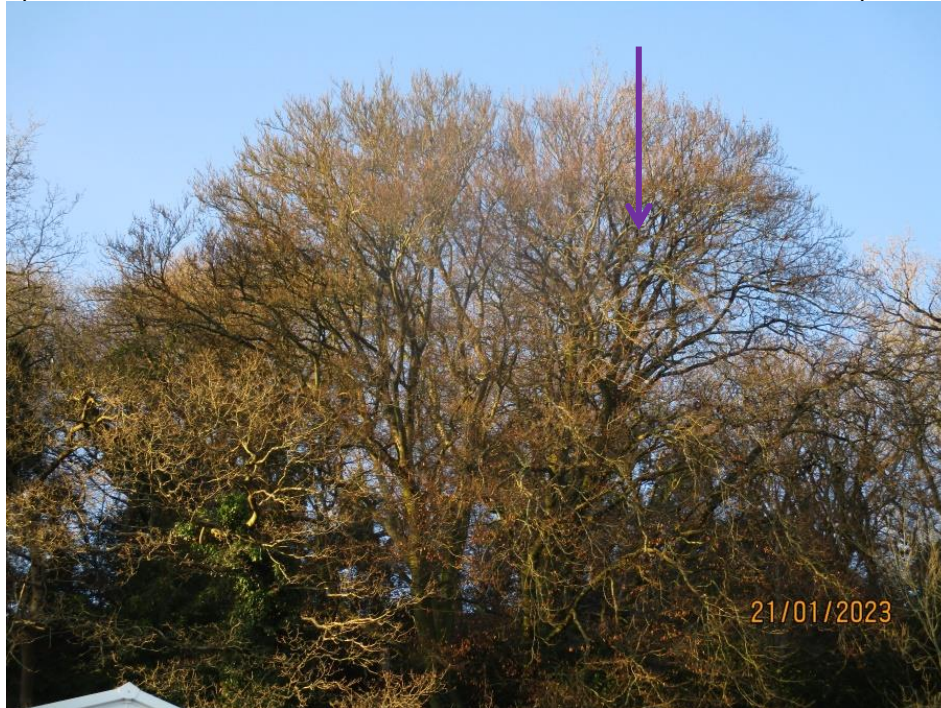
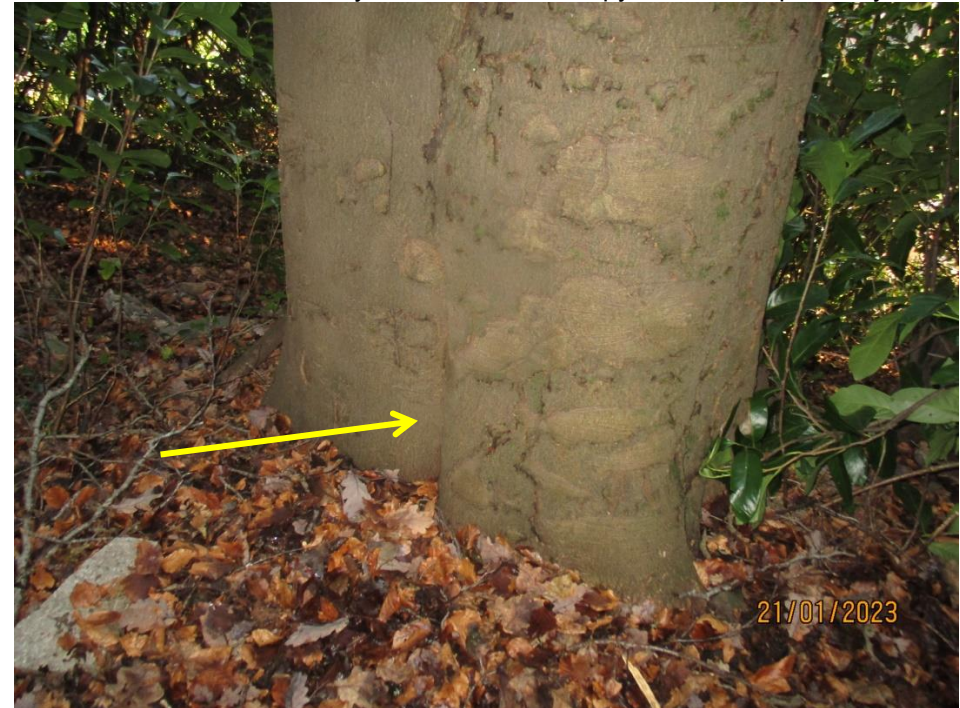
| 663 | Beech<br>( <i>Fagus sylvatica</i> ) | 27 | 12 | M | Leans north to north east and is weighted that way.<br>No pronounced buttress development on tension side (western) of stem (yellow arrow).<br>Sounding does not indicate internal decay.<br>Good bud density, no significant defects observed. Larger of two beech trees and slightly more dominant. | 8. Reduce by 4m | Medium | 2 years |

**Appraisal:** No obvious explanation for under developed buttress roots on the tension side of the stem. Lack of buttressing could indicate root damage in the corresponding area or disruption to the stem, affecting growth. This tree like 662 is the source of anxiety to the near residents. Reduction work would reduce the anticipated low current risk and provide some comfort for the residents. Reduction work would also keep the two trees' crowns matched as they form a mutual canopy due to their proximity.

| Tree tag | Recommendations | Priority |
|---|---|---|
| 663 | 8. Crown reduce by 4m. | Medium |

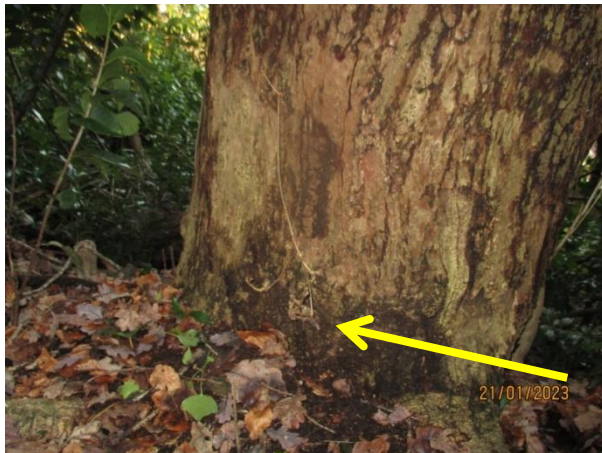
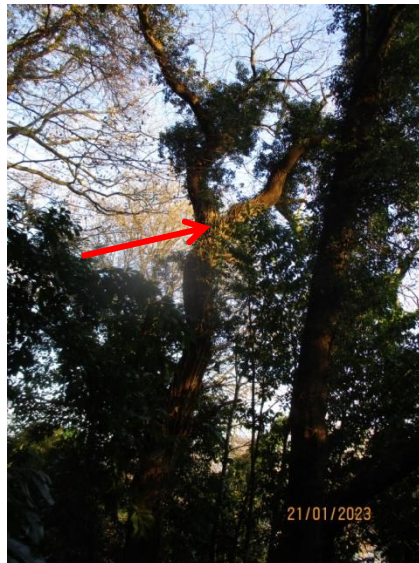
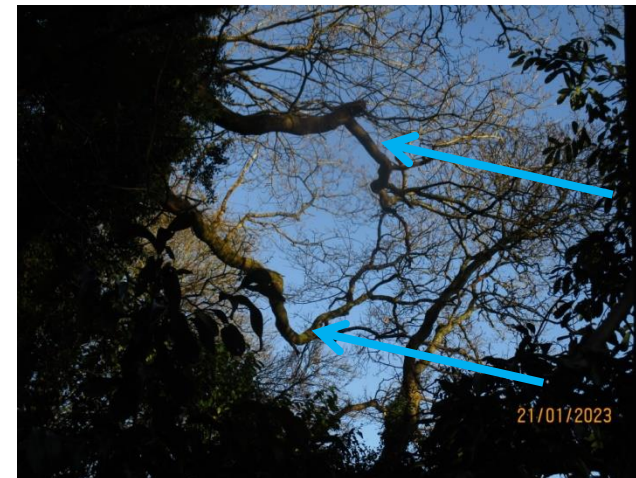
| 664 | Oak<br>( <i>Quercus spp</i> ) | 18 | 12 | OM | Significant ivy covering; weighted to north east (elongated upper branches – blue arrows).<br>Black rhizomorphs and necrotic bark / cambium at base on tension side (yellow arrow).<br>Lost limbs, 2 at 4 metres and at 8 metres. Crown is formed by two significant limbs originating at 12 metres from ground level (red arrow).<br>Branches in excess of 14m in length and end weighted. Good bud density in these branches at ends, rest of tree sparse. | 9. Reduce to 5m | High | NA |

**Appraisal:** The decay at the base of the tree is likely to have affected the roots on the tension side of the tree making failure more likely. The asymmetrical crown is caused by mutual shading from other trees in the woodland. The elongated branches even if fully healthy are at risk of failure due to their length. Failure of these branches could reach the gardens below. Considering the trees poor health, risk posed by the main branches and the proximity to potential targets this tree should be significantly reduced or removed completely. Retaining a high stump would retain habitat and dead wood within the woodland, both important for biodiversity.

| Tree tag | Recommendations | Priority |
|---|---|---|
| 664 | 9. Reduce to 5m pole | High |
