# GeoShield Verification Report

PROJECT REFERENCE: GEO102875

PROJECT: Neath Port Talbot Hospital (Orthopaedic Unit).

REPORT NUMBER: 001

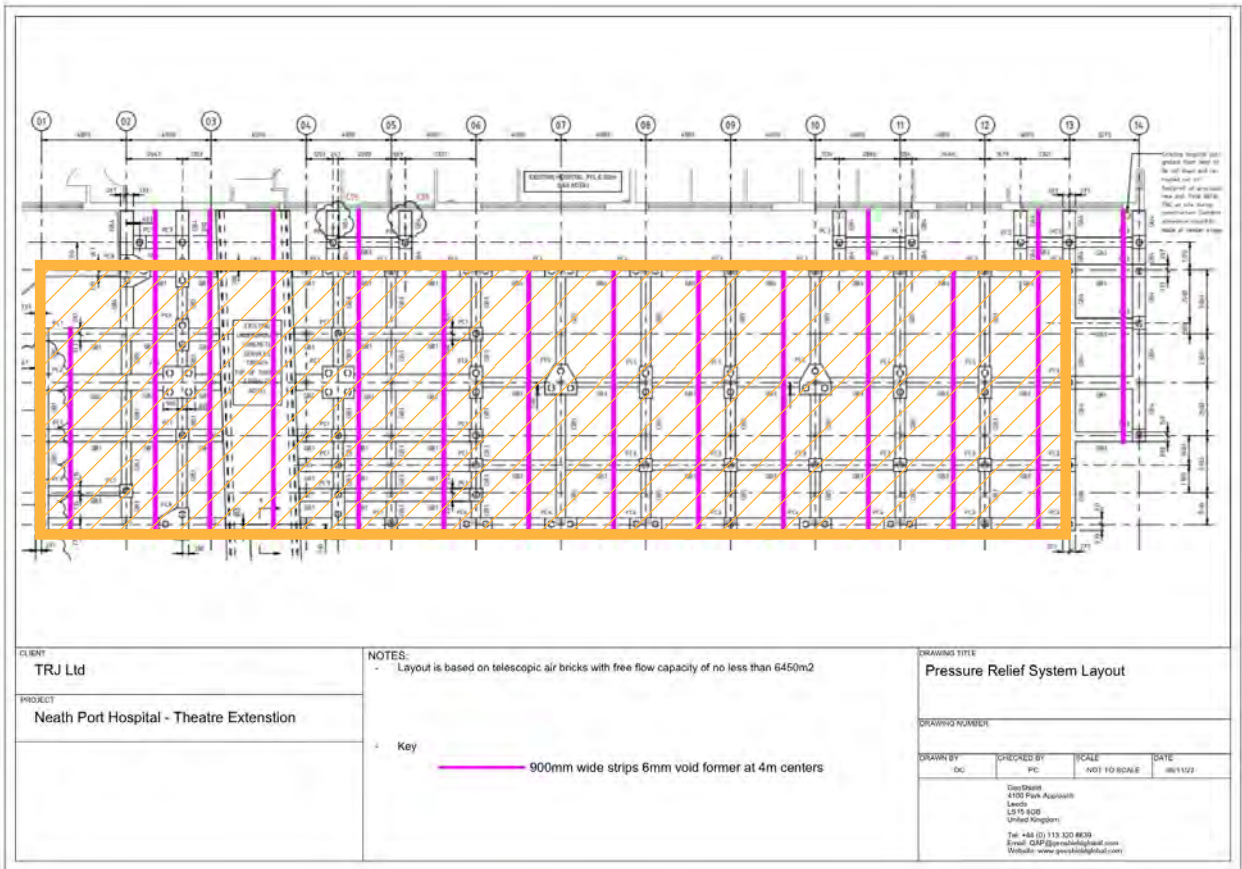
The area highlighted in orange above shows where the installers have installed the JUTA GP1 Gas Membrane and verification took place during this visit.

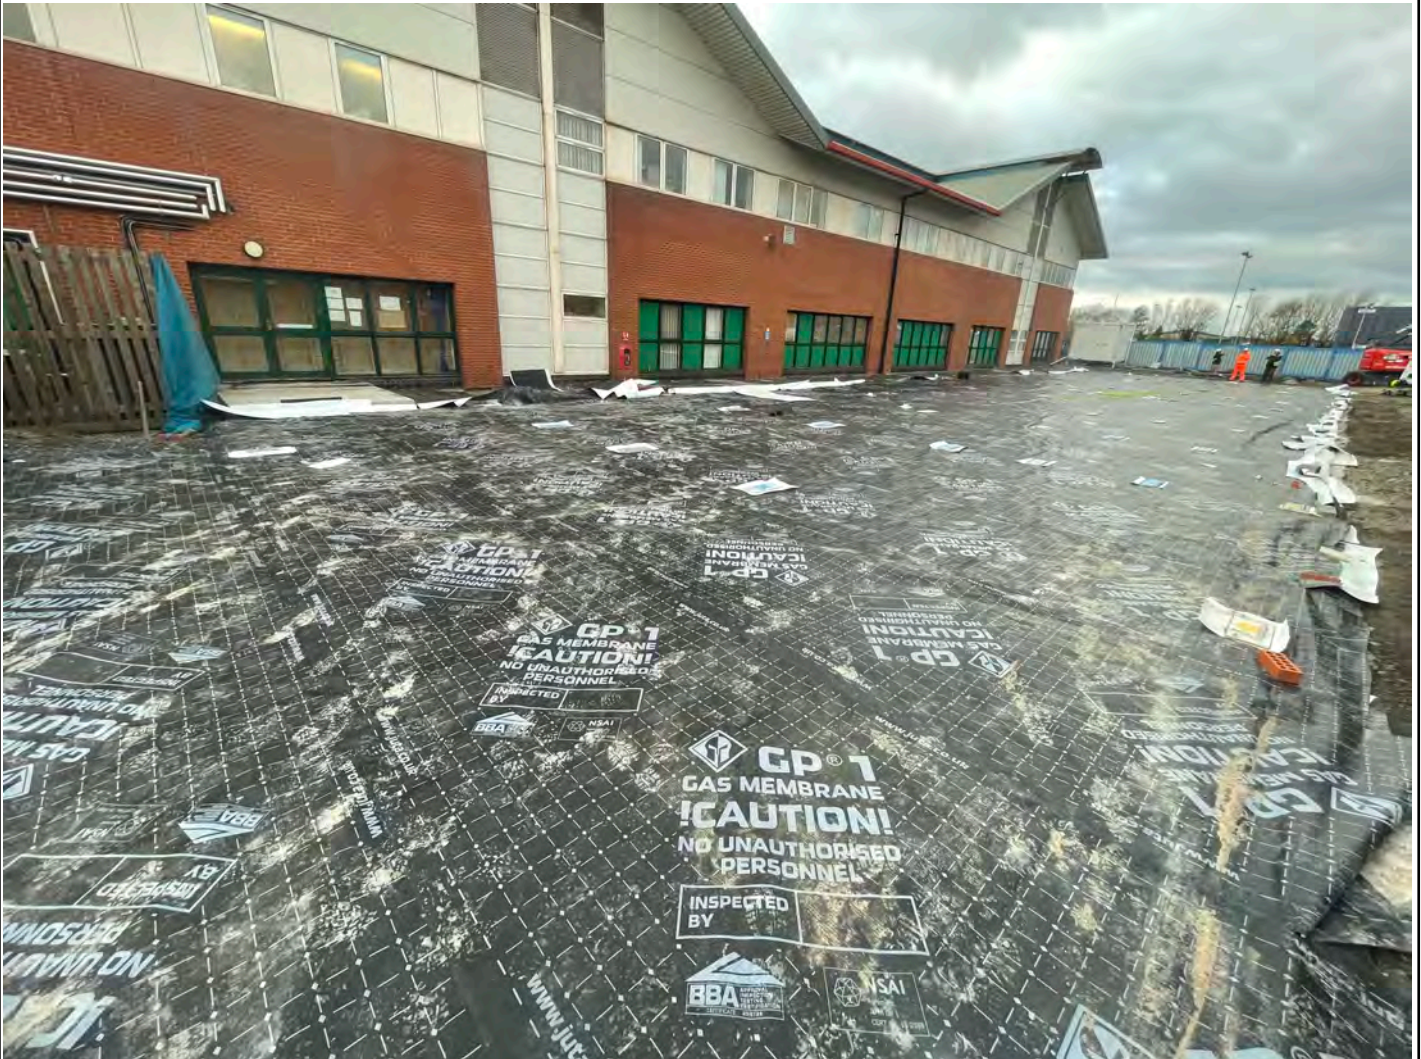
The photograph above shows an overview photograph of the installed

JUTA GP1 Gas Membrane to the majority of the main building.

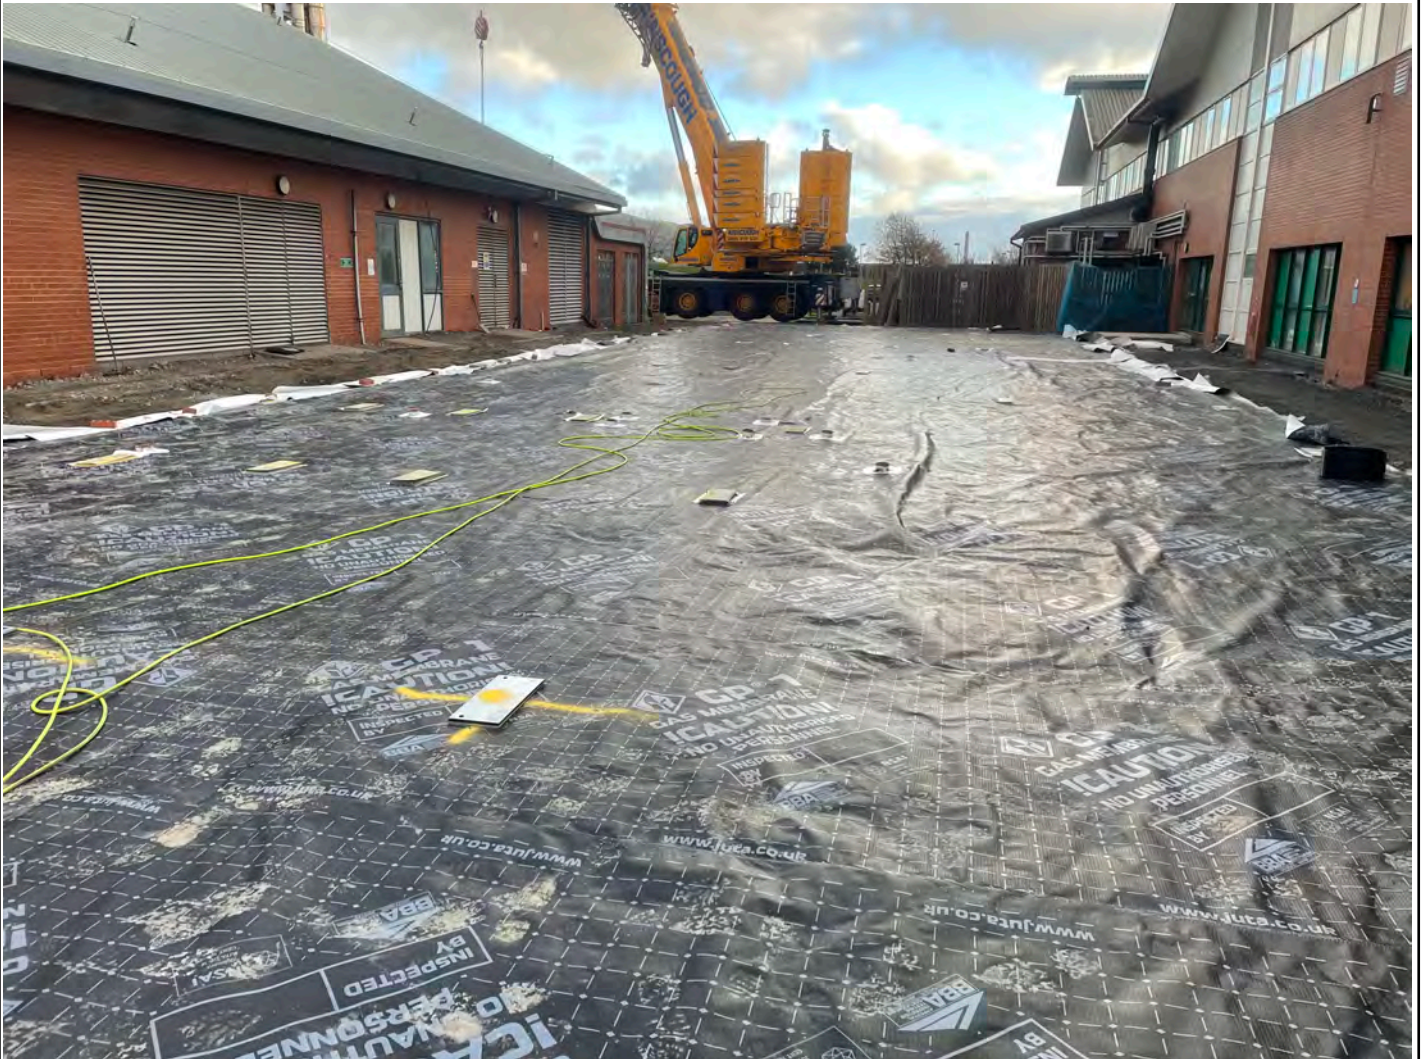
The photograph above shows an additional overview photograph. Three bays

still need to be installed after the modules have been installed.

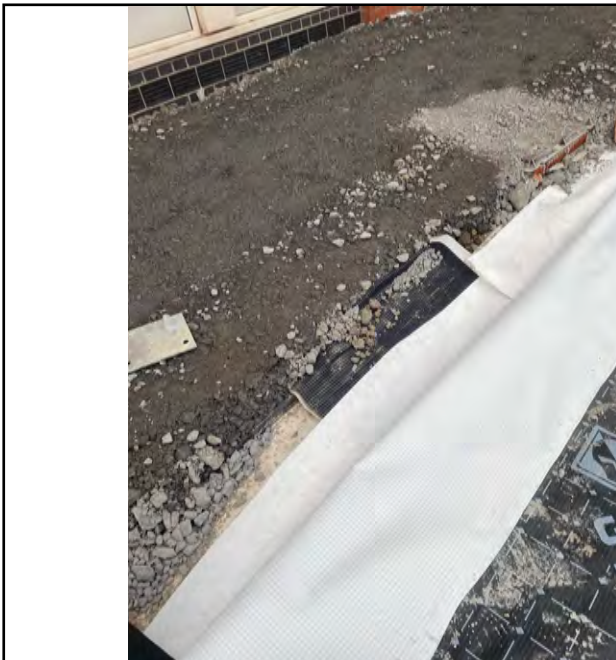
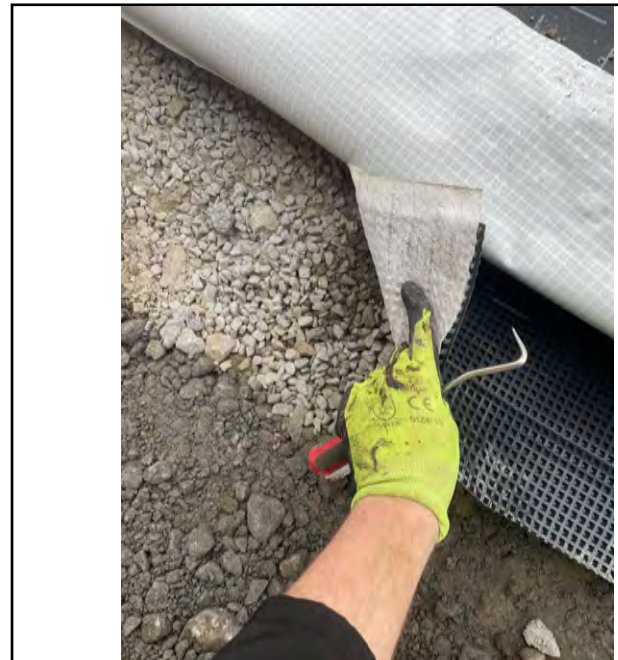
LOCATION/GRID LINE: Gridlines A-F/01-13.

NOTES: Vent mat installed (pressure relief system).

The first photograph below shows the vent mat installed under the JUTA GP1 Gas

Membrane as part of the pressure relief system. As shown in the second photograph

below Geotextile fleeced side of the vent mat has been installed face down as per the...

... manufacturers specification. The vent mat has been installed the complete width of

the modular building where the gas membrane has been installed so the can limit to vents.

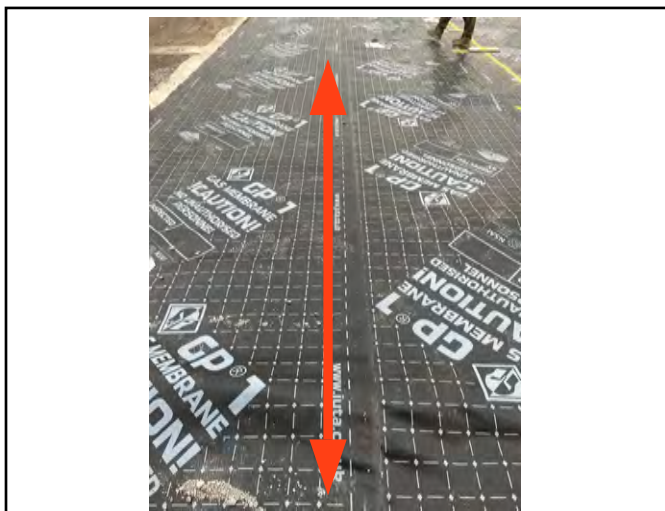
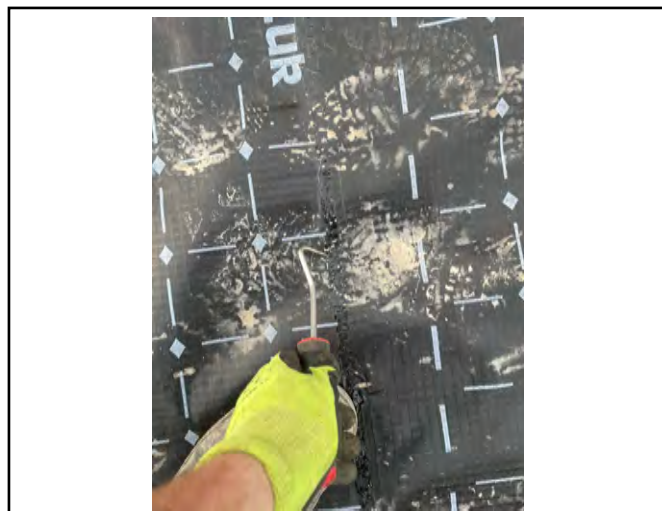
LOCATION/GRID LINE: Gridlines A-F/01-13.

NOTES: Installation of the JUTA GP1 Gas Membrane.

The first photograph below shows an overview of a welded lap of the JUTA GP1 Gas Membrane. The installers have first lapped the gas membrane at least 100mm before using a hot air leister and roller to weld each lap.

The installers have achieved a strong and consistent 40mm weld. A couple miss welds were identified when carrying out air lance testing. All these faults have been patch repaired using JUTA GP1 SAM. The second photograph above shows a pick and probe test carried out to a welded lap. No faults or defects remained after this visit. Verified in accordance with CIRIA 735.

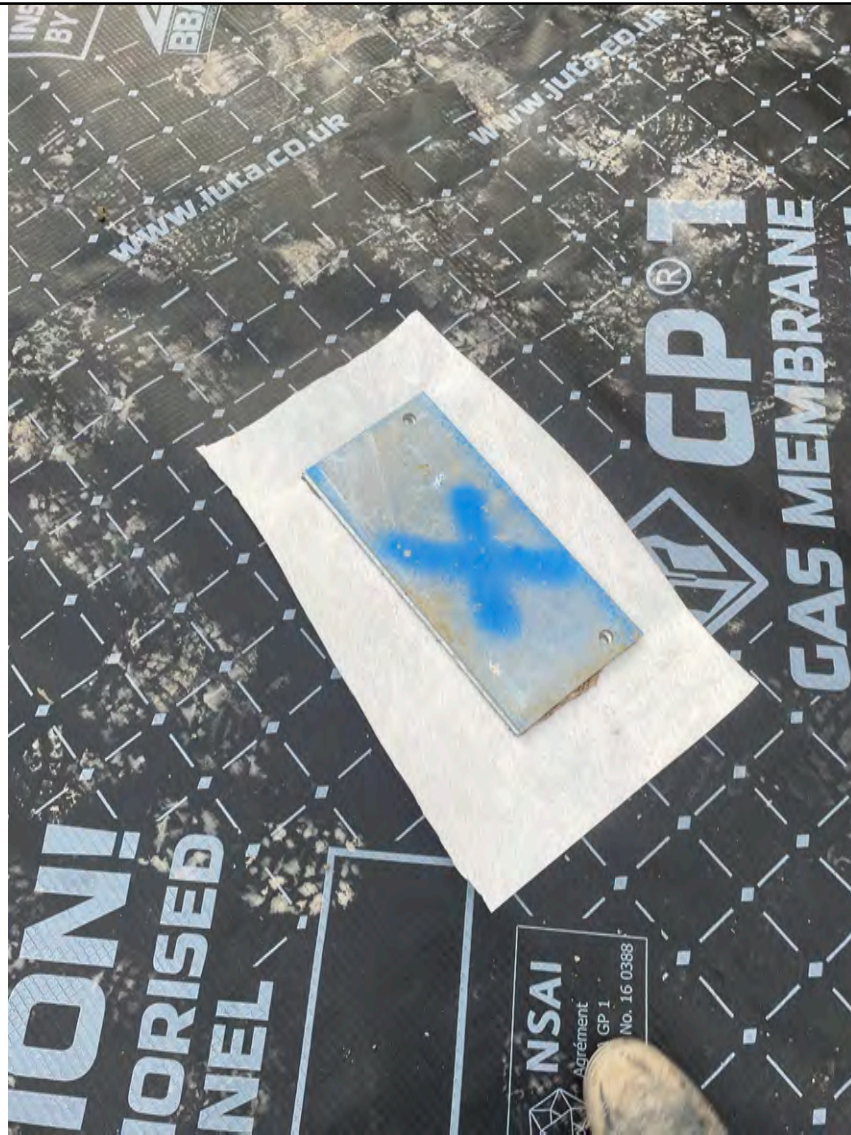
The photograph above shows the installers have installed the Geotextile fleece

in between the steel plates and membrane, there is also Geotextile fleece under the

gas membrane to protect the membrane from any small bumps in the concrete under

the membrane.

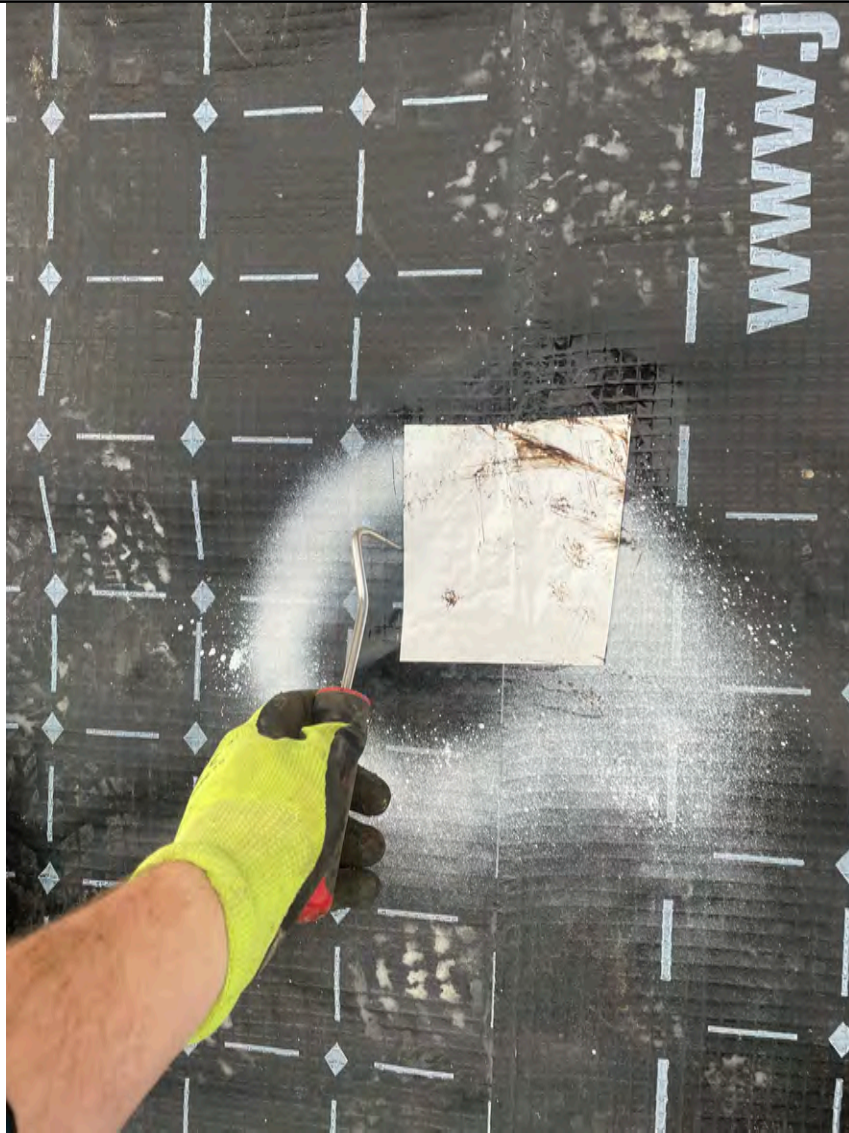
The photograph above shows a pick and probe test carried out to a patch repair.

Air lance testing identified two miss welds, both have

been patch repaired as shown above. A hot air leister and roller has been used to

aid in the adherence of the JUTA GP1 SAM.

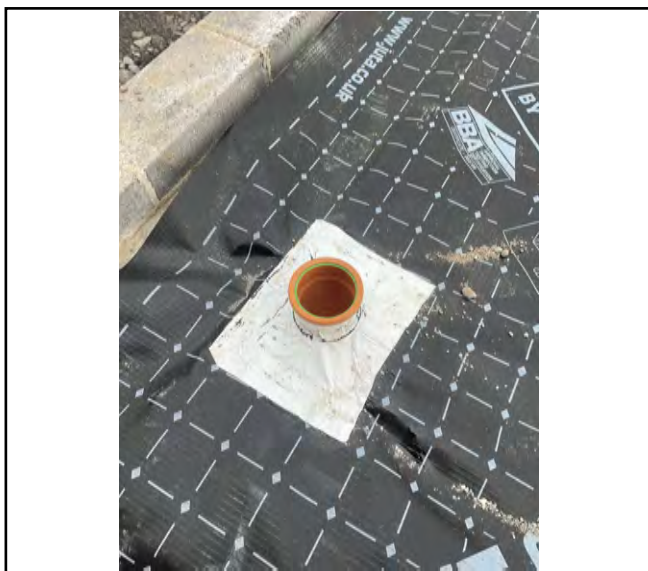
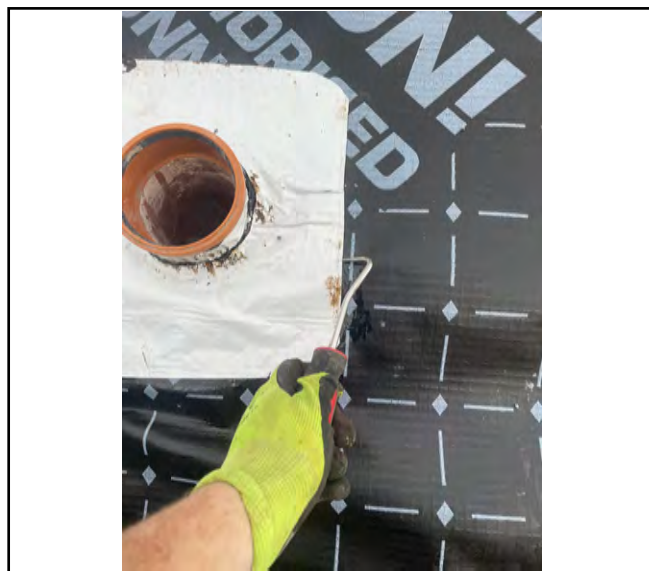
LOCATION/GRID LINE: Gridlines A-F/01-13.

NOTES: Pipe penetration and steel plates sealed.

The first photograph below shows an example of a sealed pipe penetration which was verified during this visit. The installers have first cut the JUTA GP1 Gas Membrane tight around each pipe to minimise any gaps.

Heat has been applied to aid in the adherence of the JUTA GP1 SAM. The second photograph shows a pick and probe test carried out to a sealed pipe penetration.

A strong seal has been achieved. Verified in accordance with CIRIA 735.

Next JUTA GP1 SAM has been used to seal each pipe the JUTA GP1 Gas Membrane.

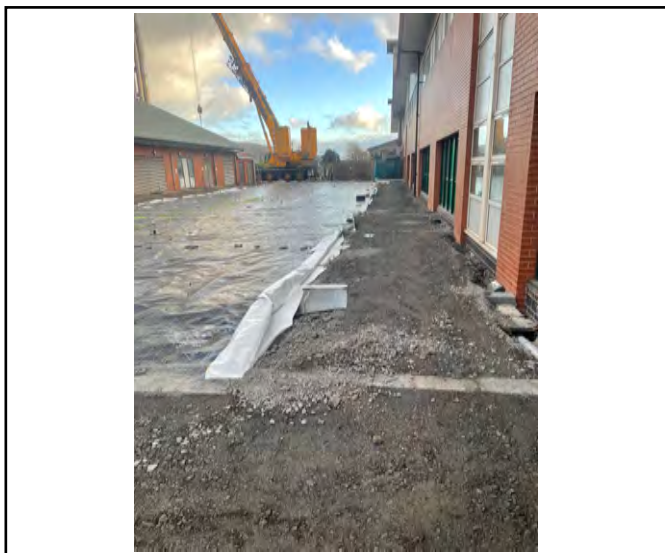
Overview photograph of area where  
three bays are still to be installed.

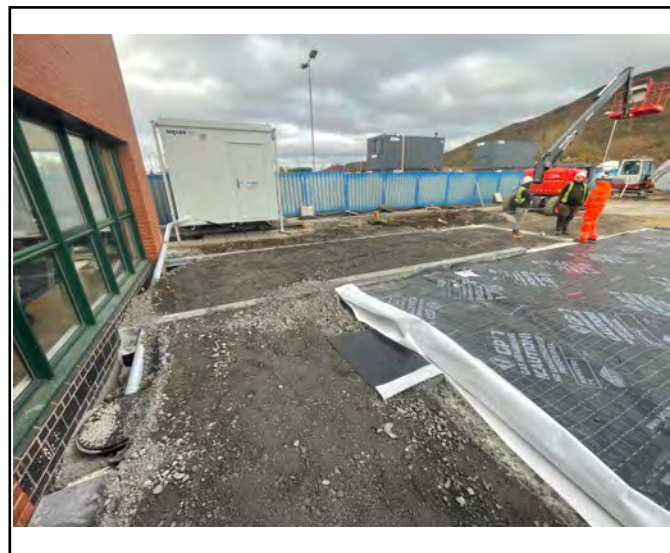
Additional overview of one of the  
bays to be sealed.

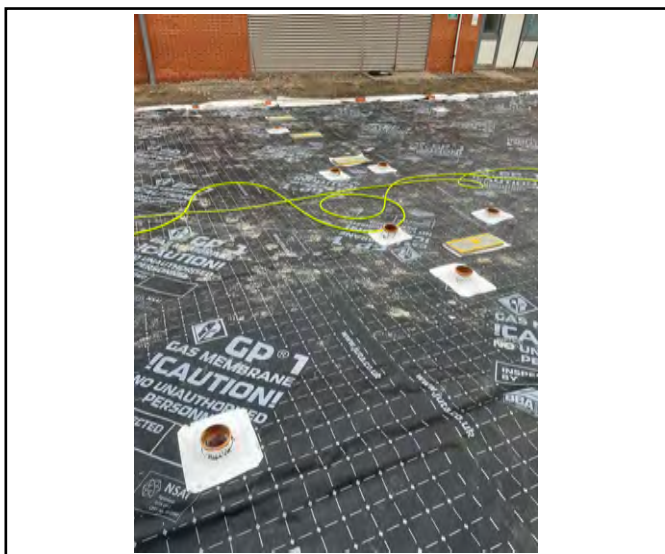
Additional sealed details using JUTA

GP1 SAM.

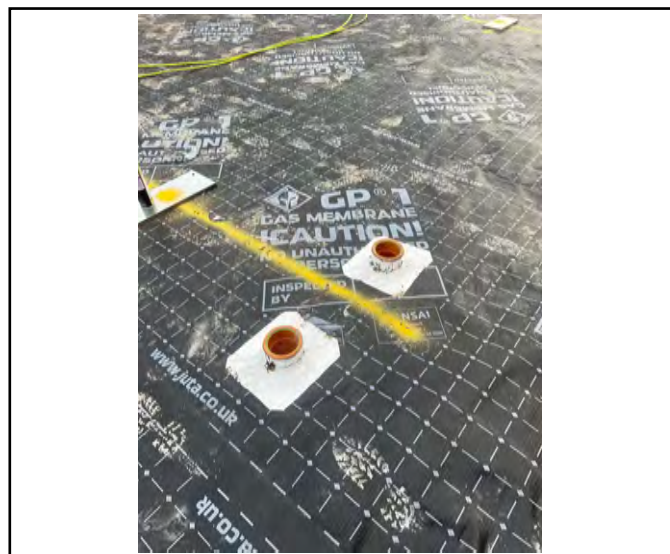
Additional sealed details.

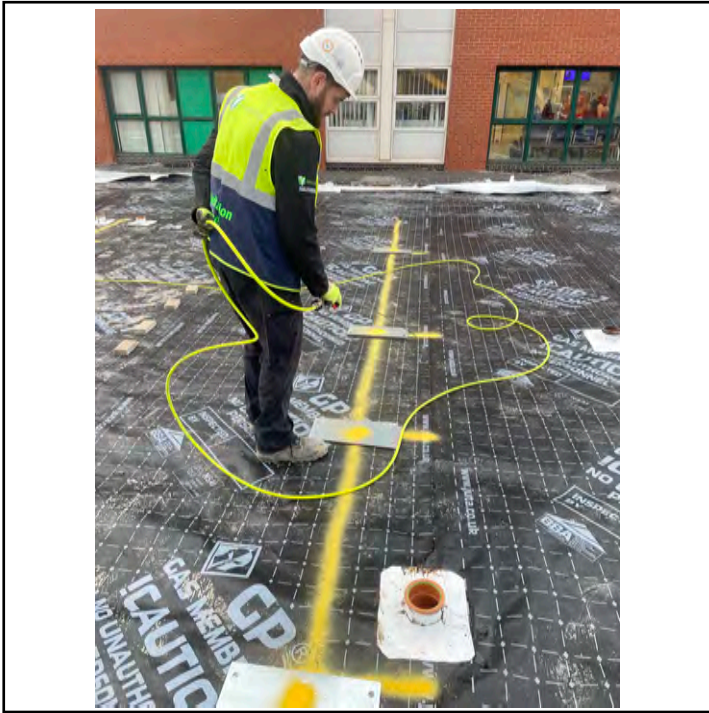
Air lance test to welded lap.

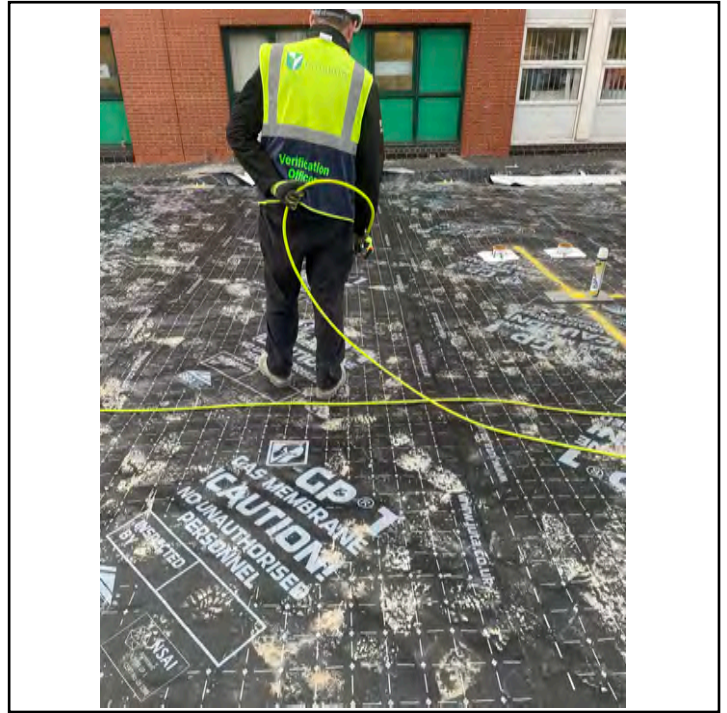
Air lance test to welded lap.

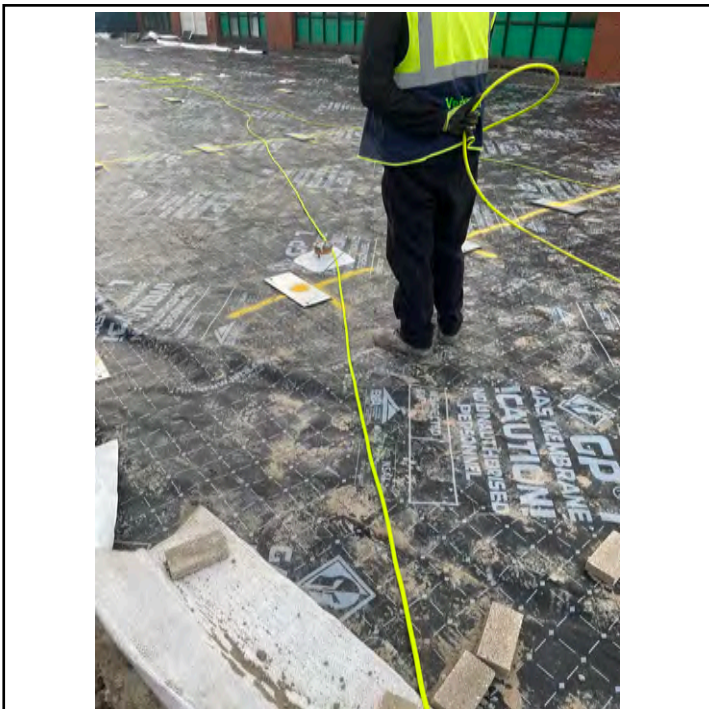
Air lance test to sealed pipe penetration.

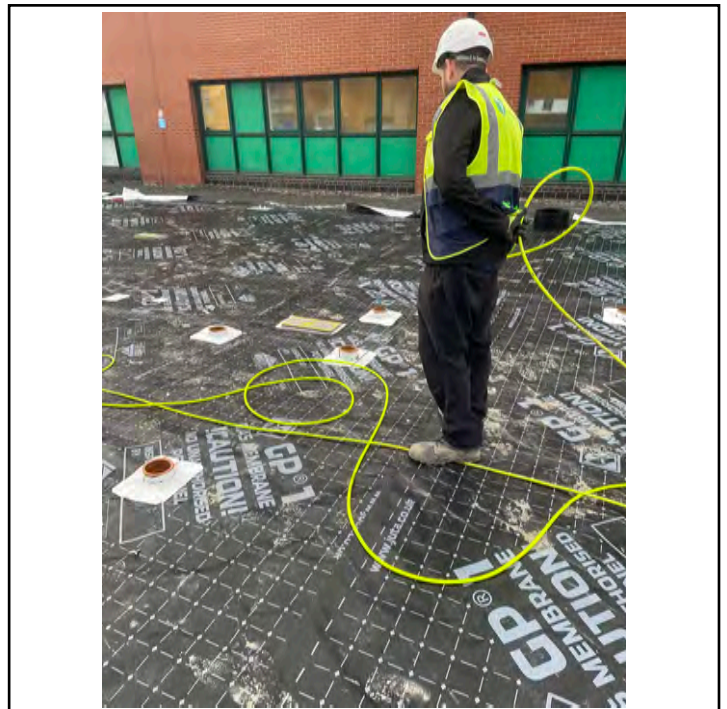
Air lance test to sealed pipe penetration.
