# GeoShield Verification Report

PROJECT REFERENCE: GEO102875

PROJECT: Neath Port Talbot Hospital (Orthopaedic Unit).

REPORT NUMBER: 002

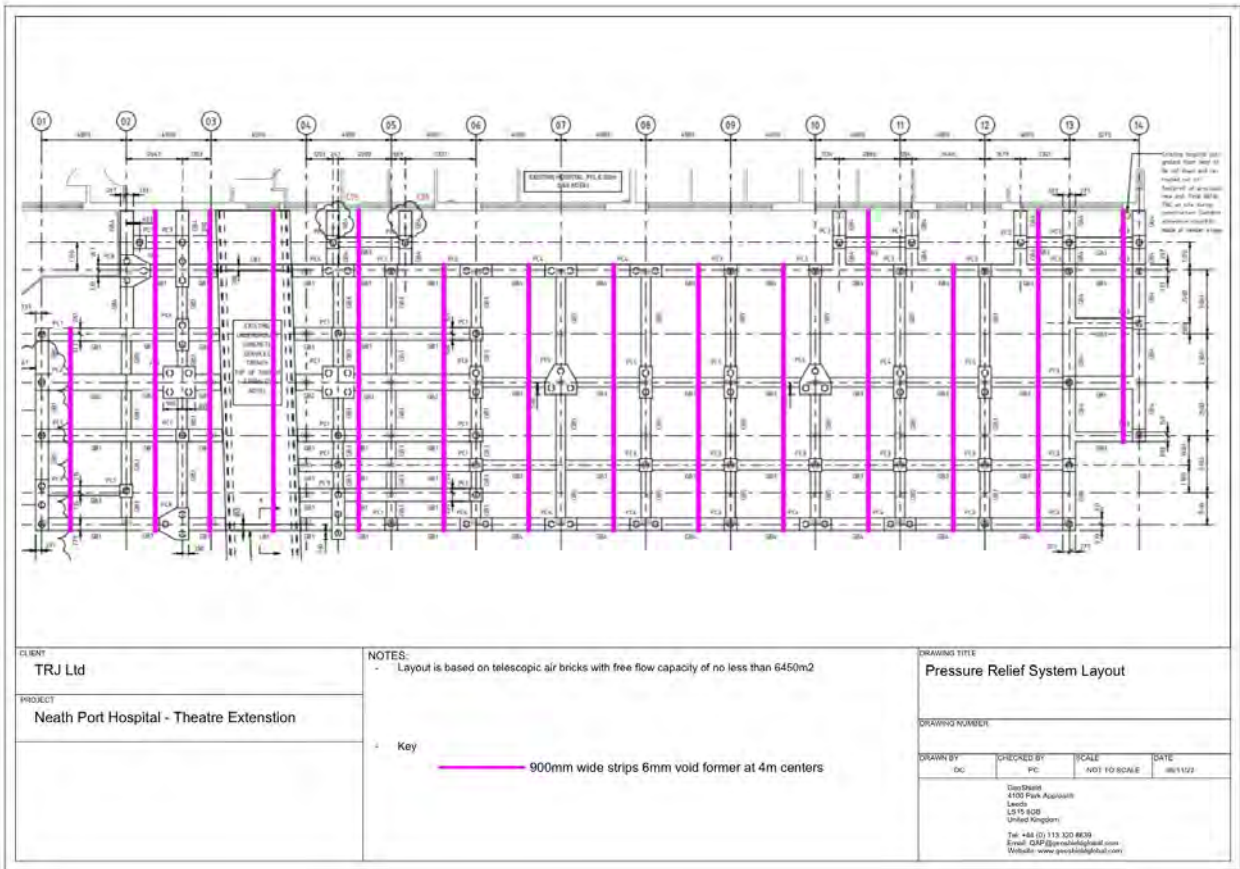
## VERIFICATION LAYOUT

The site layout above shows where the ground floor modules have started to be dropped into place, six modules installed during today's visit.

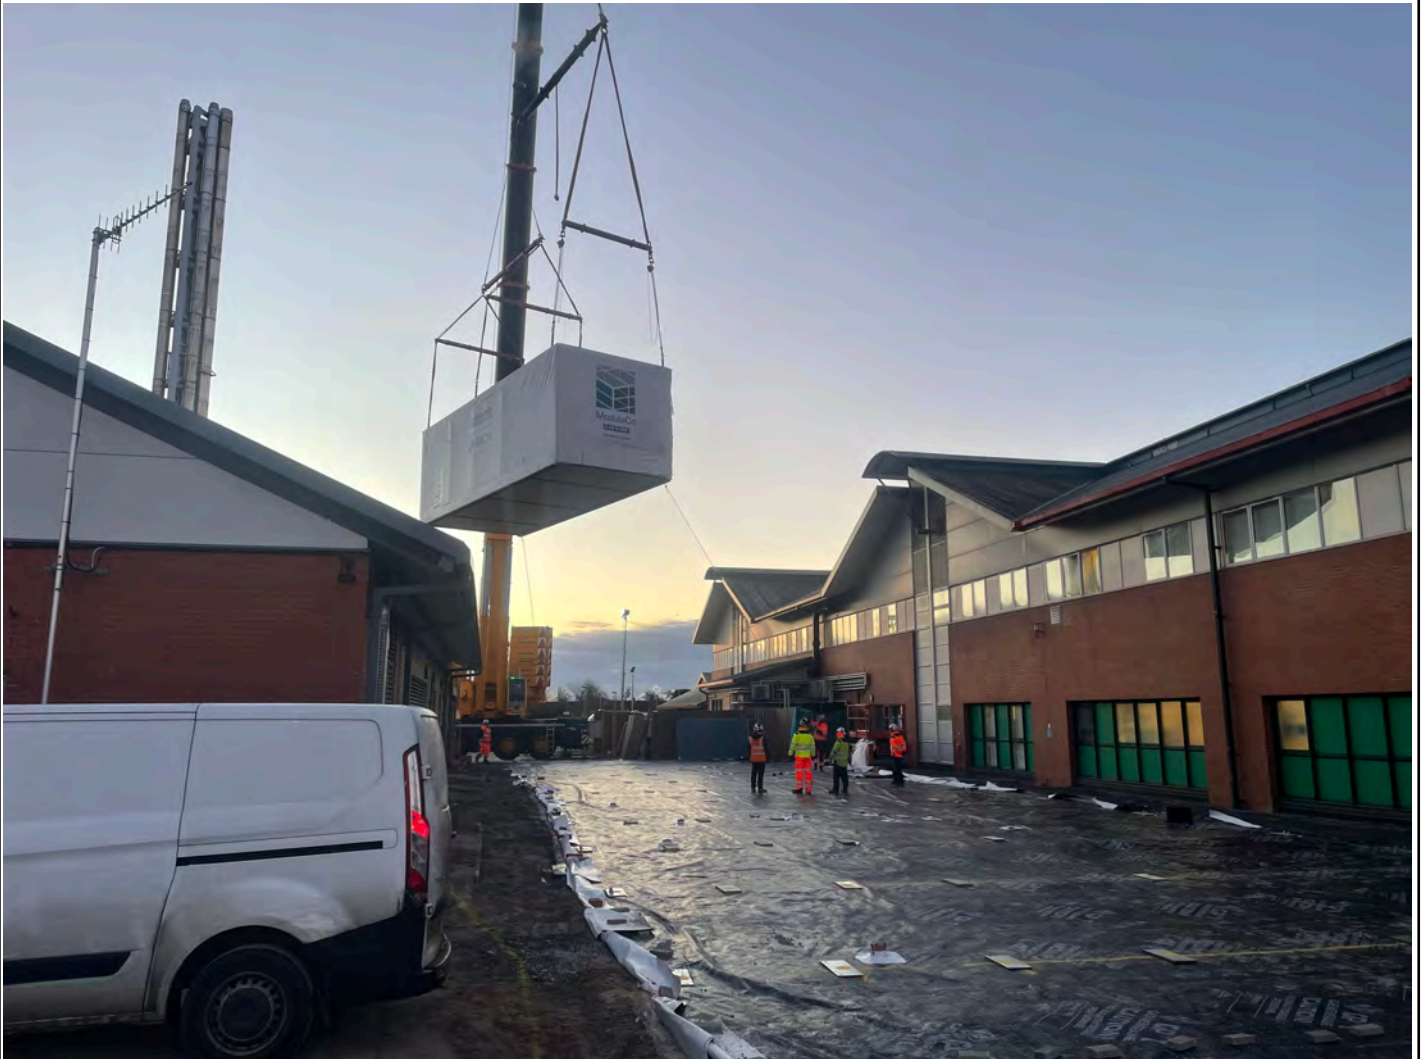
The photograph above shows an example of a module being dropped into

place using the crane.

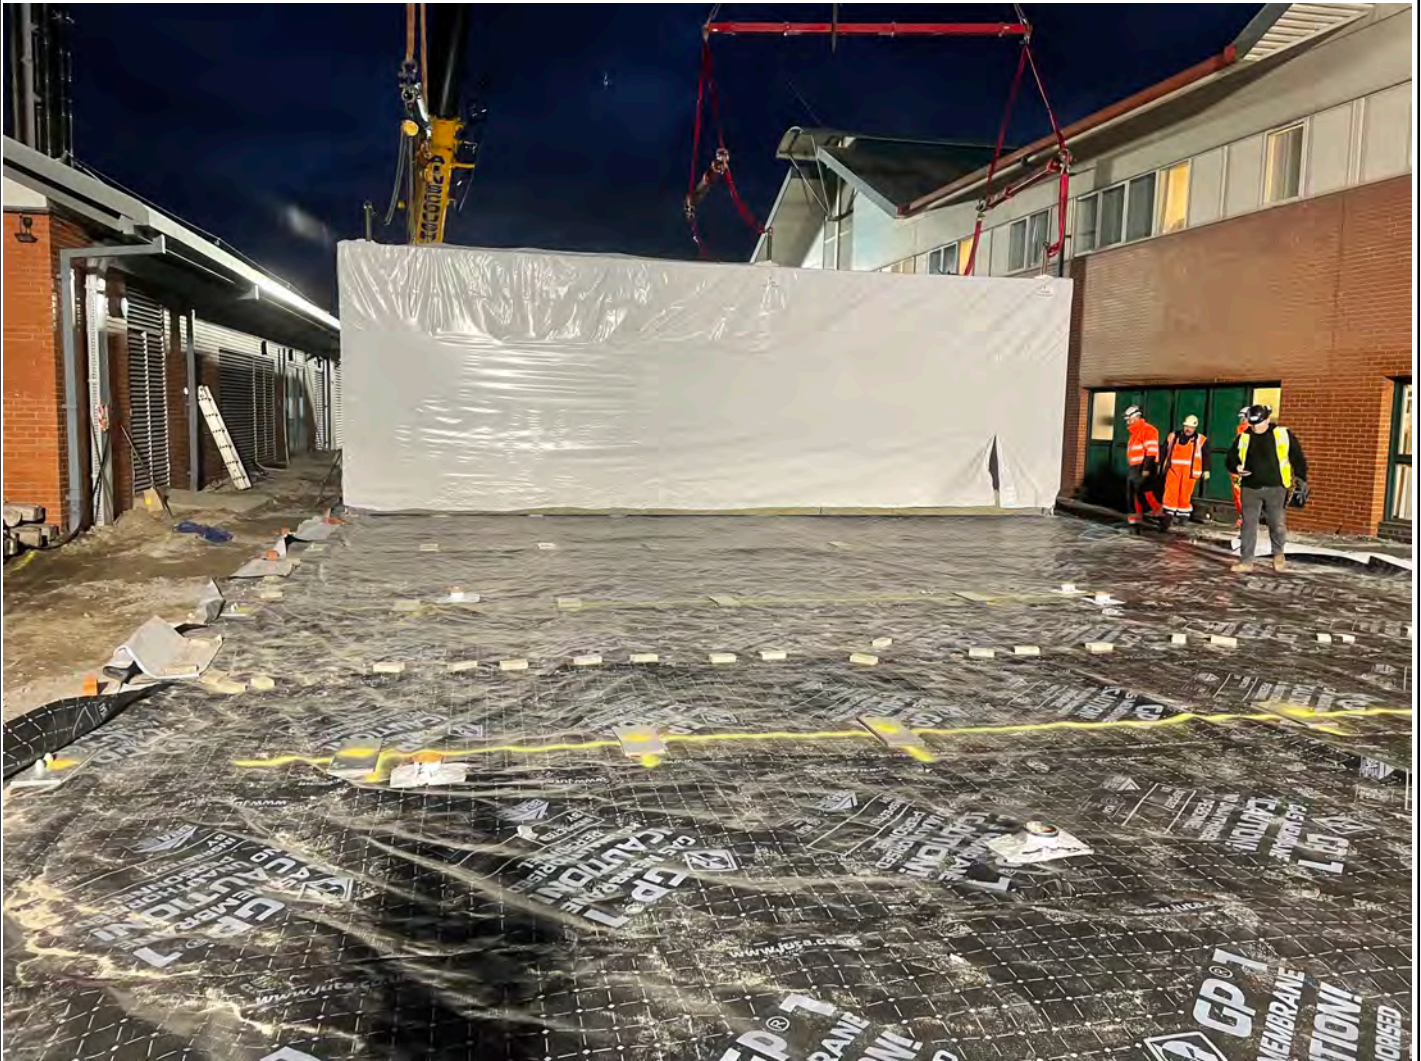
The photograph above shows a module fully dropped into place. No damage

was caused to the JUTA GP1 Gas Barrier during this verification visit.

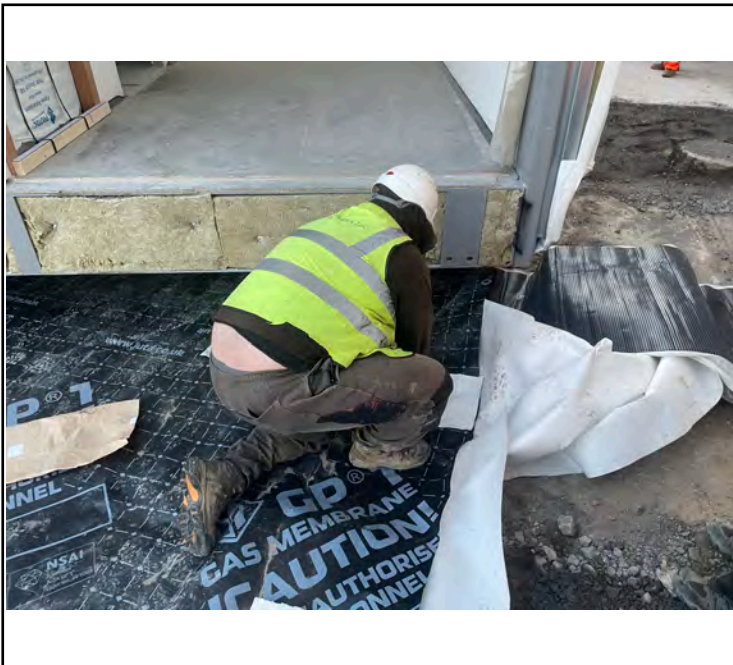
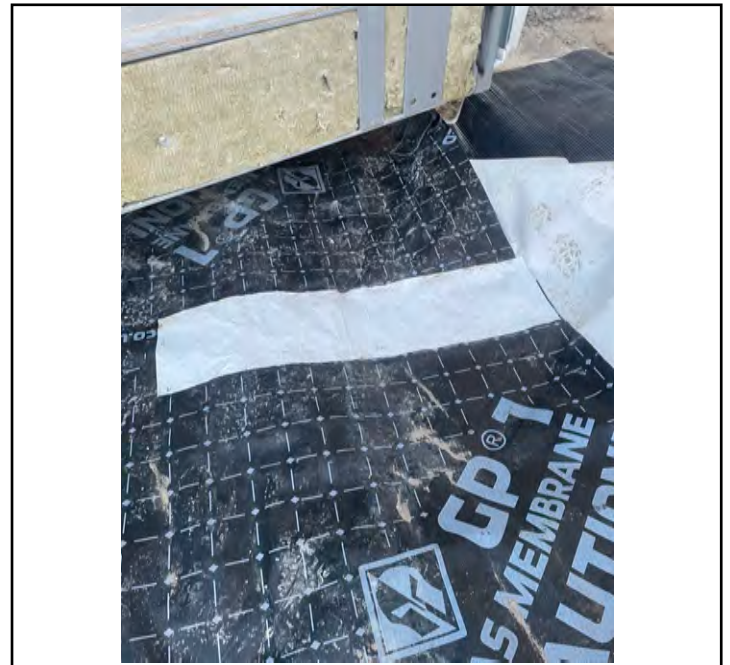
## VERIFICATION ITEM ONE

The first photograph below shows one of the installers carrying out remedial works to the JUTA GP1 Gas Membrane. One lap had not been welded far enough and it did not extend past the sides of the modular builds.

To rectify this issue the installers have applied a length of the JUTA GP1 SAM. A gas blow torch was used to aid in the adherence of the GP1 SAM.

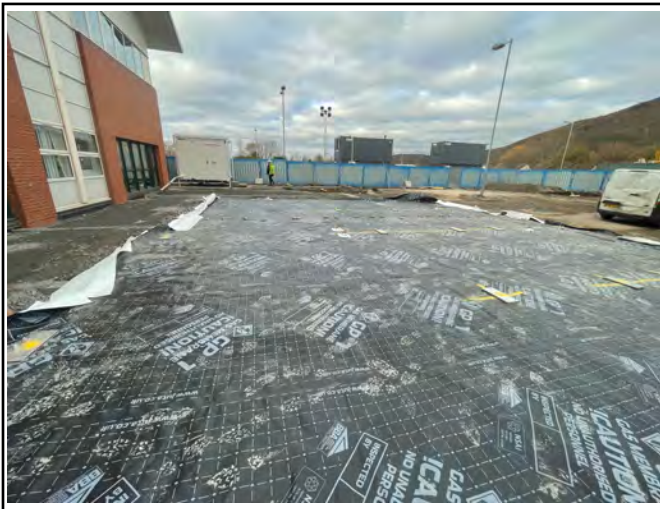
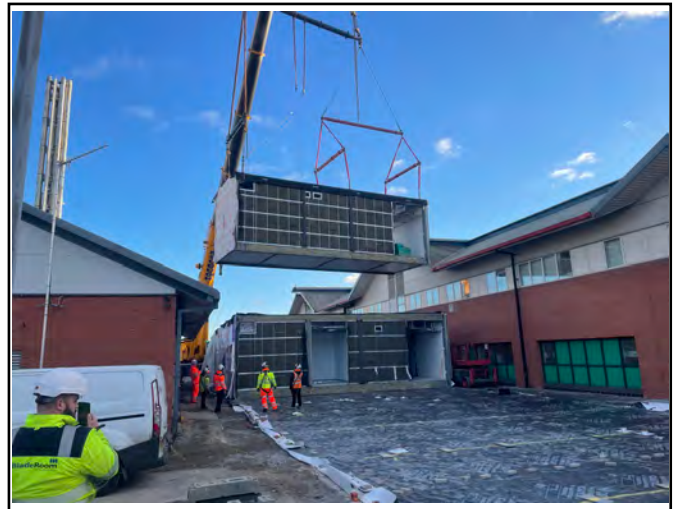
## VERIFICATION ITEM TWO

The first photograph below shows an overview of the previously installed JUTA GP1 Gas Membrane. The membrane was inspected once again before modules were dropped into place.

This was to ensure any damage to the membrane or faults identified had been rectified prior to the modules being installed. As mentioned in the last verification item, one lap needed to be sealed past the module edges, this has been done using JUTA GP1 SAM. Care has been taken to ensure no damage was caused to the JUTA GP1 SAM.

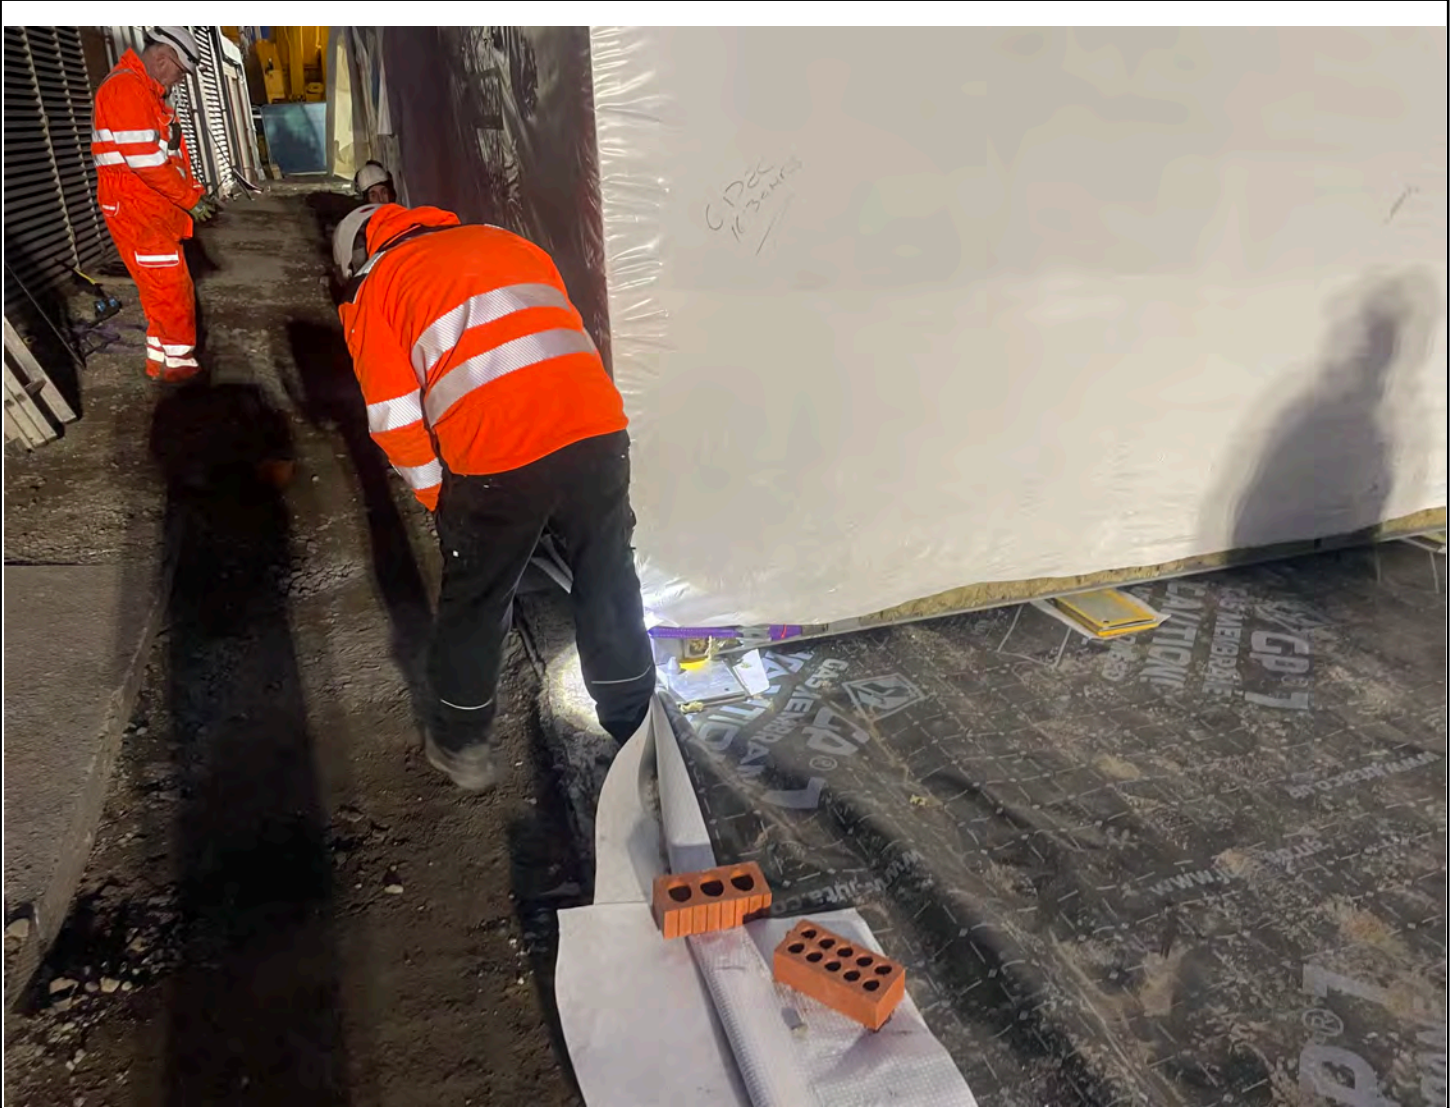
The photograph above shows a close up of one of the modules installed to the

ground floor. The plates have kept the modules having direct contact with the

membrane and the modules were dropped slowly to avoid damage being caused to

the modules.

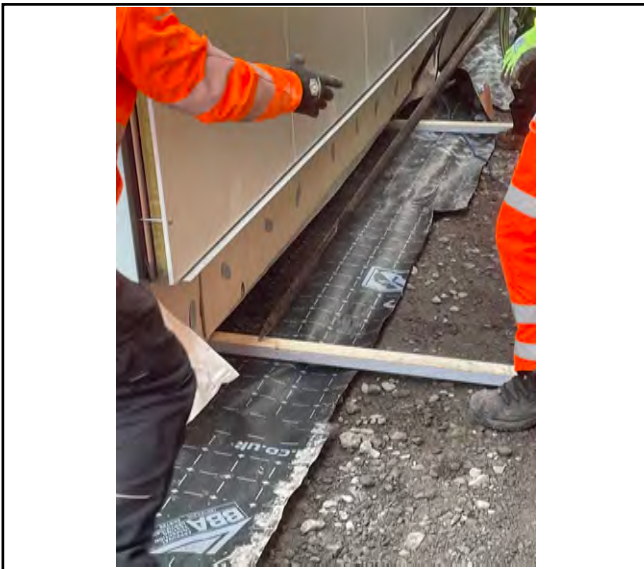
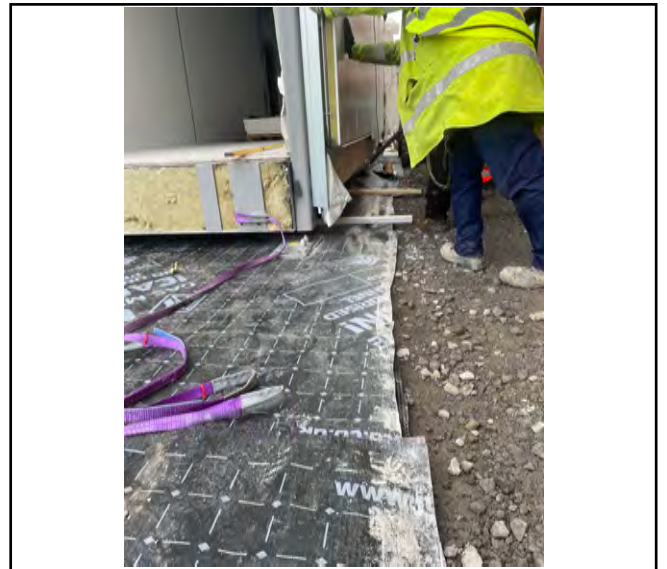
## VERIFICATION ITEM THREE

The first photograph below shows the contractors installing the ground floor modules.

If the modules needed moving pieces of wood were first slid under the modules before using metal bars to slightly move the modules.

The pieces of wood have been successful in protecting the membrane. No damage was identified and the modules were then dropped into the correct place once they have been moved.
