# GeoShield Verification Report

PROJECT REFERENCE: GEO102875

PROJECT: Neath Port Talbot Hospital (Orthopaedic Unit).

REPORT NUMBER: 003

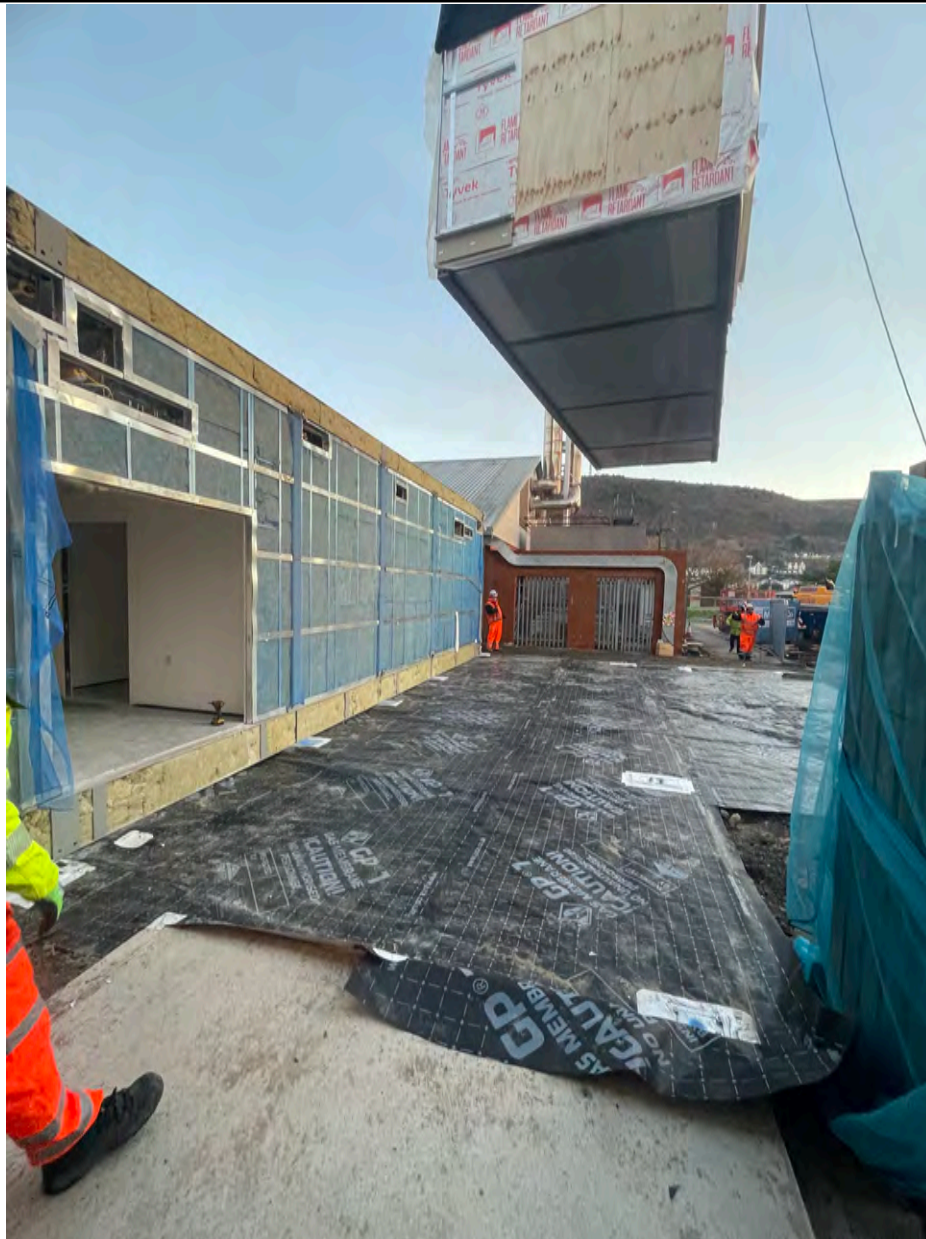
The photograph above shows one of the modules being installed during this

visit to site.

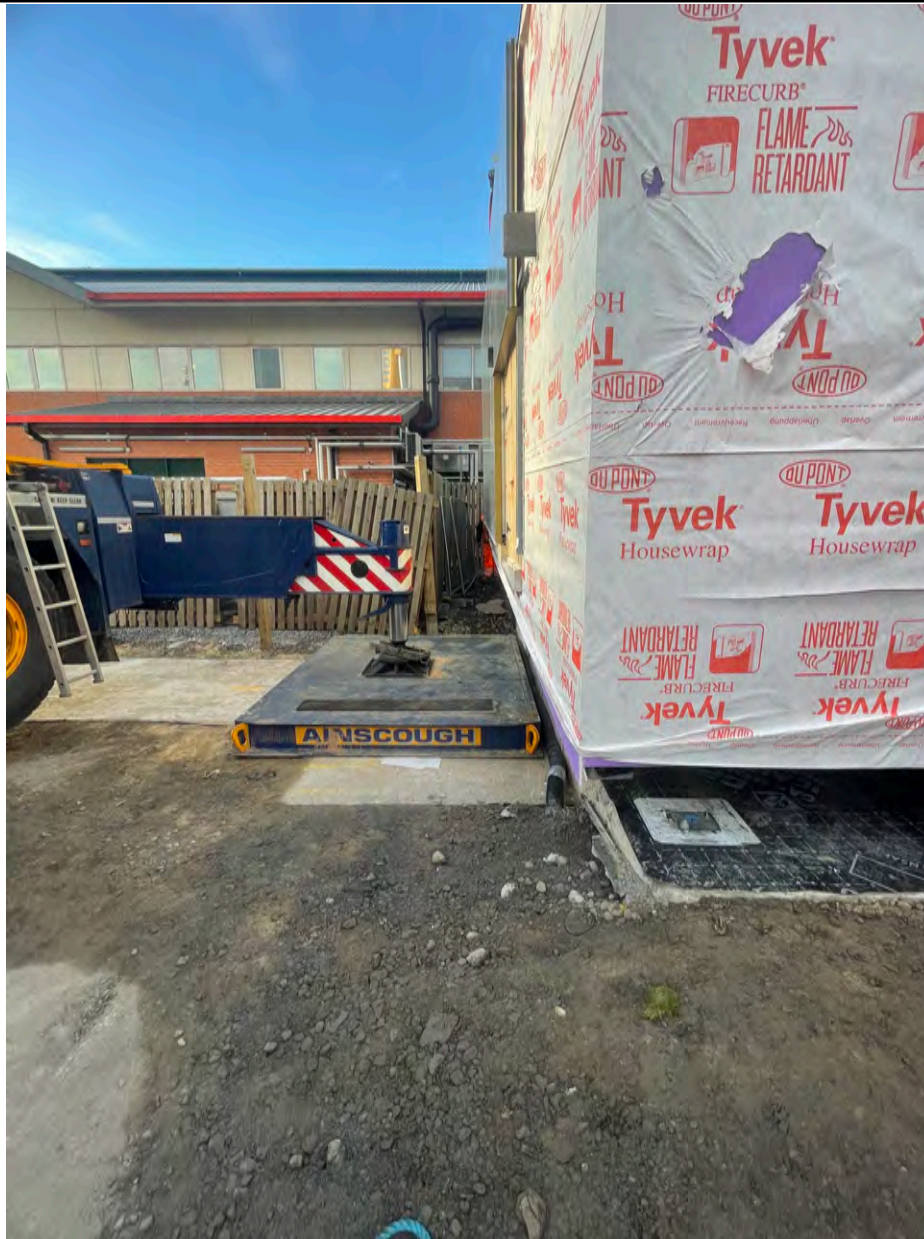
The photograph above shows the module being carefully dropped into place.

Gas membrane was not directly harmed when dropping the modules.

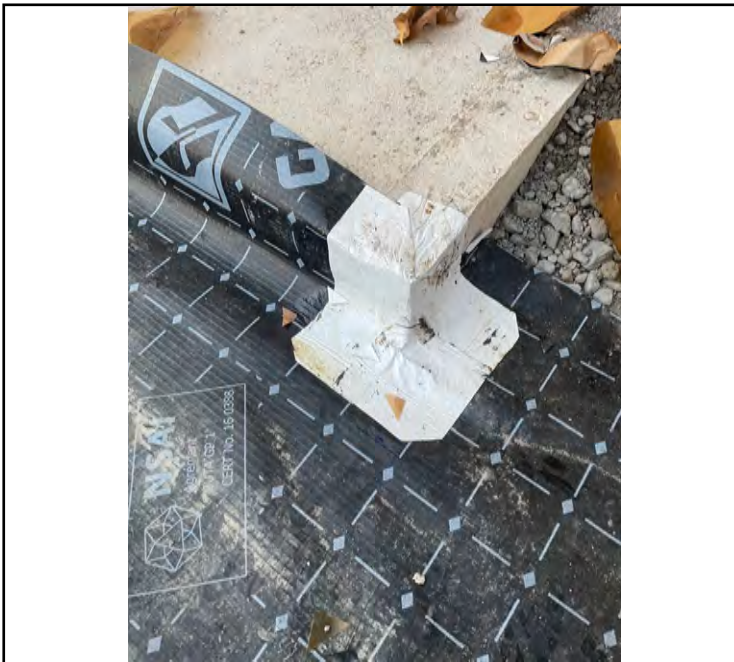
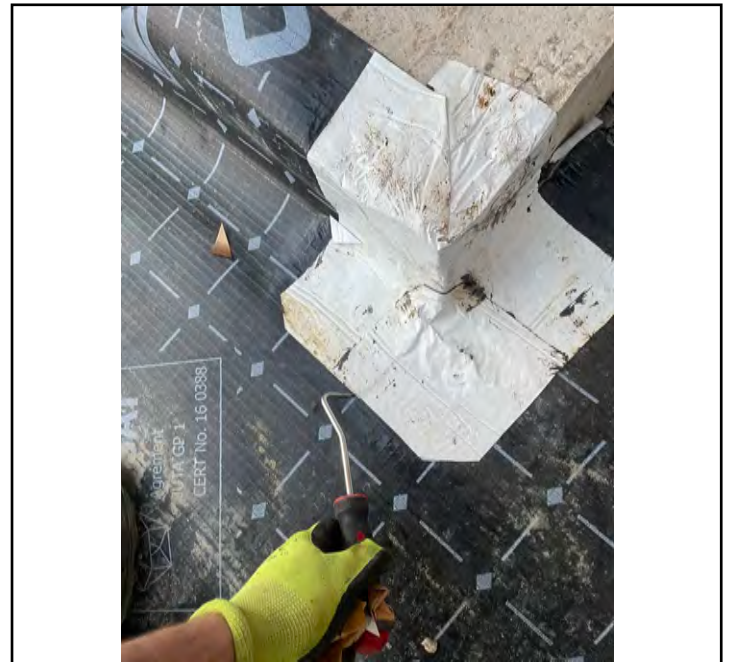
LOCATION/GRID LINE: Gridlines: 01-02/A

NOTES: Corner and lap sealed.

The first photograph below shows an example of a sealed corner detail carried out during this visit. This was not previously sealed as the module location was not known.

Once it was clear how close the module was going to be dropped into place the corner...

... was sealed using JUTA GP1 SAM. The second photograph above shows a pick and probe test. Verified in accordance with CIRIA 735. Strong seal achieved.

| Date | Nr | Remediation Description | Y/N |
|---|---|---|---|
| 07/12/2022 | 003 | 1. One corner and lap needed to be sealed as the module being | ✓ |
| | | dropped into place was close to these details and would've been | ✓ |
| | | much harder to seal and a sufficient lap could not have been | ✓ |
| | | achieved. | ✓ |

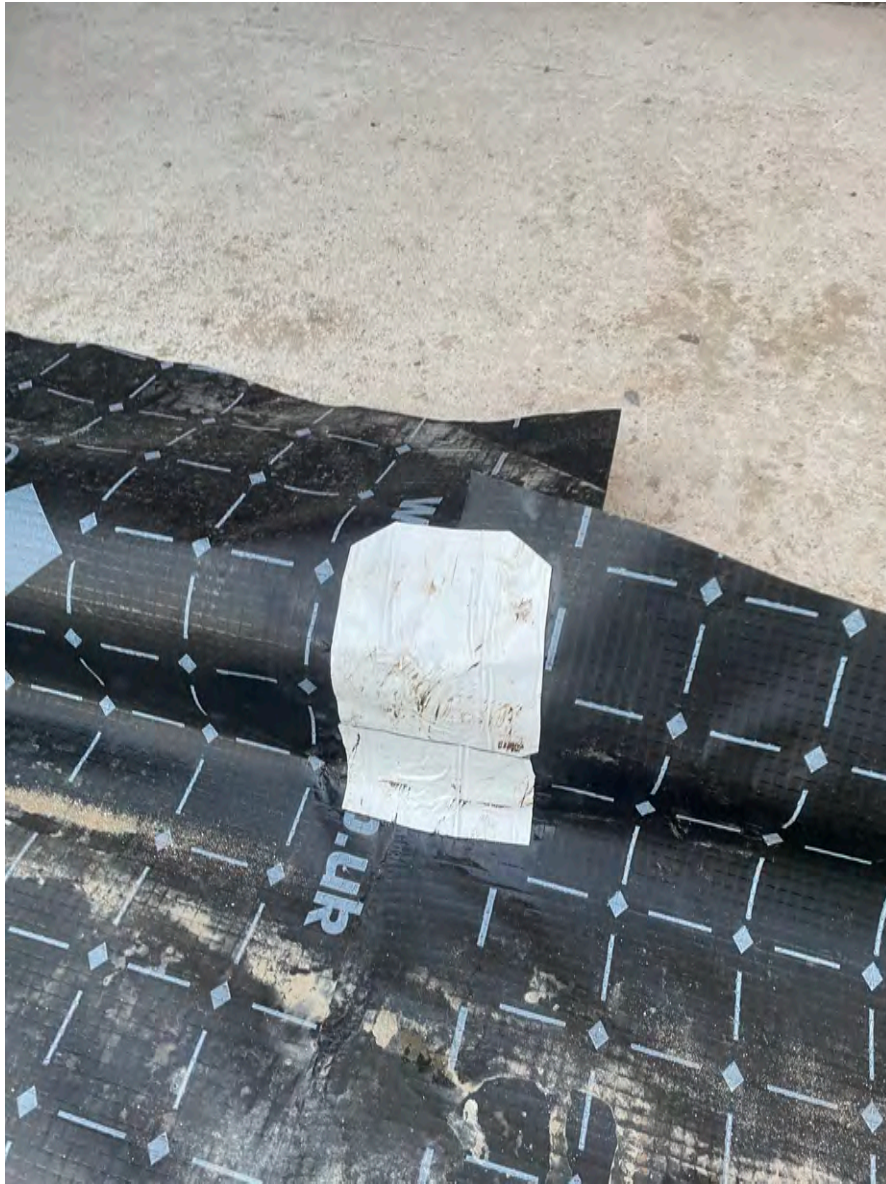
The lap shown above is adjacent to the previously shown corner in this report. It needed to be sealed using JUTA GP1 SAM. A gas blow torch has been used to aid in the adherence of the GP1 SAM.

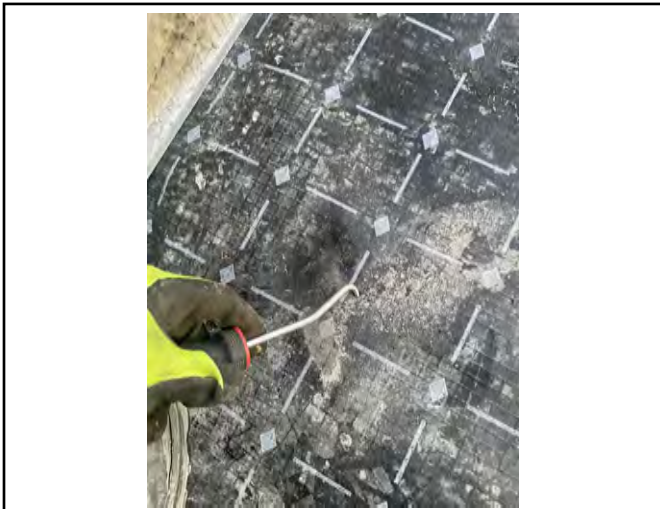
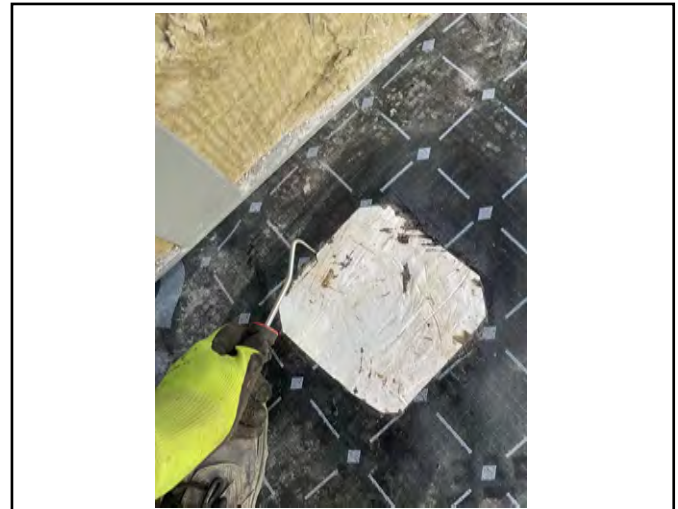
LOCATION/GRID LINE: Gridline: 03/A.

NOTES: Patch repair.

The first photograph below shows the one hole in the JUTA GP1 Gas Barrier which was identified during this visit. The area around the hole in the gas barrier has first been cleaned of debris and dust to ensure a strong seal can be achieved.

Next a 150mm square patch of the JUTA GP1 SAM has been adhered over the hole in the gas barrier. A gas blow torch and roller has been used to ensure a strong and consistent seal has been achieved. The second photograph above shows a pick and probe test carried out to the patch repair.

Verified in accordance with CIRIA 735.

| Date | Nr | Remediation Description | Y/N |
|---|---|---|---|
| | | 2. One patch repair was carried out using JUTA GP1 SAM. | ✓ |

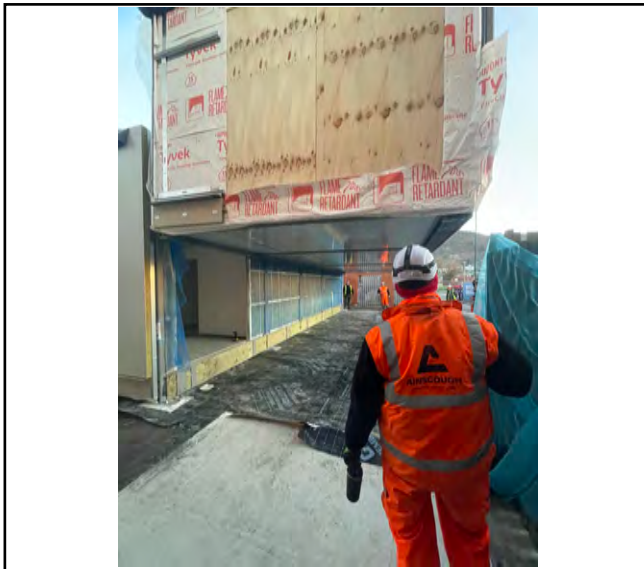
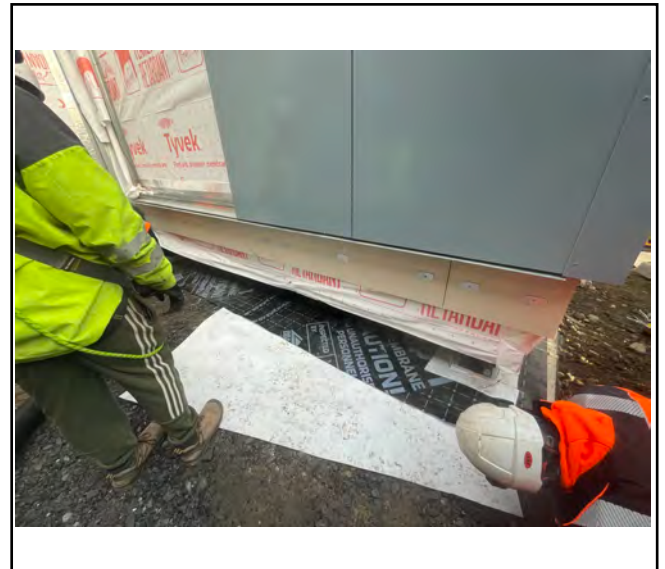
LOCATION/GRID LINE: Modules dropped into place.

NOTES: Lifted in by crane (ground floor modules)

The first photograph below shows an example of a module being dropped into place onto the JUTA GP1 Gas Barrier which was previously installed to the ground floor.

The crane and contractors have acted cautiously when dropping all the ground floor...

...modules into place and no damage has been caused when carrying out this process. As previously shown in this report one patch repair was carried out during this visit, however, this was to repair damage caused by a screw not the modules being dropped into place.

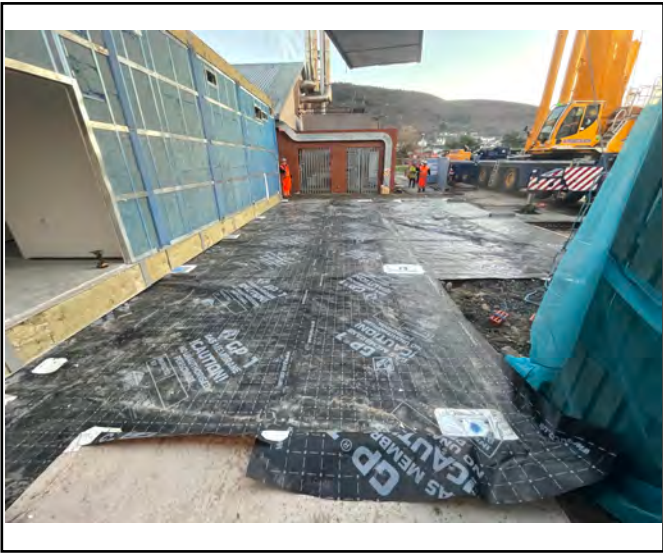
Overview of gas barrier before  
module was dropped into place.

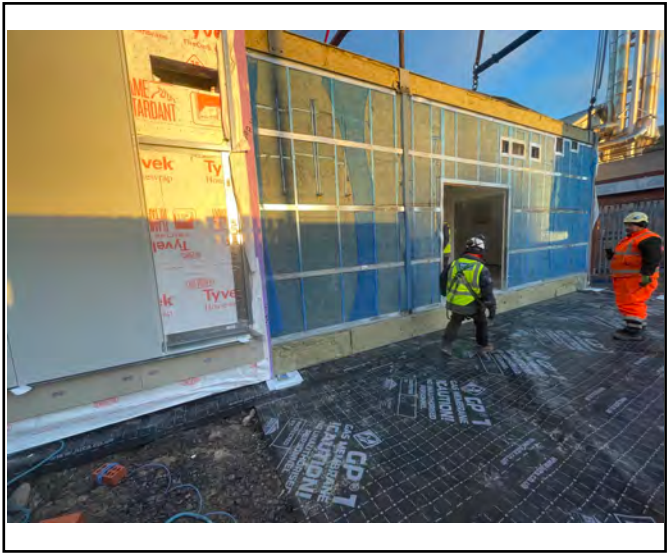
Module dropped into place, no damage  
caused.

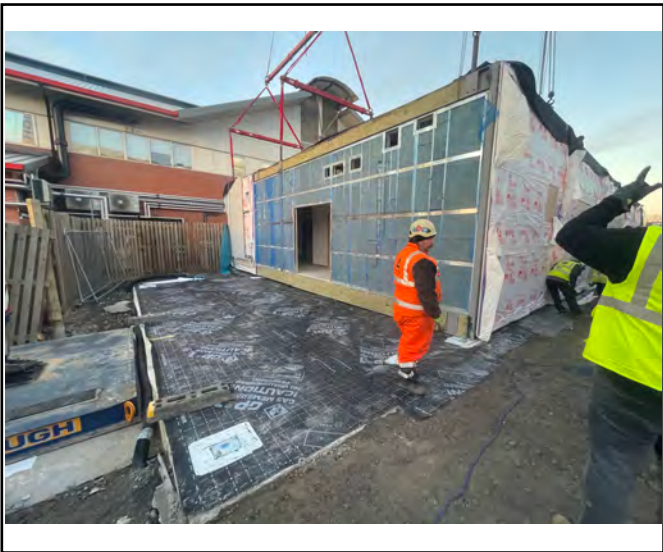
Module dropped into place.

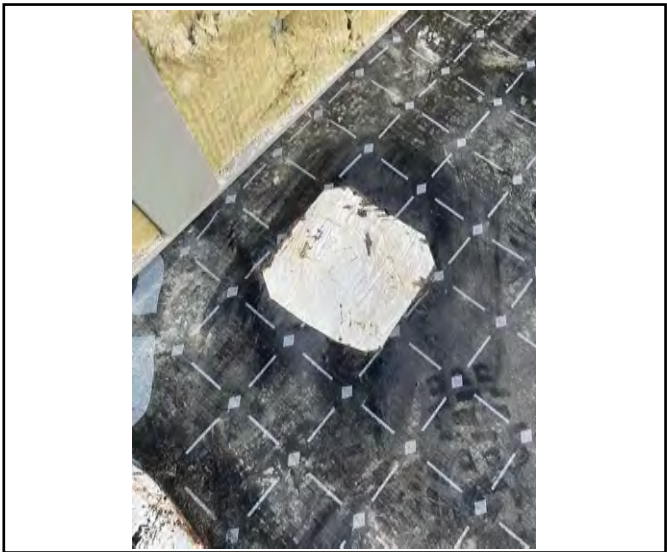
Additional photograph of patch  
repair.
