# GeoShield Verification Report

PROJECT REFERENCE: GEO102875

PROJECT: Neath Port Talbot Hospital (Orthopaedic Unit).

REPORT NUMBER: 004

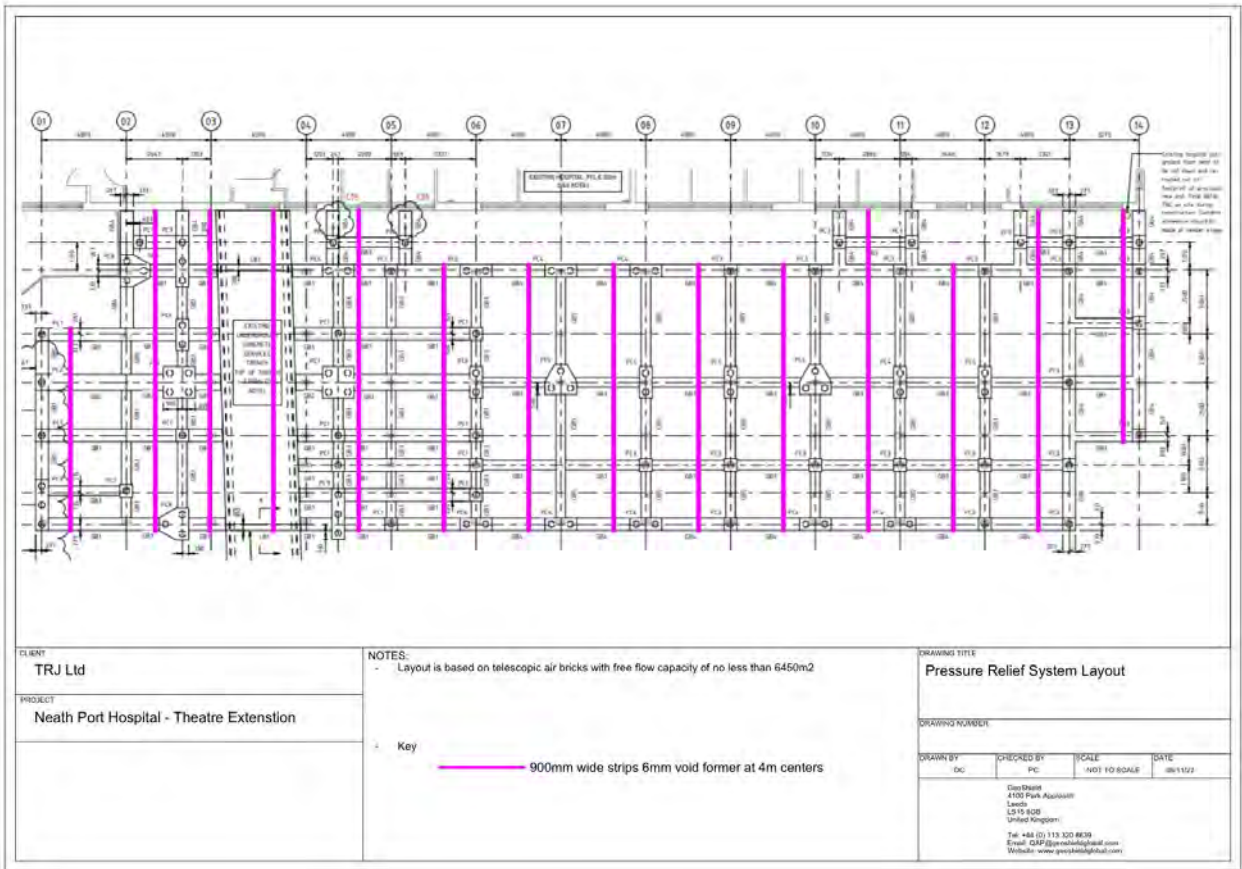
The layout above shows the site layout where the ground floor modules have been installed. Vents on opposite ends of pressure relief were verified during this visit.

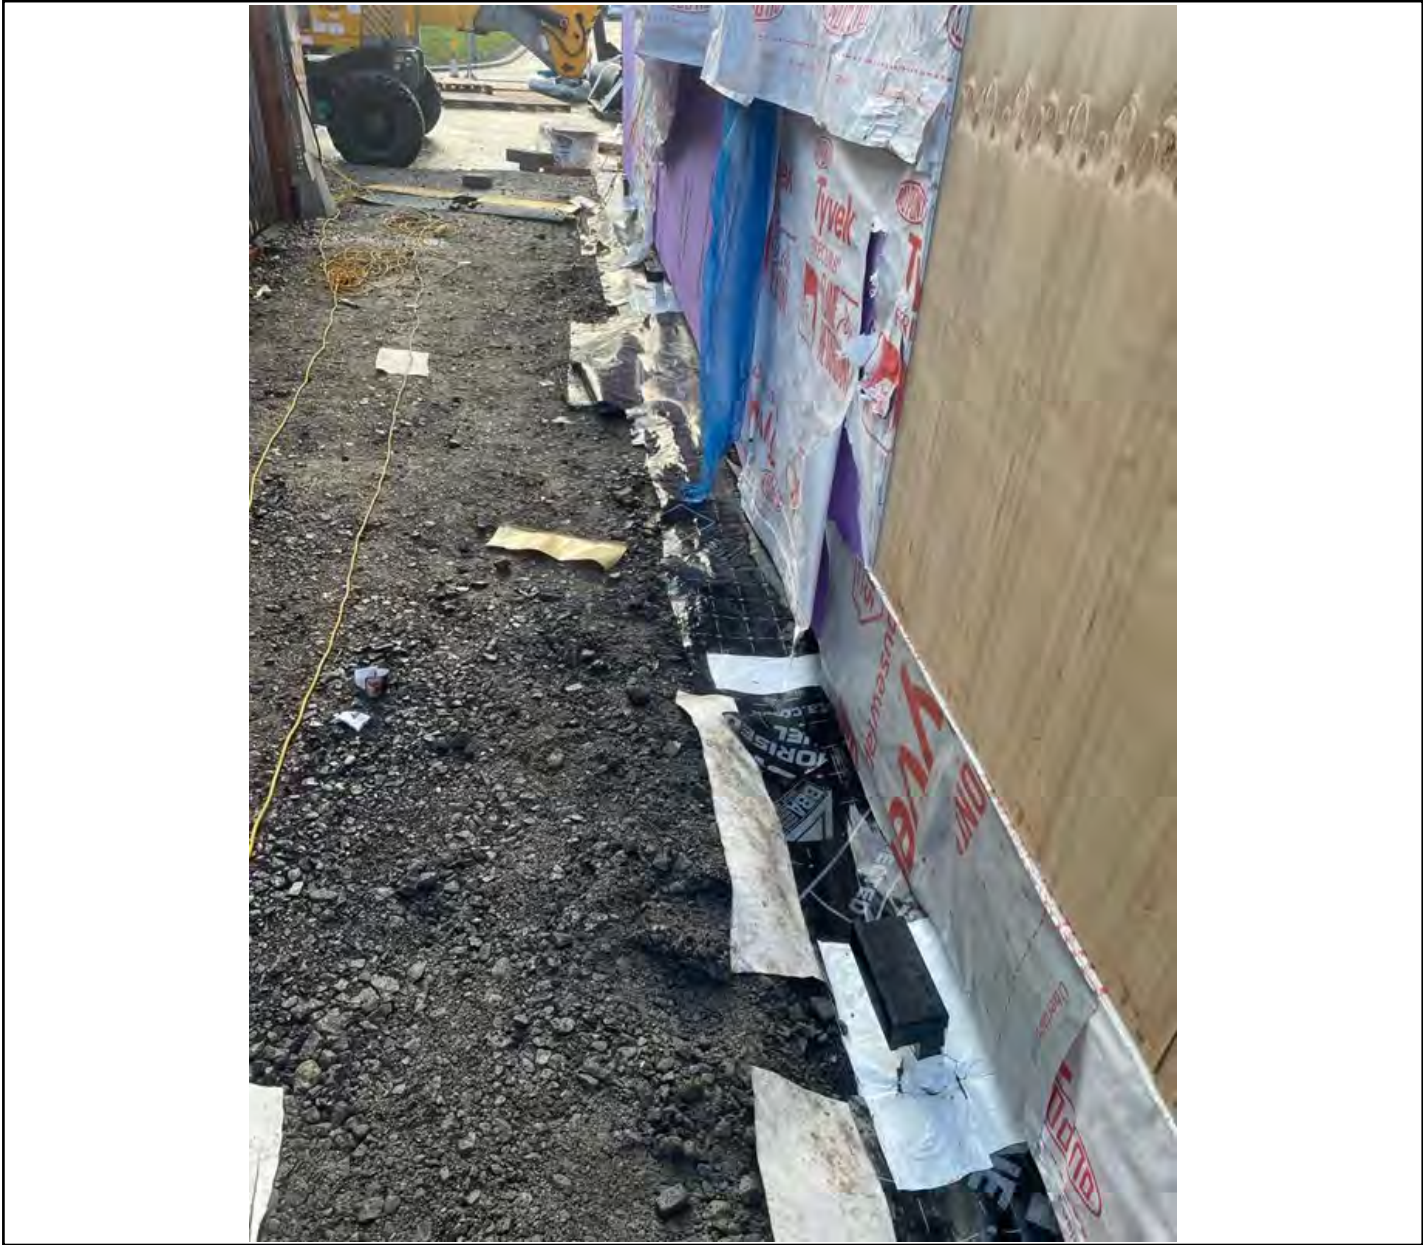
Overview photograph one elevation.

Periscope vents sealed around perimeter upon pressure relief venting.

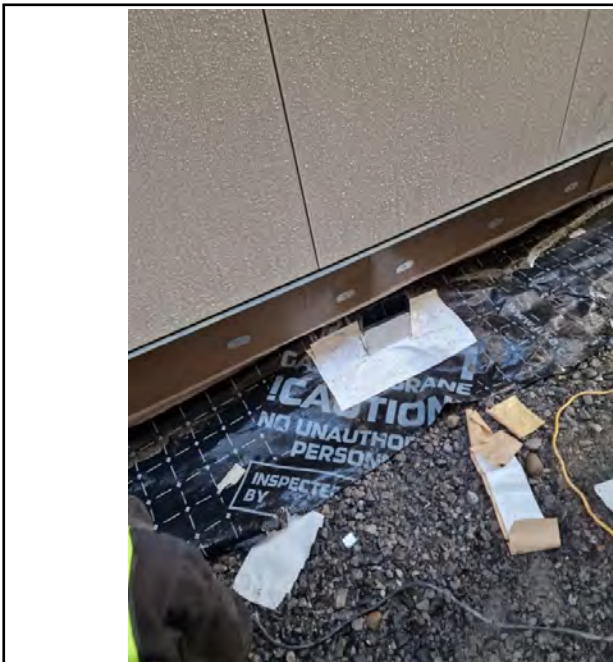
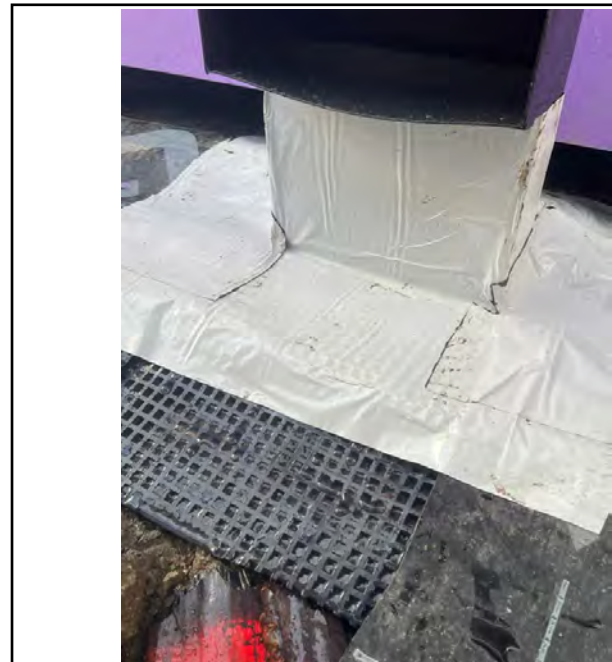
## VERIFICATION ITEM ONE

The periscope vents have been placed and sealed around the perimeter of the modular building. All vents have been placed on opposite ends of the FC6 Cuspate Geocomposite as per the design detail. The existing Juta GP1 gas membrane has been cut tightly...

...around each periscope vent prior to being sealed. The photograph on the left displays a sealed periscope vent and on the right displays evidence of the vent upon the vent mat.

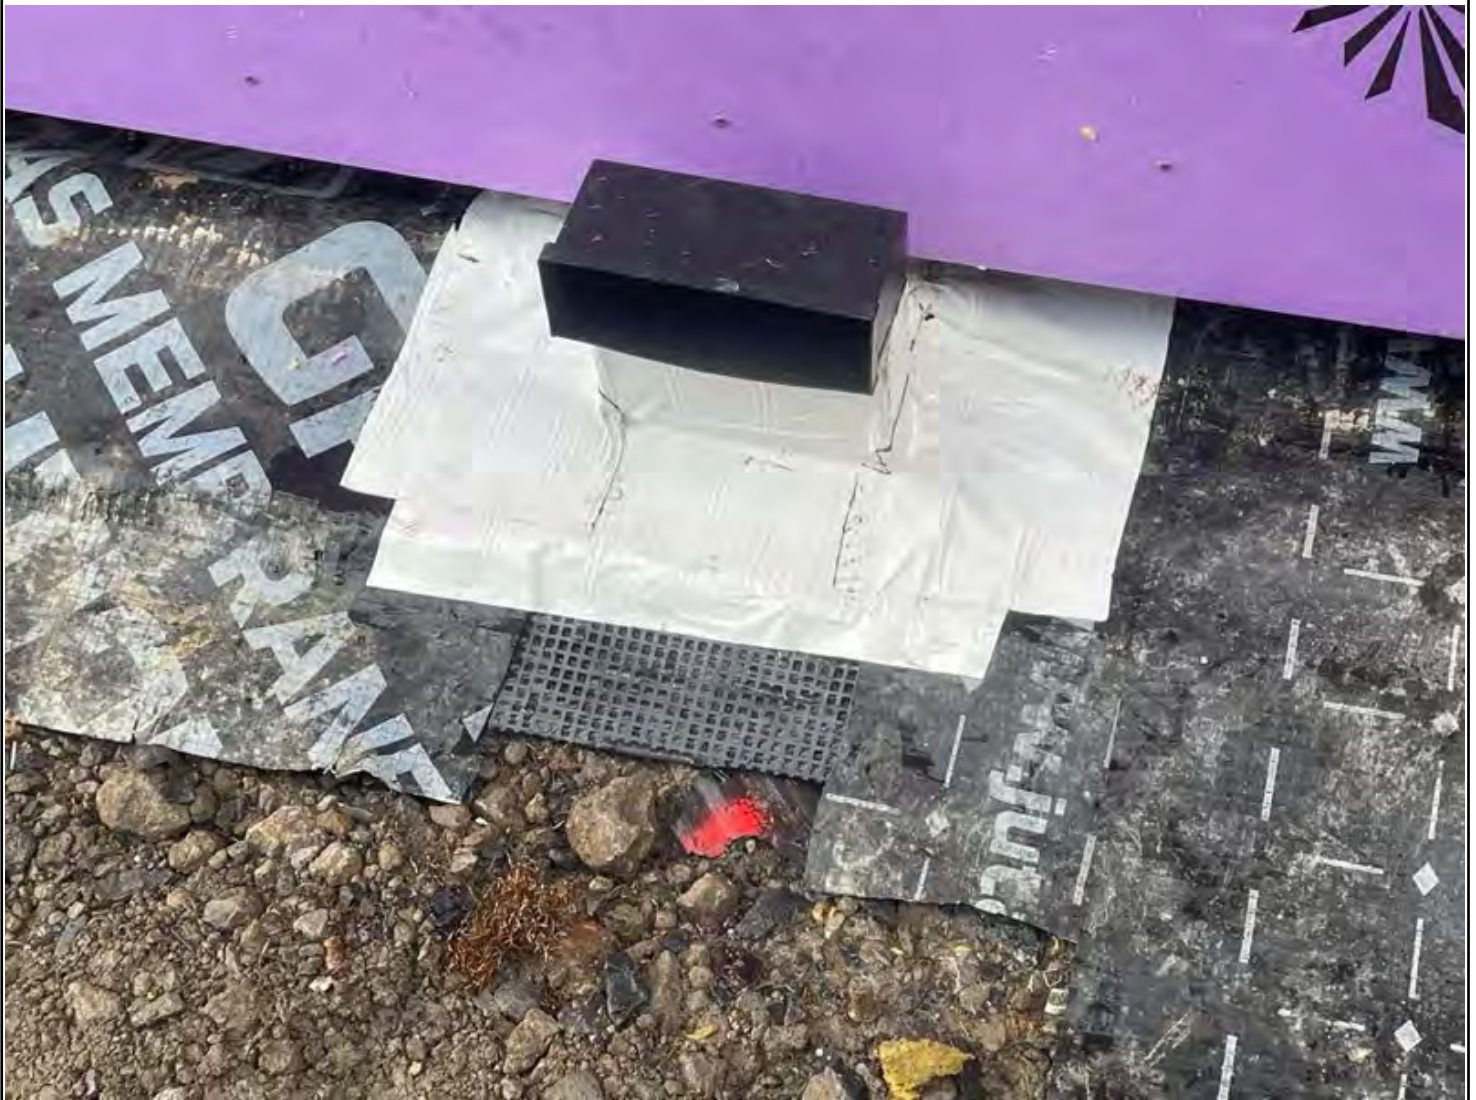
The above photograph displays an overview photograph of a successfully sealed periscope vent. All vents have been successfully sealed using Juta GP SAM which is a gas resistant self adhesive. All periscope vents have been sealed in accordance to manufactures specification and to a good NVQ standard.

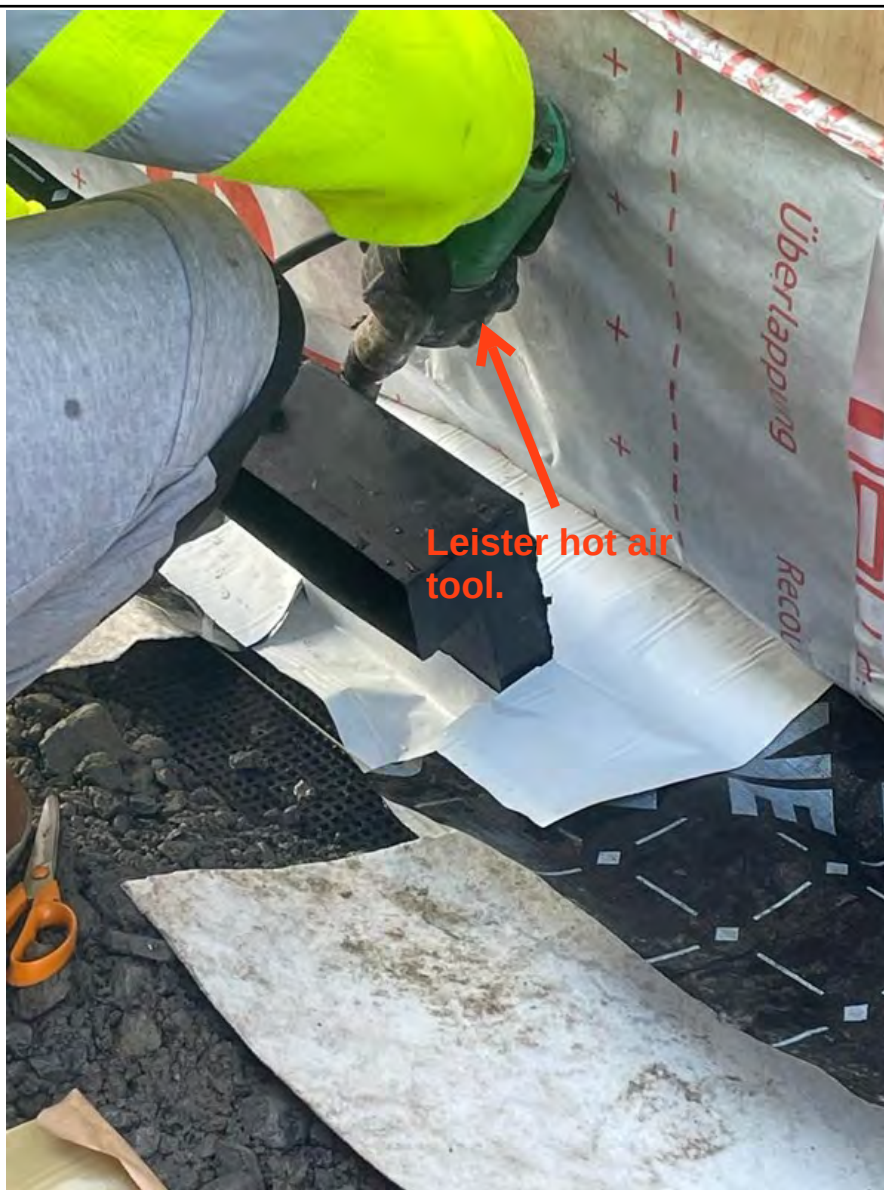
The above photograph displays evidence of the installer from MB Membranes applying adequate heat and rolled pressure using a hot air tool and silicone roller. This ensures the bituminous backing of the Juta GP SAM is suitably activated, followed by firm rolled pressure ensuring a consistent seal has been achieved upon the Juta GP1 & vent mat.

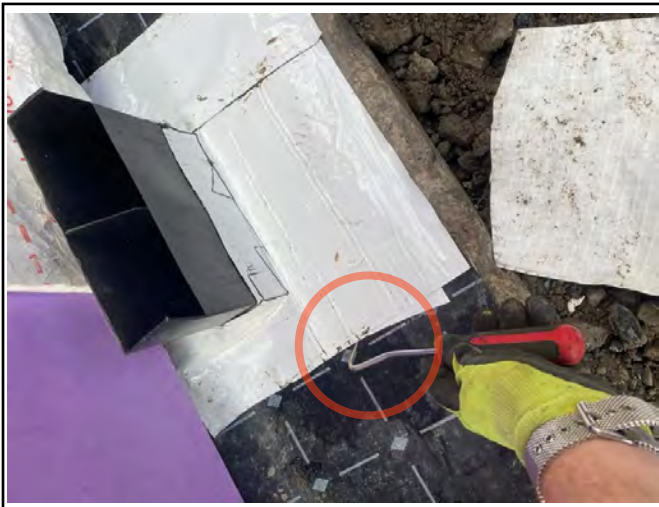
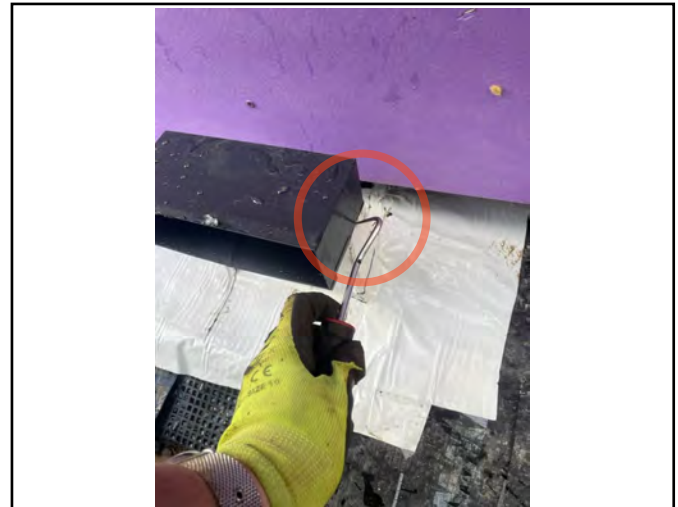
## VERIFICATION ITEM TWO

Throughout this verification visit a thorough visual inspection was conducted alongside thorough mechanical point stress tests which are also known as pick and probe testing.

This testing procedure ensured and helped identify any areas where an inconsistent...

...seal was present. The testing procedure was conducted upon all periscope vents sealed around the perimeter of the building. The photograph above on the right shows evidence of the Juta GP SAM successfully sealed upon the Juta GP1 gas membrane. The photograph above on the right displays evidence of the Juta GP SAM successfully sealed upon a periscope vent. Verified in accordance with CIRIA 735.

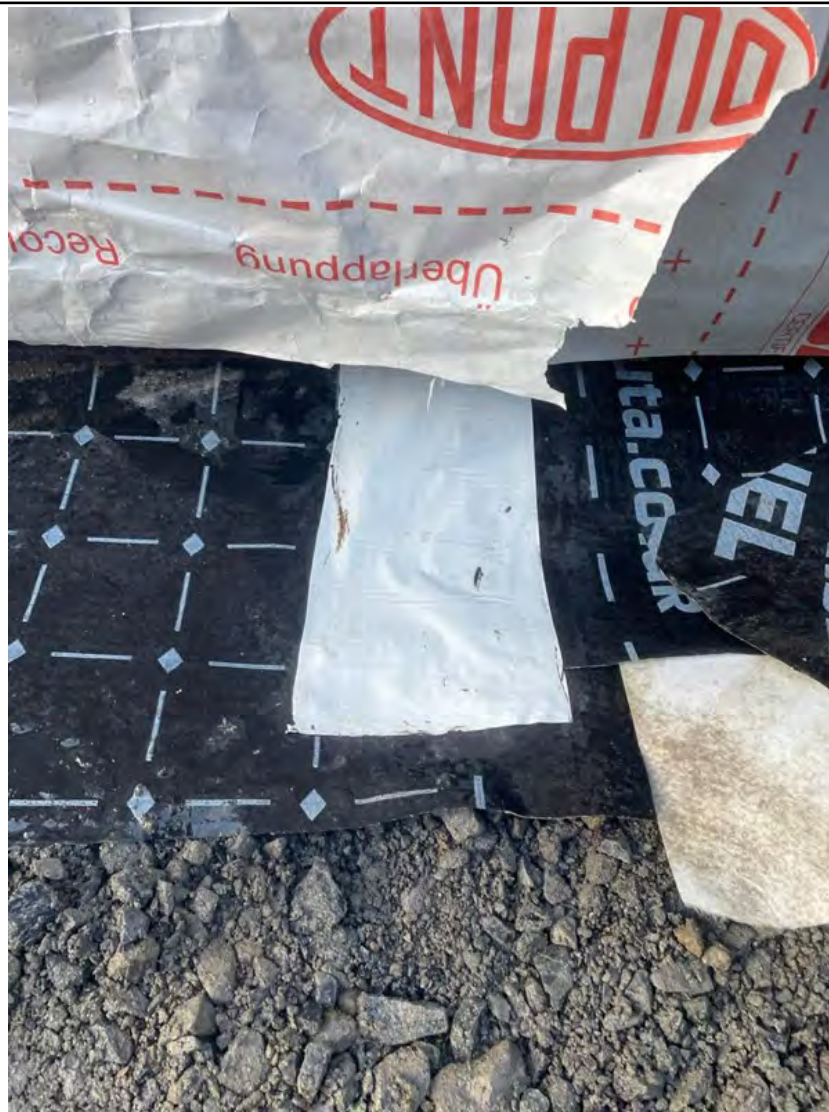
## VERIFICATION ITEM THREE

During this verification visit a number of inconsistently sealed overlaps were

identified. These were remediated on-site in the presence of Geoshield as shown

in the photograph above. A strip of Juta GP SAM applied upon the welded

overlap reinforcing the lap joint ensuring a continuous seal is achieved.

| Date | Nr | Remediation Description | Y/N |
|---|---|---|---|
| 21/12/2022 | 004 | Several patch repairs and edge of overlaps to be sealed. | ✓ |
| | | ^remediated onsite. | ✓ |

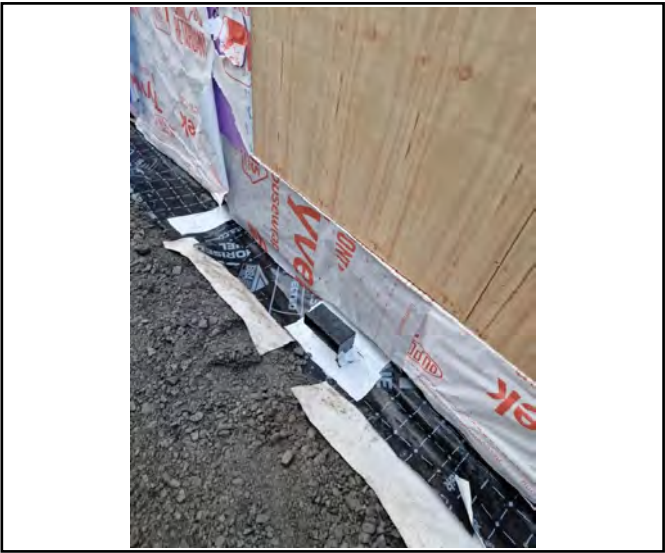
Alternate overview.

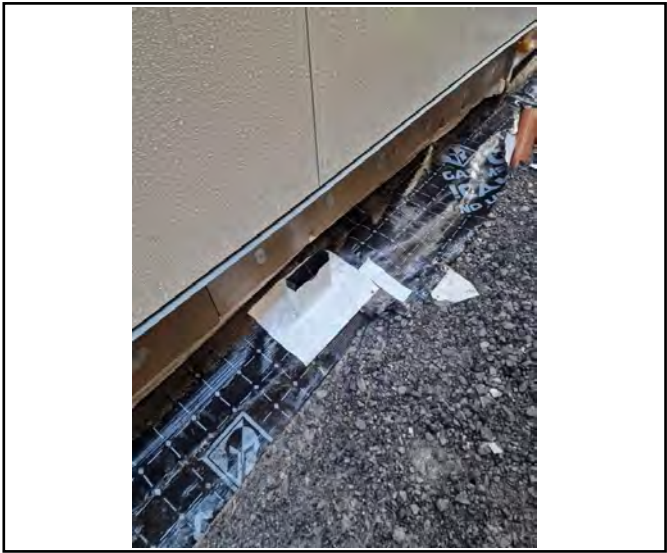
Successfully sealed periscope vent.

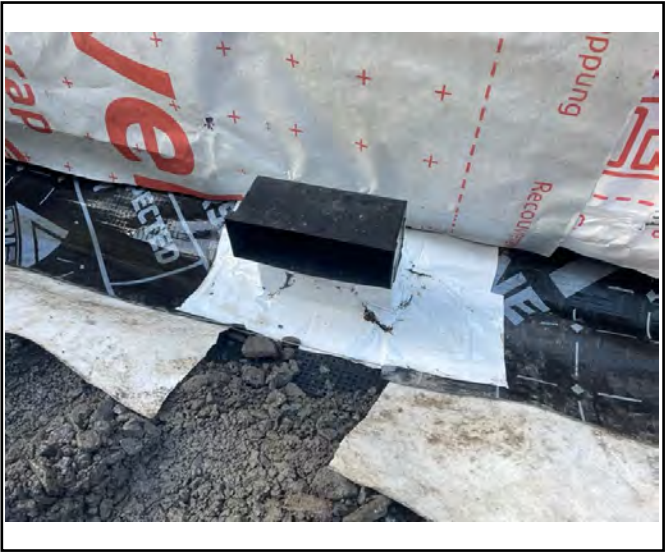
Successfully sealed periscope vent.

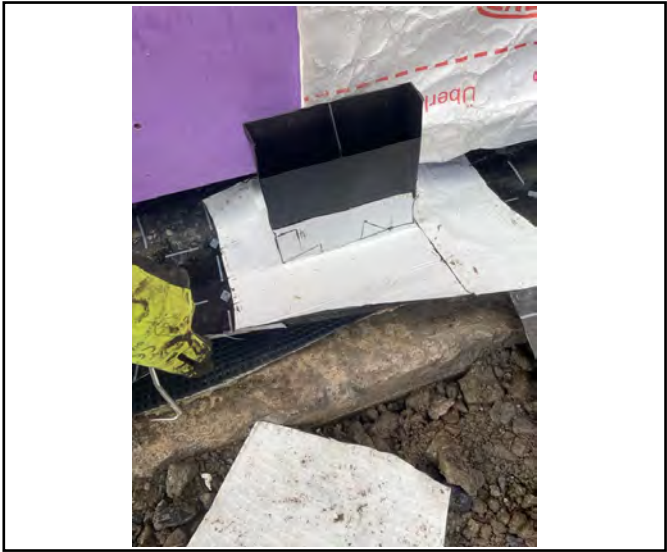
Identifying pressure relief vent mat.
