# GeoShield Verification Report

PROJECT REFERENCE: GEO102875

PROJECT: Neath Port Talbot Hospital (Orthopaedic Unit).

REPORT NUMBER: 005

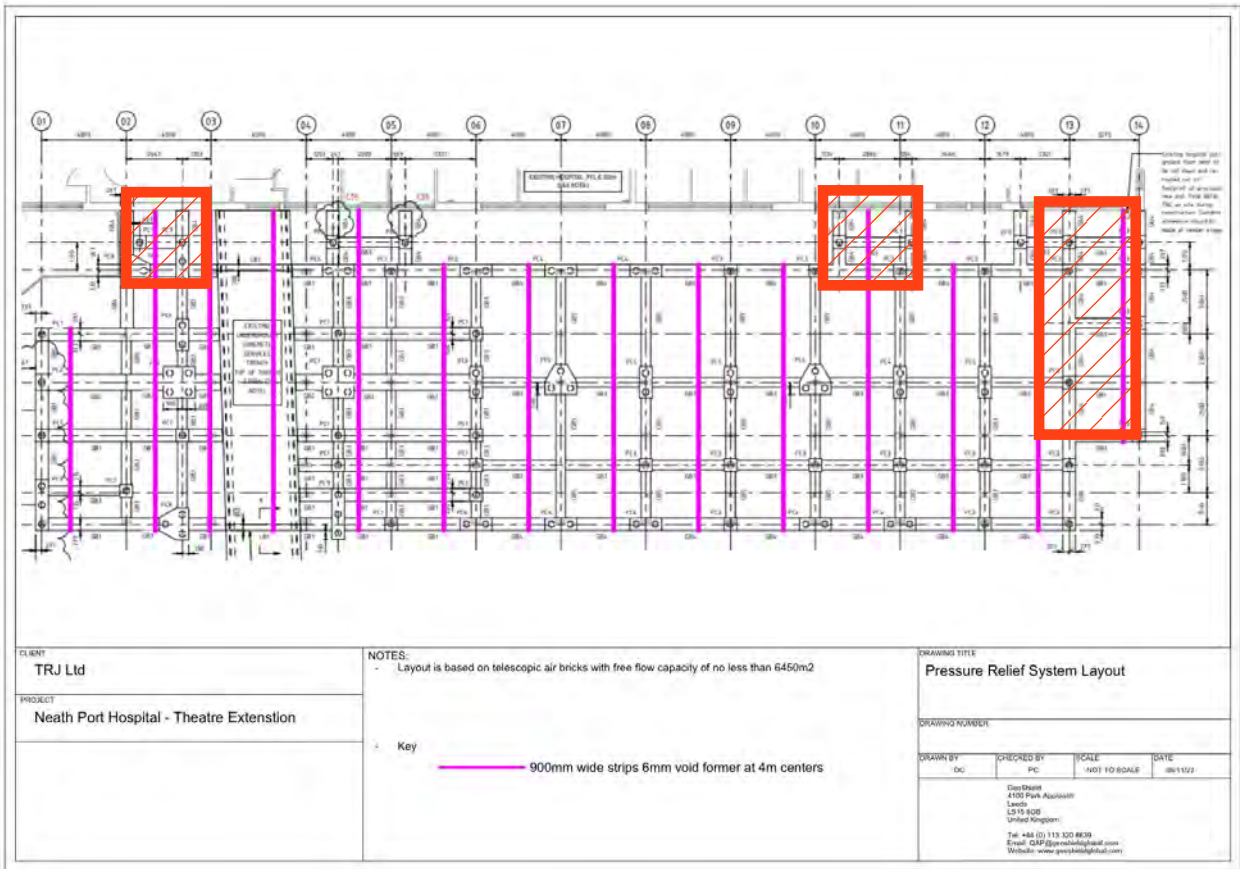
The three link areas highlighted in red above shows where the installers have installed the JUTA GP1 Gas Barrier and where verification took place during this visit.

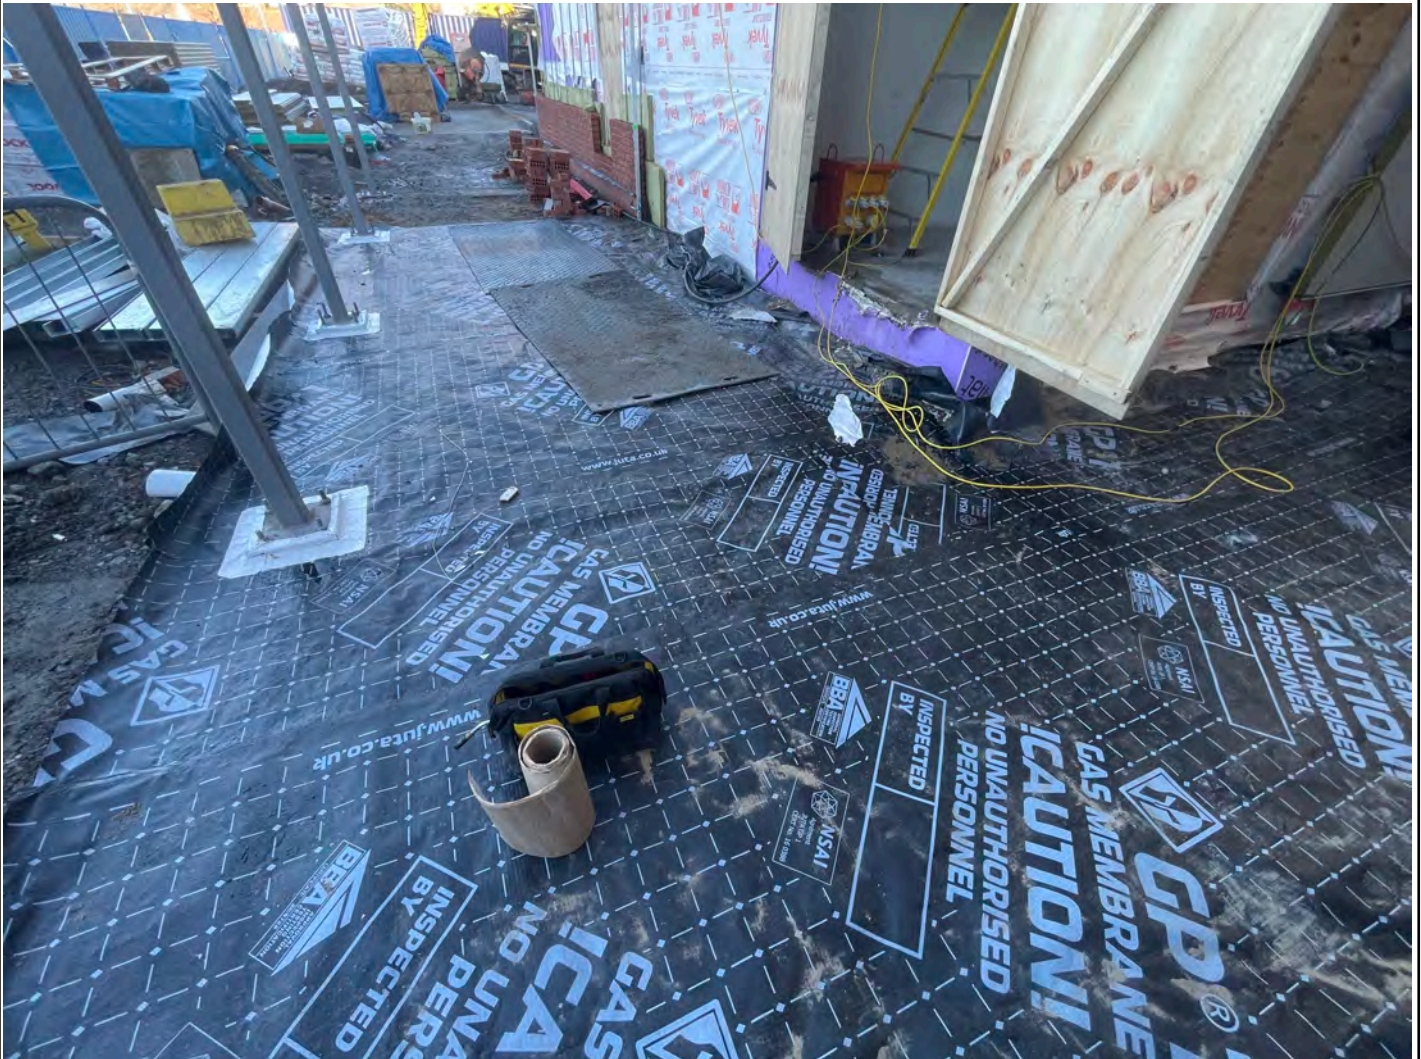
The photograph above shows an overview of one of the link areas. All three

have been verified and signed off during this visit.

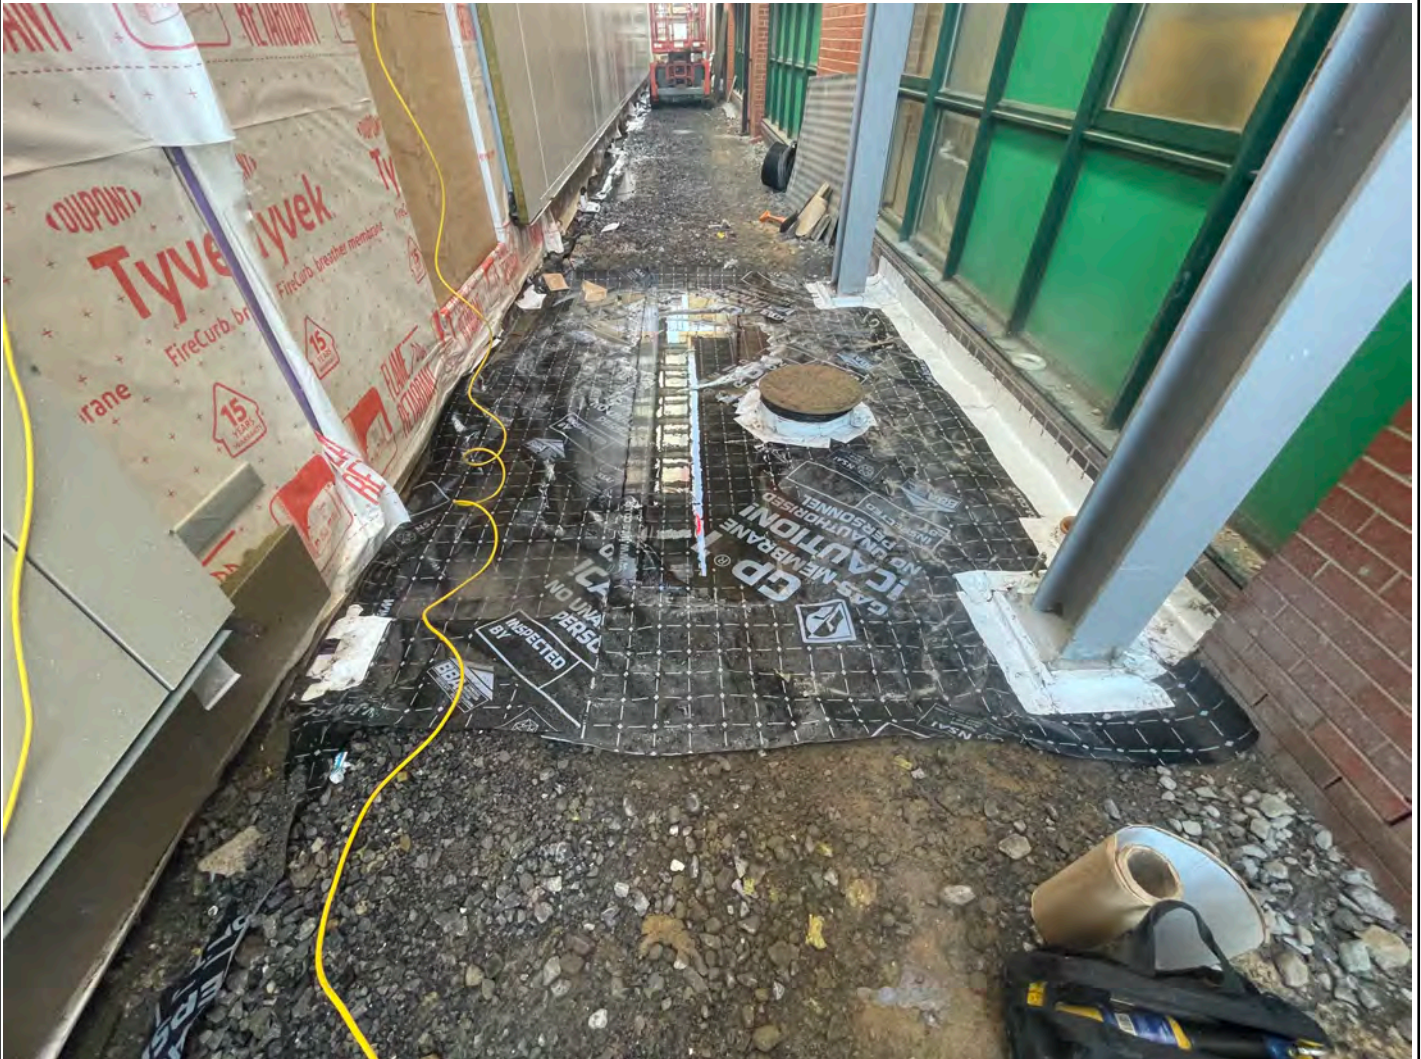
The photograph above shows an additional link area which has been verified

during this visit.

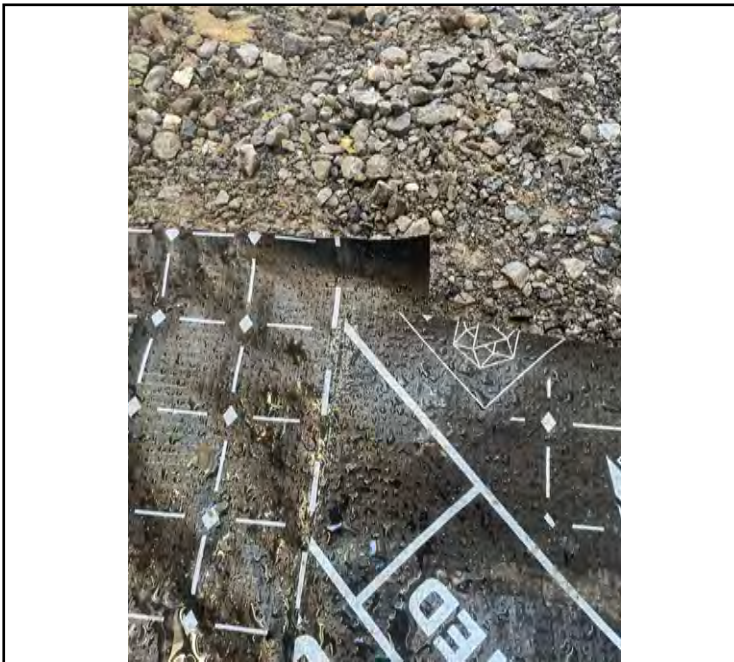
The first photograph below shows a lap of the JUTA GP1 Gas Membrane. The installers have first lapped the membrane 100mm before using a hot air leister and roller to achieve a strong and consistent 40mm weld.

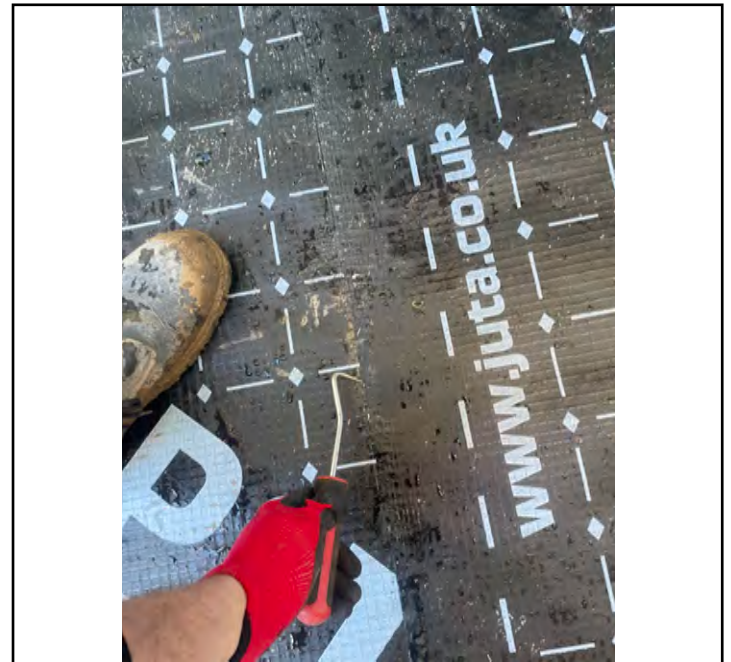
The second photograph above shows a pick and probe test carried out to a welded lap.

Verified in accordance with CIRIA 735. Any faults identified have been rectified.

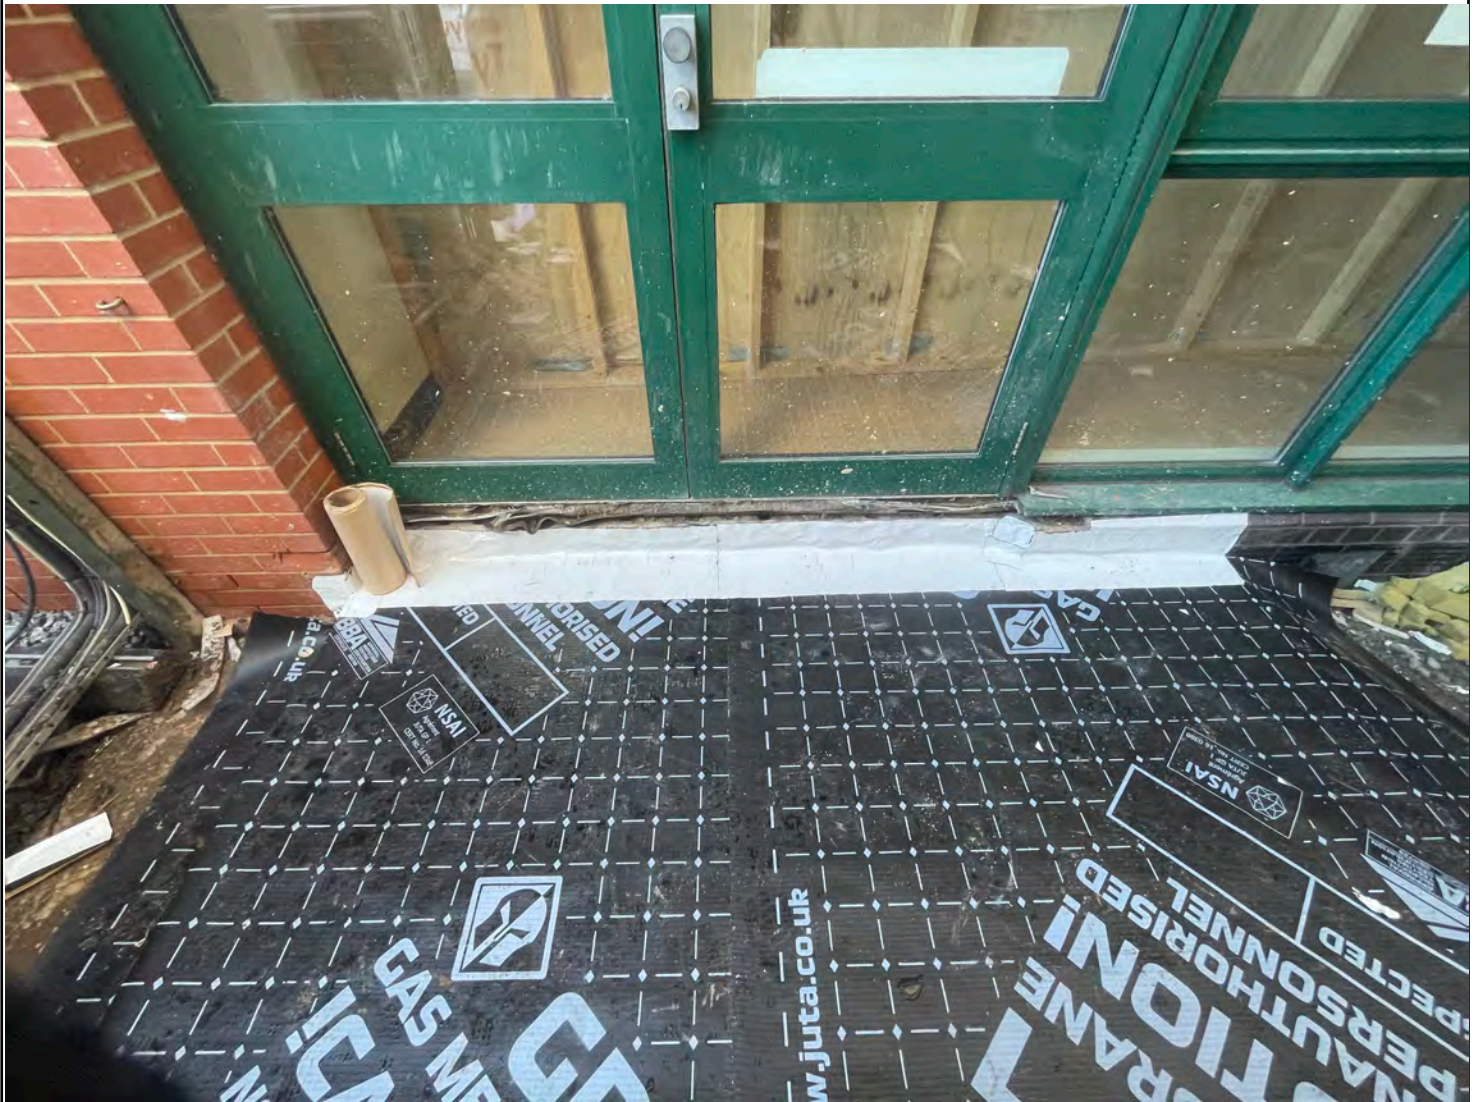
The photograph above shows the installers have sealed the JUTA GP1 Gas

Membrane to the existing hospital building using primer and JUTA GP1 SAM. A hot air

leister and roller has been used to aid in the adherence of the JUTA GP1 SAM.

No faults or defects were identified when testing this part of the design.

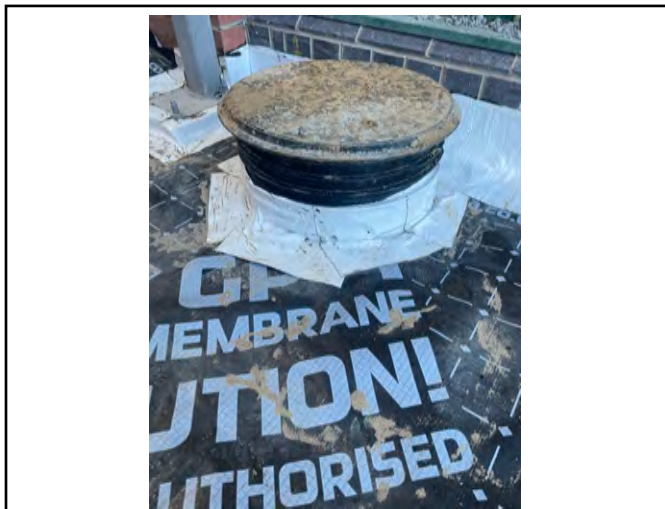
The first photograph below shows a sealed man hole. The installers have first cut the JUTA GP1 Gas Membrane tight around the man hole to minimise any gaps which need to be sealed.

Next JUTA GP1 SAM has been used to seal each penetration to the membrane.

Heat has been applied to aid in the adherence of the self adhesive membrane.

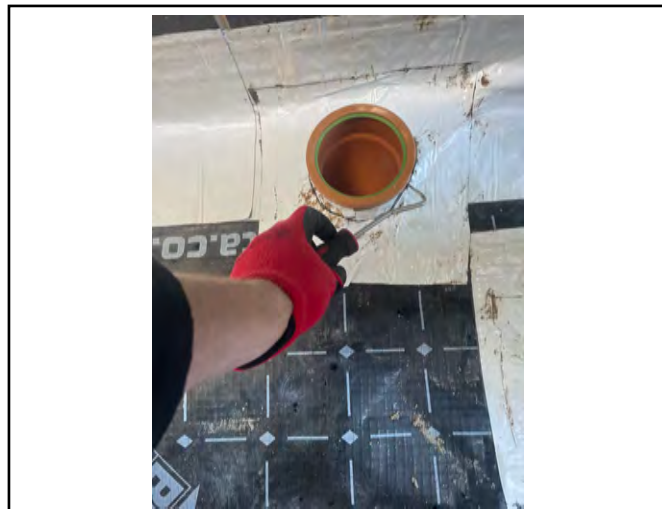
The second photograph above shows a sealed pipe penetration. Installed in accordance with BS 8485:2019. The second photograph above shows a pick and probe test carried out to a sealed penetration. Verified in accordance with CIRIA 735.

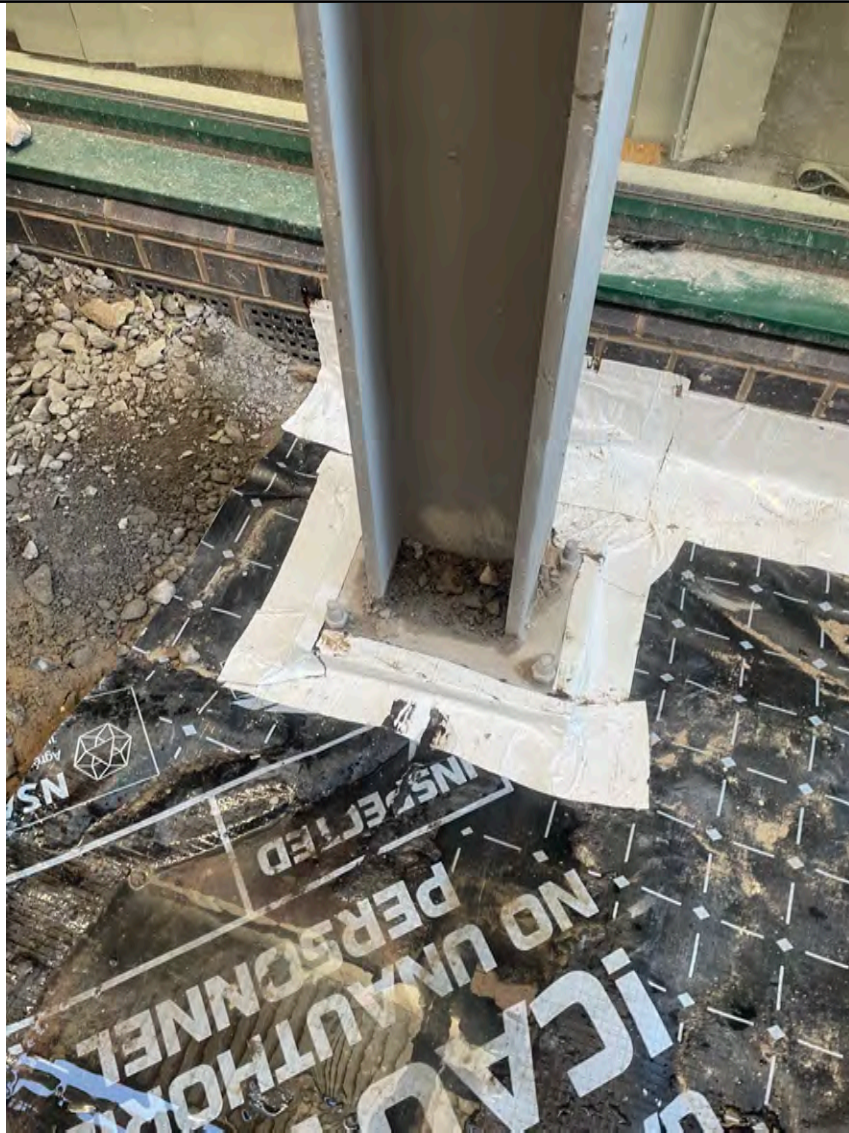
The photograph above shows a steel column which has been sealed. As with the penetrations the gas membrane has first been installed tight around the the column before sealing it using JUTA GP1 SAM.

Installed in accordance with BS 8485:2019.

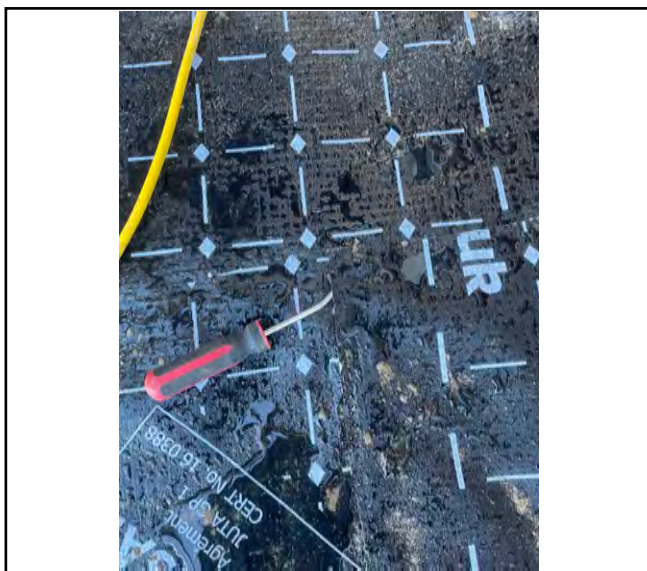
The first photograph below shows an example of one of the faults identified during this visit. Thorough pick and probe testing found a miss weld. The second photograph below shows a repair to a hole identified in the membrane.

Both faults identified have been patch repaired using 150mm patches of the JUTA

GP1 SAM. A gas blow torch has been used to aid in the adherence of the JUTA

GP1 SAM. A strong seal has been achieved.

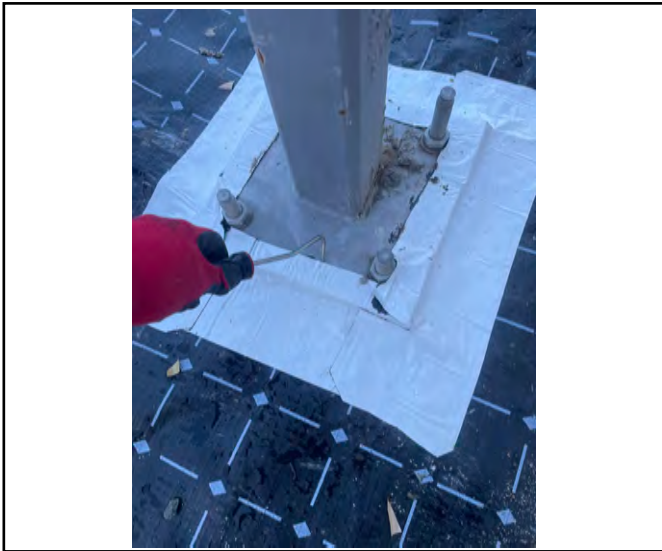
Pick and probe test carried out to a  
sealed steel column.

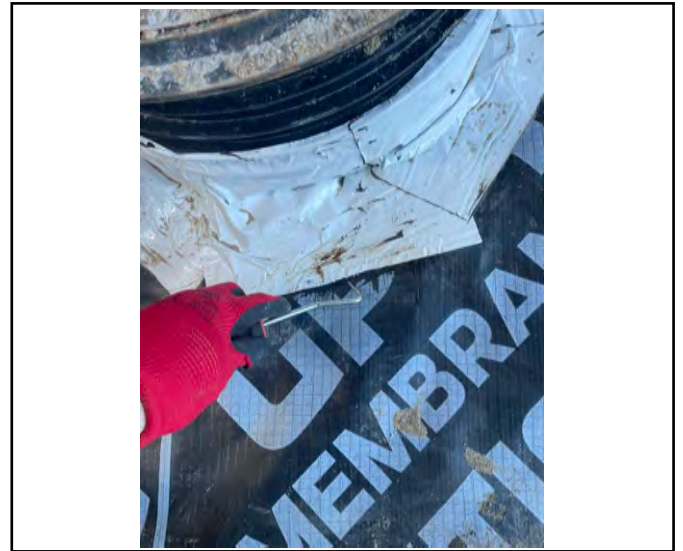
Pick and probe test carried out to a  
sealed man hole.

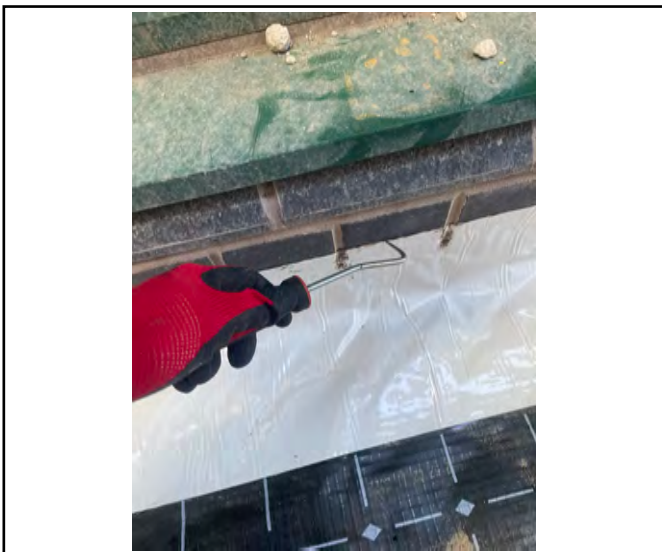
Pick and probe test carried out to the  
retro fit detail.

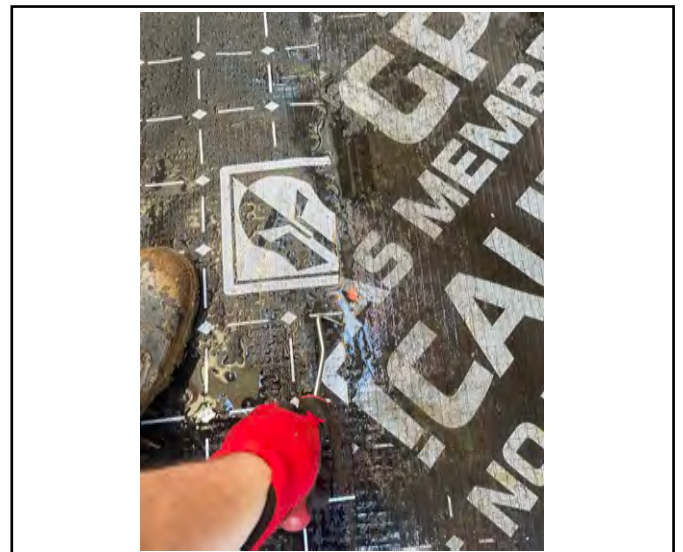
Additional pick and probe test carried  
to a welded lap of the membrane.
