RHONDDA  
GEOTECHNICAL  
SERVICES

COAL MINING RISK ASSESSMENT  
PRE-PLANNING ENQ. Q2022/0111  
NEATH PORT TALBOT C.B.C.  
RESIDENTIAL UNITS  
BRYNMORGAN VILLA CARE HOME  
LOWER BRYNMORGAN BRIDGE  
UPPER CWMTWARCH  
SWANSEA  
SA9 2XG  
16/10/2022

## **COAL MINING RISK ASSESSMENT**

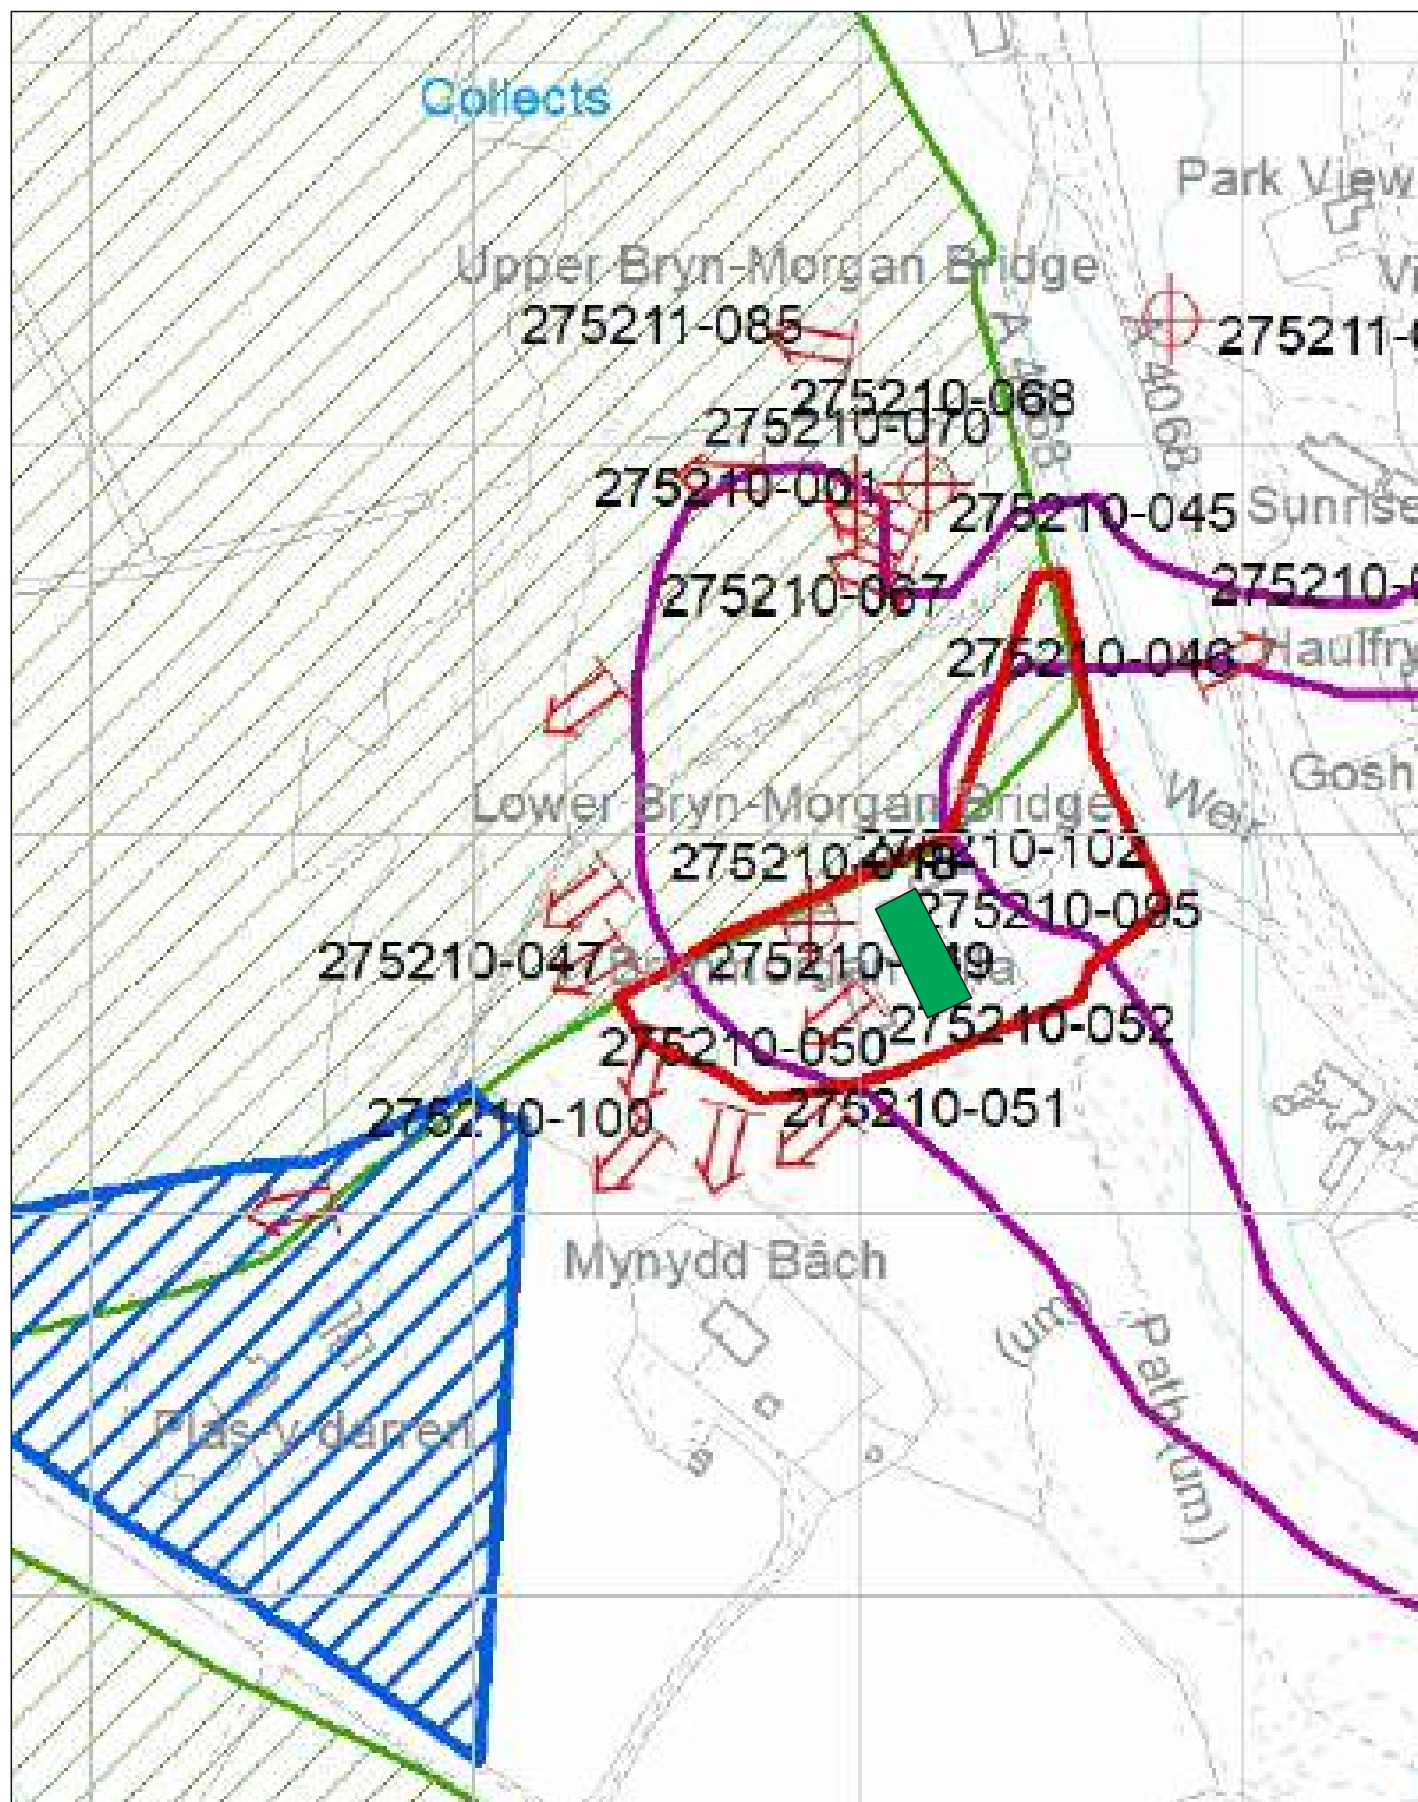
FIGURE 3

2a) The Consultants Report states that there is recorded underground mining of coal beneath the site in two seams. These are the Lower Nine Foot Top Leaf at 44m depth, last worked in 1895 and the Upper Gellideg at 157m, last worked in 1953. The report goes on to say the C.A. believe there are no shallow unrecorded workings or shallow spine roadways beneath the site. The report records eighteen mine entries within, or within 100m of the site boundary. These are shown in Figure 3, an extract of the summary of findings map. Four are shafts and fourteen are adits. The majority of these are both topographically higher than the site and outside the site boundary. Two are of direct relevance to the risk assessment. These are the shaft reference 275210-102 and adit reference 275210-095. The report contains the reference numbers of nine abandonment plans which may be of relevance to the site. These were checked but none seemed relevant to possible shallow mining beneath the site. Two seam outcrops are named within the site boundary. These are the Lower Nine Foot Bottom Leaf and the Middle Nine Foot Top Leaf. The report or SoF map does not distinguish which seam is which. The C.A. is not aware of any geological faults, fissures, breaklines or other weaknesses that have been affected by coal mining. An area of opencast mining (green hatching in Figure 3) immediately abuts the northern site boundary.

In Section 2 the report states there have been no site investigations and there are no recorded surface hazards that have required remedial action within 50m. There is a subsidence claim (blue hatching in Figure 3) southwest of the site. A

SUMMARY OF FINDINGS MAP FROM THE CONSULTANTS REPORT.  
THE EXISTING RESIDENTIAL BUILDING IS HIGHLIGHTED IN GREEN.

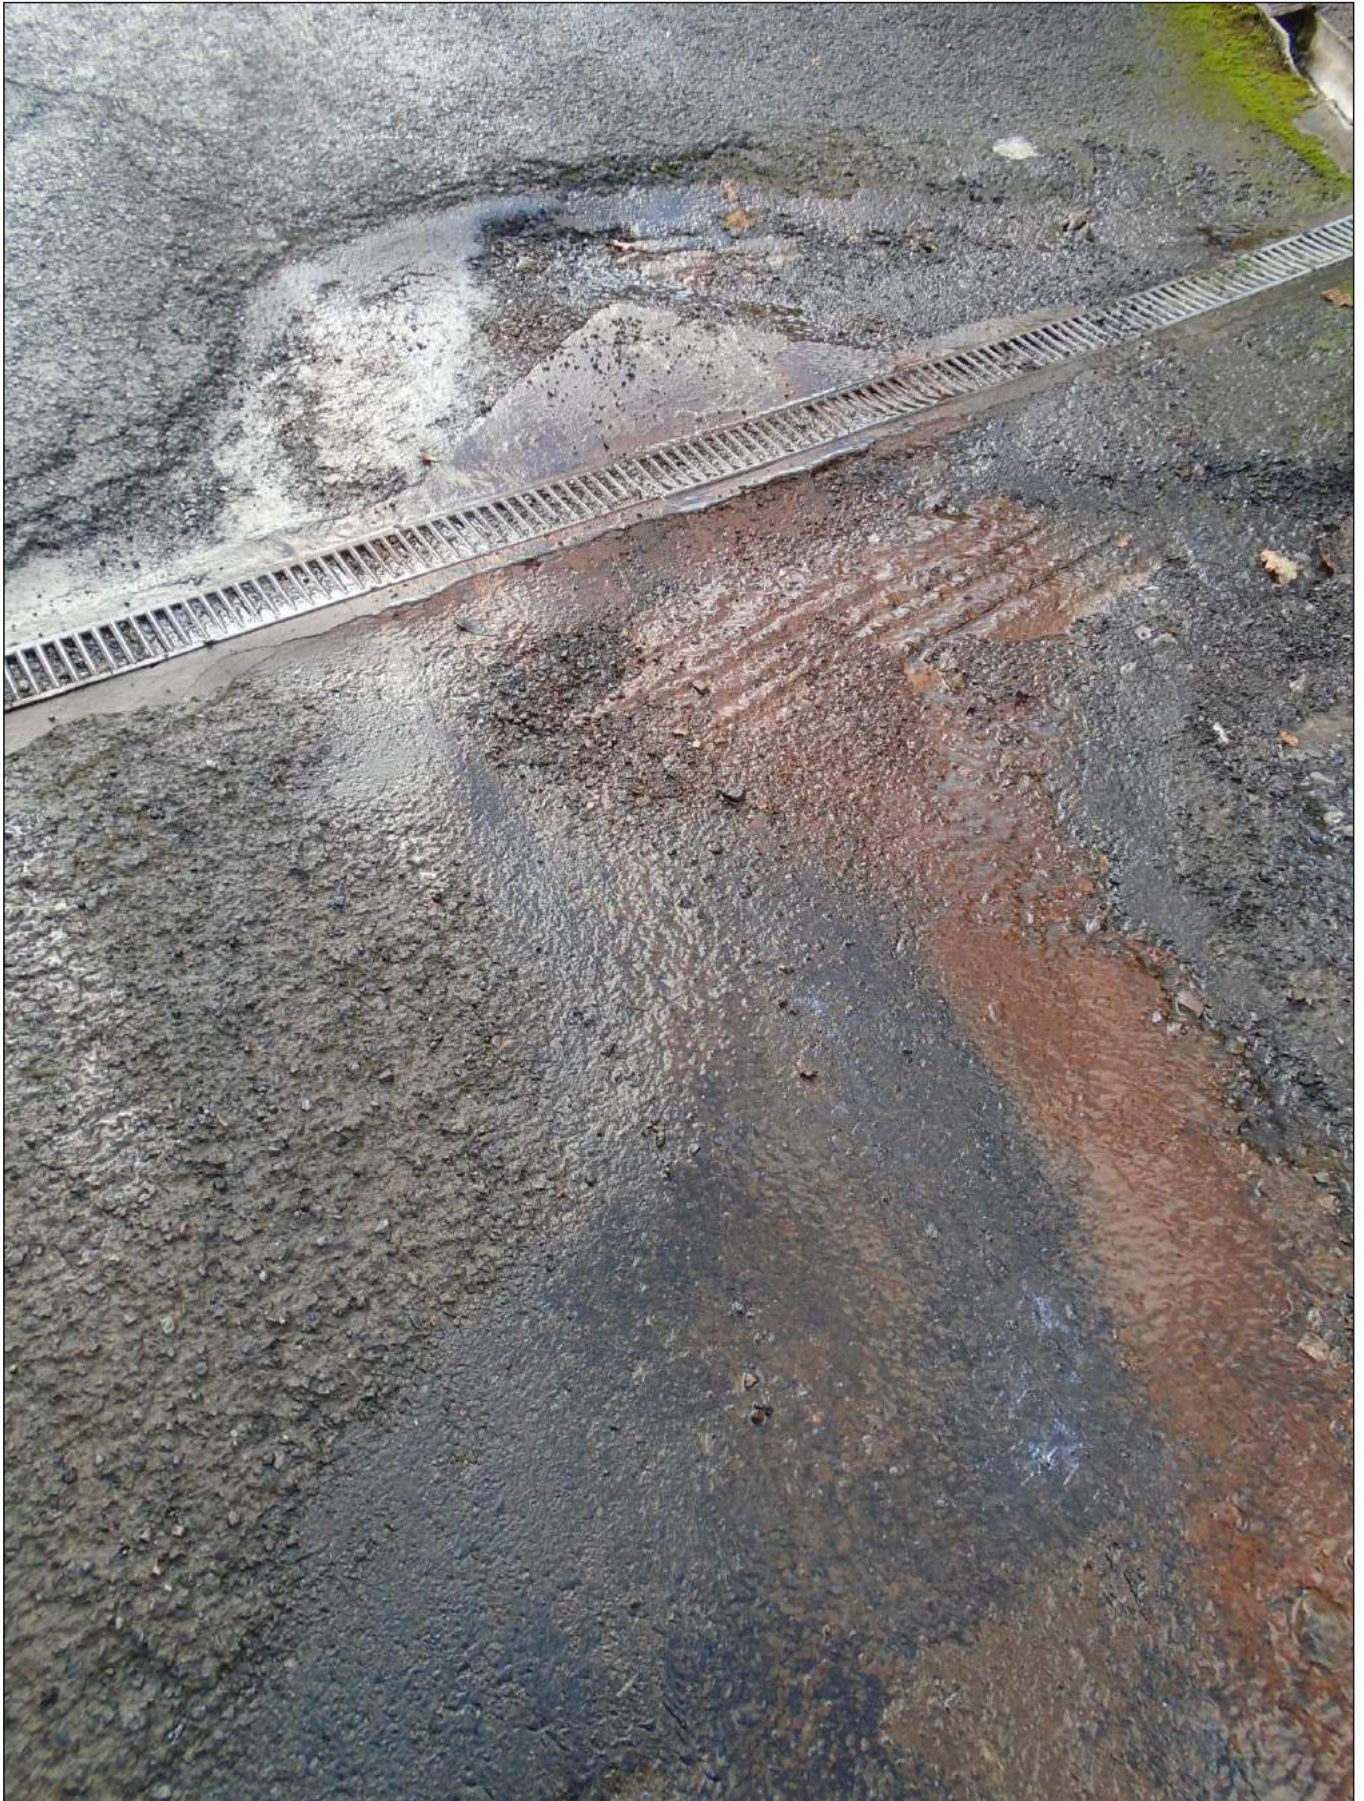
FIGURE 11

Figure 11 shows water stained with Iron Hydroxide emerging from the drive at the front of Brynmorgan Villa. This is nearly always the product of the oxidation of Iron Pyrites in coal left in old workings. Because the area is a mixture of concrete, tarmac and buildings it is not possible to pinpoint the source precisely. It could be some distance from where it is emerging, merely being forced to that spot by the built environment.

MINEWATER EMERGING AT THE FRONT OF BRYNMORGAN VILLA

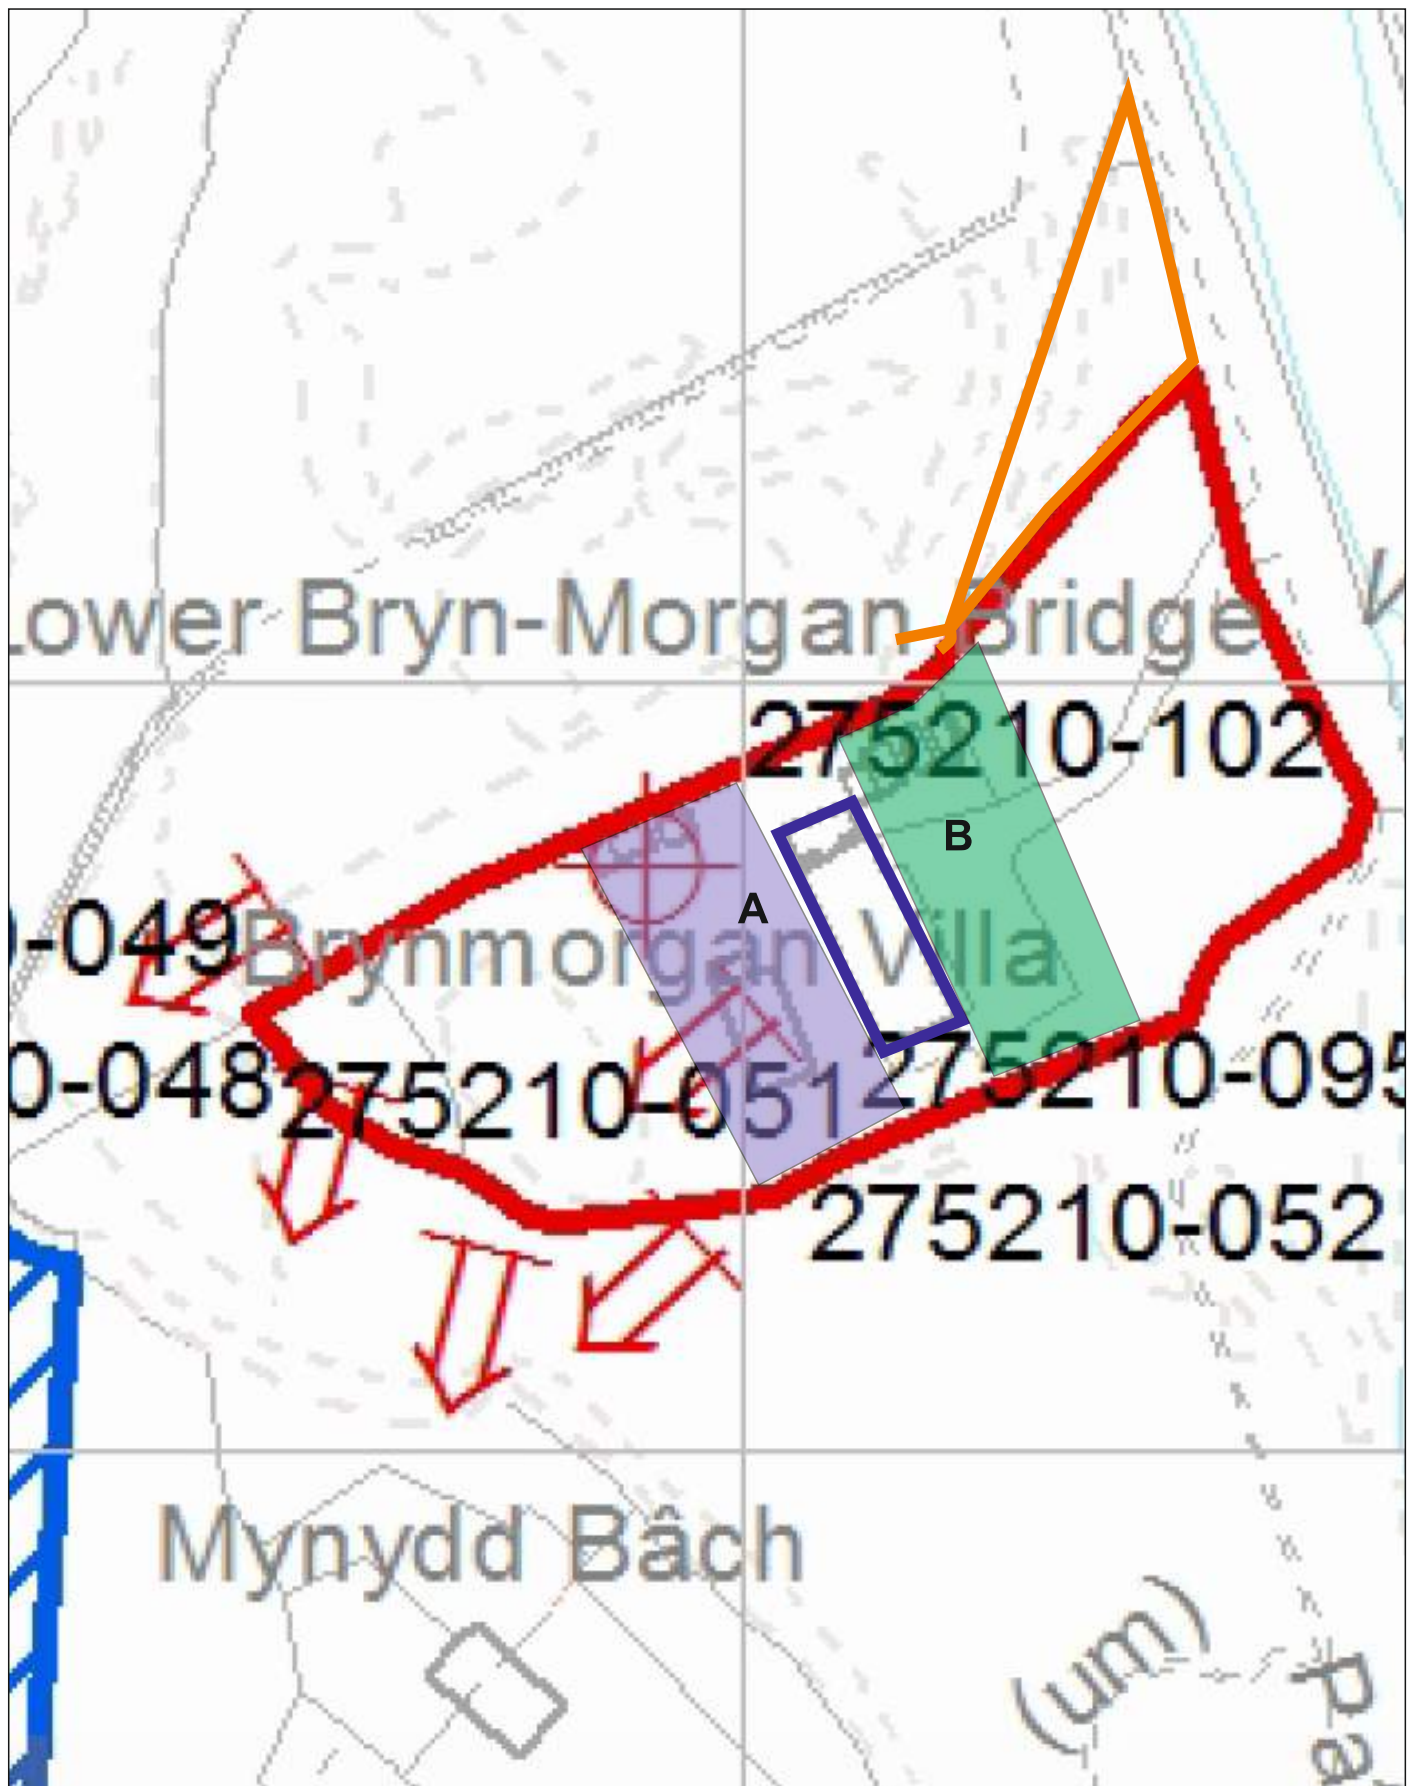
FIGURE 12

Figure 12 is the plan from a CON29 previously purchased by the applicants. This shows the positions of the mine entrances in higher resolution than Figure 3. Area A is coloured purple. The influence of the four levels just off the western site boundary can be safely disregarded. They are well away from any potential development and 8m-10m higher than the main site. This leaves two entrances of concern. 275210-095 is a level. It's position relative to the other levels suggests it may have been a drainage level as it is situated below the outcrop of the Stanllyd Seam. There is no sign of it on site and the position is partly covered with an infilled swimming pool (see Figure 13). Figure 14 shows the position of shaft 275210-102. Again, there is no physical evidence visible, and the position is covered by an outbuilding sat on a concrete slab. The reason for the presence of a shaft (as opposed to a level) has implications for the possible presence of unrecorded workings. The position strongly suggests it is an air shaft. Logically, this must be connected to workings beneath the site. The outcrop position of the Stanllyd means it does not underlie Area A. The shaft could be linked to the recorded workings in the Braslyd. Alternatively, the shaft could be to workings in the Lower Black. These would be at a depth significantly shallower than the 44m recorded in the Braslyd. They could possibly be the origin of the Minewater described in section 2h.

HIGHER RESOLUTION PLAN FROM THE CON29 SHOWING THE POSITIONS OF THE SHAFT AND LEVEL WITH MORE CLARITY. ADDITIONAL LAND ACQUISITION OUTLINED IN ORANGE.

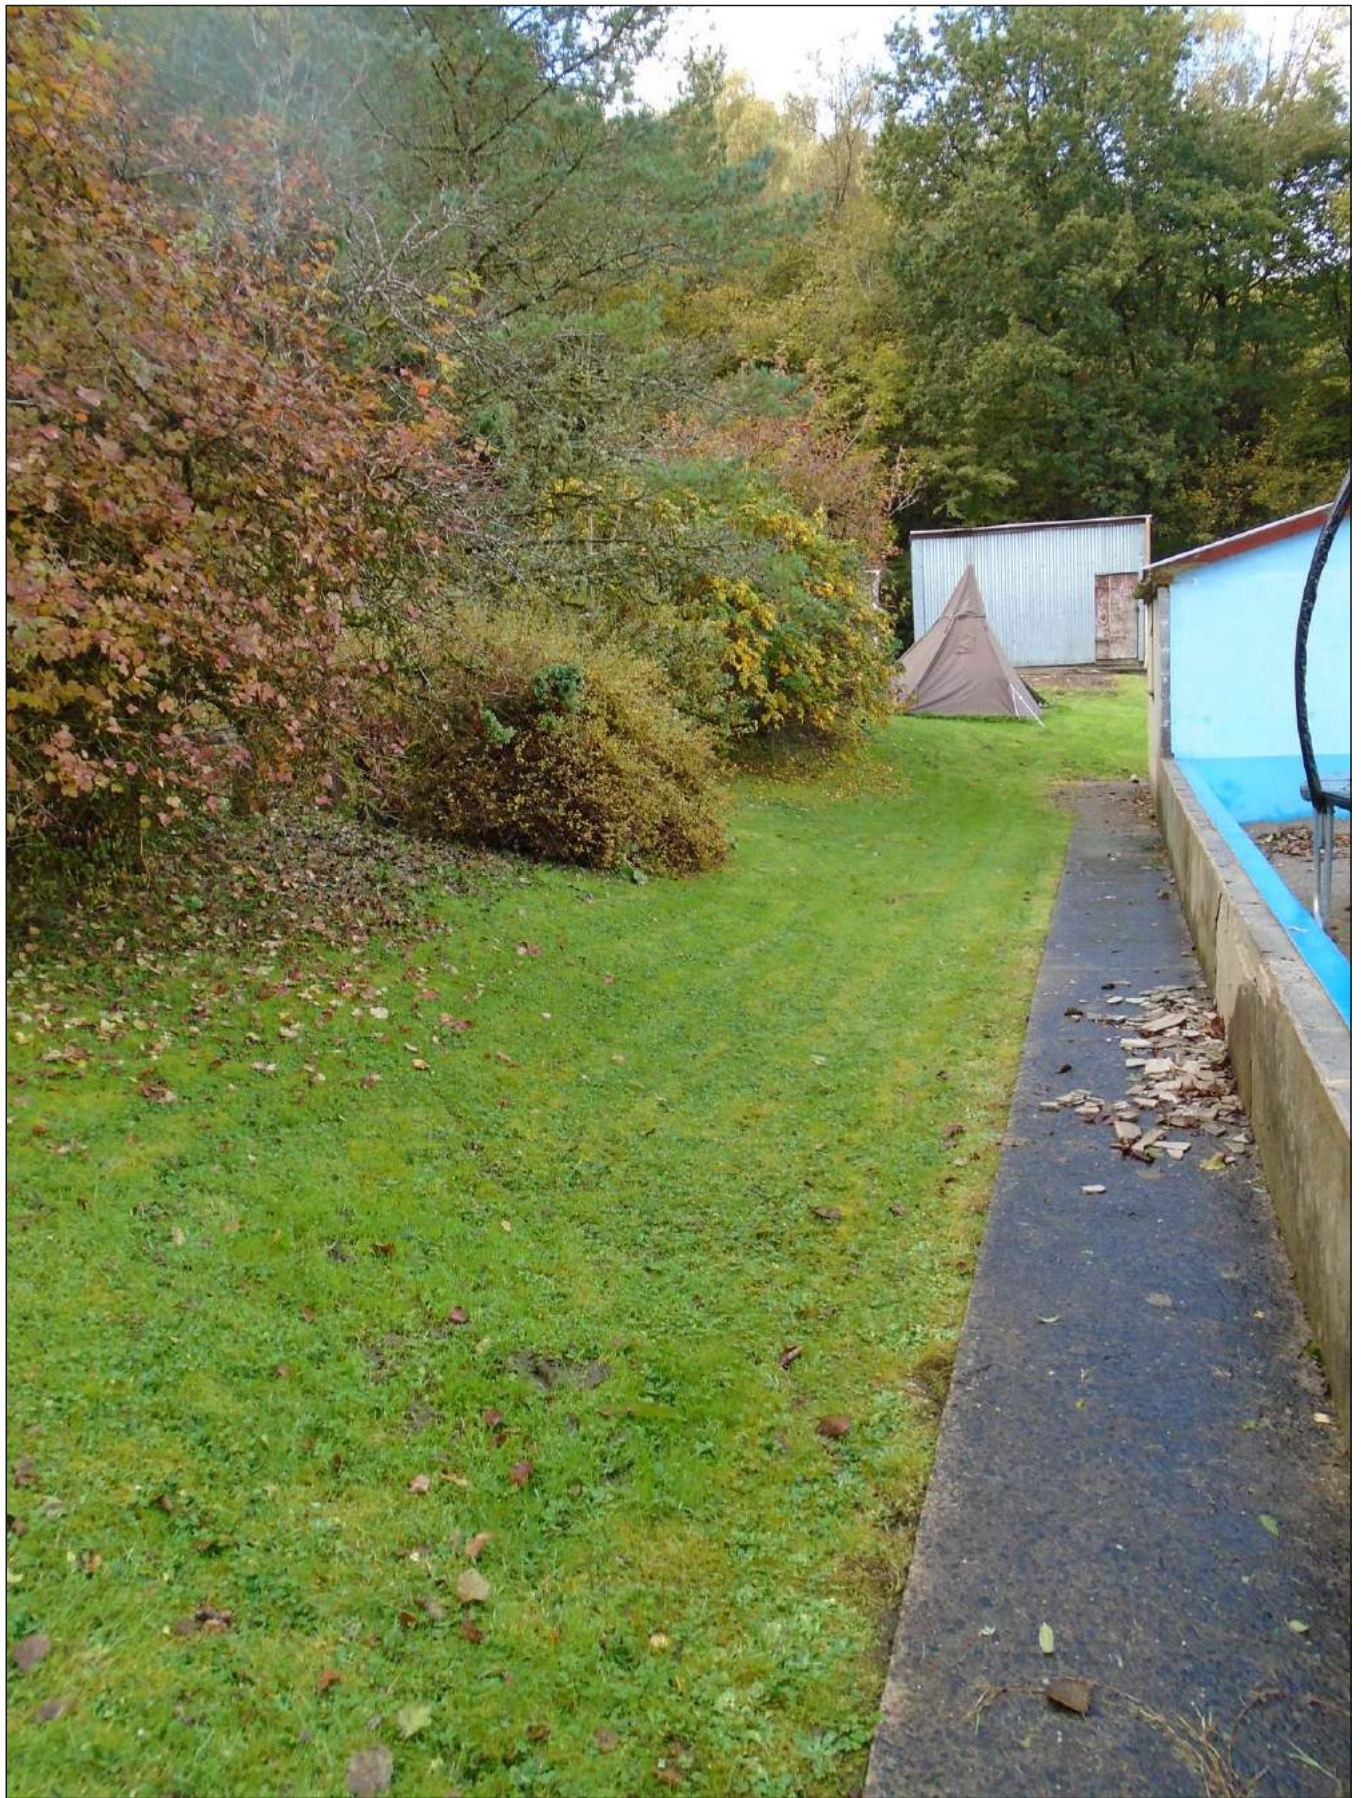
FIGURE 13  
THE POSITION OF MINE ENTRANCE REF. 275210-095

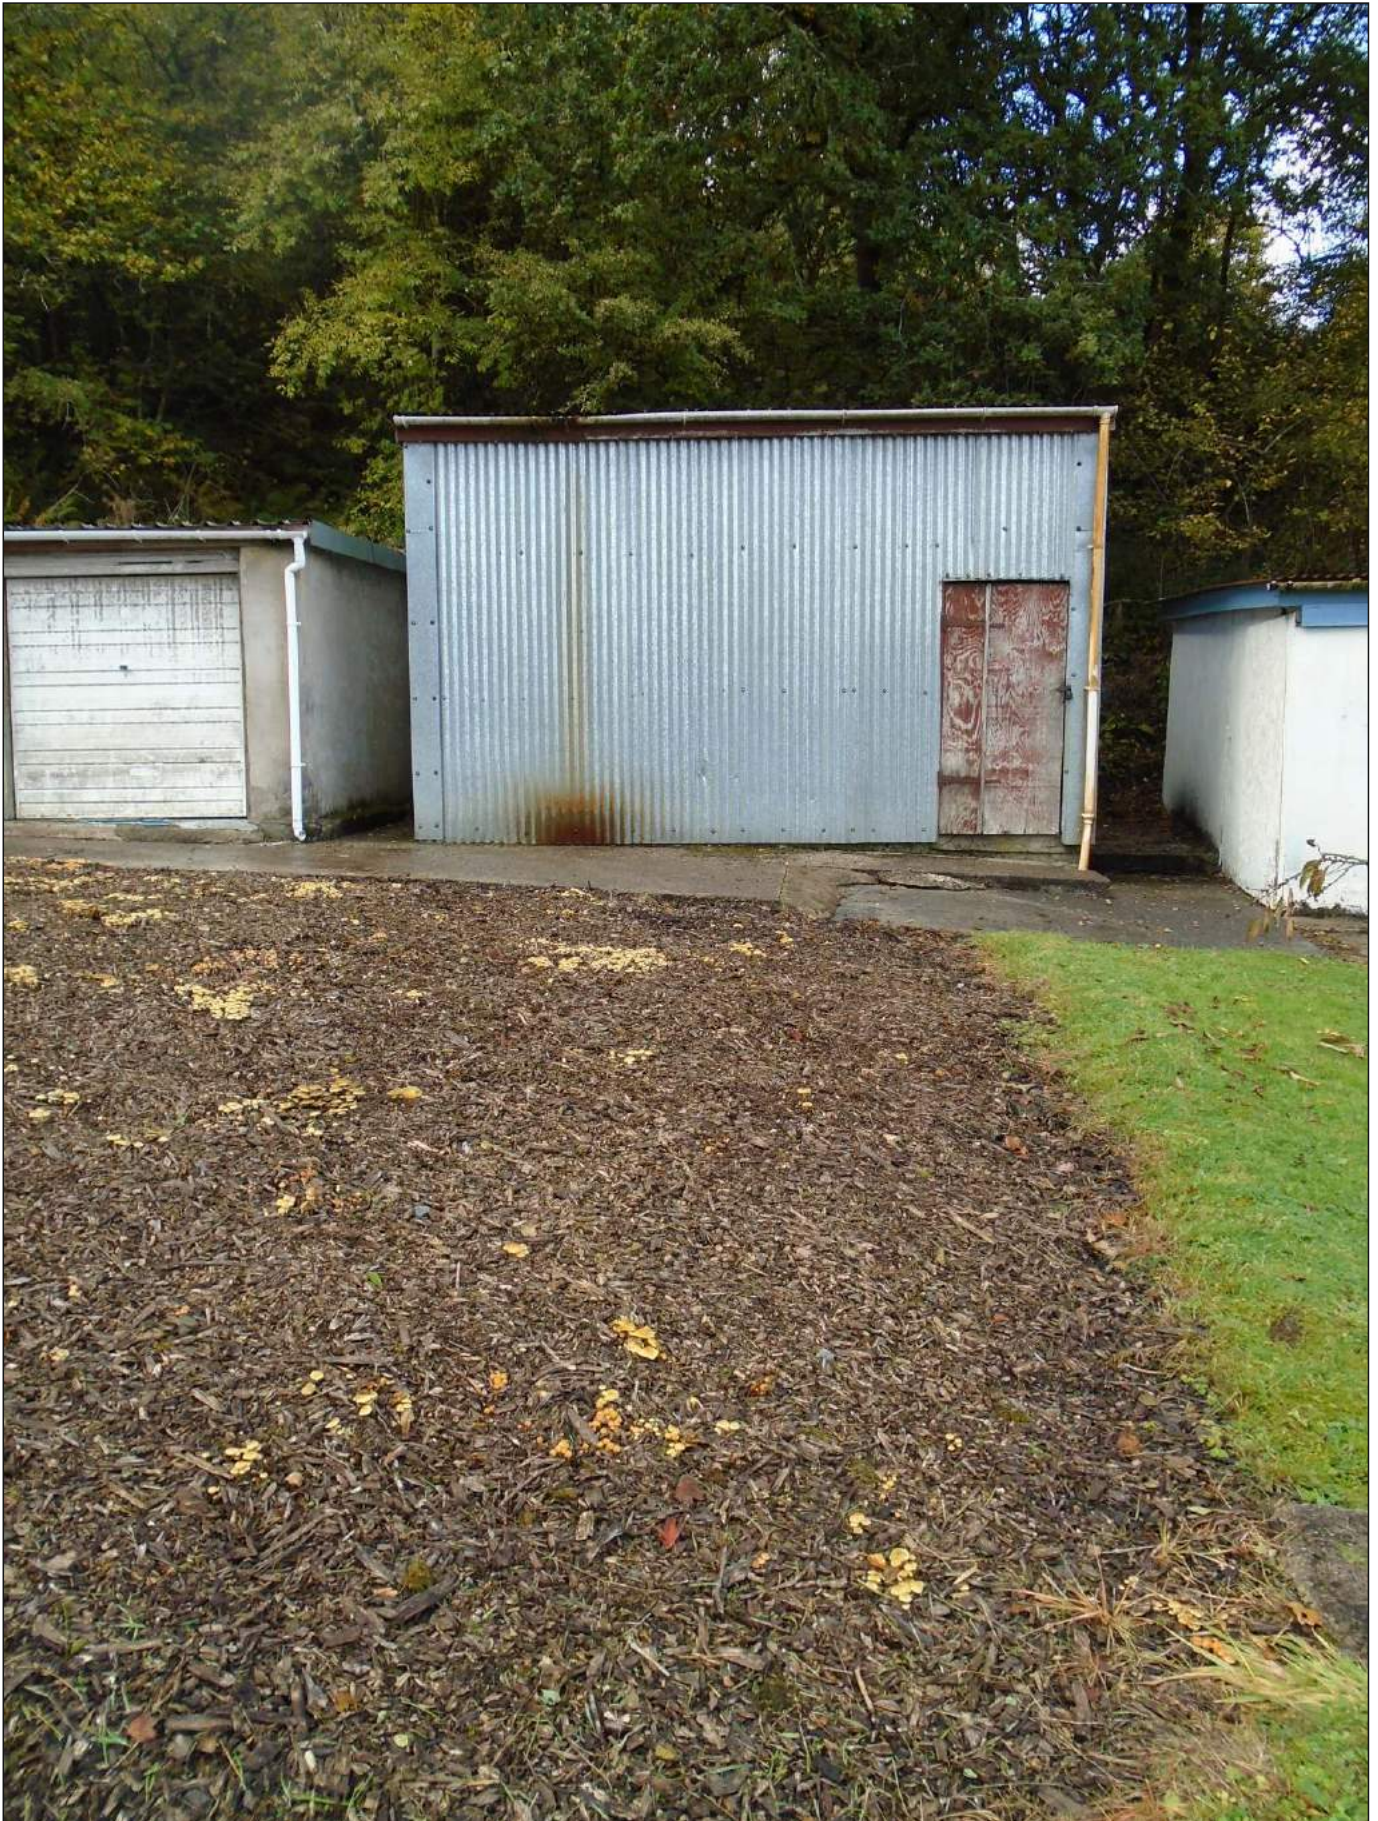
FIGURE 14

THE POSITION OF SHAFT REF. 275210-102 IS BENEATH THE CONCRETE SLAB WITH THE OUTBUILDING AT CENTRE.
