**EARLSWOOD BURN HOUSE, JERSEY  
MARINE, NEATH**

**Outline Remediation Strategy Report**

14050/LW/23/ORS

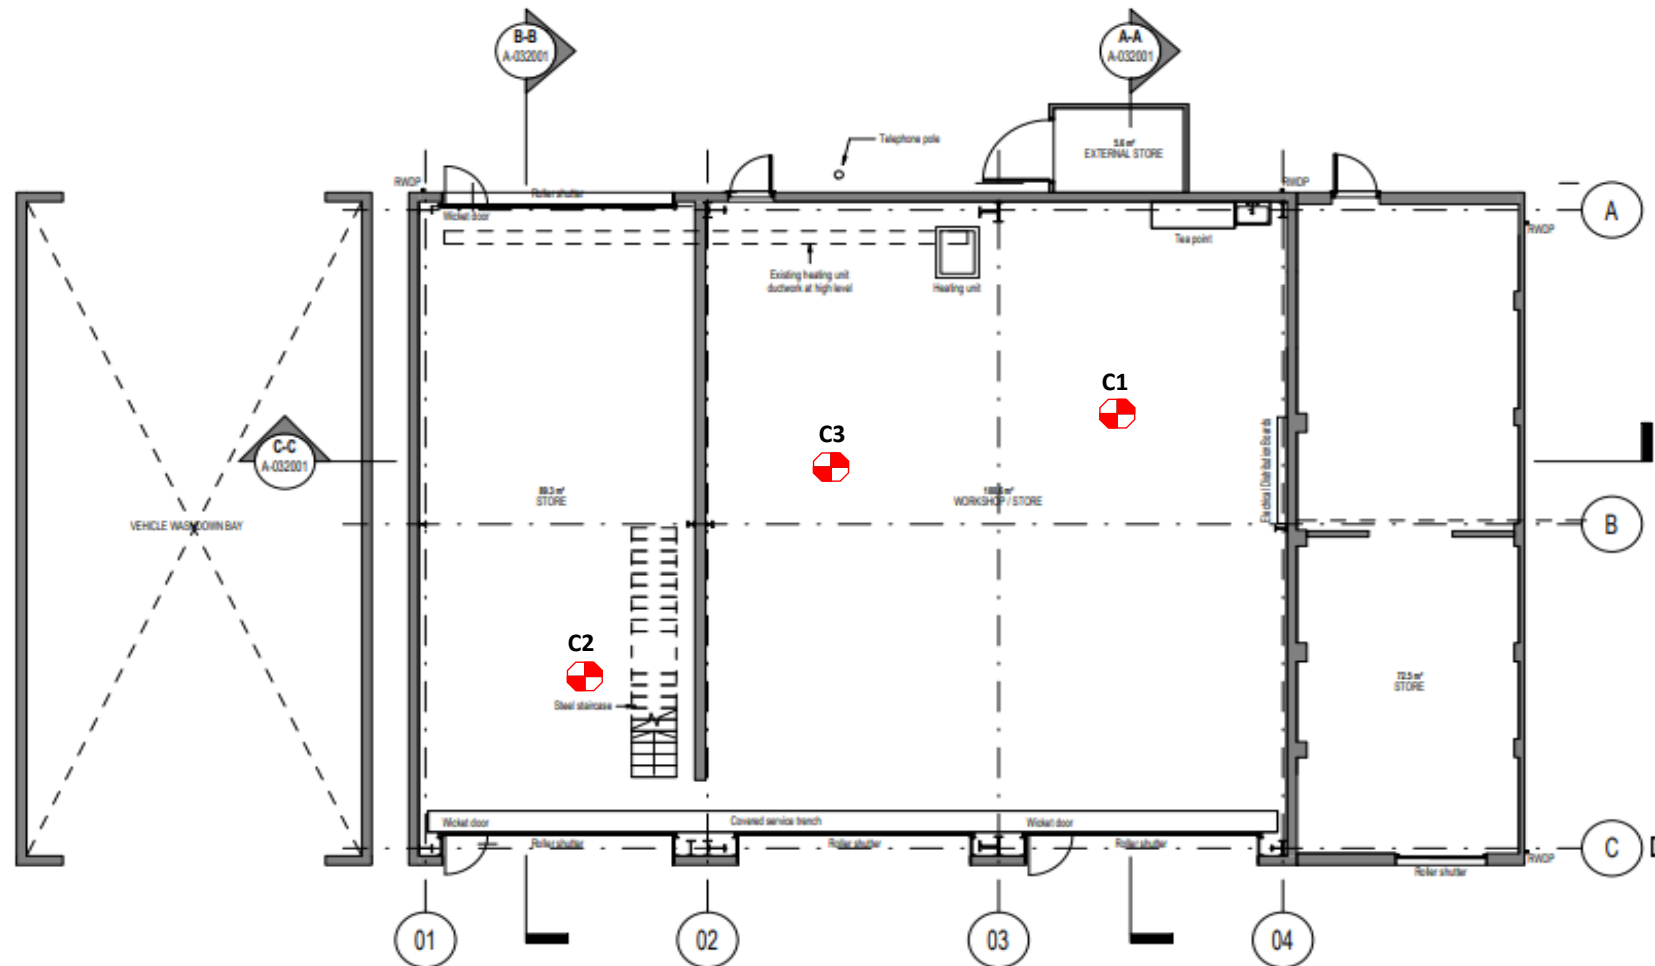
FIGURE 3: SITE PLAN of Cored Concrete Slab

The concrete slab which is situated underneath the giraffe building was cored at three locations (Core 1 to Core 3).

The locations of the cored samples are shown in Figure 3.

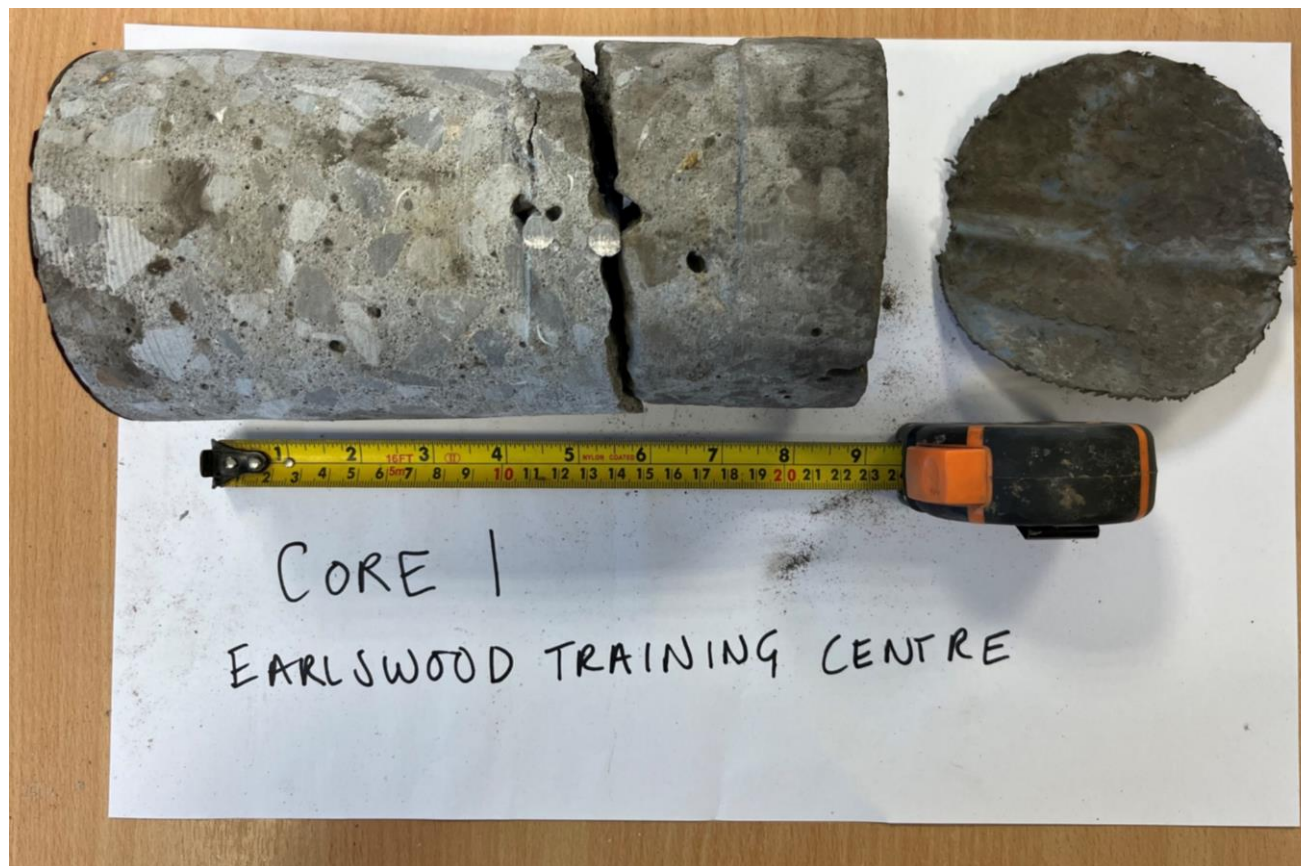
**Figure 4: Core 1**

**Core Description:** Reinforced Concrete

Core Length: 245mm

Reinforcement: 10mm, 8mm and 6mm steel

Suspected two layers of reinforcement.

Approximate air void content: 5%

Voids noted: 1mm up to 10mm.

Concrete cast on plastic membrane.

Top of floor slab painted.

No screed present.

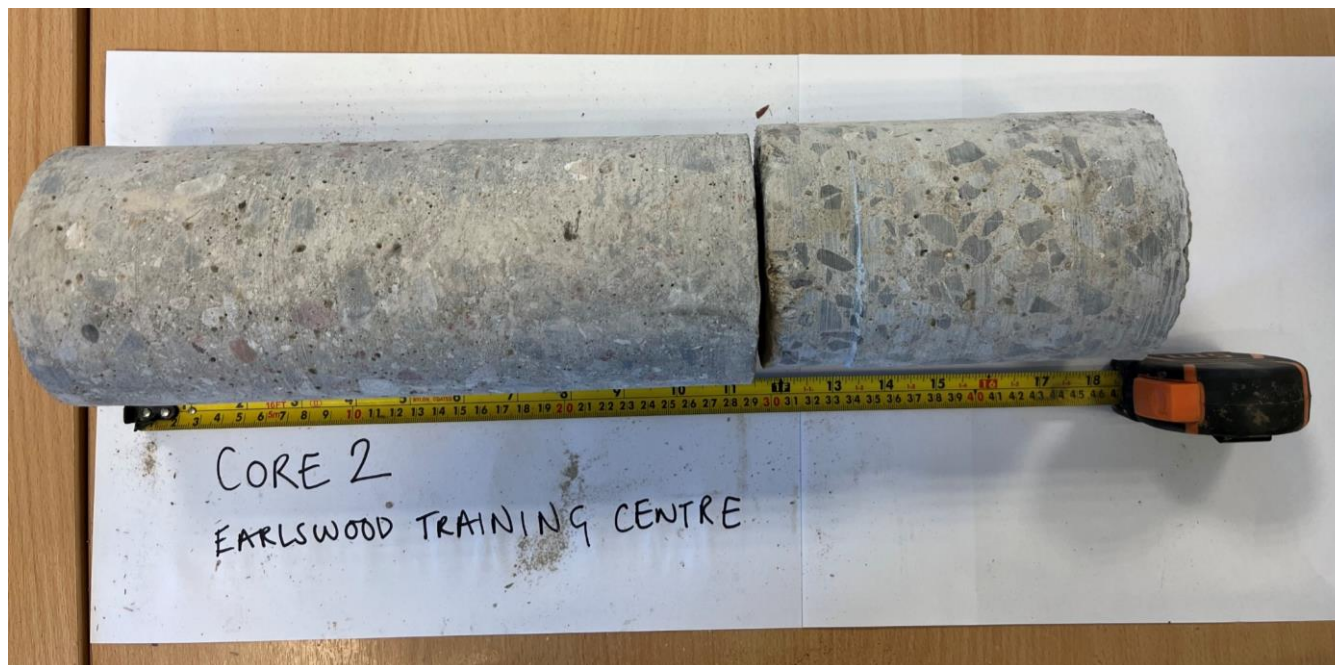
Figure 5: Core 2

#### Core Description: Reinforced Concrete

Core Length: 460mm of solid core.

10mm of core which was unable to be retrieved as solid core.

Reinforcement (within the 2nd core): 8mm steel

Approximate air void content: 5%

Voids noted: 1mm up to 5mm.

Top of floor slab painted.

No screed present.

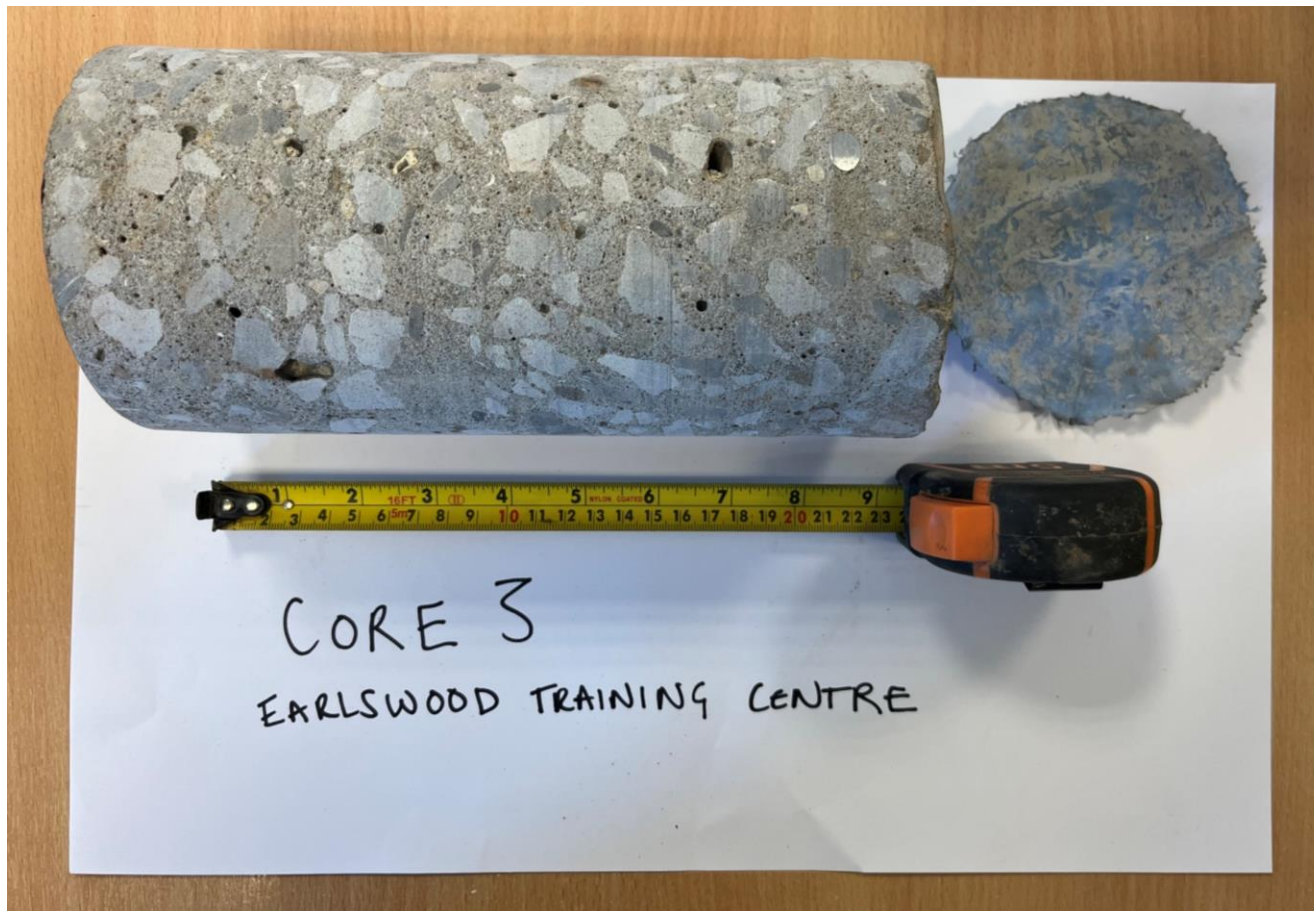
**Figure 6: Core 3**

**Core Description:** Reinforced Concrete

Core Length: 235mm  
Core Diameter: 115mm  
Reinforcement: 10mm and 8mm steel  
Distance to 10mm (from the top of the slab): 175mm  
Distance to 8mm (from the top of the slab): 195mm

Suspected mesh reinforcement.

Matrix supported aggregate.  
Aggregate size: 2mm to 30mm  
Aggregate description: Elongate, sub rounded to sub angular, siltstone, sandstone.  
Matrix cement with fine to coarse grained sand.  
Approximate air void content: 5-10%  
Voids noted: 1mm up to 15mm diameter.

Concrete cast on plastic membrane.  
Top of floor slab painted.  
No screed present.
