**Barn 2  
Pant Glas Farm  
Bryncoch, Neath**

**Structural Engineers Report**

**Job No. 965**

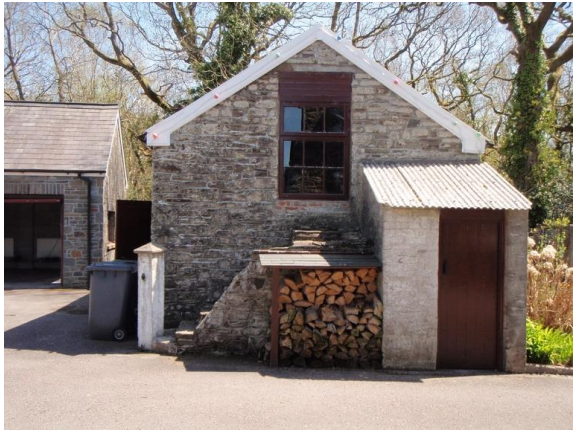
Photo 3.1

Barn 2 is a three roomed barn with a dual pitched slate covered roof and of masonry wall construction predominantly of random stone with some infill panels of red brick. The barn is approx. 13m long and 4.5m has a lean-to annex to the south eastern end. There is a small WC of brick construction with cement/asbestos roof. Walls are of stone construction. There are also steps leading up to a disused high level entrance on the North West elevation gable end.

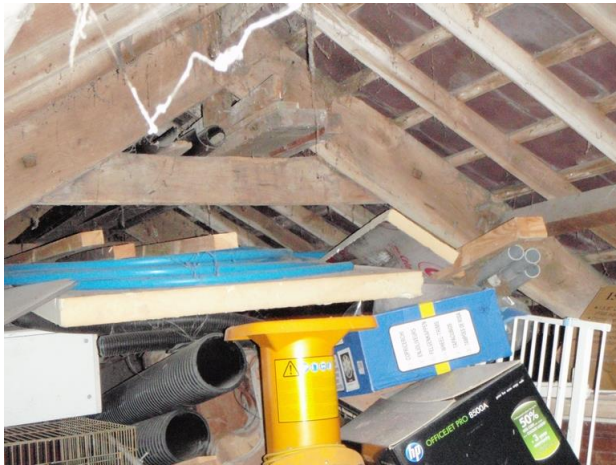
Photo 6.1

The lean-to two room structure on the south east elevation has a sloping slate mono pitched roof. The slates are fixed to battens and then to rafters. The rafters are supported on one central purlin. Most timbers appear to be in good condition. The rooms are well ventilated. The tiles appear to be in reasonable condition although once again the fixings appear to be beginning to corrode, although this is not as significant as other parts of the main barn.

Where the mono-pitched roof connects to the south east gable wall there is no lead flashing but a stone flashing has been inserted to provide a drip over the top tiles.

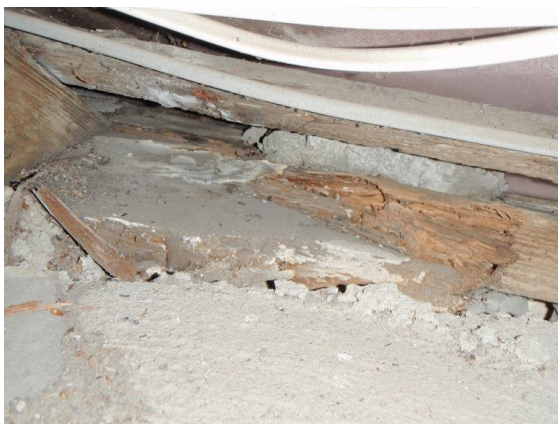
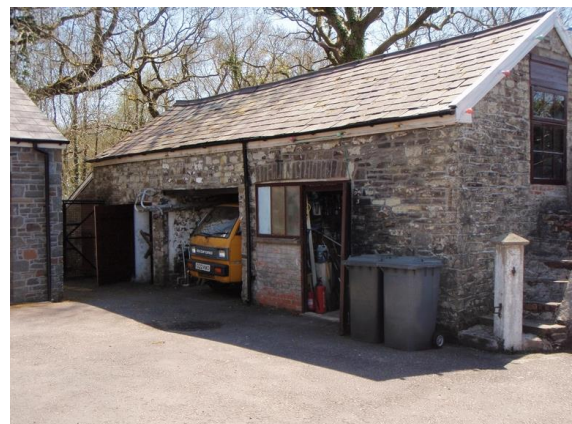
Externally the ridge line appears to be uneven, this suggests that some timbers might have failed particularly towards the south east end of the main barn see photo 6.3 and 6.4. There are also numerous tiles that have slipped or are uneven. Due to the amount of stored items on the mezzanine level it has not been possible to investigate the timberwork towards the south east end of the barn.

The main recommendation is that the roof is likely to need re-slating and the battens replacing. Any damaged rafters will need to be cut back and replaced along with new timber wall plates.

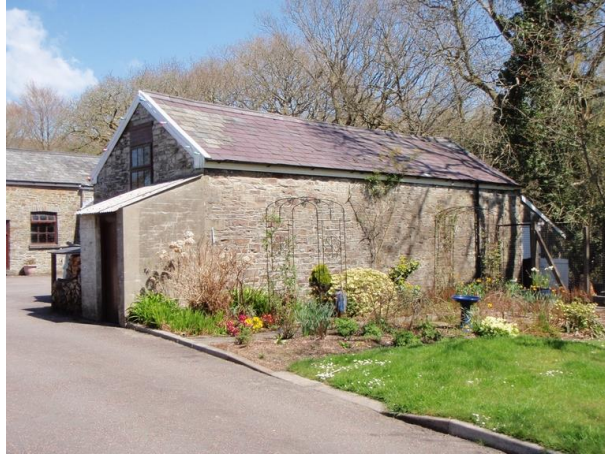
Photo 7.1

There is guttering in black uPVC to the north west elevation with a single downpipe. All appears to be in good condition. To the north east elevation there is similar half round black uPVC with one single downpipe. The single downpipe discharges onto ground level and not into a gully. There are fascia boards to the gable and to the eaves with minimum overhang. These appear to have been replaced at some point in the recent past and are painted with a white gloss finish.

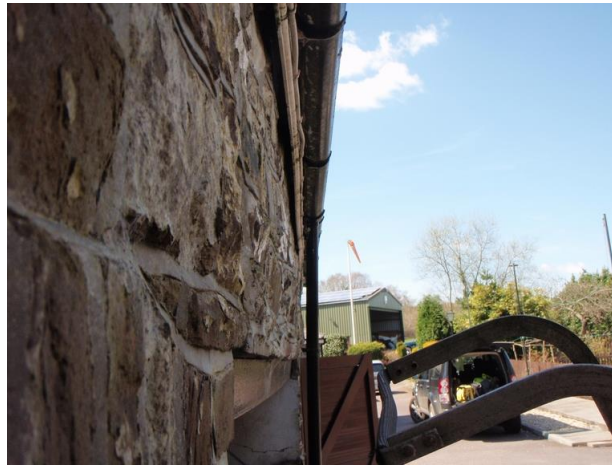
Photo 9.1

The external main walls to the barn are approx. 450mm thick and constructed from random stone local to the area and set into a lime based mortar. The lime based mortar has been re-pointed with ordinary portland cement. There are no signs of cracking or structural distress to the building. However, there is some distortion to the north east elevation wall.

The alignment of the walls has been checked using a hand held spirit level. Generally the wall to the south west elevation appears to be in good condition, vertical and shows no sign of structural distress. The same is true for the gable walls. The long wall on the north east elevation does show signs of distortion at high level and the wall appears to be leaning away from the building at high level. Upper stonework often becomes loose following thermal movement and distortion and this upper 1/2m of wall should be considered for rebuilding as part of any future refurbishment rebuilt.

It is believed that the overall stability of the building is good and therefore all walls can be retained. It is however recommended to rebuild the upper section of the north east wall when incorporating new lintels with any future development. When installing new ground slabs care should be taken to undermine the existing foundations which are likely to be at a shallow level.

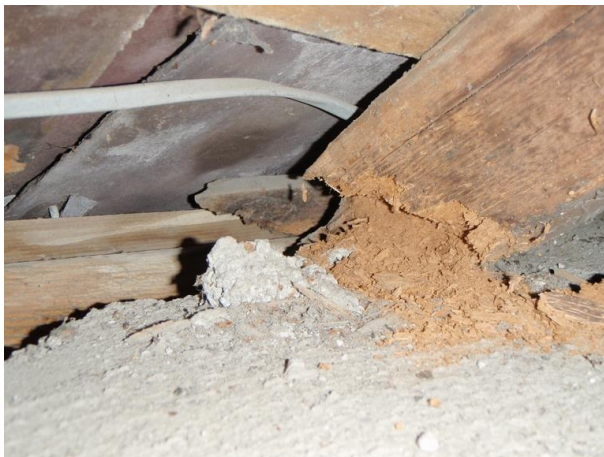
Photo 10.1

At eaves level there has been some moisture ingress which has decayed the rafter ends and wall plate. Once again on the day of the inspection the weather was fine and moisture readings within the timbers were normal.

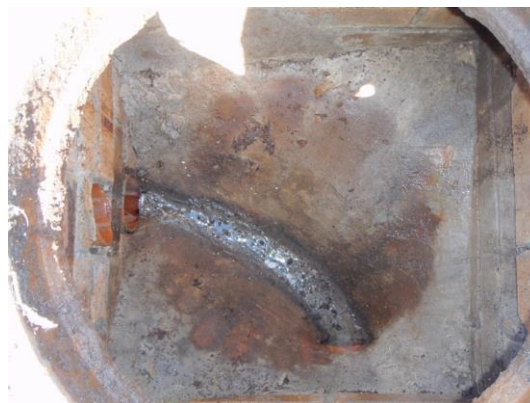
Photo 17.1

As already mentioned surface water from the roof is discharged via surface rainwater pipes onto the ground. It flows away to a soft verge or to the courtyard drainage gully. The small roofs to the lean-to and WC have no guttering and discharge to the ground. There is foul drainage to the WC and an incoming water supply. The manhole near the back door of the main house has been lifted but it is not possible to see an incoming drain from the WC area. If this is connected to the main drain it is likely to be a blind connection. The only way to determine the outfall from the toilet is to either carry out a CCTV drainage survey or to seek local knowledge.
