Barn 1  
Pant Glas Farm  
Bryncoch, Neath

**Structural Engineers Report**

**Job No. 965**

| <b>Date:</b> | 17 <sup>th</sup> May 2023 |

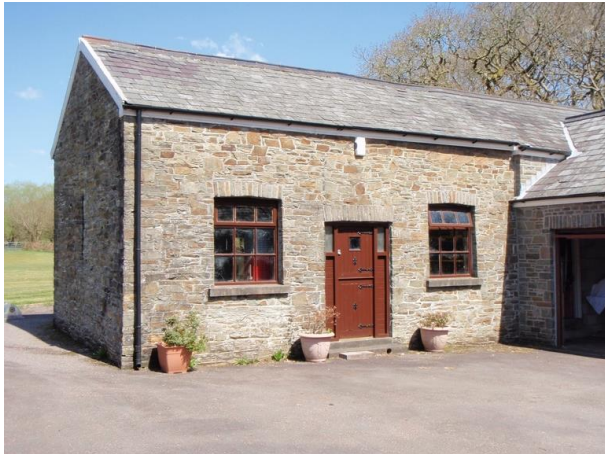
Photo 3.1

Barn 1 comprises of an original barn which has been extended to the south east and also to the south west forming an L shape on plan. The barn is of slate roof covering on either trussed rafters to the extension or cut timber rafters to the original barn which are supported on masonry external walls. The masonry external walls are of stone to the original part of the barn and are cavity wall construction to the extension part of the building. The cavity wall construction is dense blockwork inner skin and a random stone masonry external skin.

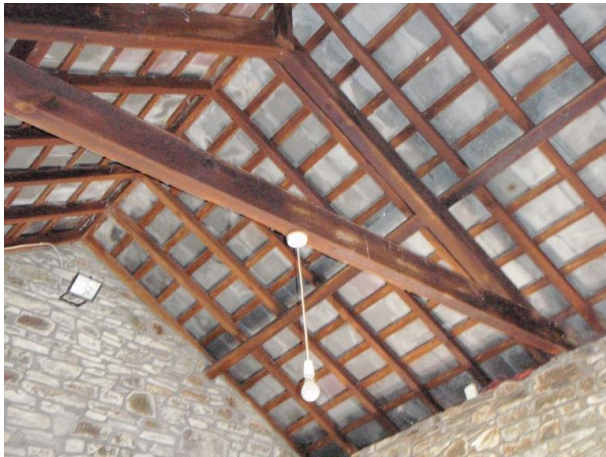
The roof to the original barn is covered in natural grey slate tiles fixed to treated timber battens which are in turn fixed to cut timber rafters which span from the wall plate level onto a purlin and up to the ridge board. The purlins are in turn supported on 2 nos. triangular trusses. All timbers appear to be in good condition and inspection of the internal eaves shows the wall plate to also be in sound condition. Internally the slates are not flaking and appear to be in sound condition. Some roofing slates have cracked or slipped.

All lead work appears to be in good condition. The main roof to the existing barns appears to have dipped in some areas. It is possible that some rafters might have slipped on their supports due to corrosion of fixings. These should be inspected when access is available to these areas.

Photo 6.1 – Original Barn Roof

Some roofing slates are cracked or have slipped and should be repaired. The depressions in the roof should be investigated further and timbers re-aligned if required. The ridge tiles are out of alignment and should be re-set.

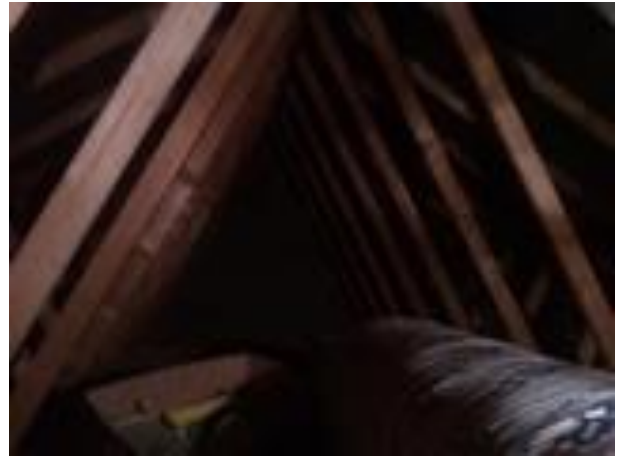
The roof to the barn extension are of timber trussed rafters which span between external walls and in turn support felt and timber battens to which the grey natural slates are fixed. All timberwork is in sound condition; the trusses appear to have horizontal binders but do not have diagonal chevron bracing. This should be installed. Also the gable walls should be checked for lateral restraint at high level. No lateral restraint straps could be seen.

Photo 6.2 – Extension Roof

The roof trusses appear to have horizontal binders but do not have diagonal chevron bracing. This should be installed. Also the gable walls should be checked for lateral restraint at high level. No lateral restraint straps could be seen.

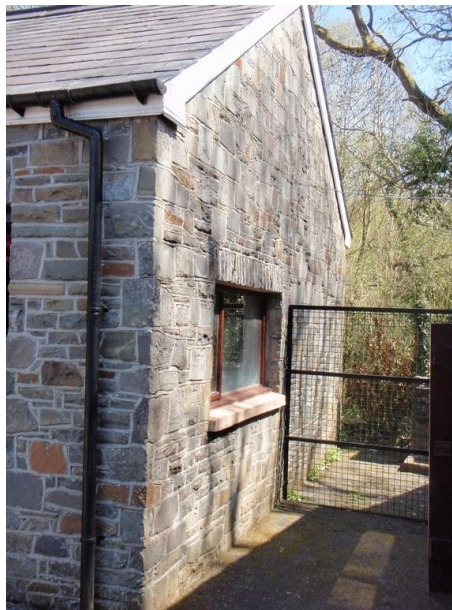
The gutters are black uPVC half round which lead to round black downpipes which discharge onto the ground in some places and into gully pots in other places. These gully pots are believed to drain to the existing drainage. All gutters appear to be in good condition.

Photo 7.1 – South West Elevation

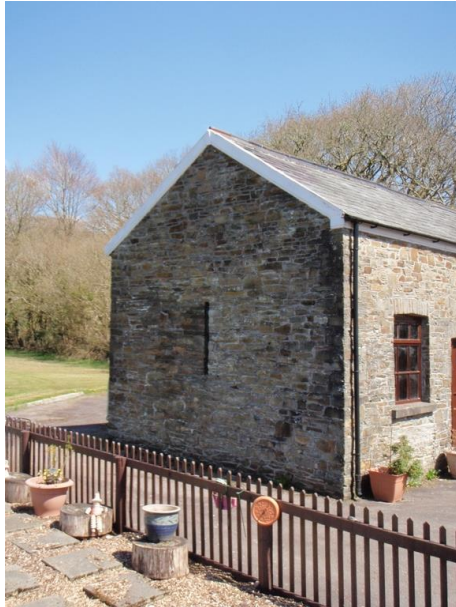
The external main wall to the existing barn is approx. 450mm wide and of solid random stone construction set in a lime based mortar. The lime based mortar has been pointed with ordinary portland cement. All walls appear vertical and stable. There are no signs of cracking or structural distress to the building.

Photo 9.1 – North West Elevation

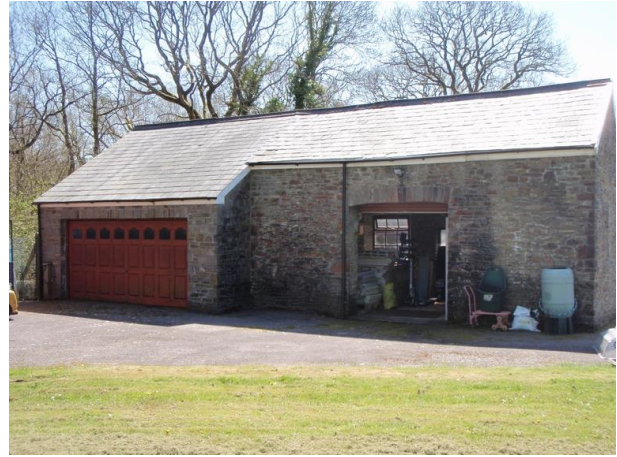
The extension part of the building is constructed from dense concrete block inner skin cavity wall construction with a stone outer leaf. All walls appear vertical and stable.

Photo 9.2 – North East Elevation

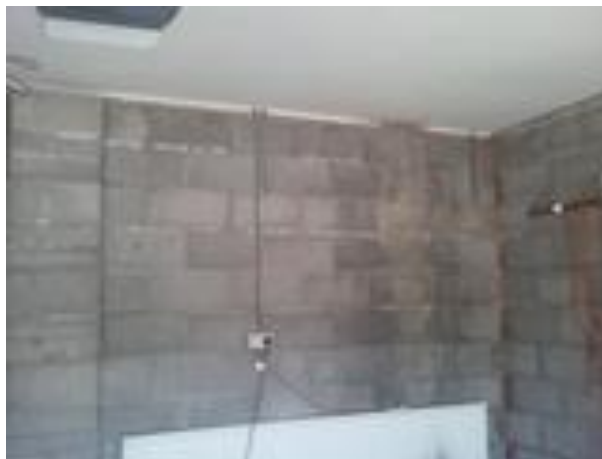
Photo 16.1

Internal partitions between the extension garages are of dense blockwork construction approx. 100mm thick. There are no significant structural issues with these walls.

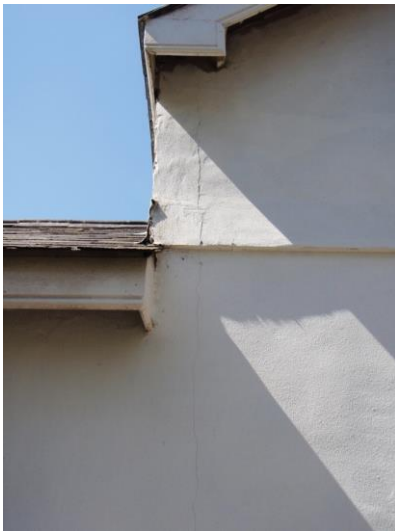
Photo 18.1

The south east facing elevation to the extension facing the road had been rendered and painted with masonry paint. The rendered blockwork wall shows some cracking at the vertical DPC joint with the stonework section of the wall. There are no retaining walls to the property but there is an inclined bank close to the rear south east elevation of the barn which drops approx. 1m down to the lane behind. This slope is considered far enough away not to cause any instability to the rear wall of the barn extension.
