**Client Name: Global Centre of Rail Excellence**

**Site: GCRE (Main Site)**

**Project No. 5209796**

# Appendix E. Mining Risk Assessment

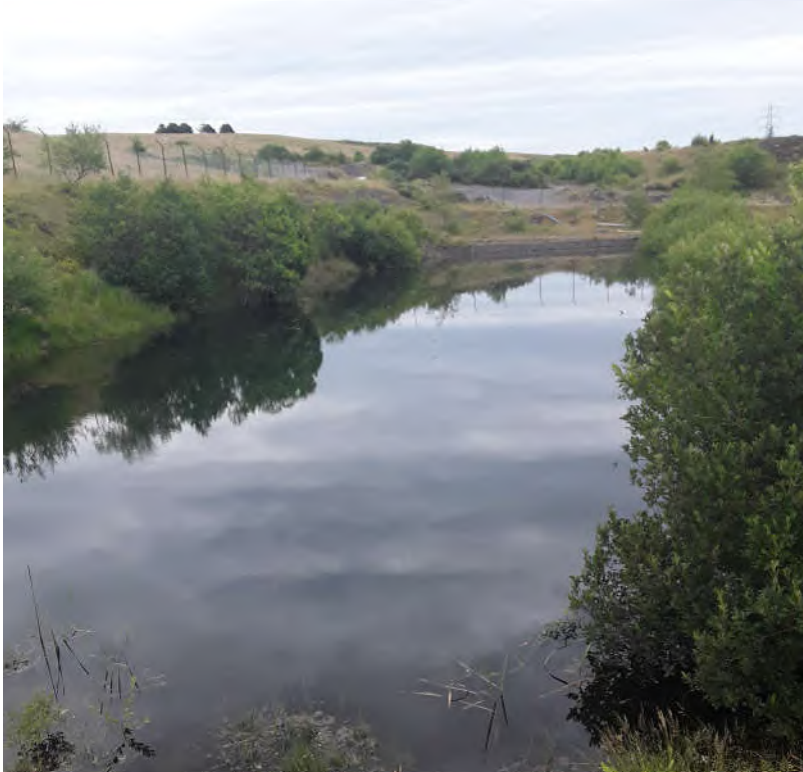
| Photo No.<br>SW-15 DP | Date:<br>12 July<br>2022 | |
|---|---|---|
| <b>Surface Water Feature SW-15 DP:</b><br>Smaller lagoon, water storage area, probably lined with low permeability material, drainage/runoff from restoration area. No water flowing observed at the time. Approximate measurements 10m wide, 50m length. Measurements DO 134.57%, ORP 163.8 mV, Cond 1,602.50 ms/cm, pH 7.62, T19.55C<br><br>The photo aspect is east. | | |

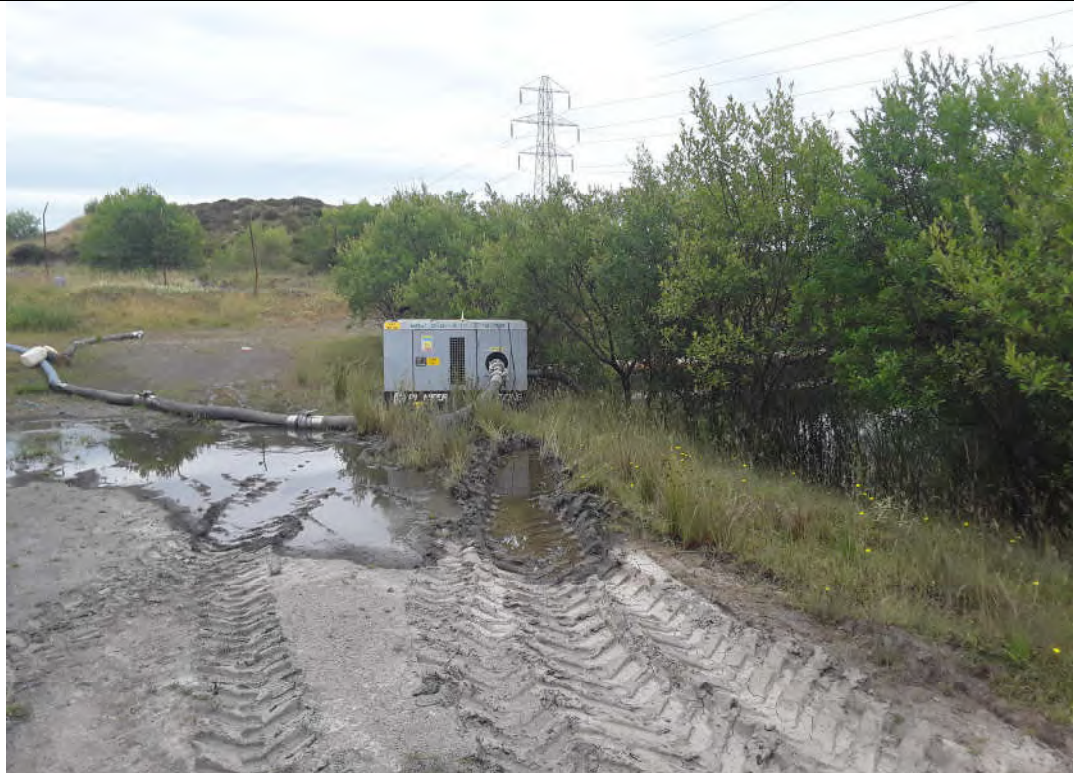
| Photo No.<br>SW-16 DP | Date:<br>12 July<br>2022 | |
|---|---|---|
| <b>Pump SW-16 DP:</b><br>Pump present on northern boundary of SW16 CE holding lagoon. Pump not on at time of walkover. Connected to SW17 DP via pipes and presumed up to pumping uphill to this lagoon.<br><br>The photo aspect is east | | |

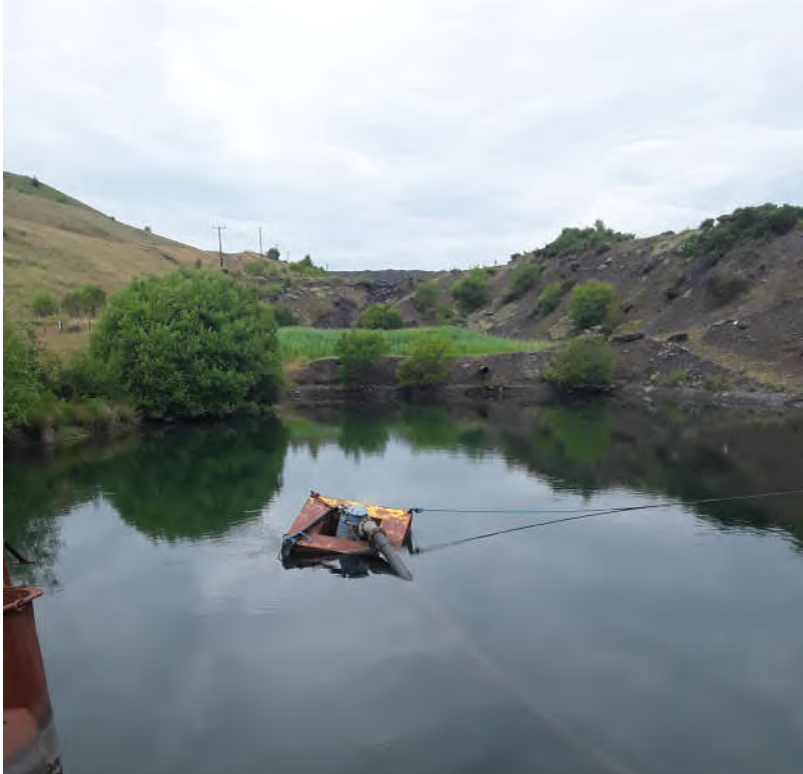
| Photo No.<br>SW-17 DP | Date:<br>12 July<br>2022 | |
|---|---|---|
| <b>Surface Water Feature SW-17 DP:</b><br>Lagoon, water storage area, probably lined with low permeability material, drainage/runoff from restoration area. No water flowing observed at the time. Submersible pump working and pumping water to lagoon to north. Not able to access for water parameter measurements. Approximate measurements 30m wide, 55m length.<br><br>The photo aspect is east. | | |

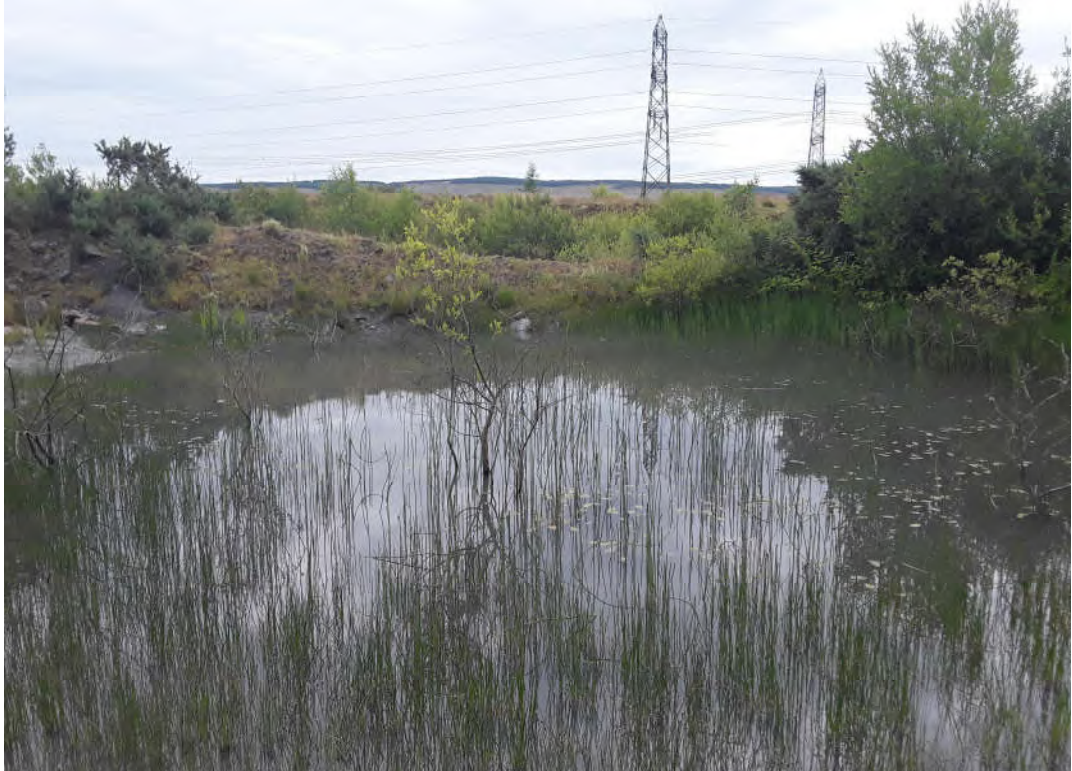
| Photo No.<br>SW-18 DP | Date:<br>12 July<br>2022 | |
|---|---|---|
| <b>Surface Water Feature SW-18 DP:</b><br>Overflow / washout pond. Water observed to be silty. Measurements DO 92.29%, ORP 147.0 mV, Cond 199.29 ms/cm, pH 7.84, T22.79C. Approximate measurements 25m wide, 30m length. The photo aspect is south. | | |

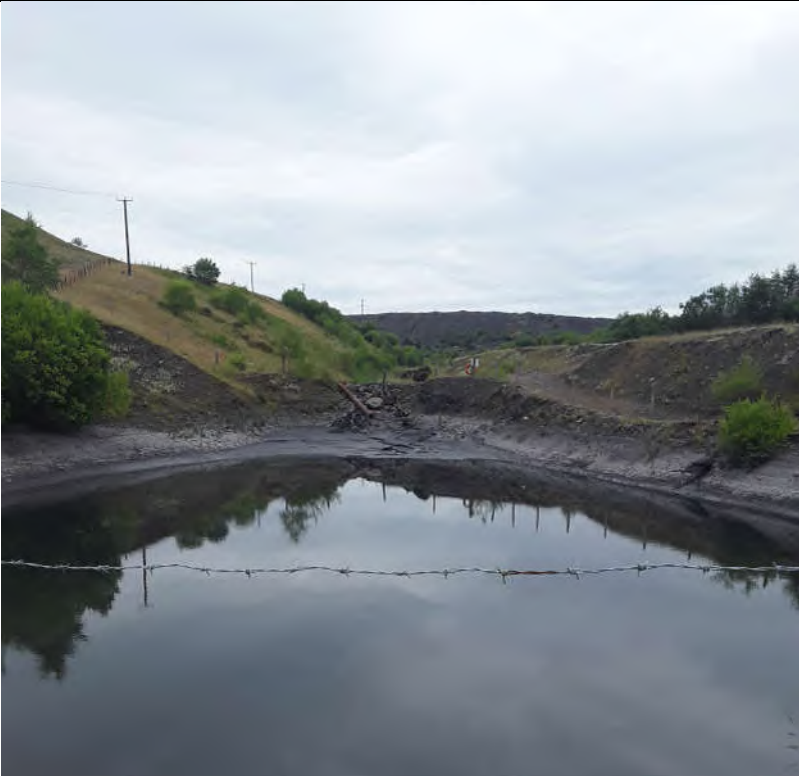
| Photo No.<br>SW-19 DP | Date:<br>12 July<br>2022 | |
|---|---|---|
| <b>Surface Water Feature SW-19 DP:</b><br>Lagoon, water storage area, probably lined with low permeability material, drainage/runoff from restoration area. No water flowing observed at the time. Black and silty. Not able to access for water parameter measurements. Approximate measurements 20m wide, 40m length.<br><br>The photo aspect is north. | | |

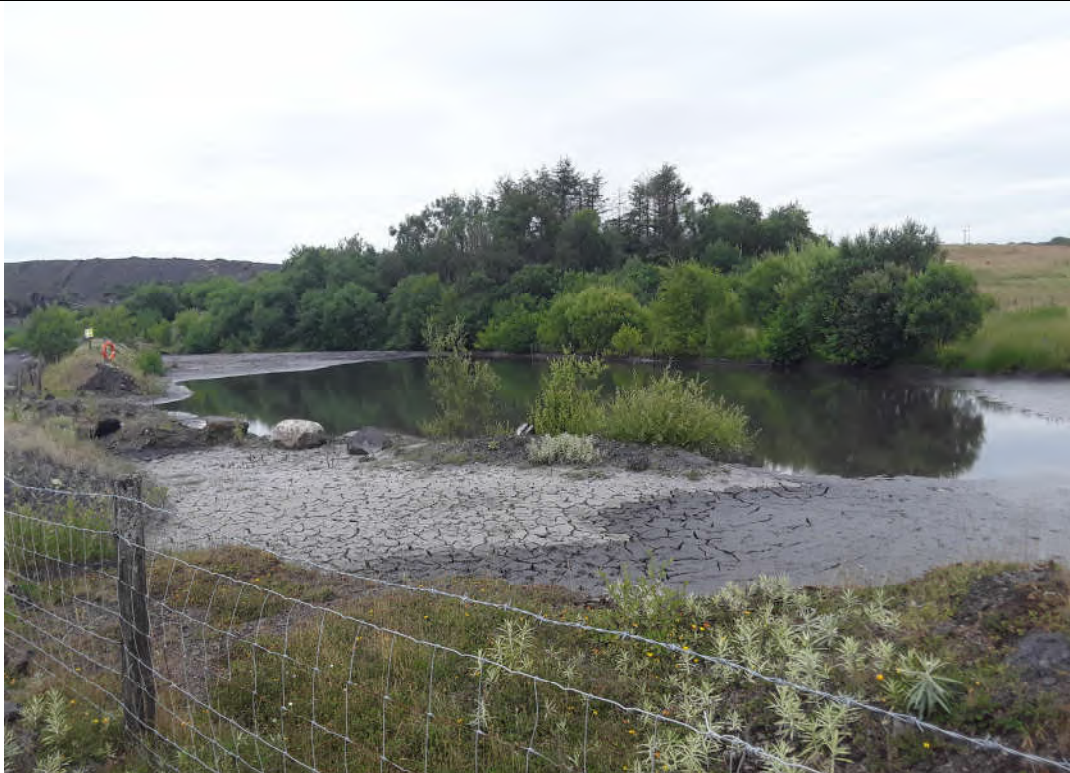
| Photo No.<br>SW-20 DP | Date:<br>12 July<br>2022 | |
|---|---|---|
| <b>Surface Water Feature SW-20 DP:</b><br>Lagoon, water storage area, probably lined with low permeability material, drainage/runoff from restoration area. No water flowing observed at the time. Black and silty. Not able to access for water parameter measurements. Approximate measurements 26m wide, 80m length.<br><br>The photo aspect is north. | | |

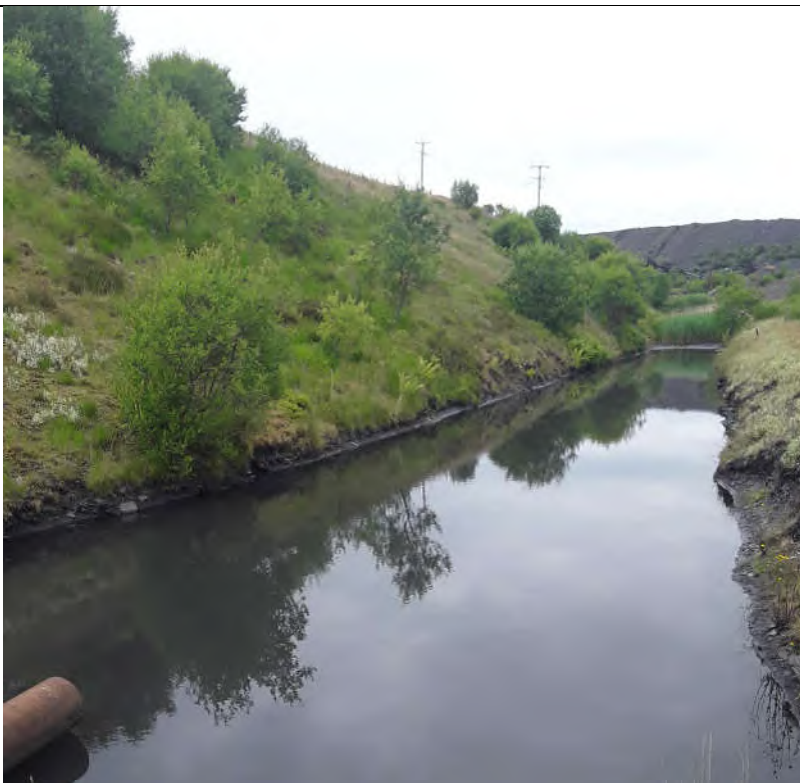
| Photo No.<br>SW-21 DP | Date:<br>12 July<br>2022 | |
|---|---|---|
| <b>Surface Water Feature SW-21 DP:</b><br>Lagoon, water storage area, probably lined with low permeability material, drainage/runoff from restoration area. No water flowing observed at the time. Black and silty. Approximate measurements 26m wide, 80m length. Measurements DO 39.87%, ORP 160.5 mV, Cond 680.60 ms/cm, pH 7.71, T20.00C<br><br>The photo aspect is north. | | |

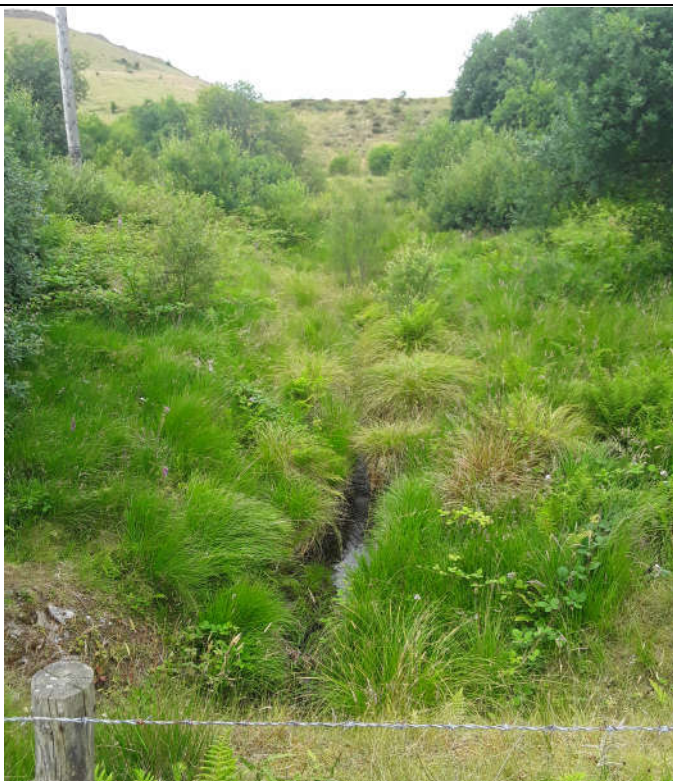
| Photo No.<br>SW-22 DP | Date:<br>12 July<br>2022 | |
|---|---|---|
| <b>Surface Water Feature SW-22 DP:</b><br>Grassed ditch extending south from the holding lagoon area. No water flowing observed at the time. Stagnant standing water 25cm deep. Becomes vegetated along ditch. Tributary of Nany Ystalwyn, Approximate measurements 70m length, 1.20m deep 2.0 m wide. The photo aspect is south. | | |

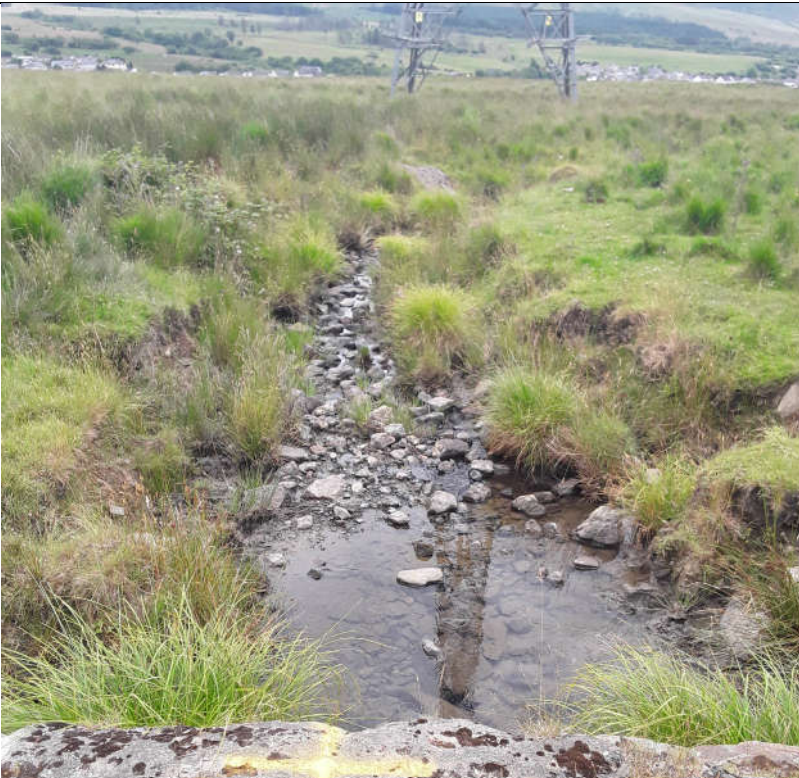
| Photo No.<br>SW-23 DP | Date:<br>12 July<br>2022 | |
|---|---|---|
| <b>Surface Water Feature SW-23 DP:</b><br>Continuation of SW22-DP extending south.<br>Rocky ditch<br>No water flowing observed at the time.<br>Standing water 20cm deep. Becomes vegetated along ditch.<br>Labelled as Nany Ystalwyn, Approximate measurements 1.20m deep 2.0 m wide.<br>Measurements DO 96.95%, ORP 164.8 mV, Cond 1,238.6 ms/cm, pH 8.17, T15.5C<br><br>The photo aspect is south. | | |

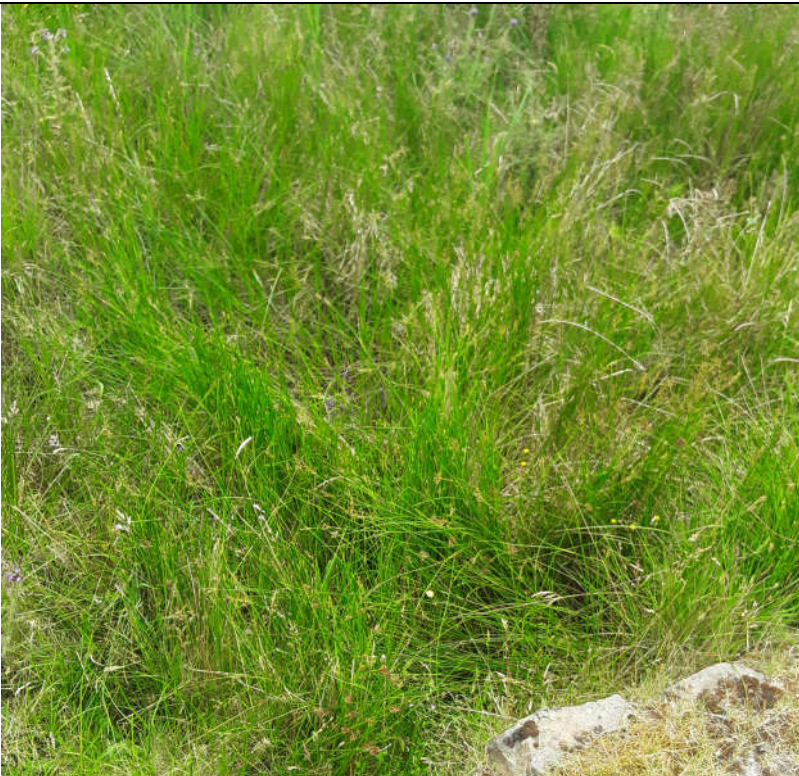
| Photo No.<br>SW-24 DP | Date:<br>12 July<br>2022 | |

| Photo No.<br>SW-24 DP | Date:<br>12 July<br>2022 | |
|---|---|---|
| <b>Surface Water Feature SW-23 DP:</b><br>Dry grassed ditch No water flowing observed at the time. Extending south from the access track<br><br>The photo aspect is south. | | |

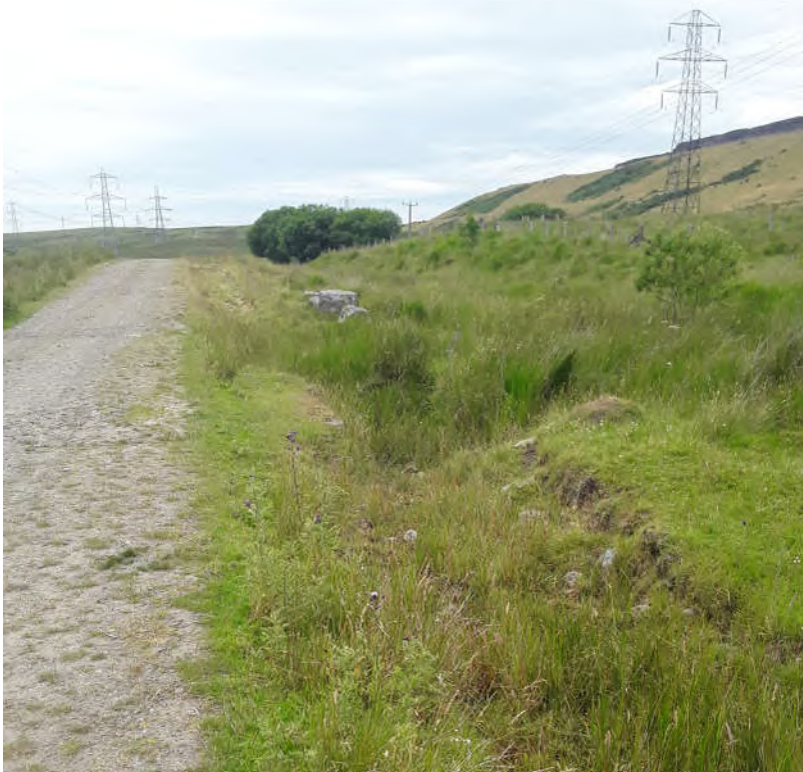
| Photo No.<br>SW-25 DP | Date:<br>12 July<br>2022 | |

| Photo No.<br>SW-25 DP | Date:<br>12 July<br>2022 | |
|---|---|---|
| <b>Surface Water Feature SW-25 DP:</b><br>Continuation of the east to west ditch to the north of the access track in the south of the site.<br><br>The photo aspect is west. | | |

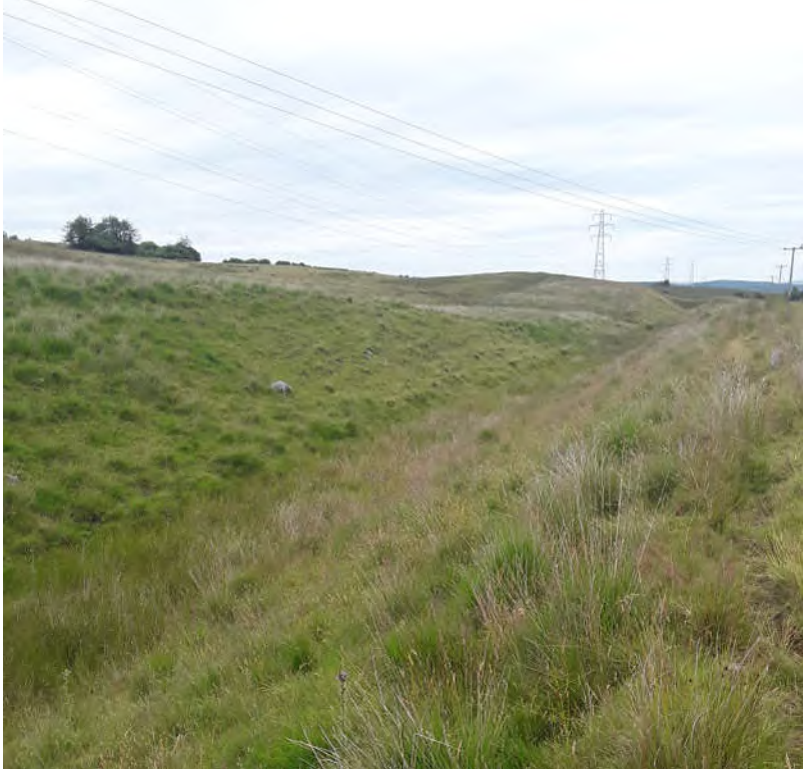
| Photo No.<br>SW-26 DP | Date:<br>12 July<br>2022 | |
|---|---|---|
| <b>Surface Water Feature SW-26 DP:</b><br>Continuation of the east to west ditch to the north of the access track in the south of the site. Drop in elevation from the road, damp at base.<br><br>The photo aspect is east. | | |

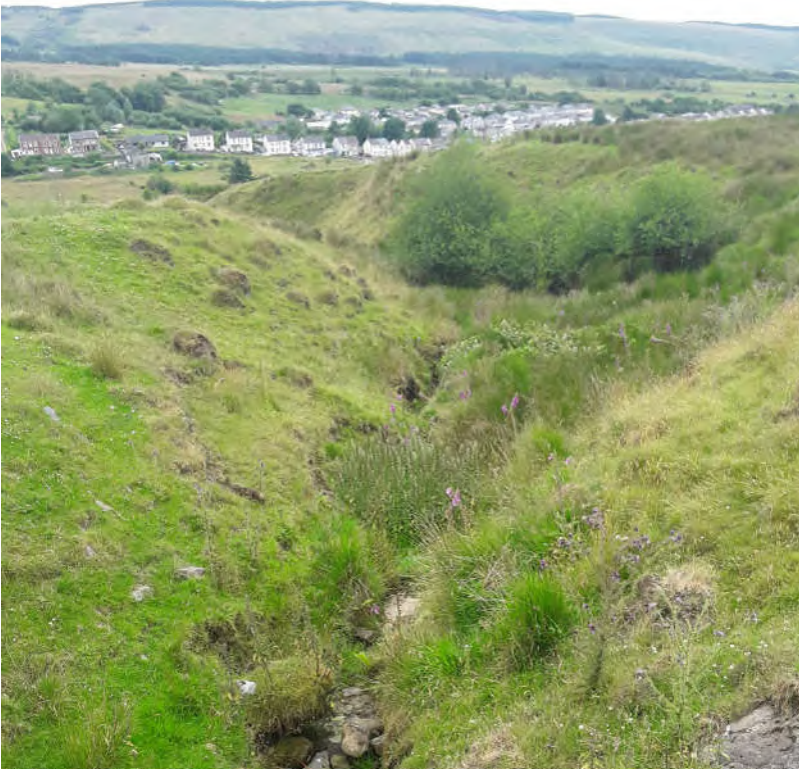
| <b>Surface Water Feature SW-27 DP:</b><br>Rocky gully extending south from the access track.<br>No water flowing observed at the time.<br>Standing water 10cm deep. Becomes vegetated along ditch.<br>Approximate measurements 2.20m deep 1.0 m wide.<br><br>The photo aspect is south. | | |

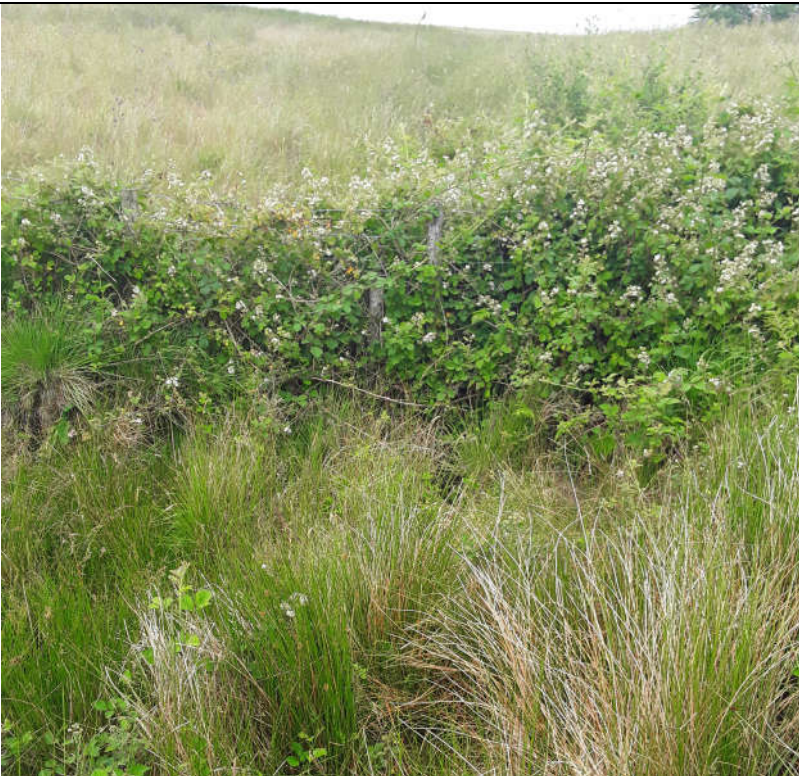
| <b>Photo No.</b><br>SW-28 DP | <b>Date:</b><br>12 July 2022 | |

| <b>Surface Water Feature SW-28 DP:</b><br>Continuation of SW27 DP, located north of the access track. Dry, grassy ditch.<br><br>The photo aspect is north. | | |

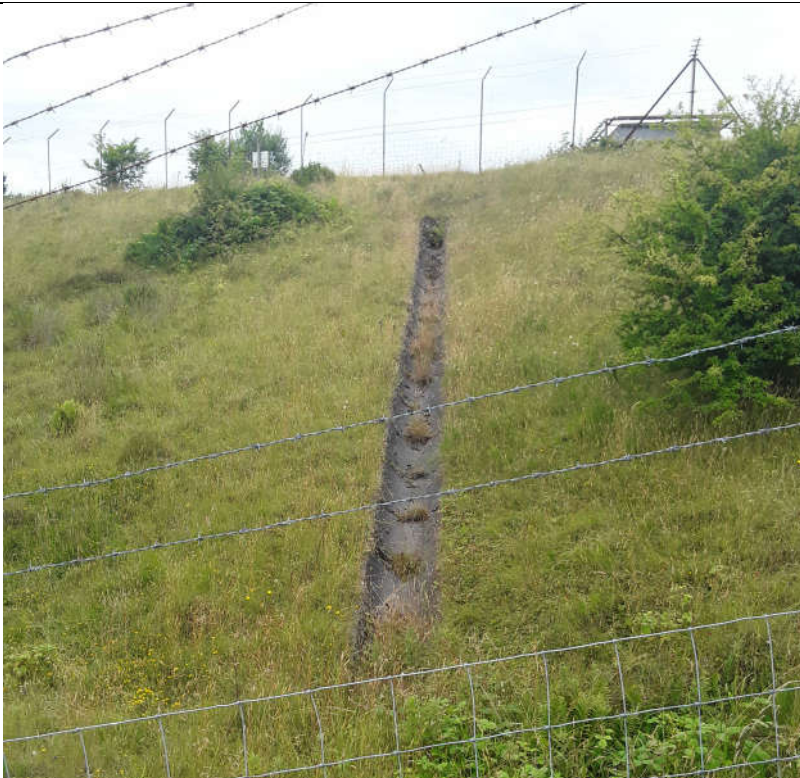
| Photo No.<br>SW-29 DP | Date:<br>12 July<br>2022 | |

| Photo No.<br>SW-29 DP | Date:<br>12 July<br>2022 | |
|---|---|---|
| <b>Surface Water Feature SW-29 DP:</b><br>Concrete lined spillway chute between SW31 and SW30. Approximately 20m long.<br><br>The photo aspect is north. | | |

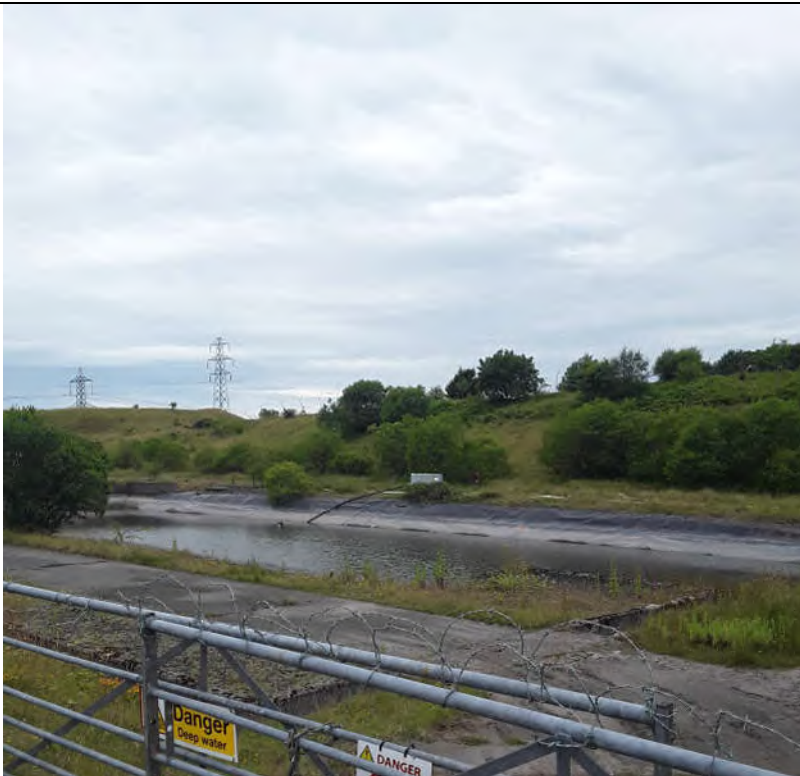
| Photo No.<br>SW-30 DP | Date:<br>12 July<br>2022 | |
|---|---|---|
| <b>Surface Water Feature SW-30 DP:</b><br>One of two holding lagoon, water storage areas, probably lined with low permeability material, drainage/runoff from restoration area. No water flowing observed at the time. Approximate measurements 25m wide, 130m length. No access.<br><br>The photo aspect is south west. | | |

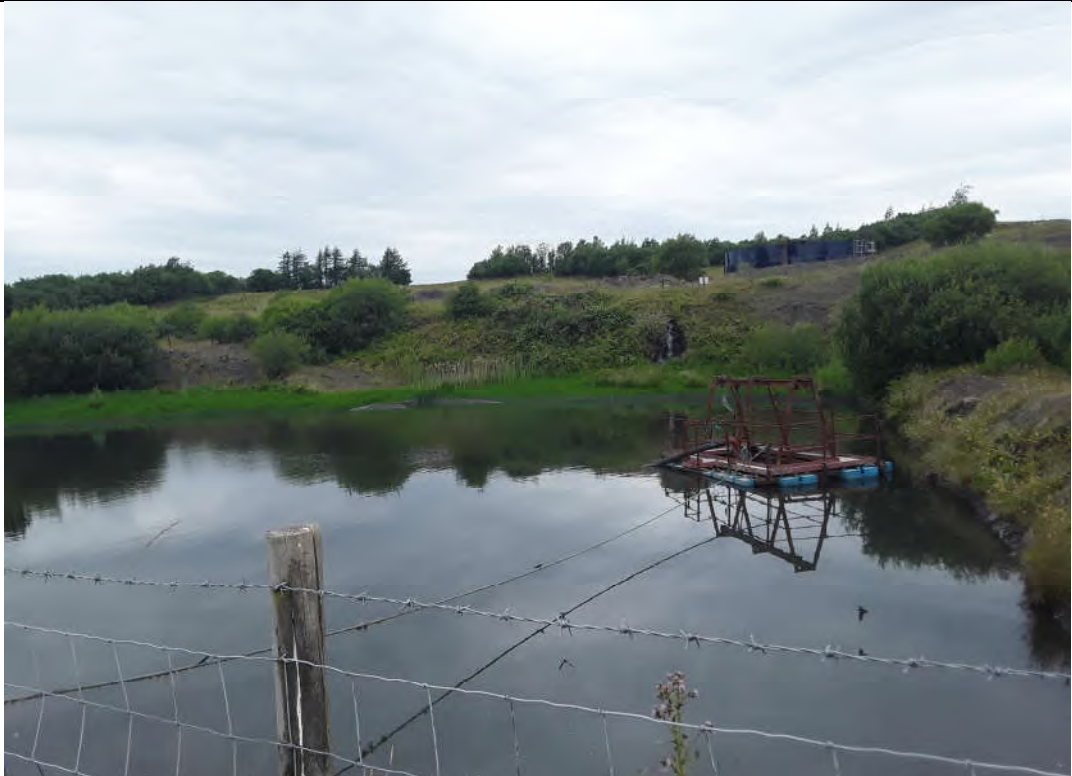
| Photo No. | Date: | |
|---|---|---|
| <b>Surface Water Feature SW-31 DP:</b><br>Holding lagoon, water storage areas, probably lined with low permeability material, drainage/runoff from restoration area. No water flowing observed at the time. Approximate measurements 40m wide, 45m length. No access. Pump not operational during walkover.<br><br>The photo aspect is north. | | |

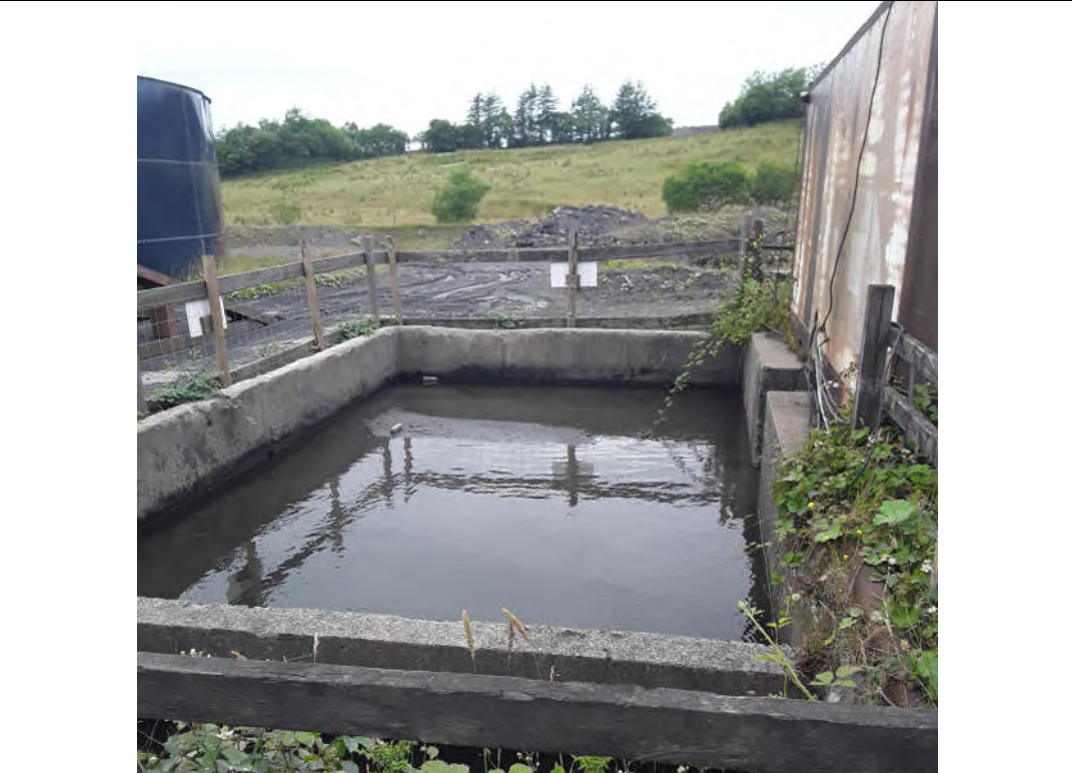
| Photo No. | Date: | |
|---|---|---|
| <b>Surface Water Feature SW-32 DP:</b><br>Holding lagoon, concrete lined drainage/runoff from restoration area. Possible wheel wash area. No water flowing observed at the time. Approximate measurements 10m wide, 5m length. No access. Pump not operational during walkover.<br><br>The photo aspect is west. | | |

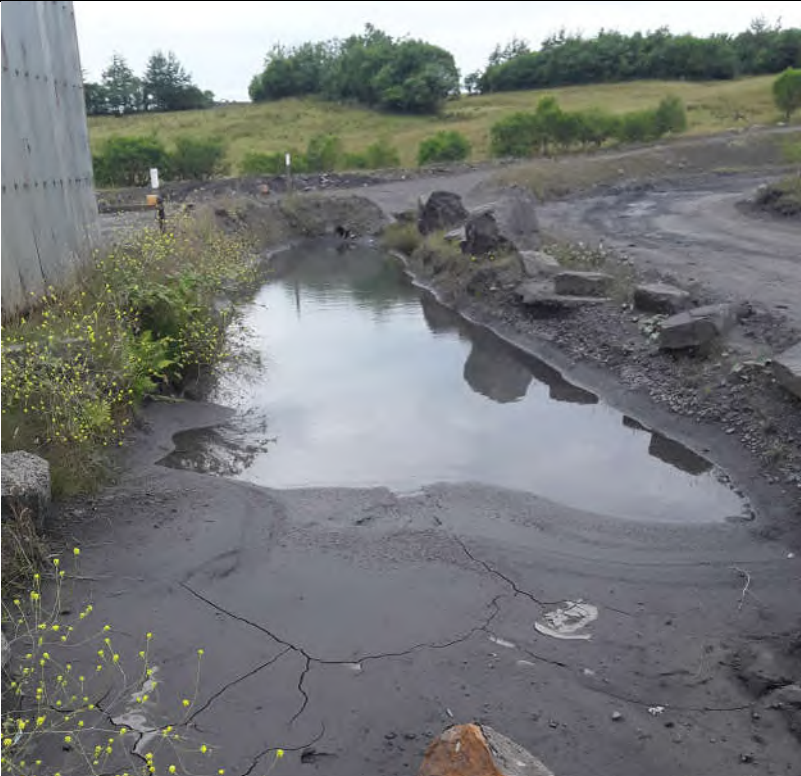
| <b>Surface Water Feature SW-33 DP:</b><br>Black silty pond.<br>Possible overspill from wheel wash area.<br>Approximate measurements 5m wide, 10m length<br>The photo aspect is west. | | |

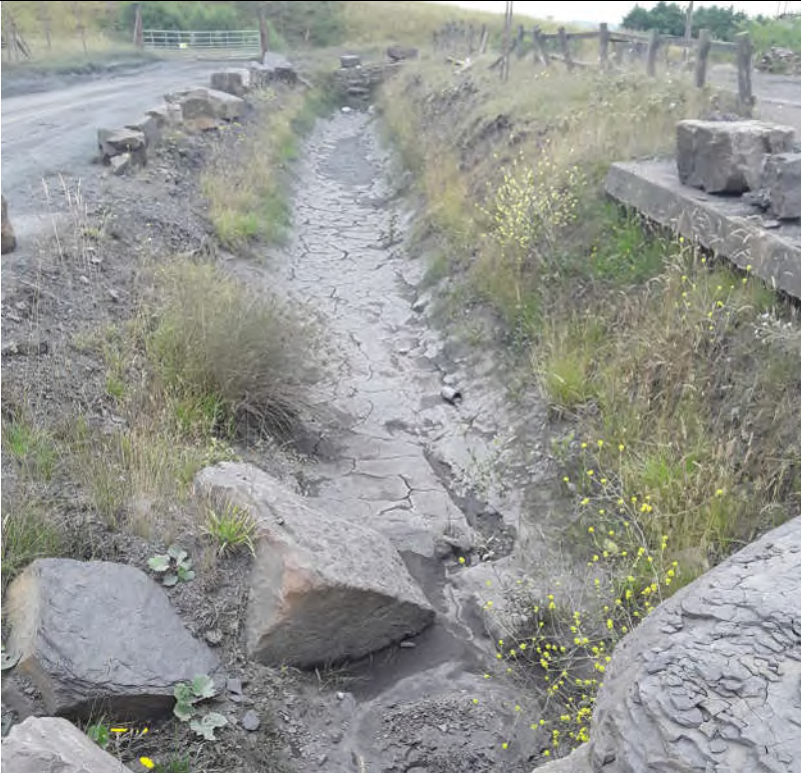
| <b>Surface Water Feature SW-34 DP:</b><br>Overflow ditch, dry<br>Approximate measurements 5m wide, 30m length<br>The photo aspect is east. | | |

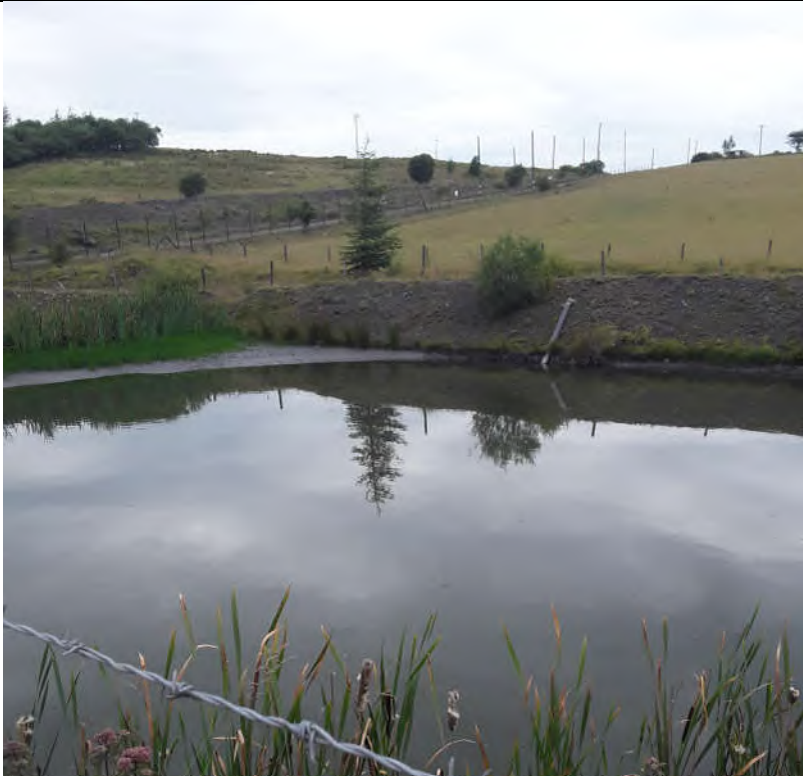
| Photo No.<br>SW-35 DP | Date:<br>12 July<br>2022 | |
|---|---|---|
| <b>Surface Water Feature SW-35 DP:</b><br>Holding lagoon, water storage area, probably lined with low permeability material, drainage/runoff from restoration area. No water flowing observed at the time. Approximate measurements 25m wide, 20 m length. No access. Not accessible<br><br>The photo aspect is north. | | |

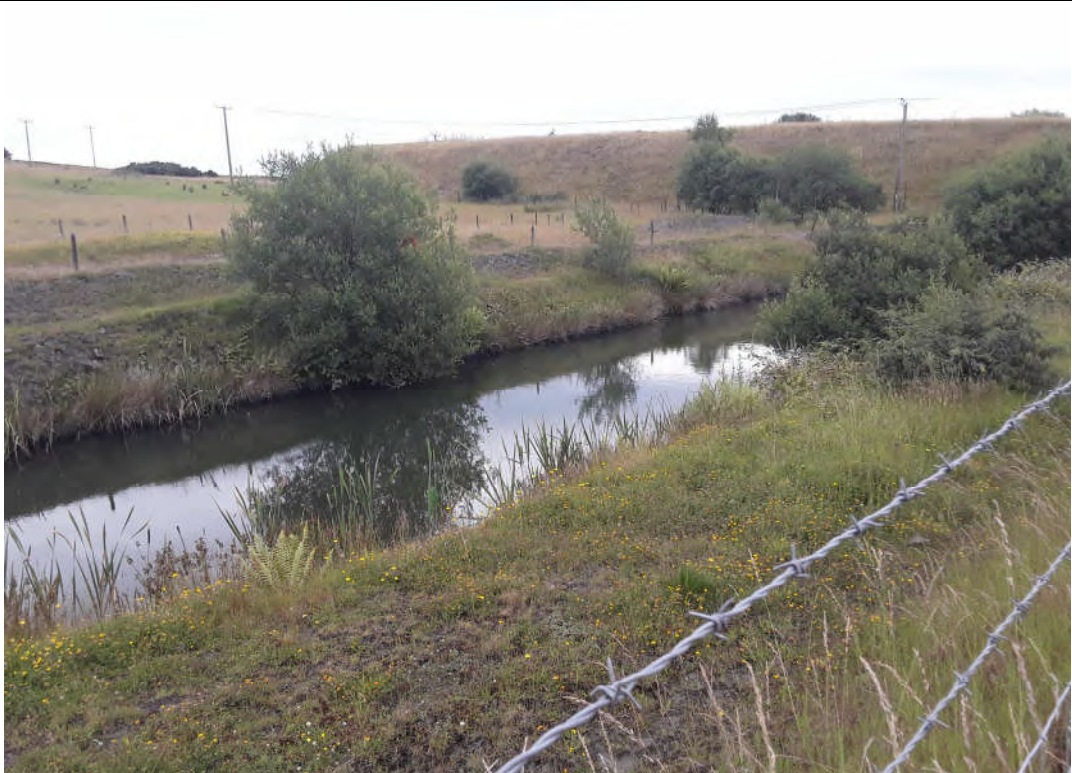
| Photo No.<br>SW-36 DP | Date:<br>12 July<br>2022 | |
|---|---|---|
| <b>Surface Water Feature SW-36 DP:</b><br>Holding lagoon, water storage area, probably lined with low permeability material, drainage/runoff from restoration area. No water flowing observed at the time. Approximate measurements 45m wide, 10 m length. No access. Not accessible<br><br>The photo aspect is north. | | |

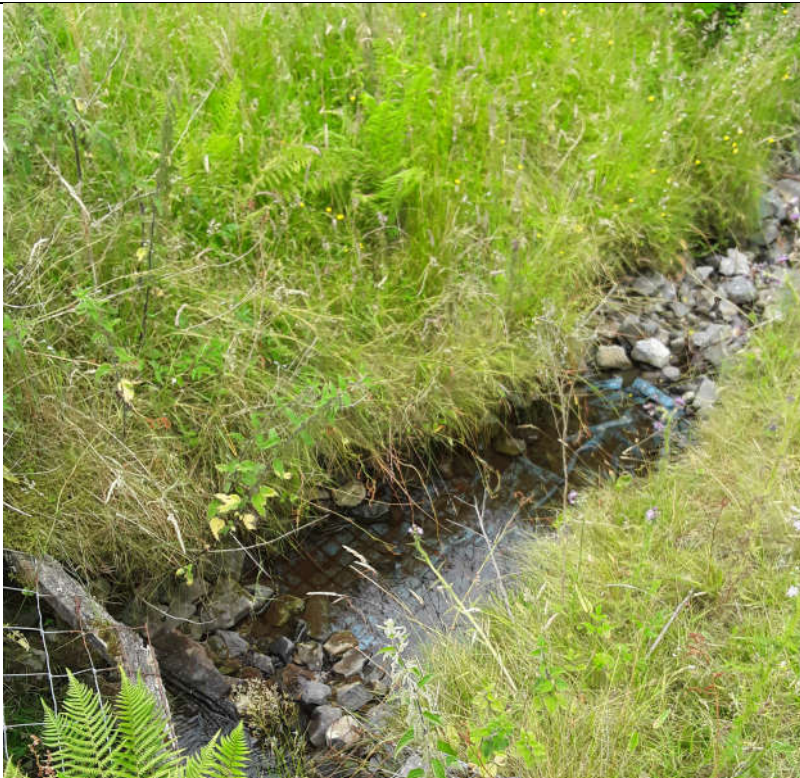
| Photo No.<br>SW-37 DP | Date:<br>12 July<br>2022 | |
|---|---|---|
| <b>Surface Water Feature SW-37 DP:</b><br>Rocky ditch with standing water, orientated east to west under road adjacent to the west. Approximate measurements 1m wide, 145 m length 0.6m deep.<br><br>Measurements DO 96.25%, ORP 144.7 mV, Cond 344.20 ms/cm, pH 8.31, T16.5C<br><br>The photo aspect is north. | | |

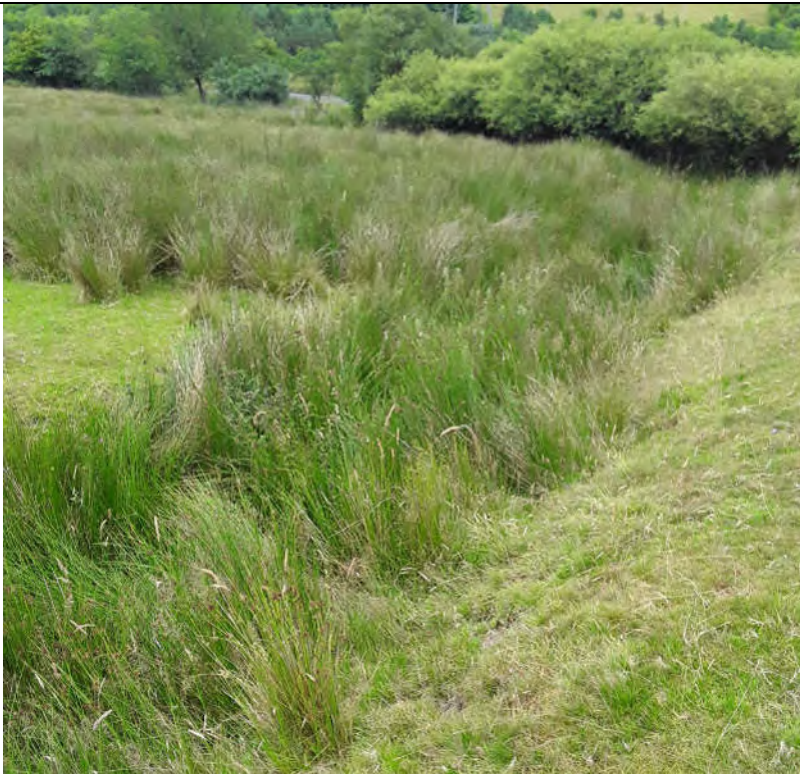
| Photo No.<br>SW-38 DP | Date:<br>12 July<br>2022 | |

| Photo No.<br>SW-38 DP | Date:<br>12 July<br>2022 | |
|---|---|---|
| <b>Surface Water Feature SW-38 DP:</b><br>Possible dry grassed ditch orientated north to south towards access track.<br><br>The photo aspect is south. | | |

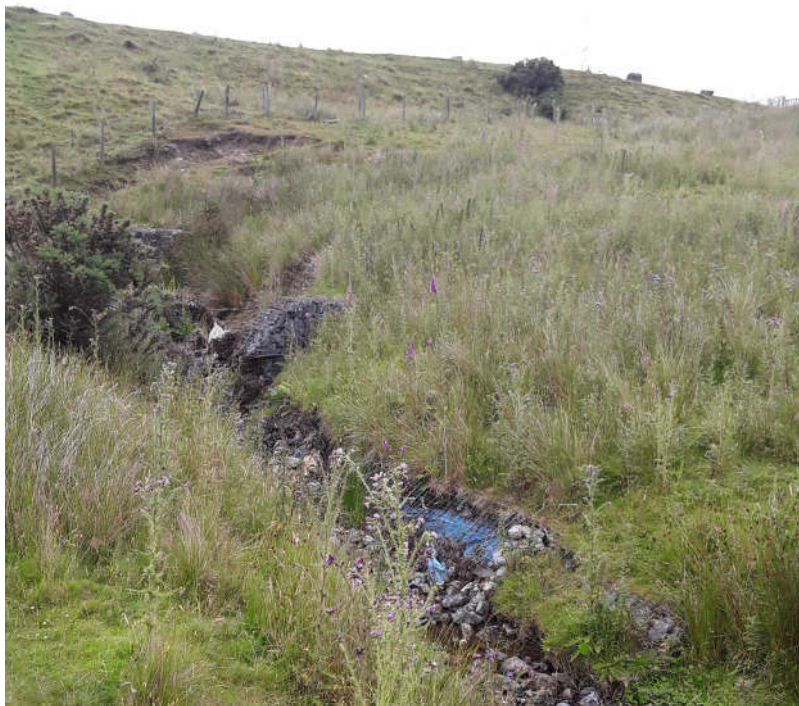
Steep rock gully, orientated north to south, dry with standing water in paces. Lows south towards River Dulais located 320 m south of photo location.

Measurements DO 95.5%, ORP 155.3 mV, Cond 412.5 ms/cm, pH 8.07, T15.4C  
The photo aspect is north

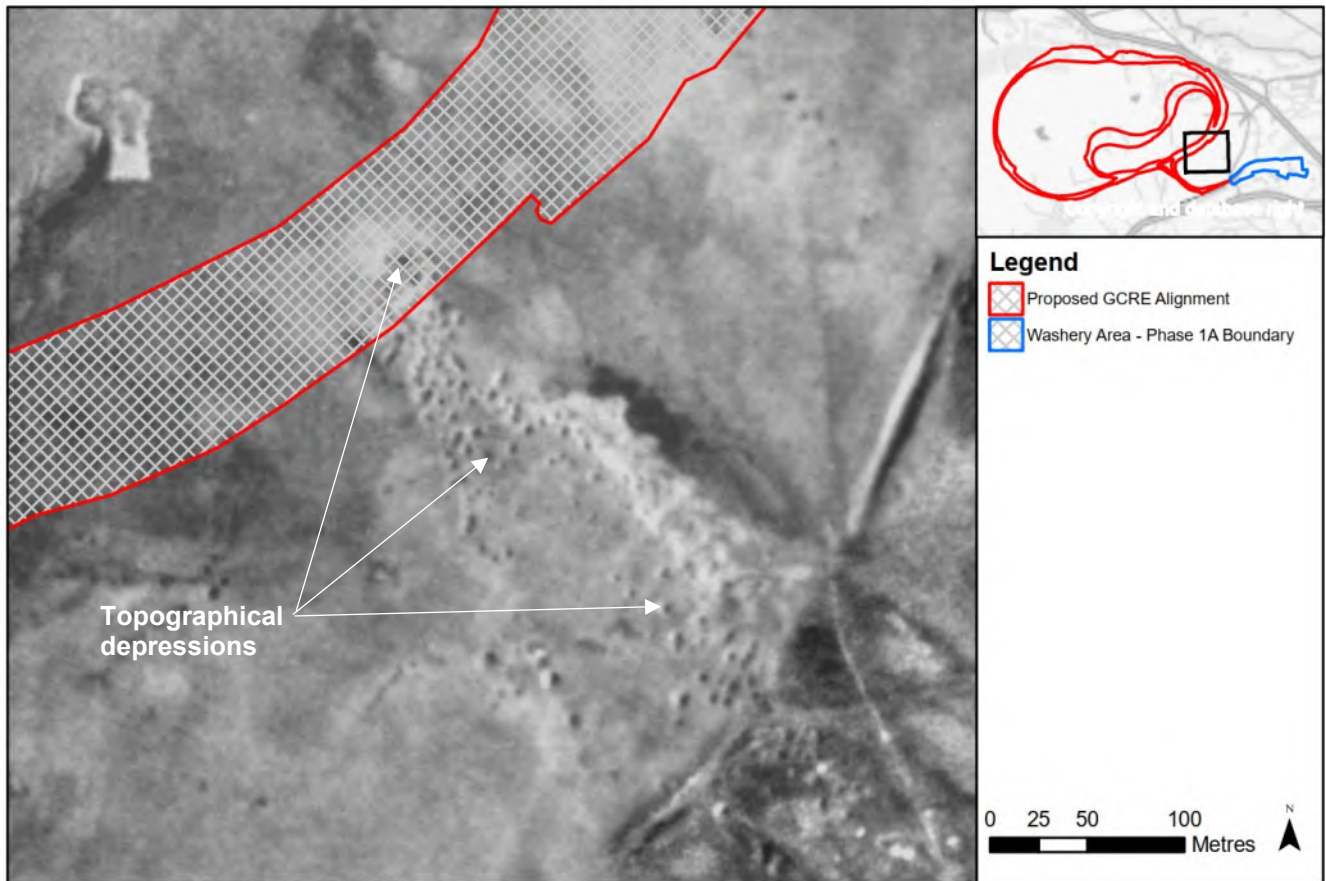
Figure 3-7 - Example of potential evidence for bell pitting in the southeast of the alignment.

Evidence of bell pitting onsite was observed in aerial imagery [1] as open bell pits or crown holes, these occur predominantly in the south of the site (Figure 3-7).

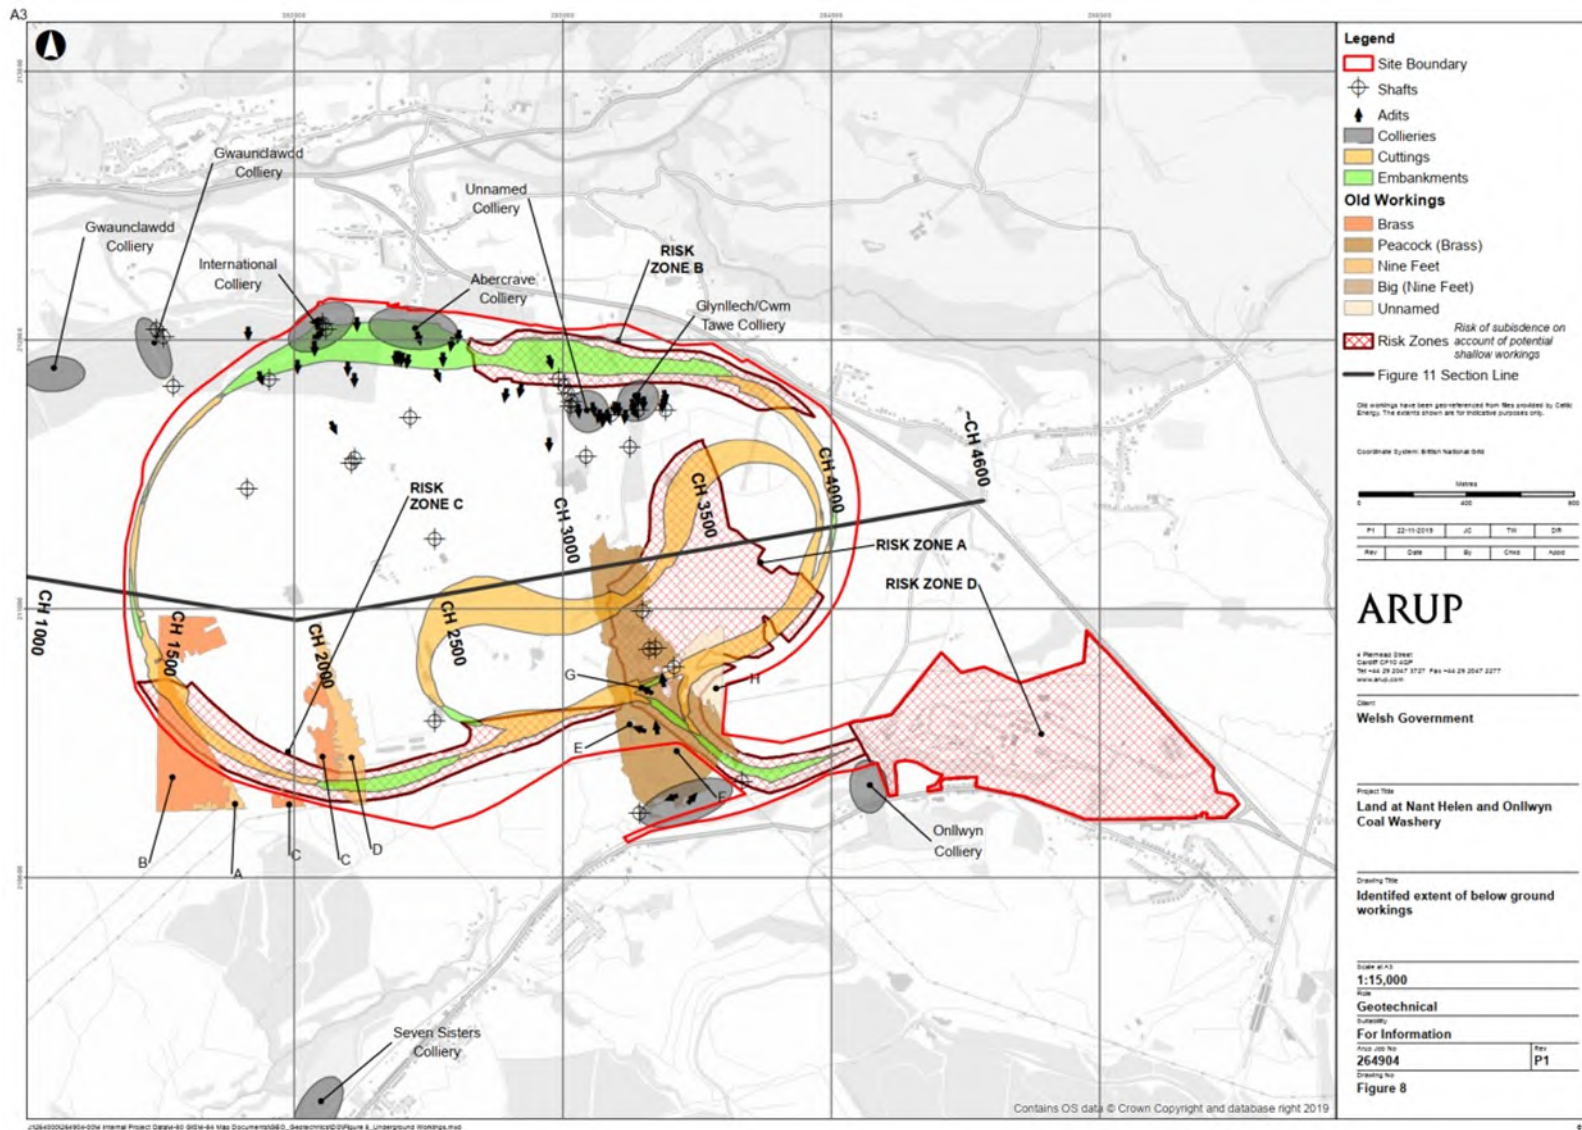
Figure 3-8 - Map of Arup risk zones from the Geotechnical and Geoenvironmental Desk Study by Arup [1].

Taking cognisance of all information, Arup identified four Risk Zones (A, B, C and D) defined by the presence of underground workings, as shown in Figure 3-8. Evidence of known workings beneath the proposed alignment was found within these zones, which therefore have a greater probability of being impacted by mining related instability.

The GI encountered voids in this area which are interpreted as unrecorded mine workings potentially related to working of the New/Lower and Grey/Middle seams. Arup's recommendation was to carry out further intrusive investigations in the area to confirm the extent of the interpreted workings.
