**Client Name: Global Centre of Rail Excellence**

**Site: GCRE (Main Site)**

**Project No. 5209796**

# Appendix E. Mining Risk Assessment

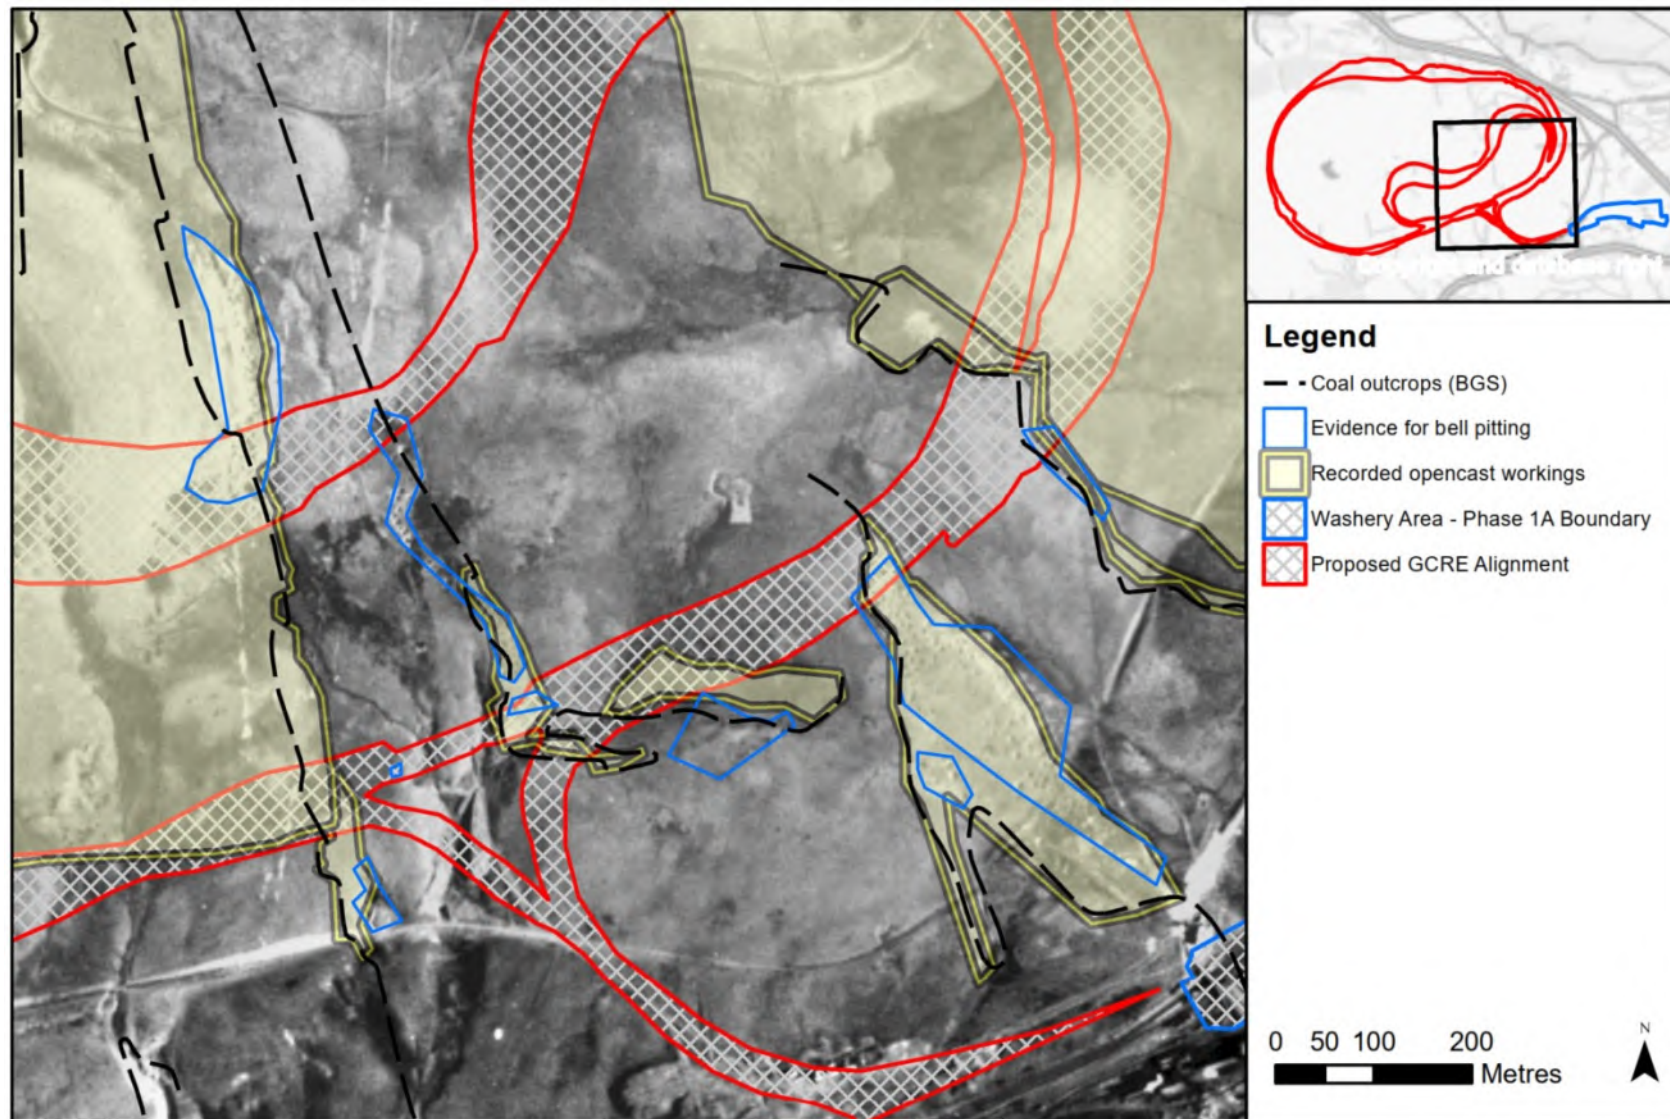
**Figure 4-3 – Areas of potential evidence for bell pits shown on the 1945 historical satellite imagery compared against BGS coal outcrops and areas of recorded opencast workings.**

As shown in Figure 4-3, many of the bell pits overlap with the areas of opencast workings and expected to have been removed, however, some bell pits likely remain in situ, particularly in the northern part of the inner loop.
