| CLIENT | GCRE Ltd |
| PROJECT | Global Centre for Rail Excellence (GCRE) |
| TITLE | Washery - CLAH Walkover Land Use Plan |

**Photograph Location Plan**

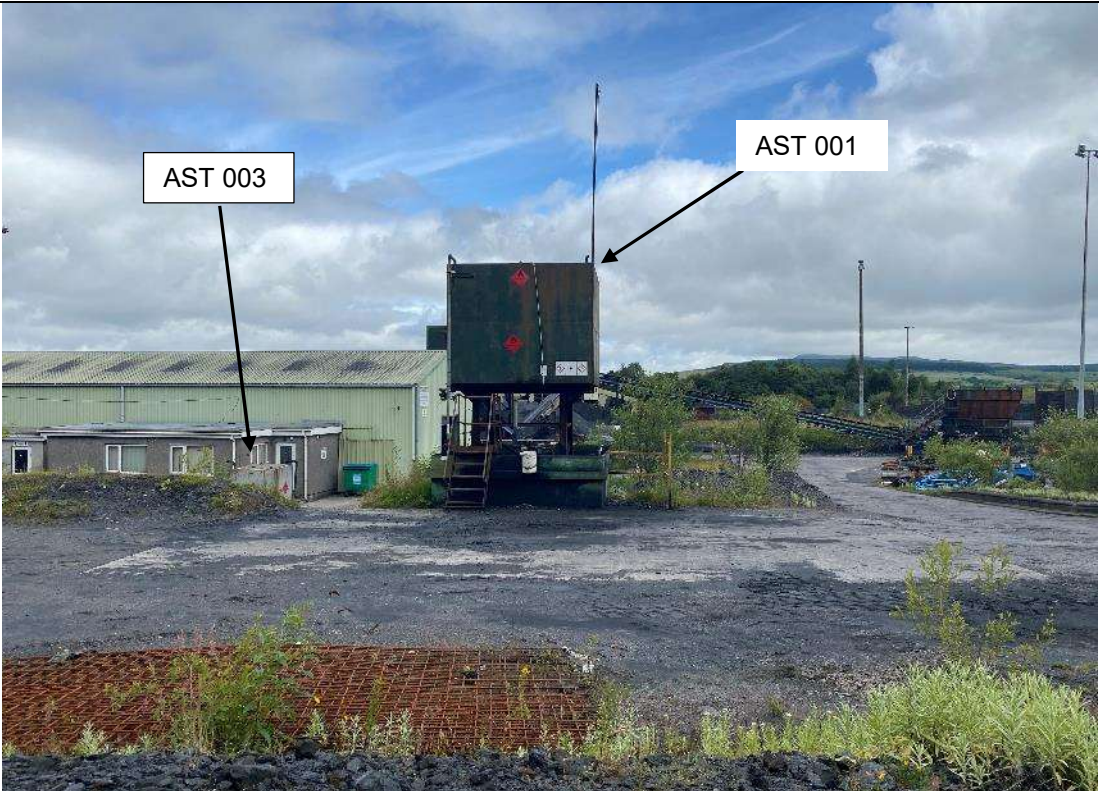
| <b>Photo No.</b><br>1 | <b>Date:</b><br>6 July 2022 | |

| <b>Fuel Storage (001 and 003)</b><br><br>View of ca. 4,000 litre diesel AST (001) in centre of picture, ca. 1,000 litre diesel AST (003) to left.<br><br>The photograph shows concrete access road in fore ground<br><br>The photograph aspect is north. | | |

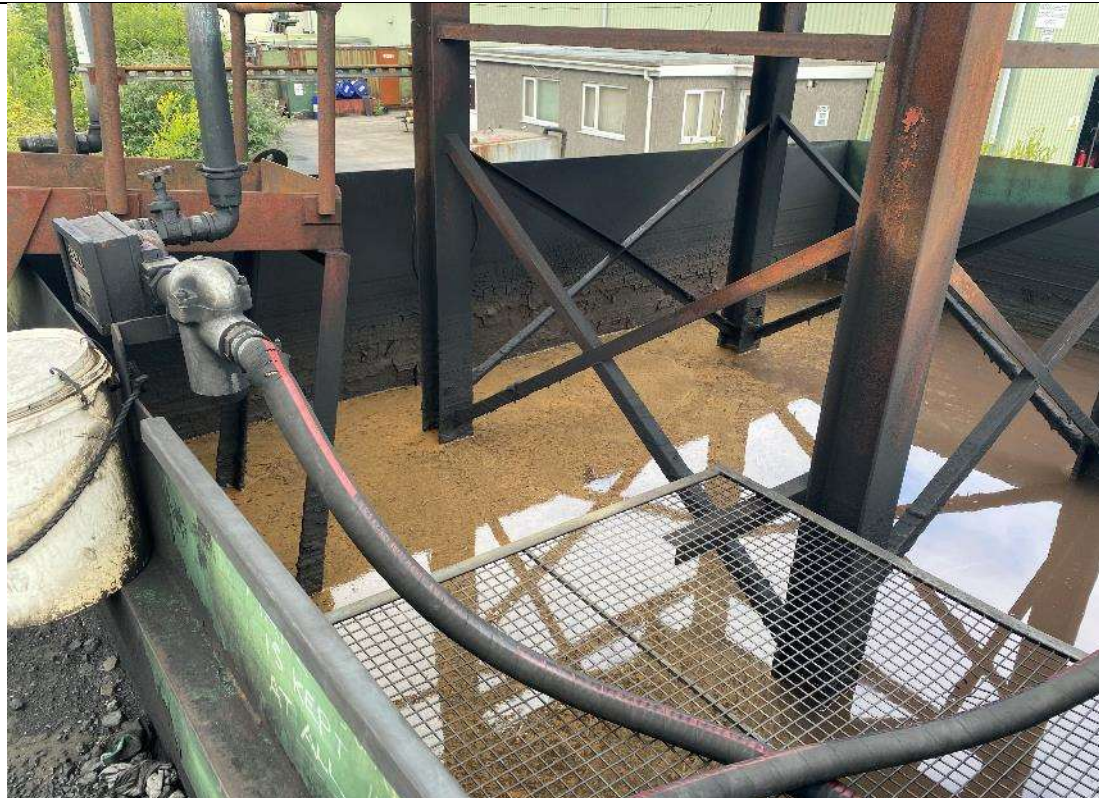
| <b>Photo No.</b><br>2 | <b>Date:</b><br>6 July 2022 | |

| <b>Fuel Storage (001)</b><br><br>View of AST bund<br><br>Bund holds mix of water and fuel. Light cracking of concrete surrounding tank base and light staining.<br><br>The photograph aspect is north-west. | | |

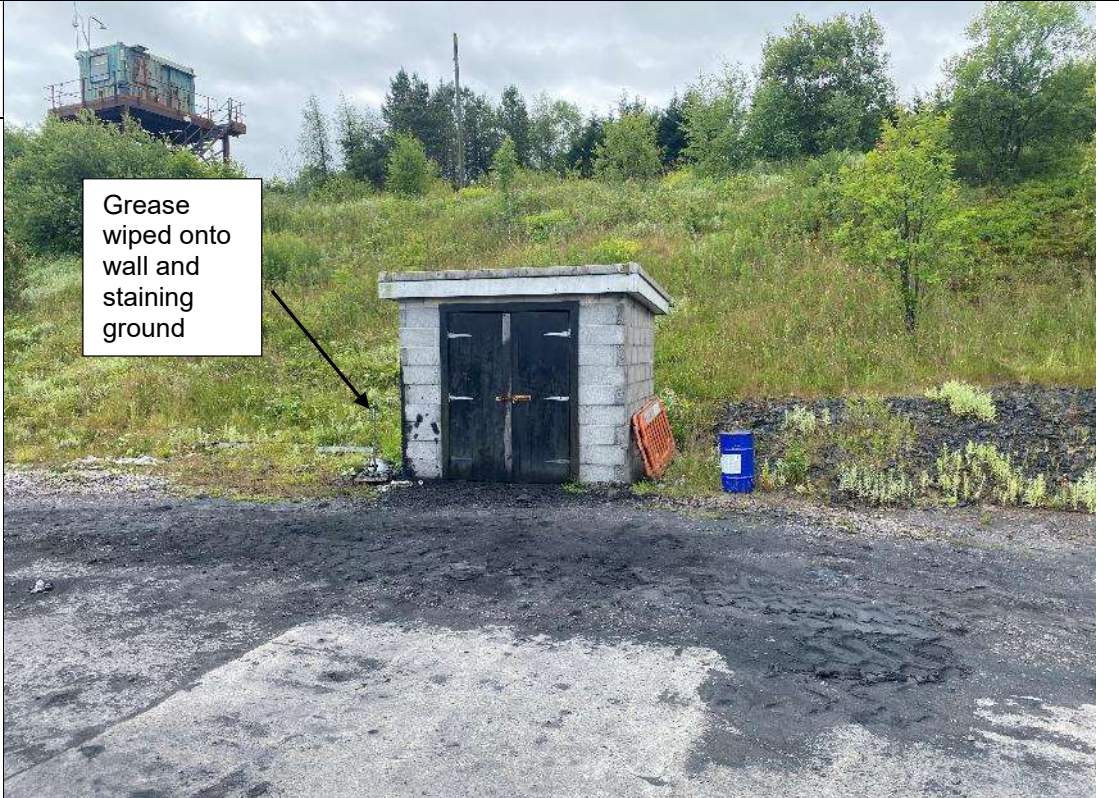
| <p><b>Photo No.</b><br/>3</p> | <p><b>Date:</b><br/>6 July 2022</p> | |

| <p><b>Grease Store (002)</b></p> <p>View of grease store (002).</p> <p>Concrete access road to foreground with colliery spoil heap/bund behind. Note oil staining on left of grease store and ground adjacent to it.</p> <p>The photograph aspect is south.</p> | | |

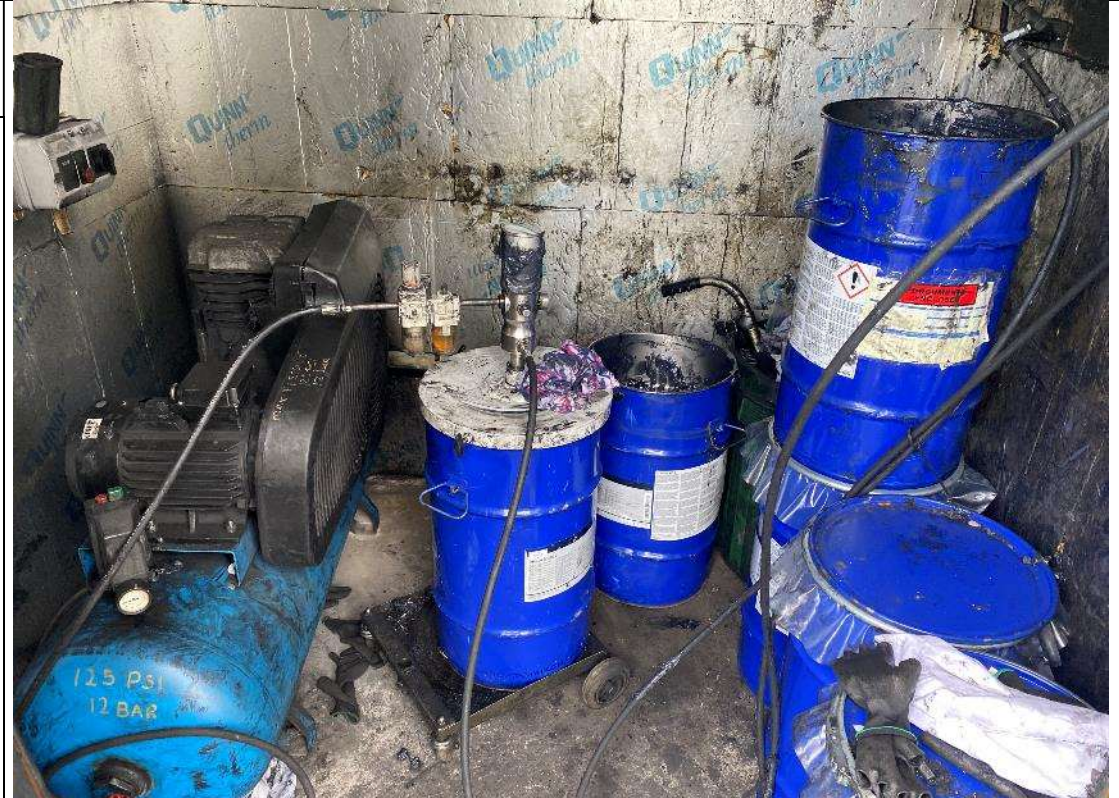
| <p><b>Photo No.</b><br/>4</p> | <p><b>Date:</b><br/>6 July 2022</p> | |

| <p><b>Interior of Grease Store (002)</b></p> <p>Drums of grease present with dispensing equipment.</p> <p>Floor slab in good condition with heavy staining.</p> | | |

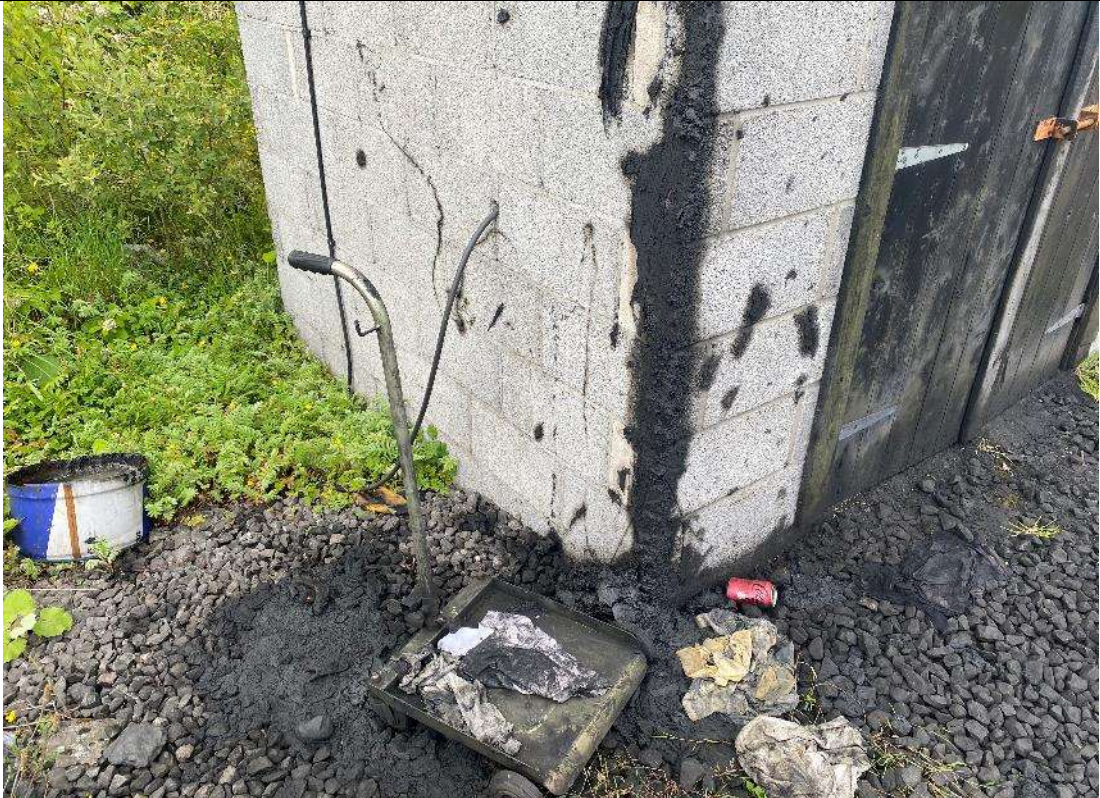
| <b>Photo No.</b><br>5 | <b>Date:</b><br>6 July 2022 | |

| <p><b>Grease Store exterior (002)</b></p> <p>Heavy staining on surrounding soils with evidence that greased equipment is being wiped against corner of structure.</p> <p>The surfacing is granular colliery spoil.</p> <p>The photograph aspect is south-west.</p> | | |

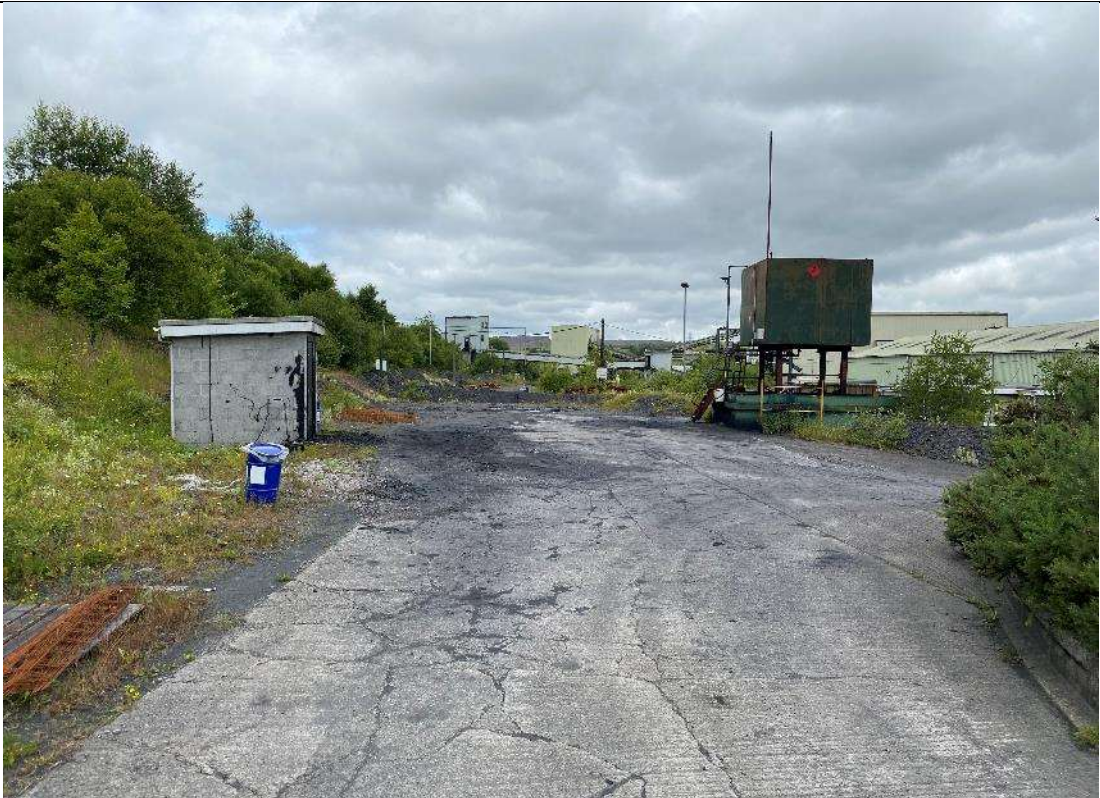
| <p><b>Grease Store (002) and AST (001)</b></p> <p>View of the grease store (002) (left) and AST (001) (right) and access road foreground. Access road is concrete and heavily cracked and stained with grease adjacent to grease store and crushed coal in other areas.</p> <p>Washery buildings to rear and repair shop to right.</p> <p>The photograph aspect is west.</p> | | |

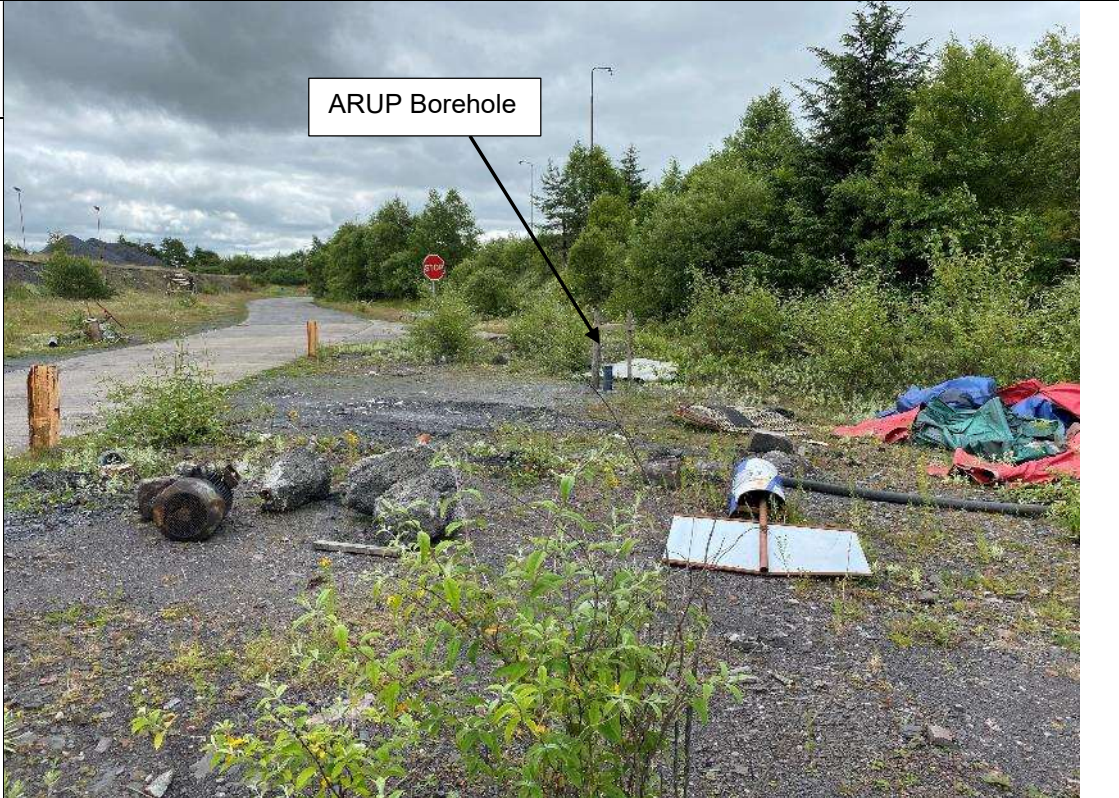
| <b>Photo No.</b><br>11 | <b>Date:</b><br>6 July 2022 | |

| <b>Machine Graveyard (005)</b><br><br>Materials dumped on surface, borehole to right.<br><br>The photograph aspect is east. | | |

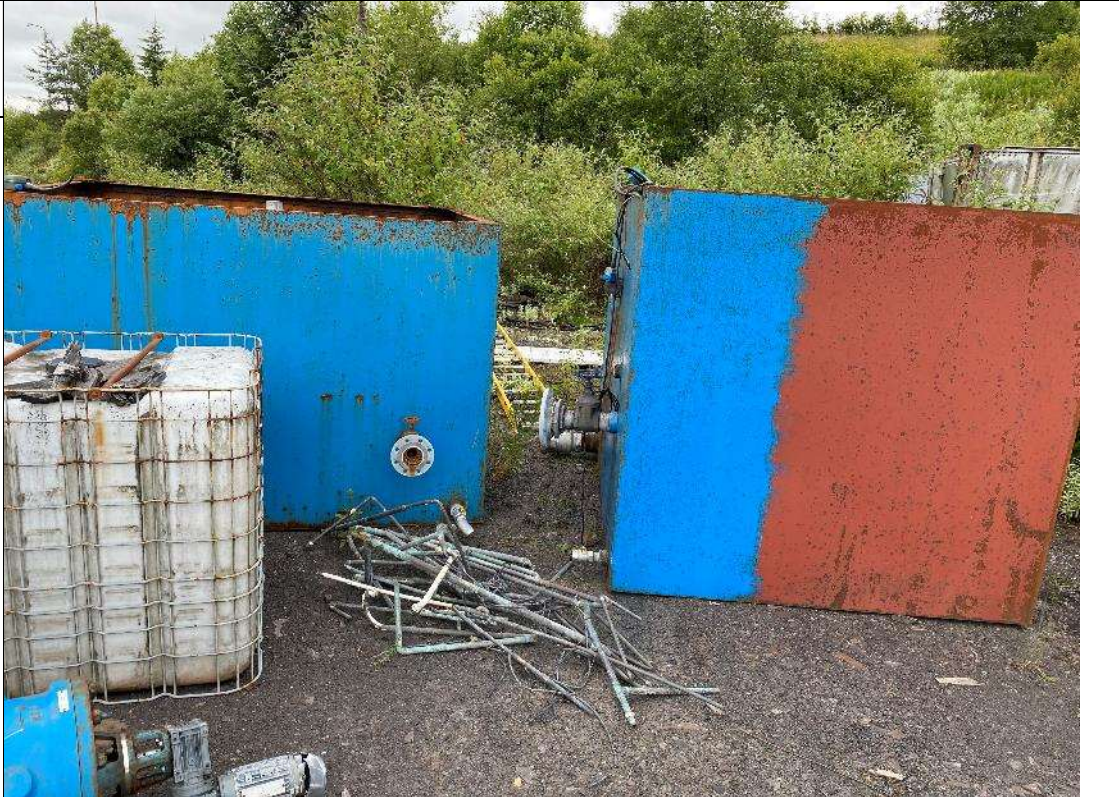
| <b>Photo No.</b><br>12 | <b>Date:</b><br>6 July 2022 | |

| <b>Machine Graveyard (005)</b><br><br>View of abandoned former tanks and IBC being used to drain them.<br><br>The photograph aspect is south. | | |

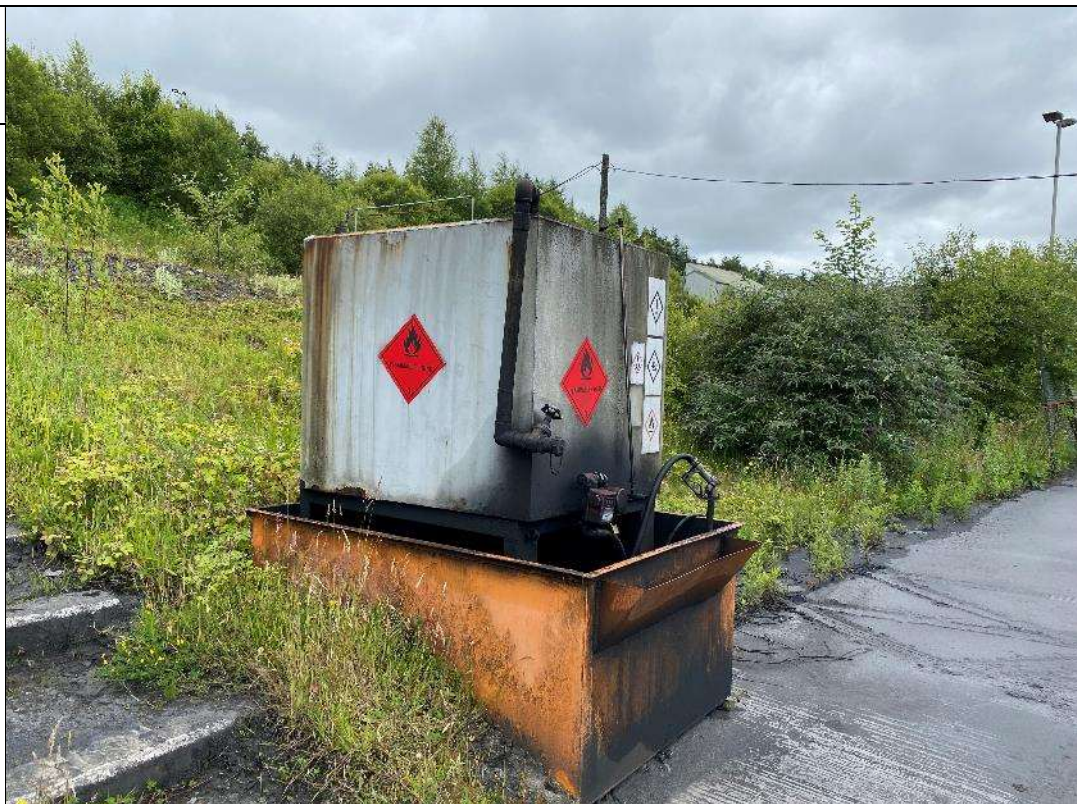
**Client Name: Global Centre of  
Rail Excellence**
**Site: GCRE (Onllywyn Washery)**
**Project No.  
5209796**
**Photo No.**  
13

**Diesel AST (003)**

View of 1,000 litre diesel  
AST and bund.  
Surrounding concrete  
intact and not stained by  
fuel. Dark silt from coal  
dust present.

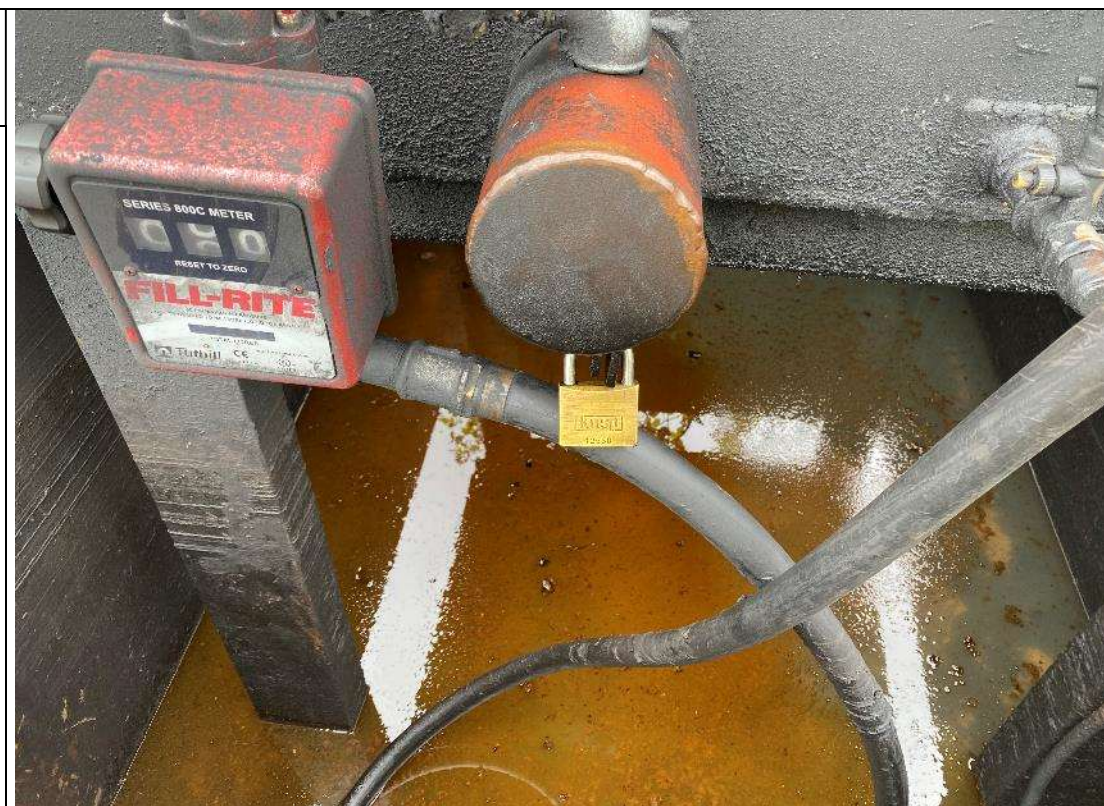
**Photo No.**  
14

**Diesel AST bund (003)**

View into bund, oil /  
diesel mixture present.

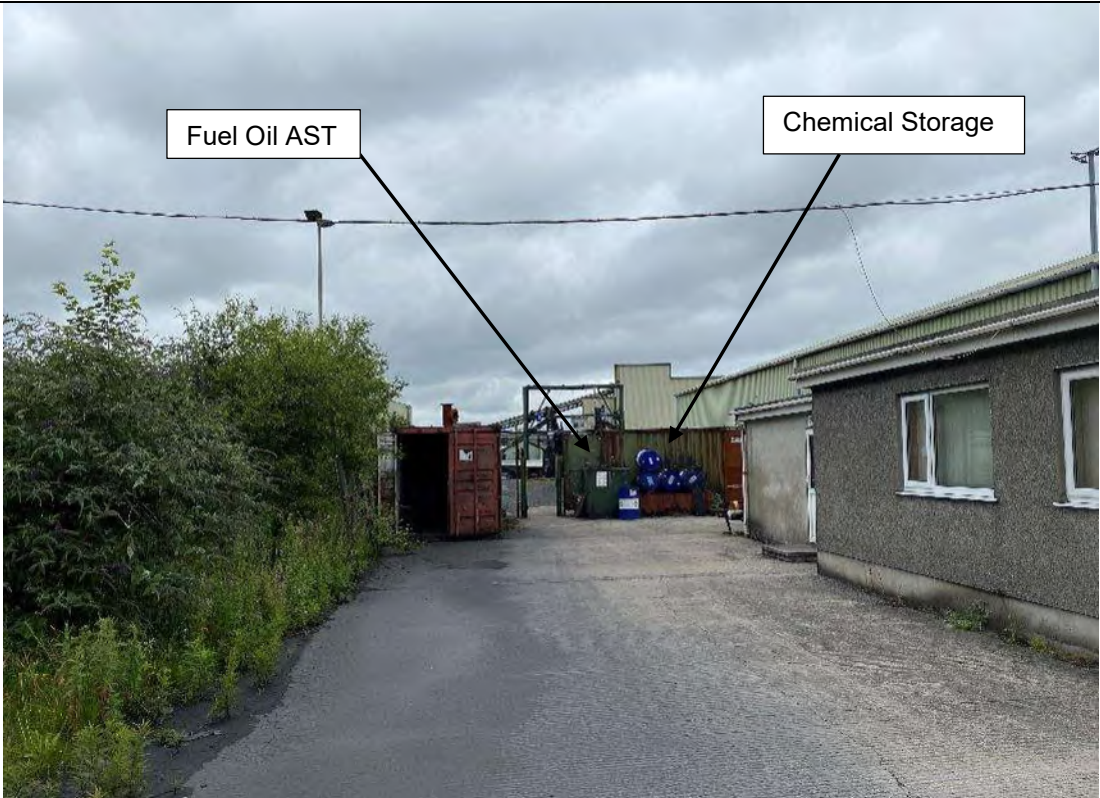
| <b>Fuel Oil AST (006) and<br/>Chemical Storage (007)</b> <p>View of yard area to south of Workshop (009). AST (006) holding kerosene to right and storage of chemical drums (gear oil, over bund (007) to left. Shipping container (013) holds suspension coils for plant.</p> <p>The photograph aspect is west.</p> | | |

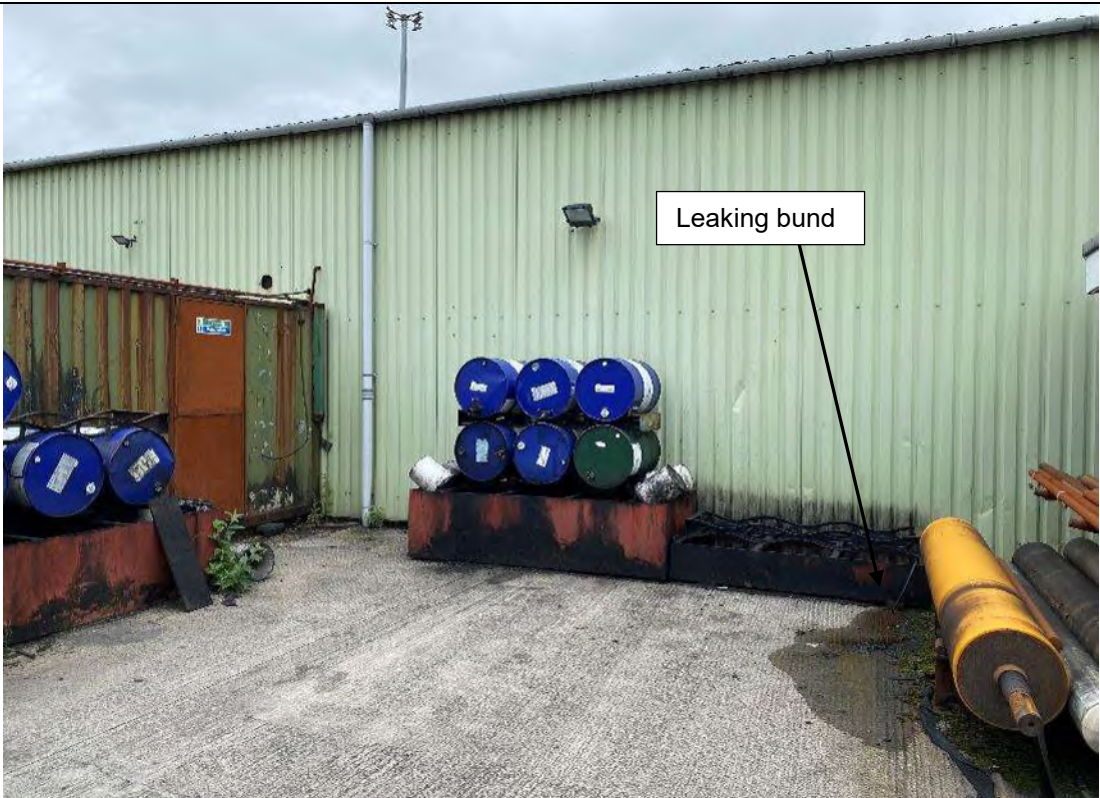
| <b>Chemical Storage<br/>(007,008 and 009)</b> <p>View of chemical storage. Racked drums of gear oil held over bunds. Chemical storage 009 empty, however, leak of fluid visible from it on right.</p> <p>The Tesco petrol filling station is visible in the background beyond the southern boundary fence.</p> <p>Photograph aspect is south.</p> | | |

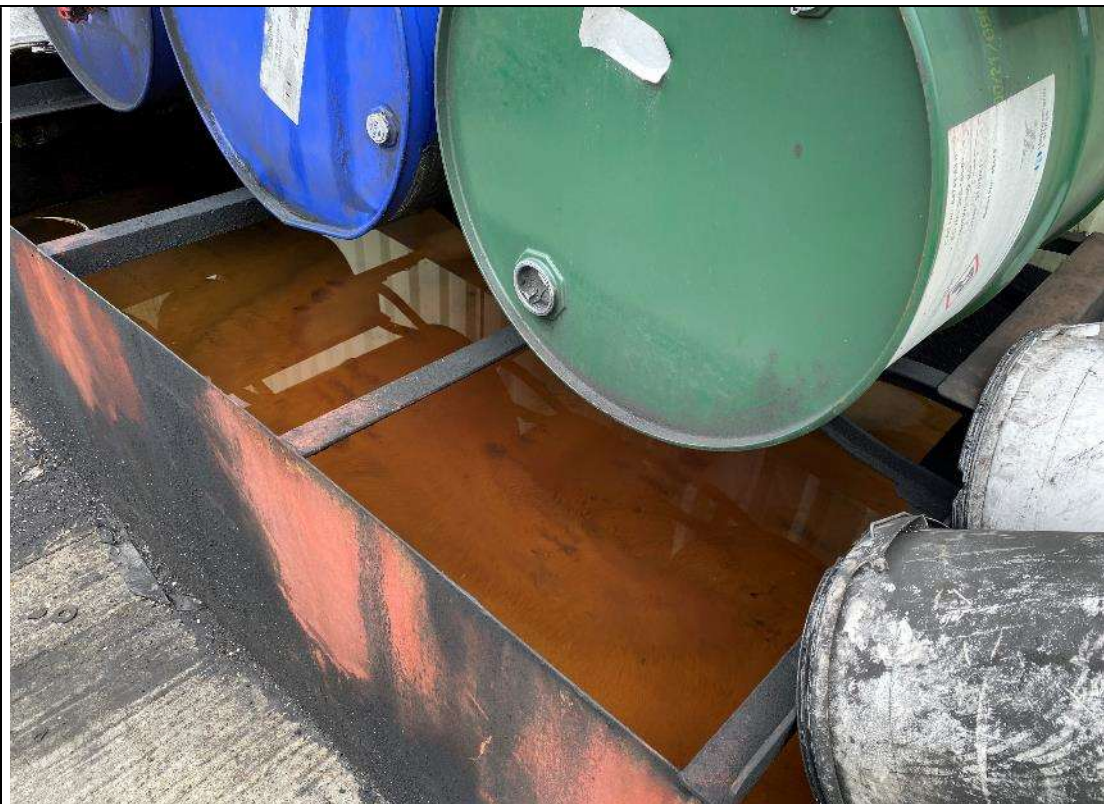
**Client Name: Global Centre of  
Rail Excellence**
**Site: GCRE (Onllywyn Washery)**
**Project No.  
5209796**
**Photo No.**  
17

**Chemical storage (008)**

View of bund holds  
mixture of water and  
assumed hydrocarbon  
(probably gear oil)

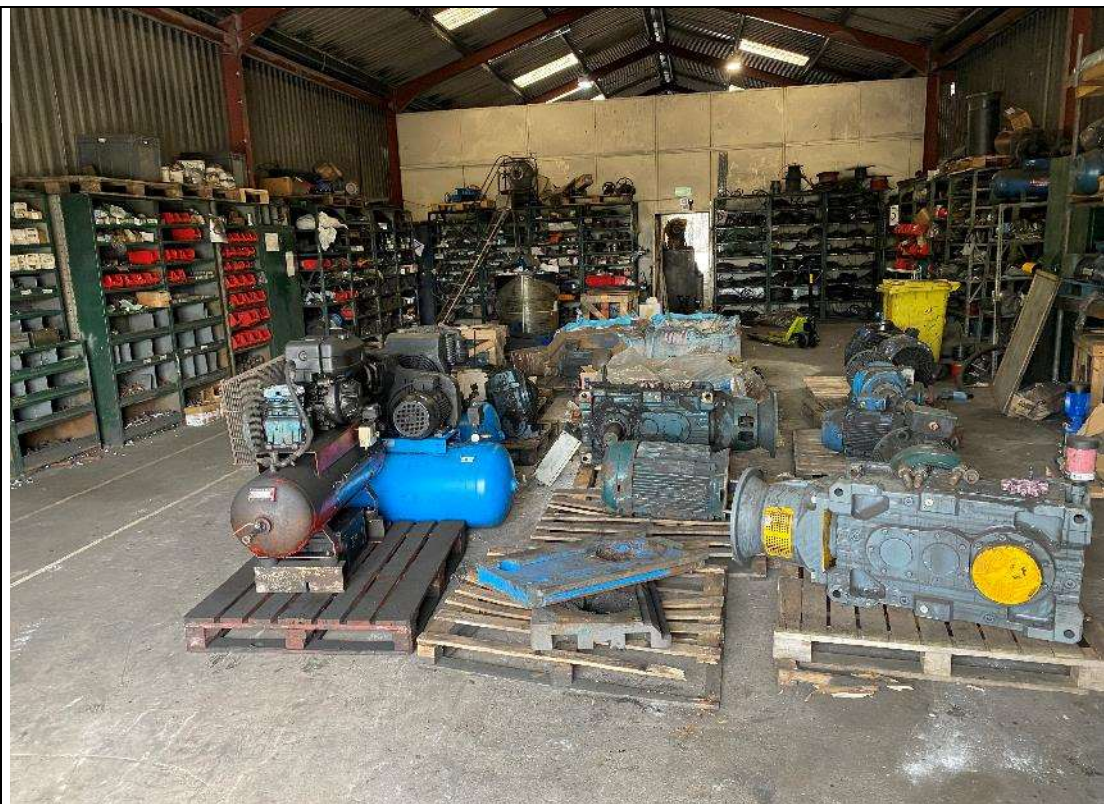
**Photo No.**  
18

**Workshop (010)**

View into eastern wing of  
workshop. Floor slab  
slightly cracked with light  
staining. Machinery in  
process of being  
repaired/stored on  
pallets. . Drums of  
roofing resin, oil and  
grease outside of  
bunded containment.

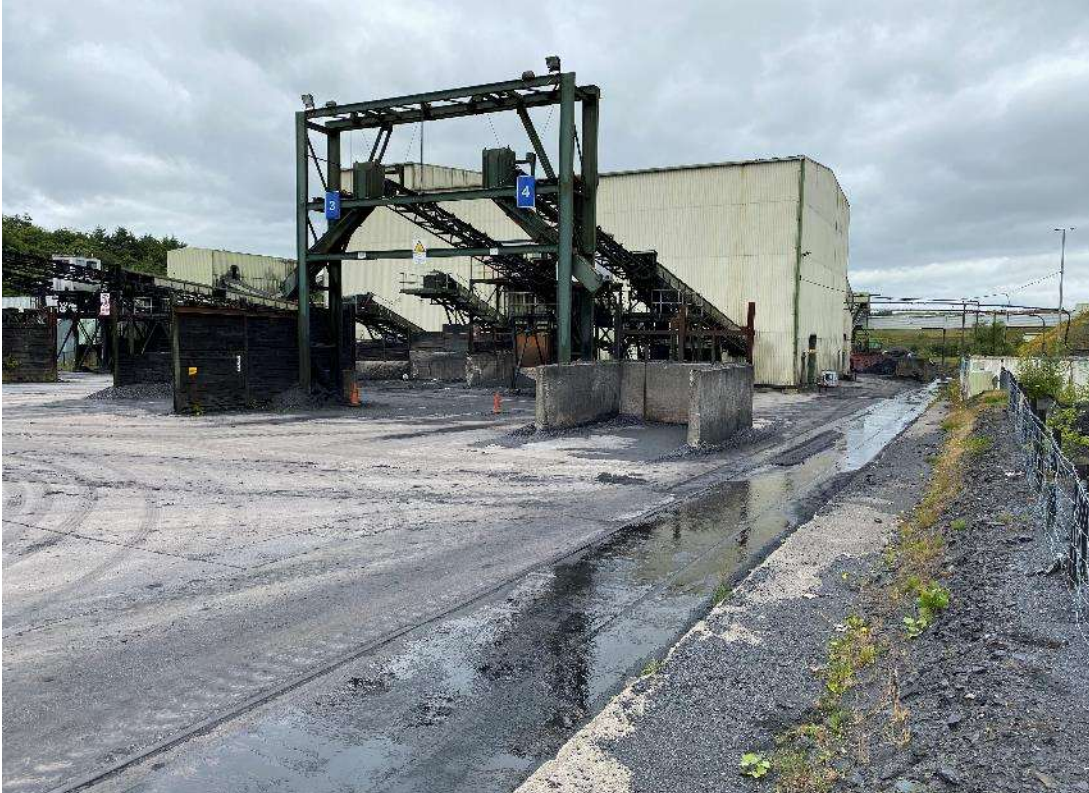
| <b>Photo No.</b><br>32 | <b>Date:</b><br>6 July 2022 |

| <b>Washery (014)</b><br><br>View of washery structure (014), surface water running off to west on road in foreground. Empty shipping container to right labelled as having held "autowash".<br><br>The photograph aspect is west. | |

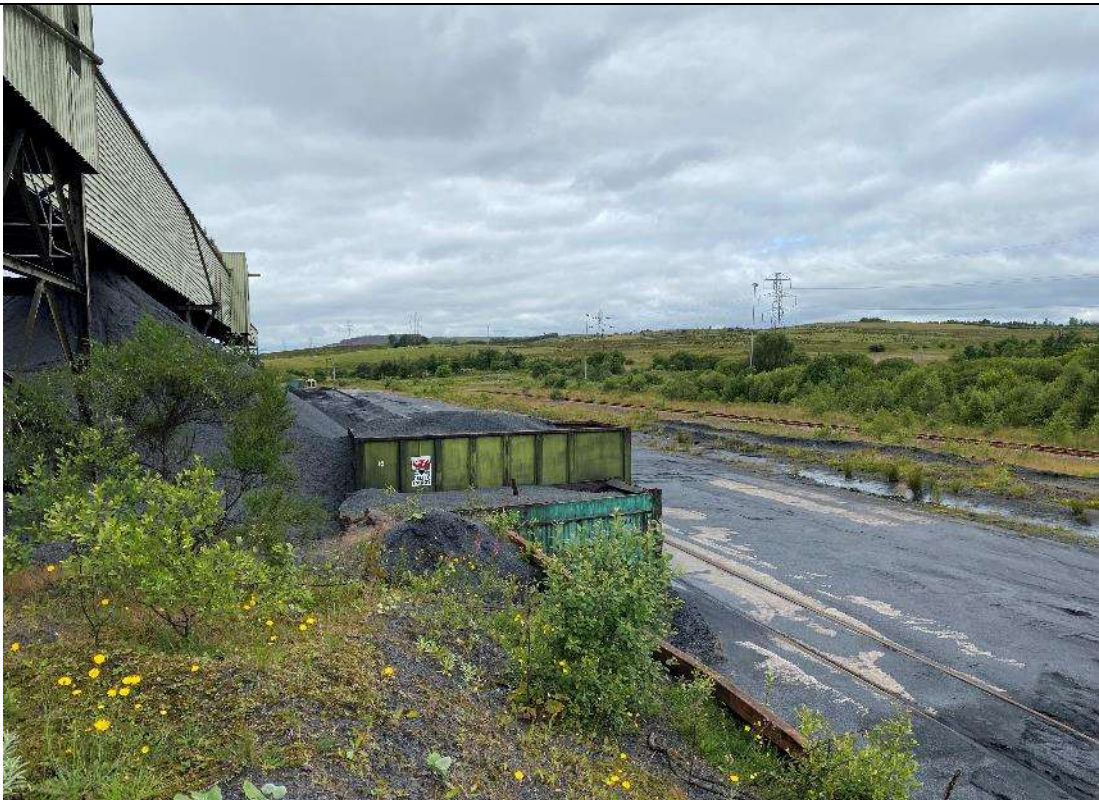
| <b>Railway Land (024)</b><br><br>View of the northern portion of Washery site with Nant Helen in the background. Railway tracks and railway land present.<br><br>Land falls at 1:1, exposed soils appear to be made ground of colliery spoil.<br><br>The photograph aspect is north-west. | | |

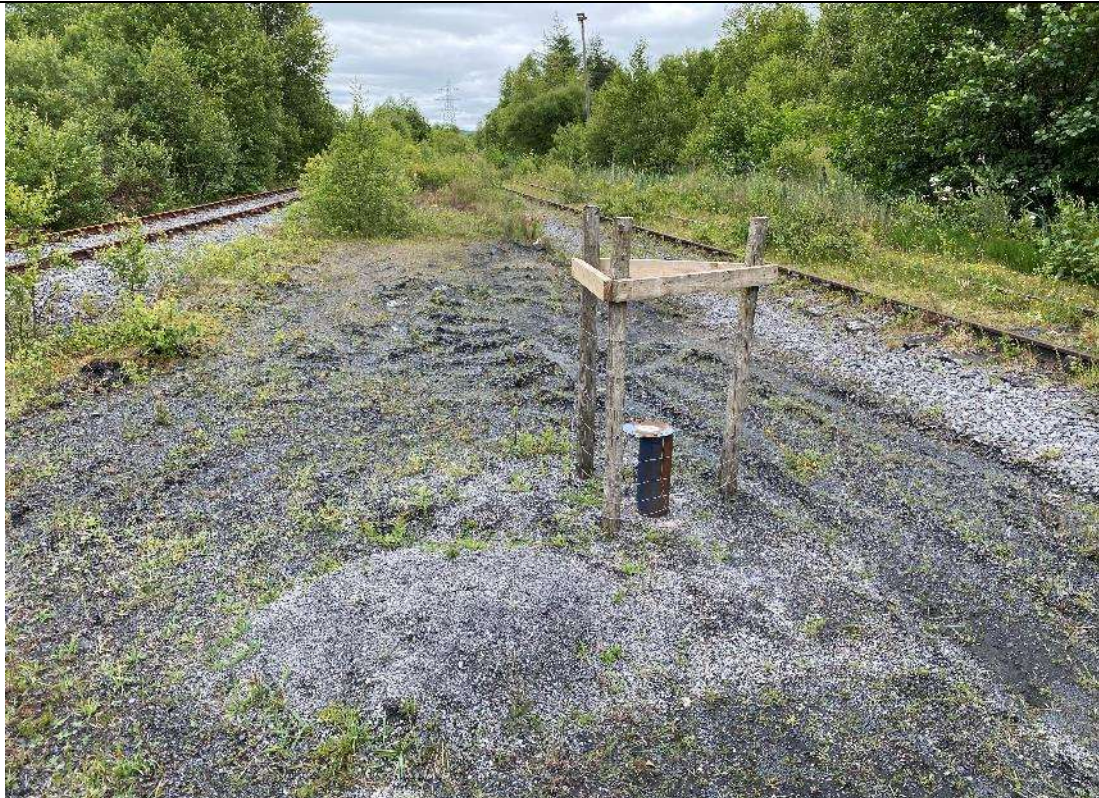
| <b>Photo No.</b><br>47 | <b>Date:</b><br>6 July 2022 | |

| <b>Railway Land (023)</b><br><br>View of railway sidings, two tracks currently present, with relict evidence of two unused tracks.<br><br>Ballast appears clean and made of BOS slag.<br><br>Monitoring well BH29R from Arup GI.<br><br>The photograph aspect is east. | | |

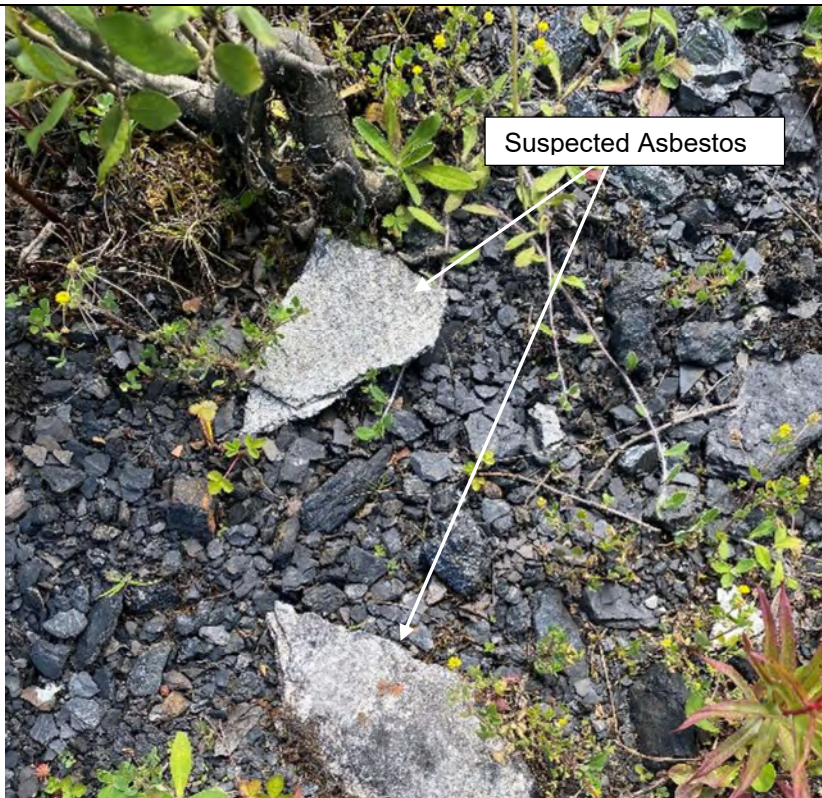
| <b>Photo No.</b><br>62 | <b>Date:</b><br>6 July 2022 | |

| <b>Suspected Asbestos<br/>Containing Material<br/>(033)</b><br><br>Fragments of cement<br>with visible fibres<br>observed on surface of<br>land to north of Plant<br>Parking (027) and south<br>of lagoon (025).<br>Suspected chrysotile<br>asbestos. | | |

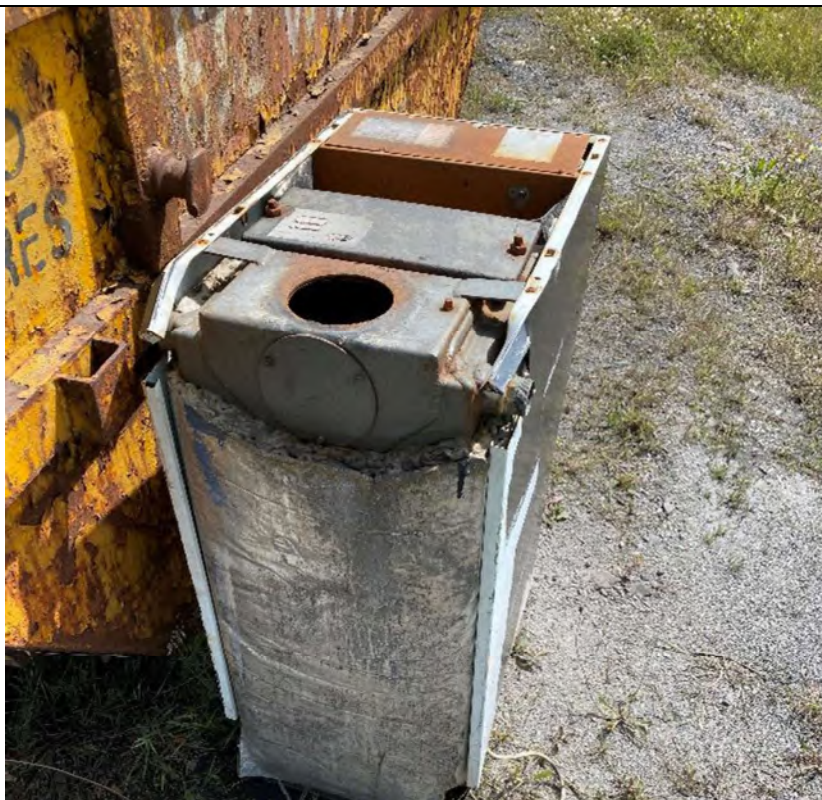
| <b>Photo No.</b><br>65 | <b>Date:</b><br>6 July 2022 | |

| <b>Scrapyard (035)</b><br><br>View of waste skips and boiler. Boiler contains fibrous white insulation (suspected ACM). | | |

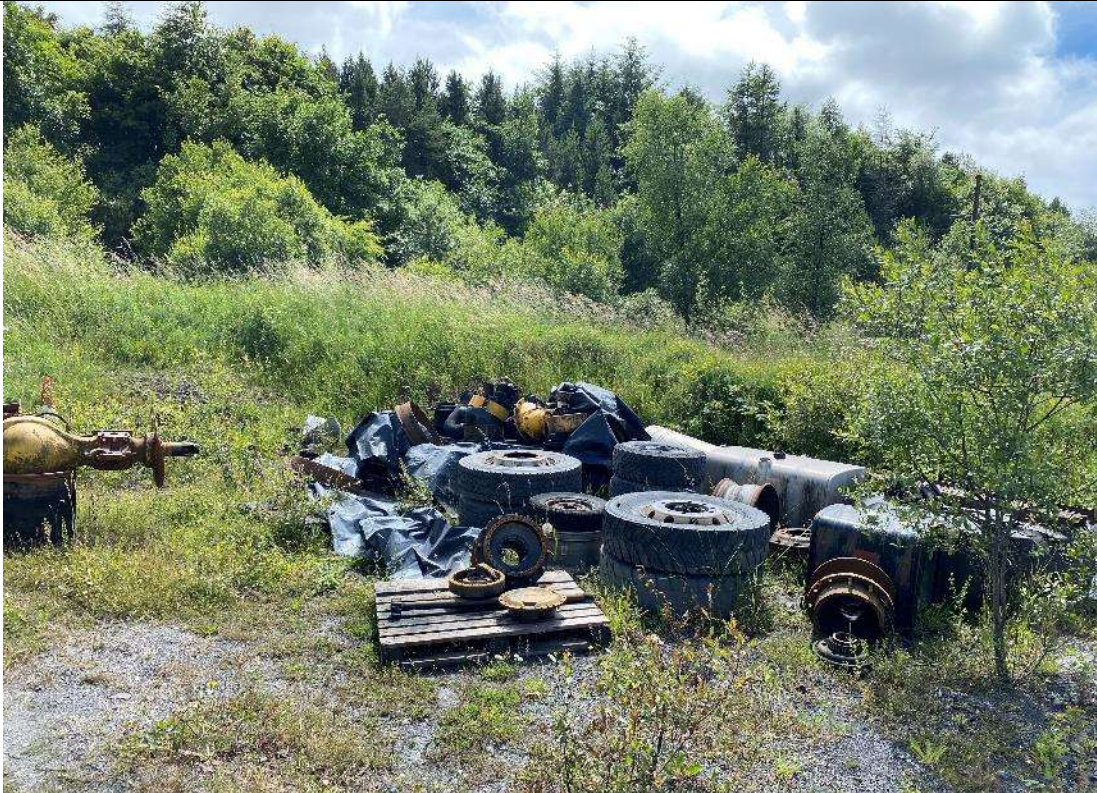
| <b>Photo No.</b><br>66 | <b>Date:</b><br>6 July 2022 | |

| <b>Scrapyard (035)</b><br><br>View of scrapyard area, holds wheels, tyres, vehicle parts, bund of made ground (C&D material).<br><br>The photograph aspect is south-west. | | |
