**Client Name: Global Centre of Rail Excellence**

**Site: GCRE (Onllywyn Washery)**

**Project No. 5209796**

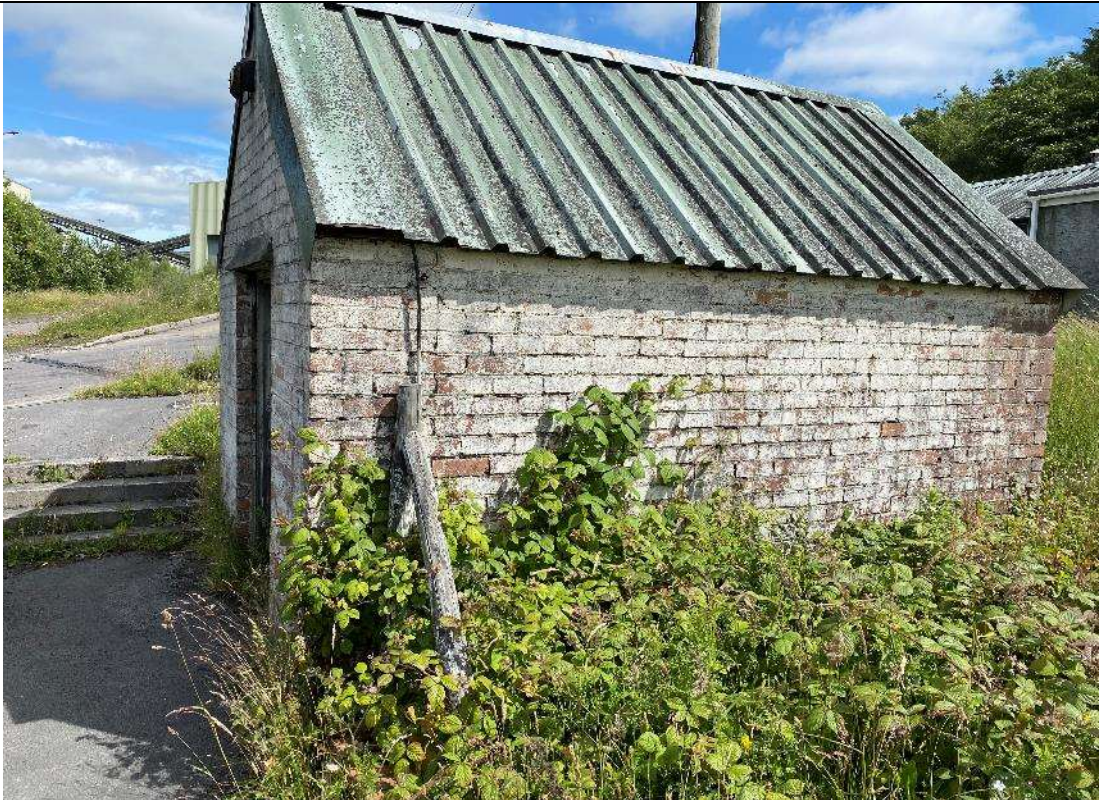
| <p><b>Photo No.</b><br/>69</p> | <p><b>Date:</b><br/>7 July 2022</p> | |

| <p><b>Chemical Store (036)</b></p> <p>View of chemical store used by site laboratory.</p> <p>The photograph aspect is east.</p> | | |

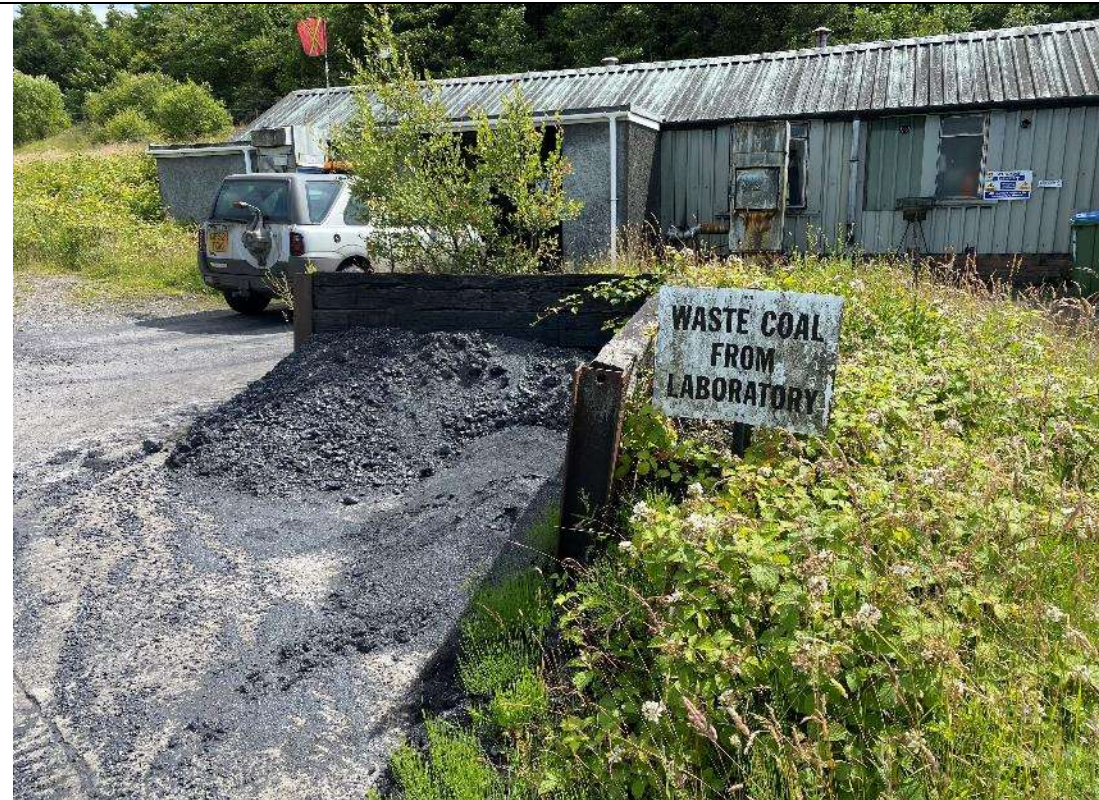
| <p><b>Photo No.</b><br/>70</p> | <p><b>Date:</b><br/>7 July 2022</p> | |

| <p><b>Laboratory (037)</b></p> <p>View of site laboratory used to assess quality and composition of coal.</p> <p>The photograph aspect is south.</p> | | |

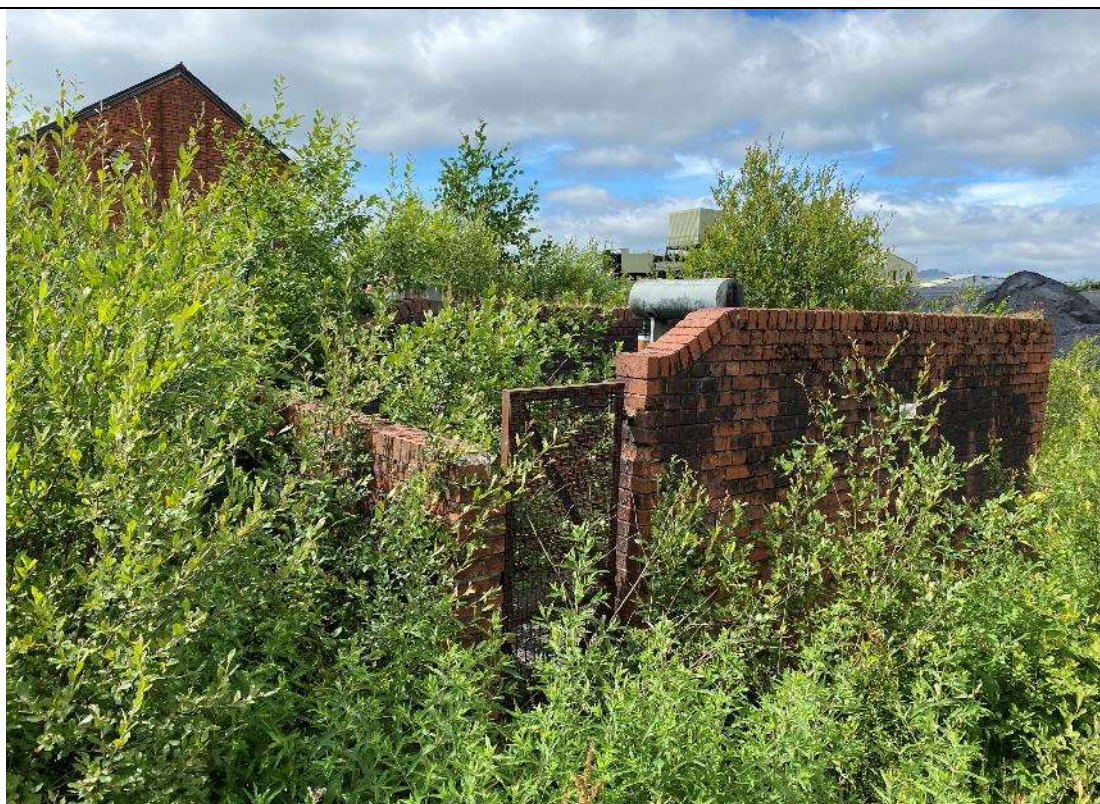
| <b>Photo No.</b><br>74 | <b>Date:</b><br>7 July 2022 | |

| <b>Electrical Substation<br/>(042)</b><br><br>View of substation.<br><br>The photograph aspect<br>is north-west. | | |

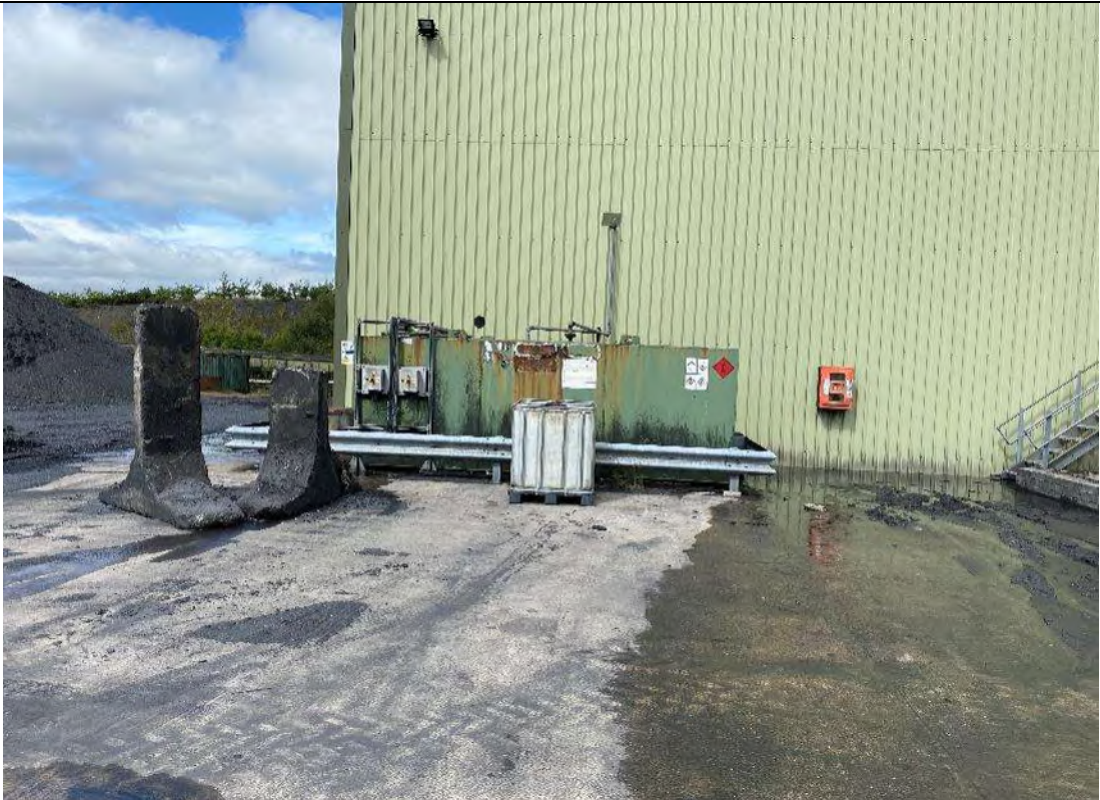
| <b>Photo No.</b><br>76 | <b>Date:</b><br>7 July 2022 | |

| <b>Diesel AST (044)</b><br><br>View of diesel AST to south of washery building (045).<br><br>The photograph aspect is north. | | |

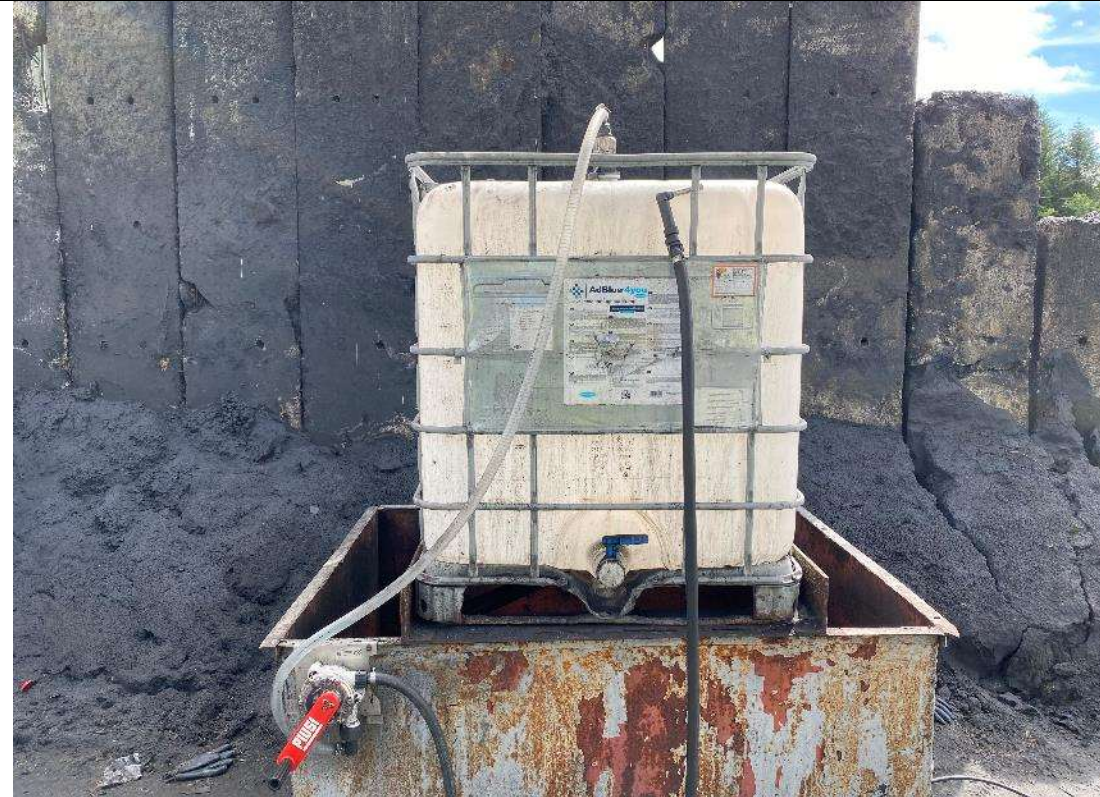
| <b>Photo No.</b><br>77 | <b>Date:</b><br>7 July 2022 | |

| <b>AdBlue IBC</b><br><br>View of bundled AdBlue IBC in washery buildings.<br><br>Location not recorded accurately. | | |

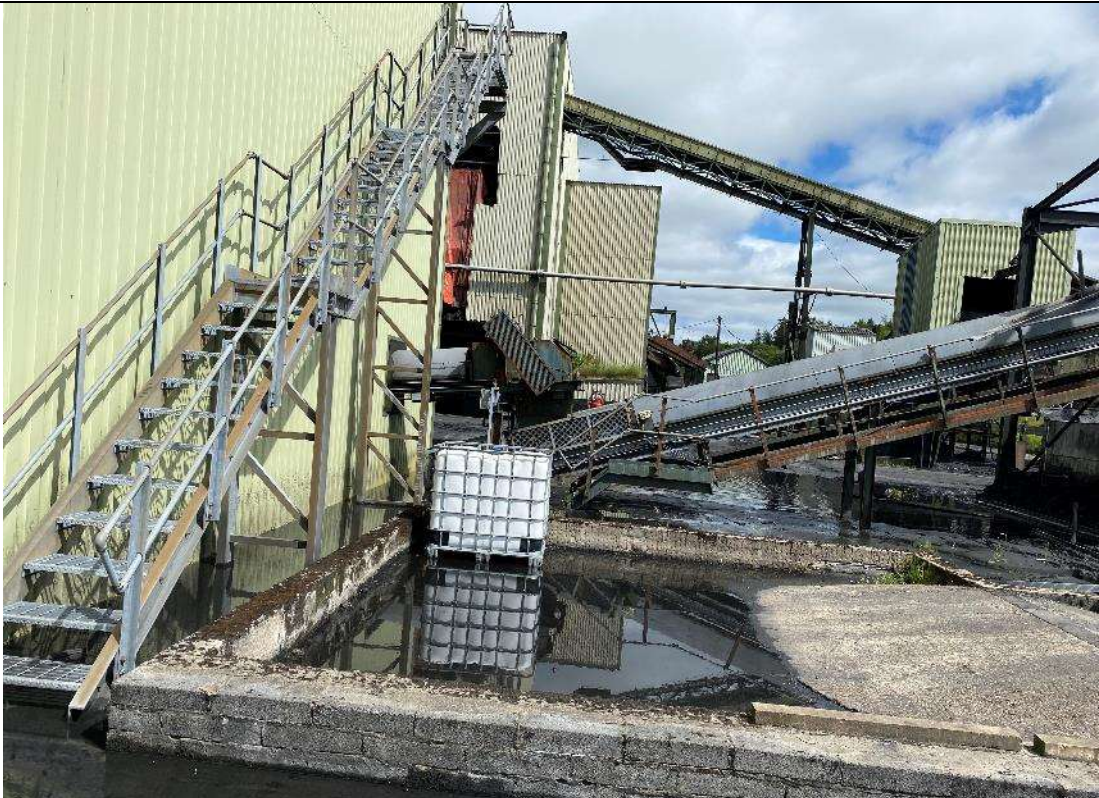
| <b>Photo No.</b><br>78 | <b>Date:</b><br>7 July 2022 | |

| <b>Washery Structure (045)</b><br><br>View of washery building 045, building 014 to rear. Empty IBC in middle ground.<br><br>The photograph aspect is north. | | |

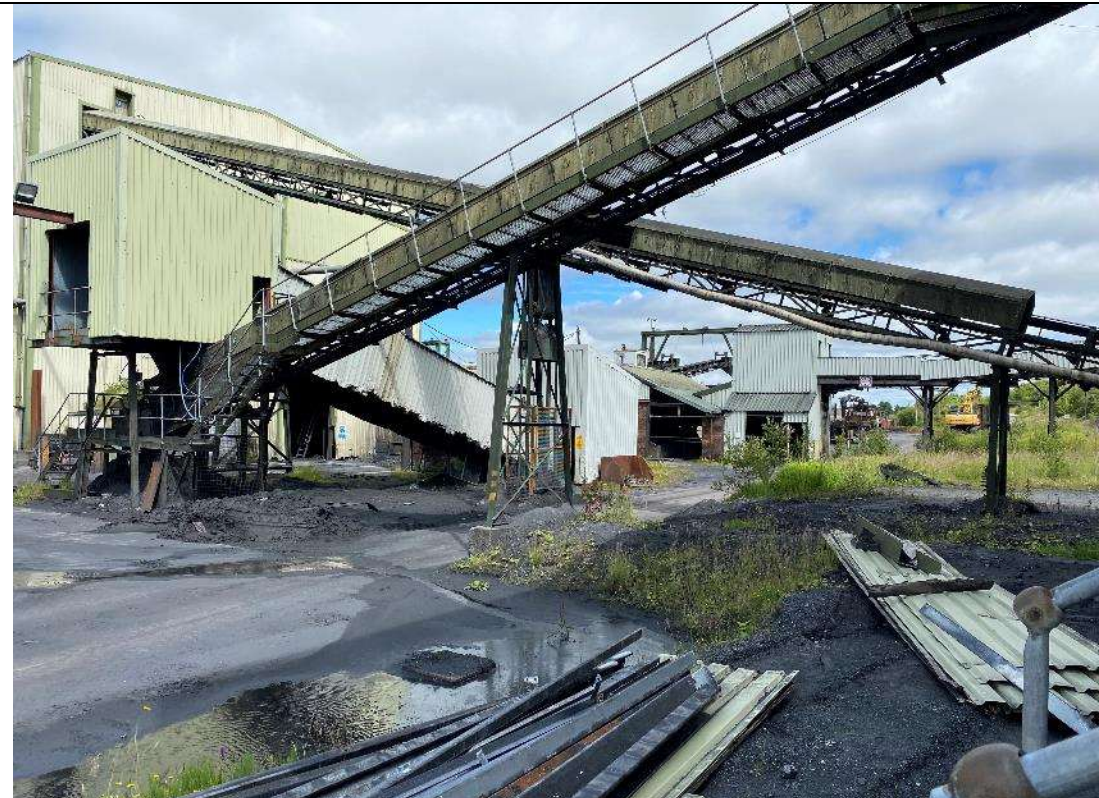
| <b>Photo No.</b><br>79 | <b>Date:</b><br>7 July 2022 | |

| <b>Washery Structures (046)</b><br><br>View of washery structure 046. Structure 047 to rear of photograph aspect<br><br>The photograph aspect is north-east. | | |

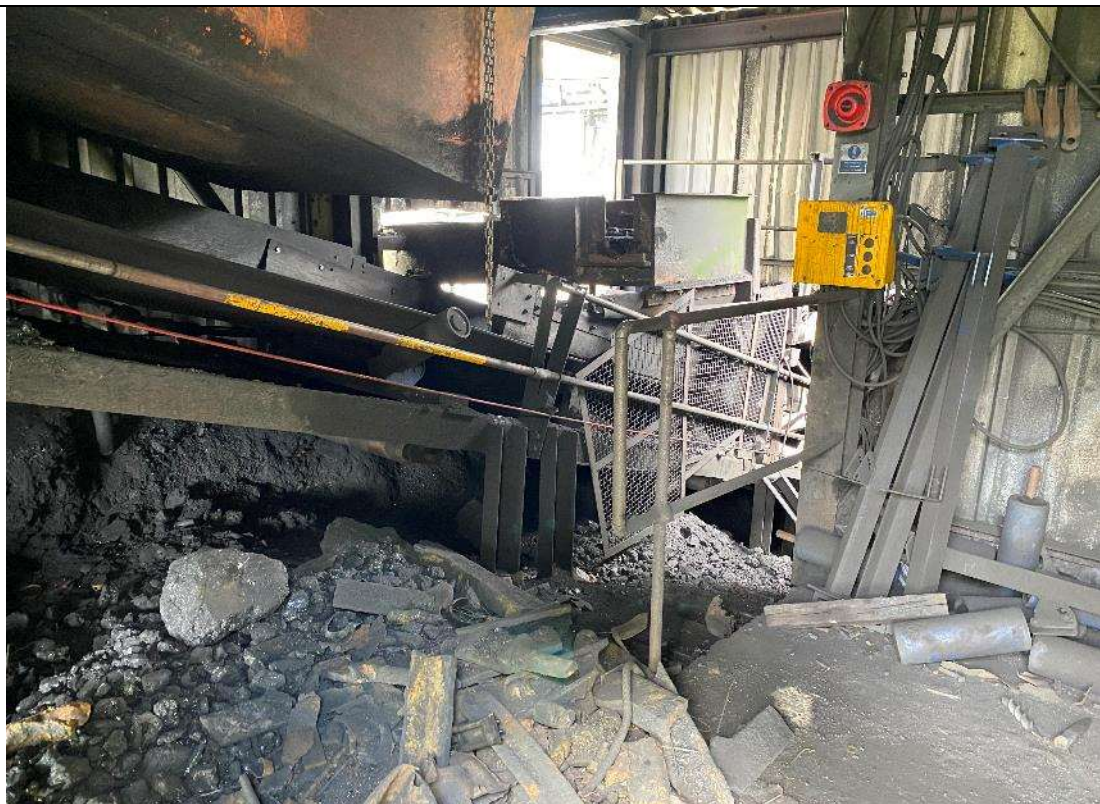
**Photo No.**  
80

**Washery Structure (047)**

View of interior of structure 047.

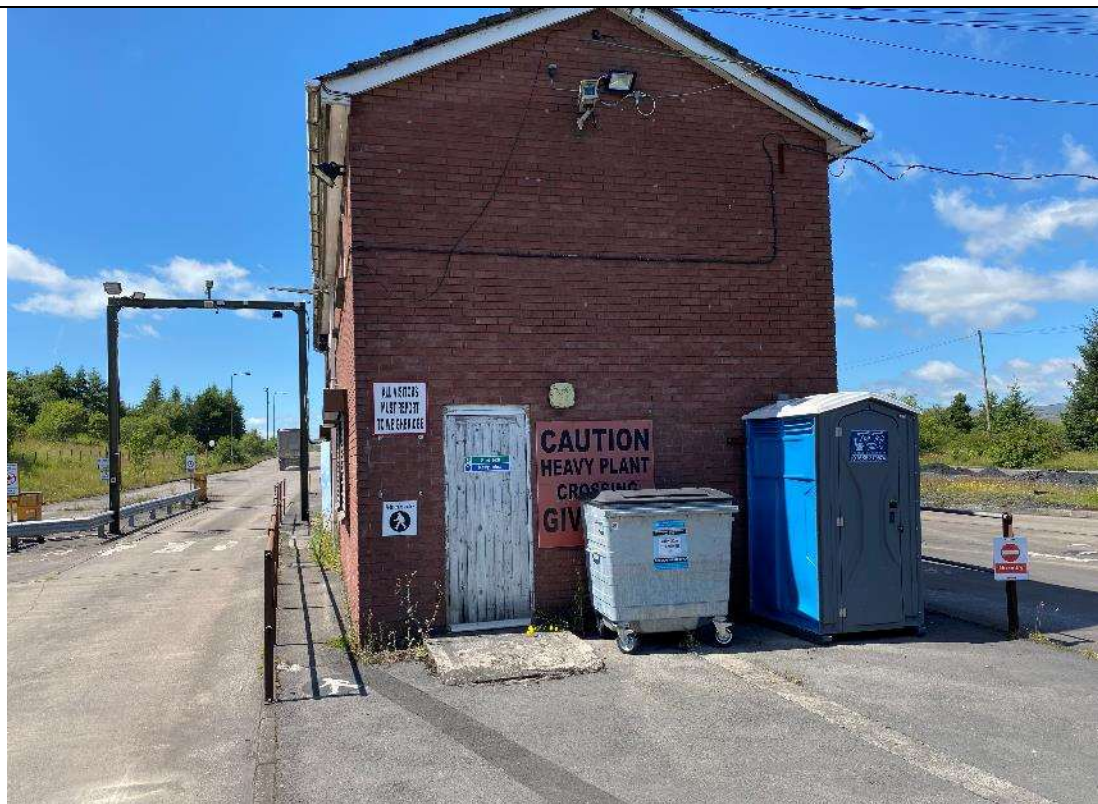
**Photo No.**  
81

**Weighbridge (048)**

View of HGV site entrance and office. Weighbridge to left.

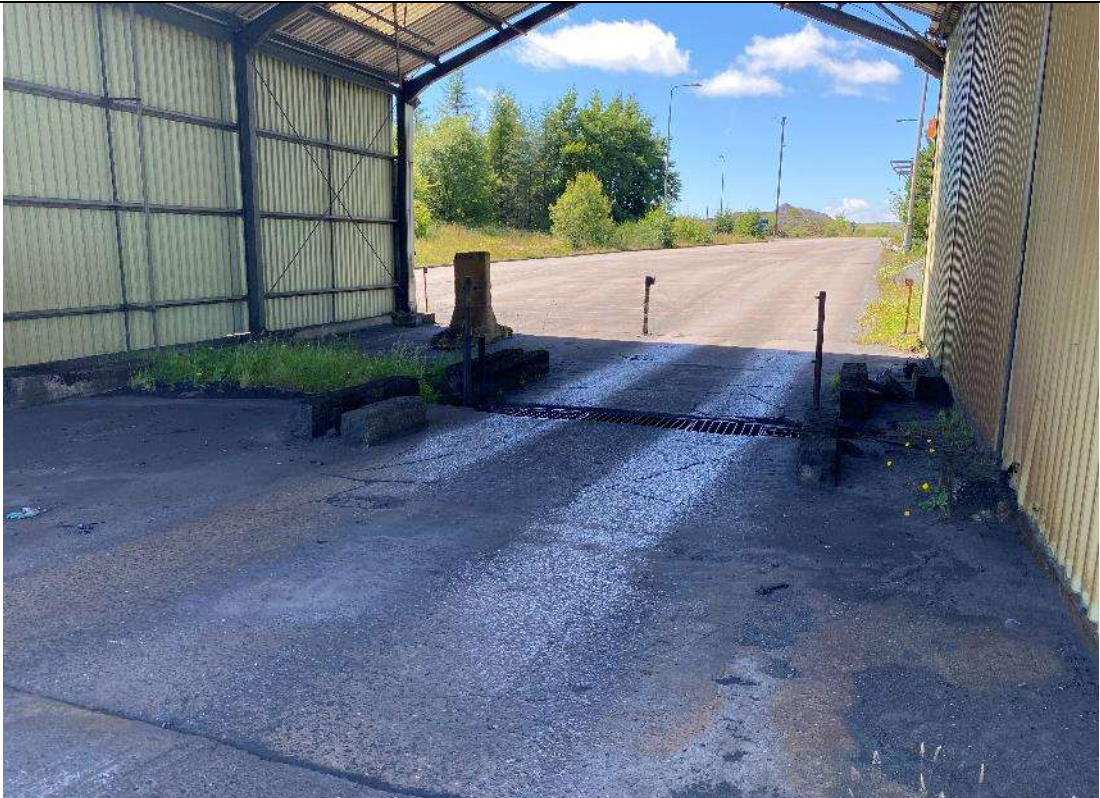
| <b>Photo No.</b><br>82 | <b>Date:</b><br>7 July 2022 | |

| <p><b>Wheel Wash (049)</b></p> <p>View of wheel wash, lagoon (050) located to right hand side supplying water for its use.</p> <p>The photograph aspect is west.</p> | | |

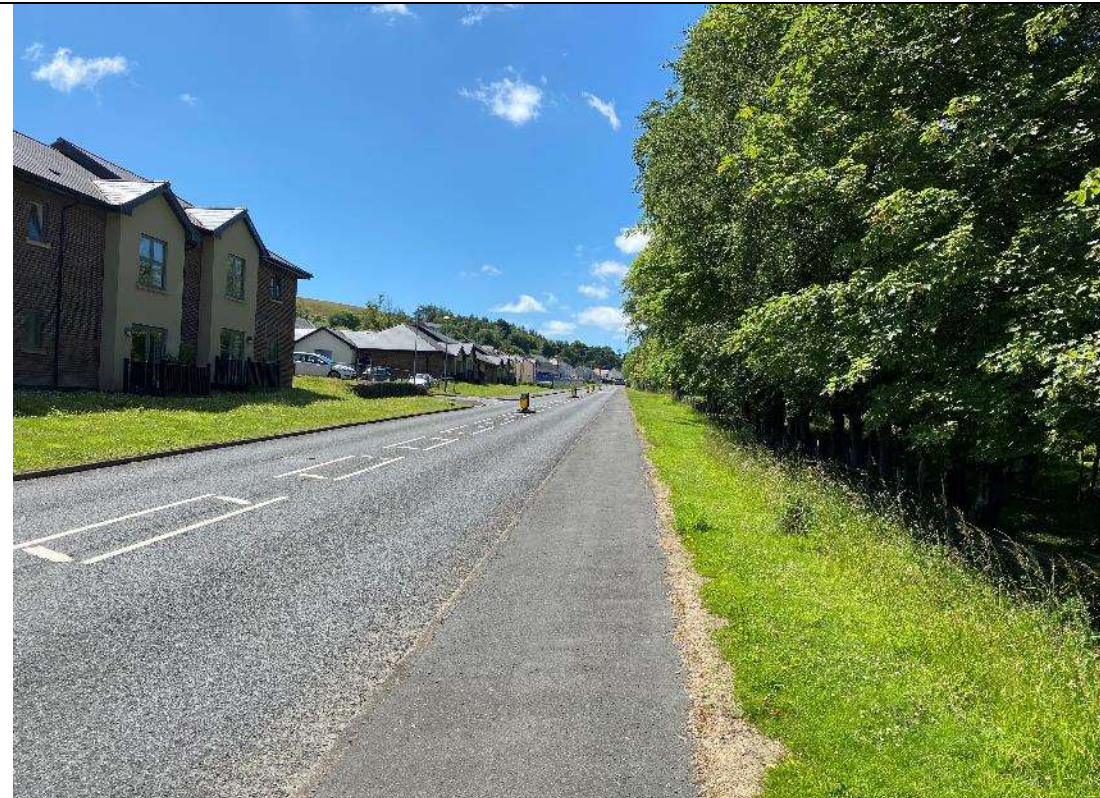
| <b>Photo No.</b><br>83 | <b>Date:</b><br>7 July 2022 | |

| <p><b>Southern Boundary</b></p> <p>View of sites southern boundary with Onllwyn.</p> <p>The photograph aspect is west.</p> | | |

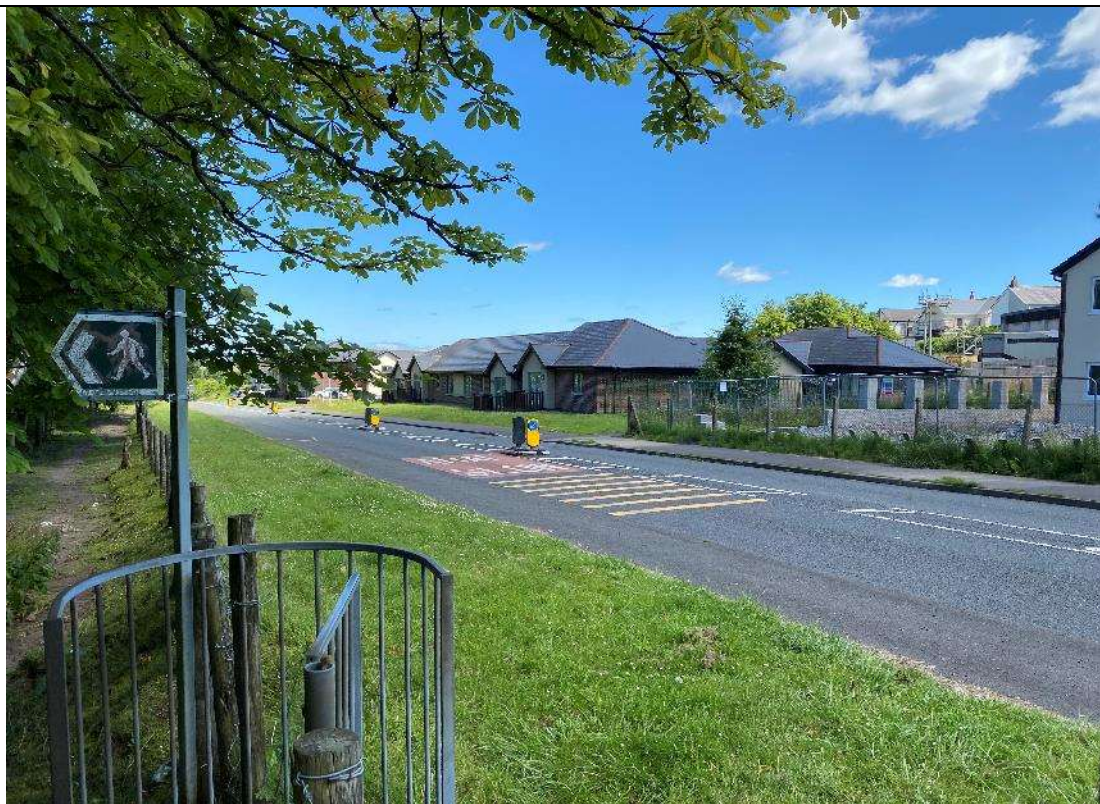
**Client Name: Global Centre of  
Rail Excellence**
**Site: GCRE (Onllywyn Washery)**
**Project No.  
5209796**
**Photo No.**  
84

**Southern Boundary**

View of sites southern  
boundary with Onllwyn.

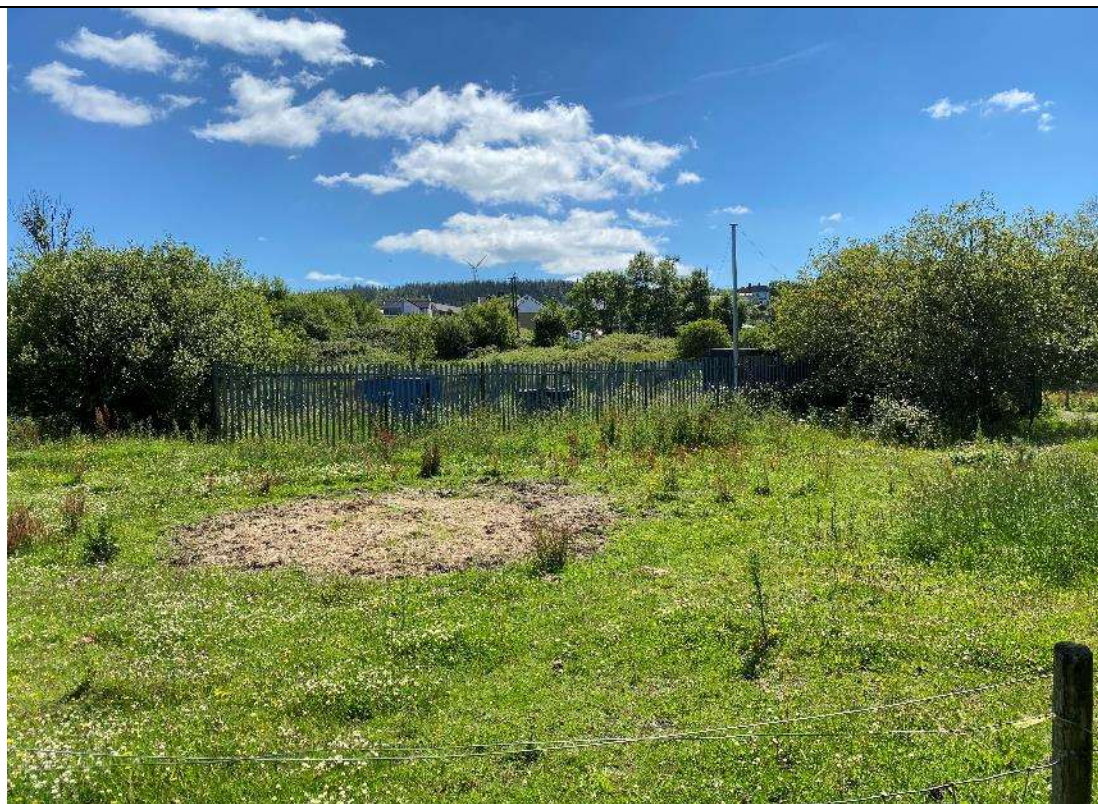
**Photo No.**  
85

**South of Washery**

View of area of colliery  
spoil in south of site.

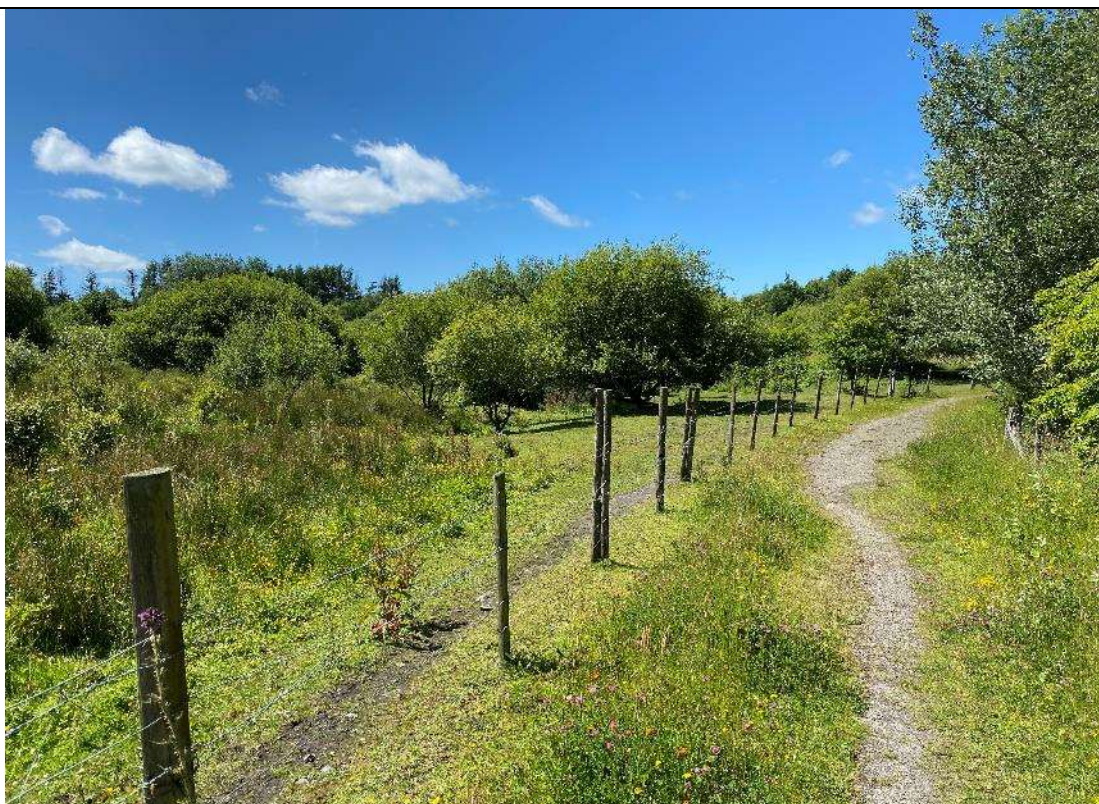
| <b>Photo No.</b><br>86 | <b>Date:</b><br>7 July 2022 | |

| <b>Former Railway Land<br/>(051)</b><br><br>View of former railway track crossing south eastern end of Washery site.<br><br>The photograph aspect is south-east. | | |

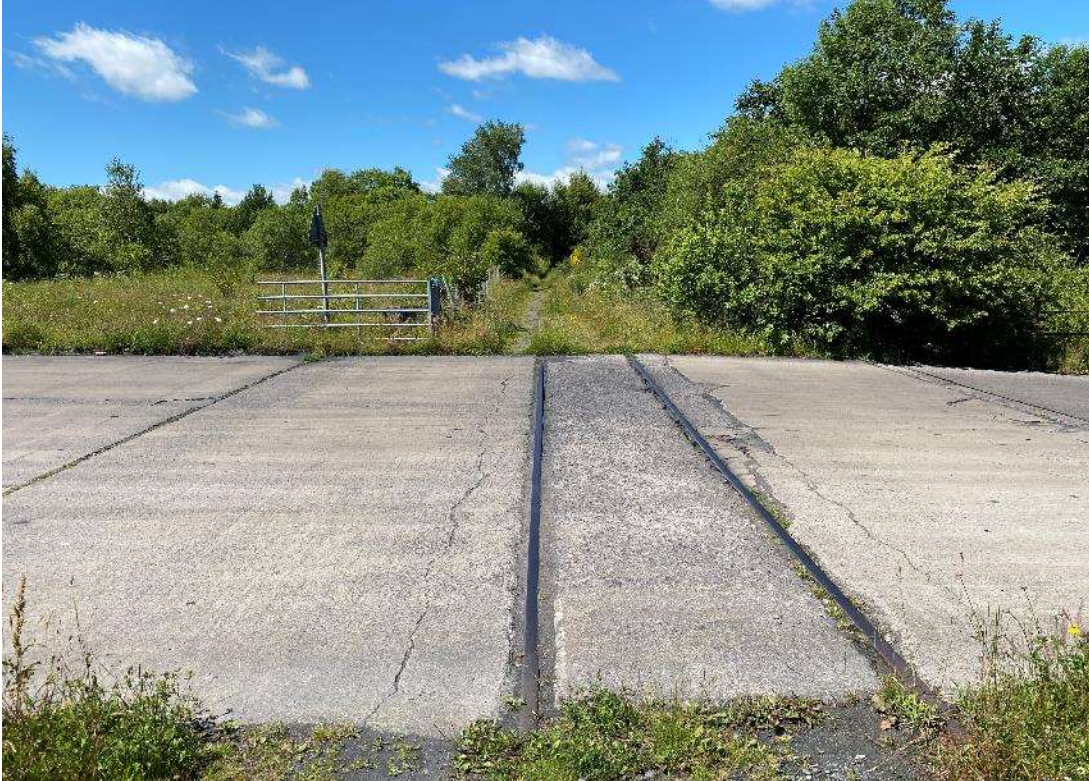
| <b>Photo No.</b><br>87 | <b>Date:</b><br>7 July 2022 | |

| <b>Former Railway Land<br/>(051)</b><br><br>View of former railway track crossing south eastern end of Washery site.<br><br>The photograph aspect is north-west. | | |

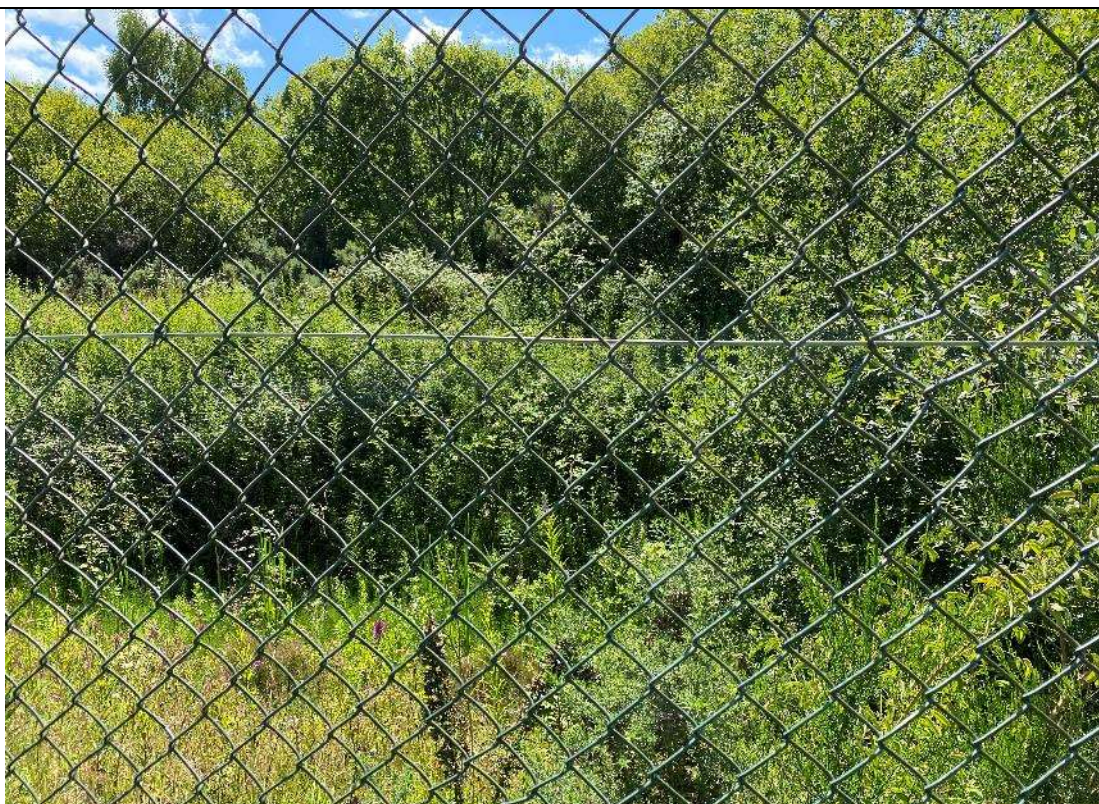
| <b>Photo No.</b><br>88 | <b>Date:</b><br>7 July 2022 | |

| <b>Lagoons (052 to 054)</b><br><br>View of lagoons in east of site. Vegetation to thick to view well.<br><br>The photograph aspect is west. | | |

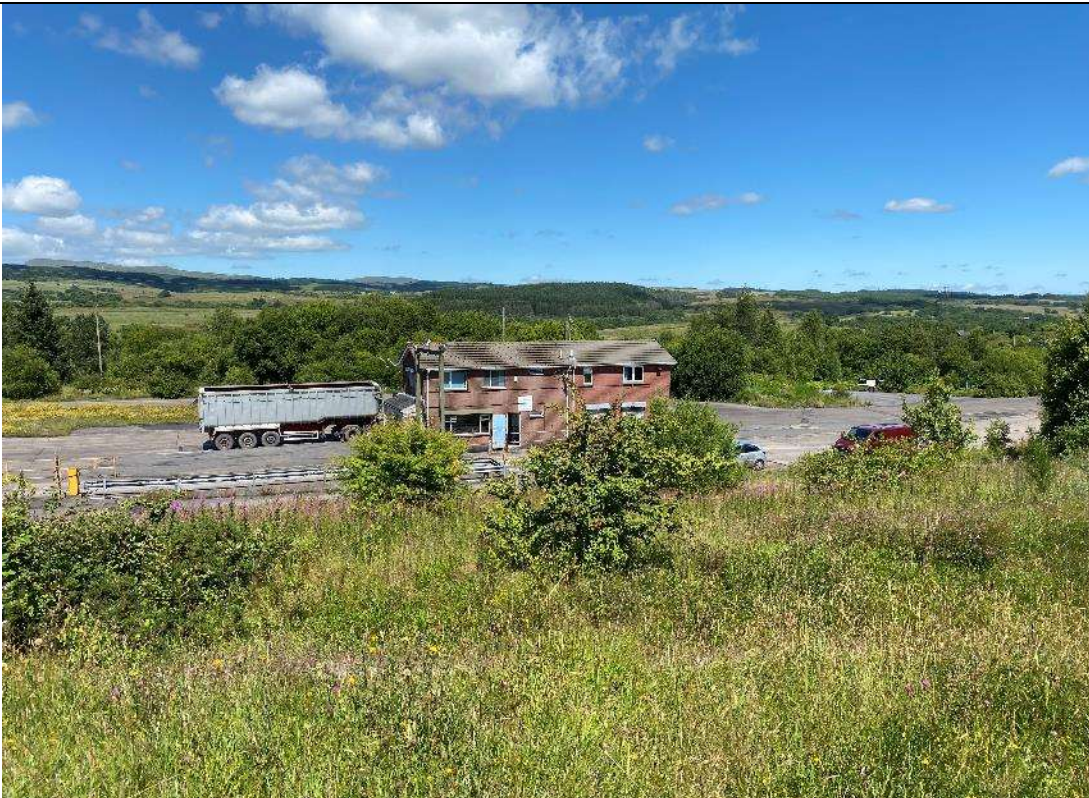
| <b>Photo No.</b><br>89 | <b>Date:</b><br>7 July 2022 | |

| <b>Weighbridge (048)</b><br><br>View of weighbridge and site office from colliery spoil heap.<br><br>The photograph aspect is north. | | |

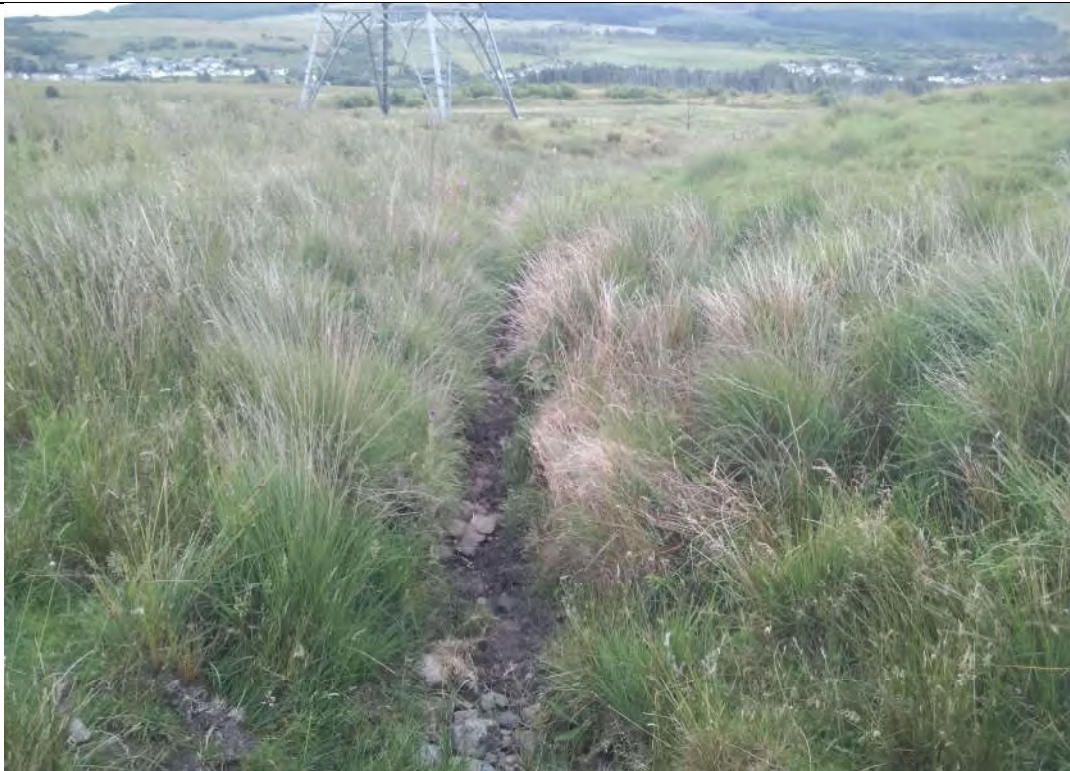
| Photo No. | Date: | |
|---|---|---|
| <b>Surface Water Feature SW-01 CE:</b><br>Surface Water Course (Minor ditch), possibly used as a field drainage/runoff. No water flowing observed at the time. Approximate measurements 1.2m wide, 0.8m depth. | | |

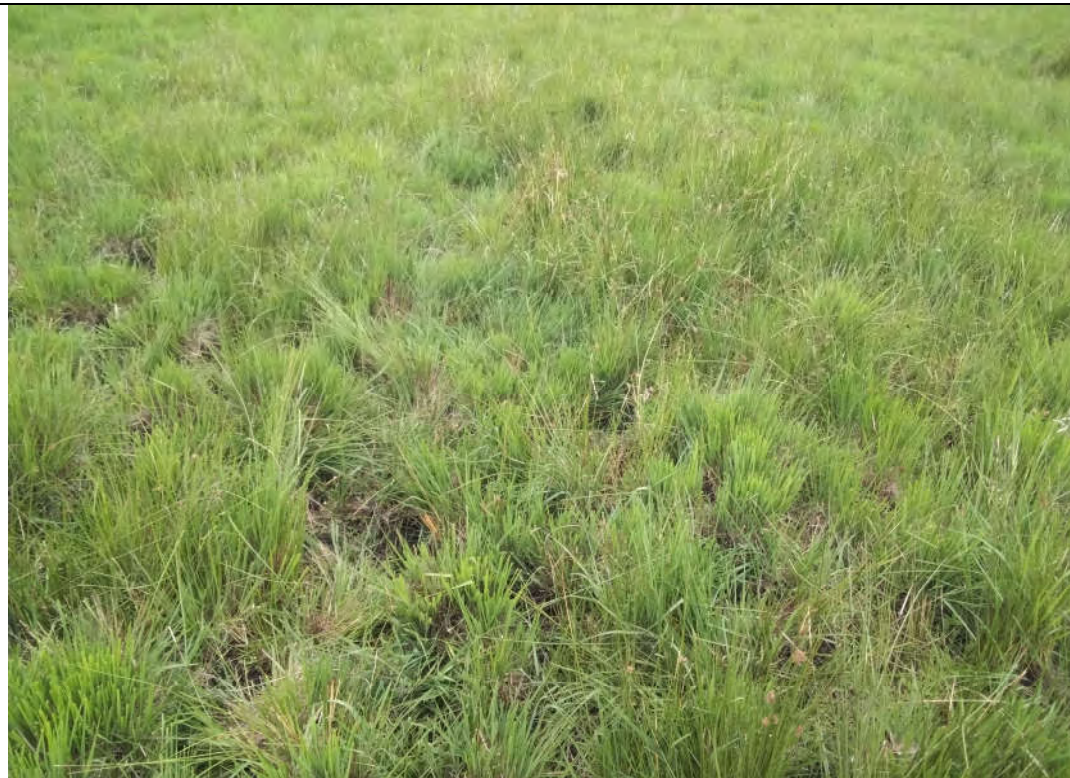
| Photo No. | Date: | |
|---|---|---|
| SW-02 CE | 12 July 2022 | |

| Photo No. | Date: | |
|---|---|---|
| <b>Surface Water Feature SW-02 CE:</b><br>Marshy Land, rainfall/runoff. Mildly wet. No water flowing observed at the time. Approximate measurements 10m wide. | | |

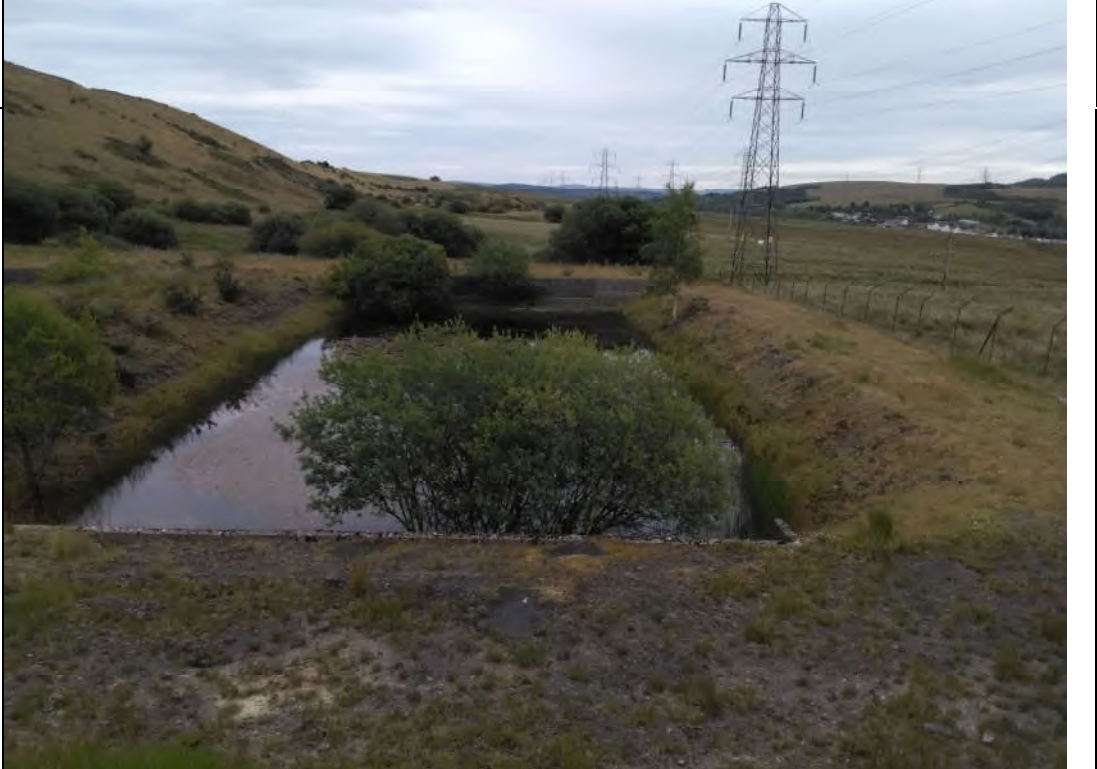
| <b>Surface Water Feature SW-03 CE:</b><br>Lagoon, water storage area, probably lined with low permeability material, drainage/runoff from restoration area. No water flowing observed at the time. Approximate measurements 5m wide, 10m length. Measurements DO 103.83%, ORP 137.5 mV, Cond 134.34 ms/cm, pH 7.34, T22.8C | | |

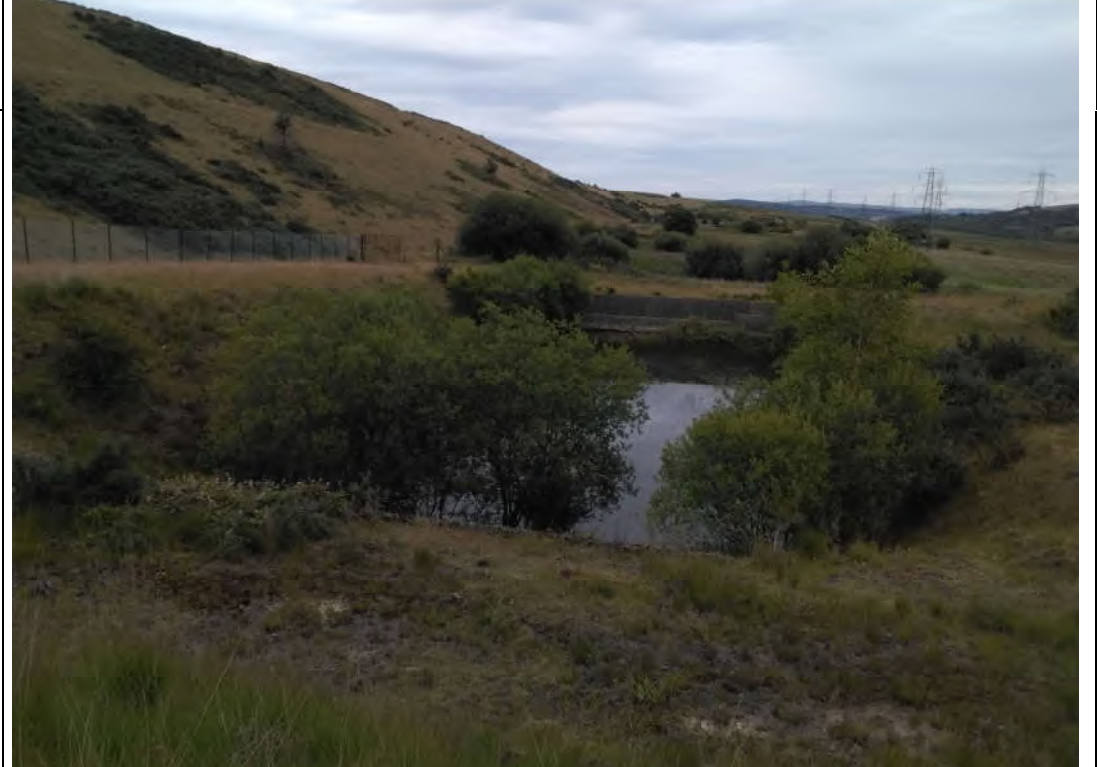
| <b>Surface Water Feature SW-04 CE:</b><br>Lagoon, water storage area, probably lined, drainage/runoff from restoration area. No water flowing observed at the time. Approximate measurements 5m wide, 10m length. DO 95.89%, ORP 211.0 mV, Cond 144.6ms/cm, pH 7.61, T21.7 | | |

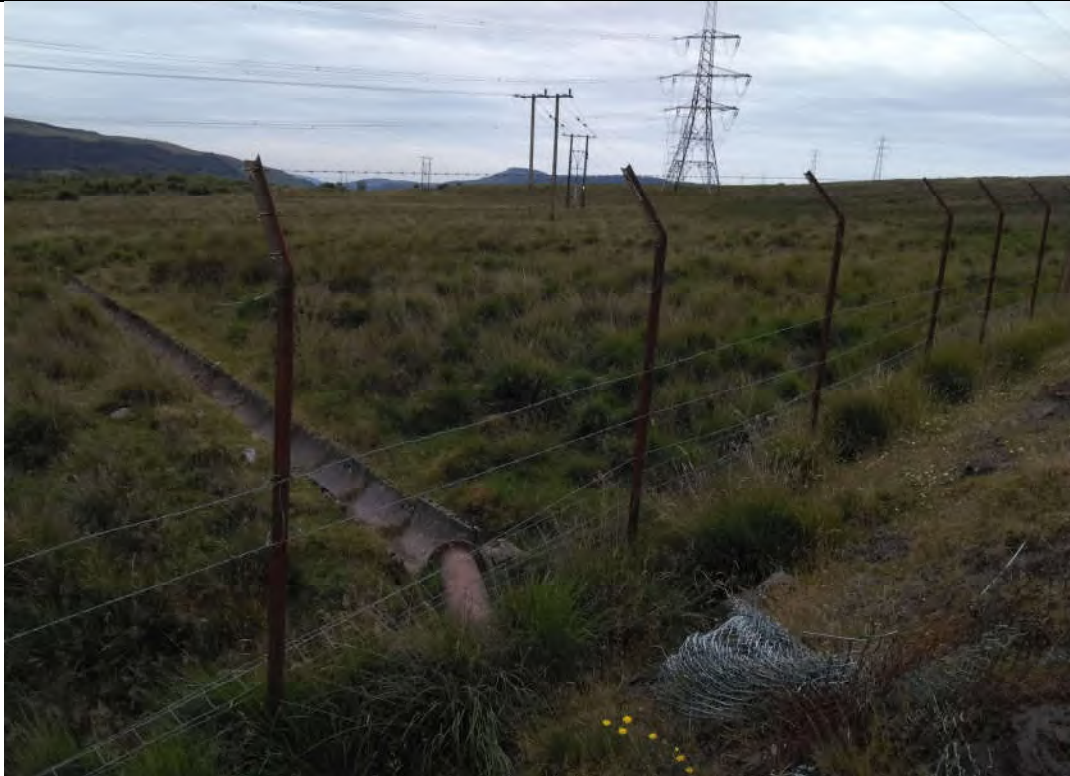
| Photo No.<br>SW-06 CE | Date:<br>12 July<br>2022 | |
|---|---|---|
| <b>Surface Water Feature SW-06 CE:</b><br>Discharge ditch from lagoon, lined with concrete cast approximately 70cm wide and 40cm depth, drainage/runoff from lagoon.<br>No water flowing observed at the time.<br>Approximate measurements 5m wide, 10m length. | | |

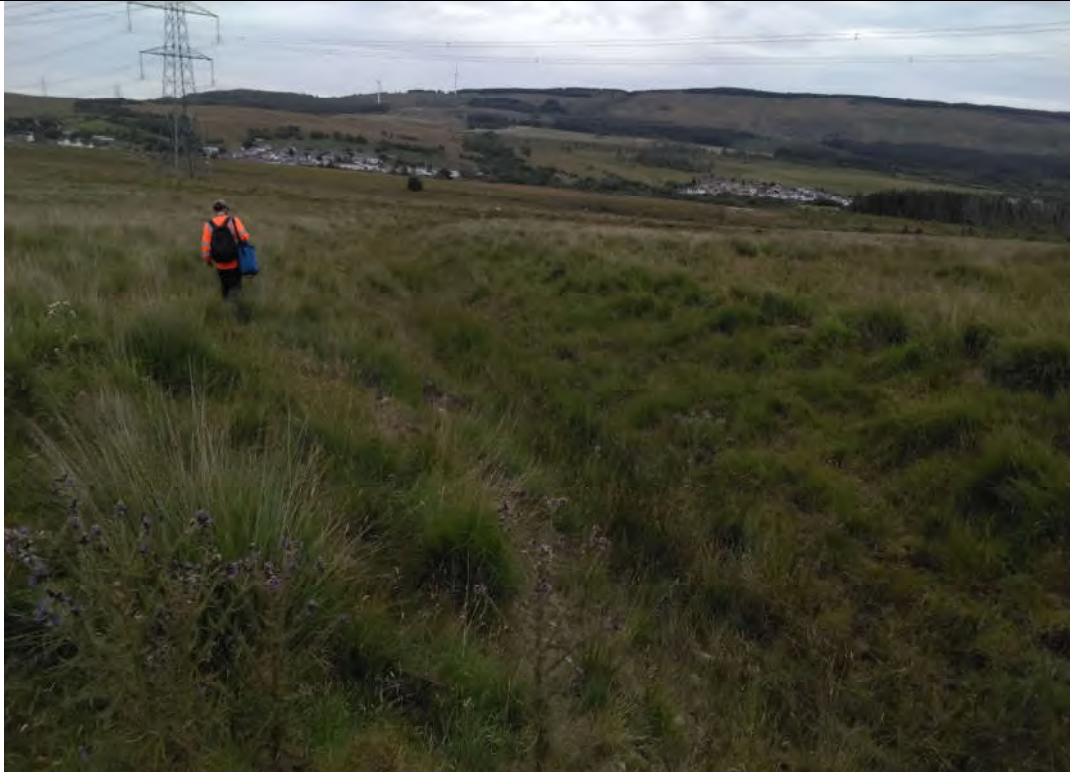
| Photo No.<br>SW-07 CE | Date:<br>12 July<br>2022 | |
|---|---|---|
| <b>Surface Water Feature SW-07 CE:</b><br>Surface Water Course (minor ditch), possibly used as a field drainage/runoff.<br>Not lined. No water flowing observed at the time. Approximate measurements 3m wide, 2m depth. | | |

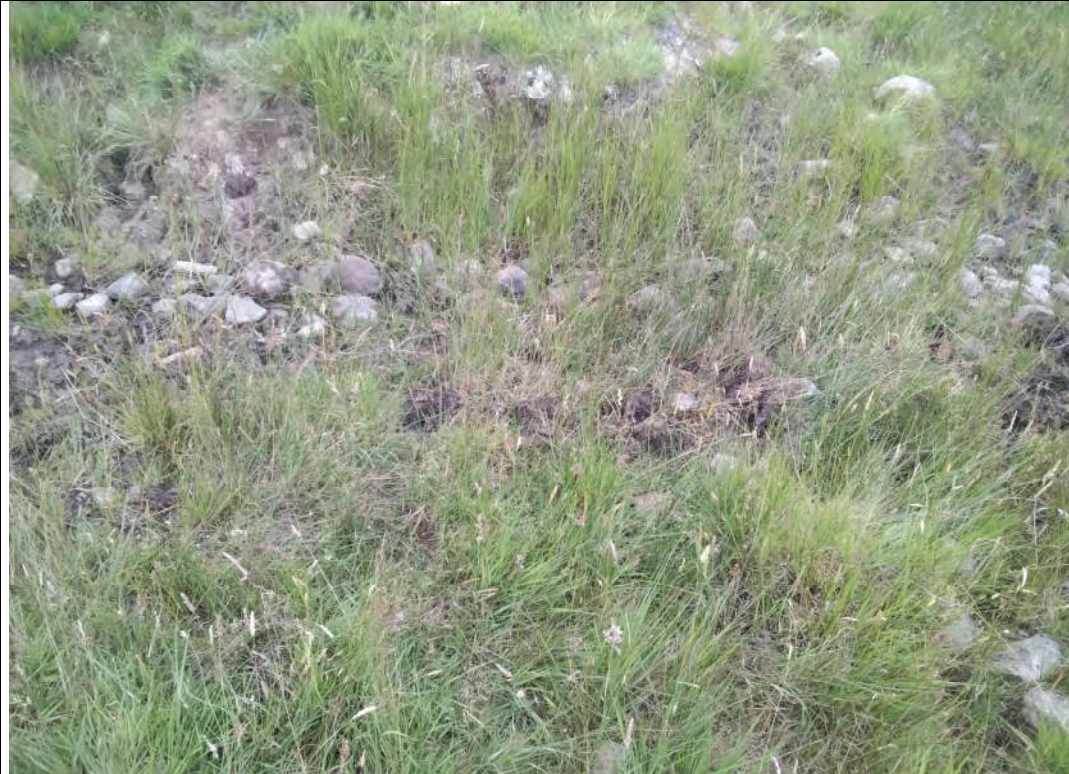
| Photo No. | Date: | |
|---|---|---|
| <b>Surface Water Feature SW-11 CE:</b><br>Surface Water Course (minor ditch), possibly used as a field drainage/runoff. Not lined. Ground slightly wet. No water flowing observed at the time. Approximate measurements 2.5m wide, 0.5m depth. | | |

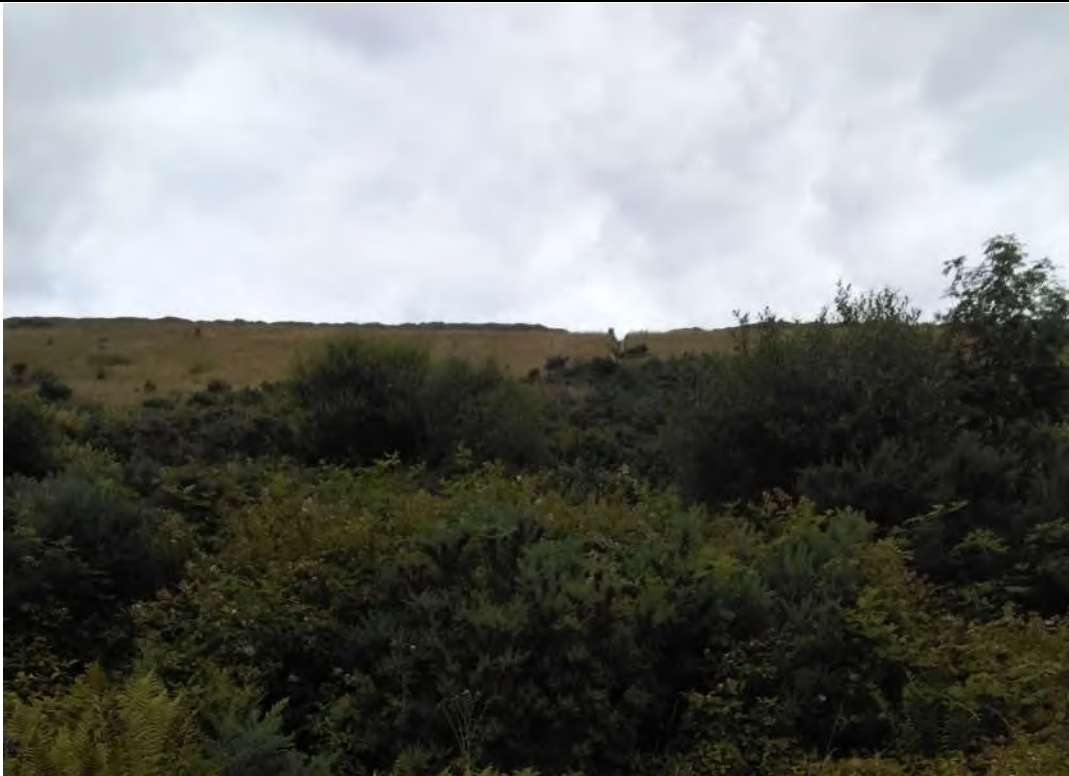
| Photo No. | Date: | |
|---|---|---|
| <b>Surface Water Feature SW-14 CE:</b><br>Surface Water Course (Minor ditch), possibly used as to collect restoration area drainage/runoff. Lined. No water flowing observed at the time. Approximate measurements 5m wide, 1m depth. | | |
