**Client Name: Global Centre of Rail Excellence**

**Site: GCRE (Onllywyn Washery)**

**Project No. 5209796**

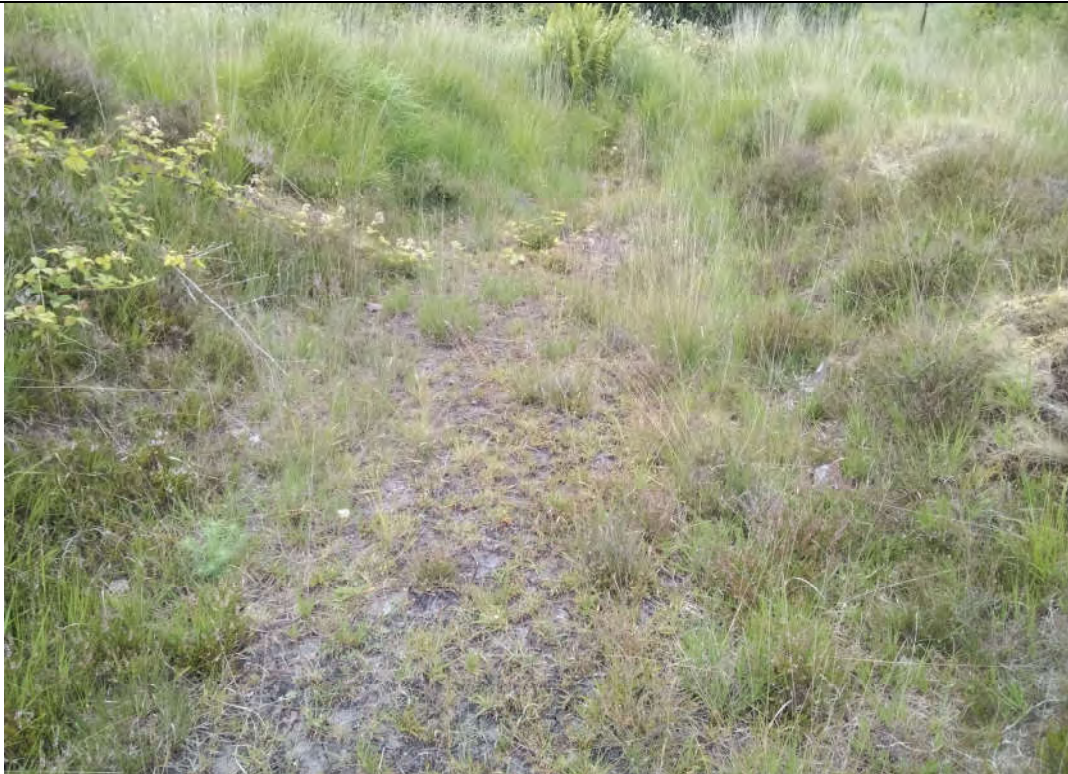
| Photo No. | Date: | |
|---|---|---|
| <b>Surface Water Feature SW-15 CE:</b><br>Surface Water Course (Minor ditch), possibly used as to collect restoration area drainage/runoff. Lined. No water flowing observed at the time. Approximate measurements 5m wide, 1m depth. | | |

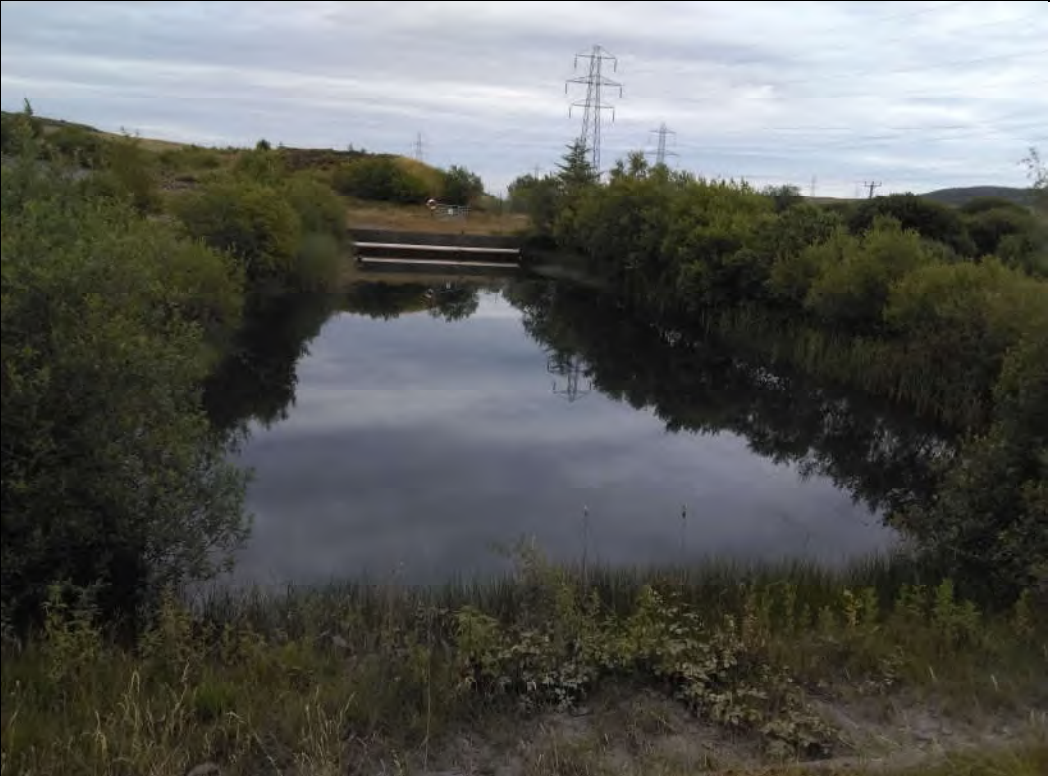
| Photo No.<br>SW-16 CE | Date:<br>12 July<br>2022 | |
|---|---|---|
| <b>A Surface Water Feature SW-16 CE:</b><br>Lagoon, water storage area, probably lined, drainage/runoff from restoration area.<br>No water flowing observed at the time in or out. Approximate measurements 10m wide, 20m length.<br>DO 126%, ORP 164.9 mV, Cond 1497ms/cm, pH 7.7, T21.41 | | |

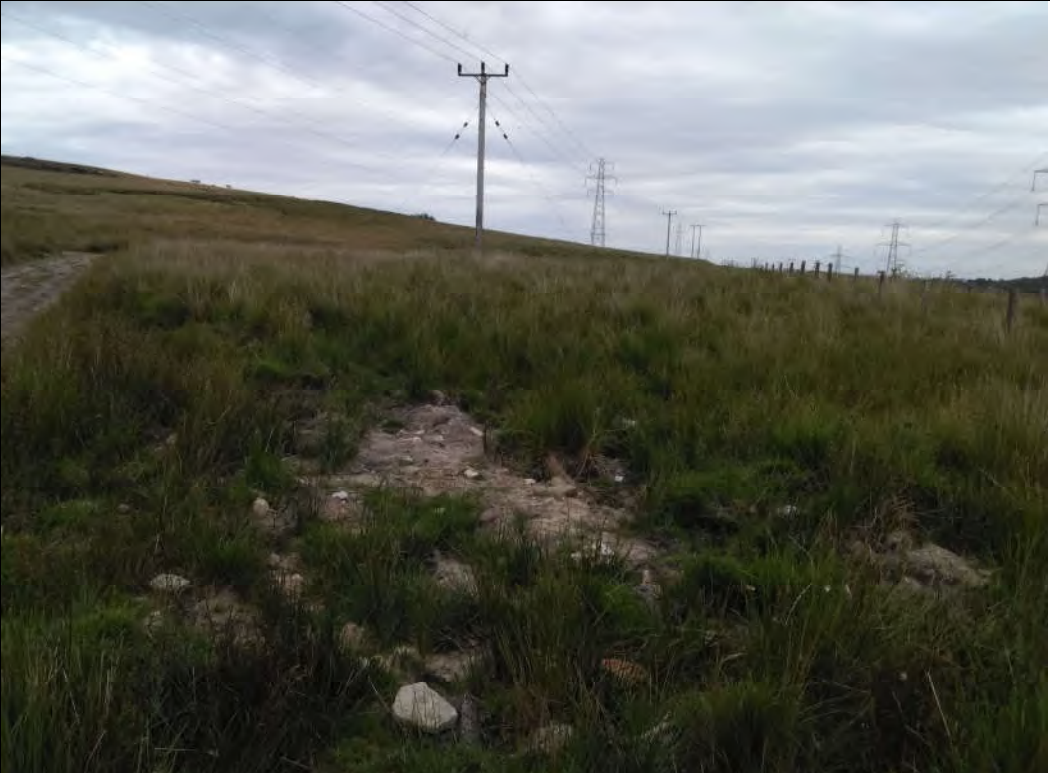
| Photo No.<br>SW-17 CE | Date:<br>12 July<br>2022 | |
|---|---|---|
| <b>A Surface Water Feature SW-17 CE:</b><br>Surface Water Course (Minor ditch), possibly used as to collect restoration area drainage/runoff. Lined.<br>No water flowing observed at the time.<br>Approximate measurements 1m wide, 0.5m depth. | | |

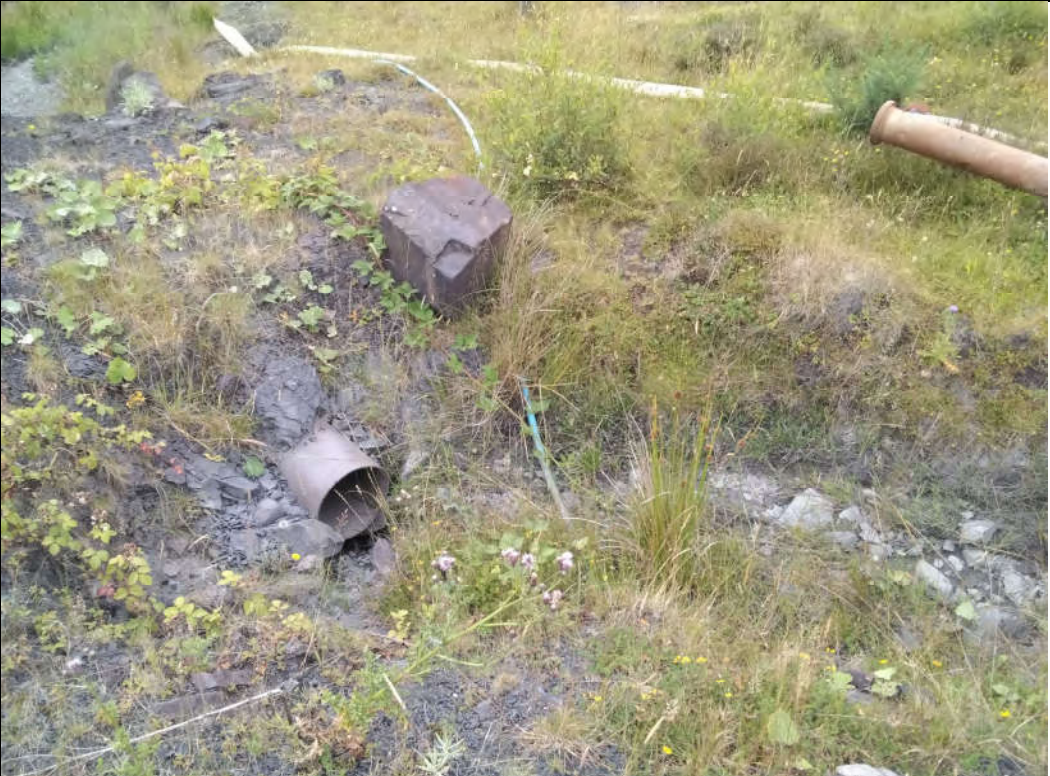
| Photo No. | Date: | |
|---|---|---|
| <b>A Surface Water Feature SW-18 CE:</b><br>Surface Water Course (Minor ditch), connecting two lagoons. Not lined. No water flowing observed at the time. Approximate measurements 1m wide, 0.5m depth. | | |

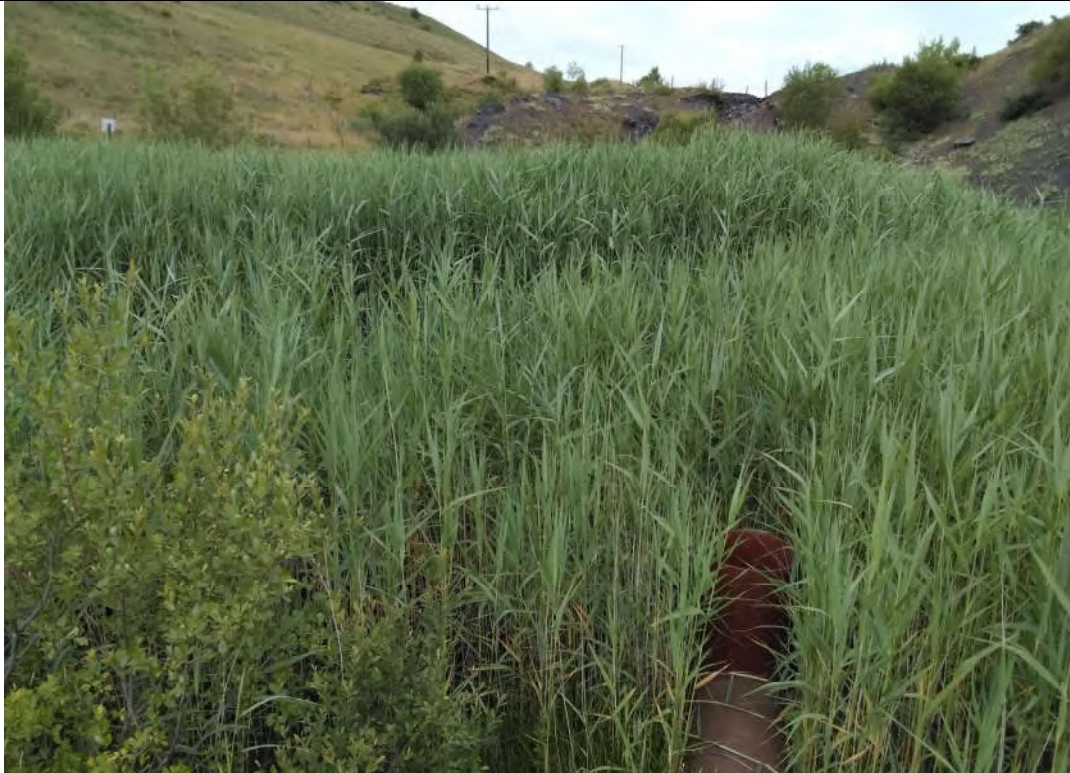
| Photo No. | Date: | |
|---|---|---|
| <b>A Surface Water Feature SW-19 CE:</b><br>Lagoon, quite dry, probably lined but looked silted up, drainage/runoff from restoration area. No water flowing observed at the time in or out. No measurements obtained as mainly dry. | | |

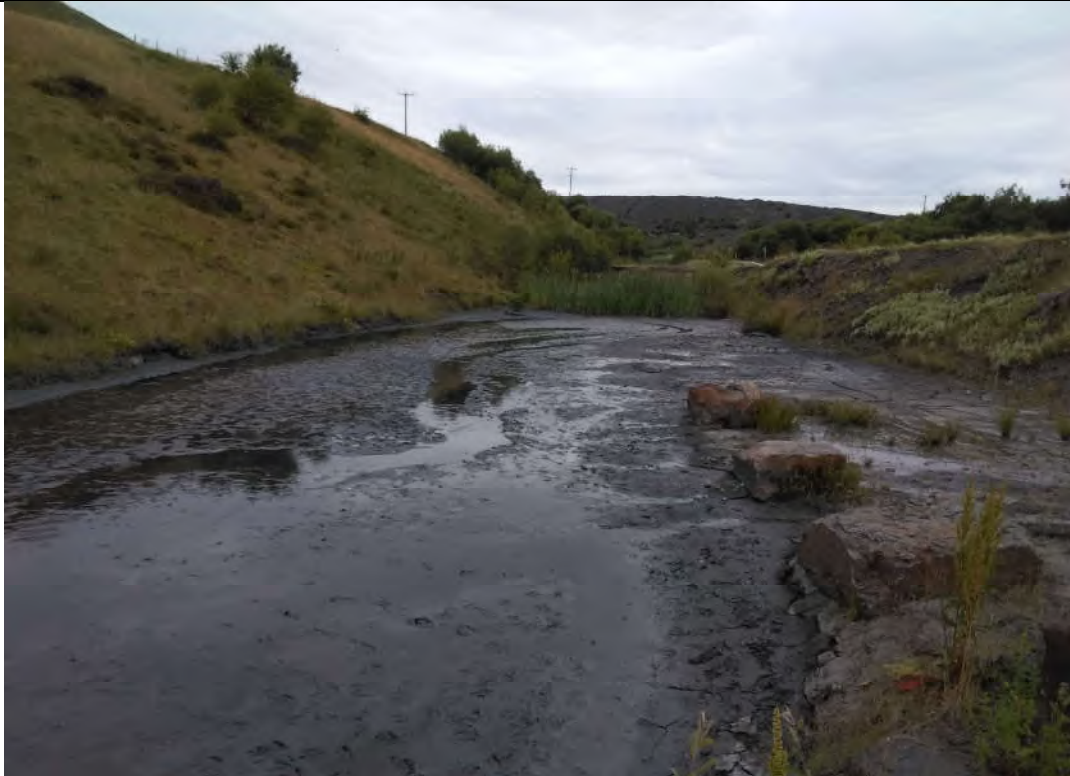
| Photo No. | Date: | |
|---|---|---|
| <b>A Surface Water Feature SW-20 CE:</b><br>Lagoon, quite dry, probably not lined but looked silted up, drainage/runoff from restoration or adjacent areas.<br>Minimal water flowing observed at the time in or out, flow 0.335m/s. 5m wide by 20m long. No measurements obtained low water present. | | |

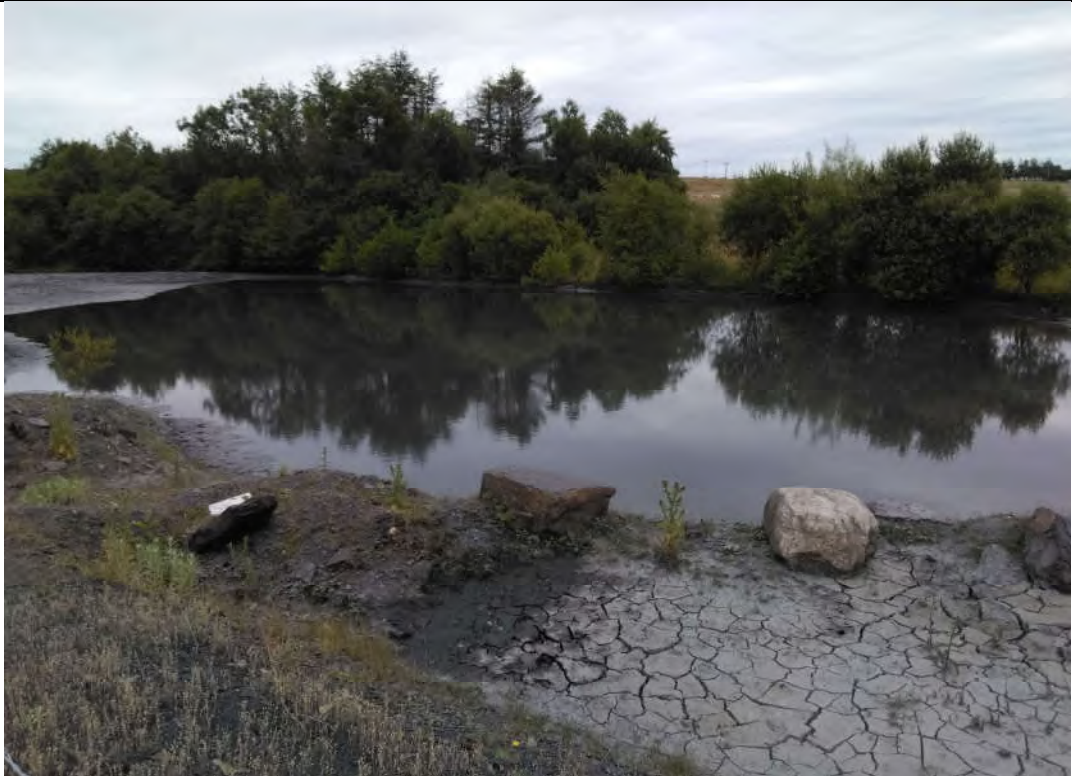
| <b>A Surface Water<br/>Feature SW-22 CE:</b><br>Lagoon, no flow out,<br>probably not lined but<br>looked but within a low<br>permeability material,<br>possibly water storage<br>area from runoff from<br>adjacent areas.<br>20m wide by 50m long.<br>No measurements<br>obtained H&S concerns. | | |

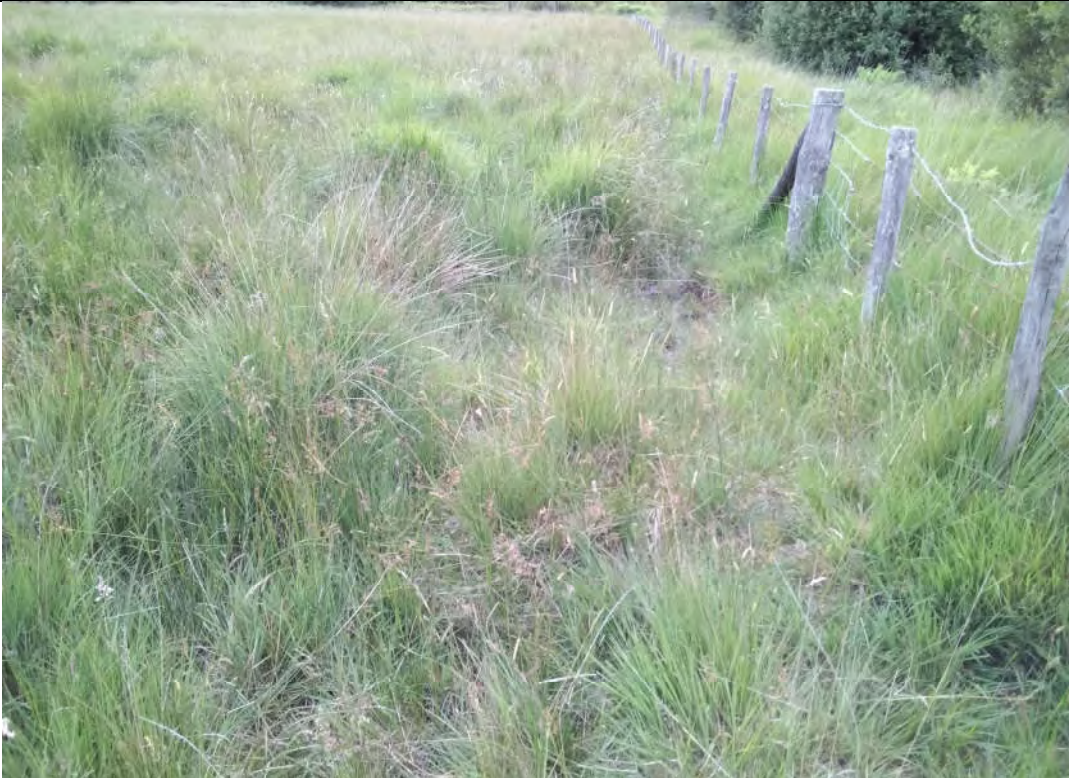
| Photo No.<br>SW-24 CE | Date:<br>12 July<br>2022 | |
|---|---|---|
| <b>A Surface Water Feature SW-24 CE:</b><br>Marshy Land, rainfall/runoff.<br>Soil mostly dry, but occasional signs of moist soil. No water flowing observed at the time.<br>Approximate measurements 2m wide. | | |

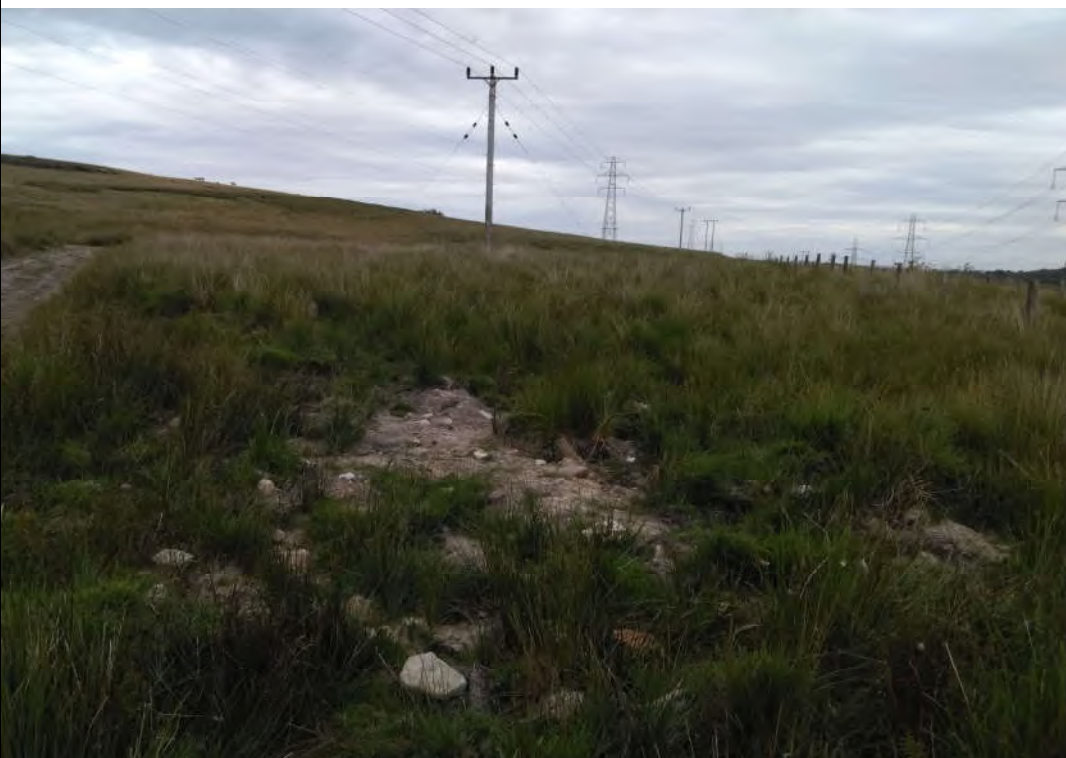
| Photo No.<br>SW-25 CE | Date:<br>12 July<br>2022 | |
|---|---|---|
| <b>A Surface Water Feature SW-25 CE:</b><br>Marshy Land, rainfall/runoff.<br>Soil mostly dry, but occasional signs of moist soil. No water flowing observed at the time.<br>Approximate measurements 2m wide. | | |

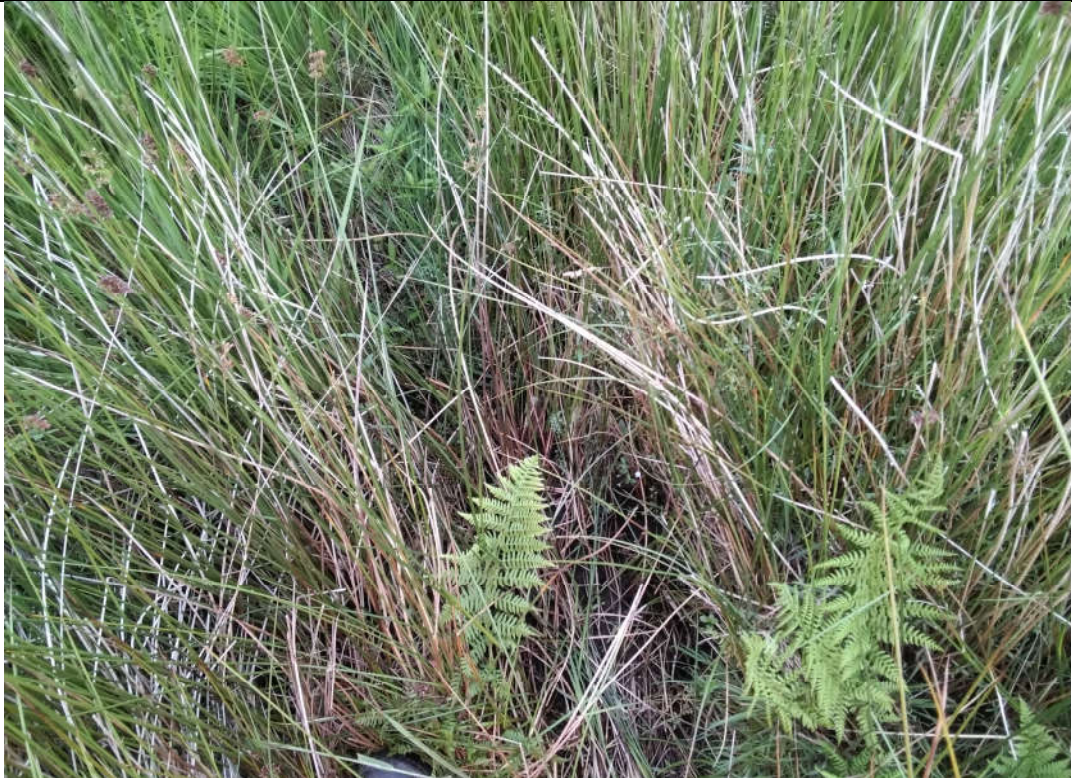
| Photo No. | Date: | |
|---|---|---|
| <b>A Surface Water Feature SW-26 CE:</b><br>Surface Water (minor ditch), land drainage, no flow at the time, area slightly moist. No water flowing observed at the time. Approximate measurements 2m wide by 0.3m depth. | | |

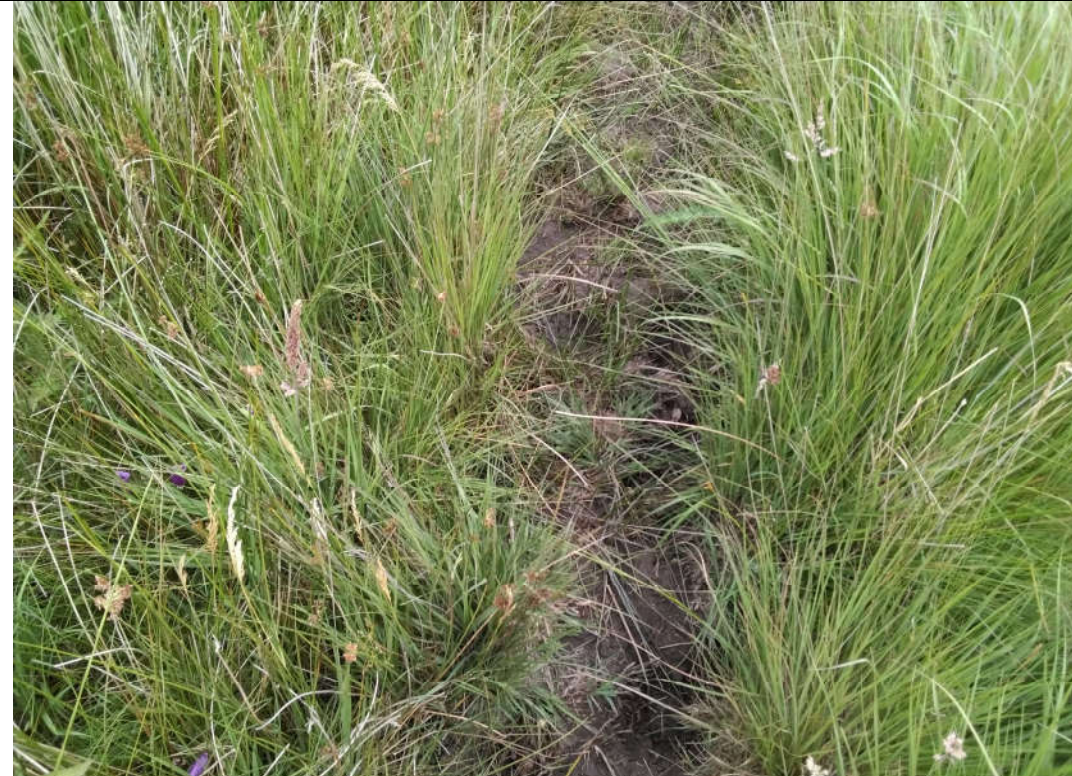
| Photo No. | Date: | |
|---|---|---|
| <b>A Surface Water Feature SW-29 CE:</b><br>Surface Water (minor ditch), land drainage from adjacent areas, dry at the time, not likely to be lined. Approximate measurements 2m wide by 0.2 depth. | | |

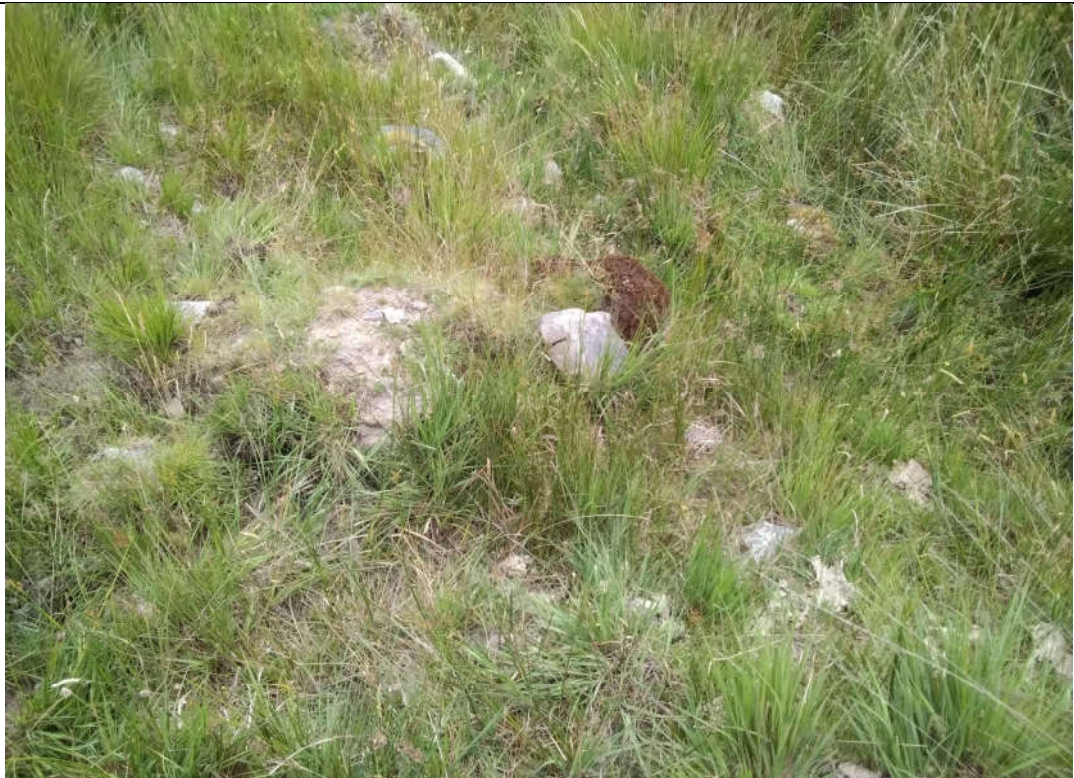
| Photo No.<br>SW-30 CE | Date:<br>12 July<br>2022 | |
|---|---|---|
| <b>Surface Water Feature SW-30 CE:</b><br>Surface Water (minor ditch), land drainage from adjacent areas, dry at the time, no likely to be lined. Approximate measurements 2m wide by 0.2 depth. | | |

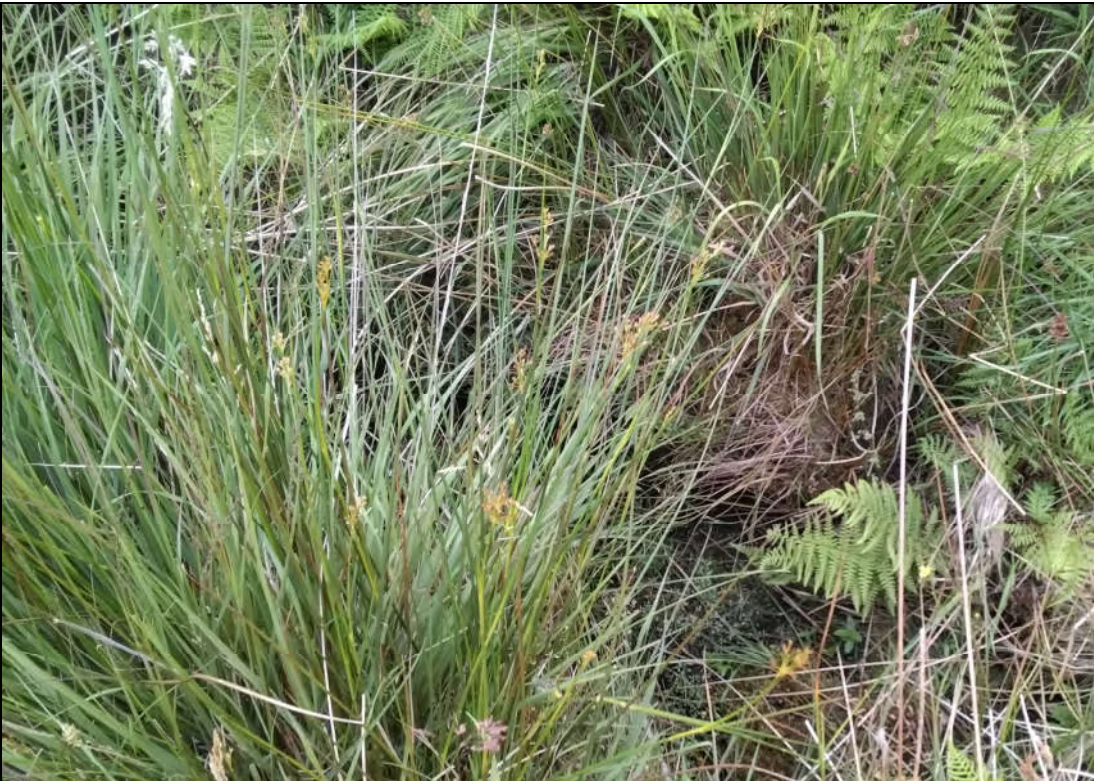
| Photo No.<br>SW-31 CE | Date:<br>12 July<br>2022 | |
|---|---|---|
| <b>Surface Water Feature SW-31 CE:</b><br>Surface Water (minor ditch), land drainage from adjacent areas, dry at the time, no likely to be lined. Approximate measurements 0.5m wide by 0.2 depth. | | |

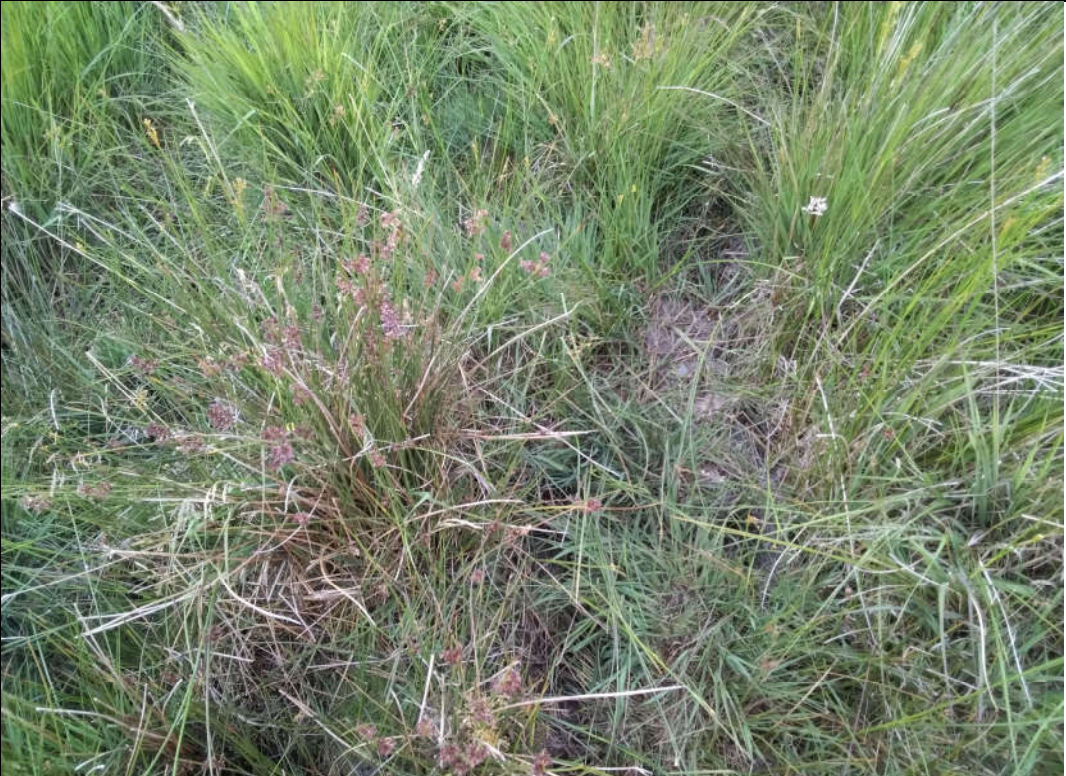
| Photo No. | Date: | |
|---|---|---|
| <b>Surface Water Feature<br/>SW-32 CE:</b><br>Marshy Land,<br>rainfall/runoff.<br>Soil mostly dry, but<br>occasional signs of moist<br>soil. No water flowing<br>observed at the time.<br>Approximate<br>measurements 2m wide. | | |

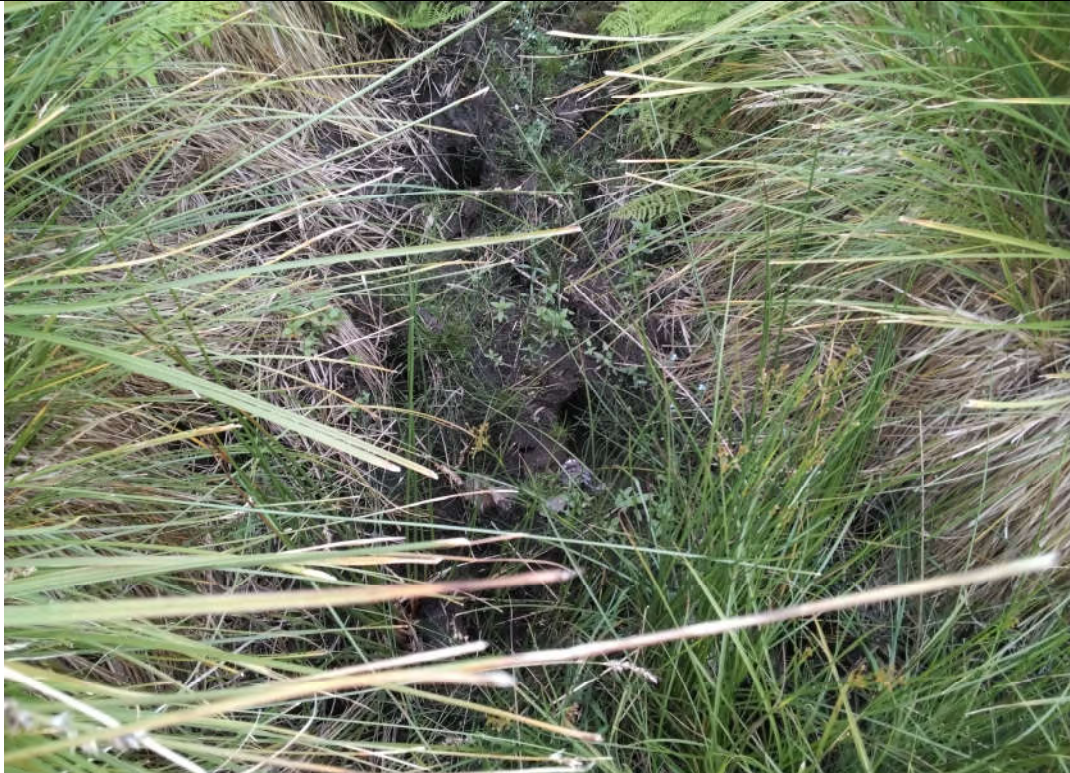
| Photo No. | Date: | |
|---|---|---|
| <b>Surface Water Feature SW-35 CE:</b><br>Surface Water (minor ditch), land drainage from adjacent areas, no flow but ground slightly moist, no likely to be lined. Approximate measurements 1m wide by 0.5 depth. | | |

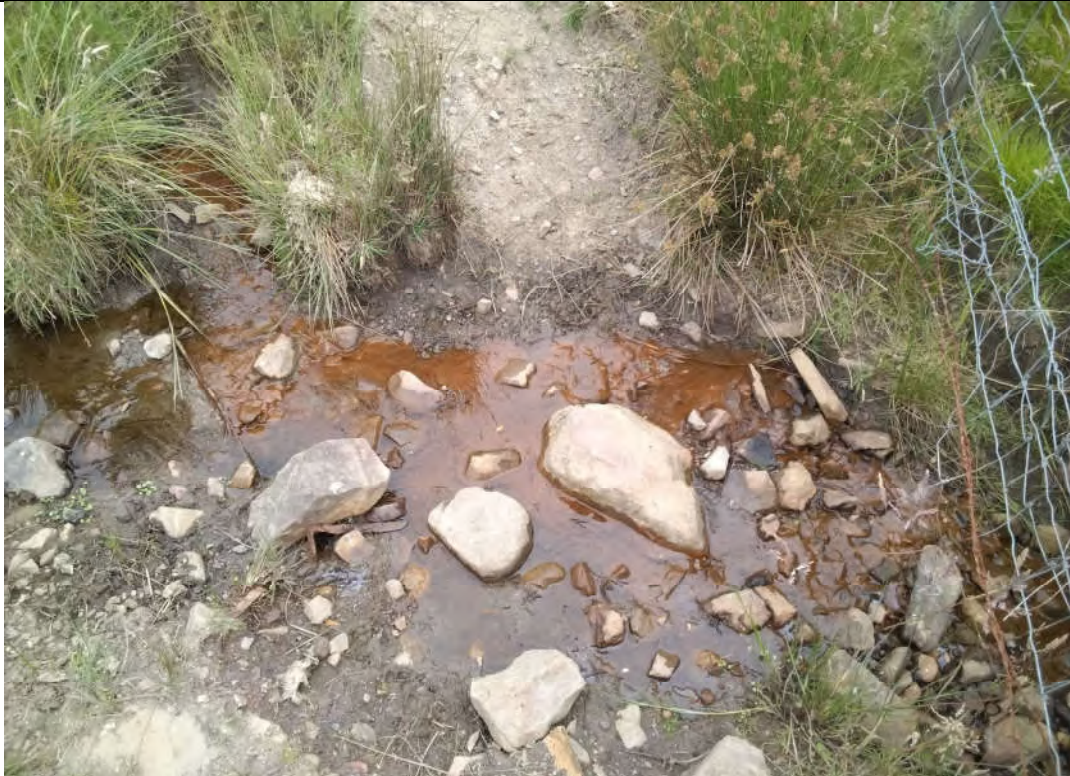
| Photo No. | Date: | |
|---|---|---|
| <b>Surface Water Feature SW-36 CE:</b><br>Surface Water Course (Stream), collecting water from all other discharge drains, rainfall, runoff. Not lined, probably natural. Approximate measurements 1m wide, 2cm depth. Average speed 0.053m/s, no readings taken | | |

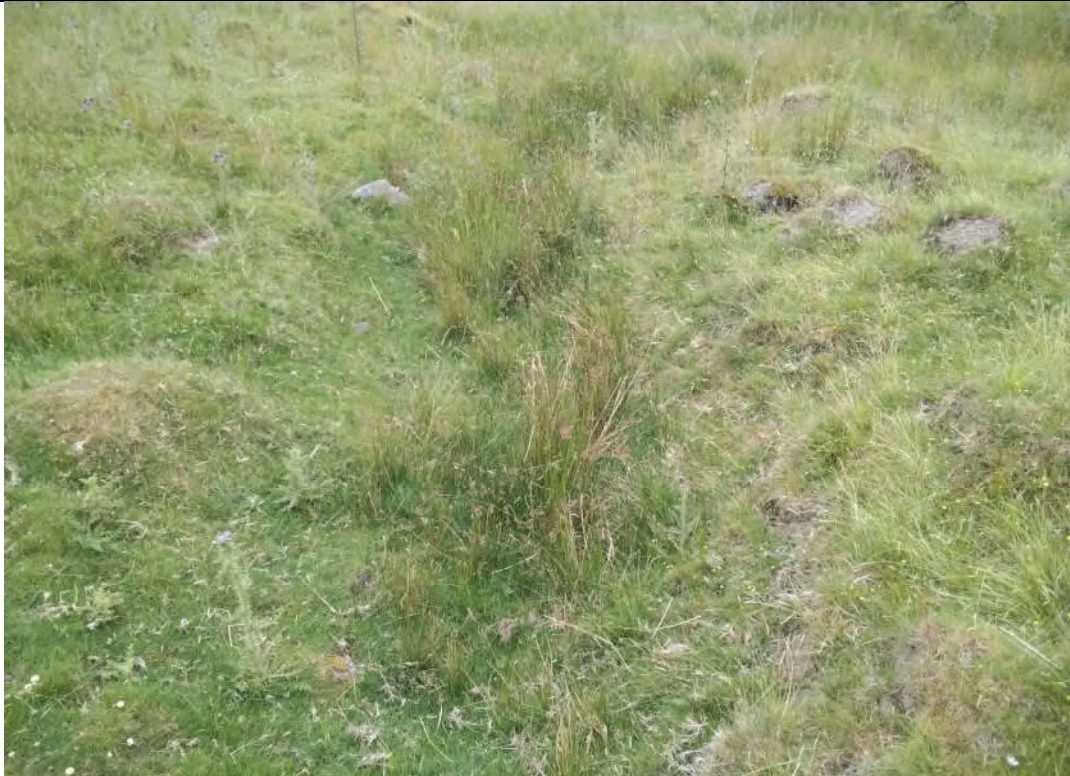
| Photo No. | Date: | |
|---|---|---|
| SW-41 CE | 12 July 2022 | |

| Photo No. | Date: | |
|---|---|---|
| <b>Surface Water Feature<br/>SW-41 CE:</b><br>Surface Water (minor ditch), land drainage/runoff from adjacent areas, dry/no flow, no likely to be lined. | | |

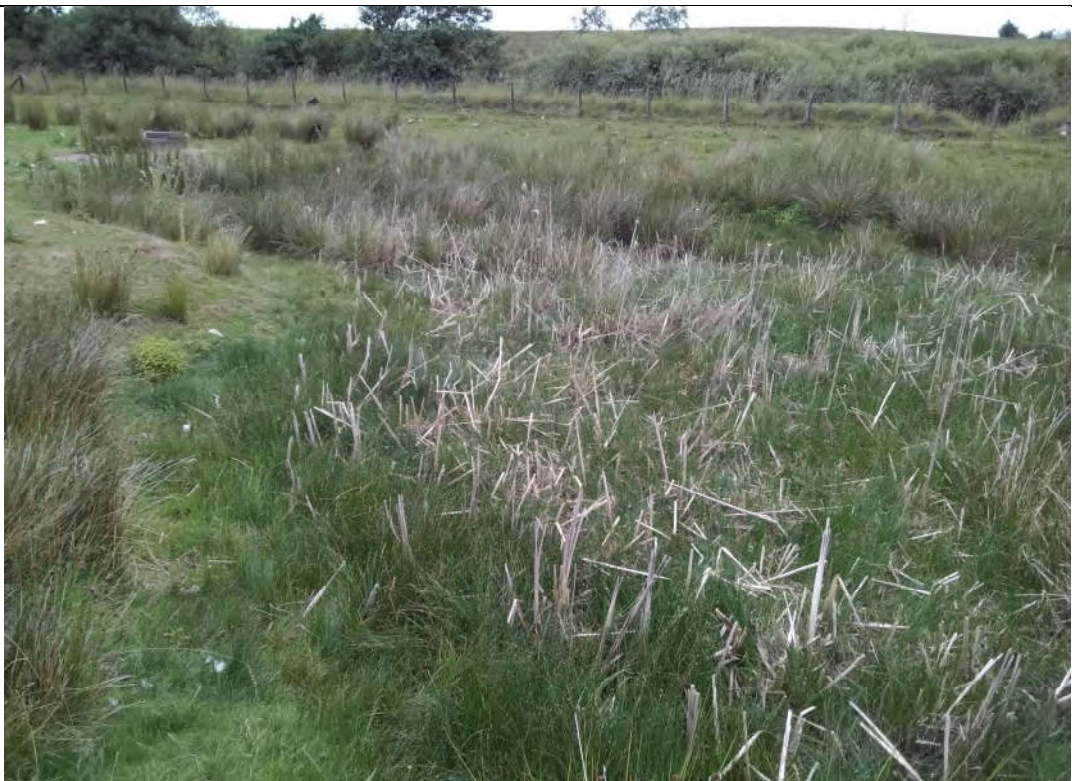
| <p><b>Photo No.</b><br/>SW-48 CE</p> | <p><b>Date:</b><br/>12 July 2022</p> | |

| <p><b>Surface Water Feature SW-48 CE:</b><br/>Lagoon dry, runoff from ditch, approximate dimensions 17m wide by 25m length.</p> | | |

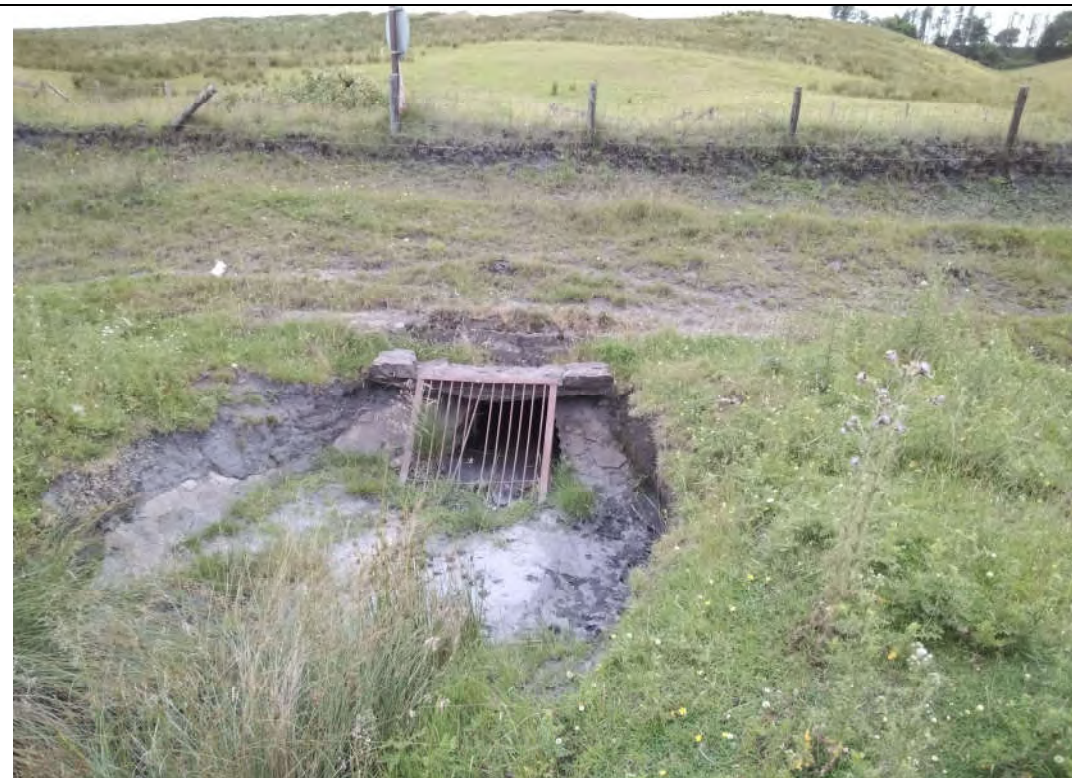
| <p><b>Photo No.</b><br/>SW-52 CE</p> | <p><b>Date:</b><br/>12 July 2022</p> | |

| <p><b>Surface Water Feature SW-52 CE:</b><br/>Surface Water (minor ditch), land drainage/runoff from adjacent restored and pastoral areas, no flow, no likely to be lined</p> | | |

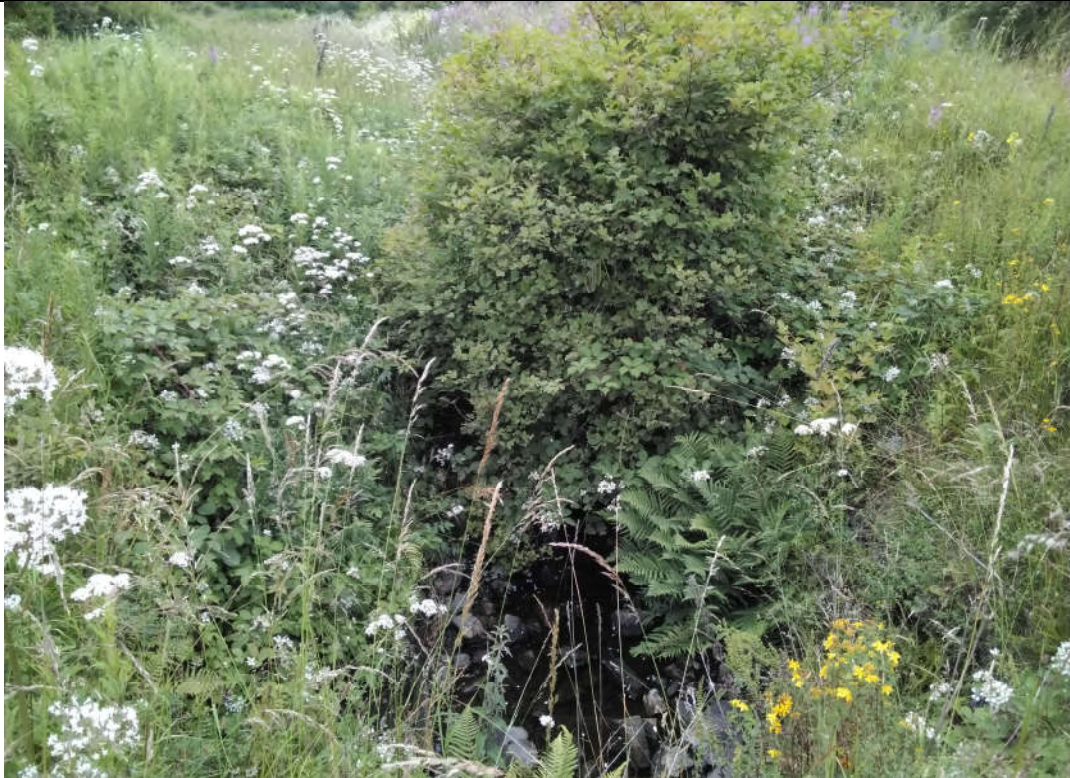
| Photo No. | Date: | |
|---|---|---|
| <b>Surface Water Feature SW-53 CE:</b><br>Surface Water (minor ditch), land drainage/runoff from adjacent restored and pastoral areas, no apparent flow, no likely to be lined. Parameters not taken due to H&S risks. | | |

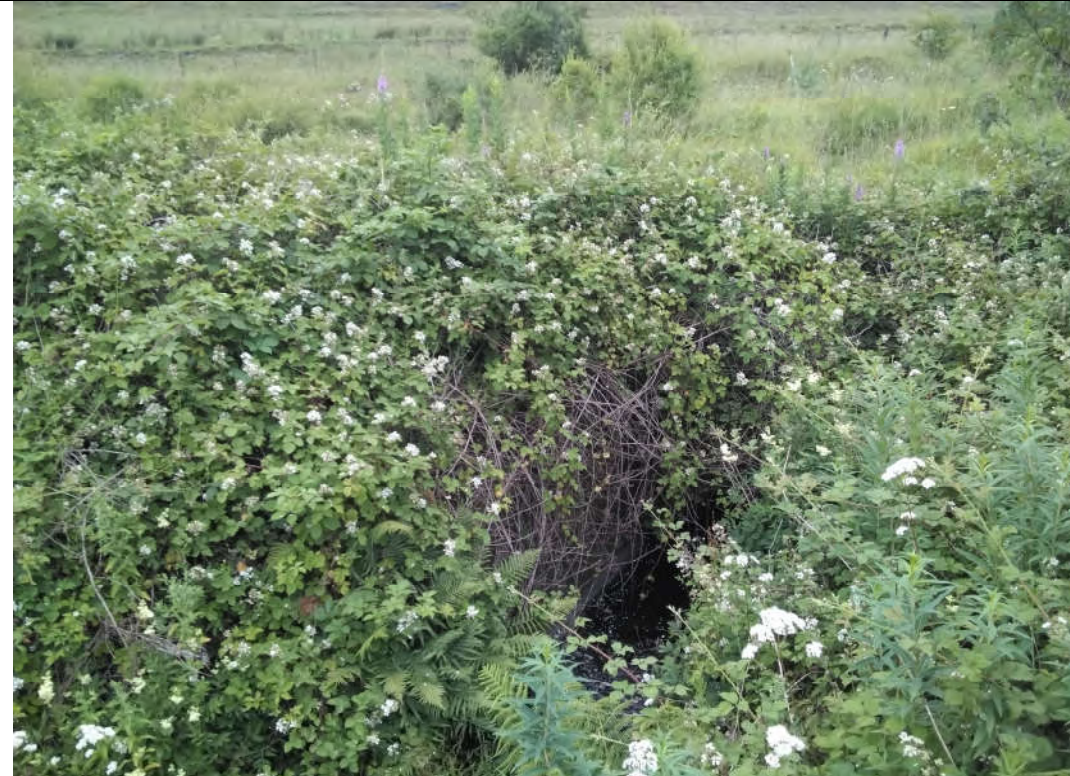
| Photo No. | Date: | |
|---|---|---|
| <b>Surface Water Feature SW-54 CE:</b><br>Surface Water (stream), land drainage/runoff from adjacent restored and pastoral areas and rainfall, flow noted, no likely to be lined. Parameters not taken due to H&S risks. | | |

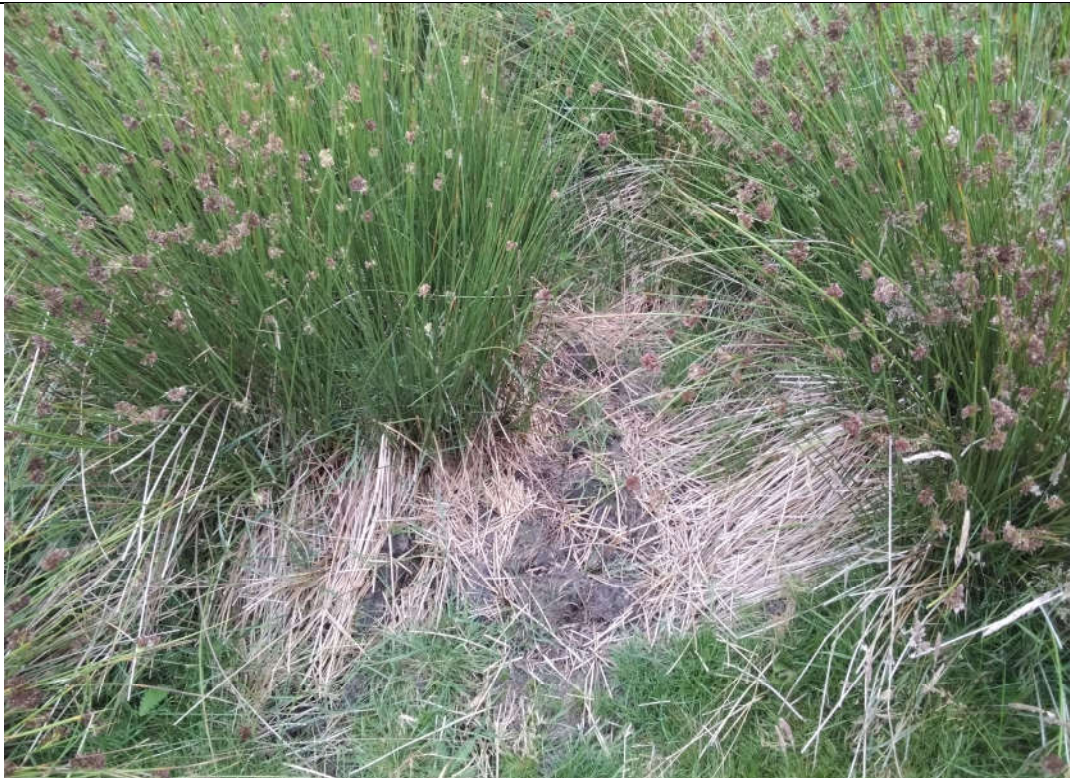
| Photo No. | Date: | |
|---|---|---|
| <b>Surface Water Feature SW-58 CE:</b><br>Marshy Land, rainfall/runoff.<br>Soil mostly dry, but occasional signs of moist soil. No water flowing observed at the time.<br>Approximate measurements 2m wide. | | |

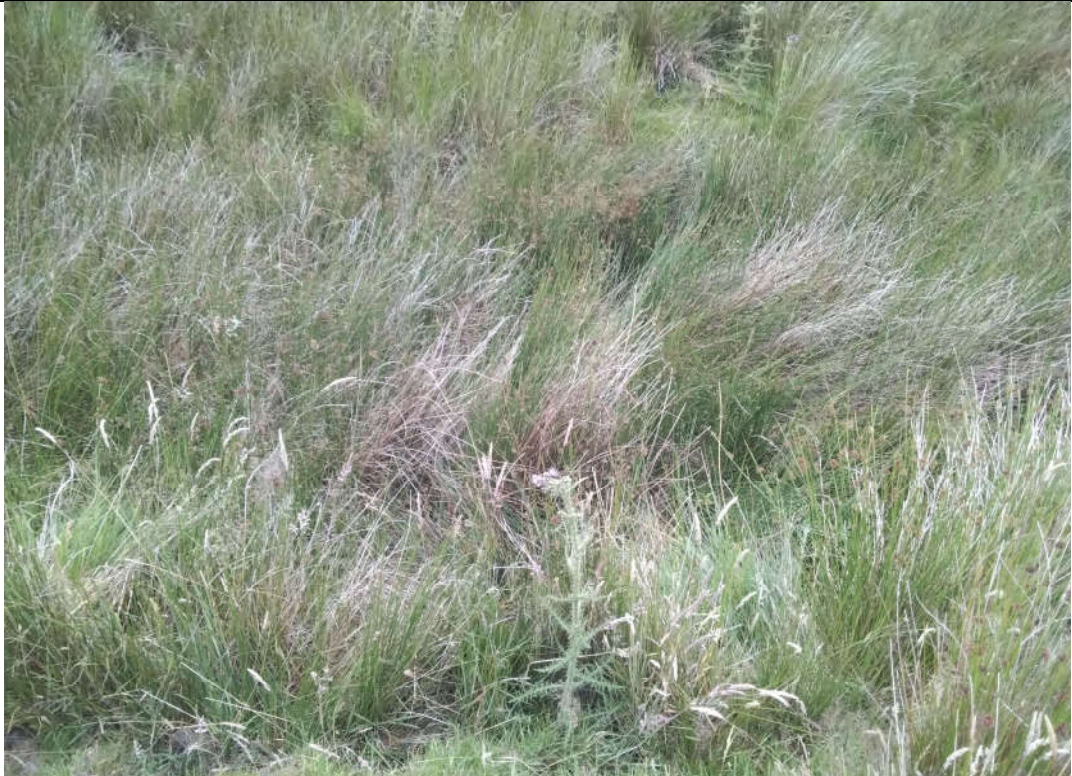
| Photo No. | Date: | |
|---|---|---|
| <b>Surface Water Feature SW-60 CE:</b><br>Surface Water (minor ditch), land drainage/runoff from adjacent restored and pastoral areas, dry, no likely to be lined. | | |

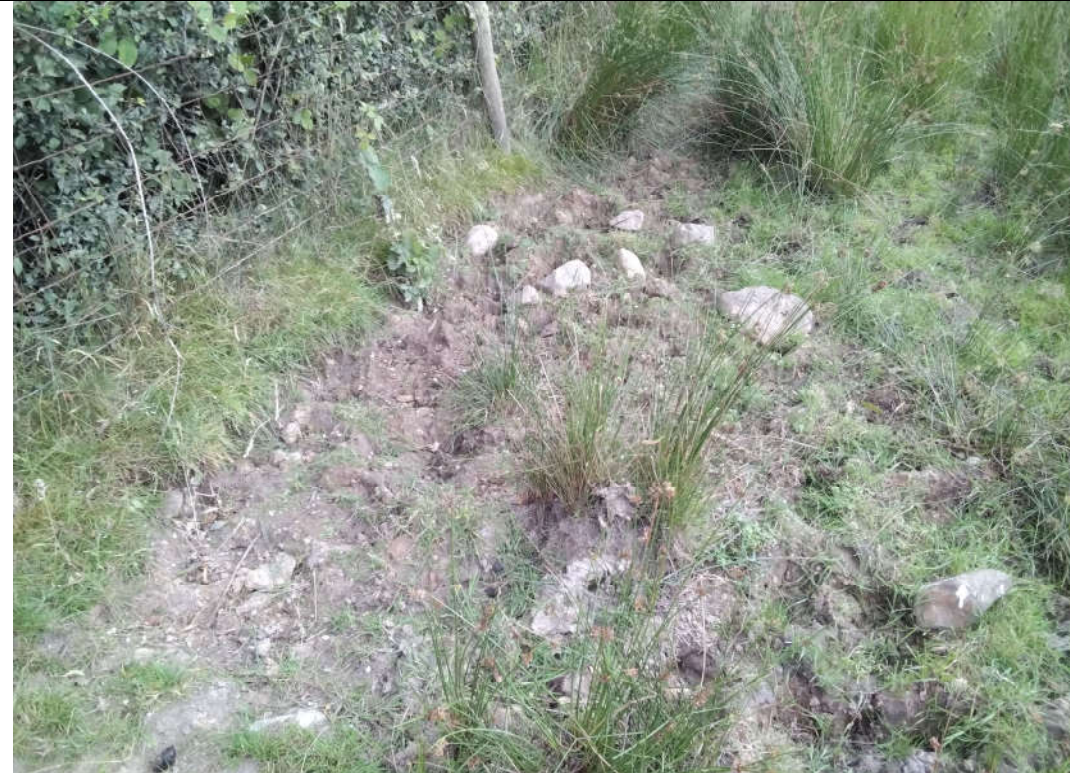
| Photo No. | Date: | |
|---|---|---|
| <b>Surface Water Feature SW-68 CE:</b><br>Marshy Land, rainfall/runoff. Soil mostly dry, but occasional signs of moist soil. No water flowing observed at the time. Approximate measurements 2m wide. | | |

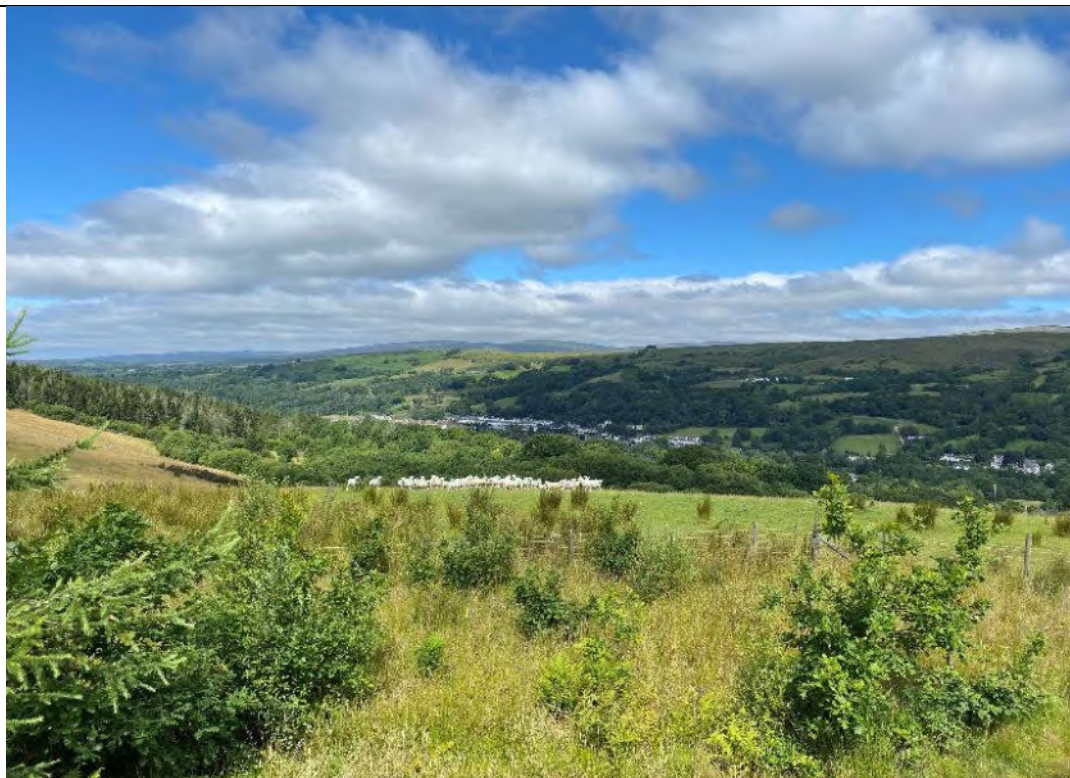
| <b>Photo No.</b><br>SW-01 DP | <b>Date:</b><br>12 July<br>2022 | |

| <b>Offsite View</b><br><br>View of northern site and land offsite.<br><br>The photograph aspect is north. | | |
