**Client Name: Global Centre of Rail Excellence**

**Site: GCRE (Onllywyn Washery)**

**Project No. 5209796**

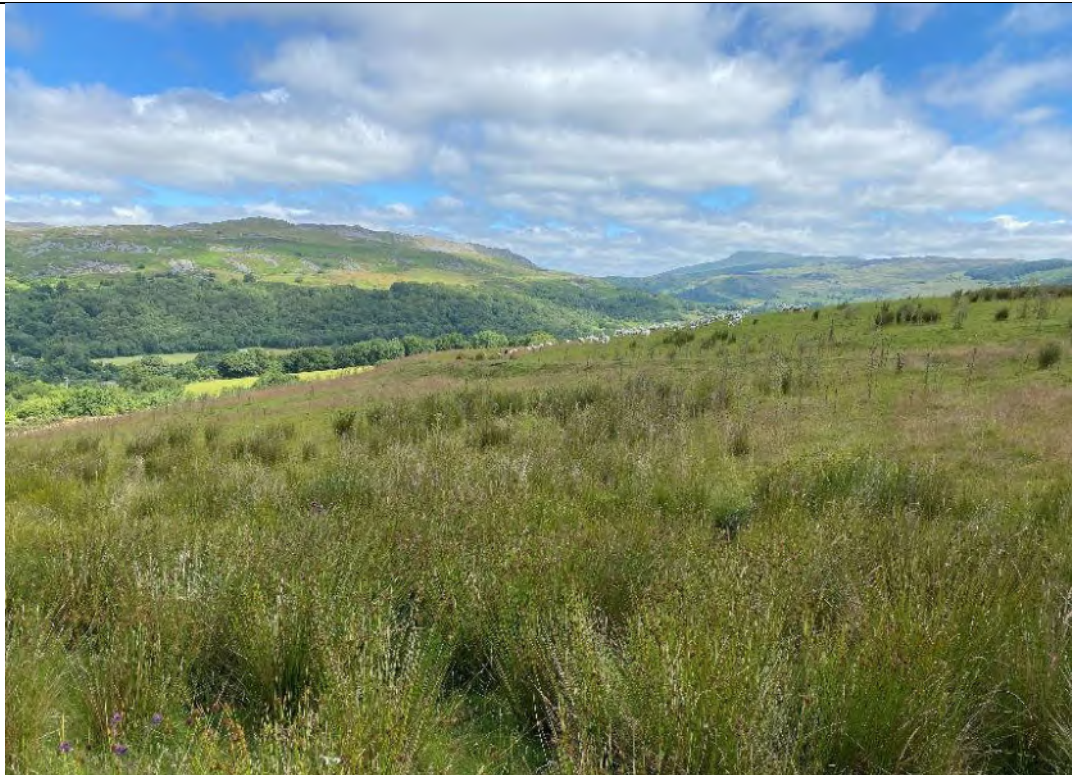
| <b>Photo No.</b><br>SW-01 CE | <b>Date:</b><br>12 July<br>2022 | |

| <b>Relict Colliery Structure</b><br><br>View of topographic change associated with former colliery use.<br><br>The photograph aspect is north. | | |

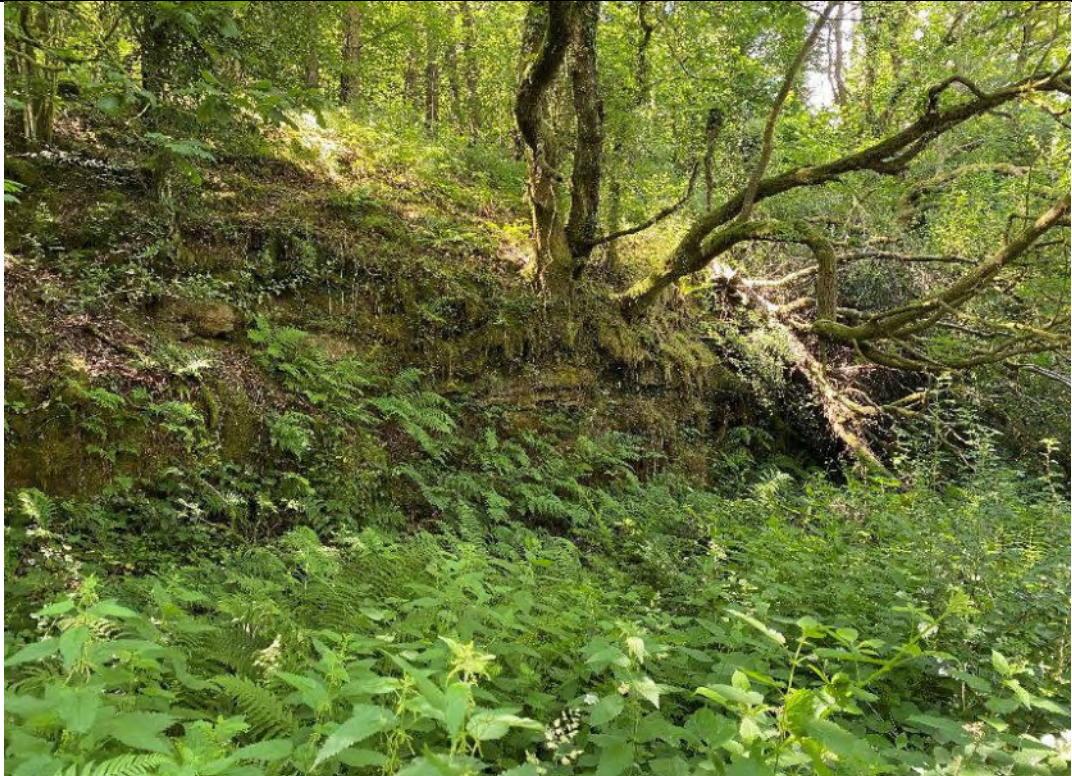
| Photo No.<br>SW-01 CE | Date:<br>12 July<br>2022 | |
|---|---|---|
| <b>Plant Crossing</b><br><br>View excavation into bedrock on northern boundary of site.<br><br>The photograph aspect is south-west. | | |

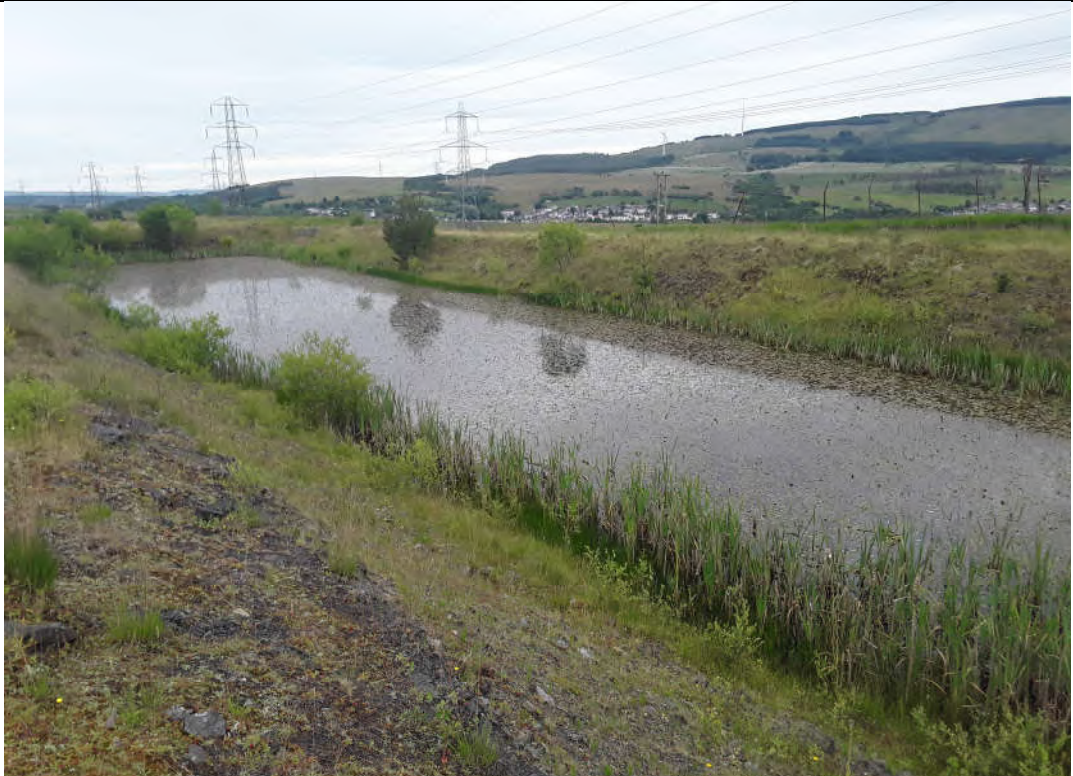
| <b>Surface Water Feature SW-01 DP:</b><br>Lagoon, water storage area, probably lined with low permeability material, drainage/runoff from restoration area. No water flowing observed at the time. Spillway (SW-02 DP connected to north-eastern corner via culvert. Approximate measurements 10m wide, 70m length. Measurements DO 150.81%, ORP 178.6 mV, Cond 136.84 ms/cm, pH 8.07, T22.17C<br>The photo aspect is east. | | |

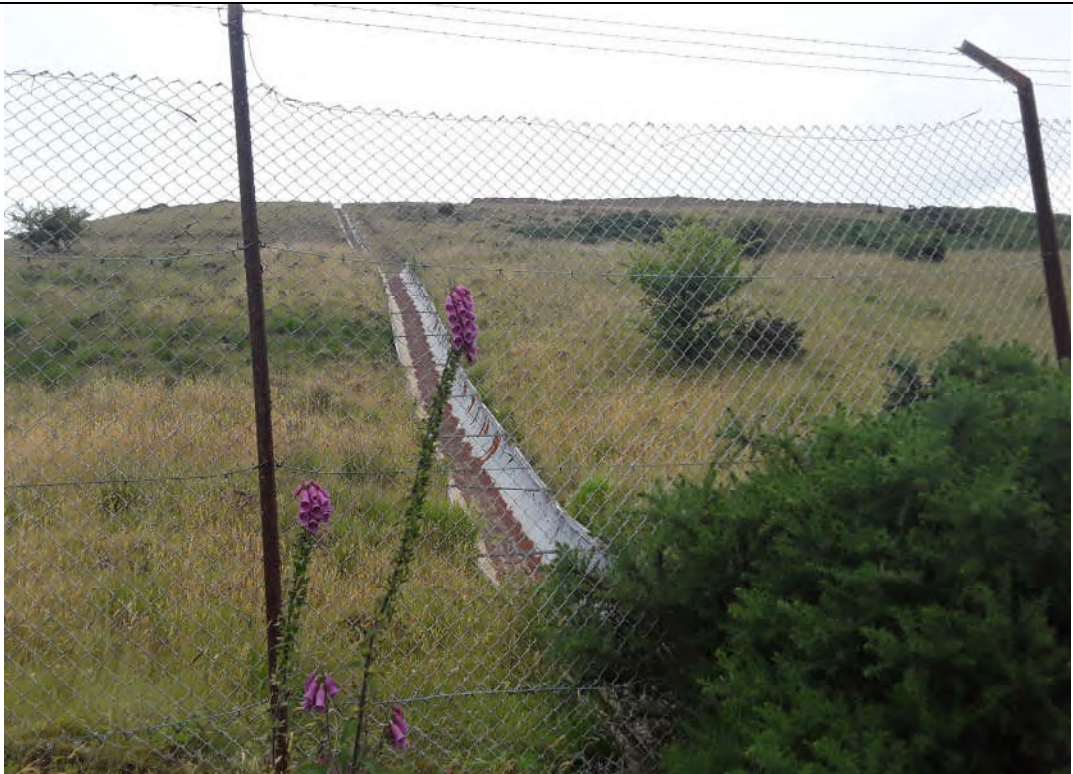
| <b>Surface Water Feature SW-02 DP:</b><br>Spillway chute orientated north to south from the top of the overburden to the lagoon (SW01-DP). No water flowing observed at the time. Constructed of metal. Joins to concrete culvert before reaching lagoon. Rusty base. Approximate measurements 170m length, 0.4m deep, 1.4m wide.<br>The photo aspect is north. | | |

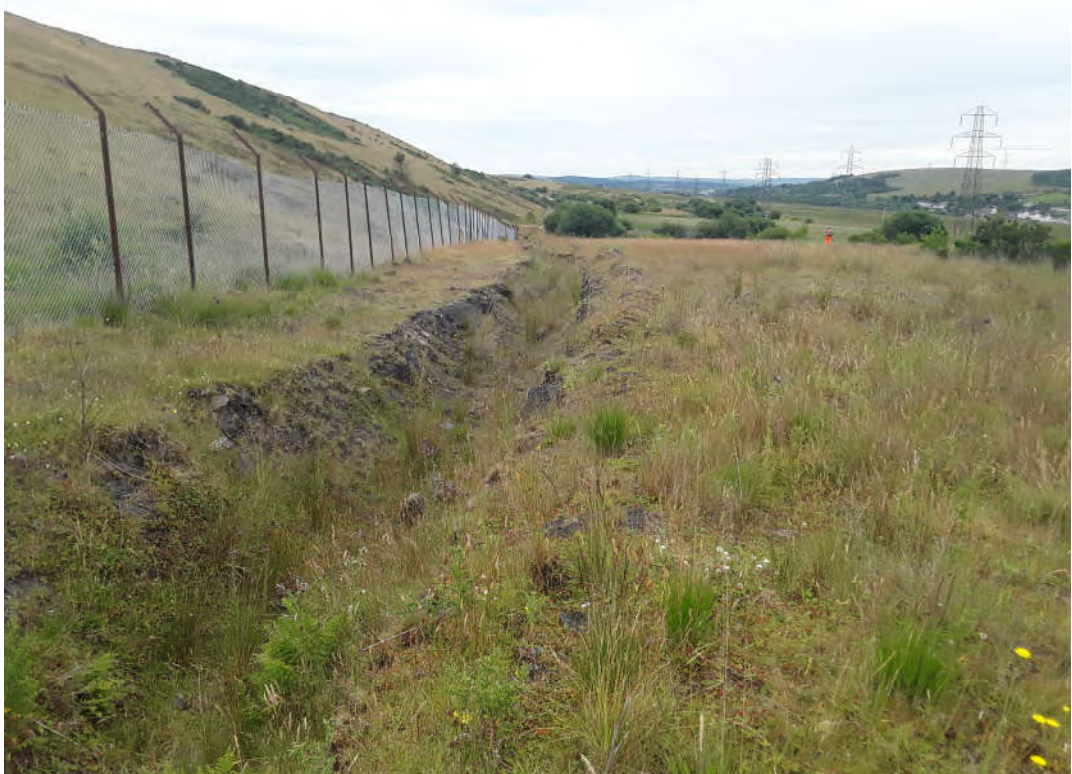
| Photo No. | Date: | |
|---|---|---|
| <b>Surface Water Feature SW-03 DP:</b><br>Overflow ditch connected to spillway chute (SW02-DP) orientated east to west along the entire length of the overburden. No water flowing observed at the time. Vegetated at base along entire length. Approximate measurements 650m length, 1.4m deep, 3.0 m wide. The photo aspect is east | | |

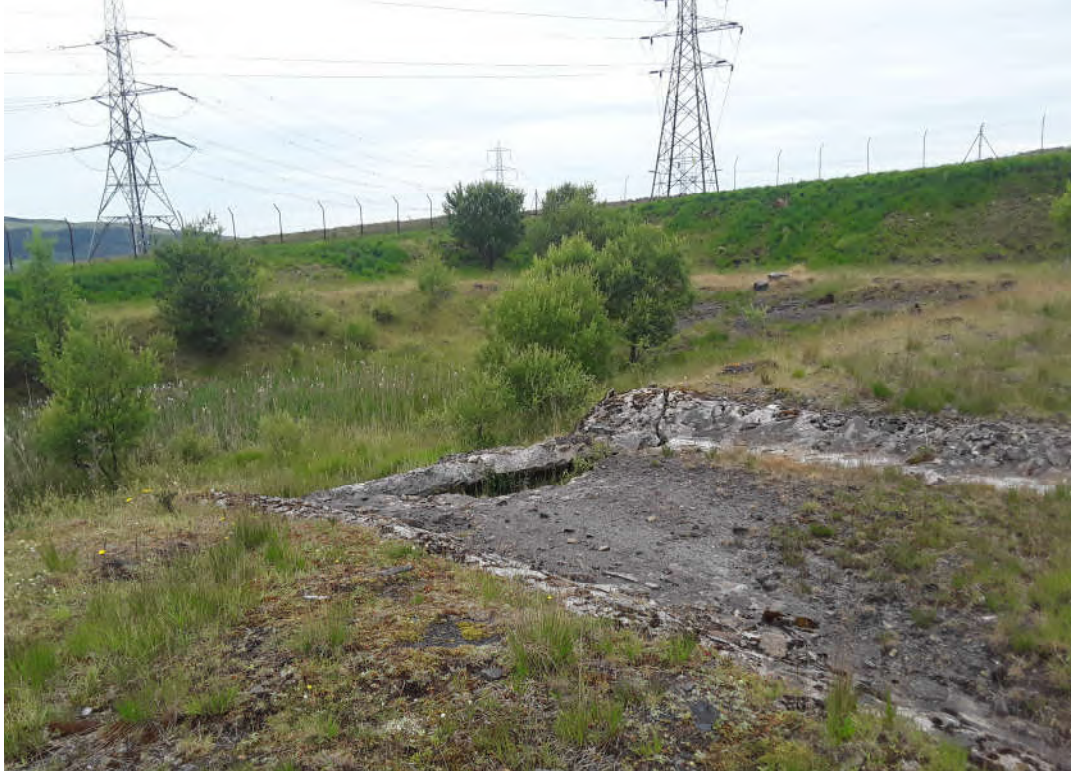
| Photo No. | Date: | |
|---|---|---|
| <b>Surface Water Feature SW-04 DP:</b><br>Concrete culvert at base of spillway chute (SW-02-DP). Poor condition. No water flowing observed at the time. Approximate measurements 0.5m deep, 4.0 m wide. The photo aspect is east | | |

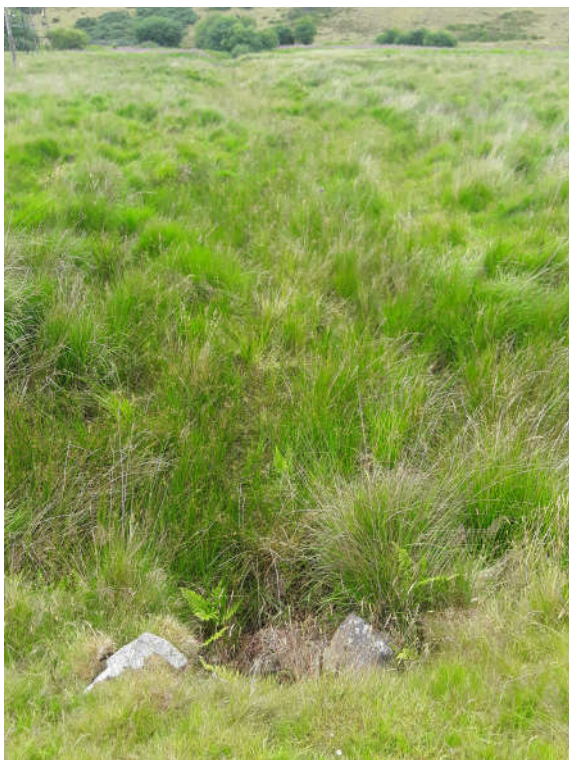
| <b>Surface Water Feature<br/>SW-05 DP:</b><br>Grassy ditch exiting from metal pipe orientated north to south below a grassed bank. Abundant rocks.<br>No water flowing observed at the time.<br>Vegetated at base along entire length.<br>Approximate measurements 650m length, 1.2m deep from the surface, 35.0 m wide.<br>The photo aspect is north | | |

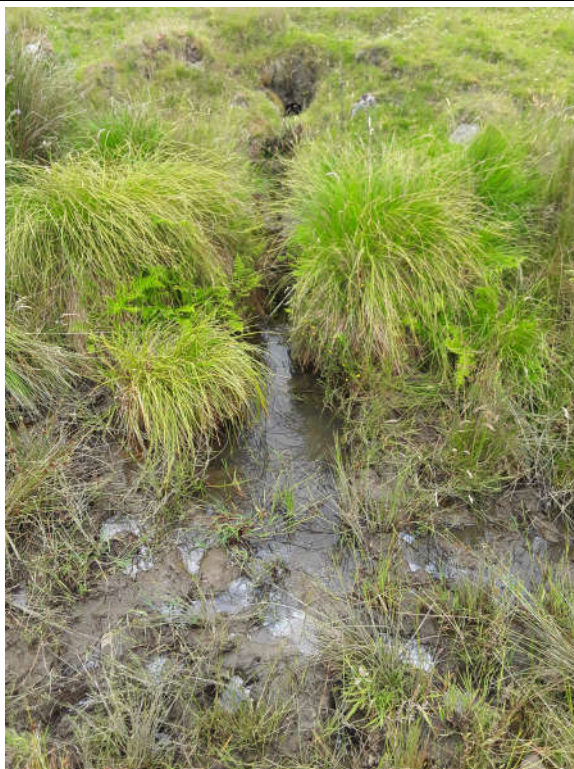
| <b>Surface Water Feature<br/>SW-06 DP:</b><br>Grassy ditch exiting from the south of the gassed bank and ditch (SW05-DP) . This channel extends east to west along the access track along the south of the site. Stagnant water not observed to be flowing. Slight sheen on water from sheep/agriculture. Approximate measurements 0.25 m deep water.<br>The photo aspect is north. Measurements DO 45.51%, ORP 87.60 mV, Cond 666.01 ms/cm, pH 7.26, T20.132C | | |

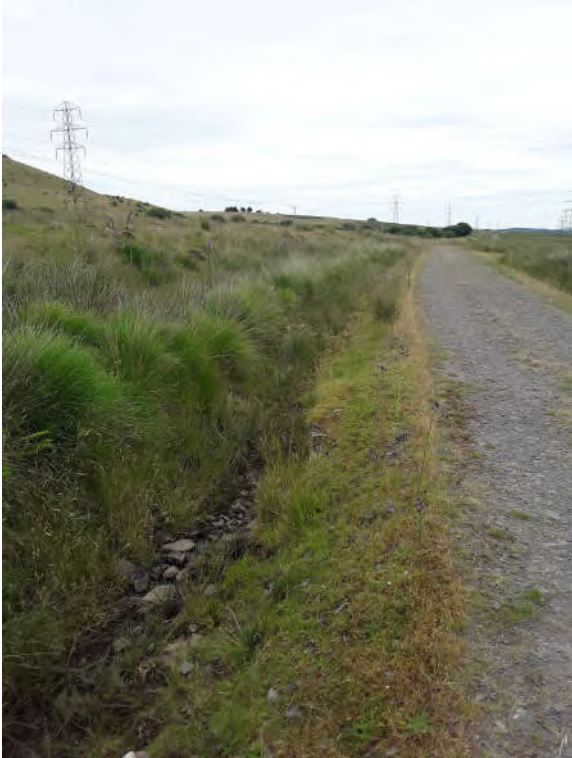
| Photo No.<br>SW-07 DP | Date:<br>12 July<br>2022 | |
|---|---|---|
| <b>Surface Water Feature SW-07 DP:</b><br>Grassed ditch extending east to west along the northern boundary of the access track in the south of the site. Abundant rocks. Multiple ditches to the north feed into this ditch.<br>No water flowing observed at the time.<br>Vegetated at base along entire length. Stagnant standing water in places. Approximate measurements 1.1km length, 1.0m deep from the surface, 2.0 m wide. The photo aspect is east. | | |

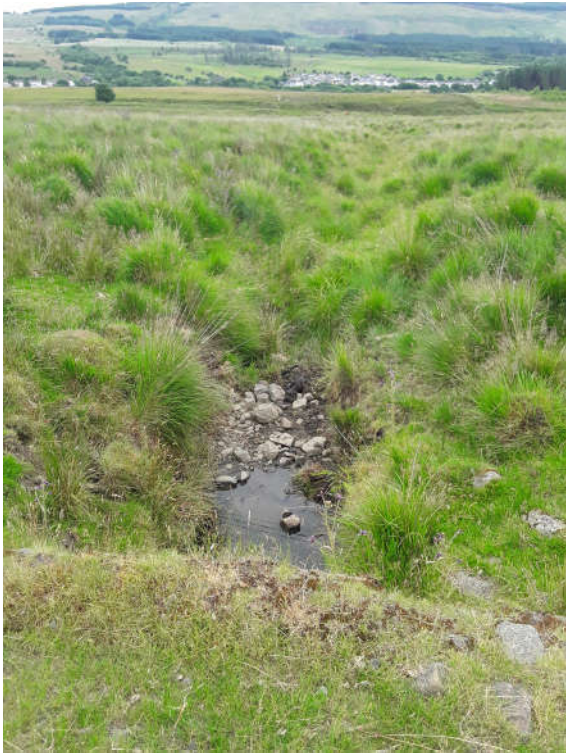
| Photo No.<br>SW-08 DP | Date:<br>12 July<br>2022 | |
|---|---|---|
| <b>Surface Water Feature SW-08 DP:</b><br>Grassed ditch extending south from the access road.<br>No water flowing observed at the time.<br>Stagnant standing water. Becomes vegetated along ditch. Tributary of Nany Ystalwyn, 250m south. Approximate measurements 250m length, 1.0m deep 2.0 m wide. The photo aspect is south. | | |

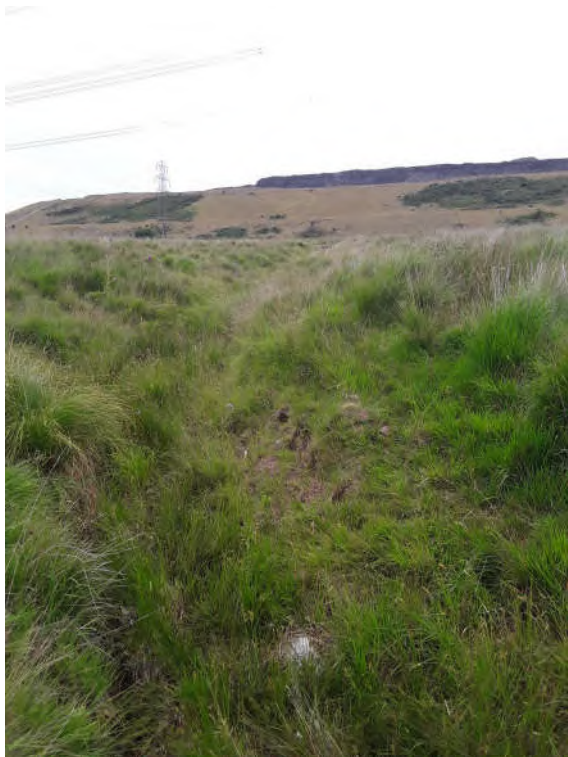
| Photo No.<br>SW-09 DP | Date:<br>12 July<br>2022 | |
|---|---|---|
| <b>Surface Water Feature SW-09 DP:</b><br>Continuation of grassed ditch extending south from SW-08 DP.<br>No water flowing observed at the time.<br>The photo aspect is south. | | |

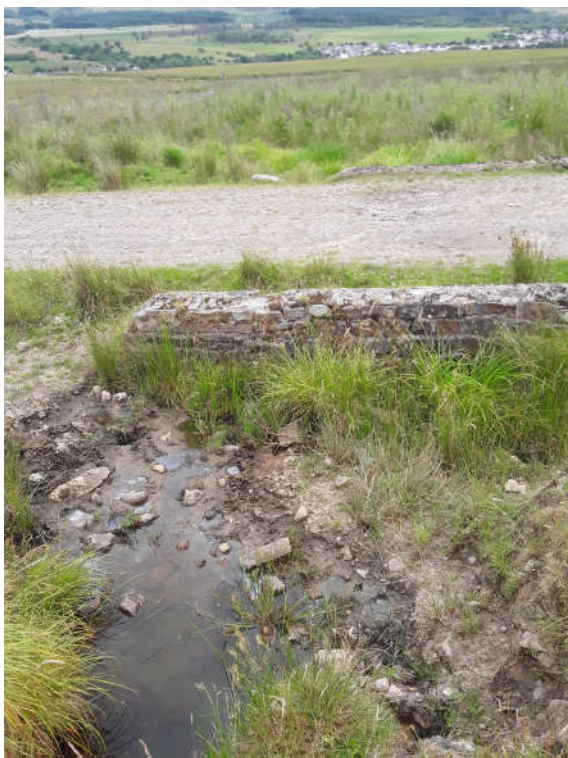
| Photo No.<br>SW-10 DP | Date:<br>12 July<br>2022 | |
|---|---|---|
| <b>Surface Water Feature SW-10 DP:</b><br>Grassed ditch orientated north to south joining the east to west ditch along the northern boundary of the access track.<br>No water flowing observed at the time.<br>Stagnant standing water.<br>Vegetated along ditch to the north.<br>The photo aspect is south. | | |

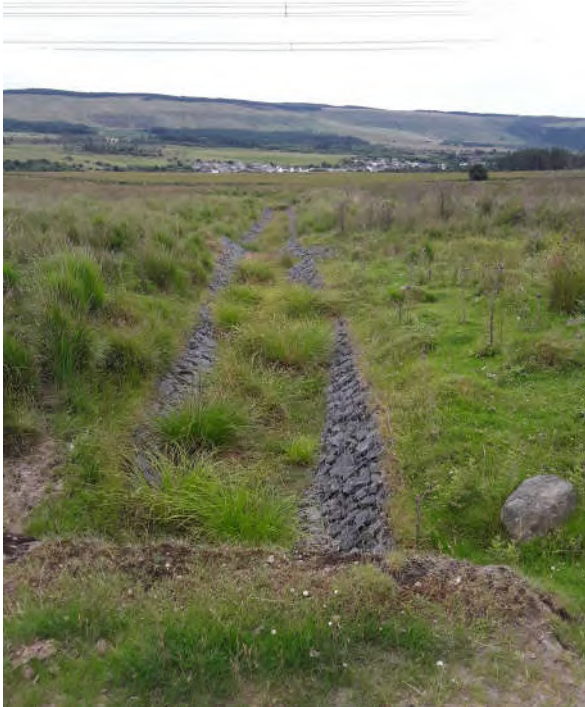
| Photo No.<br>SW-11 DP | Date:<br>12 July<br>2022 | |
|---|---|---|
| <b>Surface Water Feature SW-11 DP:</b><br>Stone lined ditch extending south from access track.<br>No water flowing observed at the time.<br>Vegetated at base along entire length.<br>Approximate measurements 70m length, 1.0m 2.0 m wide.<br>The photo aspect is south. | | |

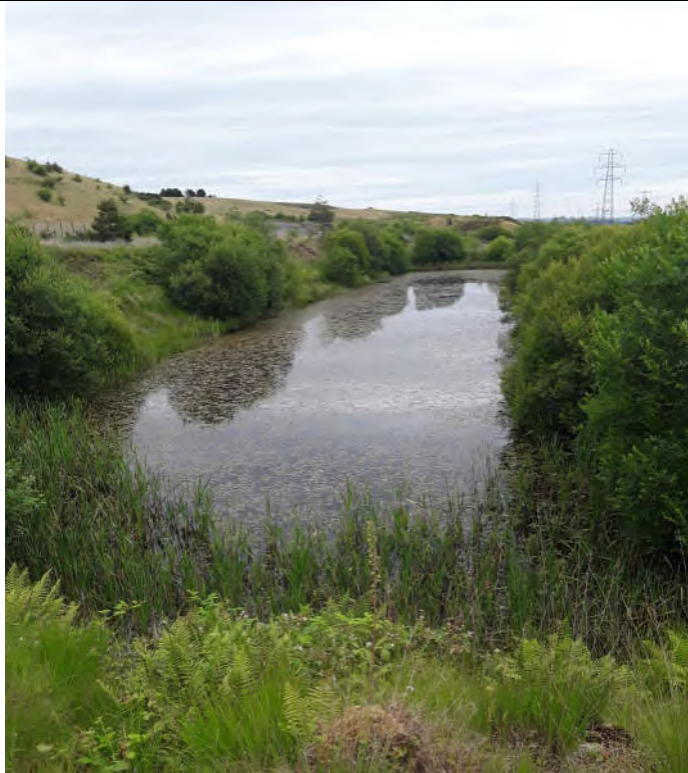
| Photo No.<br>SW-12 DP | Date:<br>12 July<br>2022 | |
|---|---|---|
| <b>Surface Water Feature SW-12 DP:</b><br>Lagoon, water storage area, probably lined with low permeability material, drainage/runoff from restoration area.<br>No water flowing observed at the time.<br>Approximate measurements 10m wide, 100m length.<br>Not accessible for water parameter measurements.<br>The photo aspect is east. | | |
