**Client Name:** Global Centre of Rail Excellence

**Site:** GCRE (Main Site)

**Project No.**  
5209796

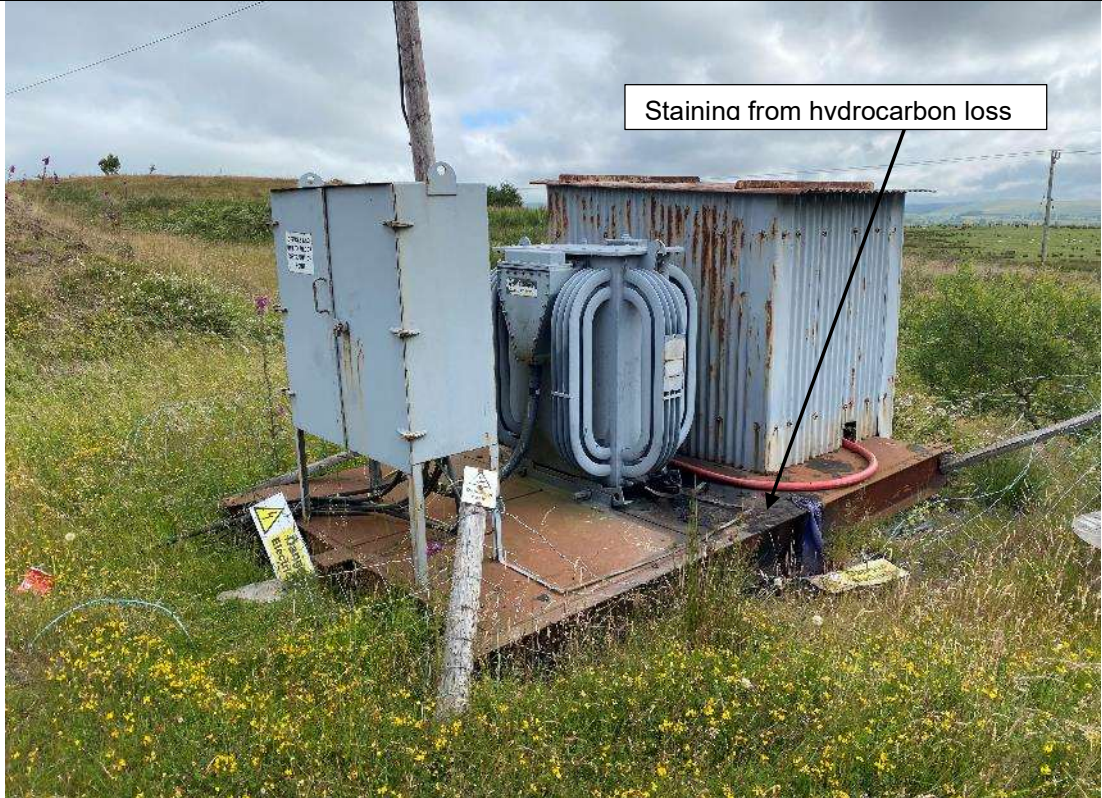
| <b>Photo No.</b><br>95 | <b>Date:</b><br>6 July 2022 | |

| <b>Electrical Substation (064)</b><br><br>Heavy staining on soils to front of transformer. Evidence of hydrocarbon leakage visible on concrete plinth.<br><br>The photograph aspect is north-east. | | |

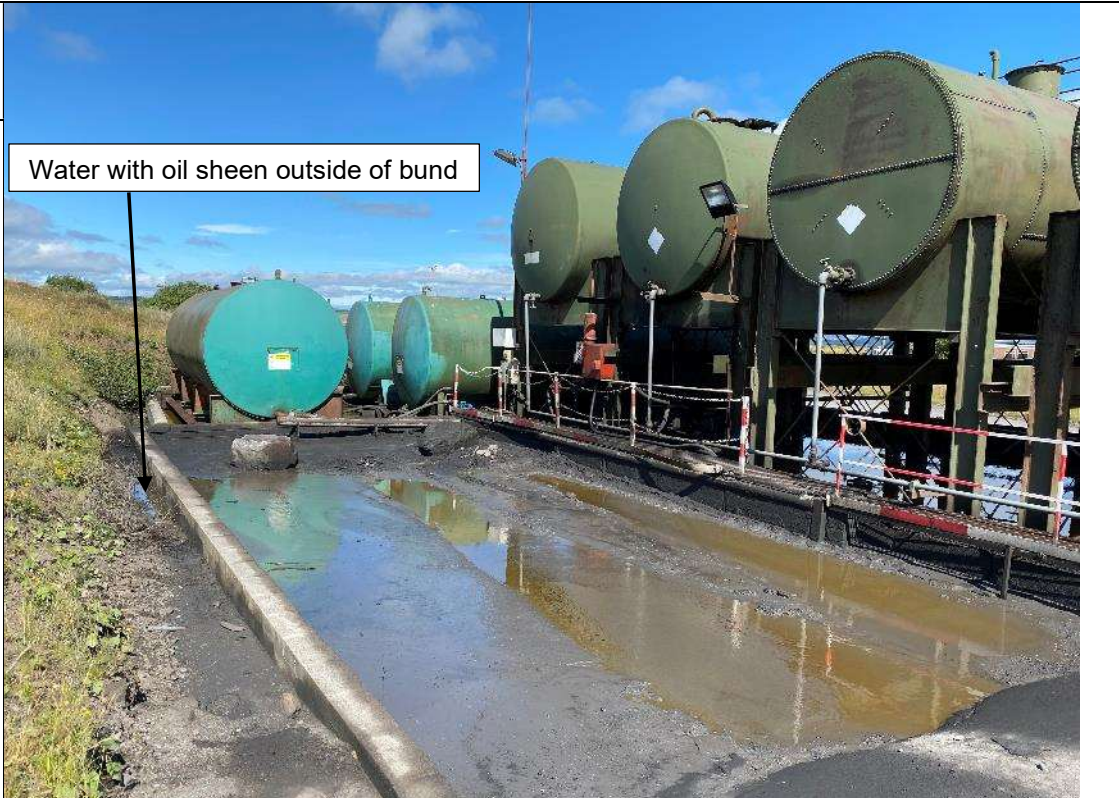
| <b>AST (056)</b><br><br>View to rear of AST and bunded area used for fuelling. Oil / water mixture outside of containment to left of photo suggests bund is not water tight.<br><br>The photograph aspect is east. | | |

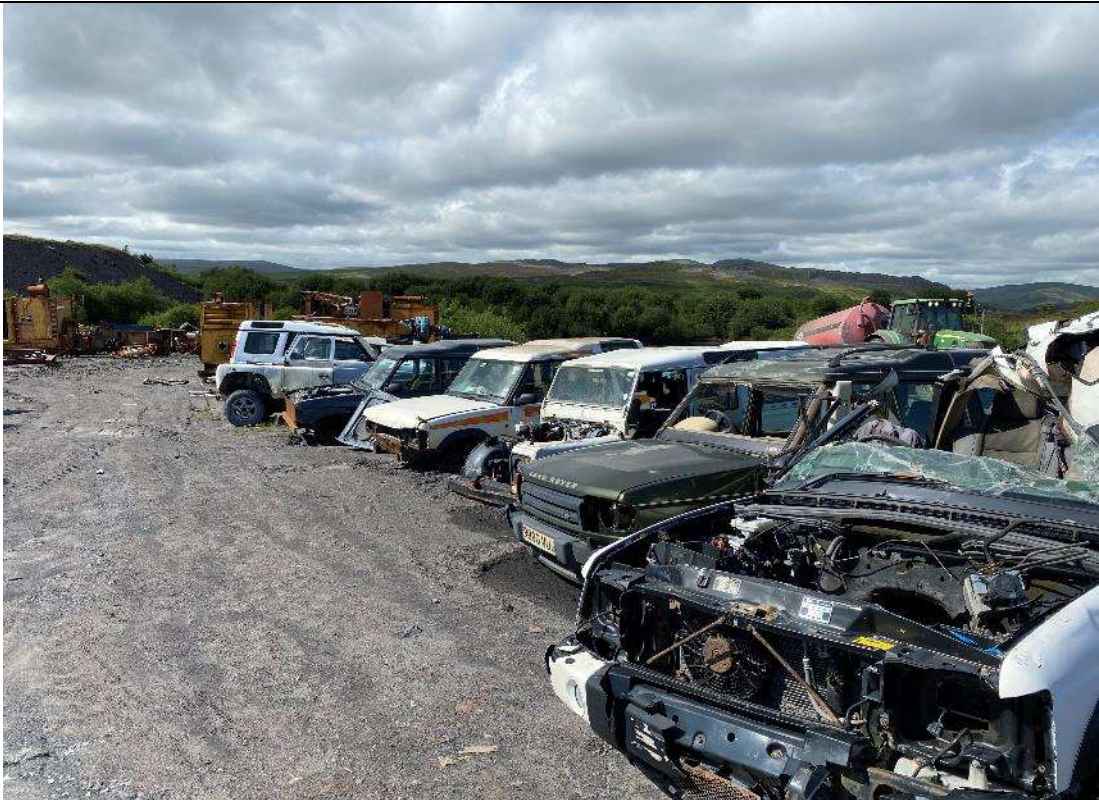
| <b>Photo No.</b><br>107 | <b>Date:</b><br>6 July 2022 | |

| <b>Scrap Yard (060) Area</b><br><br>View of stripped and abandoned 4x4s and other plant. Oils stains and leaking fluids from vehicle visible.<br><br>Aspect to the north-west. | | |

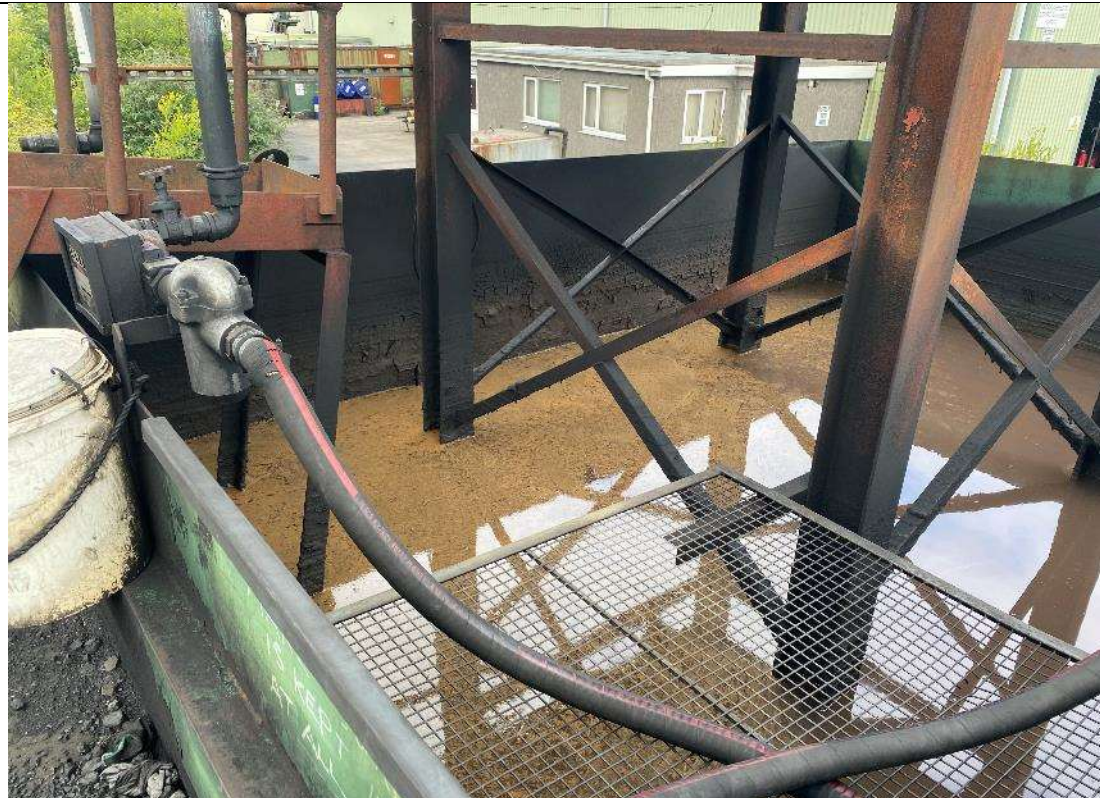
| <b>Photo No.</b><br>2 | <b>Date:</b><br>6 July 2022 | |

| <b>Fuel Storage (001)</b><br><br>View of AST bund<br><br>Bund holds mix of water and fuel. Light cracking of concrete surrounding tank base and light staining.<br><br>The photograph aspect is north-west. | | |
