**Client Name:** Global Centre of Rail Excellence

**Site:** GCRE (Onllywyn Washery)

**Project No.**  
5209796

Washery - CLAH Walkover Photograph Location Plan

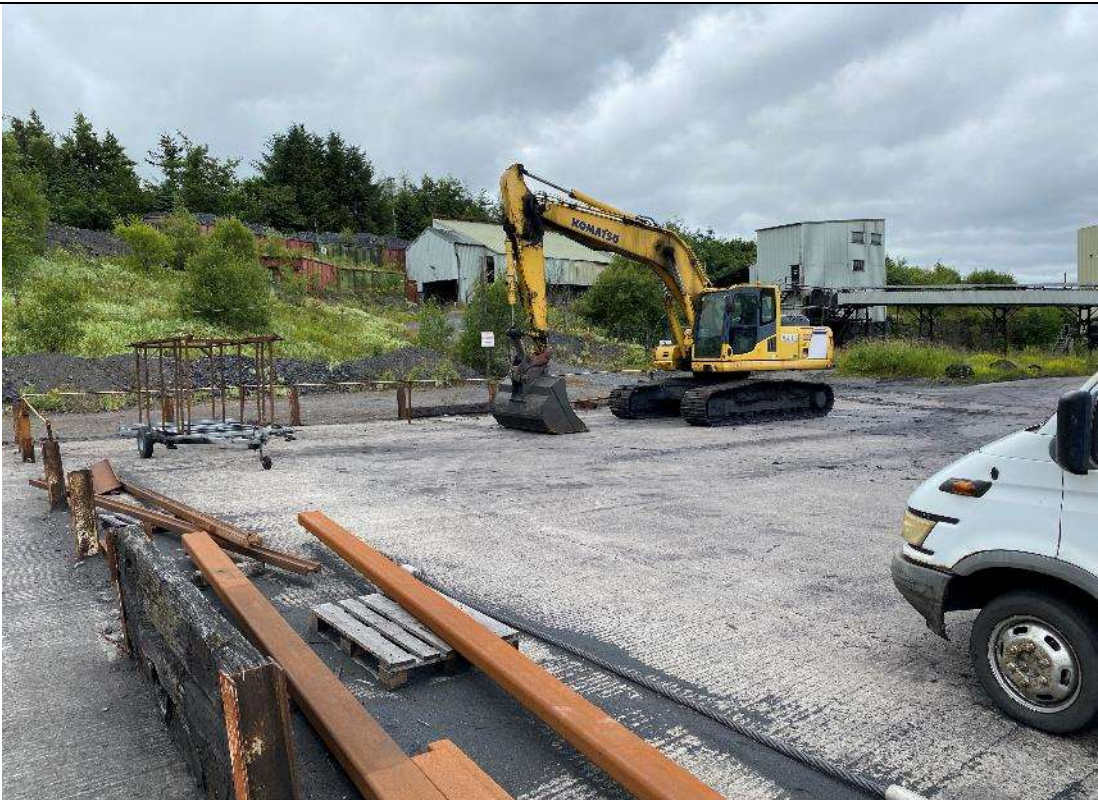
| <p><b>Photo No.</b><br/>26</p> | <p><b>Date:</b><br/>6 July 2022</p> | |

| <p><b>Washery</b></p> <p>View of yard area to west of workshop.</p> <p>Photo aspect is west.</p> | | |

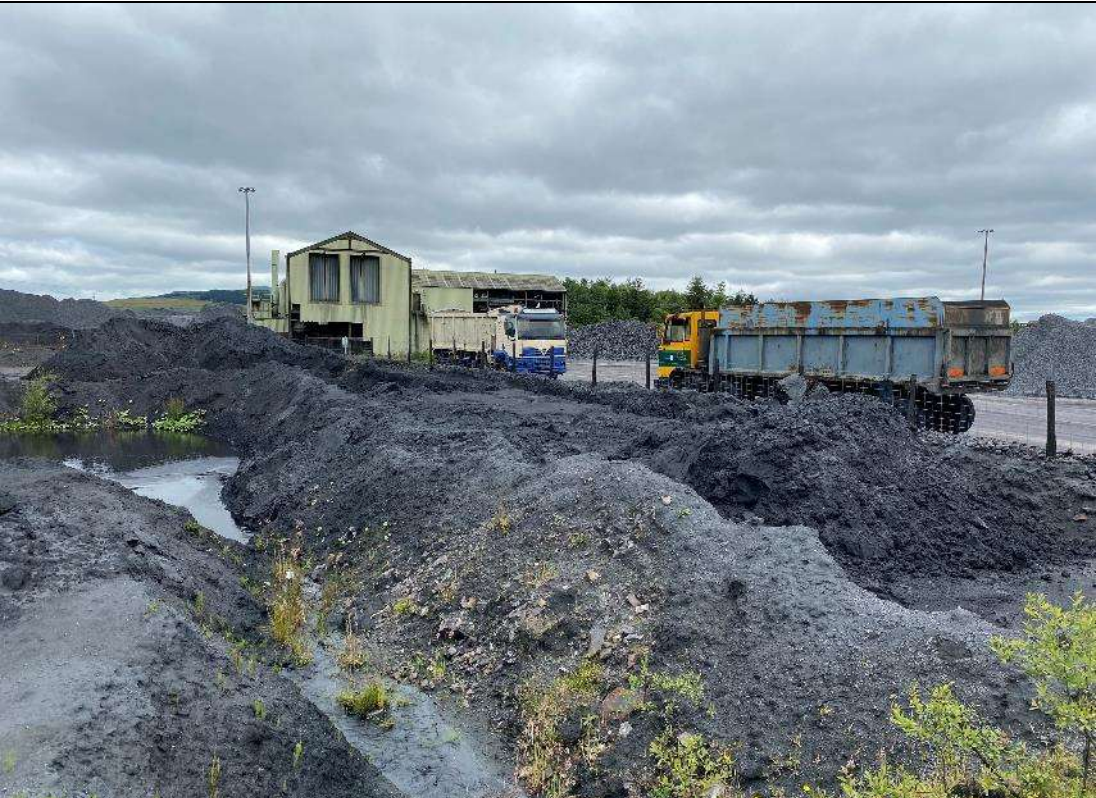
| <b>Photo No.</b><br>29 | <b>Date:</b><br>6 July 2022 | |

| <b>Washery</b><br><br>Stockpiled coal and lagoons (015).<br><br>The photograph aspect is north. | | |

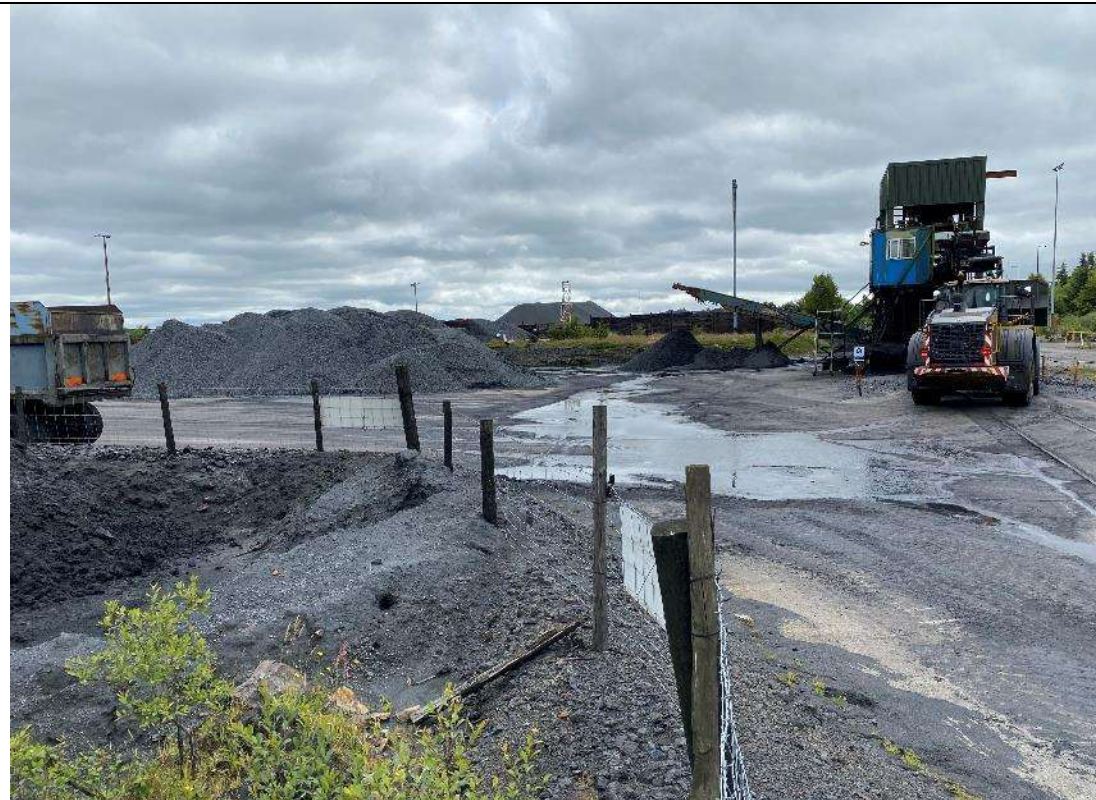
| <b>Photo No.</b><br>30 | <b>Date:</b><br>6 July 2022 | |

| <b>Washery</b><br><br>View of screening machinery (017) and stockpiled coal (016).<br><br>The photograph aspect is east. | | |

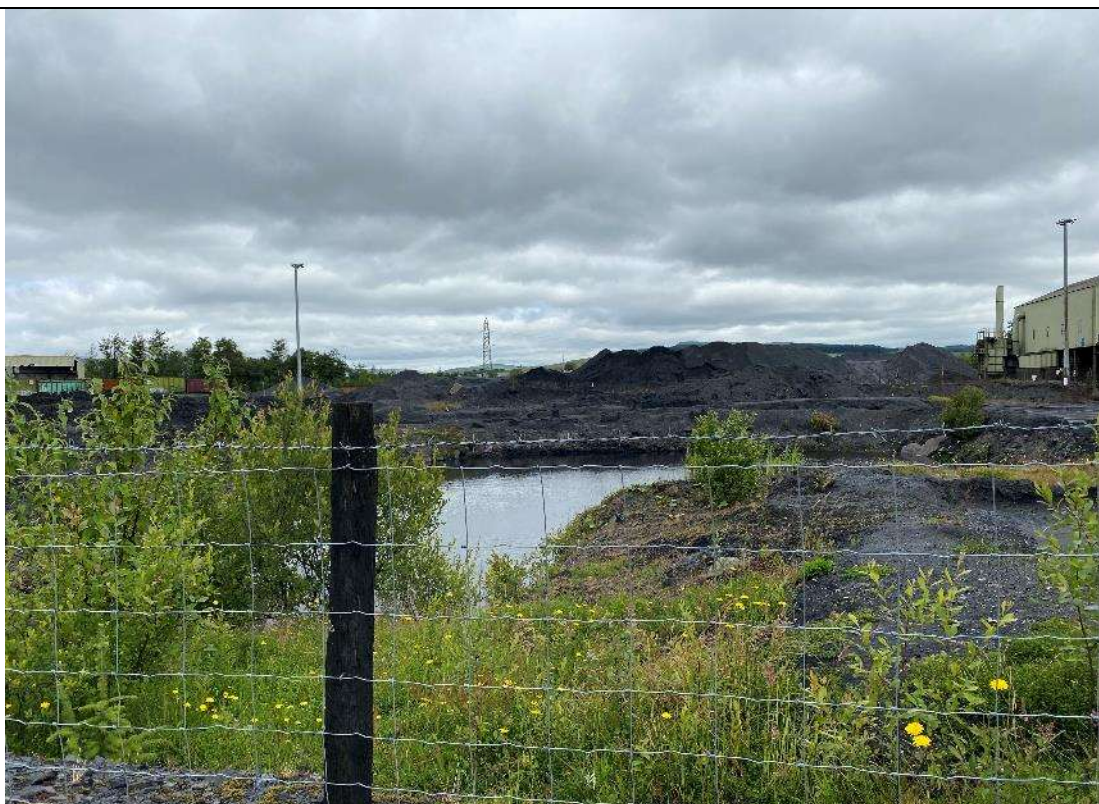
| <b>Photo No.</b><br>31 | <b>Date:</b><br>6 July 2022 | |

| <b>Lagoon (015)</b><br><br>View of the lagoon and stockpiled coal beyond.<br><br>The photograph aspect is north. | | |

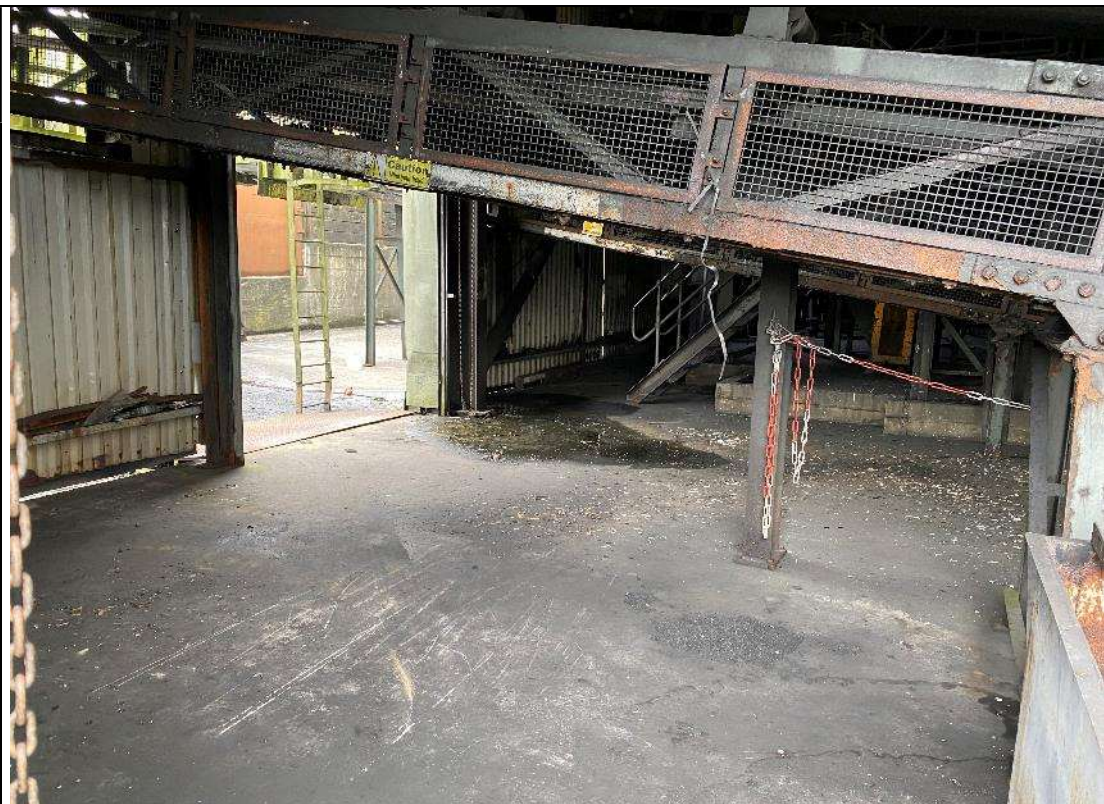
**Client Name: Global Centre of  
Rail Excellence**
**Site: GCRE (Onllywyn Washery)**
**Project No.  
5209796**
**Photo No.**  
33

**Washery Structure  
(014)**

View of interior of  
structure 014, no entry  
inside due to lone  
working restrictions.

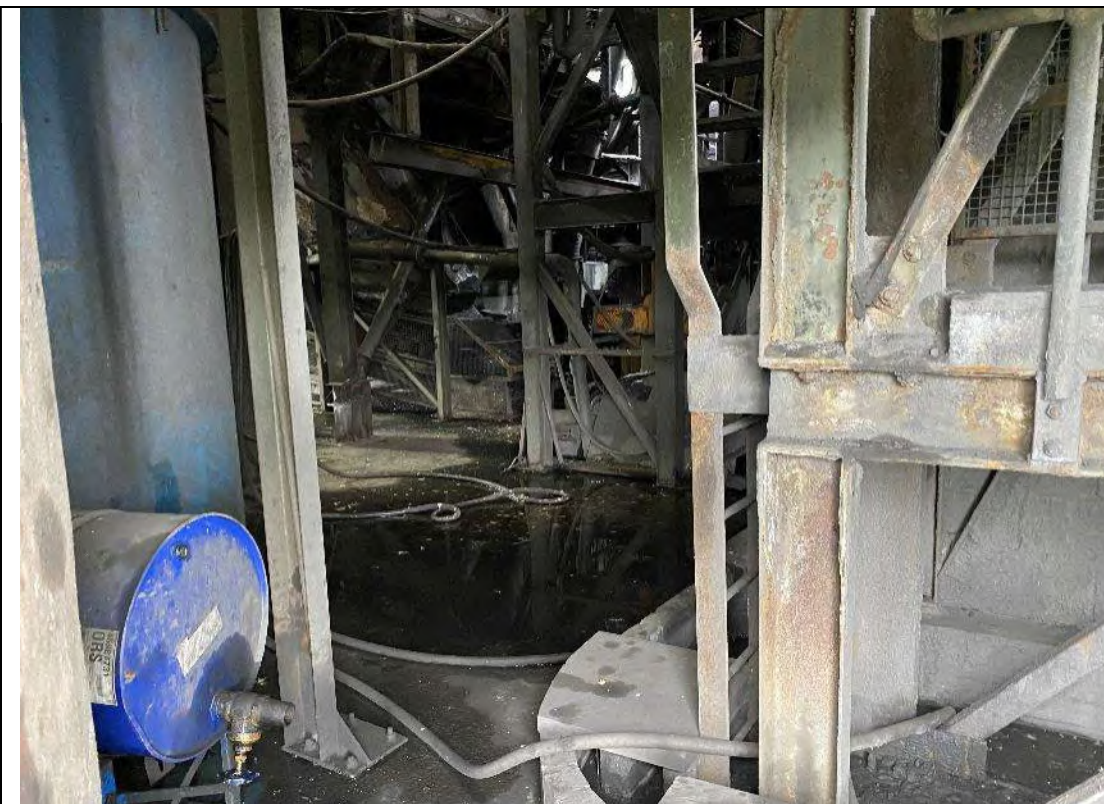
**Photo No.**  
34

**Washery Structure  
(014)**

View of interior of  
structure 014, no entry  
inside due to lone  
working restrictions.

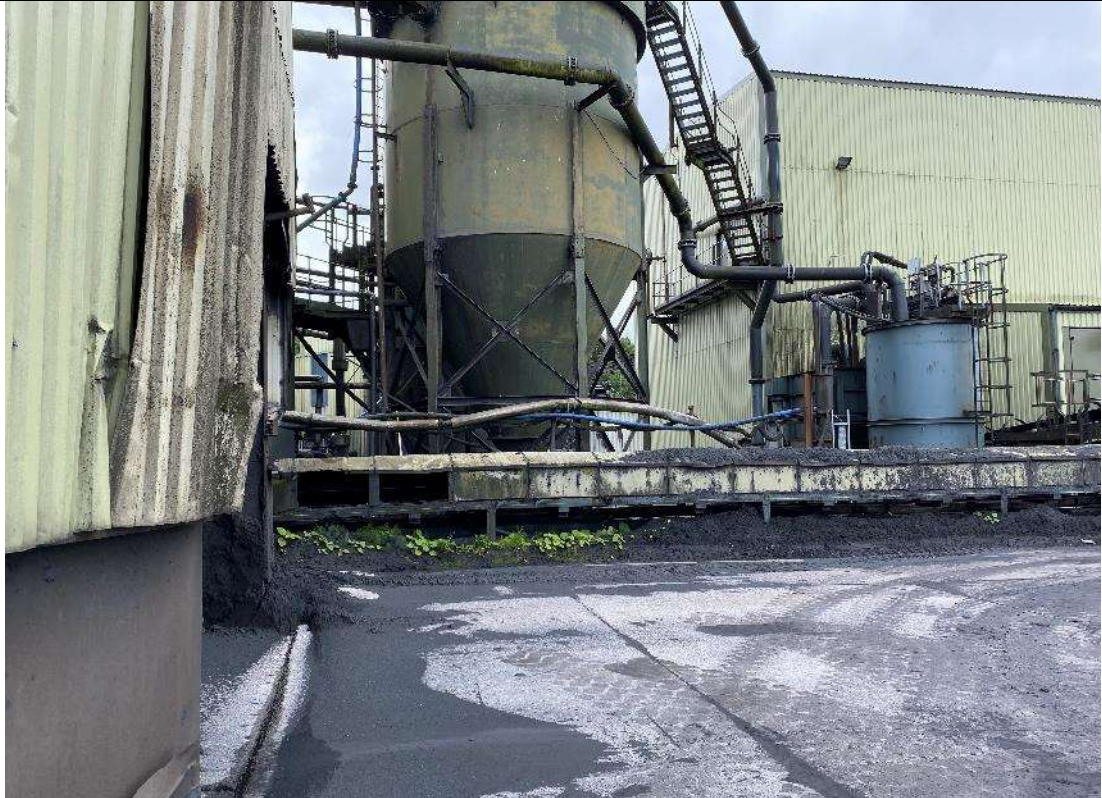
| <b>Photo No.</b><br>35 | <b>Date:</b><br>6 July 2022 | |

| <b>Washery Structure (018)</b><br><br>View of AST tanks, believed to hold water.<br><br>The photograph aspect is south. | | |

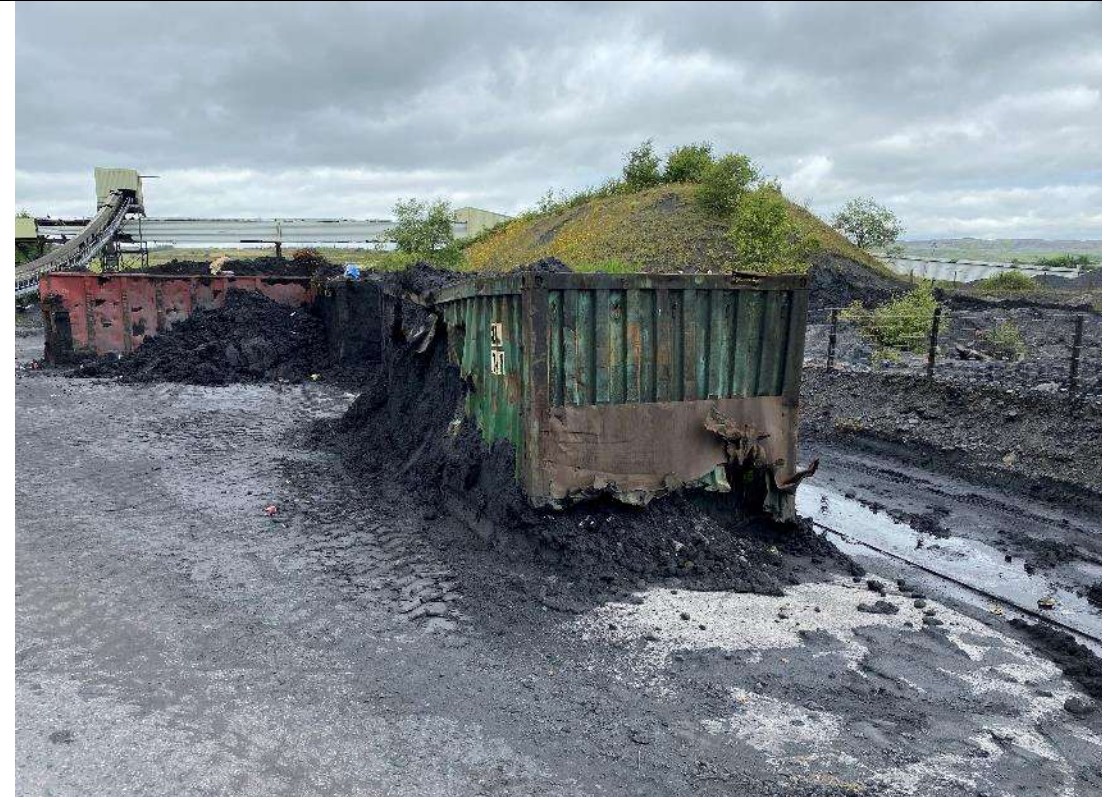
| <b>Photo No.</b><br>36 | <b>Date:</b><br>6 July 2022 | |

| <b>Washery Structure (019)</b><br><br>View of skips / shipping containers holding waste coal.<br><br>The photograph aspect is west. | | |

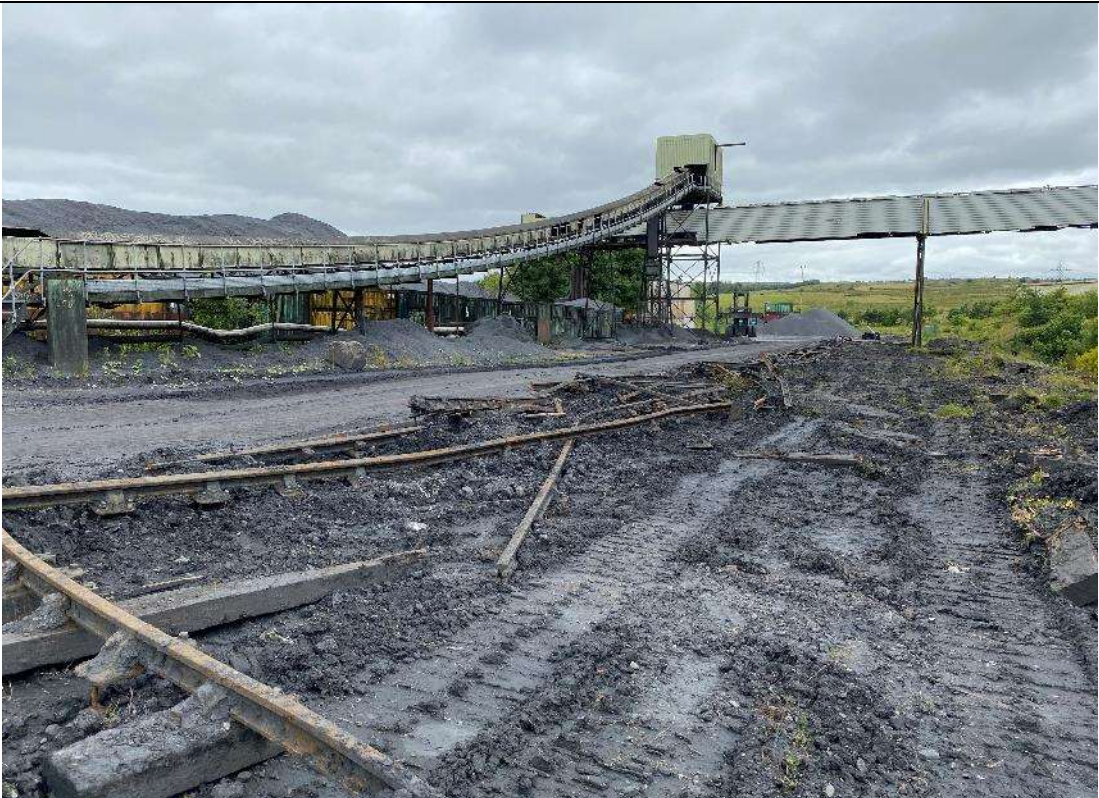
| <b>Conveyor Belt (020)<br/>and former railway line<br/>(021)</b><br><br>View of conveyor belt systems used to transfer washed coal to stockpiles / load trains.<br><br>Areas of former railway track in process of being grubbed up to right.<br><br>The photograph aspect is west. | | |

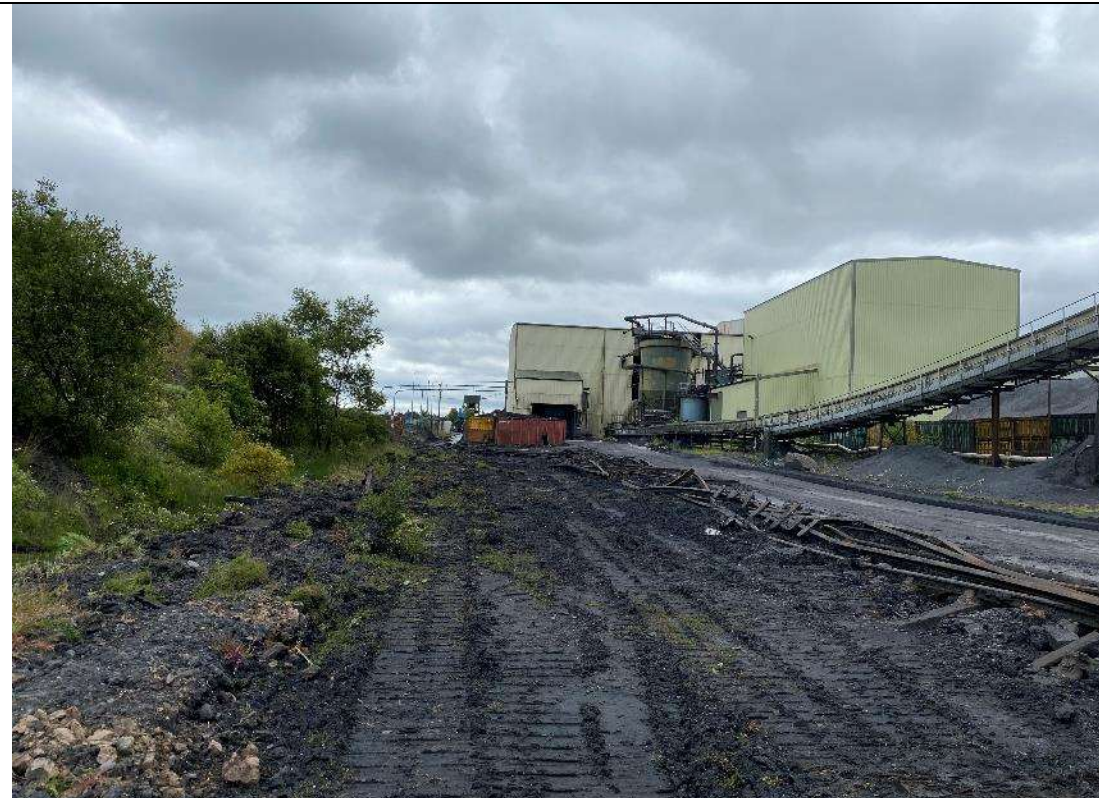
| <b>Photo No.</b><br>38 | <b>Date:</b><br>6 July 2022 | |

| <b>Washery (014)</b><br><br>View of washery building conveyor belt (020) and former area of railway track (021). Stockpile of unknown material to left.<br><br>The photograph aspect is east. | | |

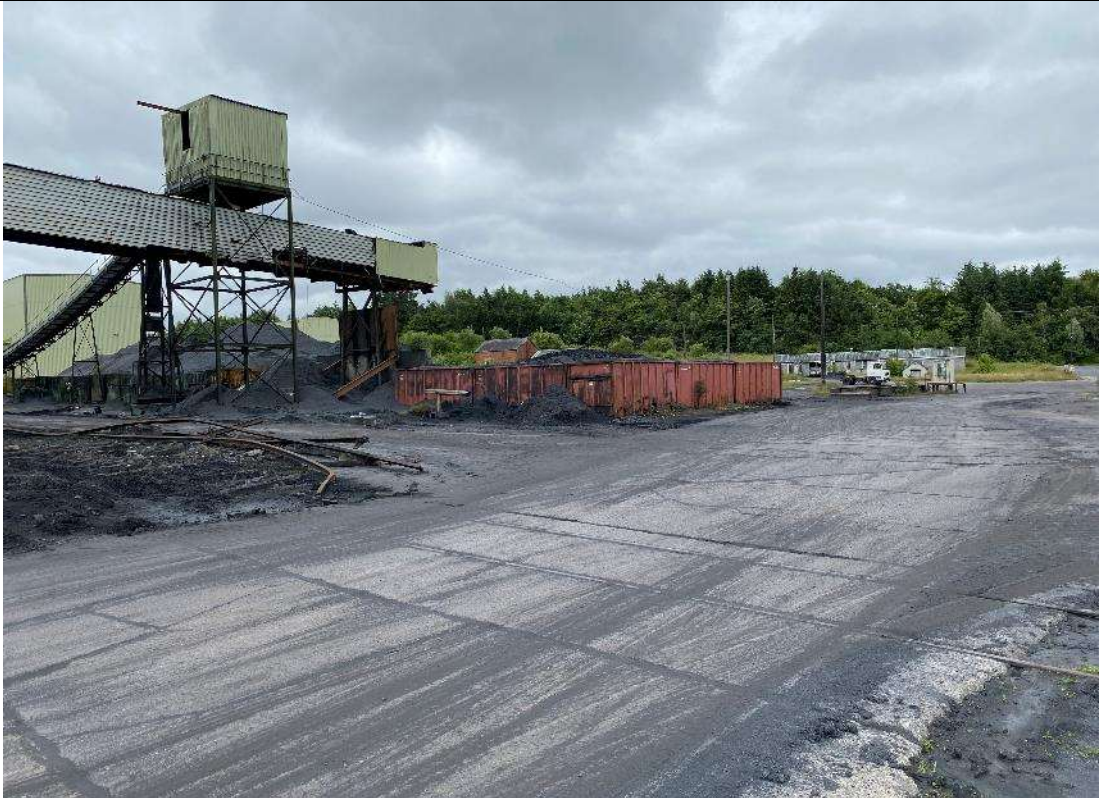
| <b>Photo No.</b><br>39 | <b>Date:</b><br>6 July 2022 | |

| <b>Washery Structures</b><br><br>View of conveyor belt from building 014 connecting with additional conveyor. Railway tracks (021) crossing concrete road way in foreground.<br><br>The photograph aspect is east. | | |

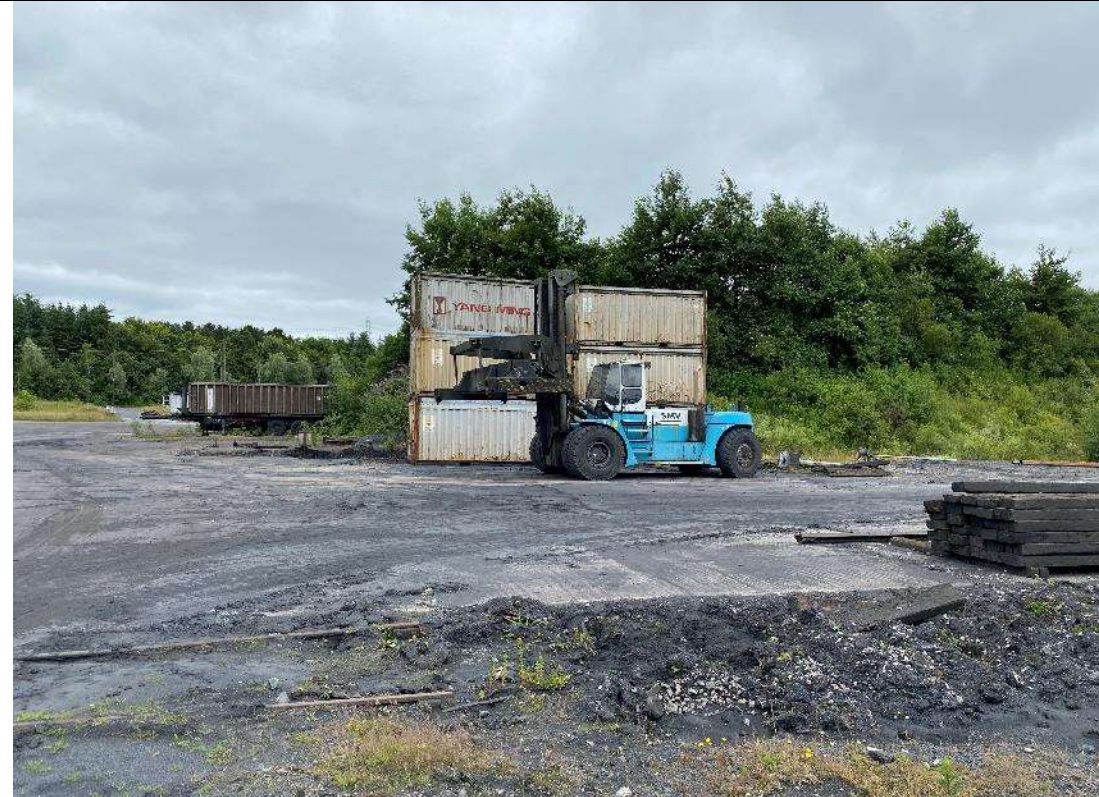
| <b>Photo No.</b><br>40 | <b>Date:</b><br>6 July 2022 | |

| <b>Washery Area (023)</b><br><br>View of unknown stockpile (023) and shipping container storage. Railway land in foreground.<br><br>The photograph aspect is south. | | |

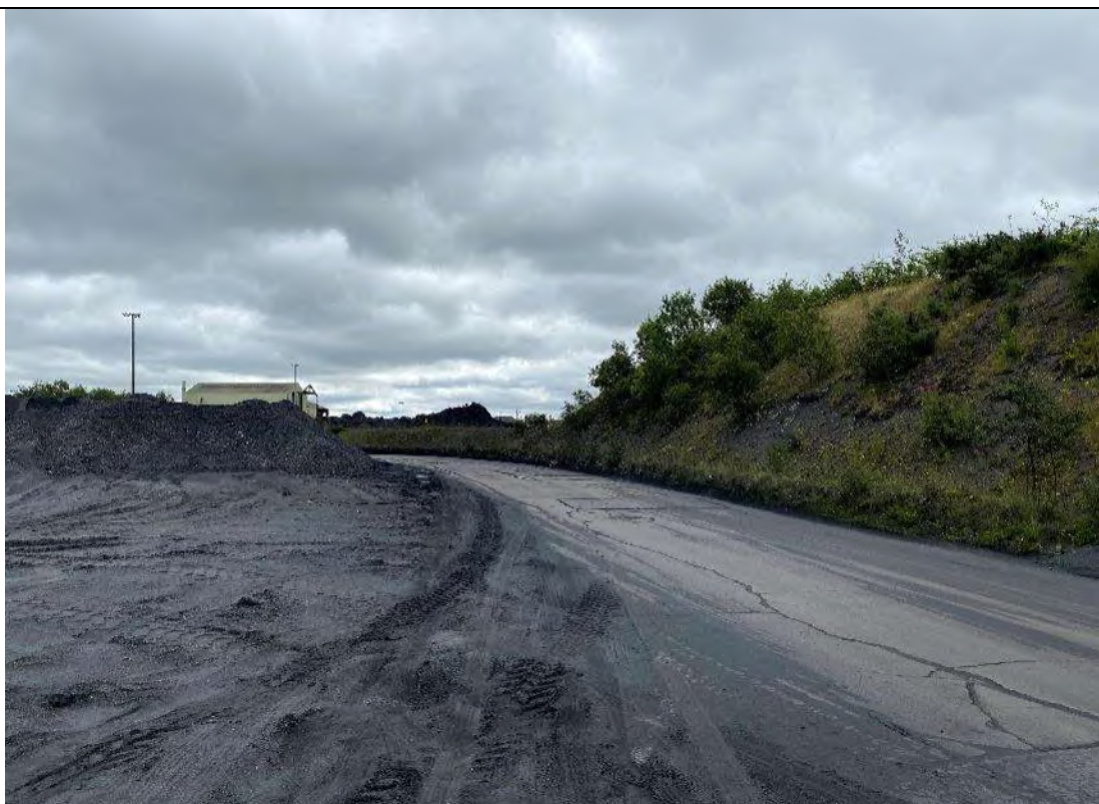
| <b>Photo No.</b><br>41 | <b>Date:</b><br>6 July 2022 | |

| <b>Stockpiles (022)</b><br><br>View of stockpile / colliery spoil separating Washery Structures from stockpile area served by conveyor belts.<br><br>The photograph aspect is east. | | |

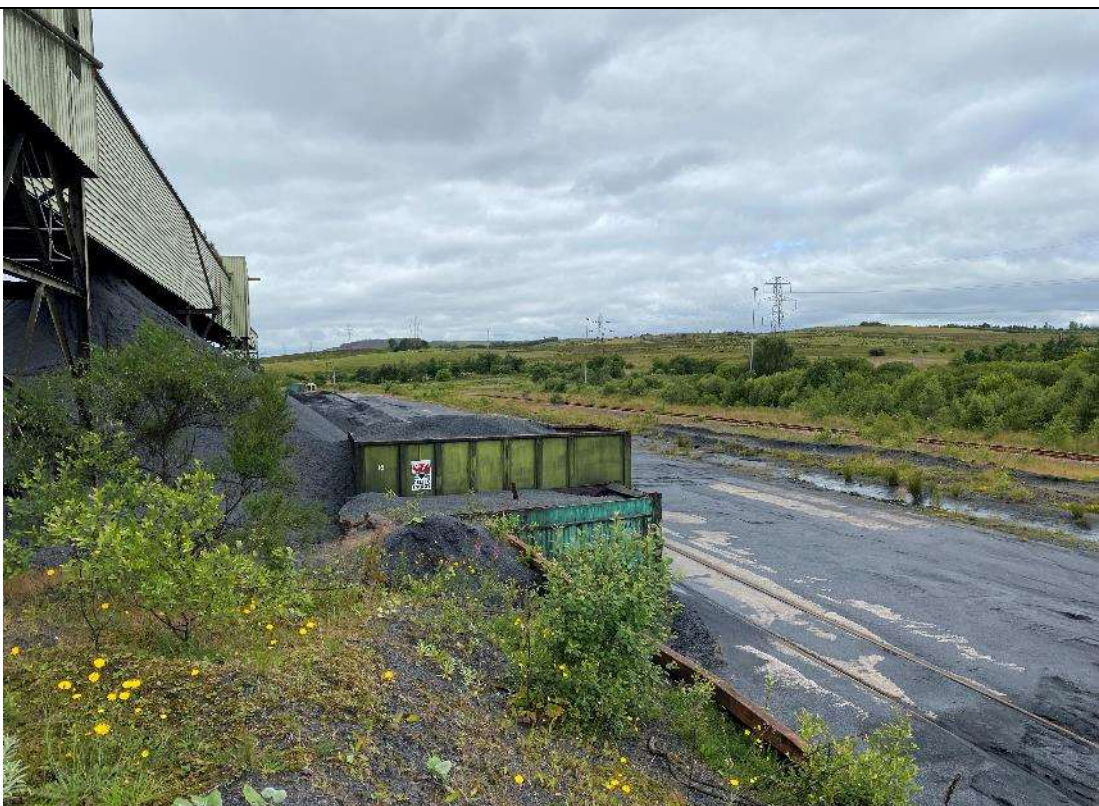
| <b>Railway Land (024)</b><br><p>View of the northern portion of Washery site with Nant Helen in the background. Railway tracks and railway land present.</p> <p>Land falls at 1:1, exposed soils appear to be made ground of colliery spoil.</p> <p>The photograph aspect is north-west.</p> | | |

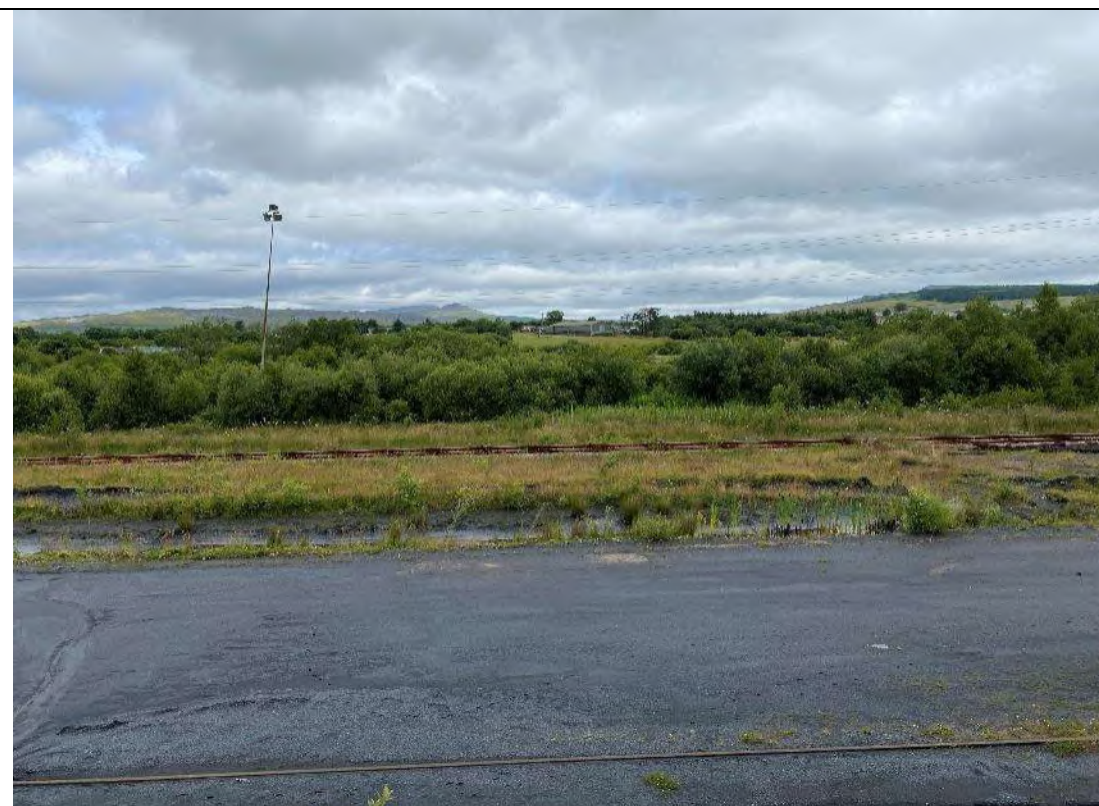
| <b>Photo No.</b><br>44 | <b>Date:</b><br>6 July 2022 | |

| <b>Retaining wall (025)</b><br><p>View of the northern portion of Washery site. Railway tracks and railway land present.</p> <p>The photograph aspect is north.</p> | | |

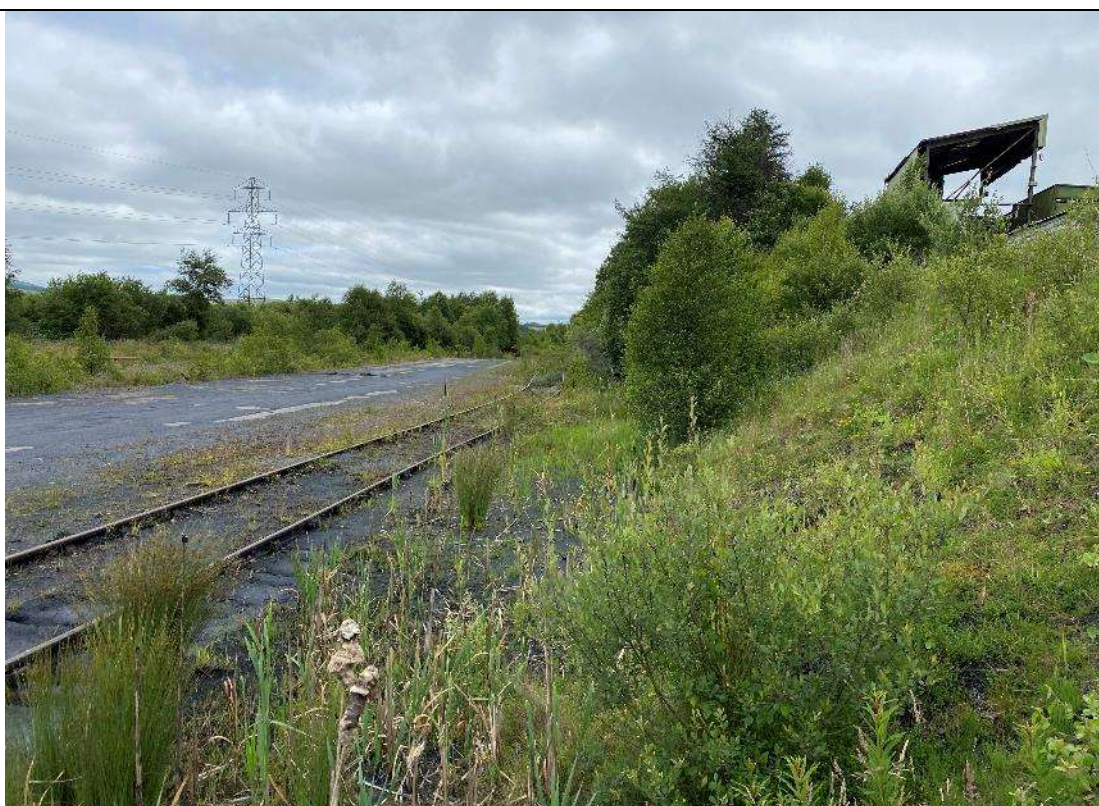
| <b>Photo No.</b><br>45 | <b>Date:</b><br>6 July 2022 | |

| <b>Retaining wall (025)</b><br><br>View of the northern portion of Washery site. Railway tracks and railway land present.<br><br>The photograph aspect is north-east. | | |

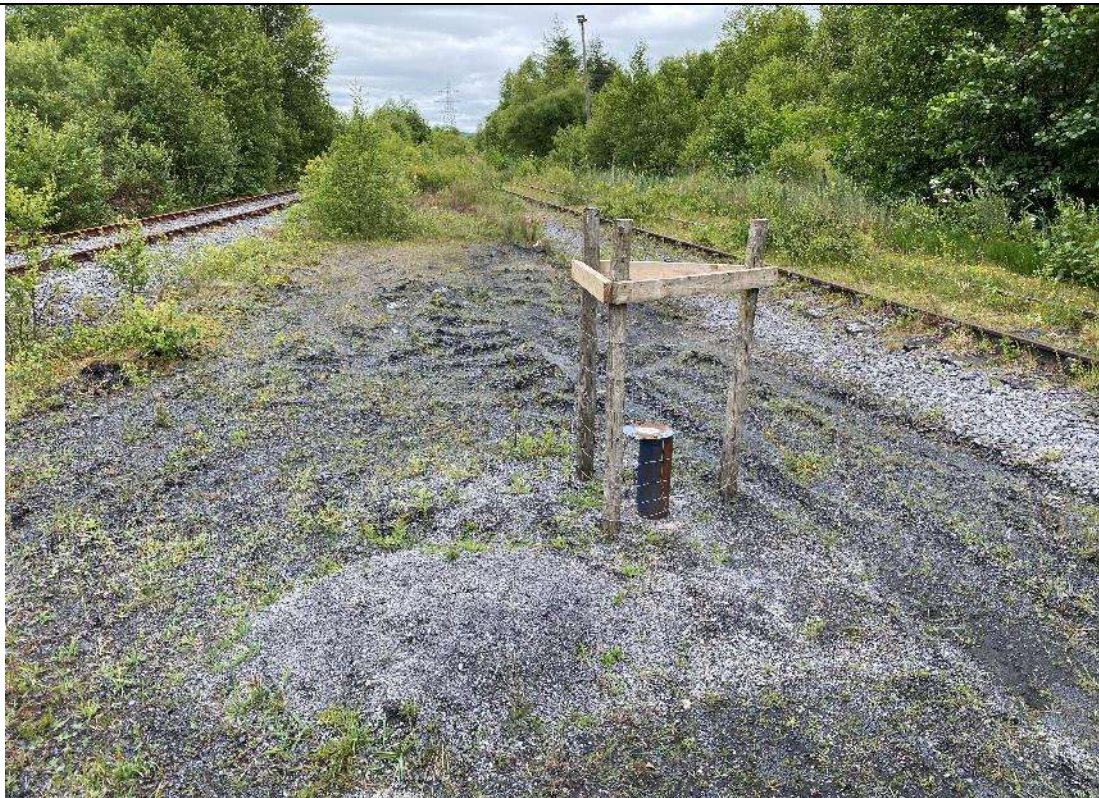
| <b>Photo No.</b><br>47 | <b>Date:</b><br>6 July 2022 | |

| <b>Railway Land (023)</b><br><br>View of railway sidings, two tracks currently present, with relict evidence of two unused tracks.<br><br>Ballast appears clean and made of BOS slag.<br><br>Monitoring well BH29R from Arup GI.<br><br>The photograph aspect is east. | | |

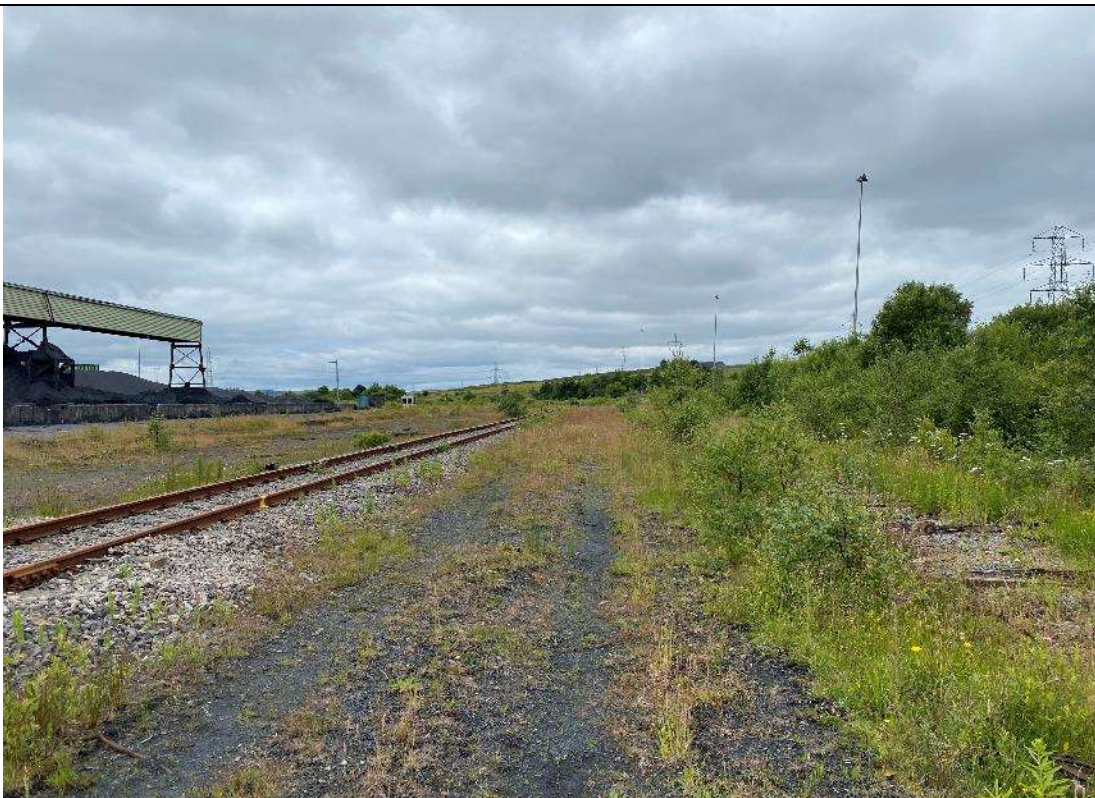
| <b>Photo No.</b><br>48 | <b>Date:</b><br>6 July 2022 |

| <b>Railway Land (023)</b><br><br>View of railway sidings, two tracks currently present, with relict evidence of two unused tracks.<br><br>The photograph aspect is west. | |

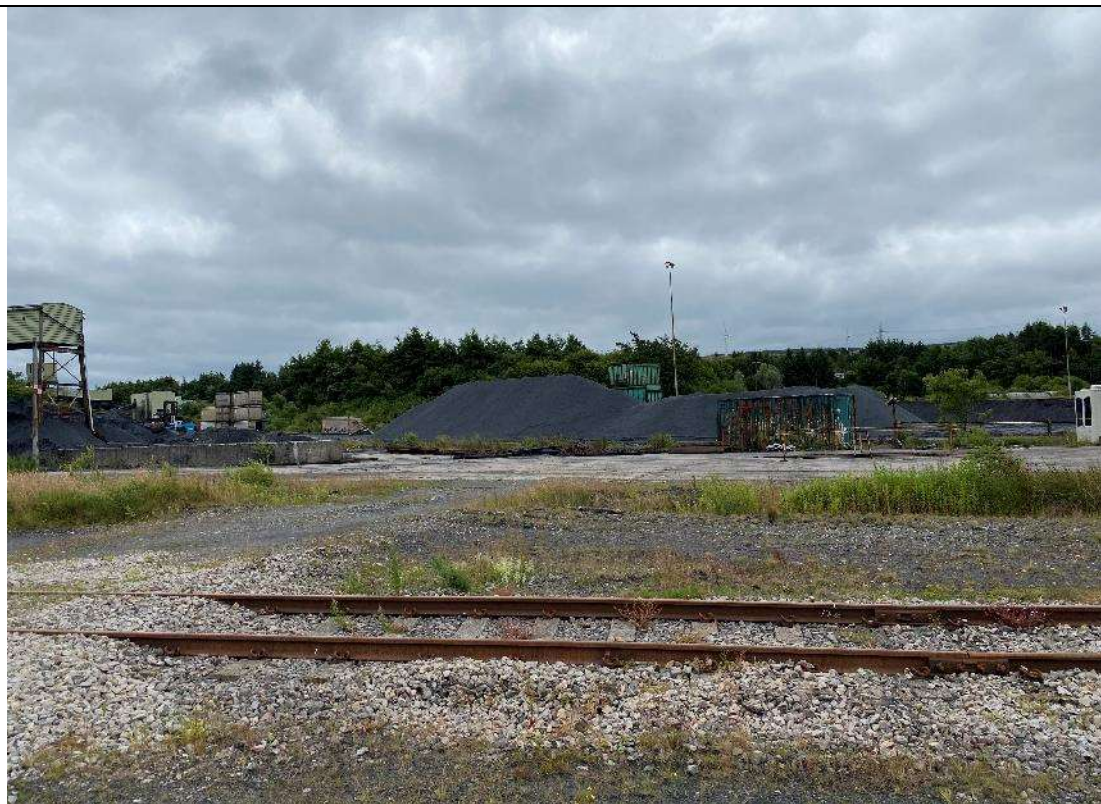
**Client Name: Global Centre of Rail Excellence**
**Site: GCRE (Onllywyn Washery)**
**Project No. 5209796**
**Photo No.**  
49

**Stockpile (023)**

View south across washery from railway land.

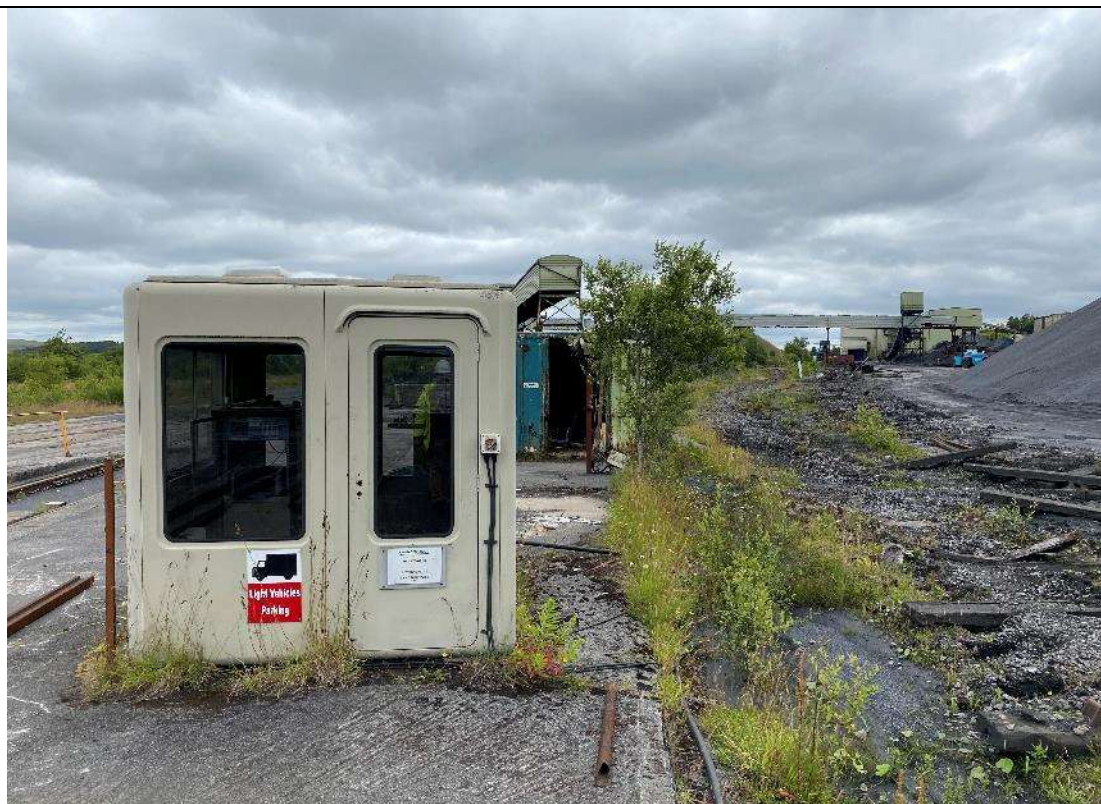
**Photo No.**  
50

**Electricity substation / control room on railway land (024)**

View of prefabricated cabin holding electrical equipment.

Former railway tracks to right running up to building 014.

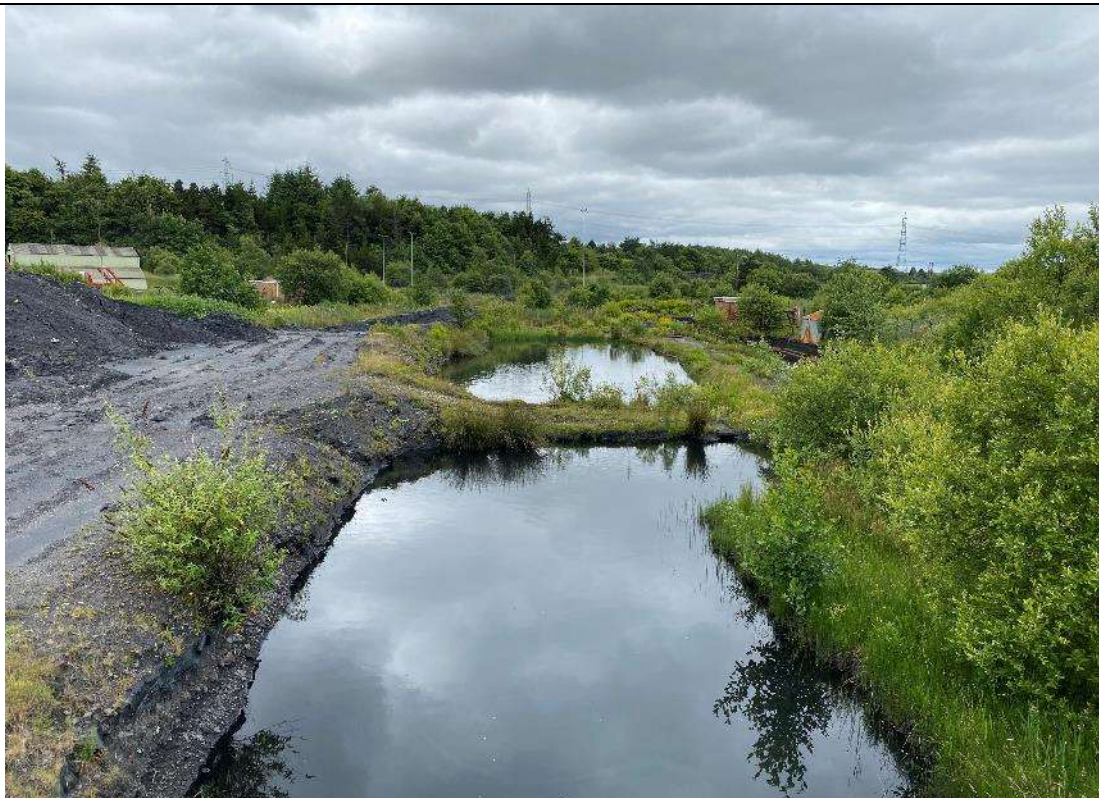
| <b>Photo No.</b><br>51 | <b>Date:</b><br>6 July 2022 | |

| <b>Lagoons (025)</b><br><br>View of lagoons in north of site.<br><br>The photograph aspect is south-west. | | |

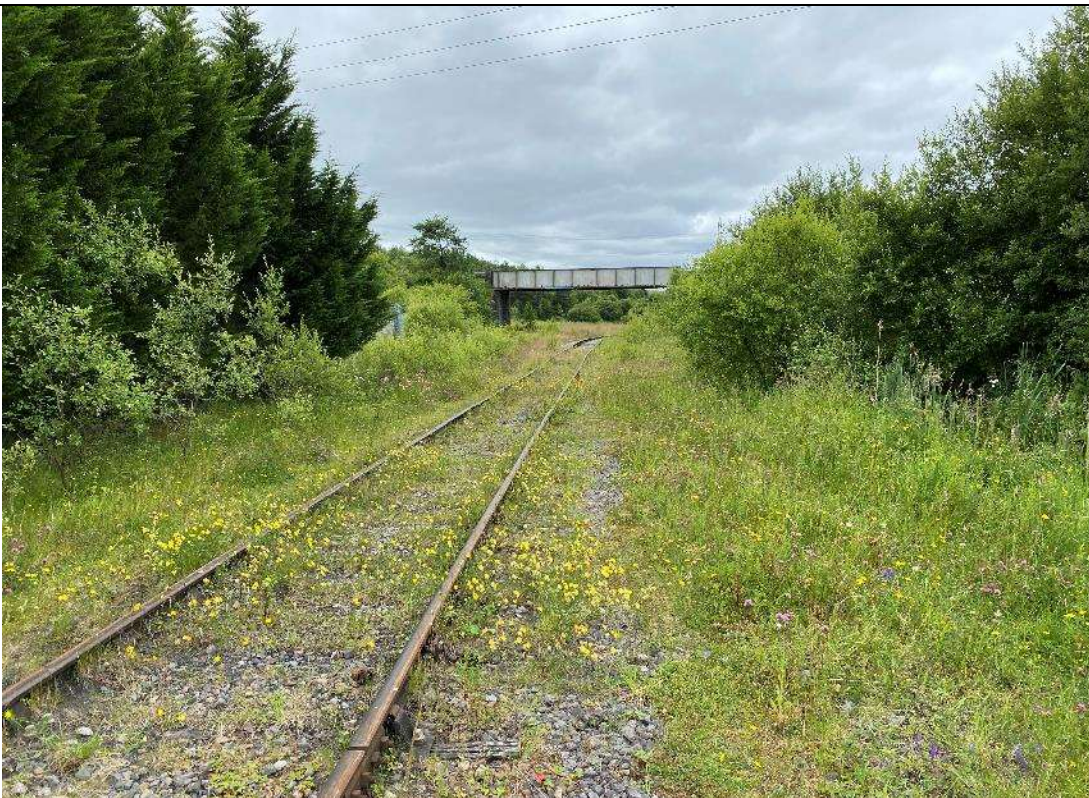
| <b>Photo No.</b><br>52 | <b>Date:</b><br>6 July 2022 | |

| <b>Railway Land (023)</b><br><br>View of railway land and off-site bridge crossing it used to access Washery from the north.<br>Light staining on ballast.<br><br>The photograph aspect is west. | | |

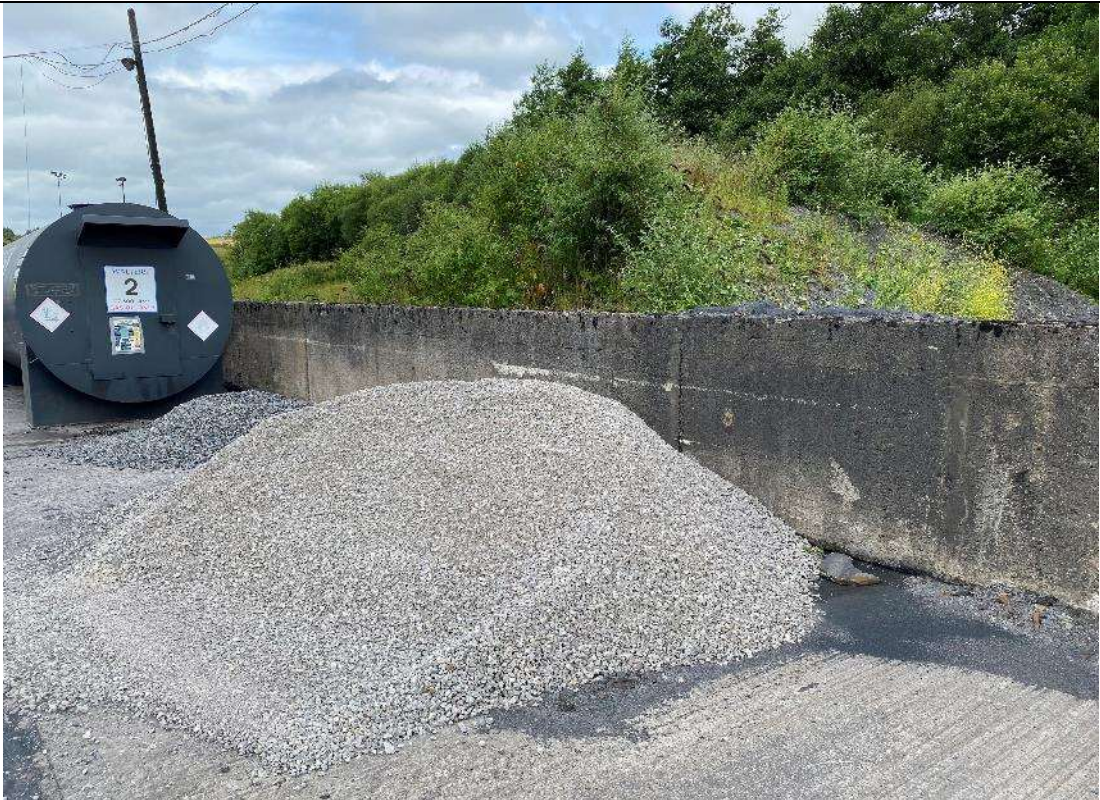
| <b>Photo No.</b><br>55 | <b>Date:</b><br>6 July 2022 | |

| <b>Loading Bays (026)</b><br><br>View of loading bay and stockpiled gravel and empty AST beyond.<br><br>The photograph aspect is west. | | |

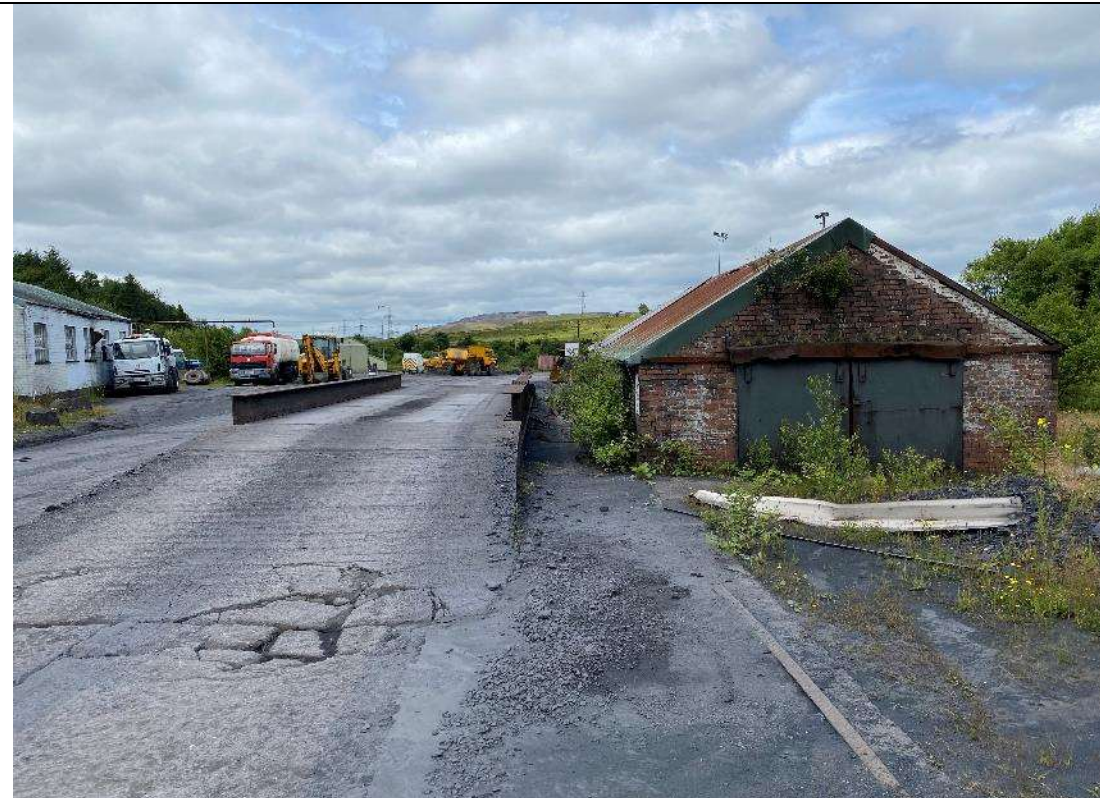
| <b>Photo No.</b><br>56 | <b>Date:</b><br>6 July 2022 | |

| <b>Plant Parking (027)</b><br><br>View of area used for plant parking, former weighbridge and building of unknown use to right.<br><br>The photograph aspect is west. | | |
