**Client Name:** Global Centre of Rail Excellence

**Site:** GCRE (Onllywyn Washery)

**Project No.**  
5209796

Washery - CLAH Walkover Photograph Location Plan

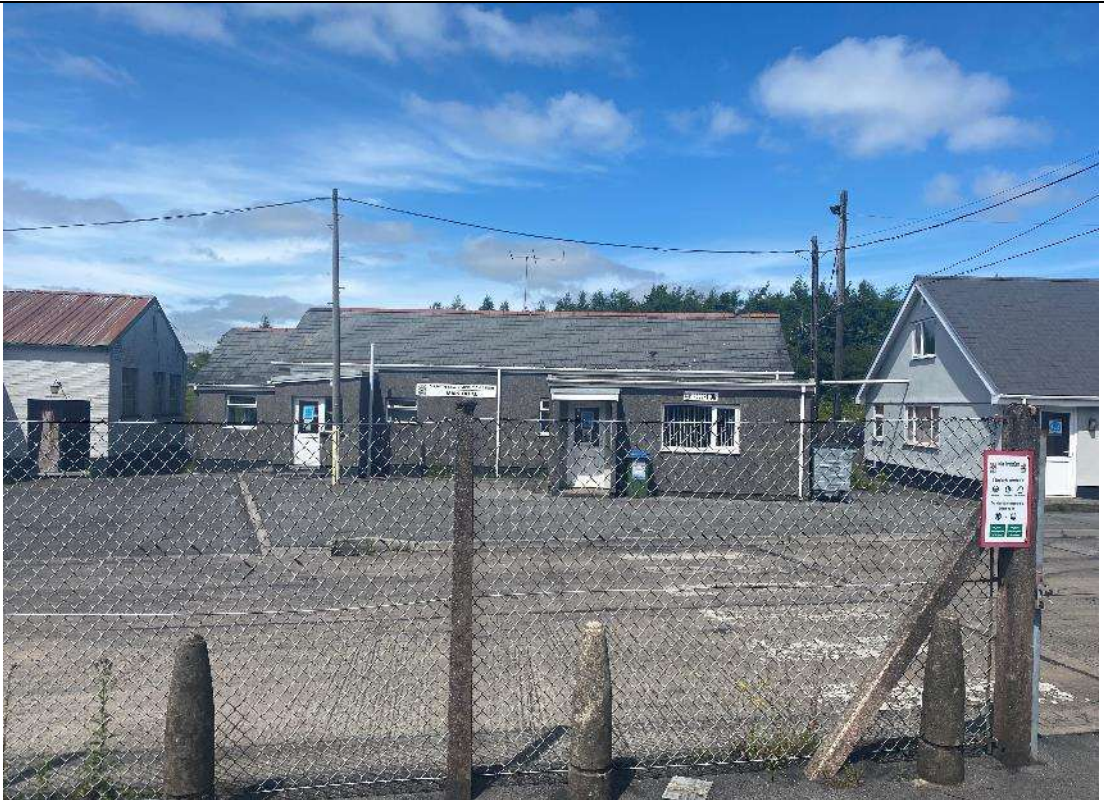
| <b>Photo No.</b><br>59 | <b>Date:</b><br>6 July 2022 | |

| <b>Site Office (031)</b><br><br>View of the site office (031) and Visitors Centre (032) to right. Buildings associated with former colliery use.<br><br>The photograph aspect is north. | | |

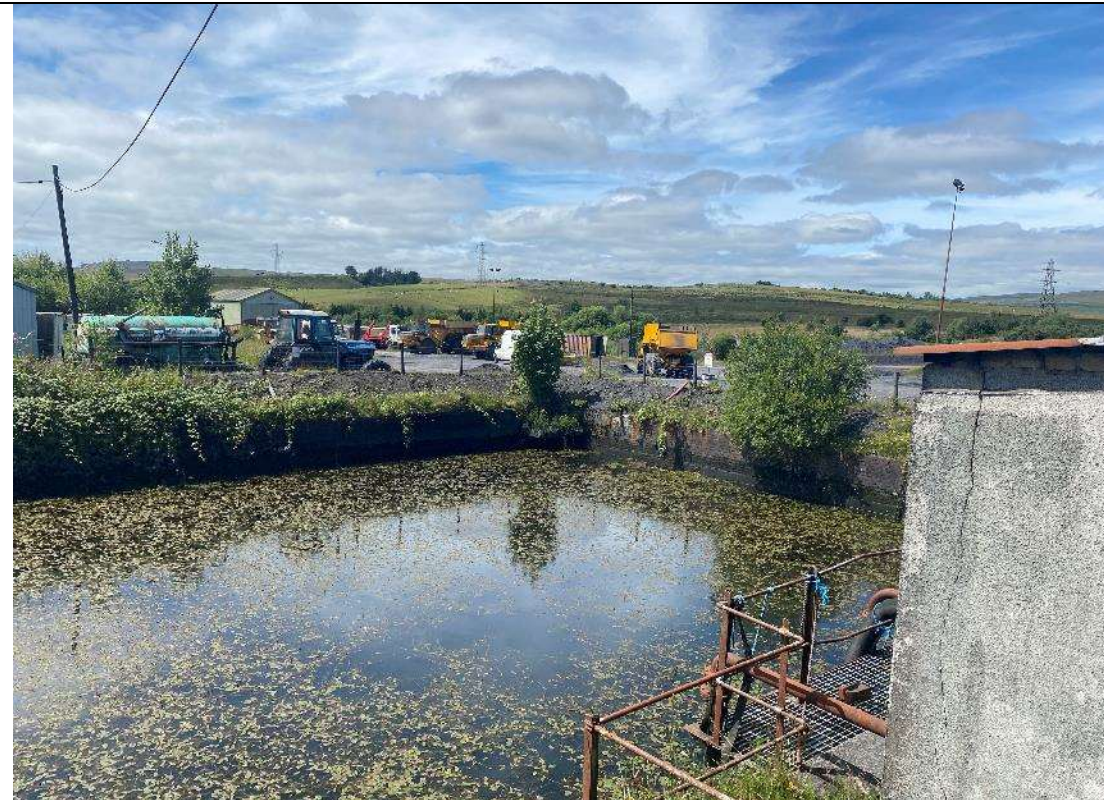
| <b>Photo No.</b><br>60 | <b>Date:</b><br>6 July 2022 | |

| <b>Lagoon (030)</b><br><br>View of the lagoon that supplies welfare unit baths and corner of pump house. View to plant parking area beyond.<br><br>The photograph aspect is north-west. | | |

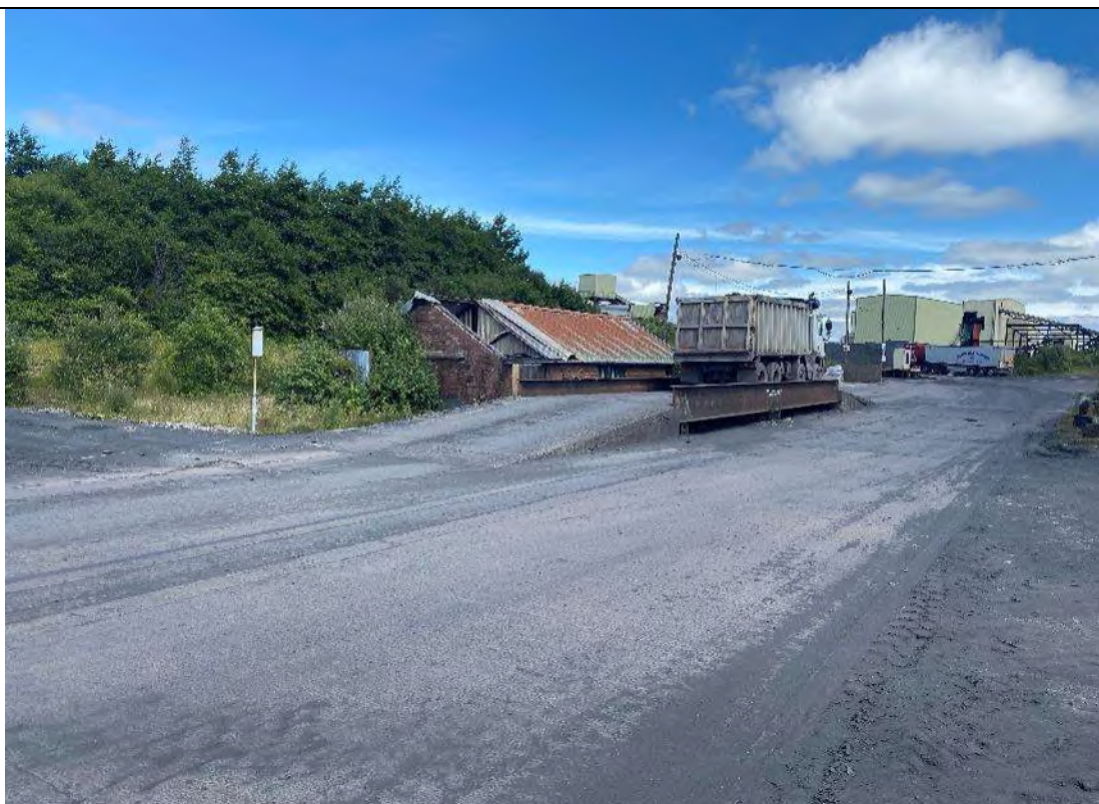
| <b>Photo No.</b><br>61 | <b>Date:</b><br>6 July 2022 | |

| <b>Plant Parking area<br/>(027)</b><br><br>View of the site boundary fence and the reduction in ground level in the adjacent Tesco delivery yard.<br><br>The photograph aspect is east-north-east. | | |

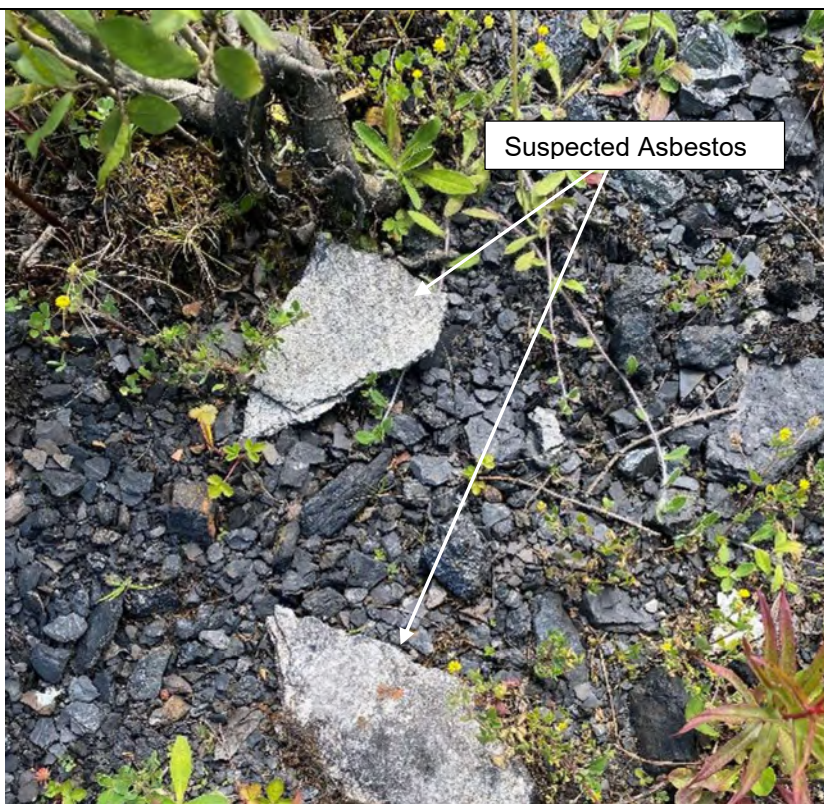
| <b>Photo No.</b><br>62 | <b>Date:</b><br>6 July 2022 | |

| <b>Suspected Asbestos<br/>Containing Material<br/>(033)</b><br><br>Fragments of cement<br>with visible fibres<br>observed on surface of<br>land to north of Plant<br>Parking (027) and south<br>of lagoon (025).<br>Suspected chrysotile<br>asbestos. | | |

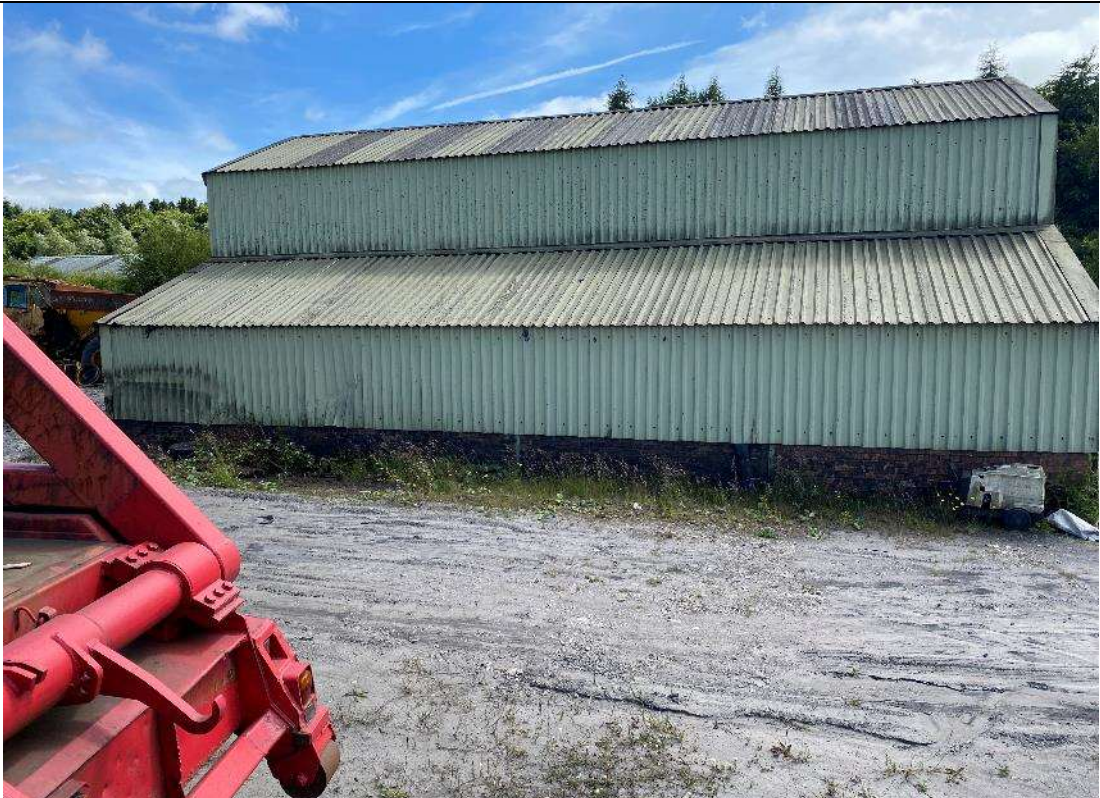
| <b>Photo No.</b><br>63 | <b>Date:</b><br>6 July 2022 | |

| <b>Vehicle Repair Garage (034)</b><br><br>View of vehicle repair garage, building locked. Yard area used for parking plant and scrapyard (035) of vehicle parts.<br><br>The photograph aspect is south. | | |

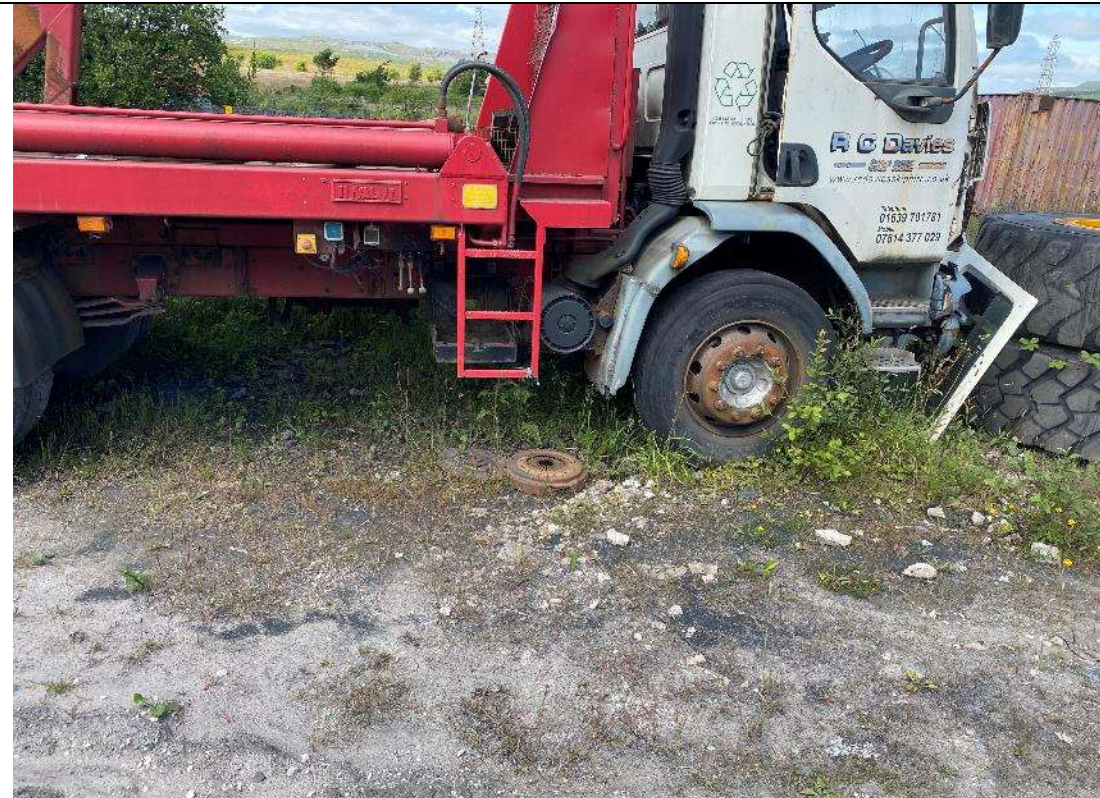
| <b>Photo No.</b><br>64 | <b>Date:</b><br>6 July 2022 | |

| <b>Scrapyard (035)</b><br><br>View of abandoned skip lorry, tyres etc.<br><br>The photograph aspect is north. | | |

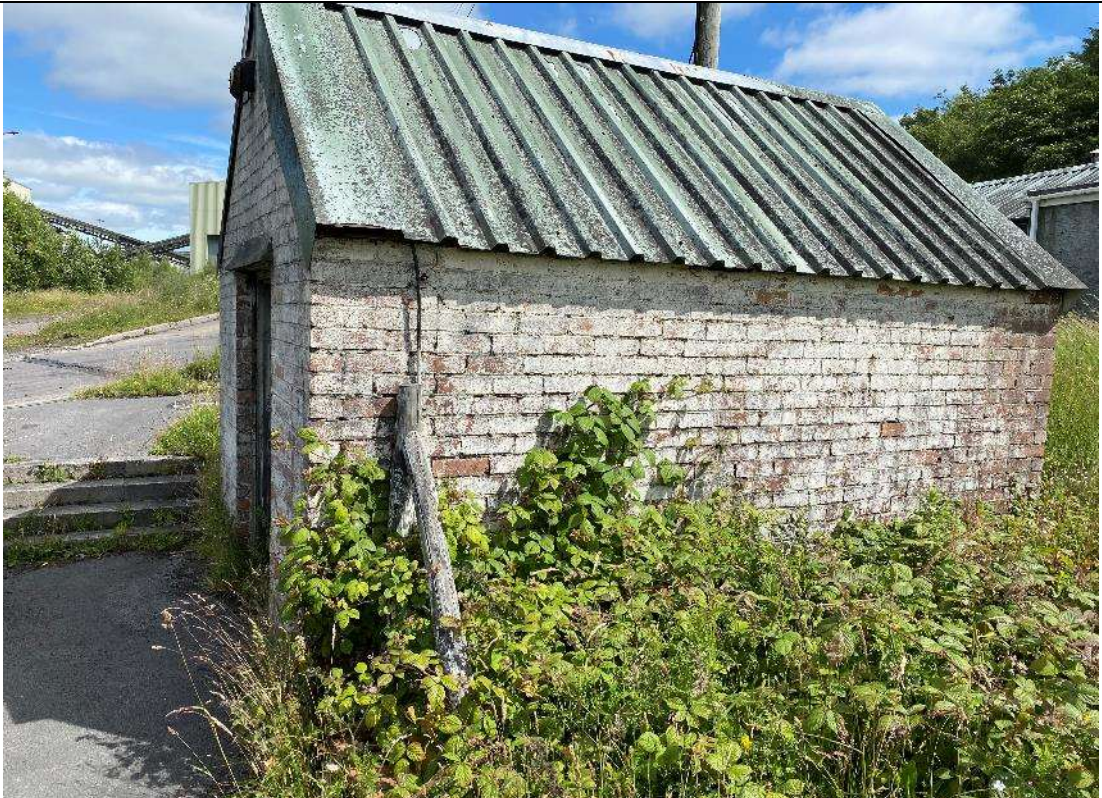
| <b>Photo No.</b><br>69 | <b>Date:</b><br>7 July 2022 | |

| <b>Chemical Store (036)</b><br><br>View of chemical store used by site laboratory.<br><br>The photograph aspect is east. | | |

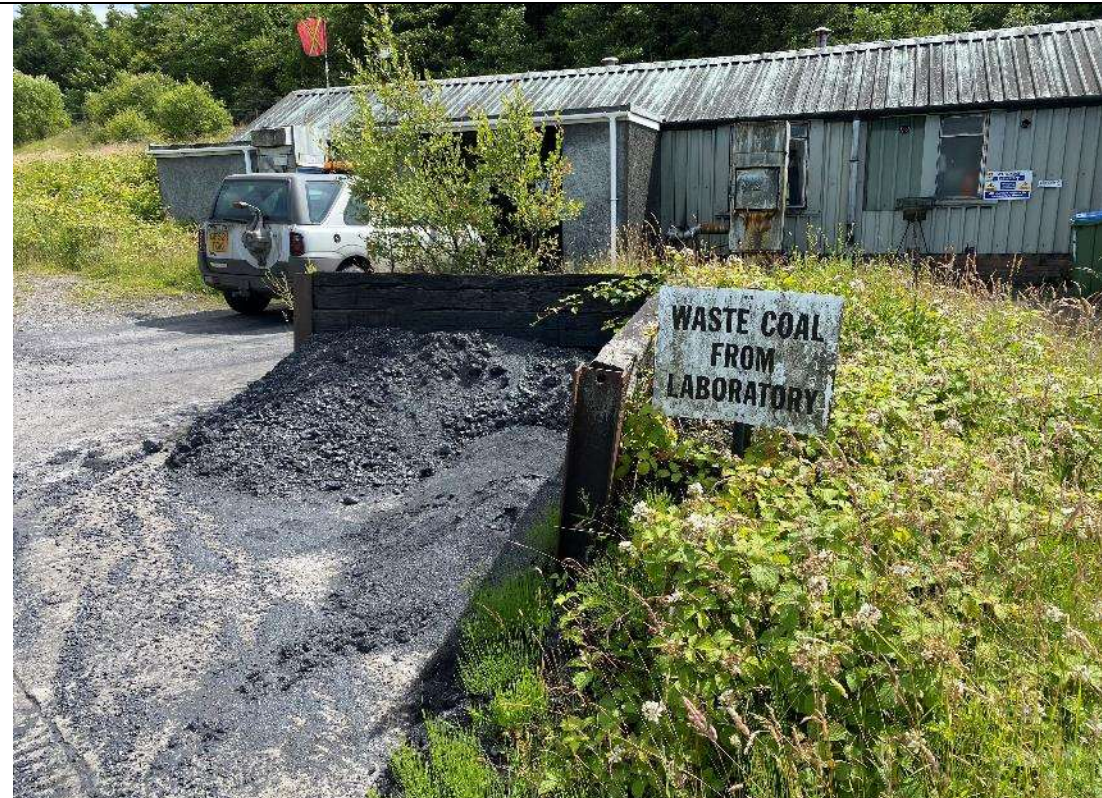
| <b>Photo No.</b><br>70 | <b>Date:</b><br>7 July 2022 | |

| <b>Laboratory (037)</b><br><br>View of site laboratory used to assess quality and composition of coal.<br><br>The photograph aspect is south. | | |

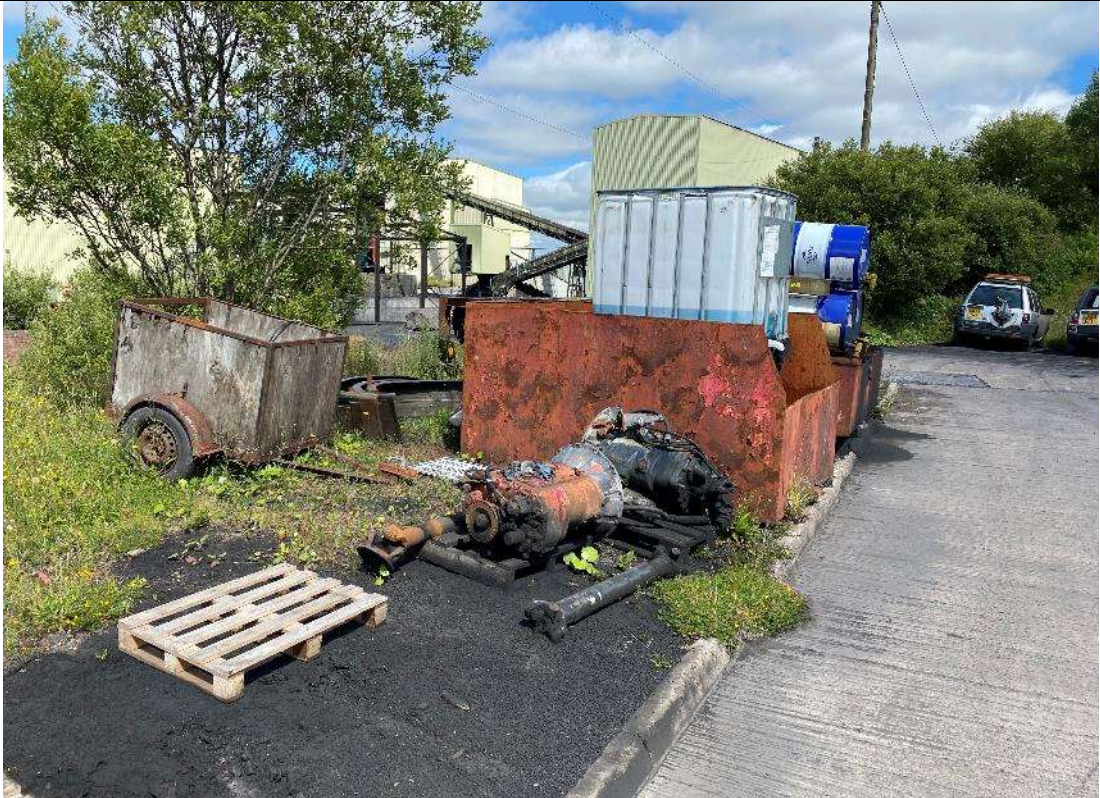
| <b>Photo No.</b><br>72 | <b>Date:</b><br>7 July 2022 | |

| <b>Vehicle Repair Garage (038)</b><br><br>View of AdBlue (039) and lube oil (040) and oil barrel bundled storage (041). Engine parts, tyres and scrap material in foreground and surrounds.<br><br>The photograph aspect is east. | | |

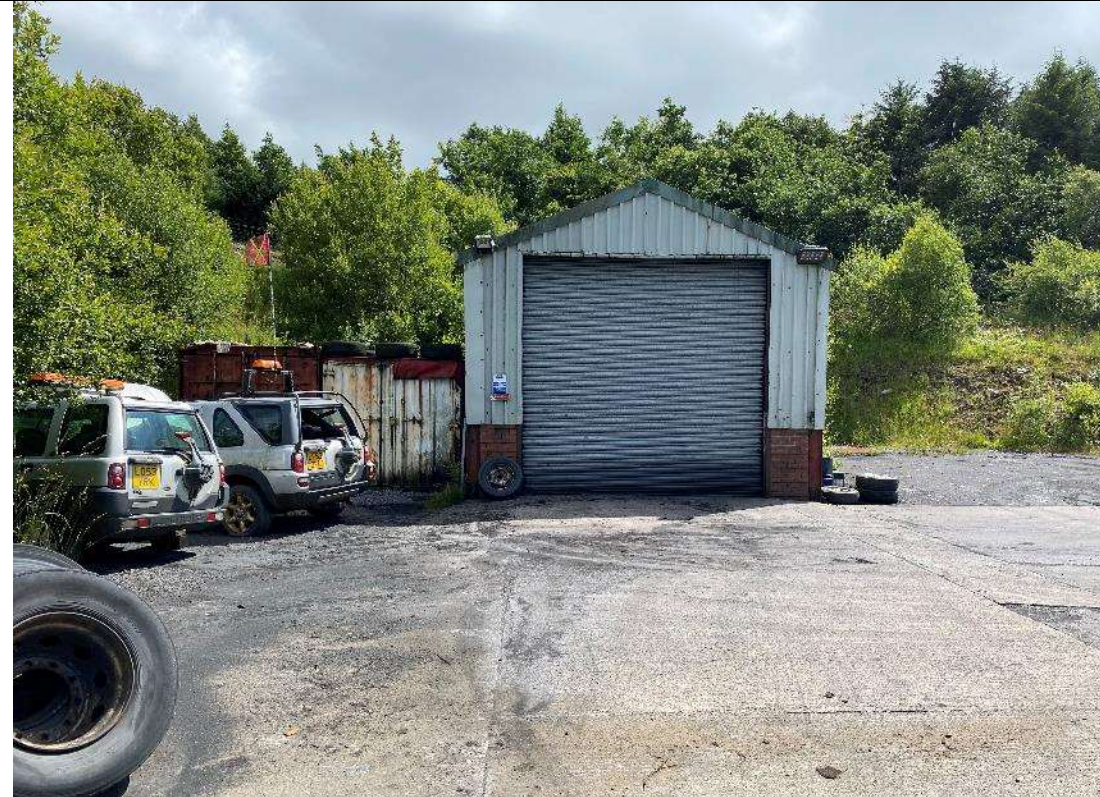
| <b>Photo No.</b><br>73 | <b>Date:</b><br>7 July 2022 | |

| <b>Vehicle Repair Garage (038)</b><br><br>View vehicle repair garage and land rovers being repaired / stripped for parts. Heavy staining on concrete from coal dust.<br><br>The photograph aspect is south. | | |

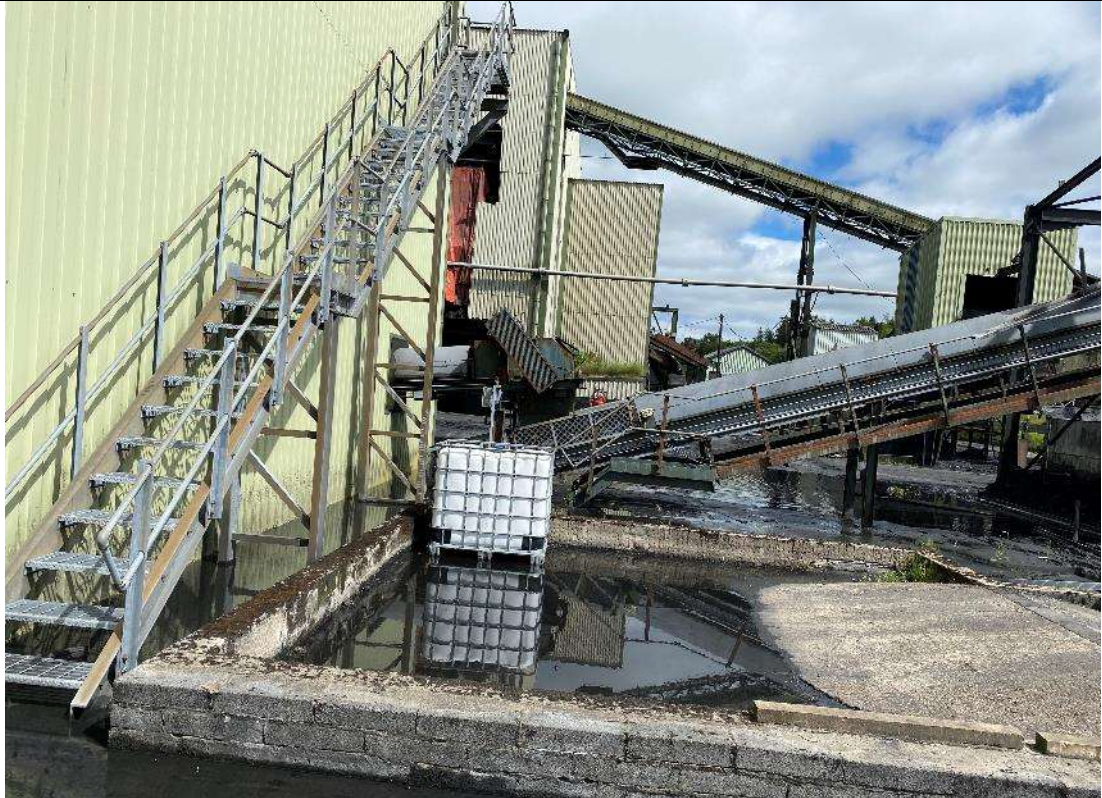
| <b>Photo No.</b><br>78 | <b>Date:</b><br>7 July 2022 | |

| <b>Washery Structure (045)</b><br><br>View of washery building 045, building 014 to rear. Empty IBC in middle ground.<br><br>The photograph aspect is north. | | |

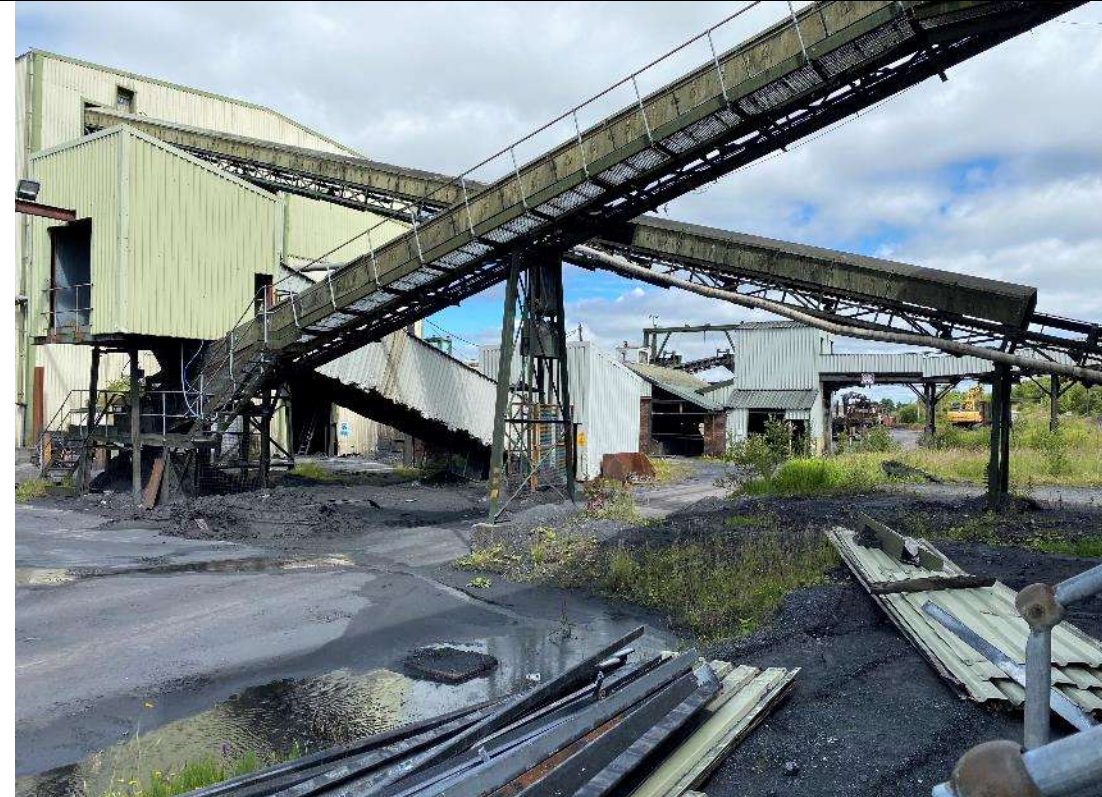
| <b>Photo No.</b><br>79 | <b>Date:</b><br>7 July 2022 | |

| <b>Washery Structures (046)</b><br><br>View of washery structure 046. Structure 047 to rear of photograph aspect<br><br>The photograph aspect is north-east. | | |

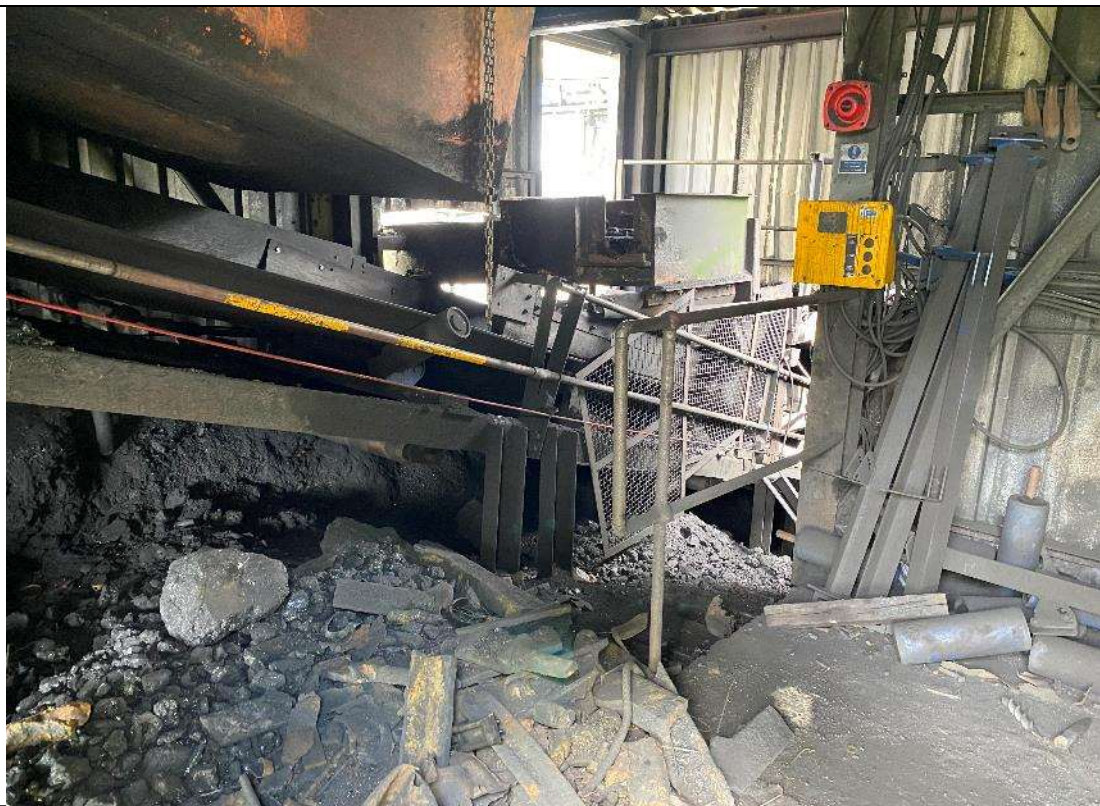
**Photo No.**  
80

**Washery Structure (047)**

View of interior of structure 047.

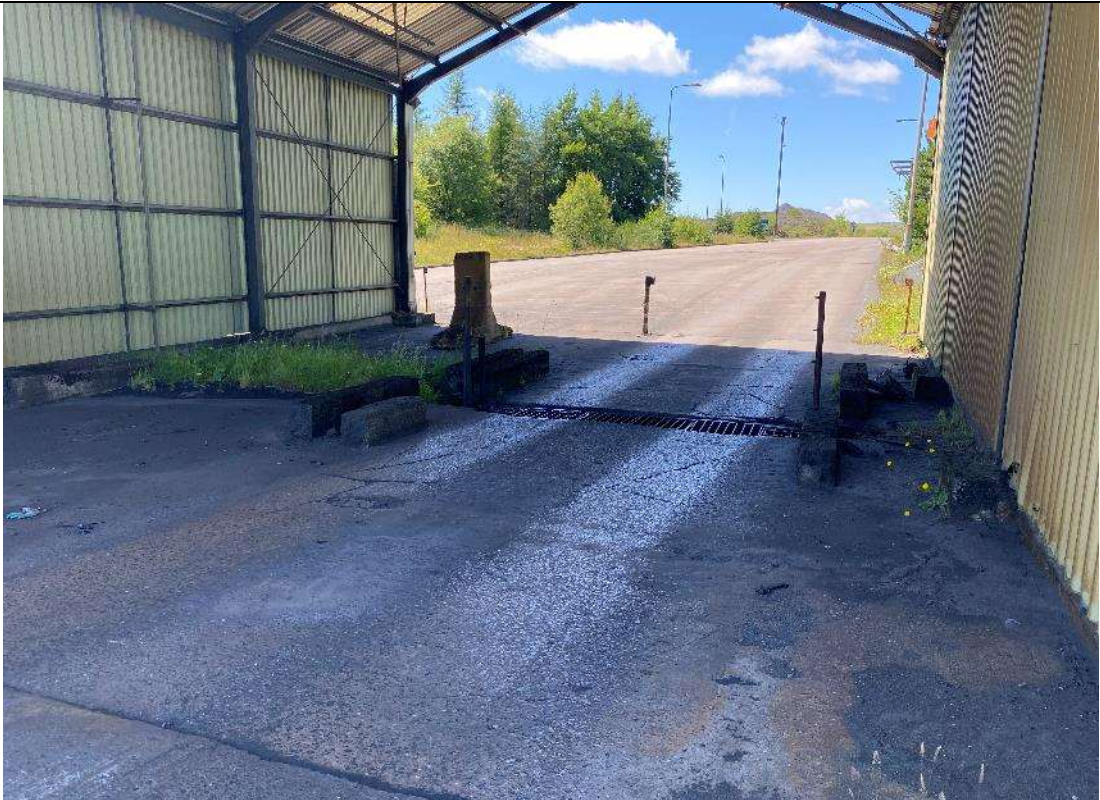
| <p><b>Photo No.</b><br/>82</p> | <p><b>Date:</b><br/>7 July 2022</p> | |

| <p><b>Wheel Wash (049)</b></p> <p>View of wheel wash, lagoon (050) located to right hand side supplying water for its use.</p> <p>The photograph aspect is west.</p> | | |

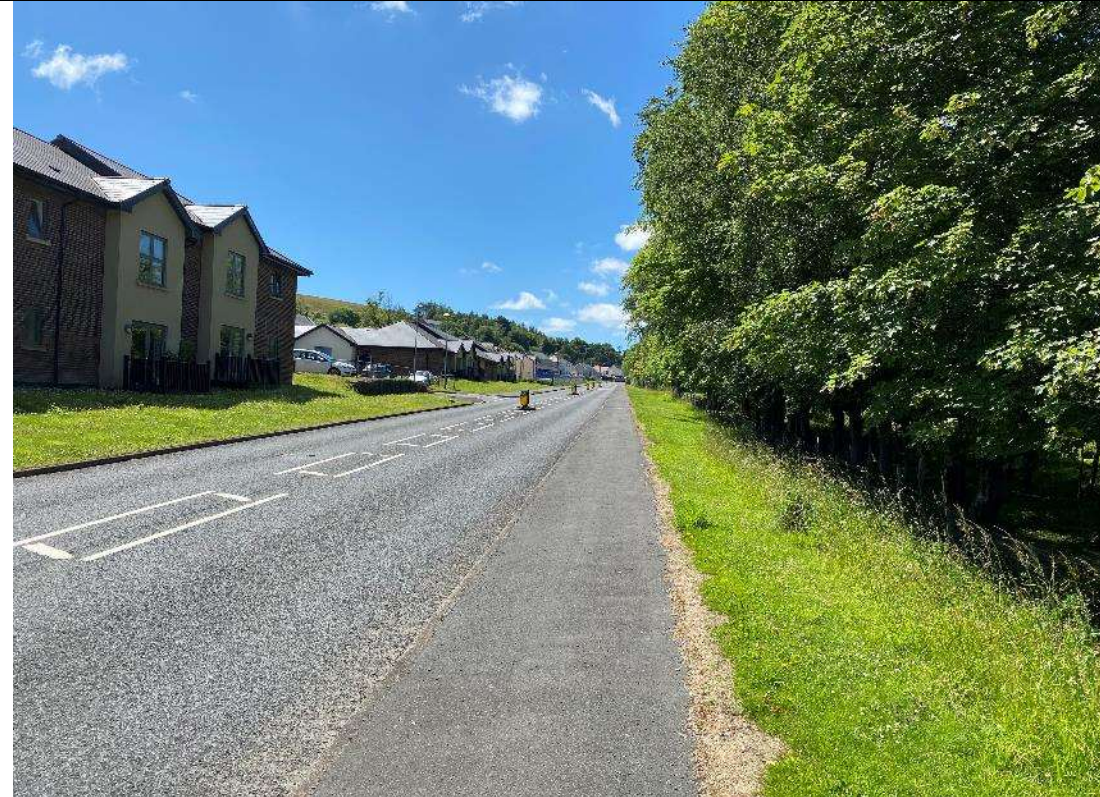
| <p><b>Photo No.</b><br/>83</p> | <p><b>Date:</b><br/>7 July 2022</p> | |

| <p><b>Southern Boundary</b></p> <p>View of sites southern boundary with Onllwyn.</p> <p>The photograph aspect is west.</p> | | |

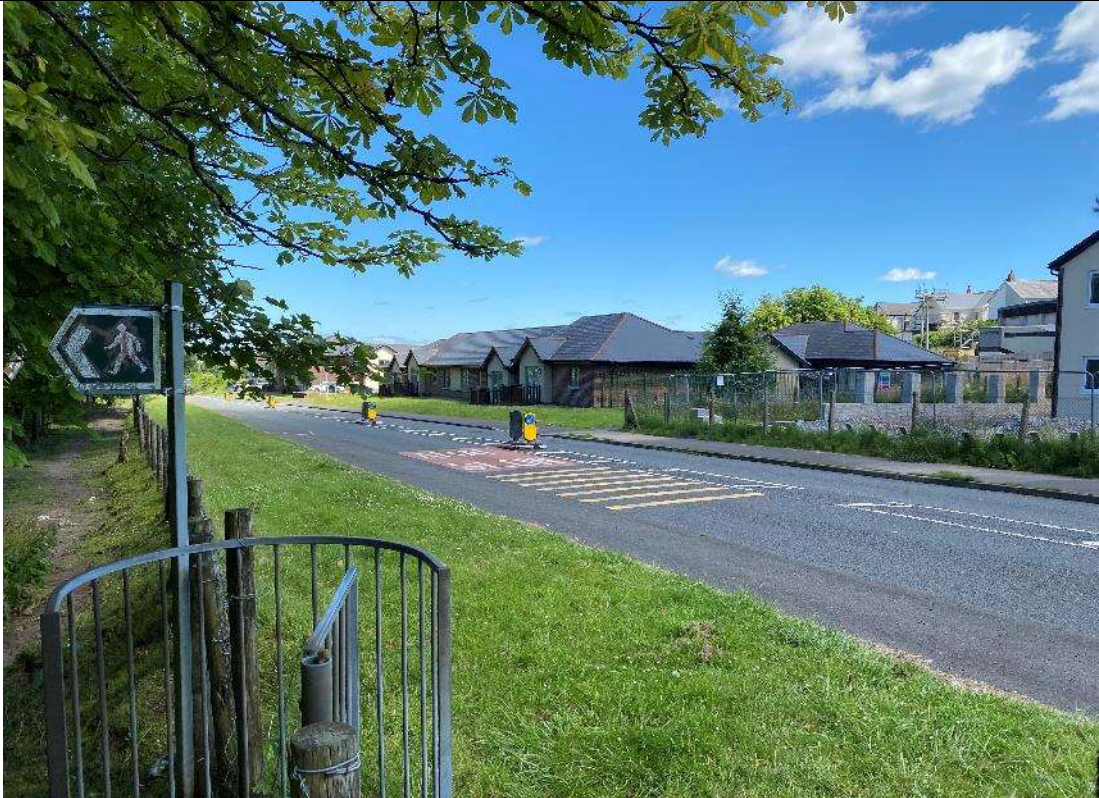
| <b>Photo No.</b><br>84 | <b>Date:</b><br>7 July 2022 | |

| <b>Southern Boundary</b><br><br>View of sites southern boundary with Onllwyn.<br><br>The photograph aspect is east. | | |

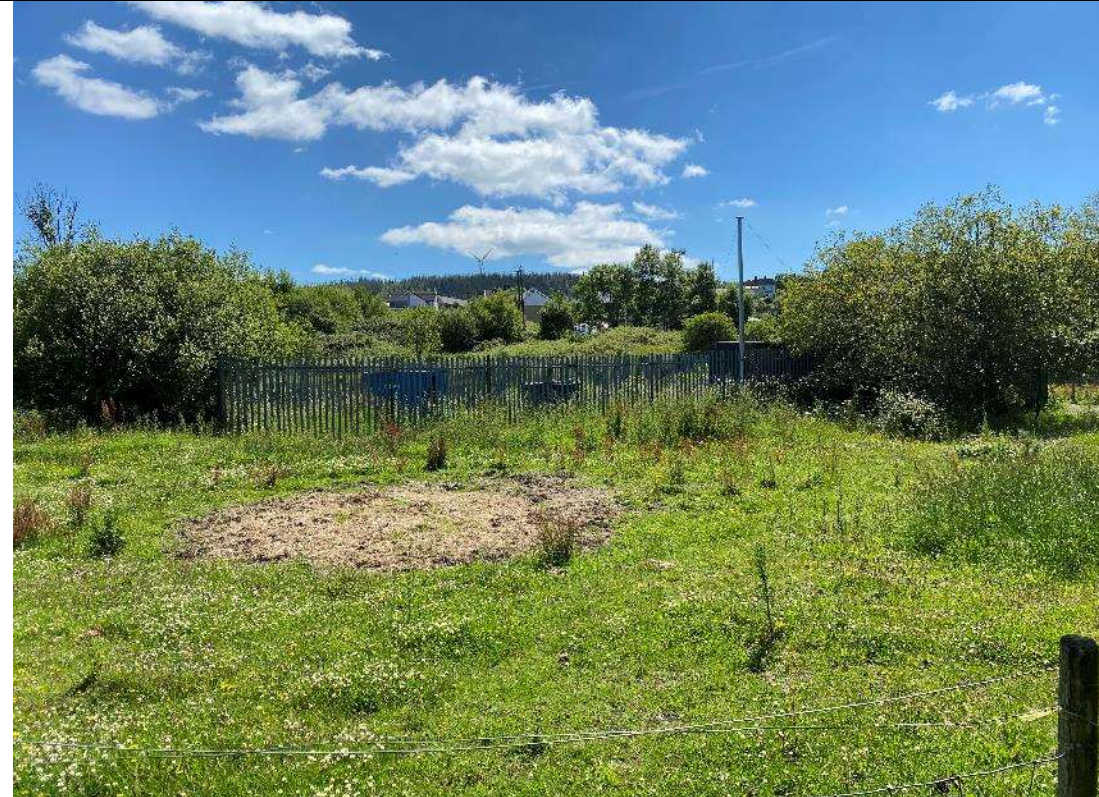
| <b>Photo No.</b><br>85 | <b>Date:</b><br>7 July 2022 | |

| <b>South of Washery</b><br><br>View of area of colliery spoil in south of site.<br><br>The photograph aspect is south. | | |

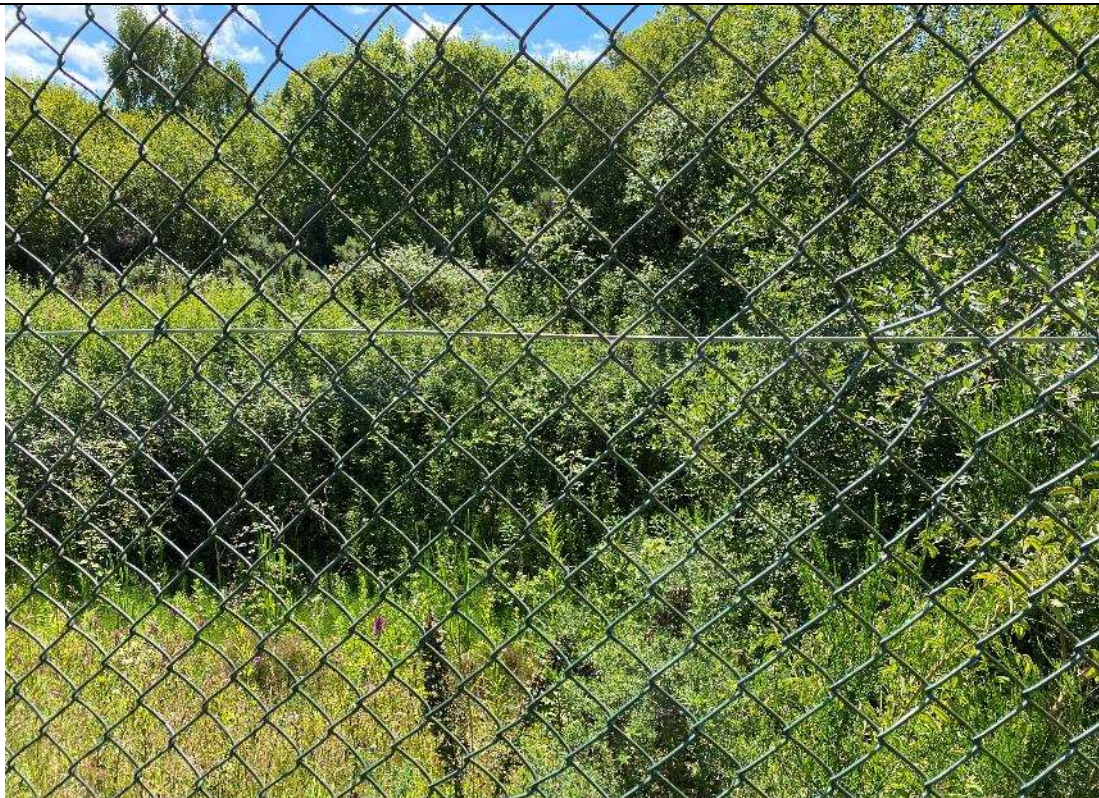
| <b>Photo No.</b><br>88 | <b>Date:</b><br>7 July 2022 | |

| <b>Lagoons (052 to 054)</b><br><br>View of lagoons in east of site. Vegetation to thick to view well.<br><br>The photograph aspect is west. | | |

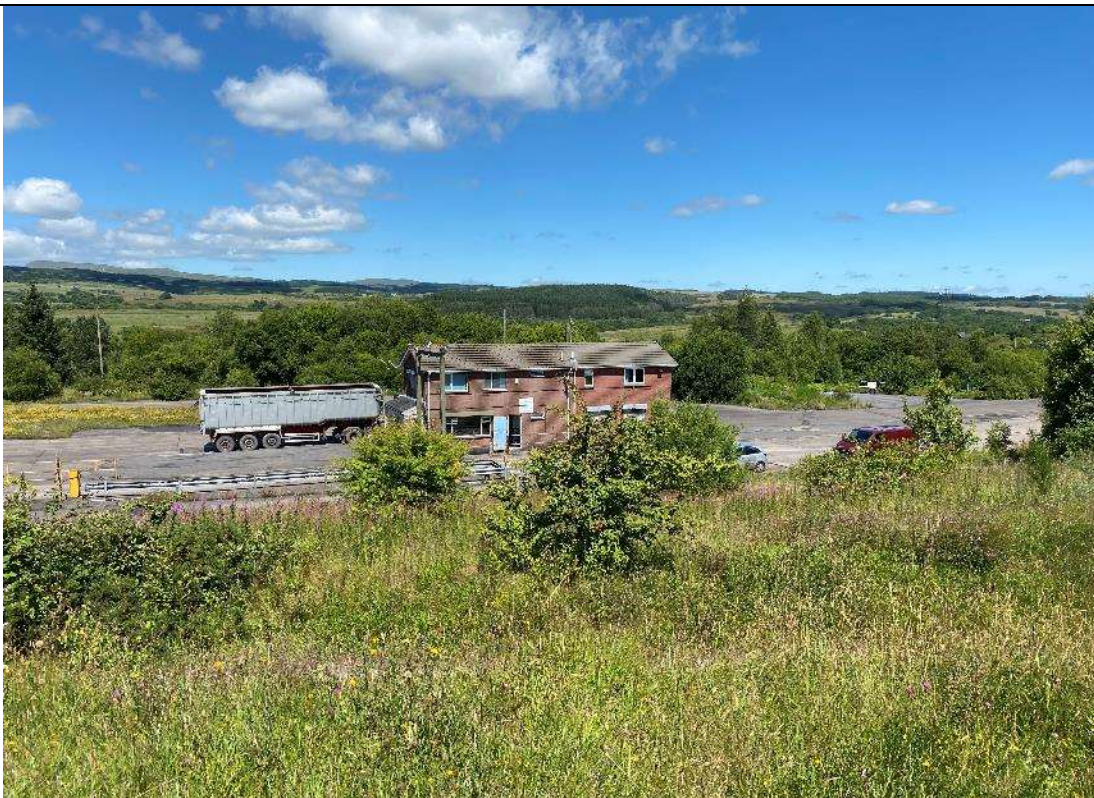
| <b>Photo No.</b><br>89 | <b>Date:</b><br>7 July 2022 | |

| <b>Weighbridge (048)</b><br><br>View of weighbridge and site office from colliery spoil heap.<br><br>The photograph aspect is north. | | |

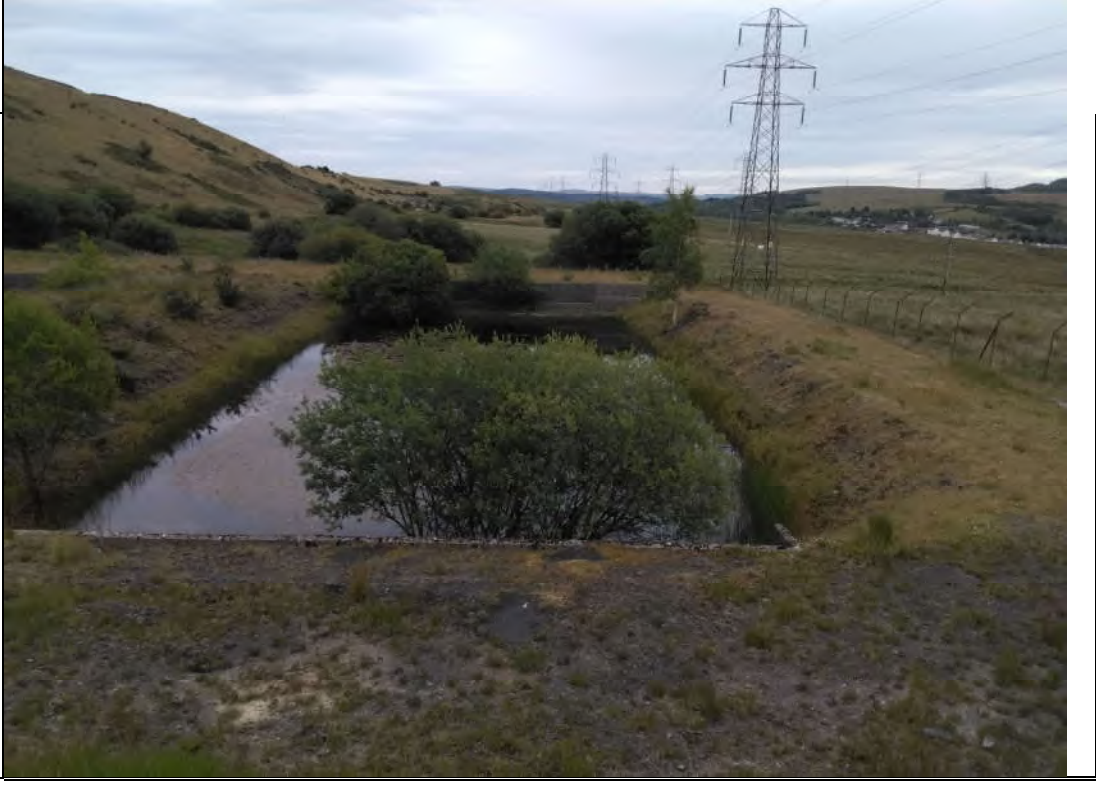
| <b>Surface Water Feature SW-03 CE:</b><br>Lagoon, water storage area, probably lined with low permeability material, drainage/runoff from restoration area. No water flowing observed at the time. Approximate measurements 5m wide, 10m length. Measurements DO 103.83%, ORP 137.5 mV, Cond 134.34 ms/cm, pH 7.34, T22.8C | | |

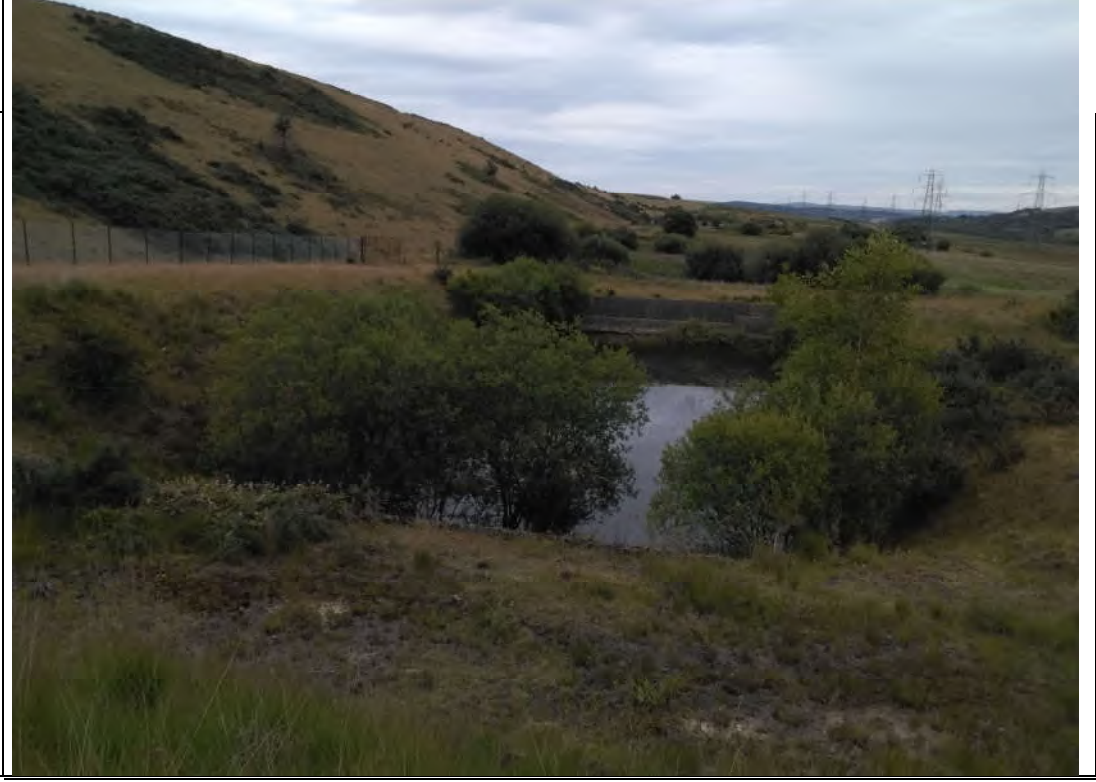
| <b>Surface Water Feature SW-04 CE:</b><br>Lagoon, water storage area, probably lined, drainage/runoff from restoration area. No water flowing observed at the time. Approximate measurements 5m wide, 10m length. DO 95.89%, ORP 211.0 mV, Cond 144.6ms/cm, pH 7.61, T21.7 | | |
