**Structural Survey (Inspection)**

**Moose Hall  
Castle Street  
Neath  
SA11 3LU**

Structural Surveys UK were commissioned to undertake a Full Structural Survey (Inspection) to a residential property at Moose Hall, Castle Street in Neath.

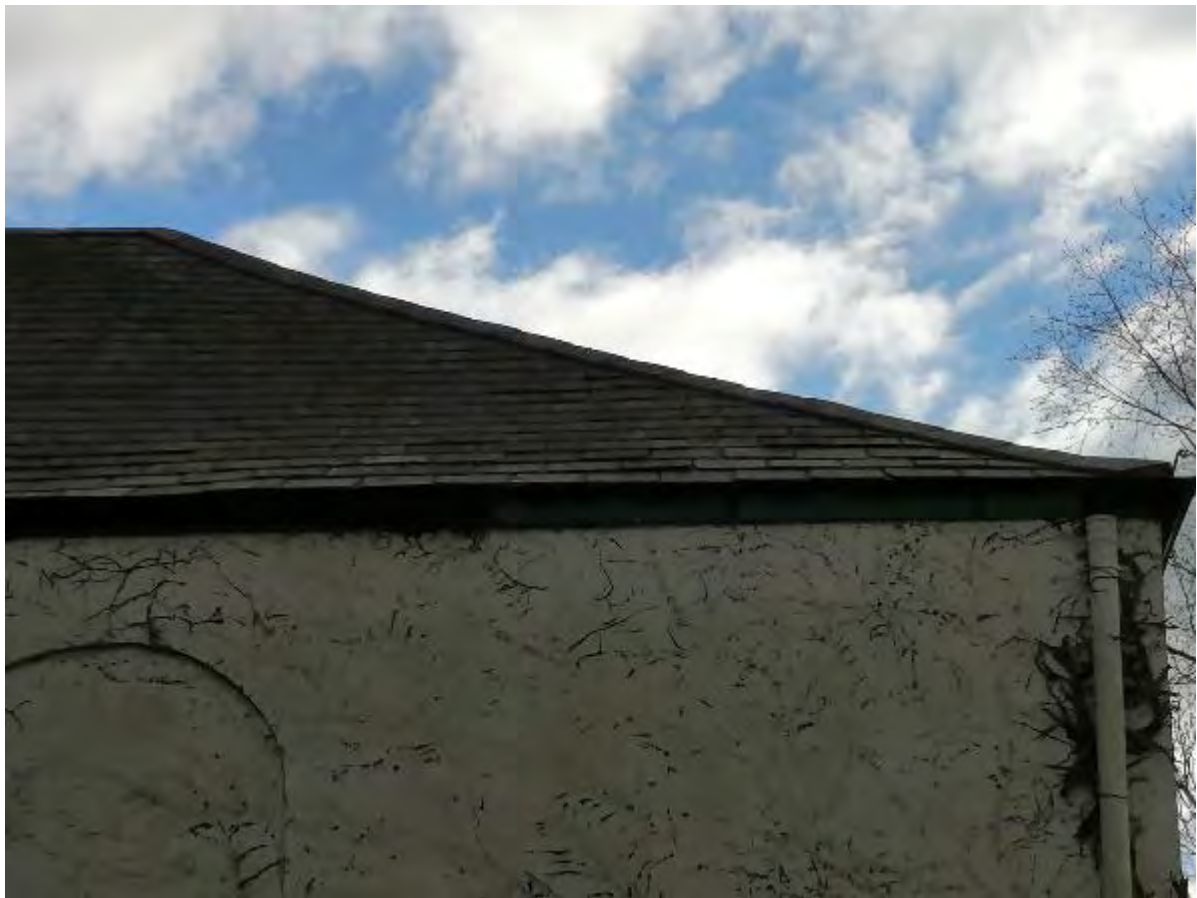
Further inspection externally also highlighted poor guttering to the roof line with multiple missing gutter sections and defective sections to the rear roof profile – see examples in photos 11-14 below, which can lead to rainwater discharging down the face of the wall (potential damp issues). New gutter sections will require installation to improve the roof drainage around the periphery of the roof profile.

Photo 11 – Missing Guttering and Displaced Edge Tiles (Rear Roof Profile)

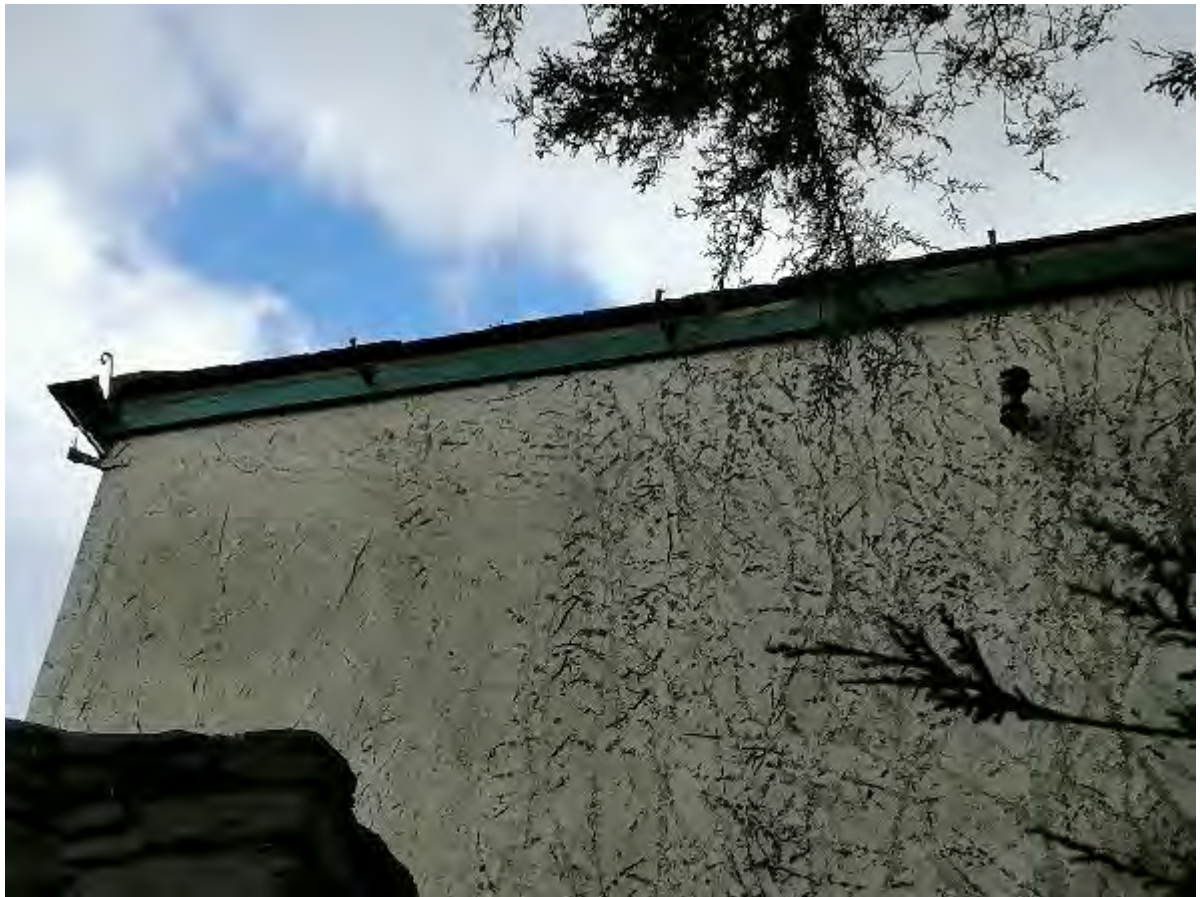
Photo 12 – Missing Guttering (Rear Roof Profile)

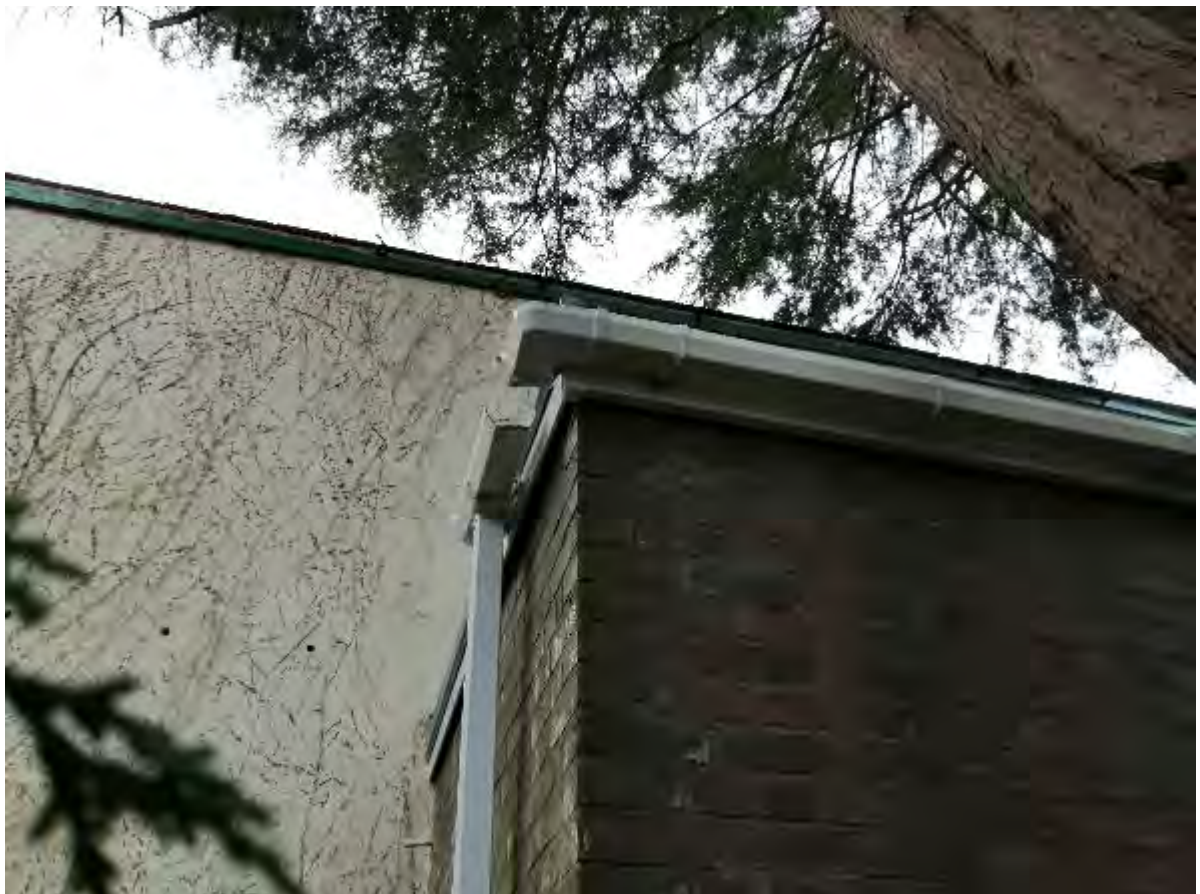
Photo 13 – Missing Guttering (Rear Roof Profile)

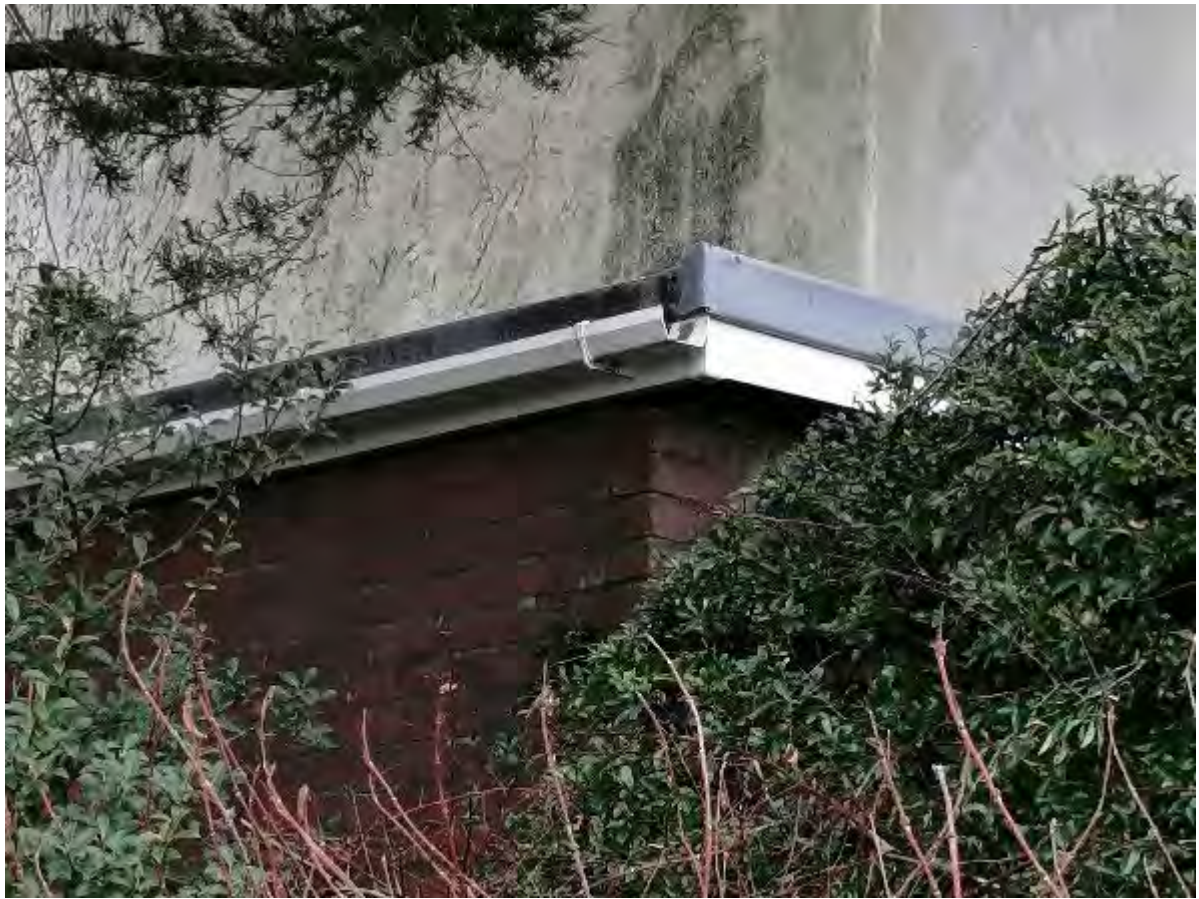
Photo 14 – Defective Guttering (Rear Roof Profile)

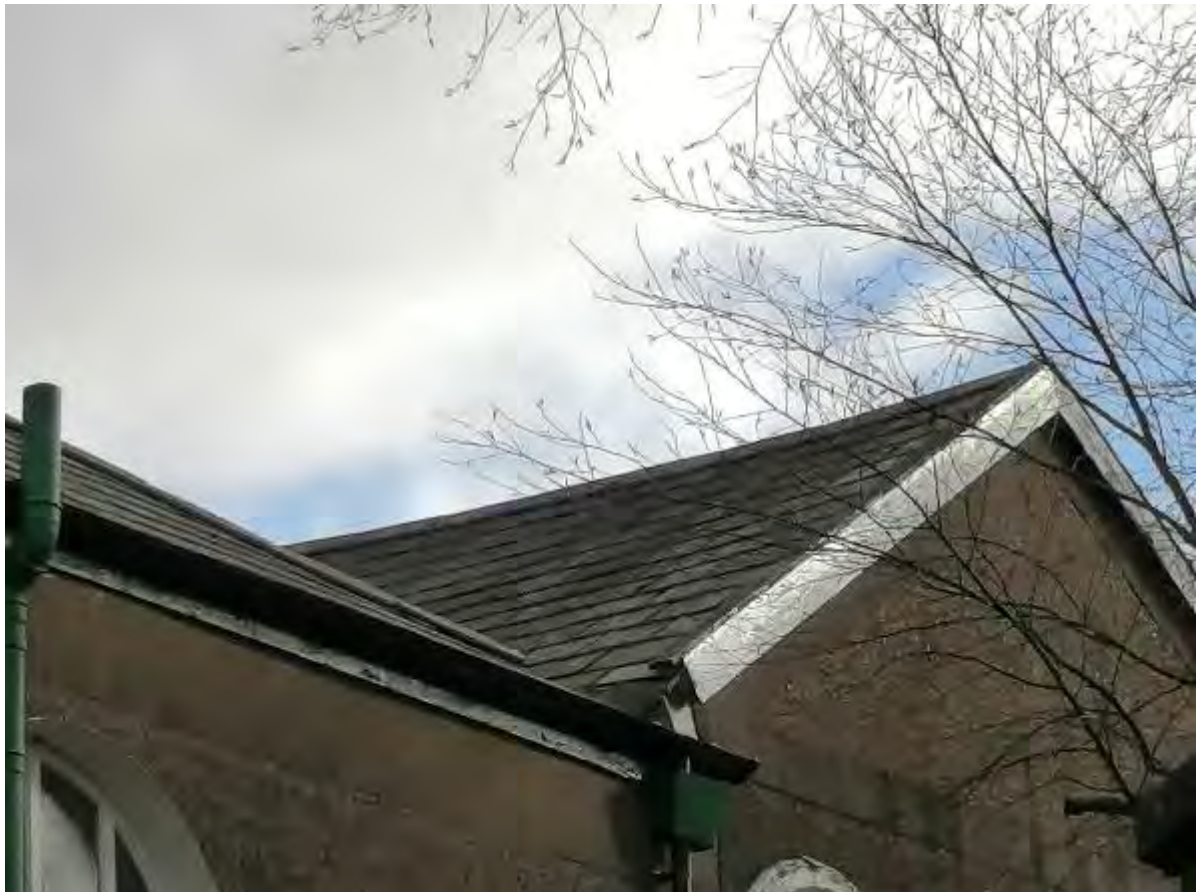
Photo 15 – Weathered Fascia Board (Left Roof Profile)

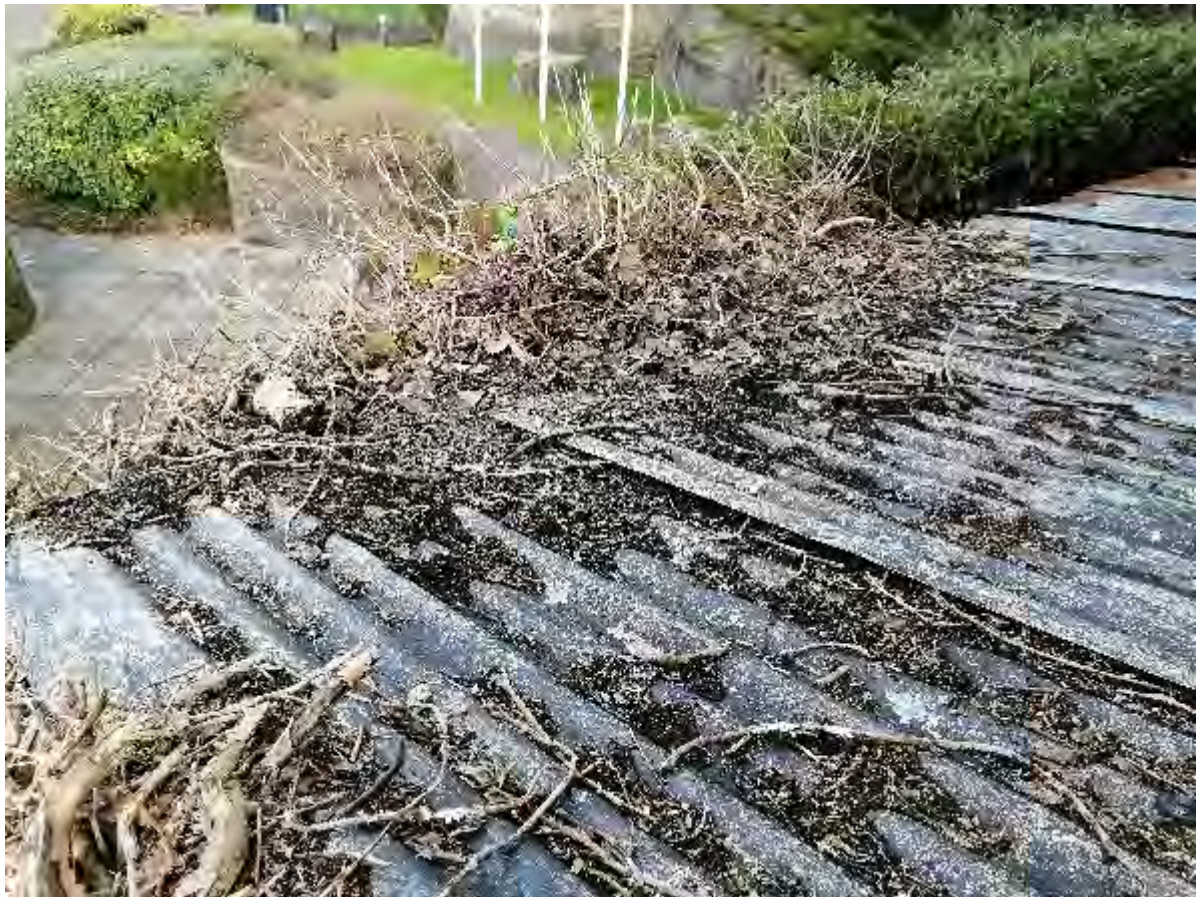
Photo 18 – Vegetation Growth and Corrosion to Sheeting Material (Rear Roof Profile)

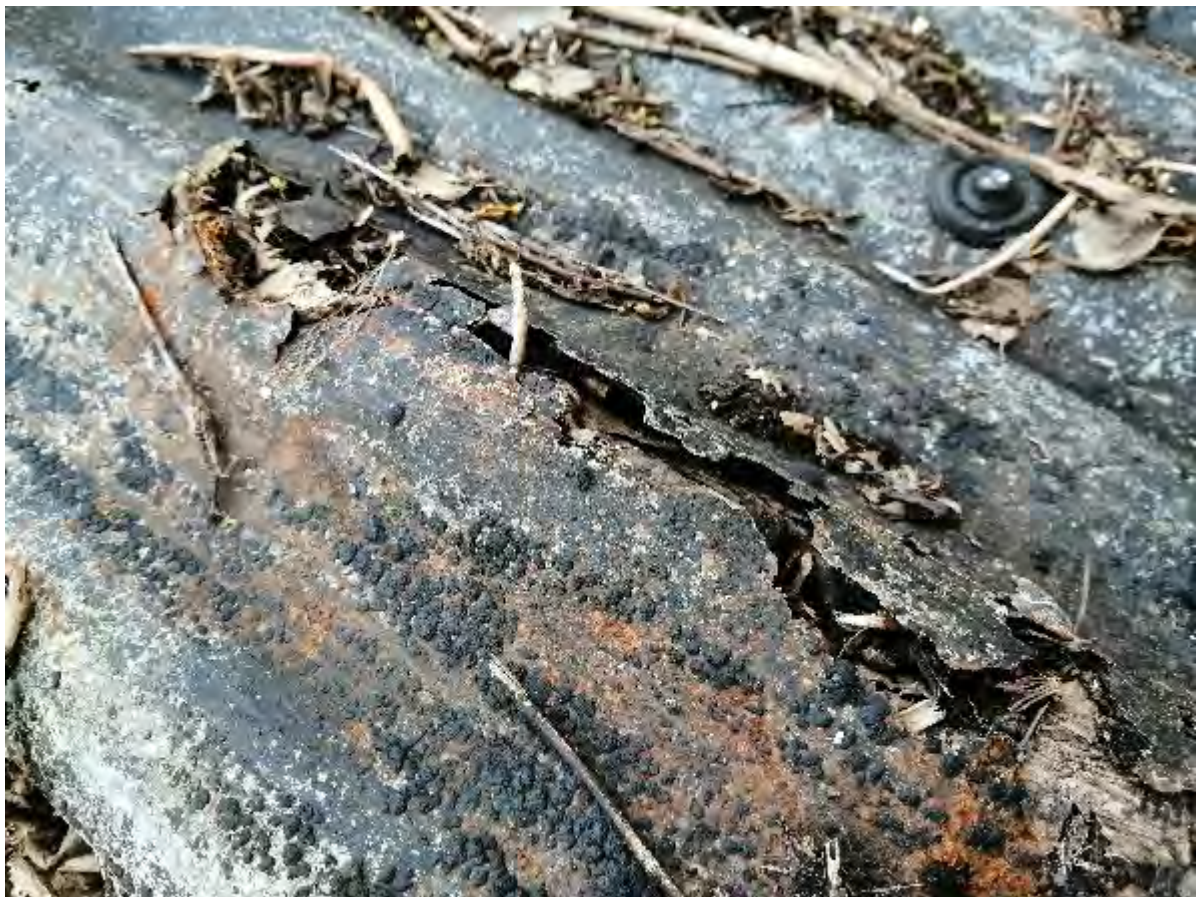
Photo 19 – Holes and Corrosion to Sheeting Material (Rear Roof Profile)

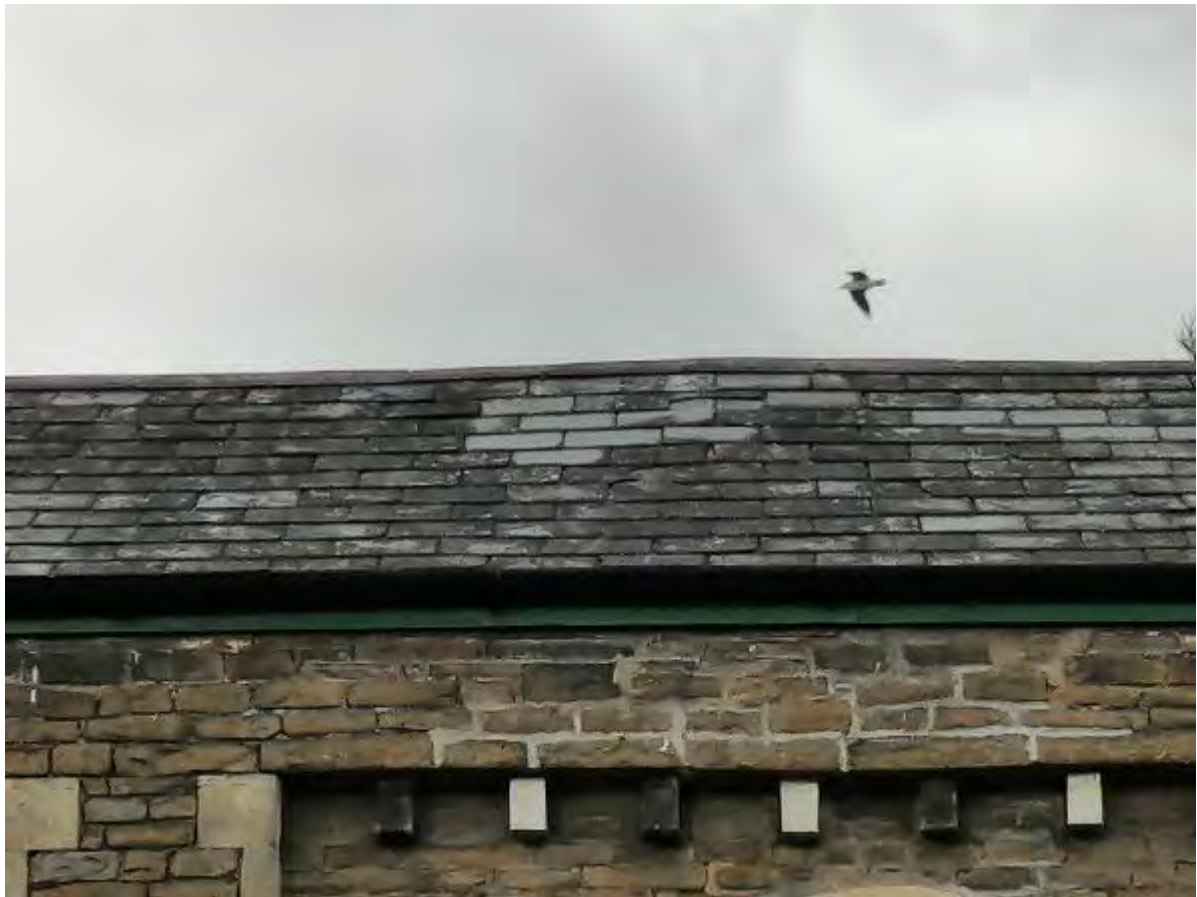
Photo 20 – Damaged Slate Tiles and Sagging to Roof (Front Roof Profile)

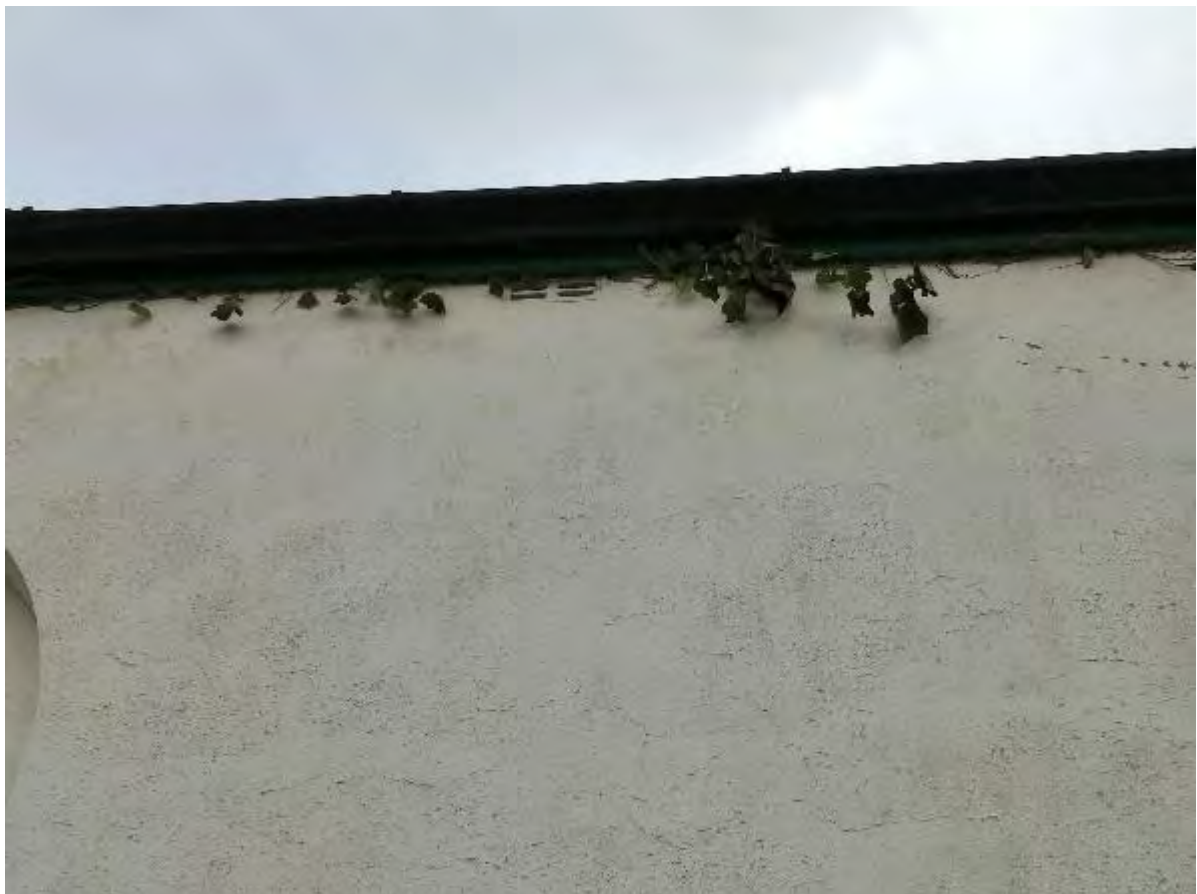
Photo 21 – Vegetation Growth (Right Roof Profile)

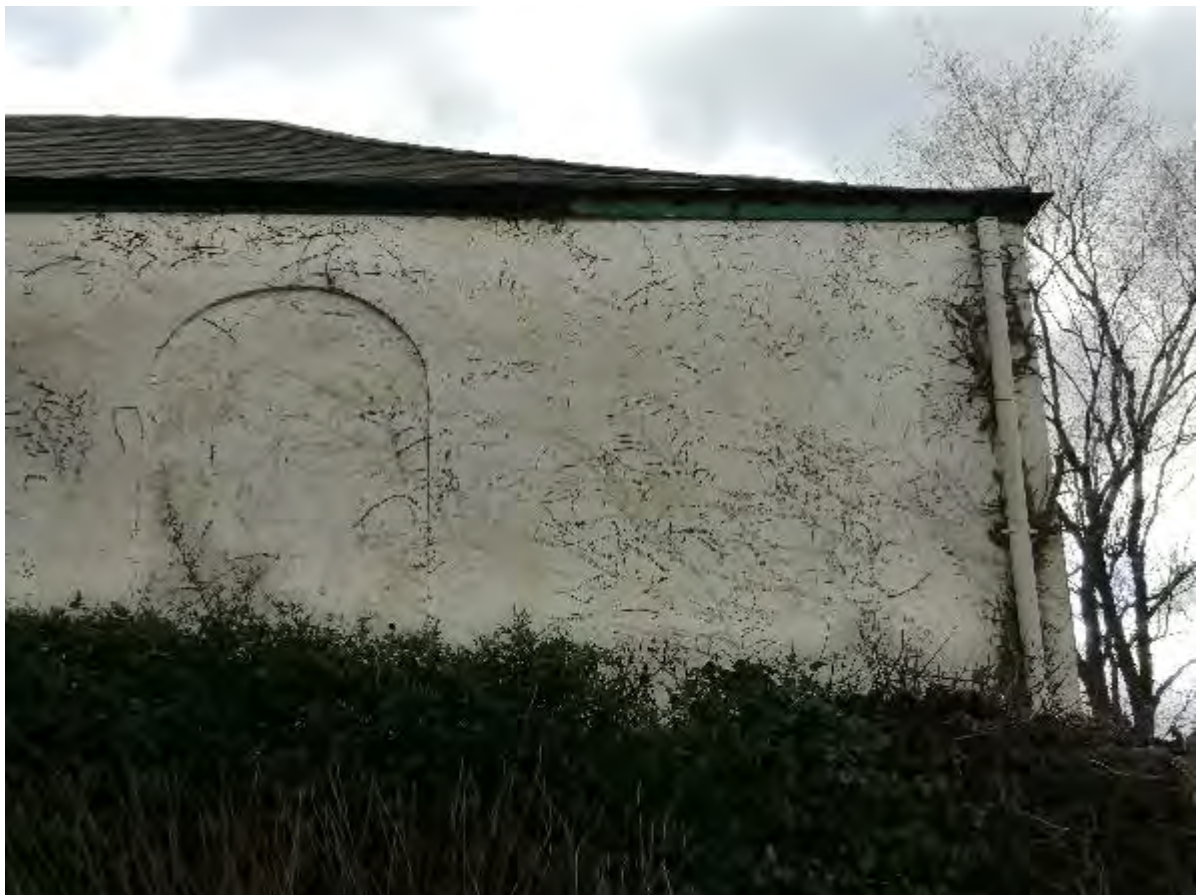
Photo 30 – Vegetation Growth (Rear Wall Elevation)

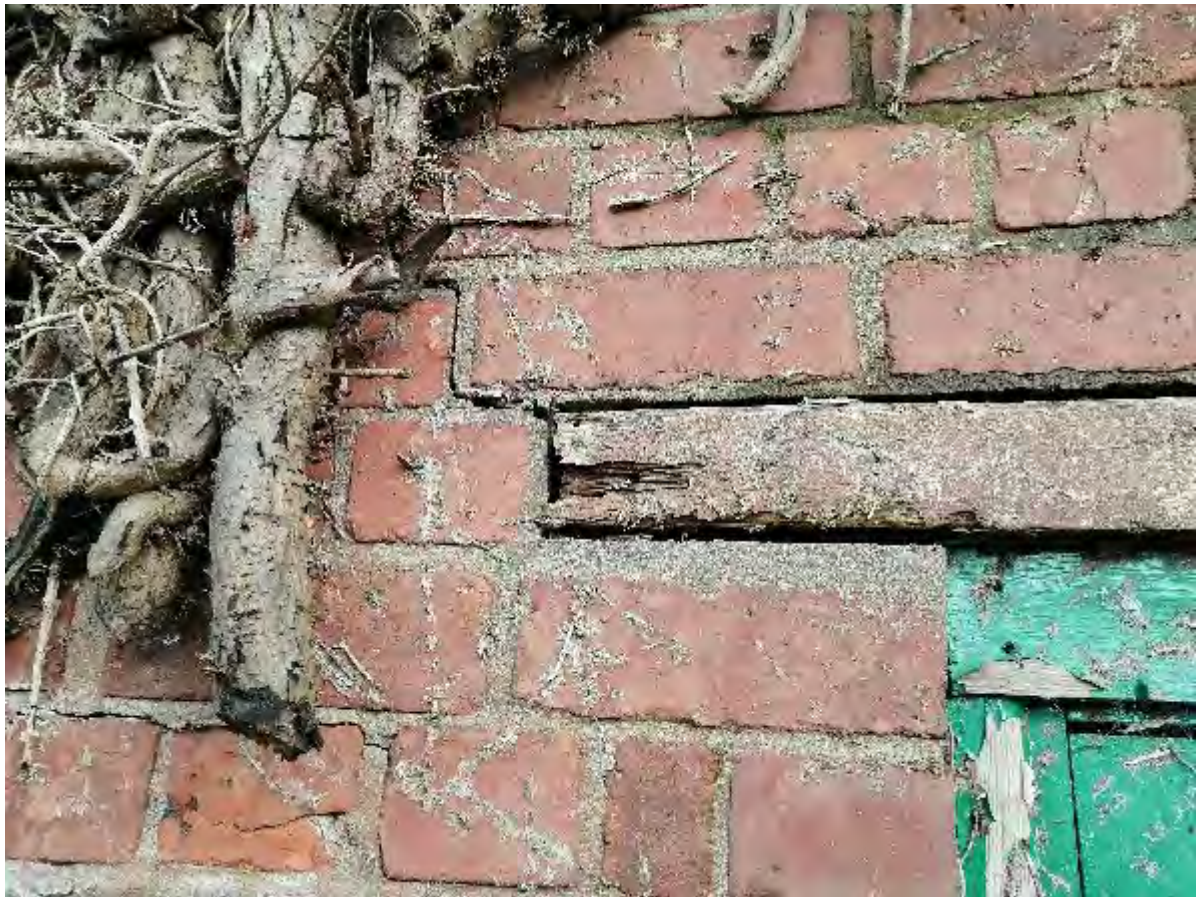
Photo 35 – Steped Cracking to Mortar and Rotten Doorway Lintel (Left Wall Elevation)

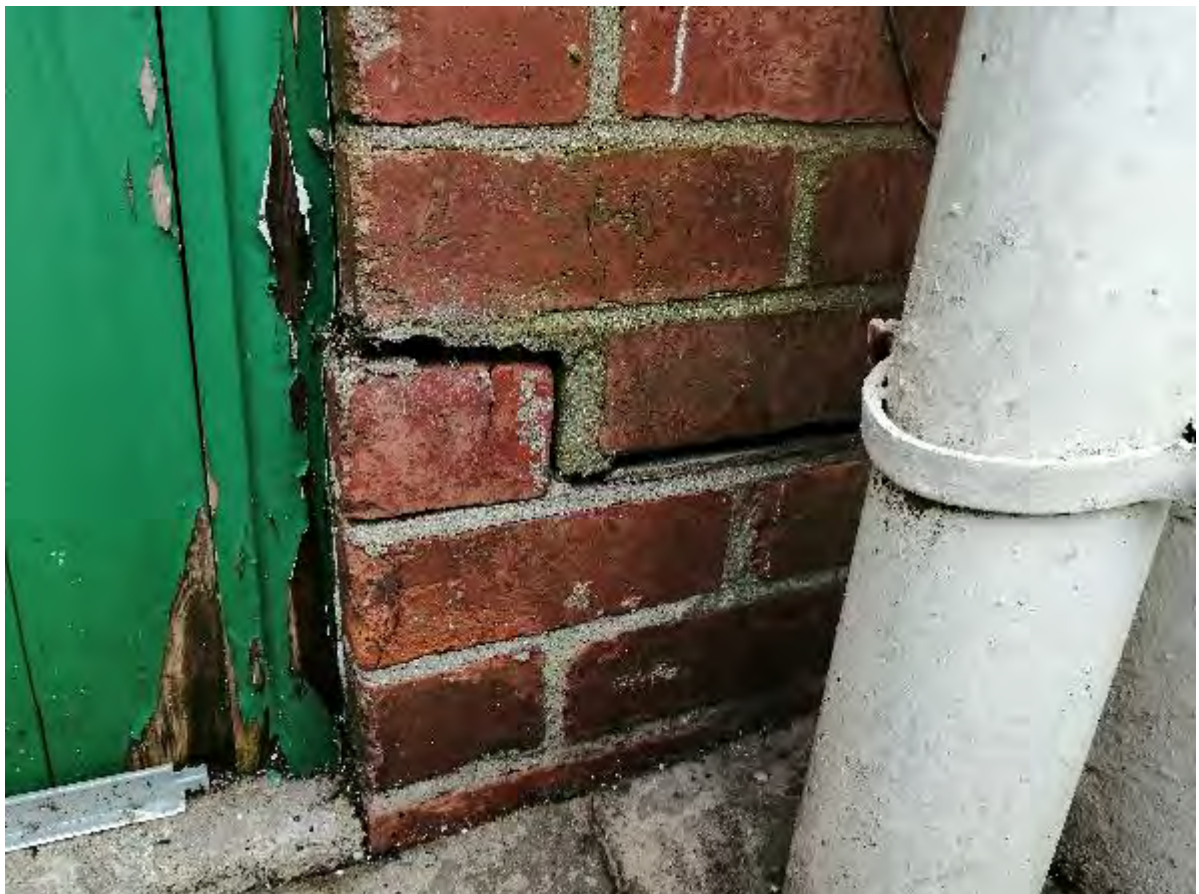
Photo 36 – Cracking to Mortar (Left Wall Elevation)

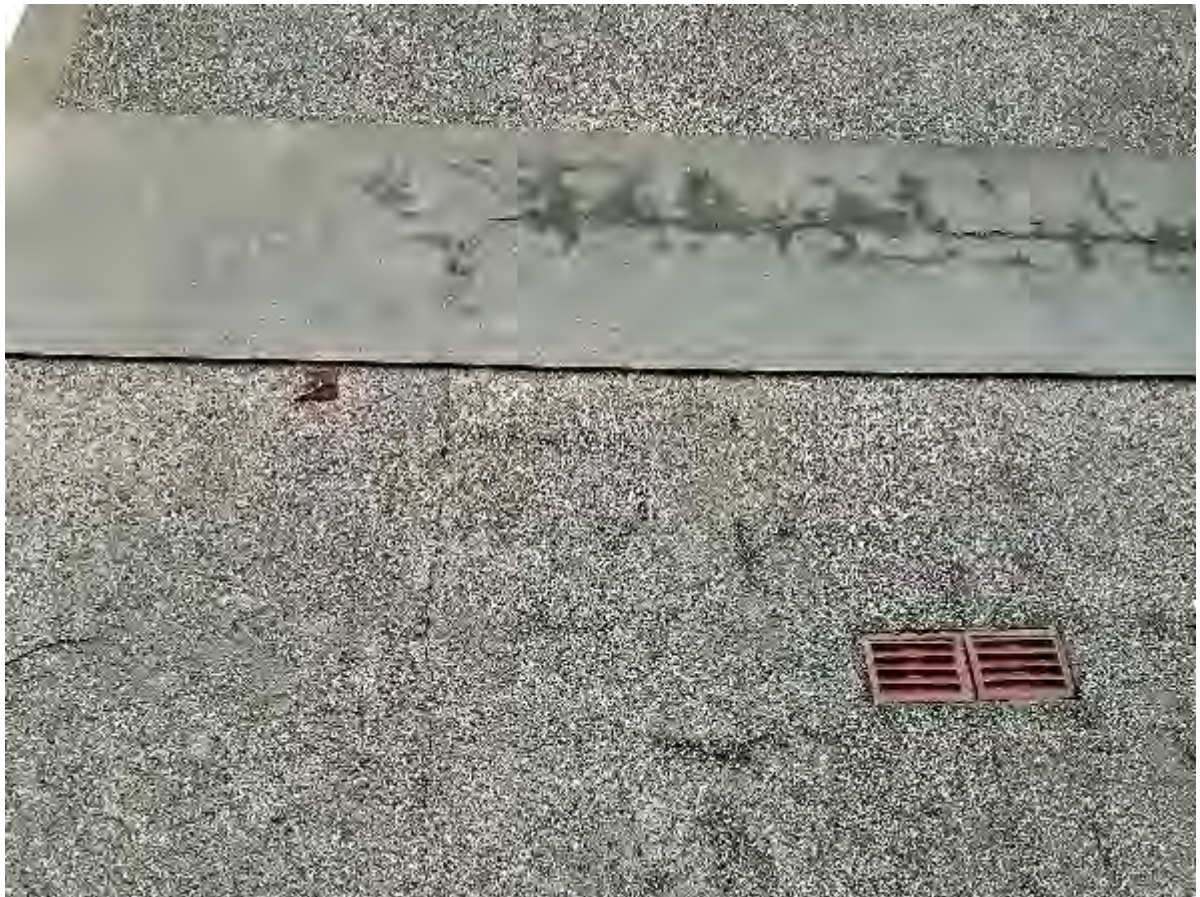
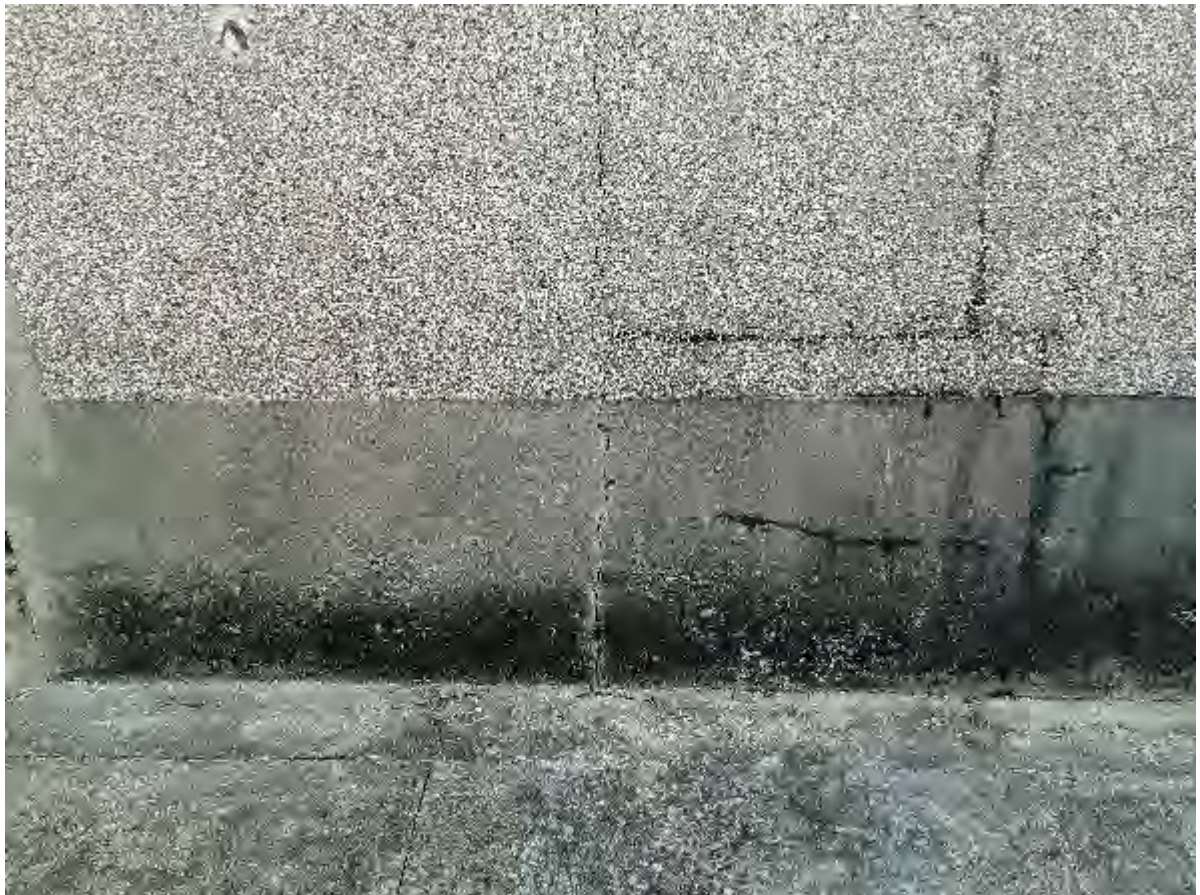
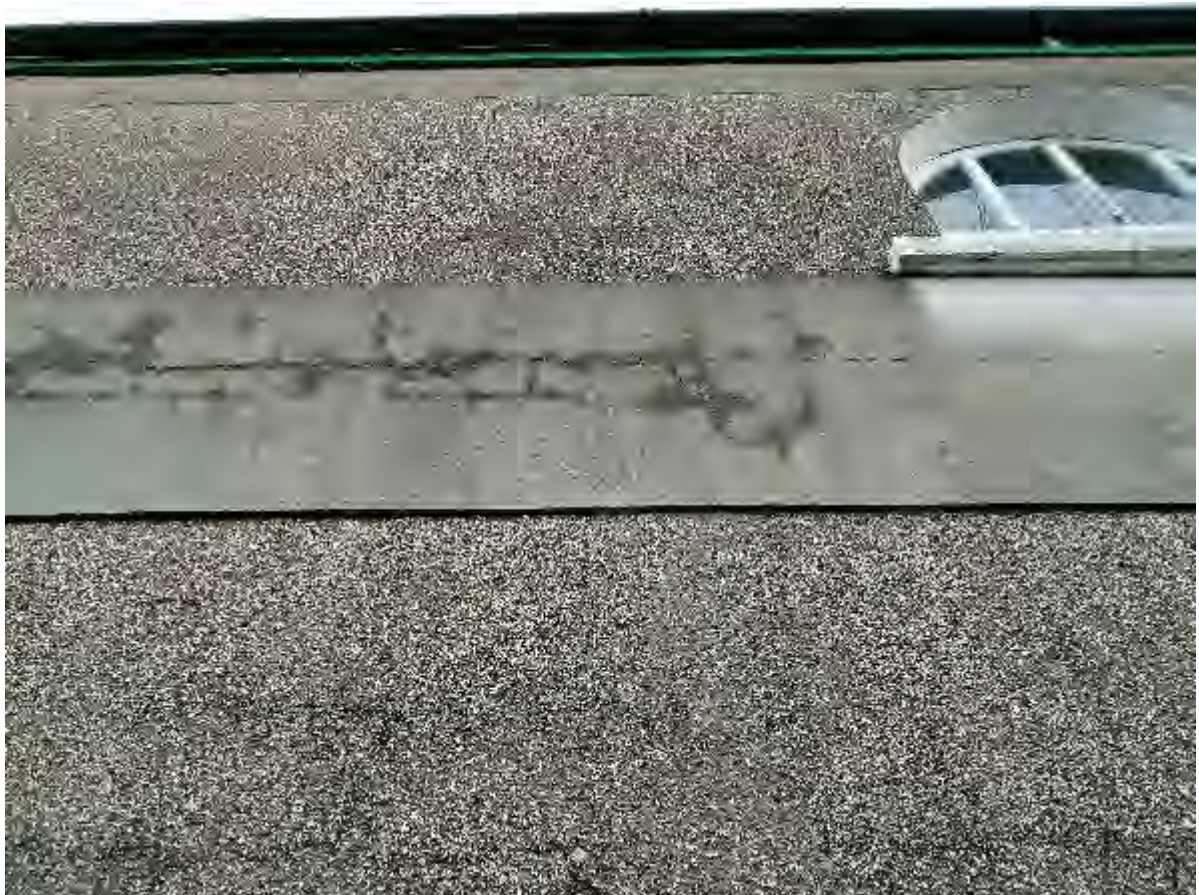
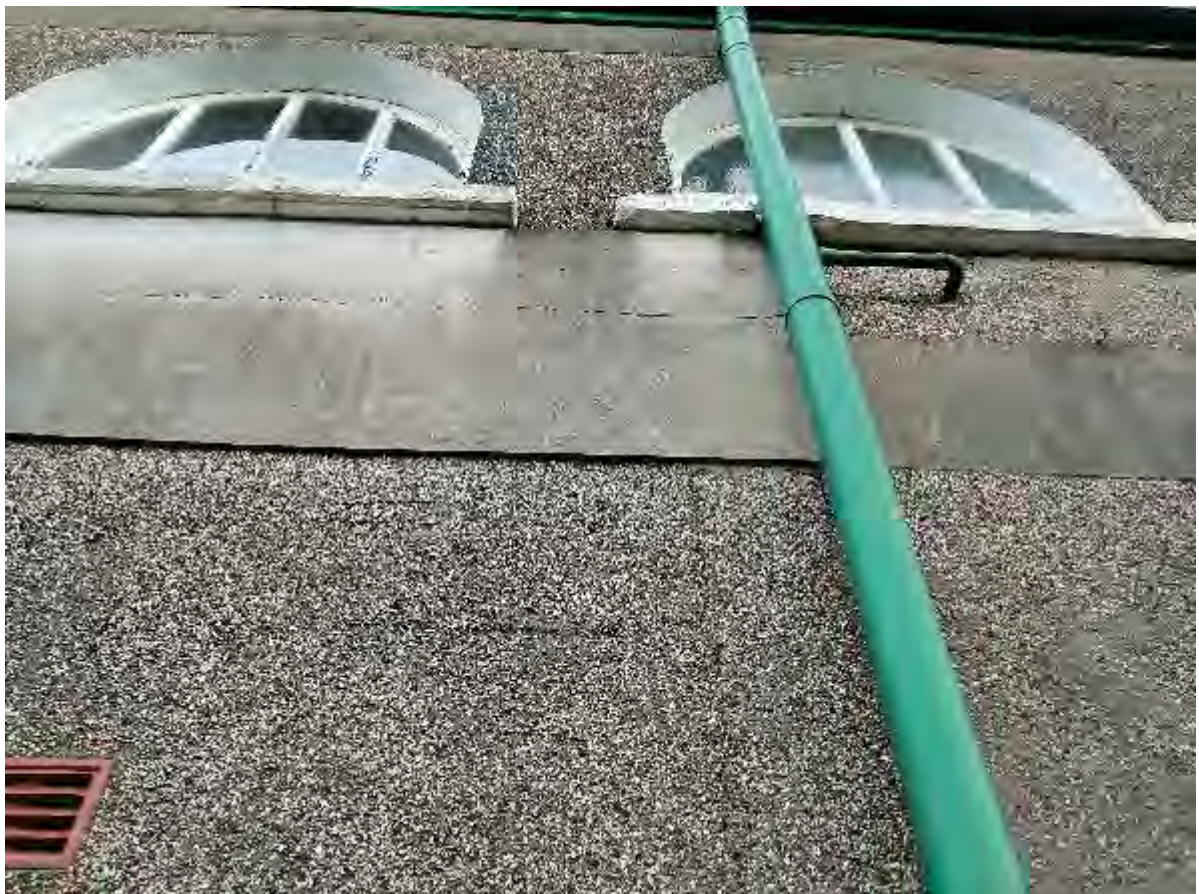
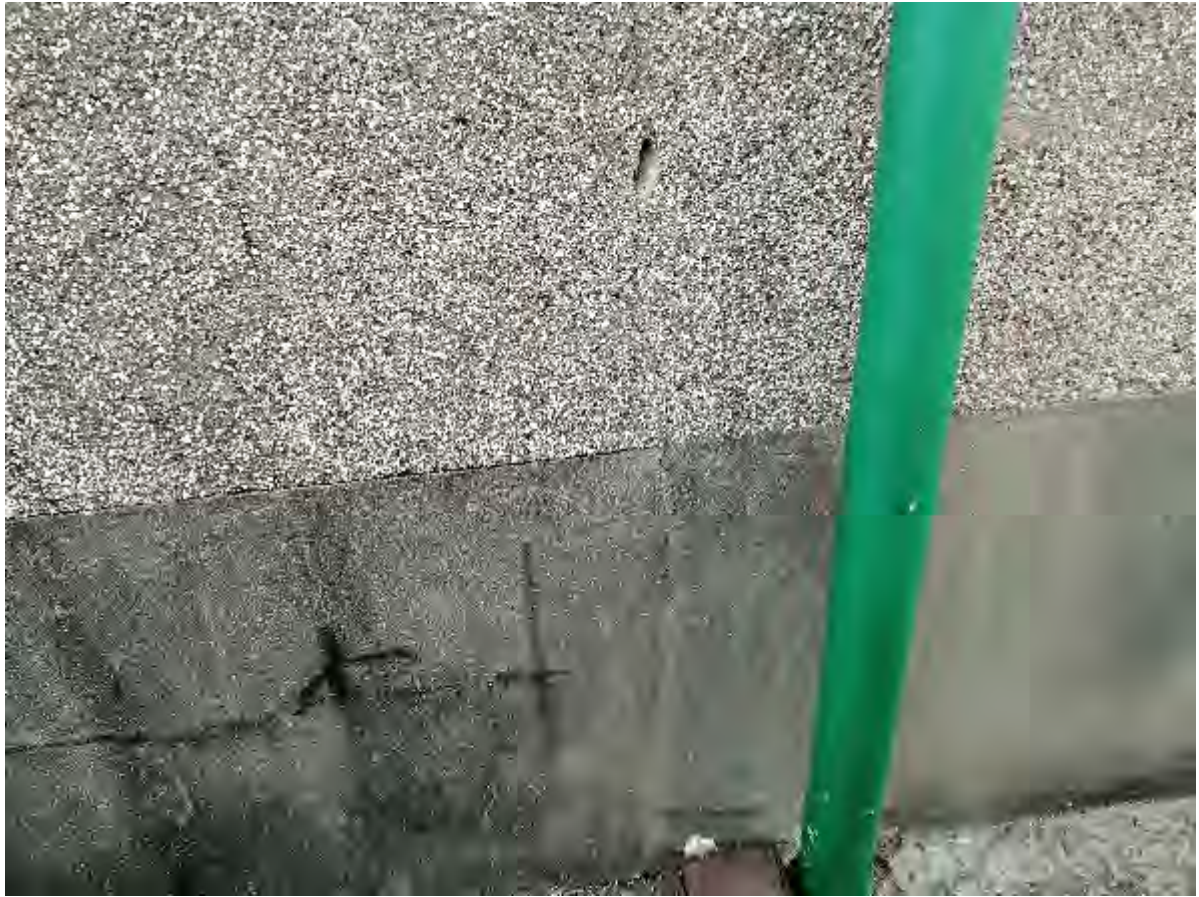
Photo 37 – Render Cracking Around Old Opening (Left Wall Elevation)
