**Structural Survey (Inspection)**

**Moose Hall  
Castle Street  
Neath  
SA11 3LU**

Structural Surveys UK were commissioned to undertake a Full Structural Survey (Inspection) to a residential property at Moose Hall, Castle Street in Neath.

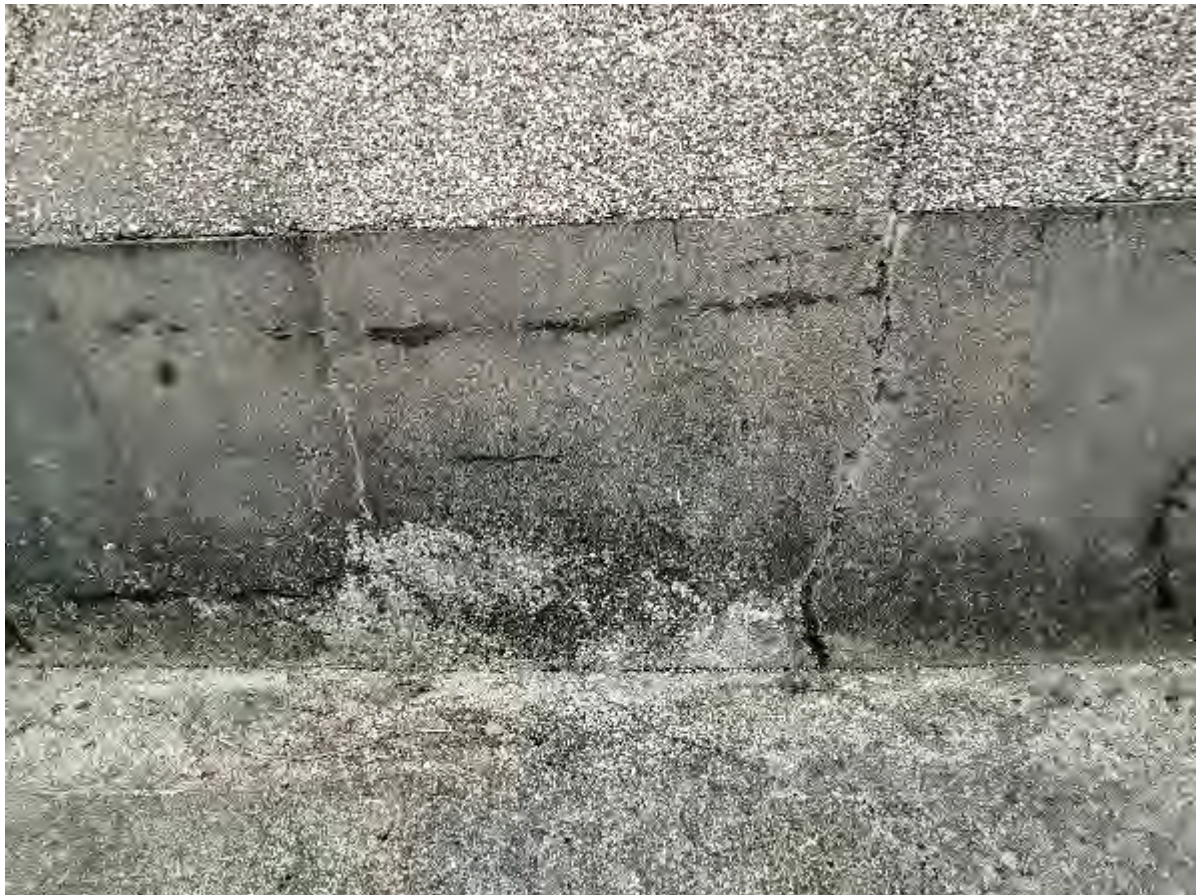
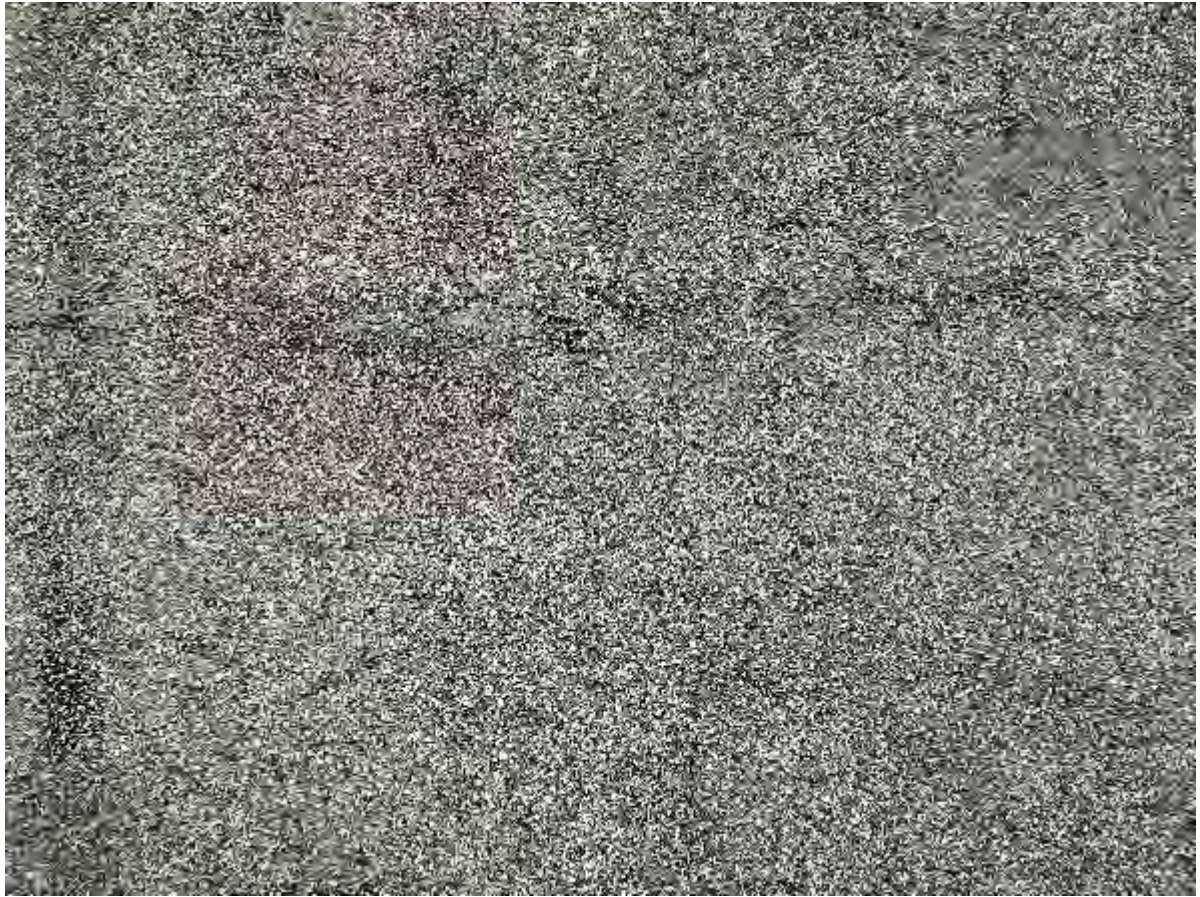
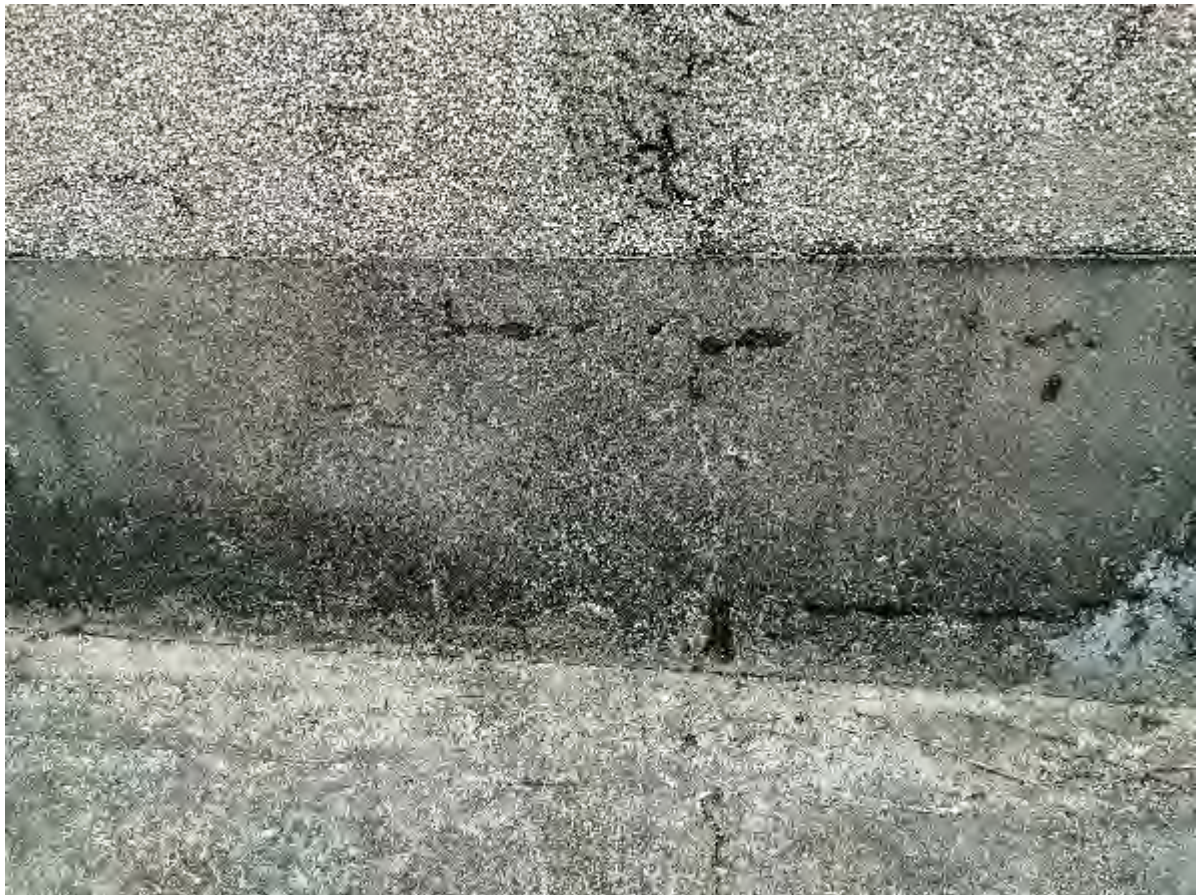
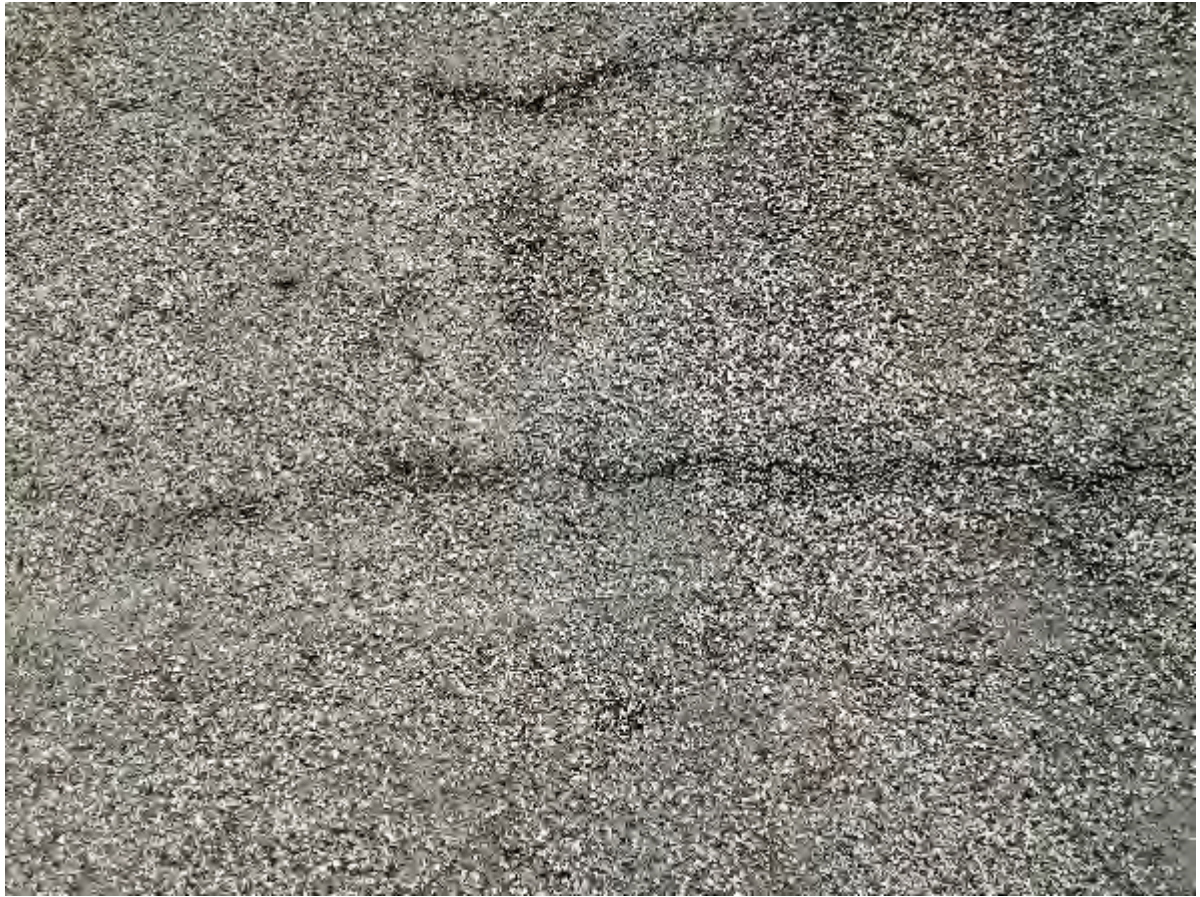
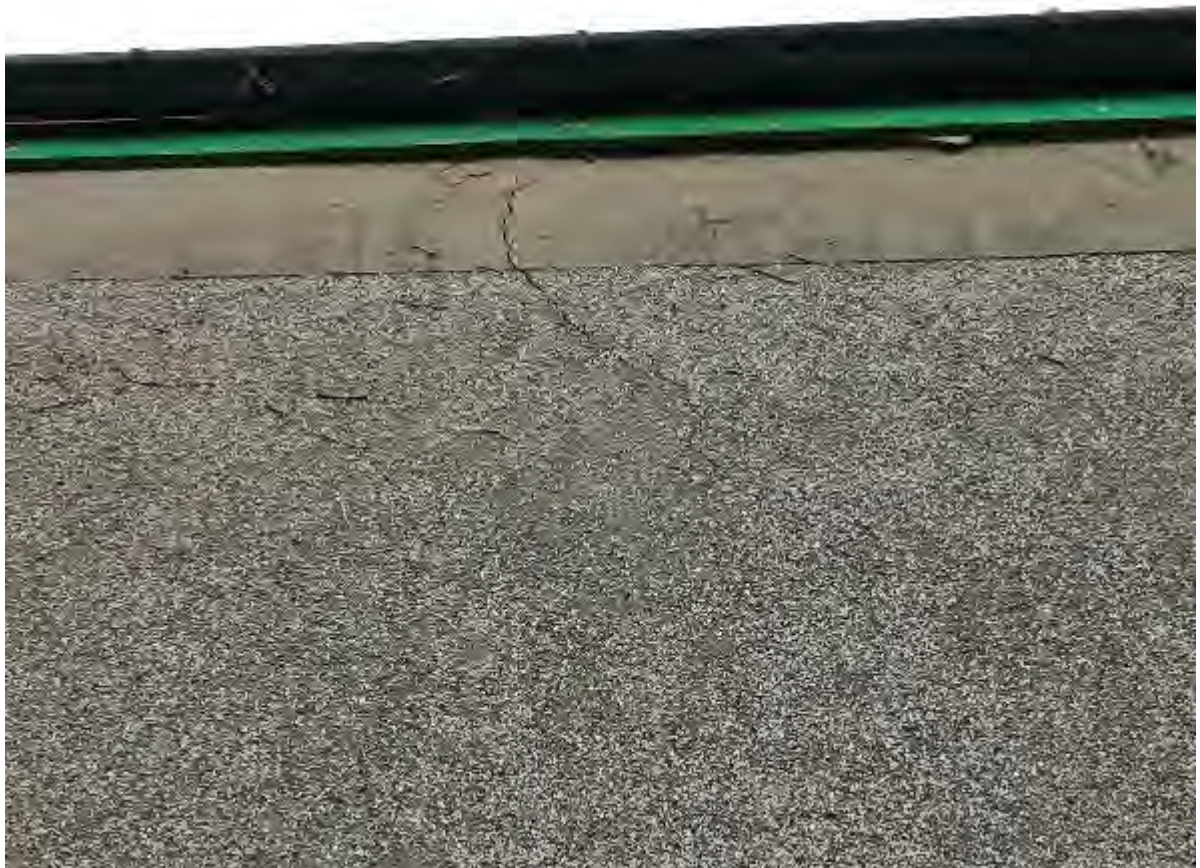
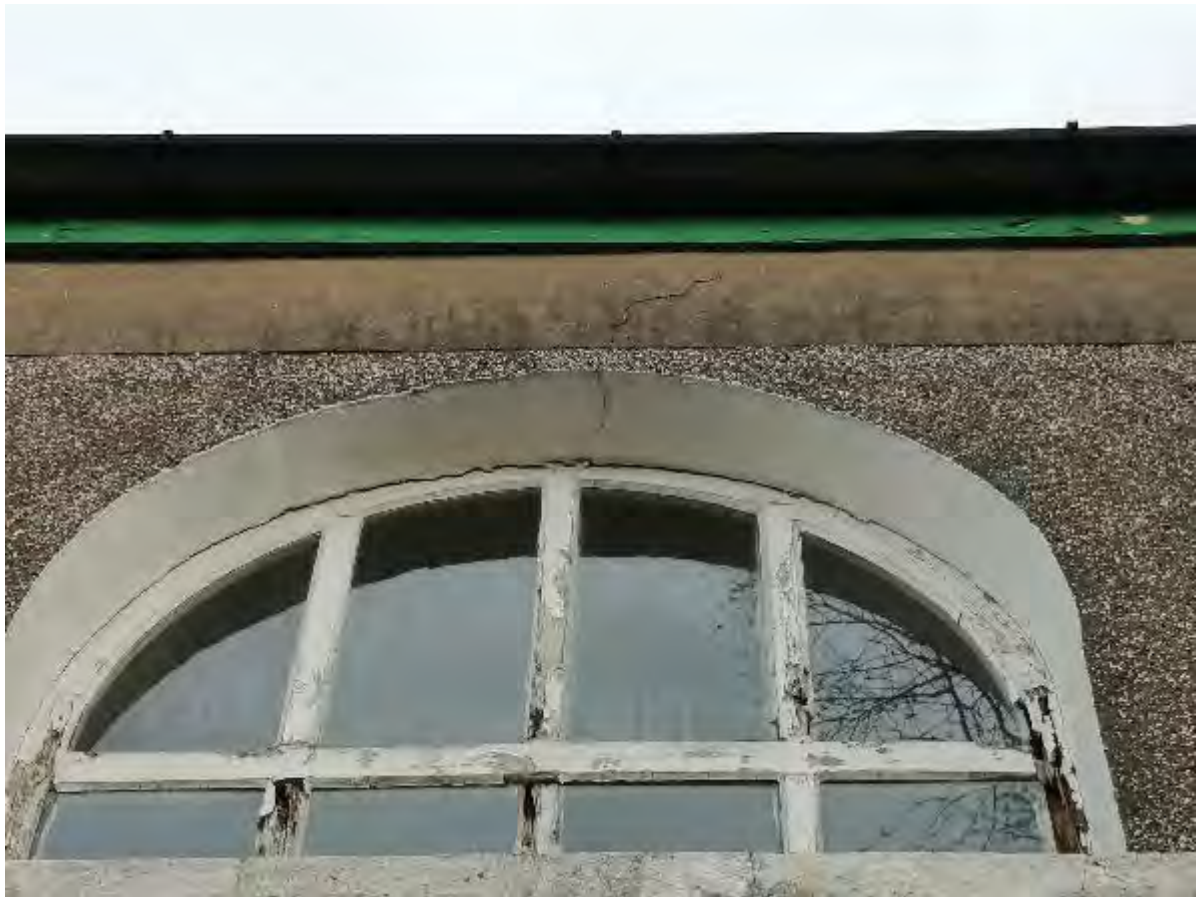
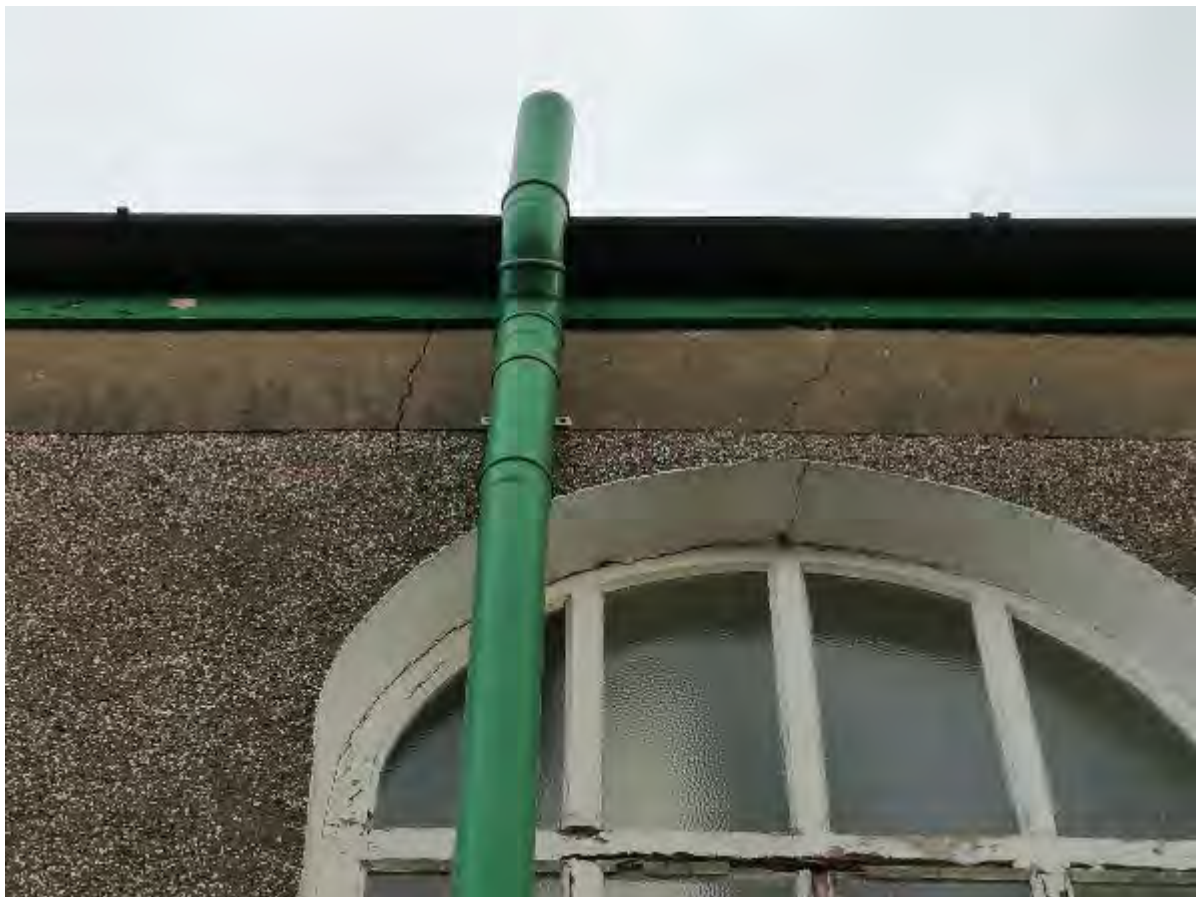
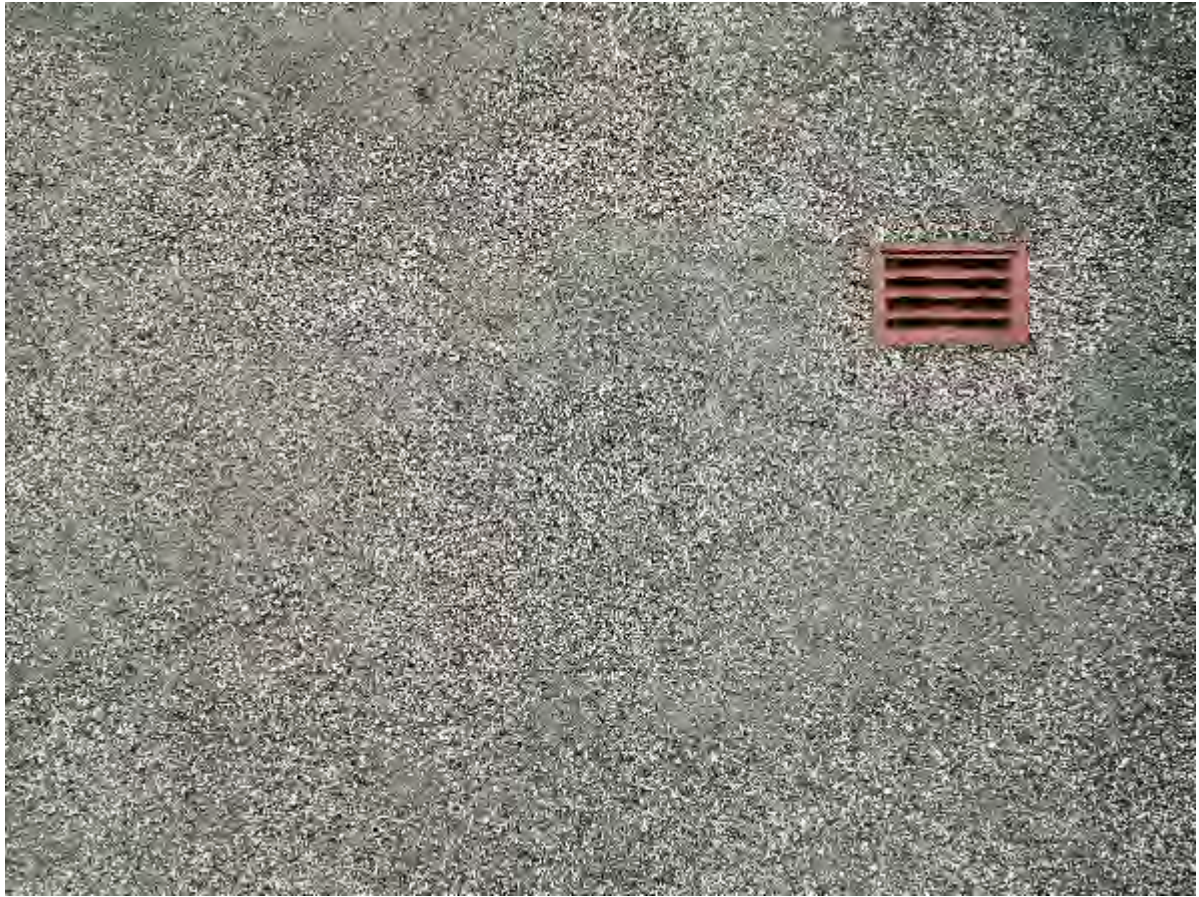
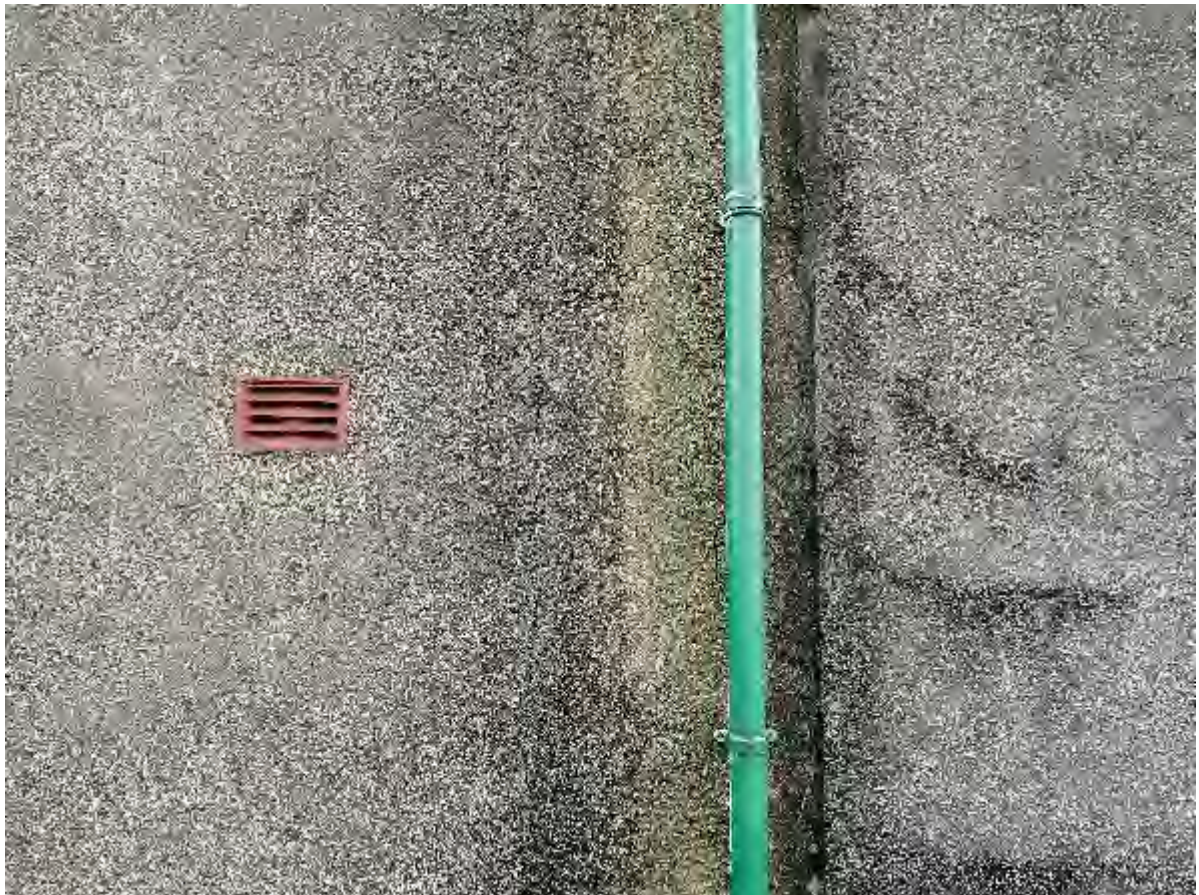
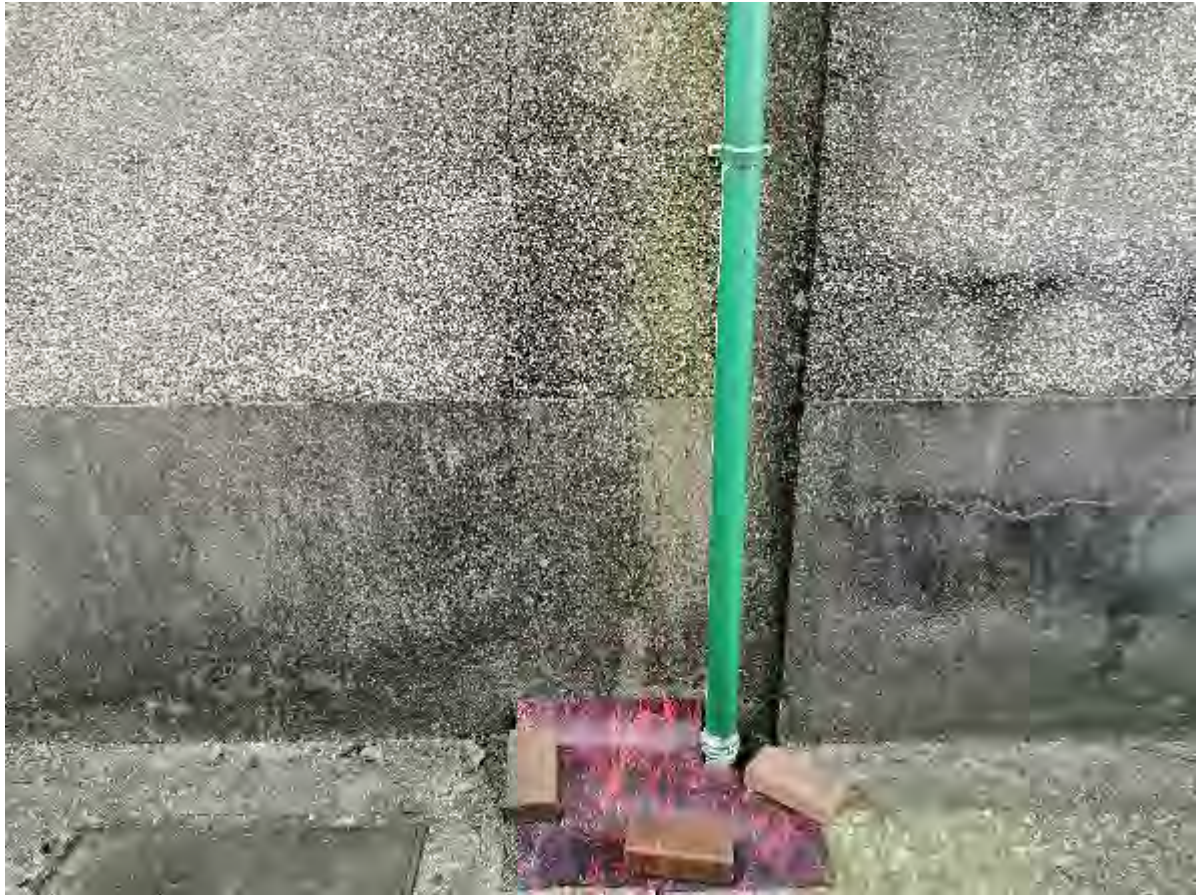
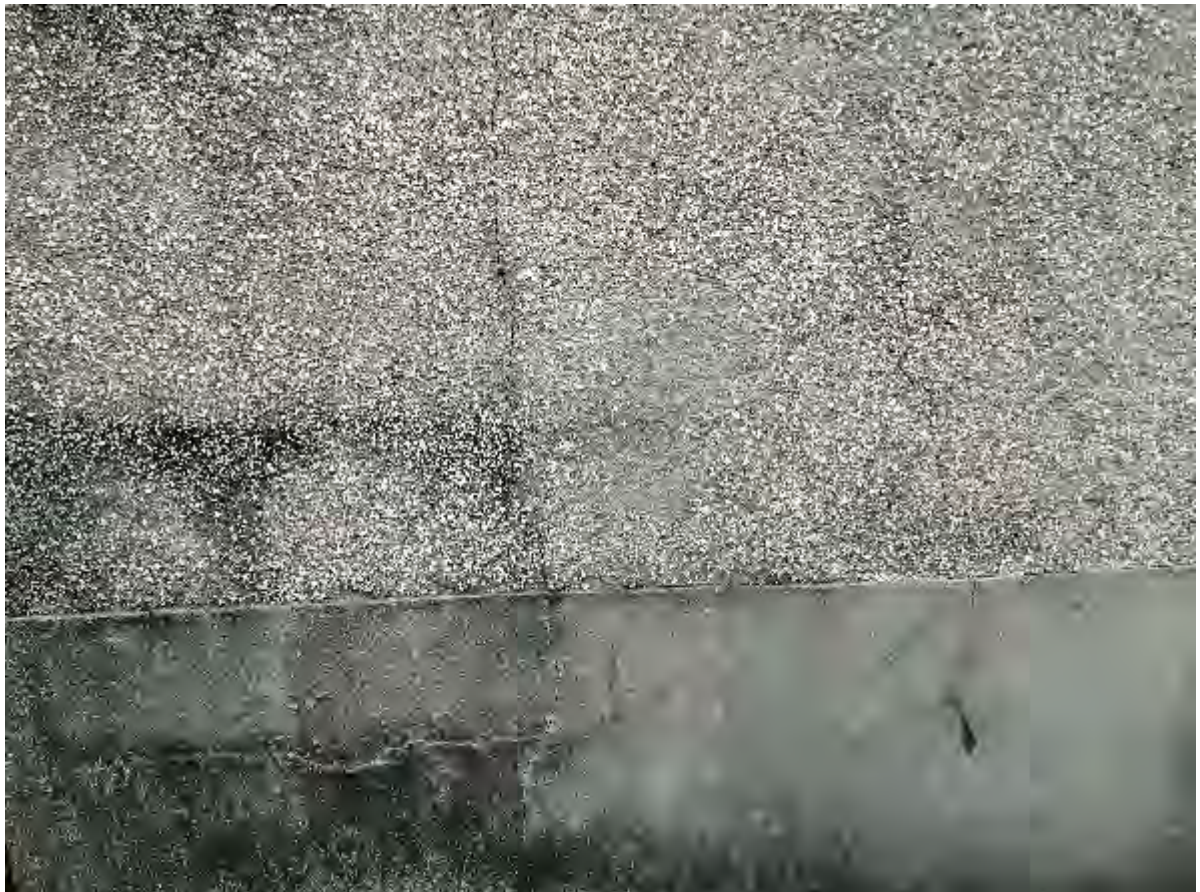
Our inspection of the external walls confirmed shrinkage cracking (damage category 1 to 2) to the left and right wall elevations – see Photos 42-51, 54, 74-83, 85 and 87 below. This cracking is considered ‘non-structural’ and has most likely developed initially during construction, i.e. due to poor preparation and mix design of the render, poor application and inadequate curing (which will have led to the render drying out prematurely and cracking over time). Moisture effects will have also exacerbated the development of these cracks through repeated wetting and drying. This cracking is low grade in nature and expected to be confined to the external render only. There is no loss of structural support or failure of the wall panel at this location. Minor local crack repair works are required. The condition of the external render is expected to be part of the cause of the majority of the penetrating damp throughout the property (discussed later in the report) - Condition Rating **2** See Section 7.0 Recommendations for guidance on repair works required.

Photo 42 – Render Shrinkage Cracking (Left Wall Elevation)

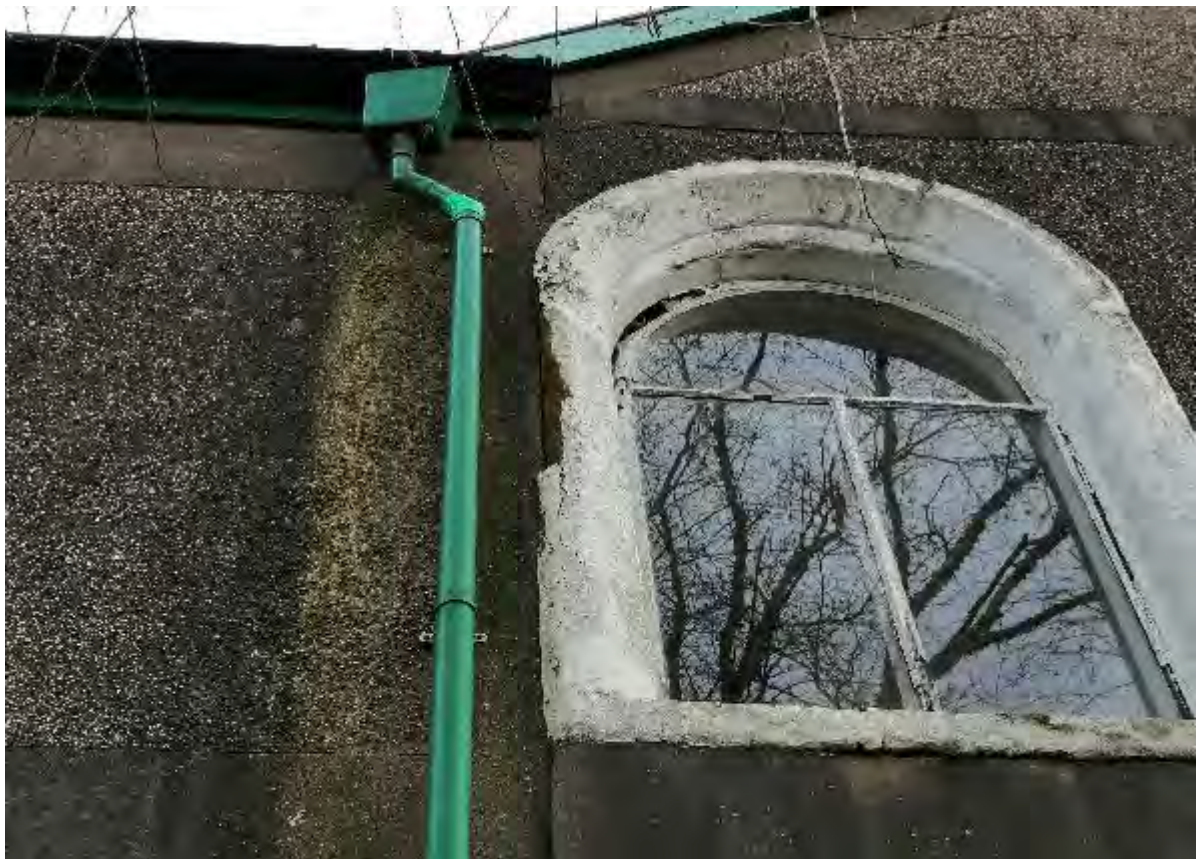
Photo 52 – Cracking Between Original Property and Front Extension and Rot to Timber Window Frame (Left Wall Elevation)

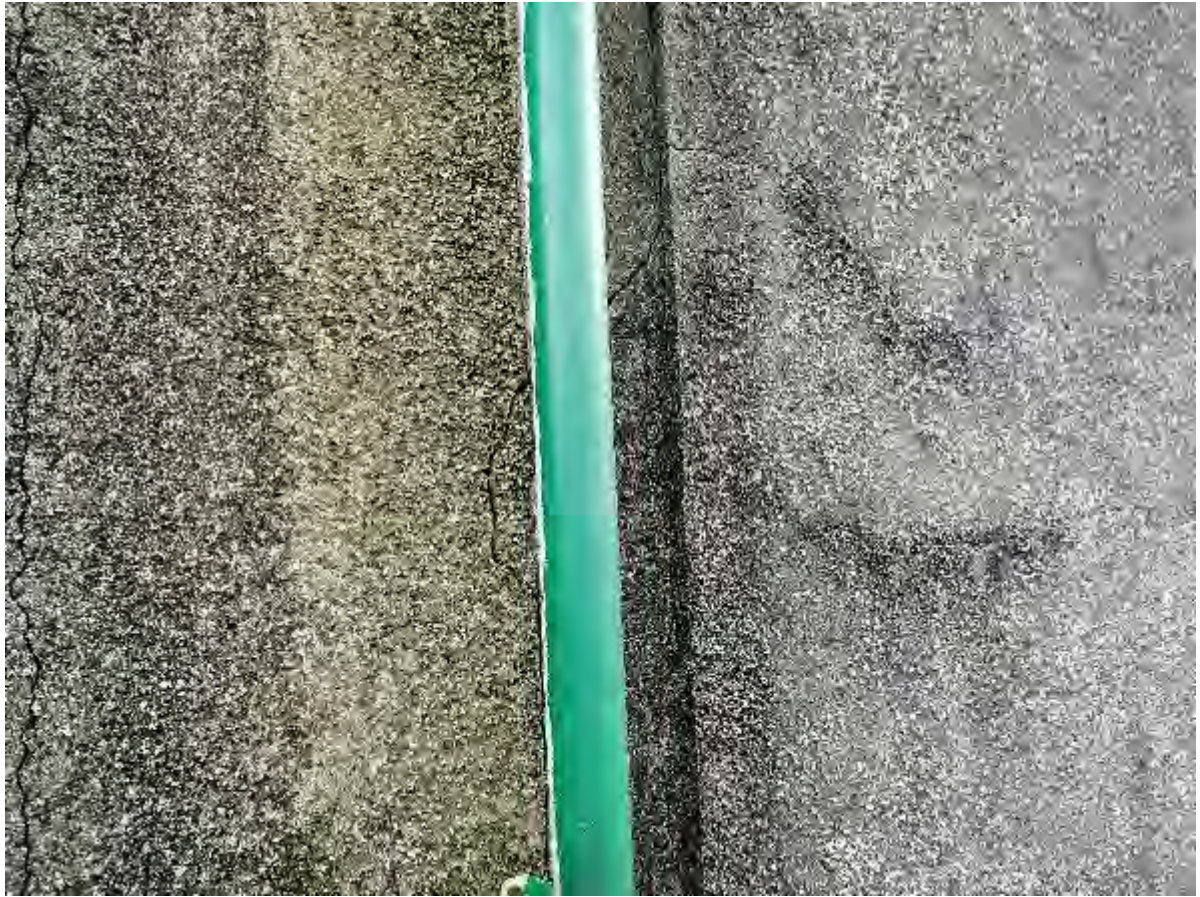
Photo 53 – Cracking Between Original Property and Front Extension (Left Wall Elevation)

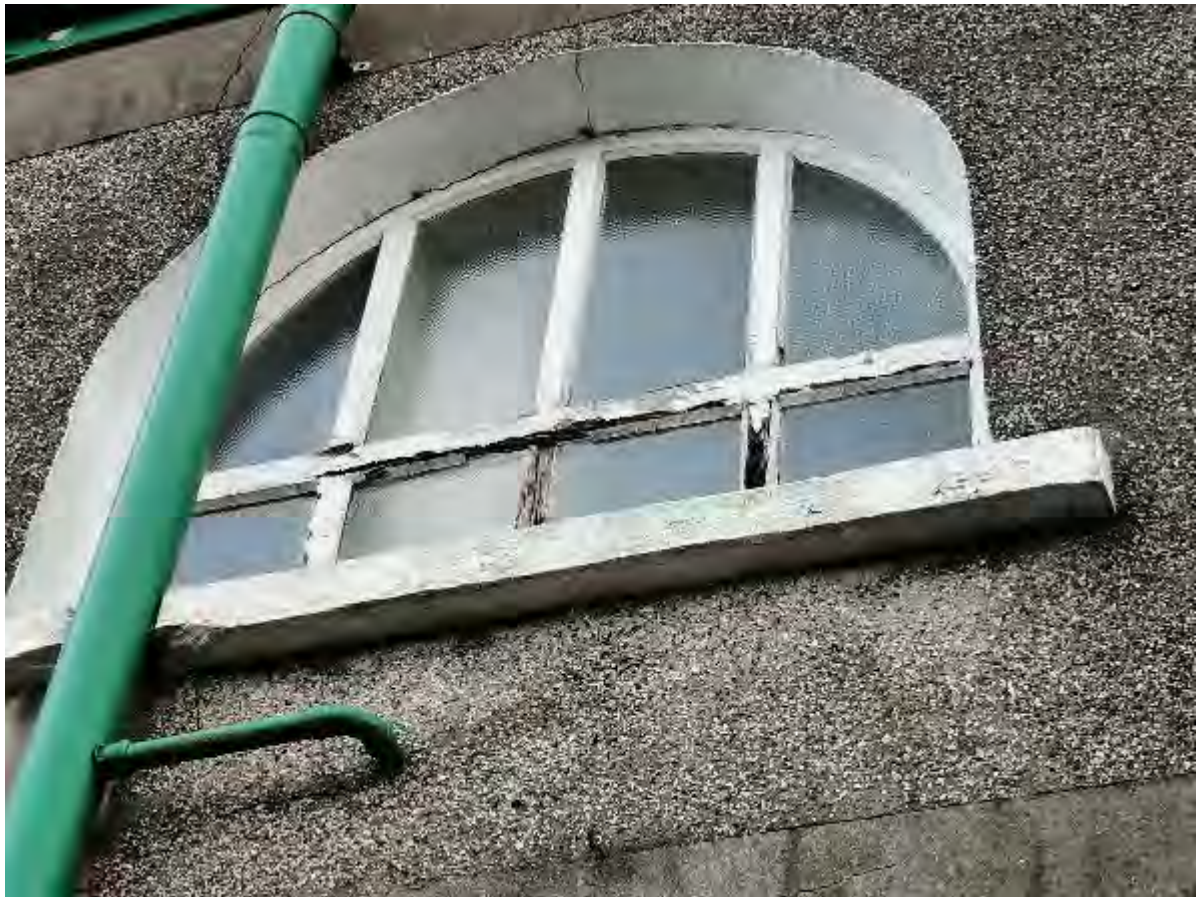
Photo 55 – Rot to Timber Window Frame (Left Wall Elevation)

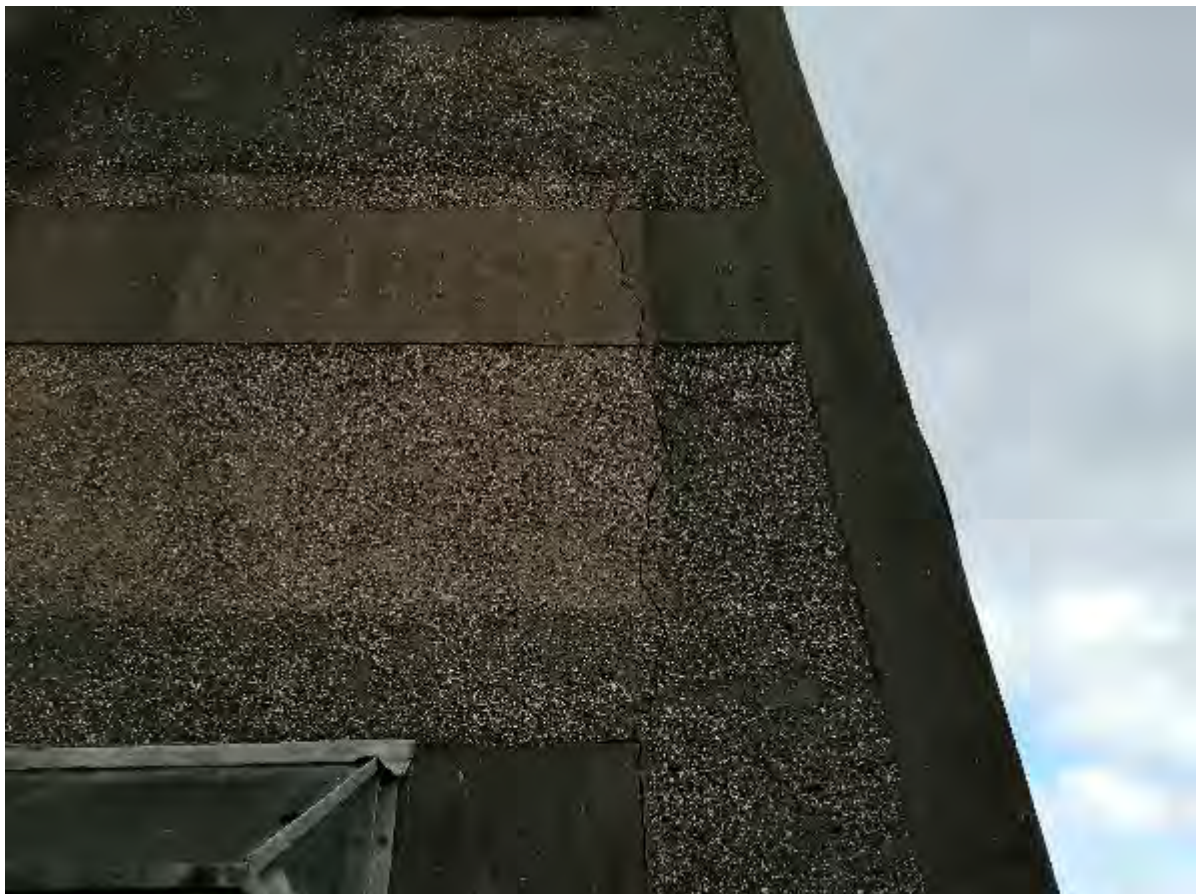
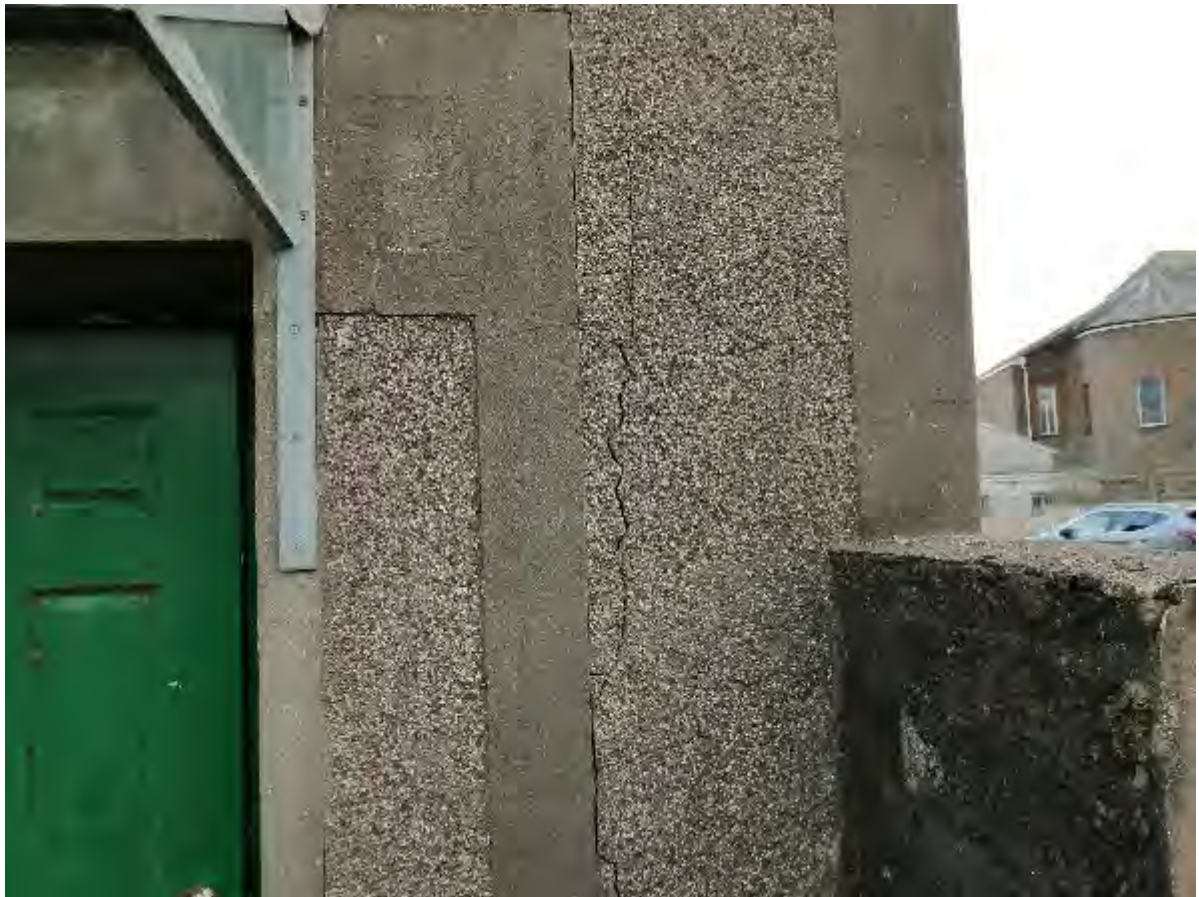
Photo 56 – Wall Crack (Left Wall Elevation)

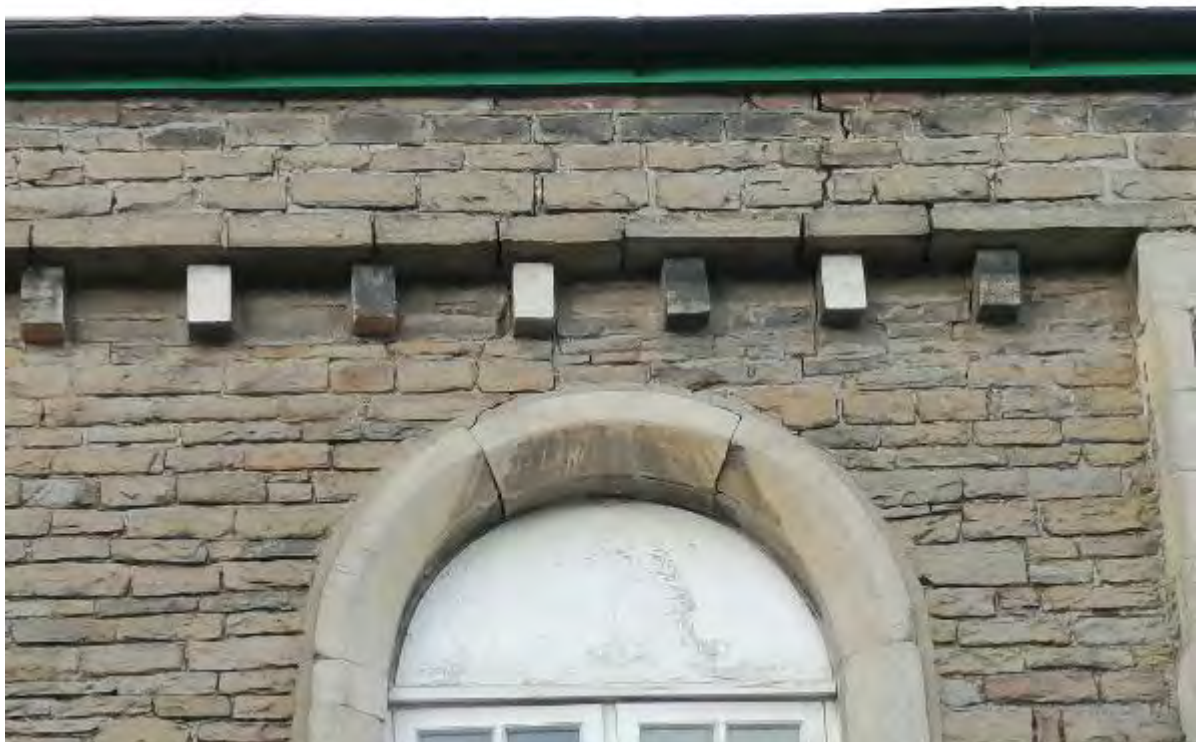
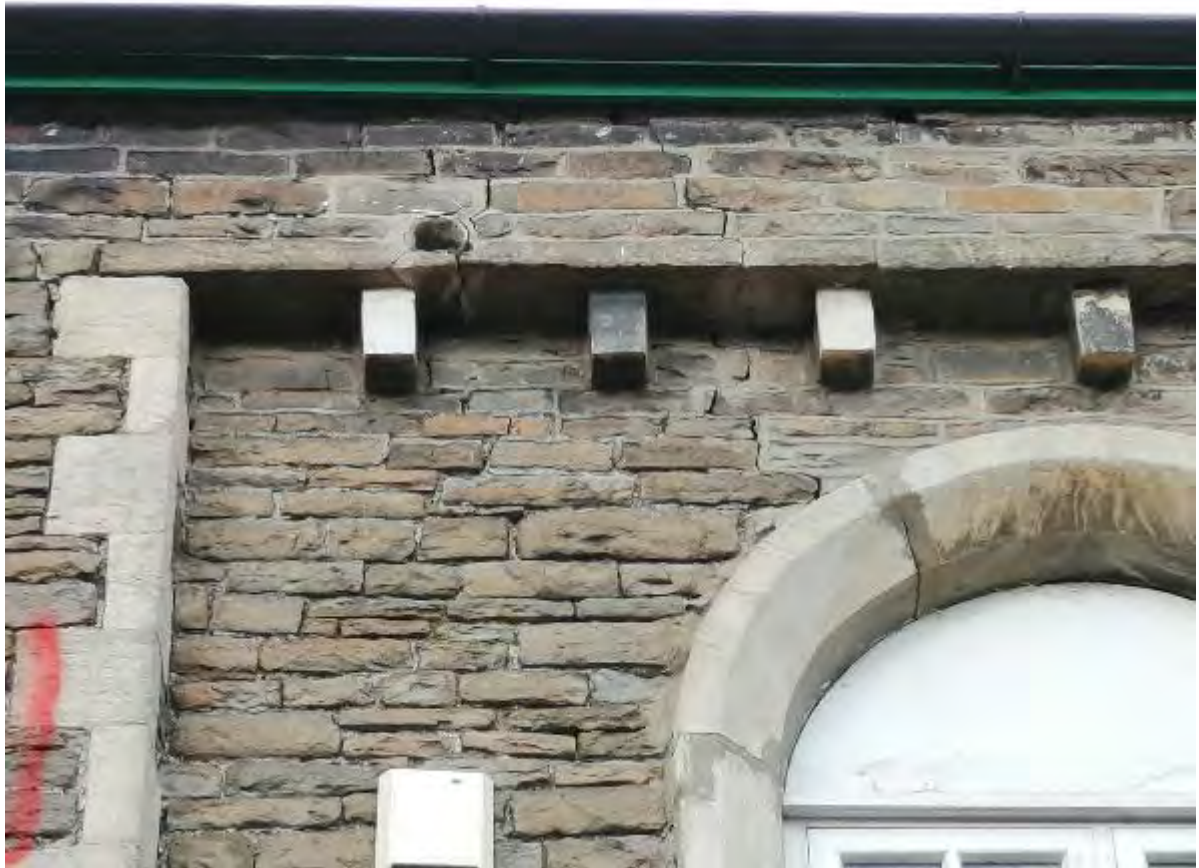
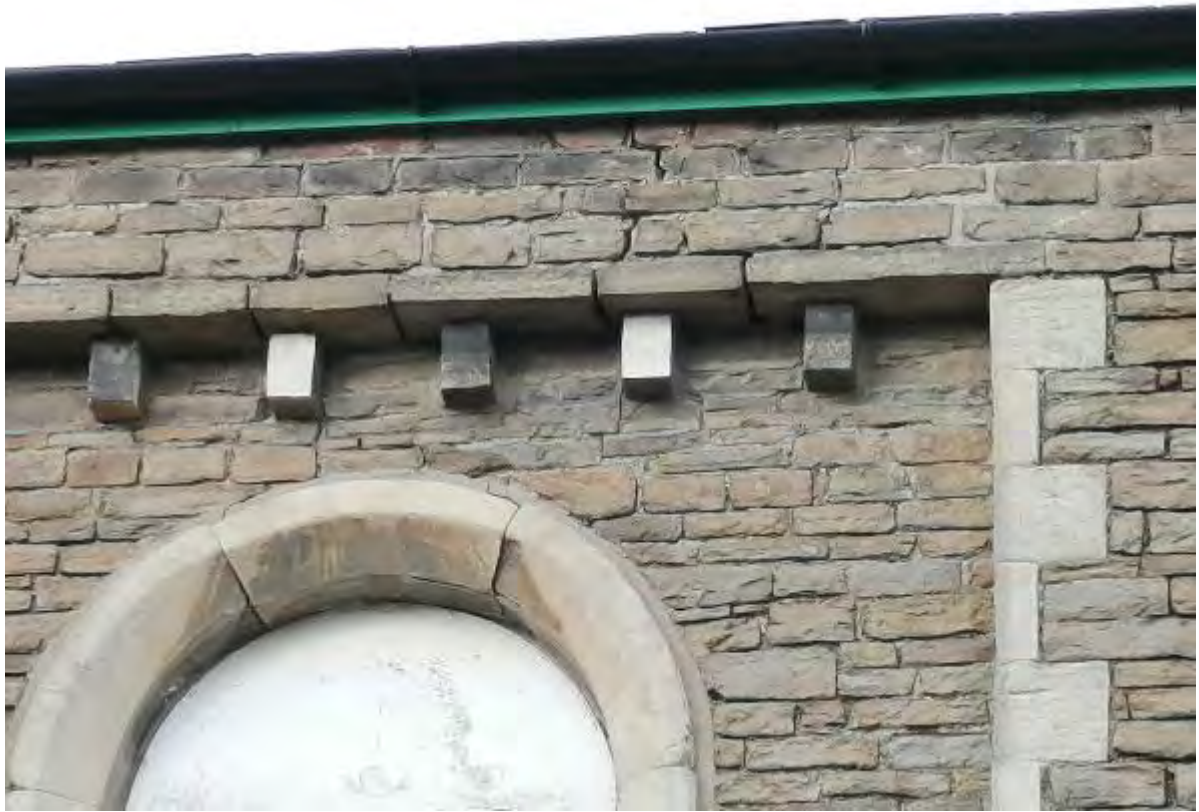
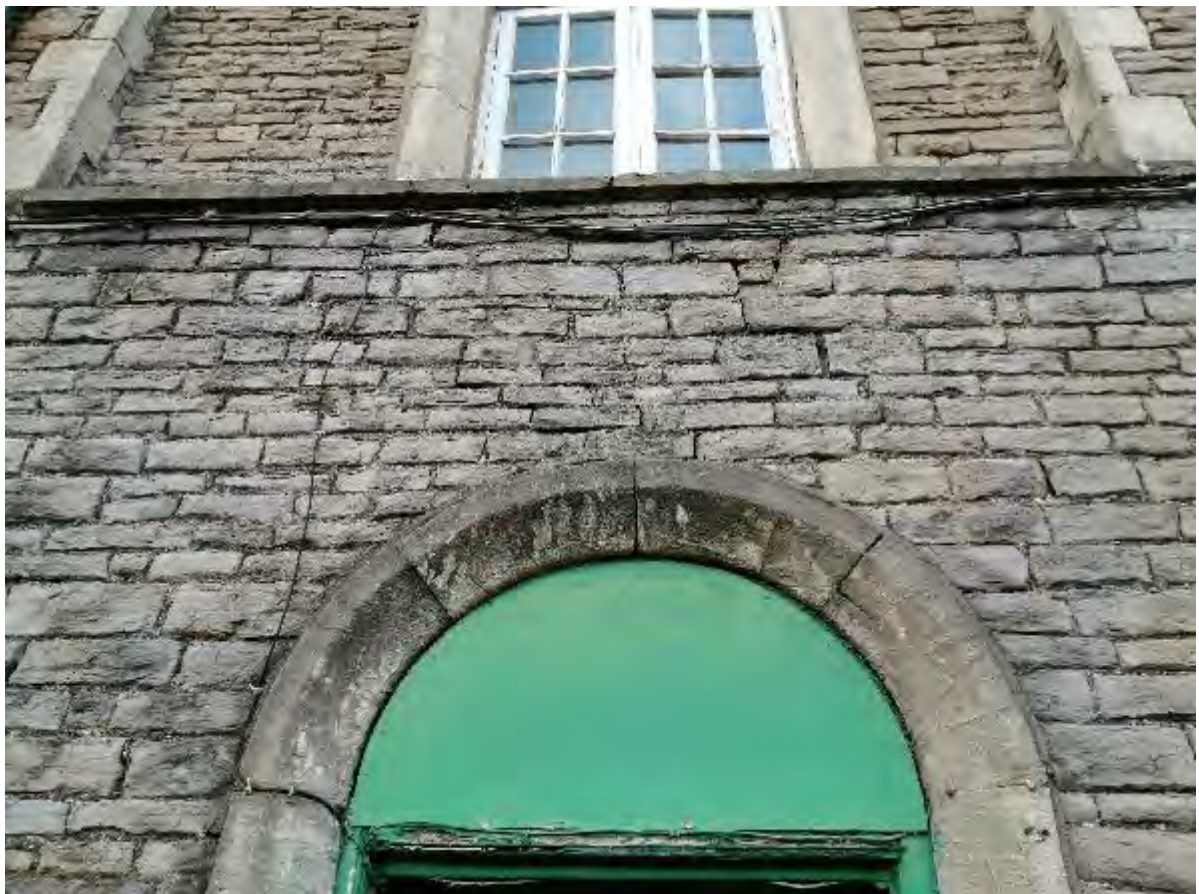
Cracking (damage category 1 to 2) and weathering was noted to the mortar of the stonework to the front wall elevation – see photos 58-60 and 65-70 below. The cracking noted above the archways are expected to be caused by minor movement within the window arches below caused by weathering of the archway mortar. Condition Rating **2** See Section 7.0 Recommendations for guidance on repair works required.

Photo 58 – Cracking to Mortar Above Archway (Front Wall Elevation)

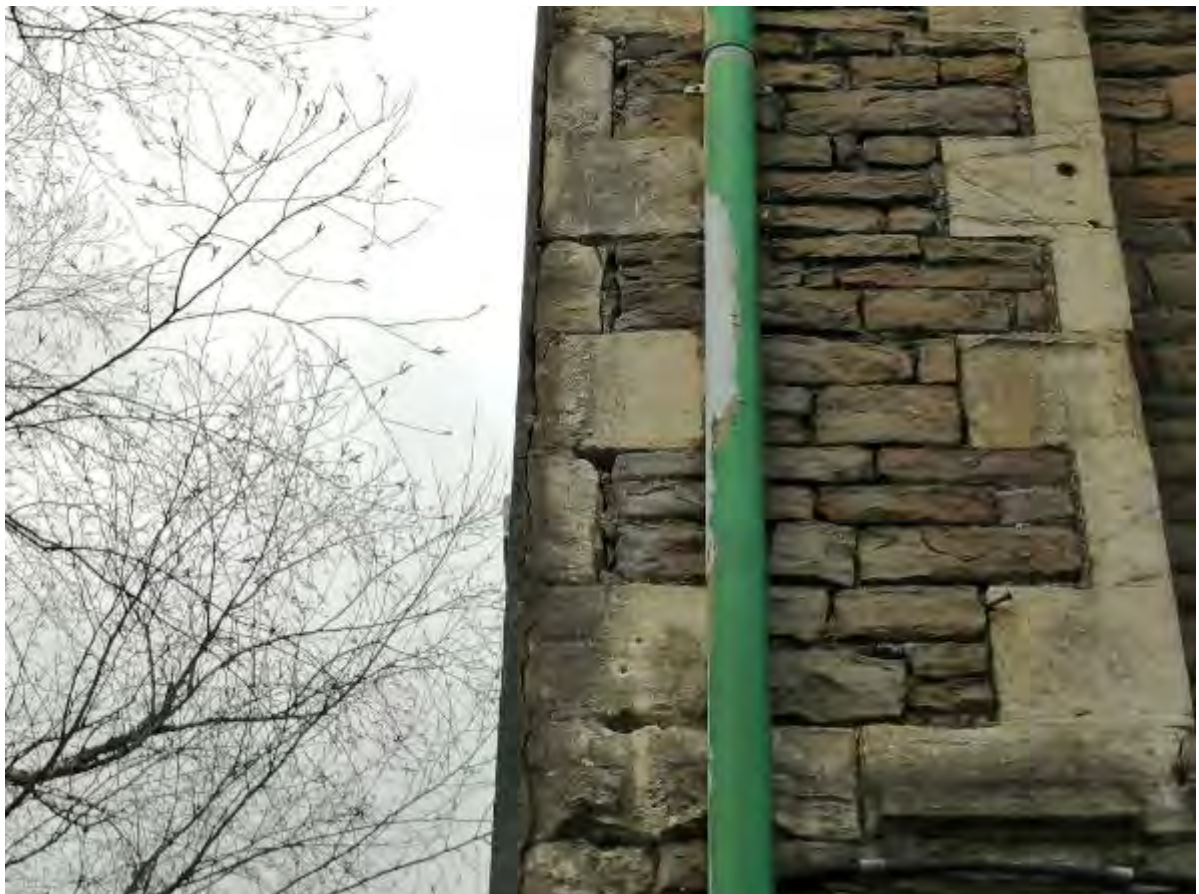
Photo 60 – Weathered Mortar and Exposed Render Edge (Front Wall Elevation)
