**Structural Survey (Inspection)**

**Moose Hall  
Castle Street  
Neath  
SA11 3LU**

Structural Surveys UK were commissioned to undertake a Full Structural Survey (Inspection) to a residential property at Moose Hall, Castle Street in Neath.

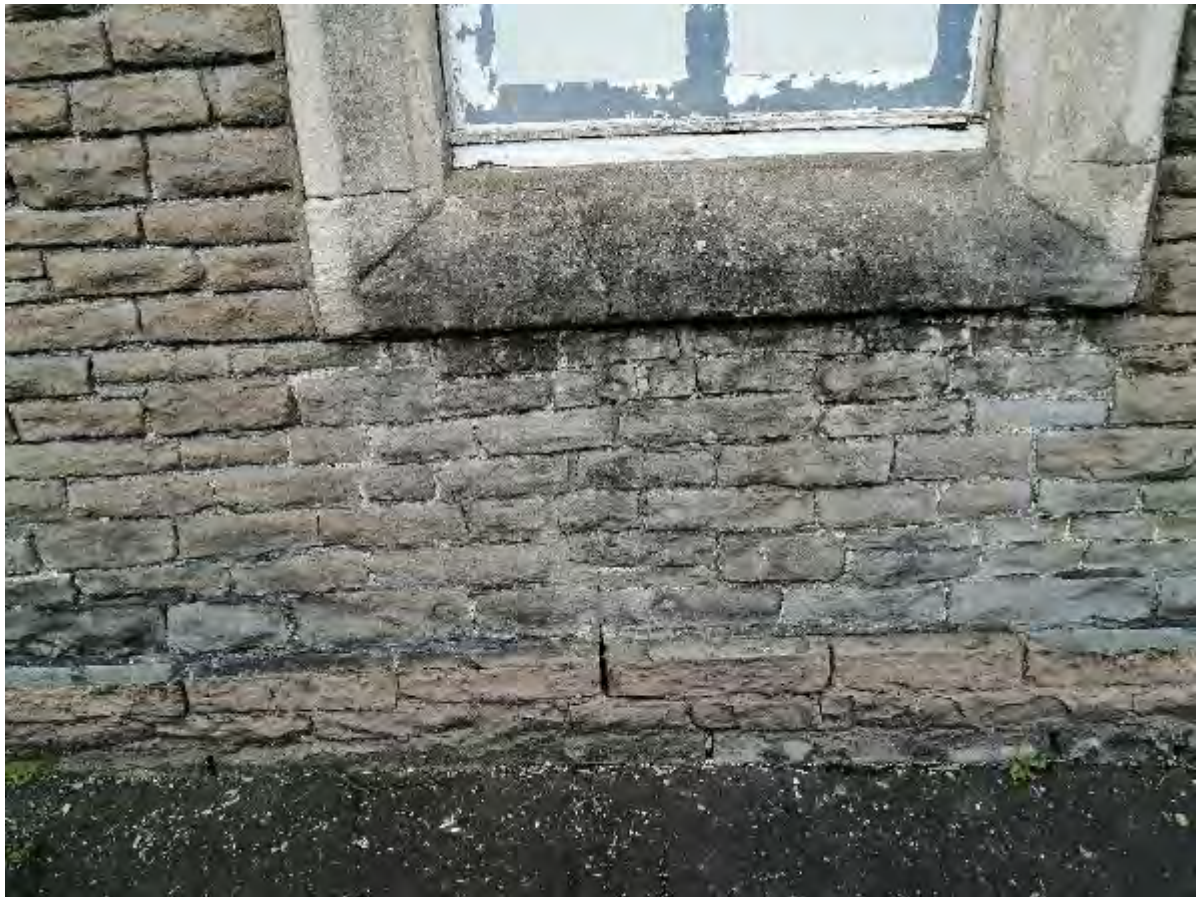
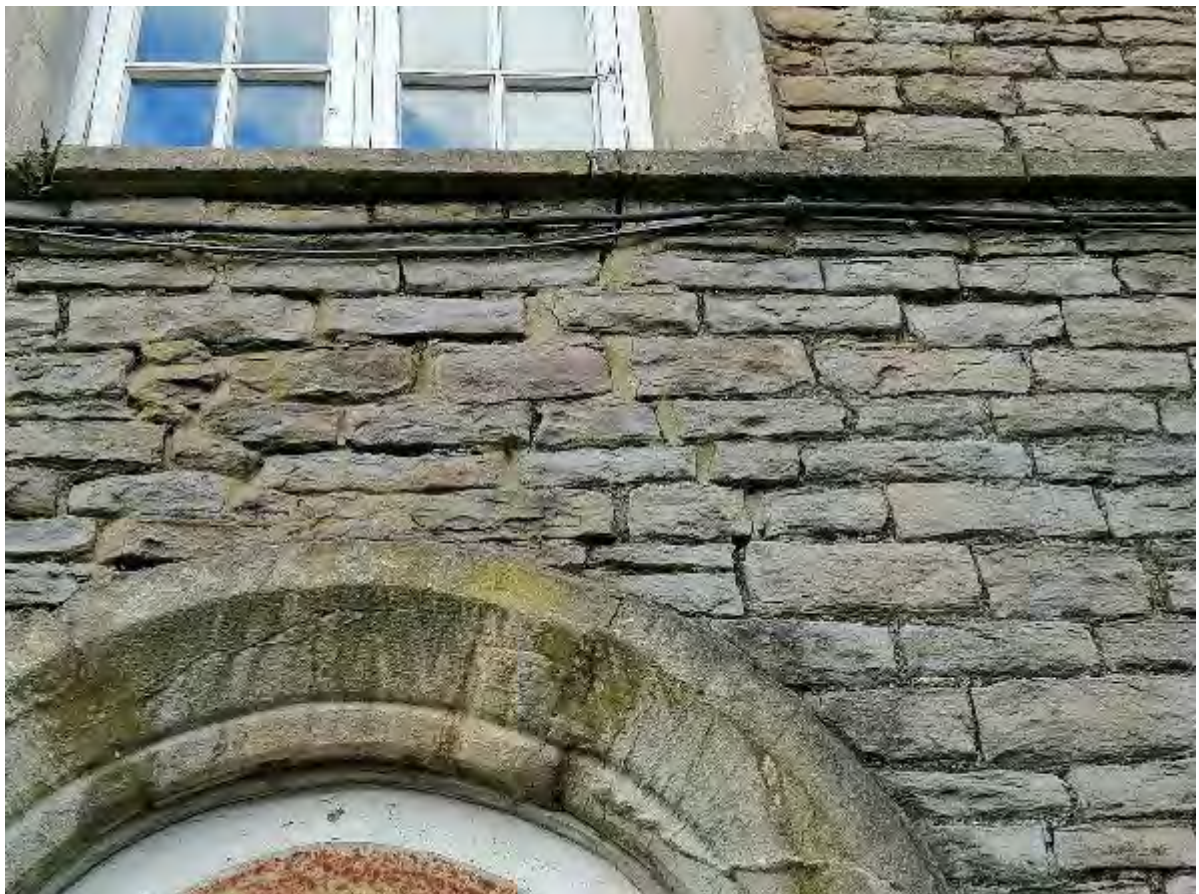
Photo 61 – Cracking to Mortar (Front Wall Elevation)

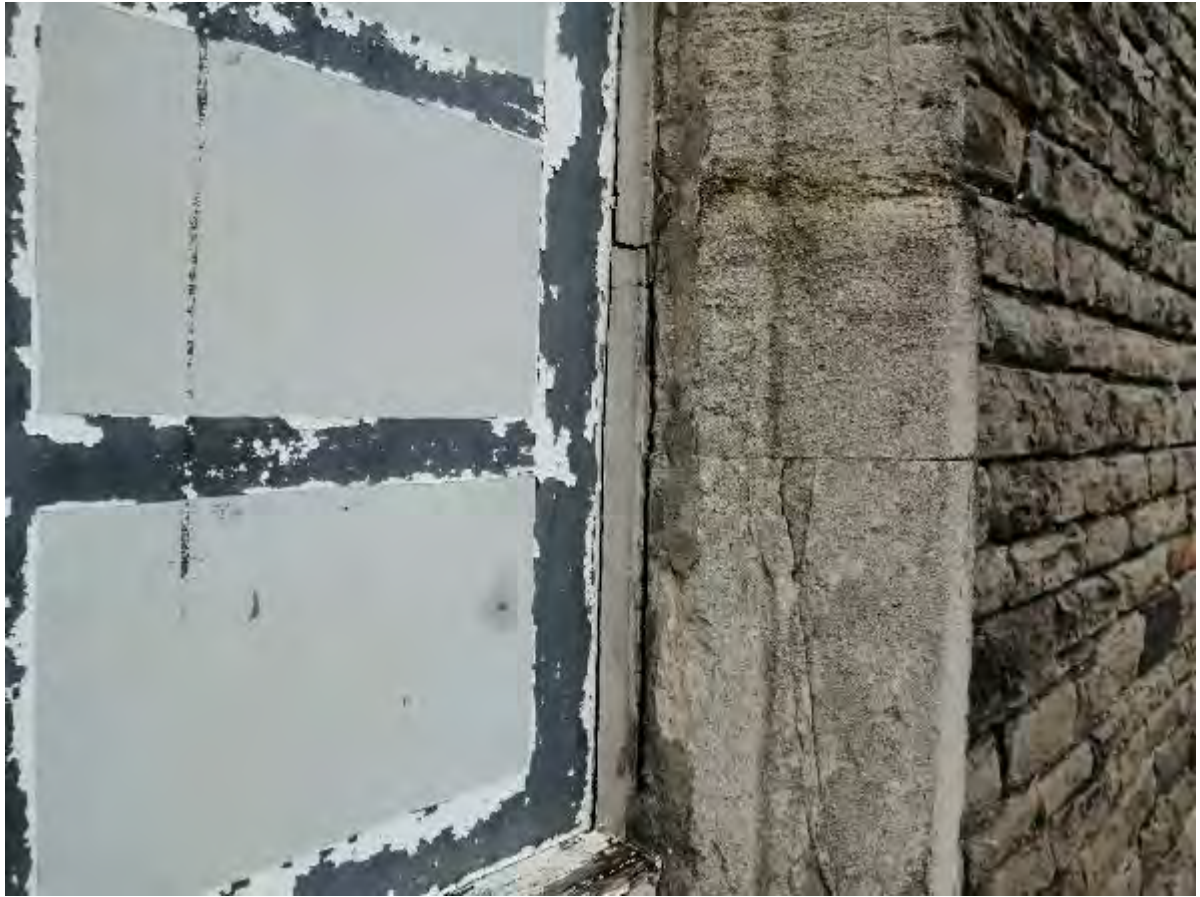
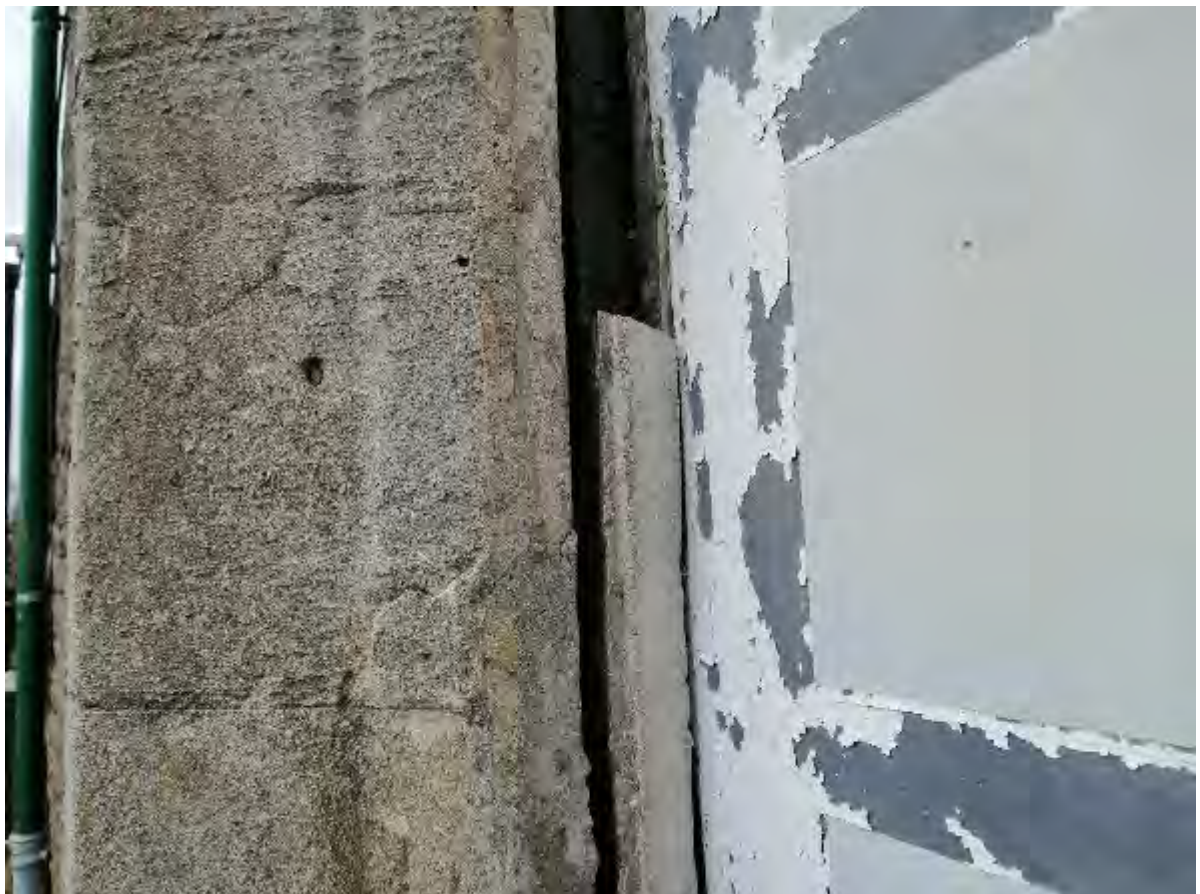
Cracking (damage category 1) and gaps in the stonework mortar were noted around the timber window of the front wall elevation – see photos 63-64 below. It is recommended that the mortar in these areas is repaired and repointed to maintain weather tightness of the property. Condition Rating **2** See Section 7.0 Recommendations for guidance on repair works required.

Photo 63 – Cracking and Gaps Around Timber Window Frames (Front Wall Elevation)

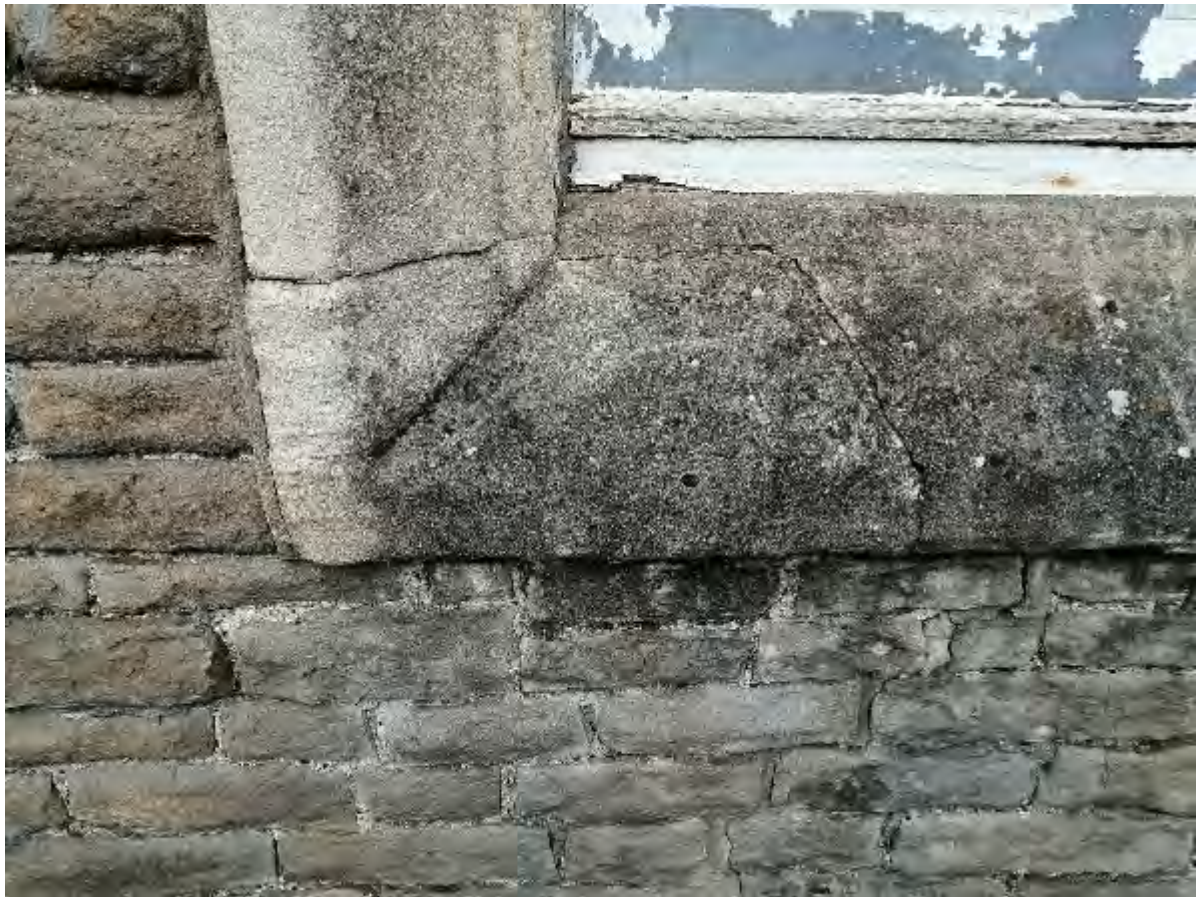
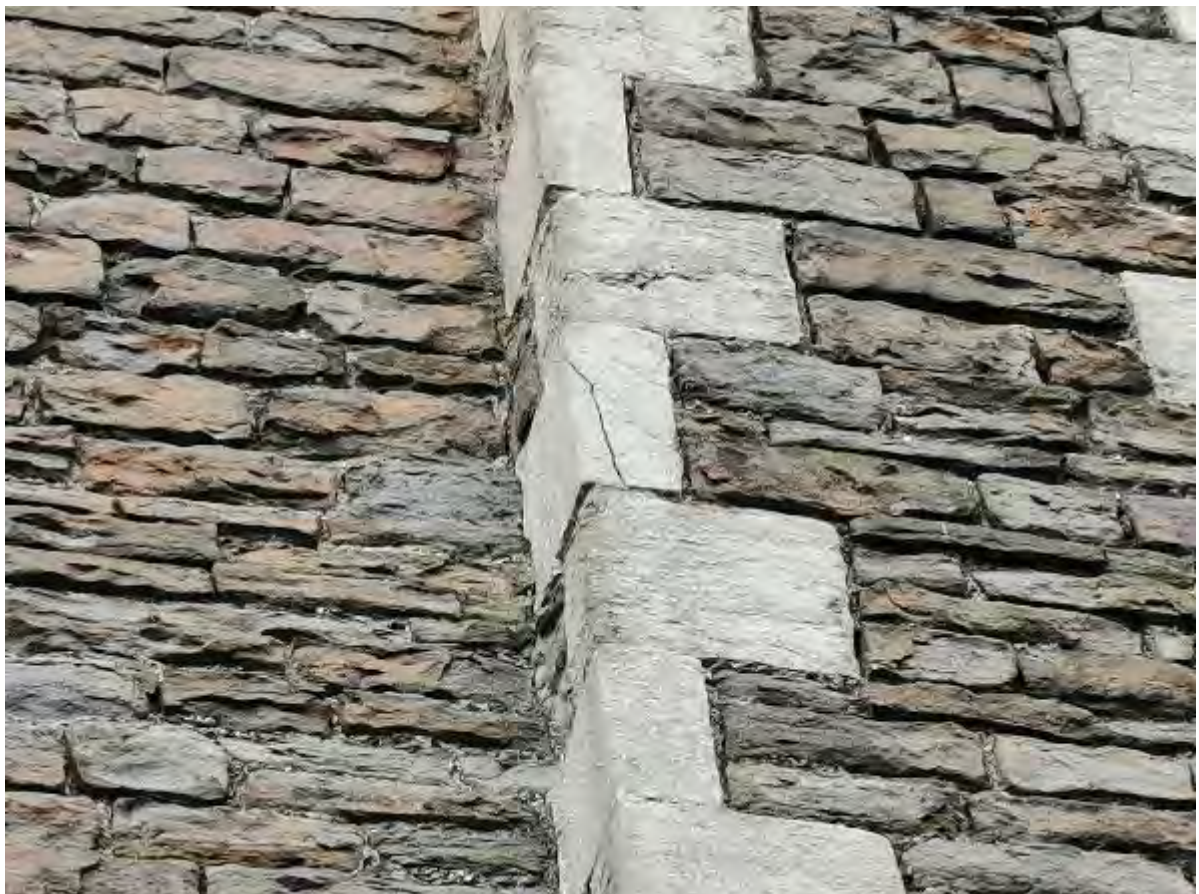
Cracking (damage category 1 to 2) and weathering was noted to the mortar of the stonework to the front wall elevation – see photos 58-60 and 65-70 below. The cracking noted above the archways are expected to be caused by minor movement within the window arches below caused by weathering of the archway mortar. Condition Rating **2** See Section 7.0 Recommendations for guidance on repair works required.

Photo 65 – Cracking to Stonework (Front Wall Elevation)

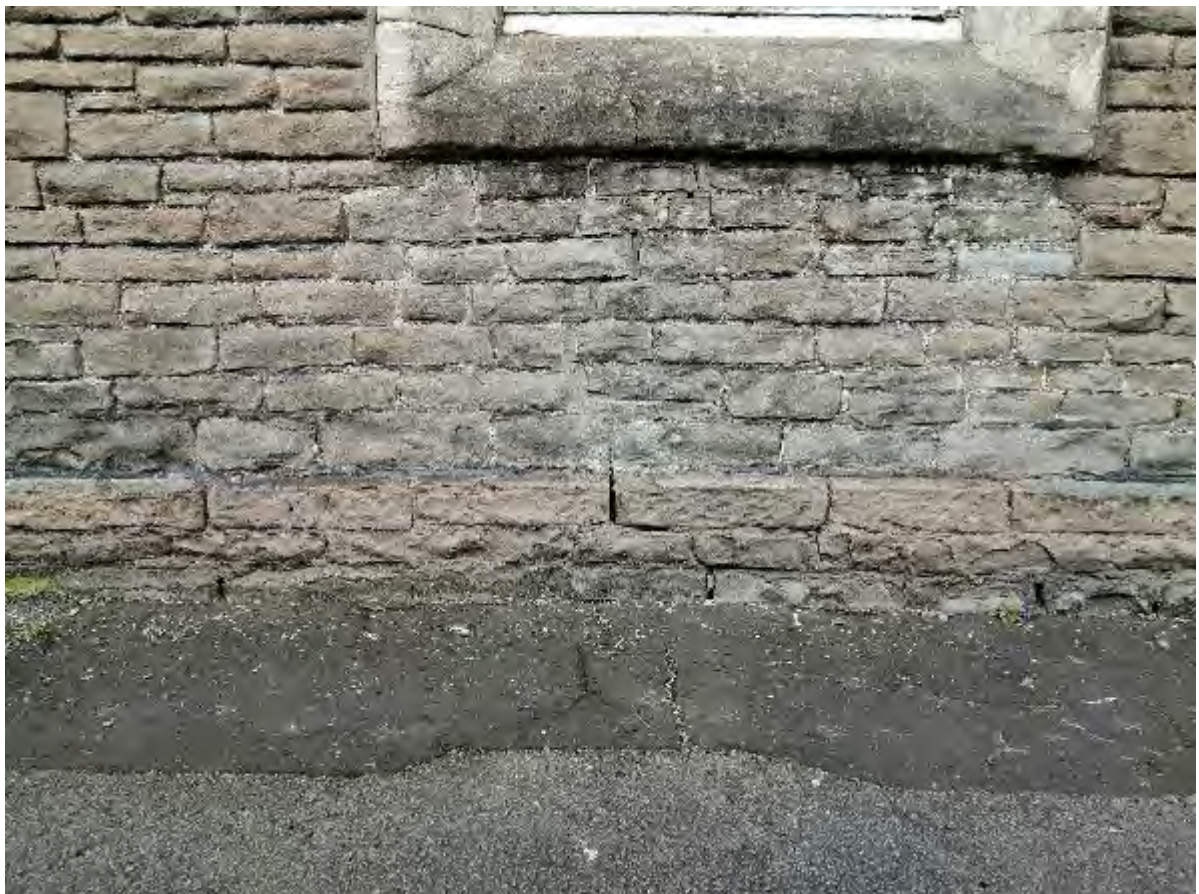
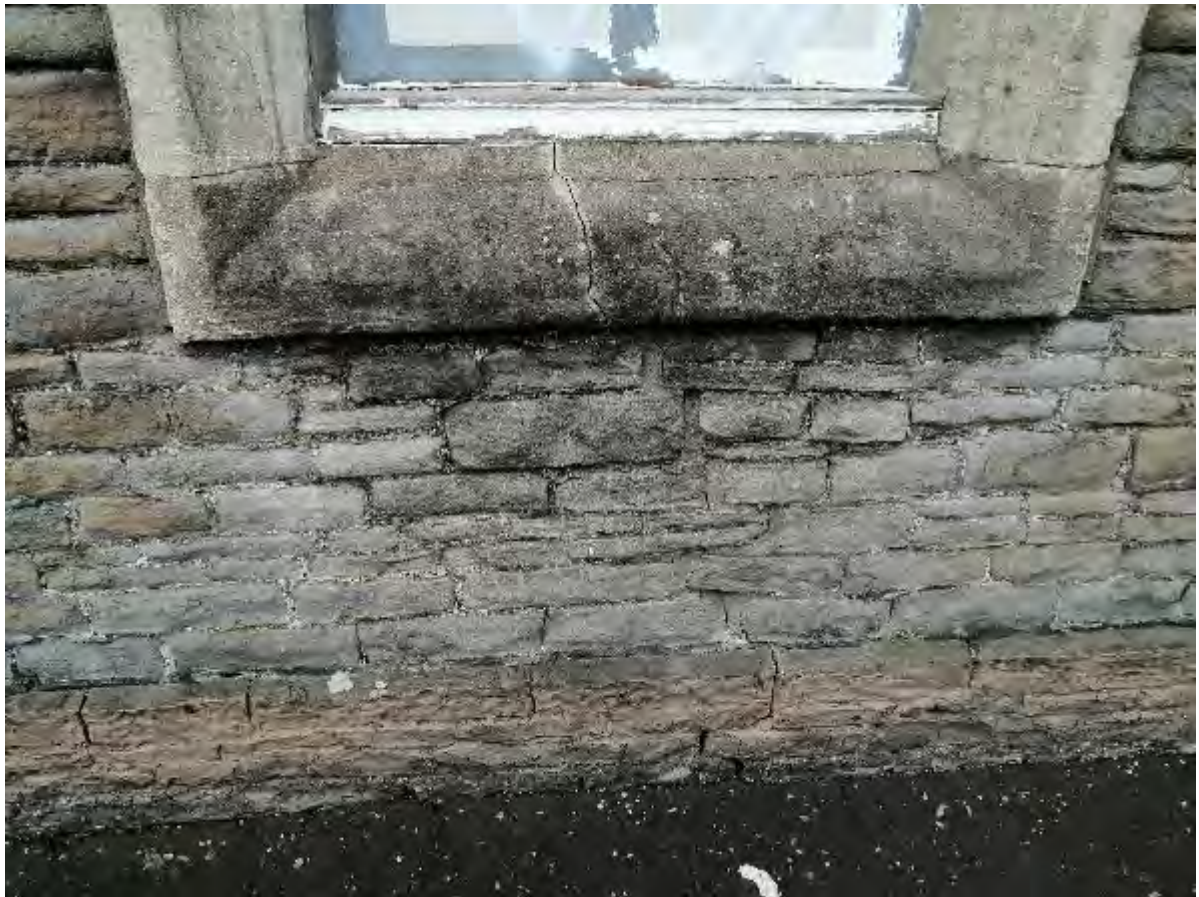
Photo 66 – Cracking to Mortar (Front Wall Elevation)

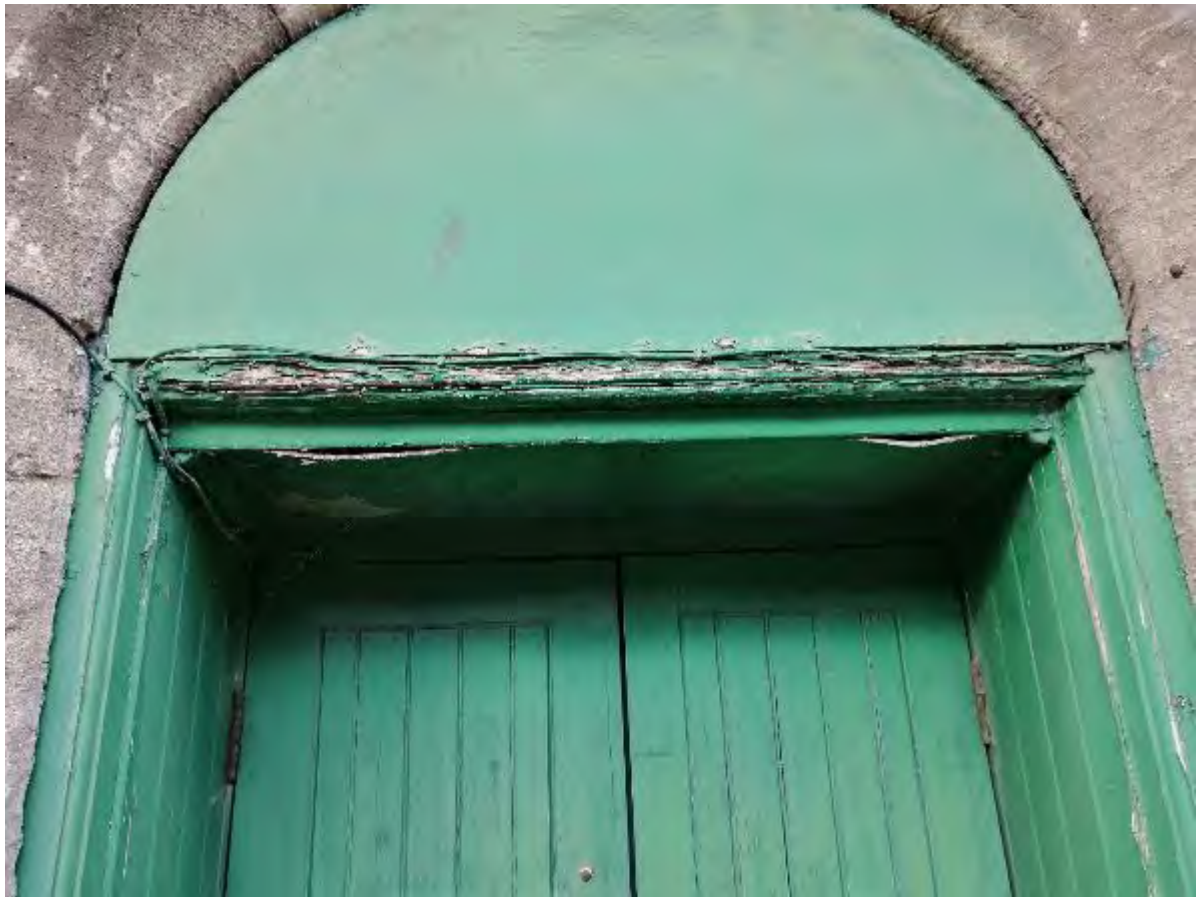
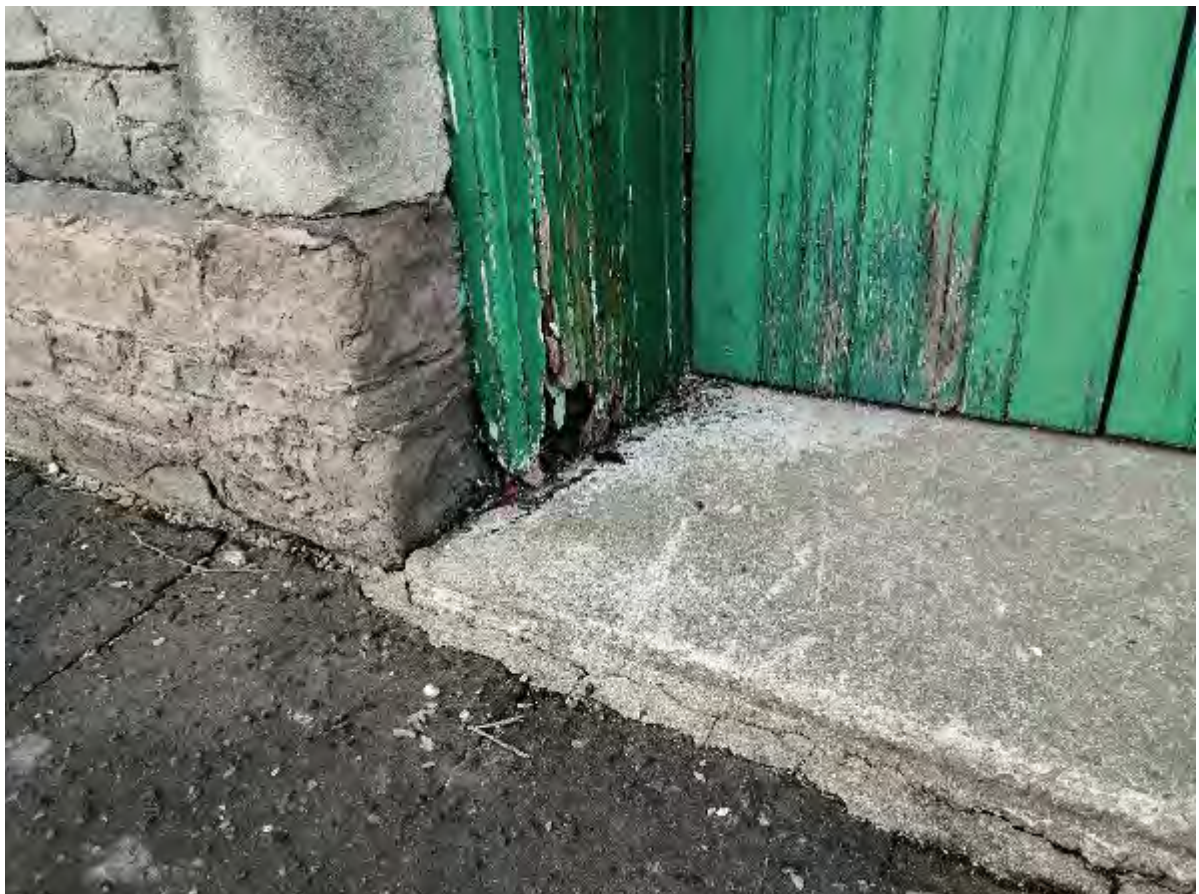
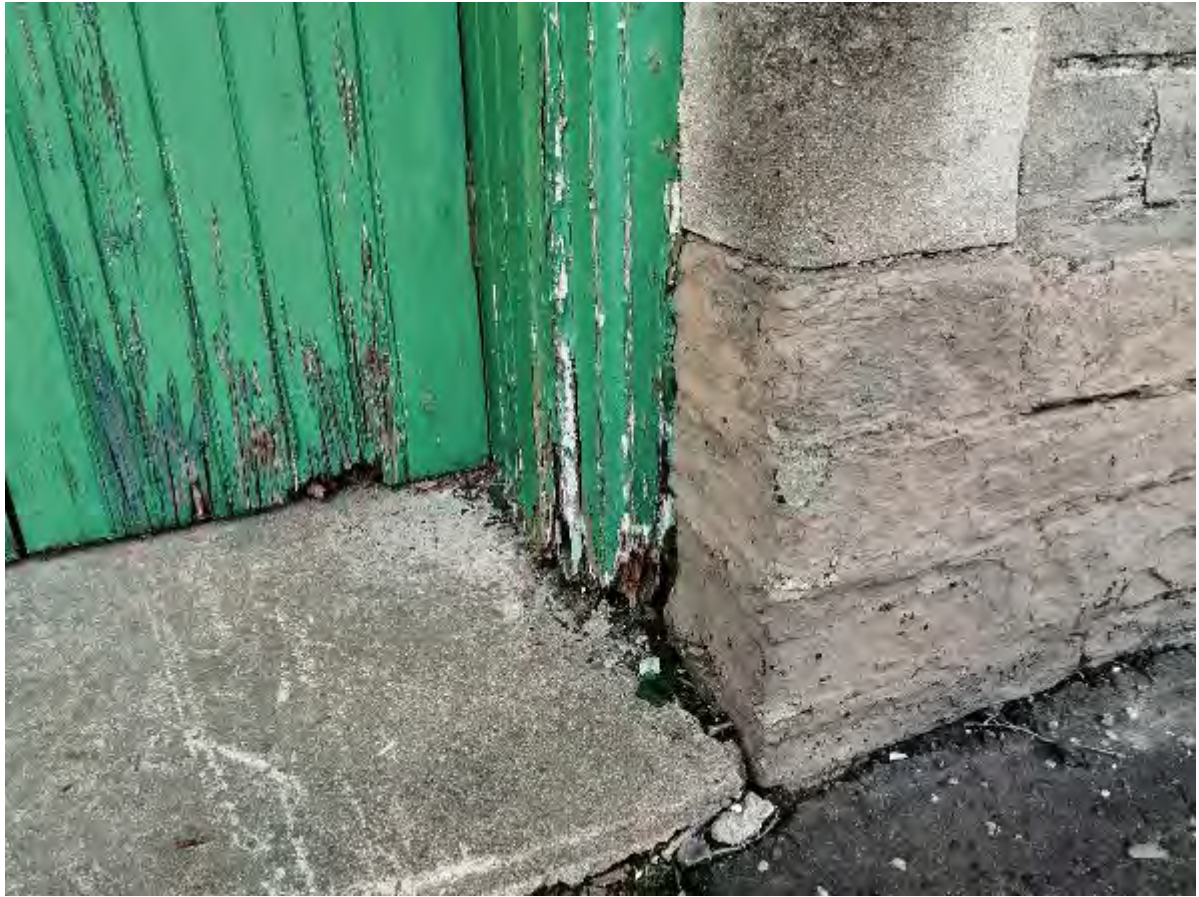
Photo 71 – Weathering and Rot to Timber Door Frame (Front Wall Elevation)
