**Structural Survey (Inspection)**

**Moose Hall  
Castle Street  
Neath  
SA11 3LU**

Structural Surveys UK were commissioned to undertake a Full Structural Survey (Inspection) to a residential property at Moose Hall, Castle Street in Neath.

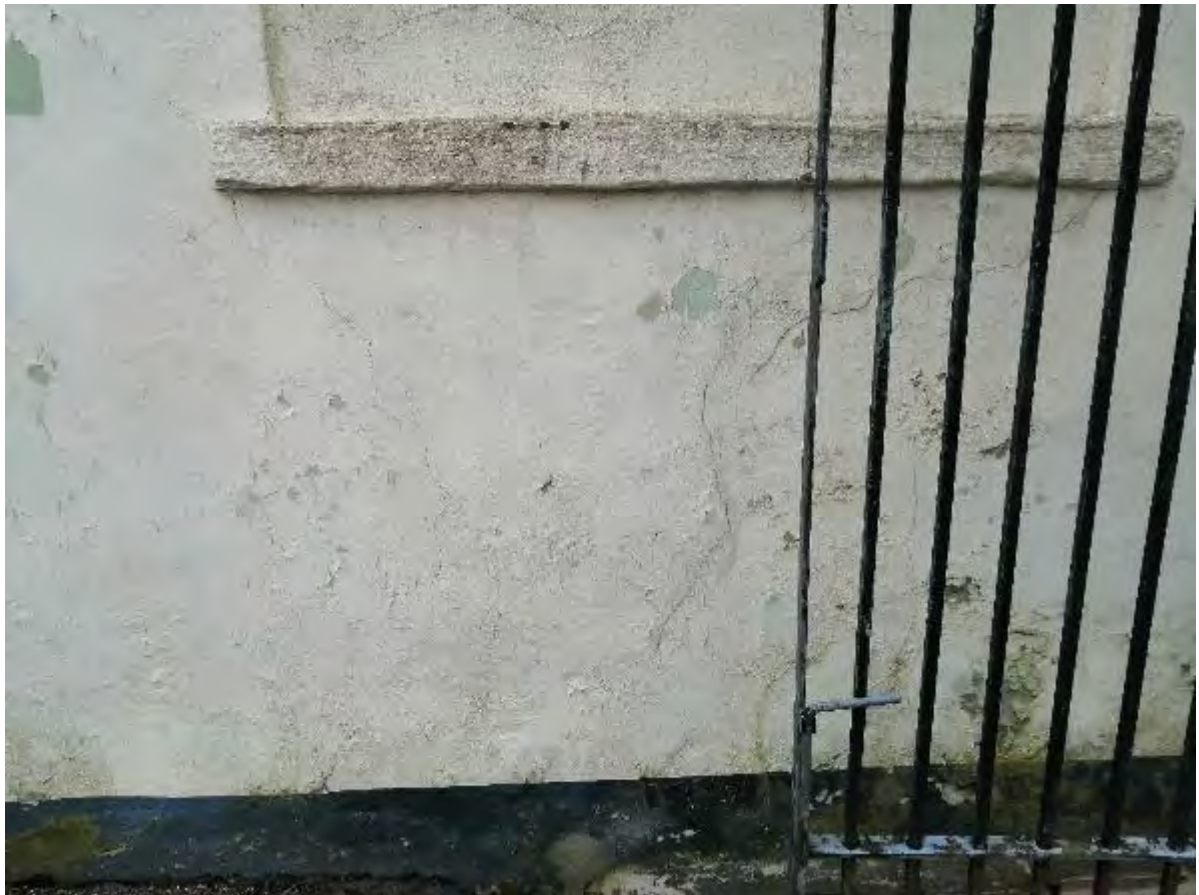
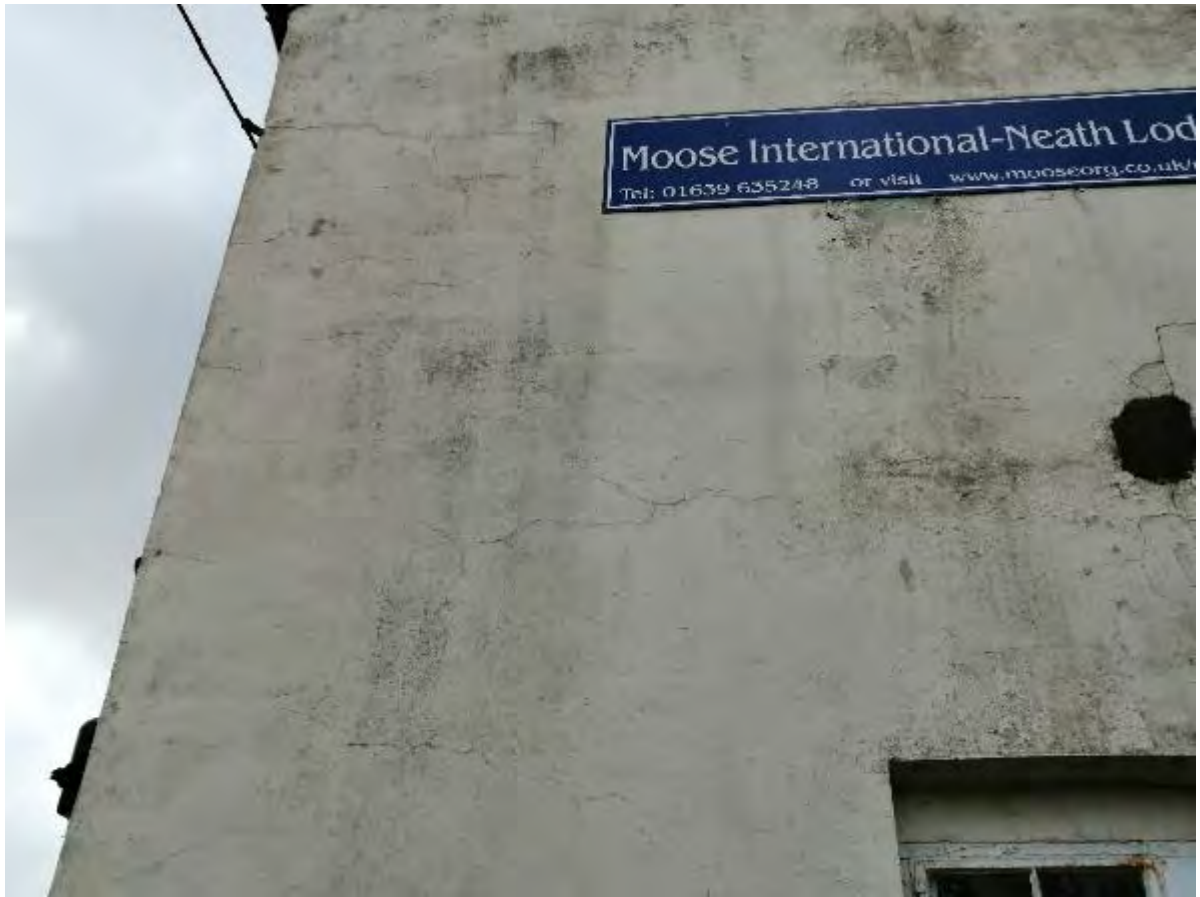
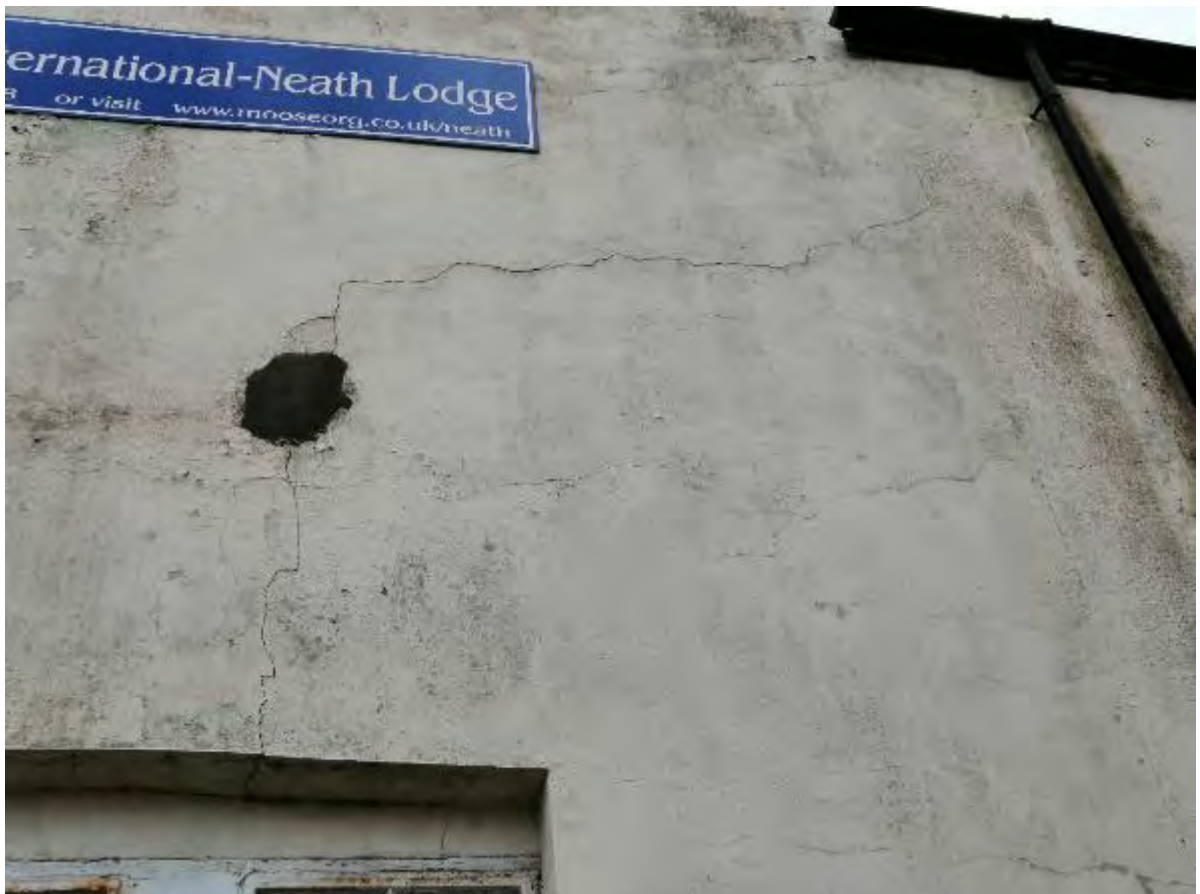
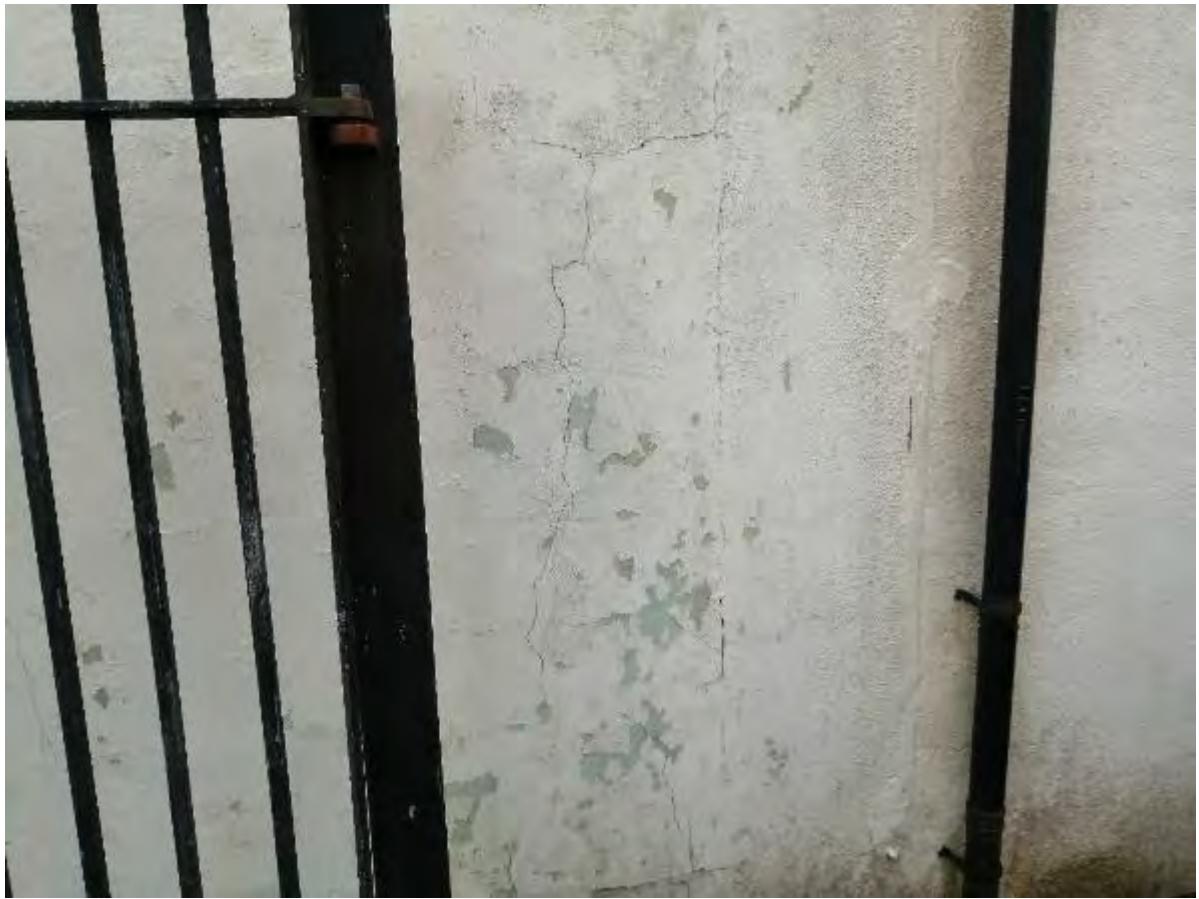
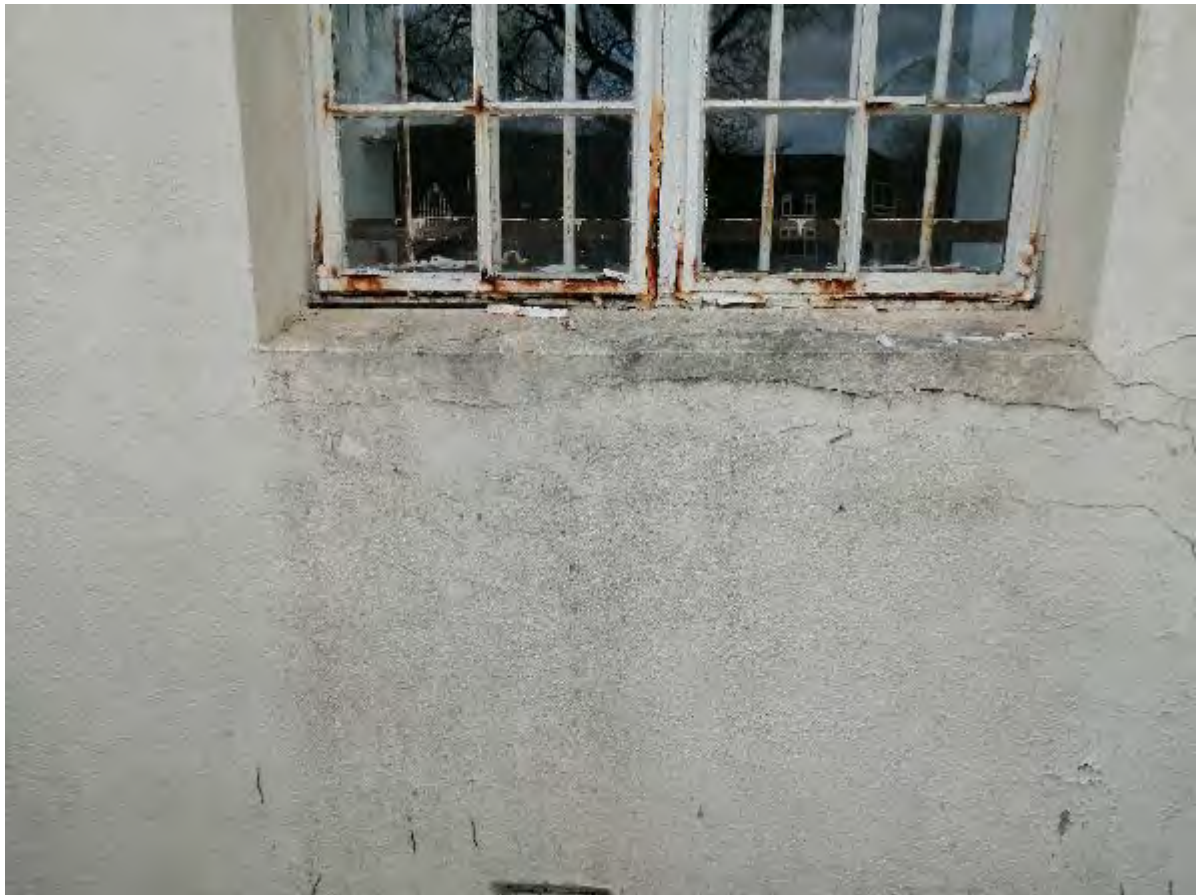
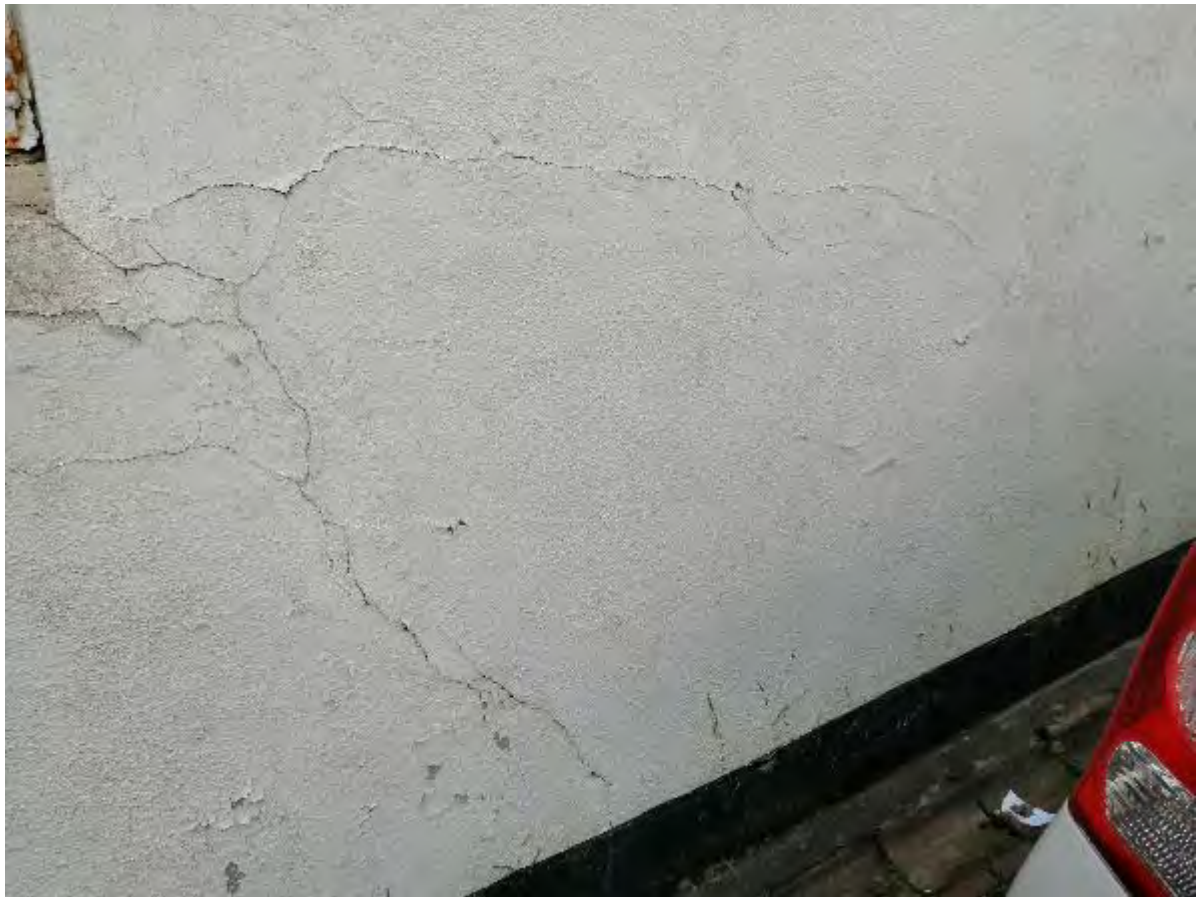
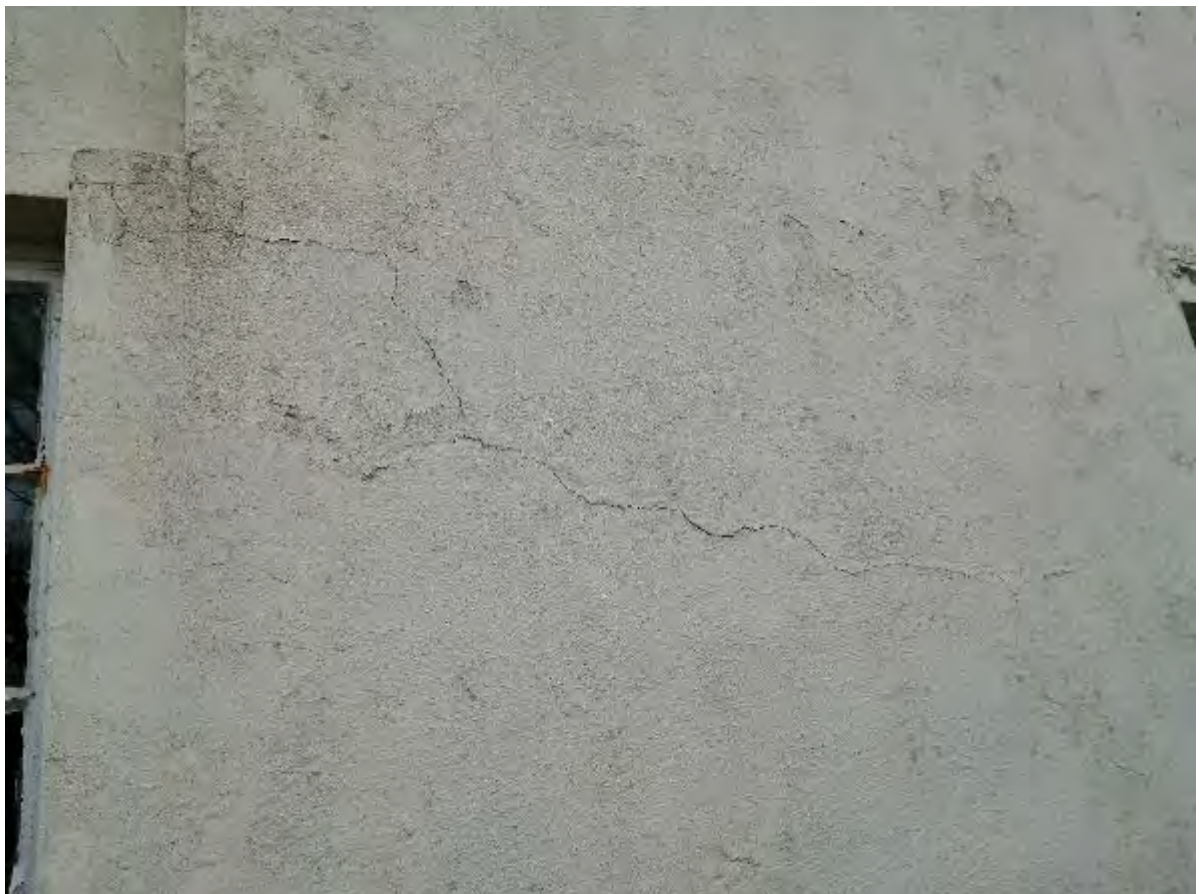
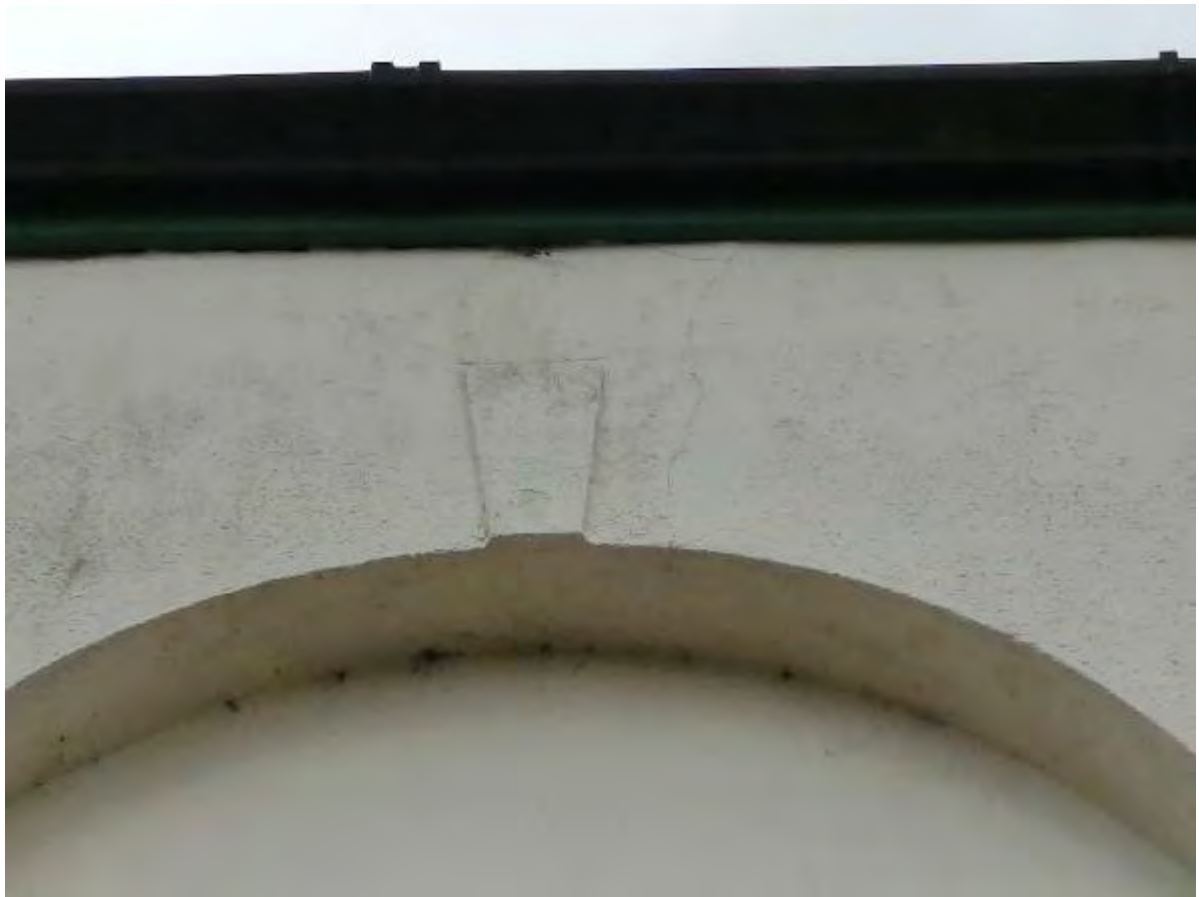
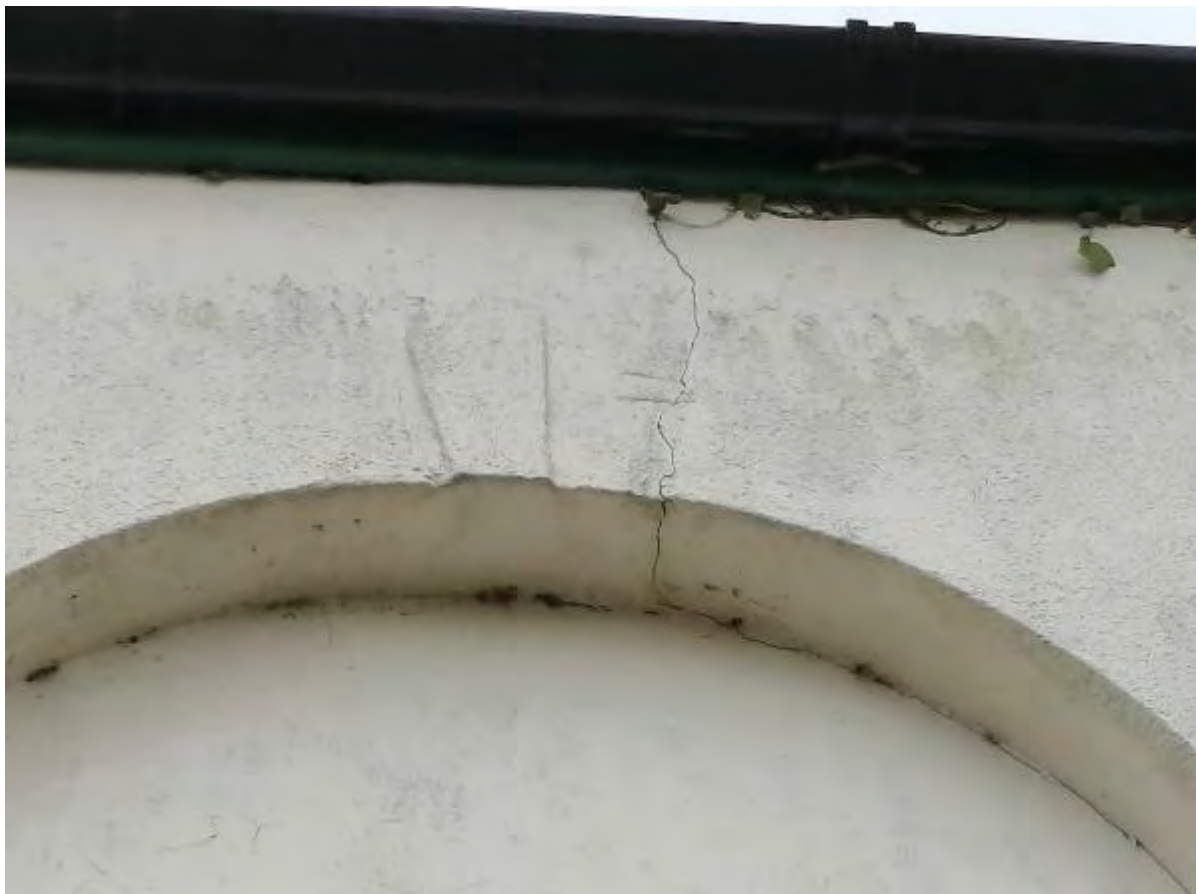
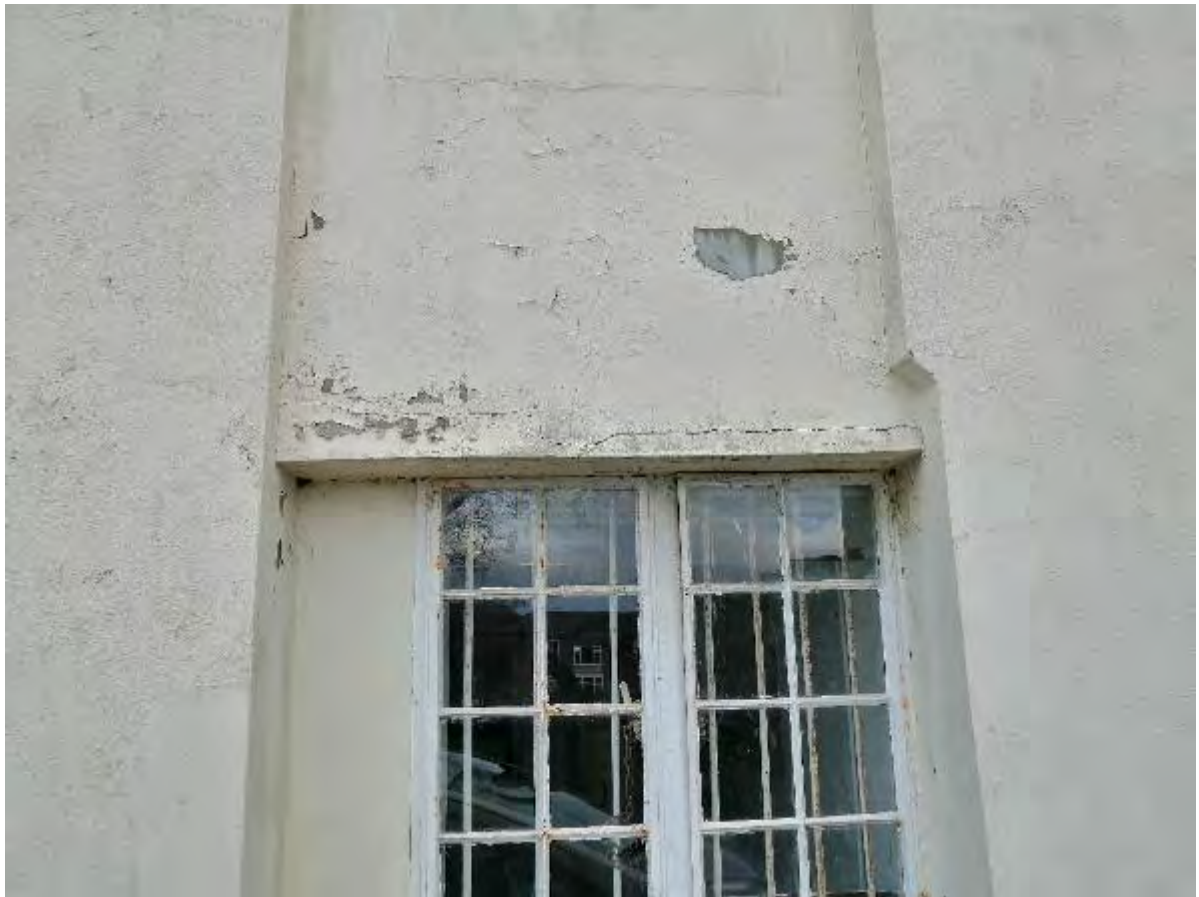
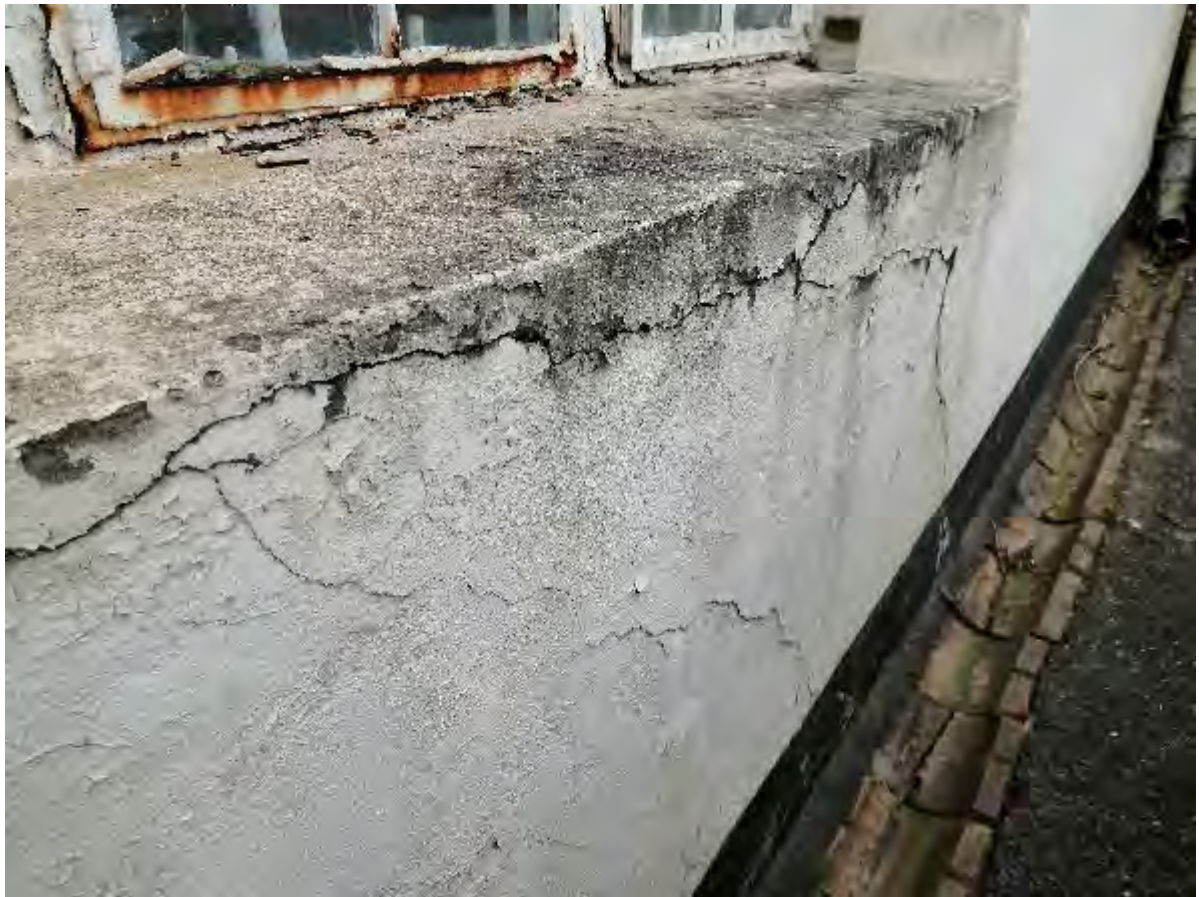
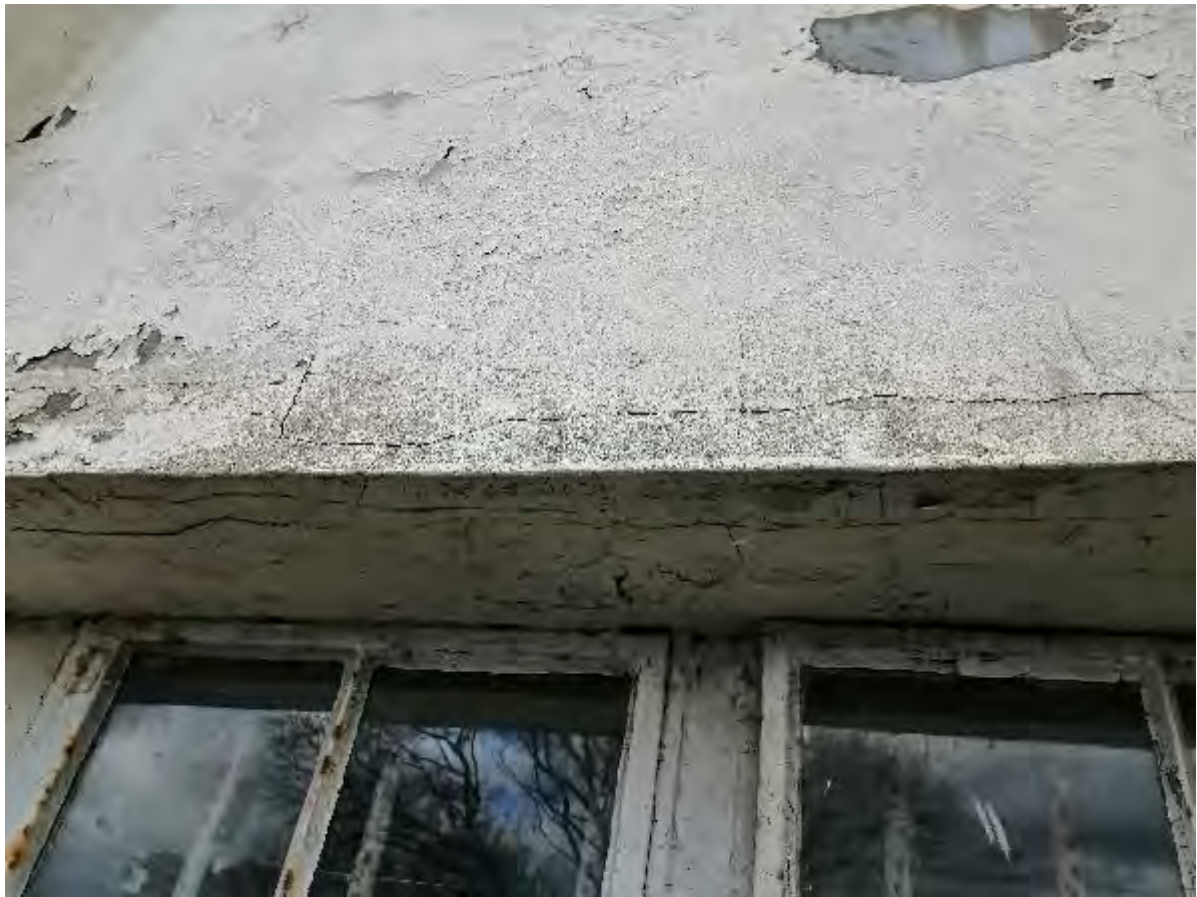
Our inspection of the external walls confirmed shrinkage cracking (damage category 1 to 2) to the left and right wall elevations – see Photos 42-51, 54, 74-83, 85 and 87 below. This cracking is considered ‘non-structural’ and has most likely developed initially during construction, i.e. due to poor preparation and mix design of the render, poor application and inadequate curing (which will have led to the render drying out prematurely and cracking over time). Moisture effects will have also exacerbated the development of these cracks through repeated wetting and drying. This cracking is low grade in nature and expected to be confined to the external render only. There is no loss of structural support or failure of the wall panel at this location. Minor local crack repair works are required. The condition of the external render is expected to be part of the cause of the majority of the penetrating damp throughout the property (discussed later in the report) - Condition Rating **2** See Section 7.0 Recommendations for guidance on repair works required.

Photo 74 – Render Shrinkage Cracking (Right Wall Elevation)

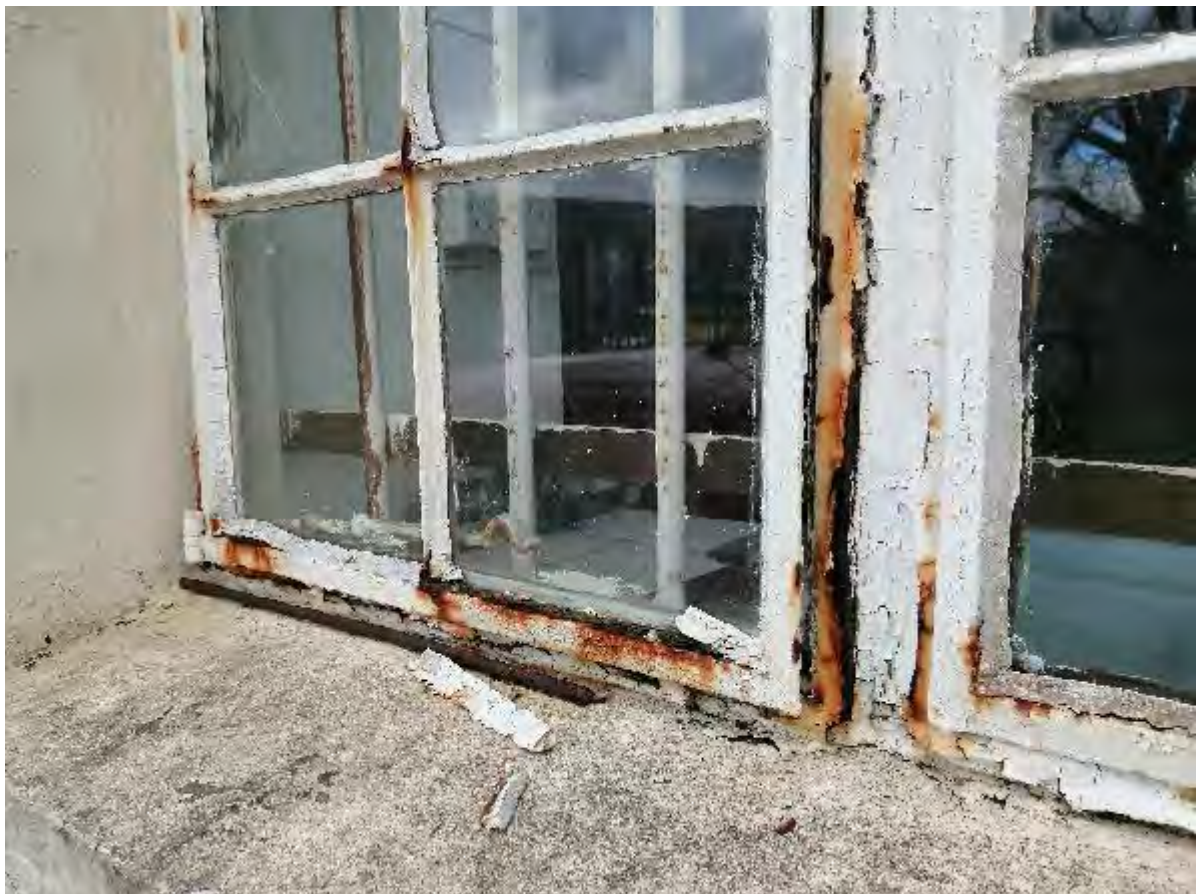
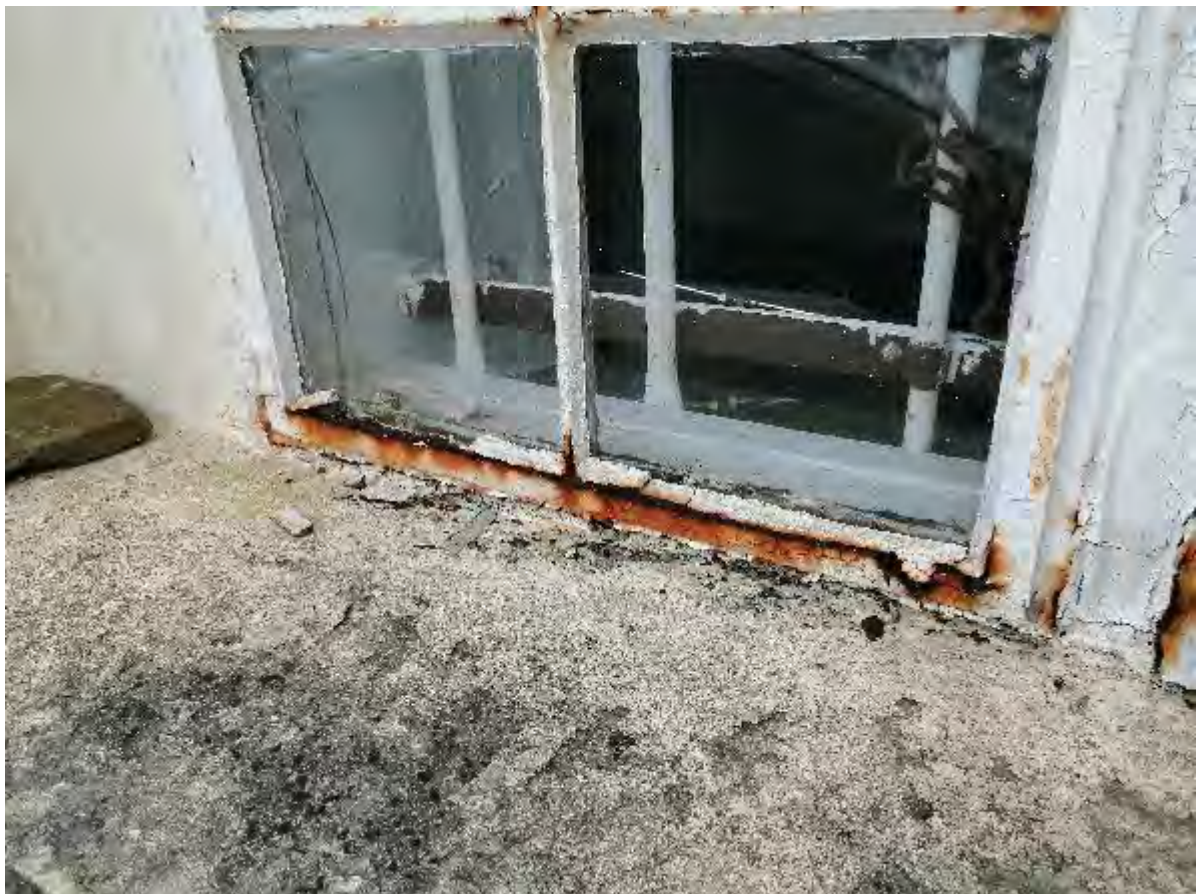
Photo 84 – Corrosion to Metal Window Frame (Right Wall Elevation)

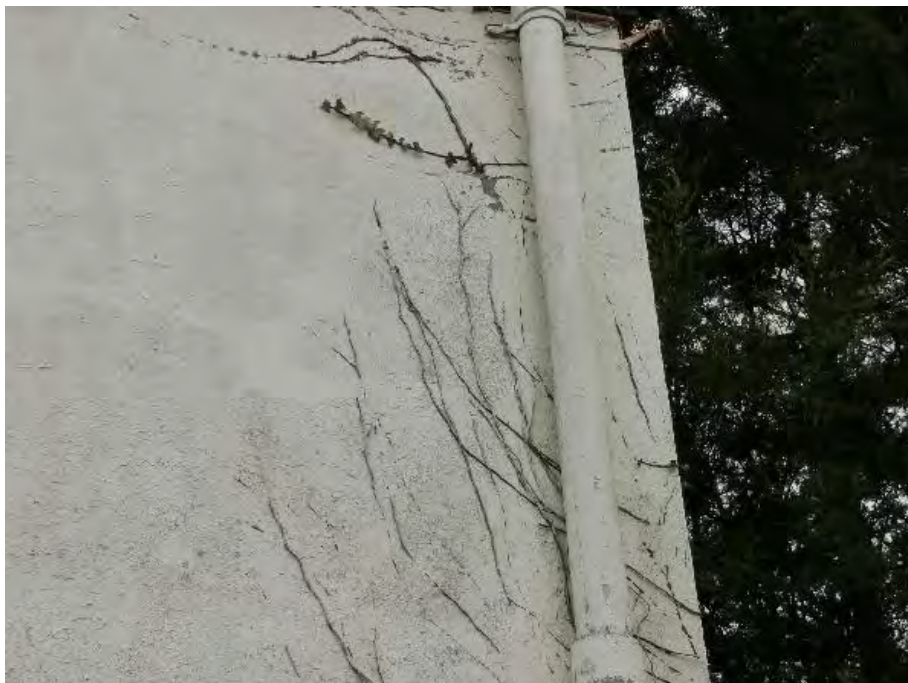
Photo 88 – Vegetation Growth (Right Wall Elevation)
