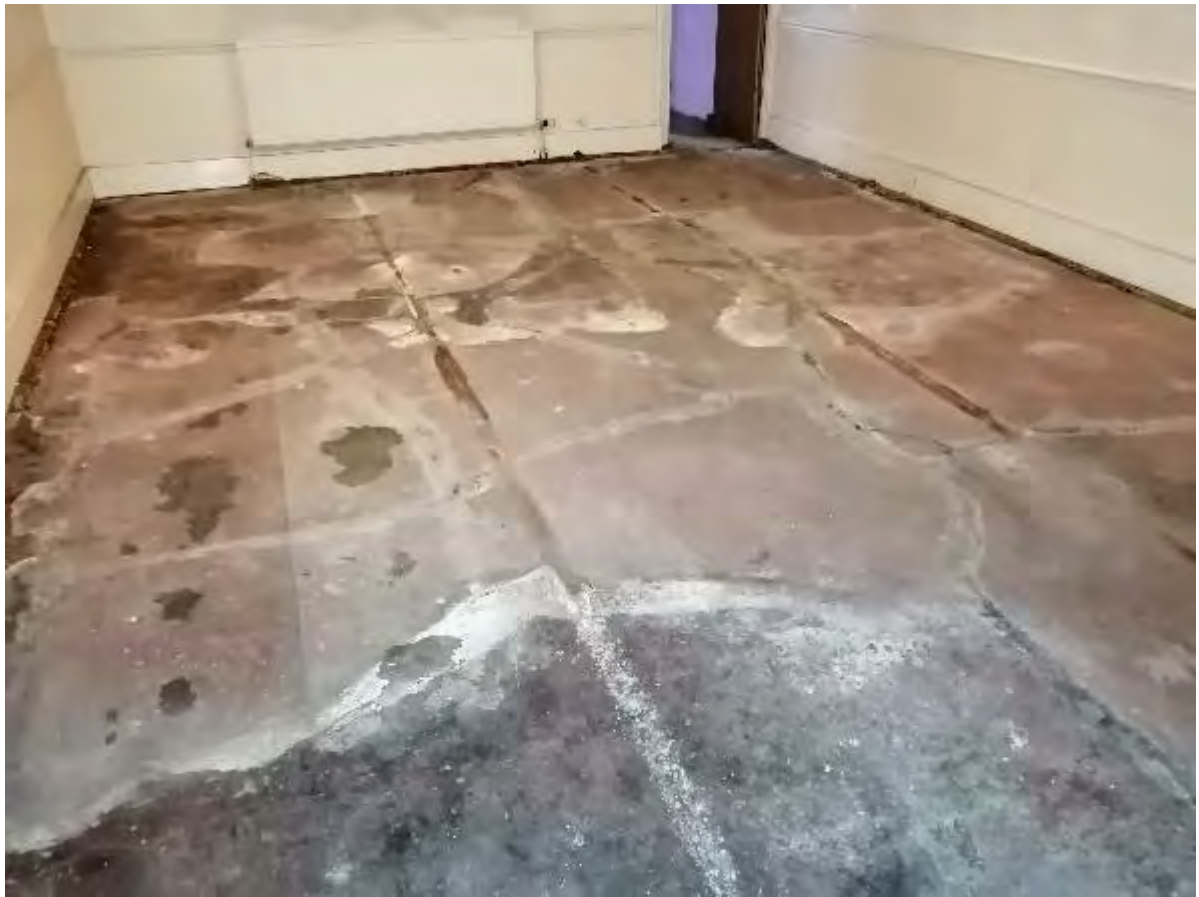
Photo 187 – Concrete Floor Cracking (Front Room)

Also cracking (damage category 1) was noted to the concrete floor of front room 2 and the storage room – see photos 187 and 209 below. It is expected that minor compaction of the material below the concrete slab has occurred (gaps were noted to the slab periphery) and subsequently minor settlement of the concrete floor slab which has caused the cracking and so remedial works will be necessary - Condition Rating **2** See Section 7.0 Recommendations for guidance on repair works required.

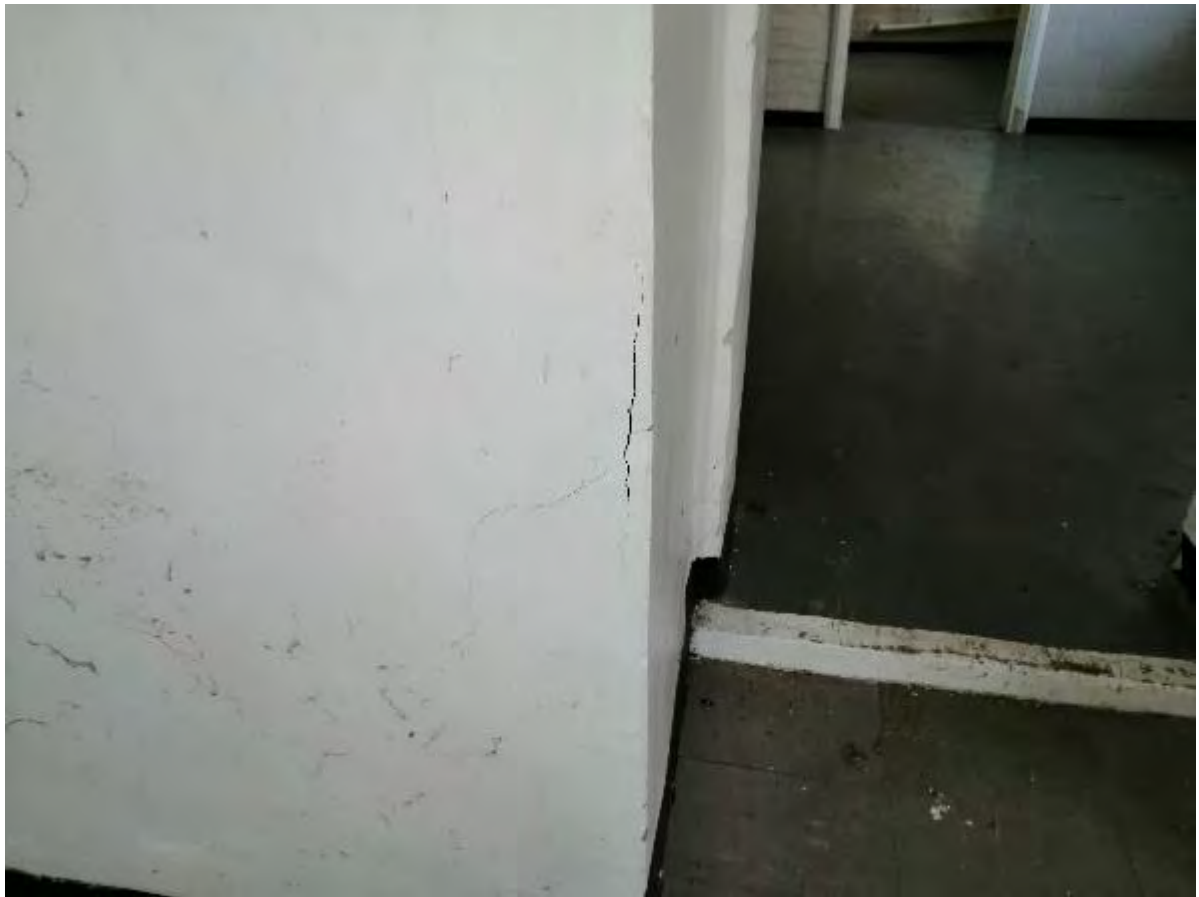
Photo 195 – Wall Plaster Cracking and Detached Plaster (Side Room 1)

Areas of detached plaster were noted to the side room 1 – see photos 195-196 and 198 below. These areas of detached plaster are expected to be part caused by penetrating damp to the walls in these areas. Condition Rating **2** See Section 7.0 Recommendations for guidance on repair works required.

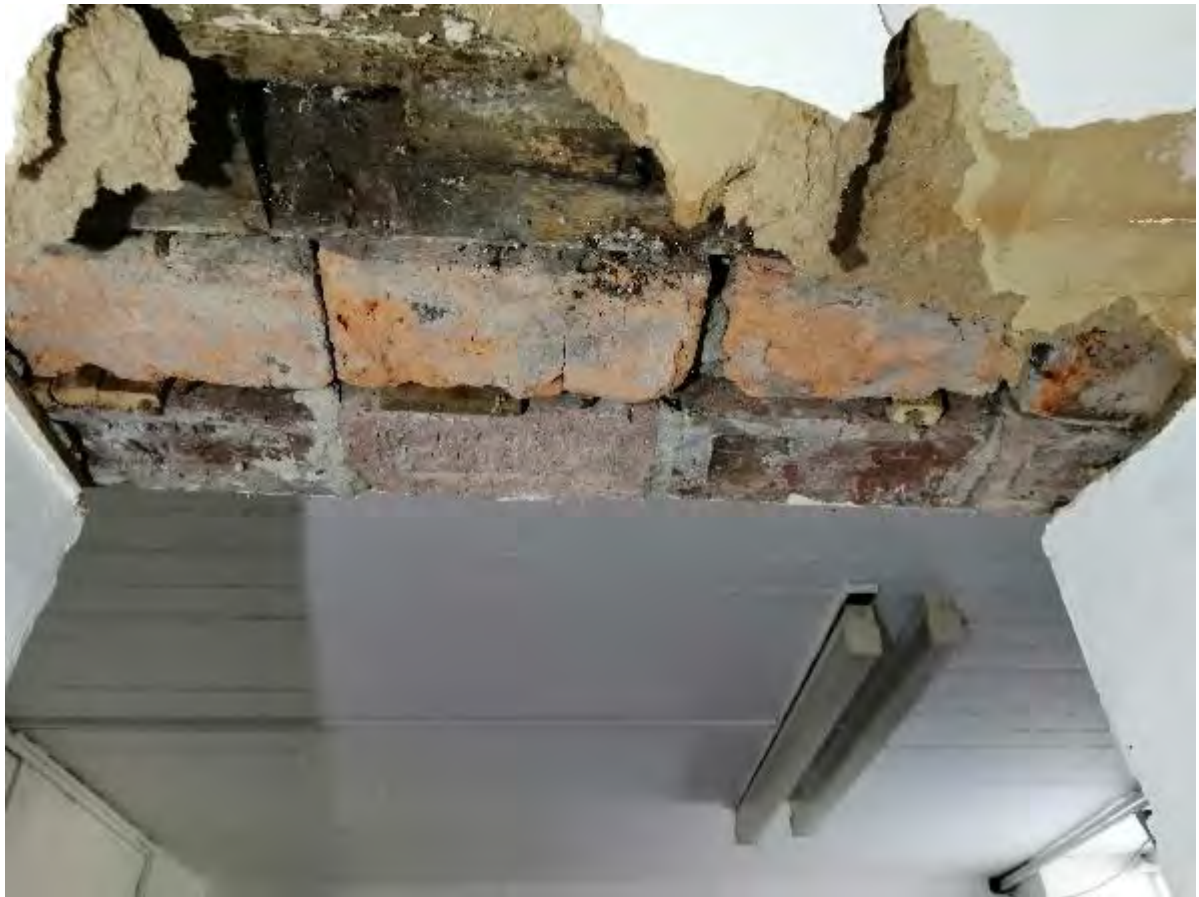
Photo 197 – No Doorway Lintel (Side Room 1)

During the survey, no lintel was noted to the doorway between side room 1 and side room 2 – see photo 197 below. The absence of a lintel for the doorway opening means that the brickwork is not held in place and is unsupported. It is recommended that a lintel is installed in this doorway to support the masonry above (N.B the remnants of a timber lintel were visible but is substandard to support the masonry above) - Condition Rating **3** See Section 7.0 Recommendations for guidance on repair works required.

- During the survey, no lintel was noted to the doorway between side room 1 and side room 2 – see photo 197. The absence of a lintel for the doorway opening means that the brickwork is not held in place and is unsupported. It is recommended that a lintel is installed in this doorway to support the masonry above (N.B the remnants of a timber lintel were visible but is substandard to support the masonry above).

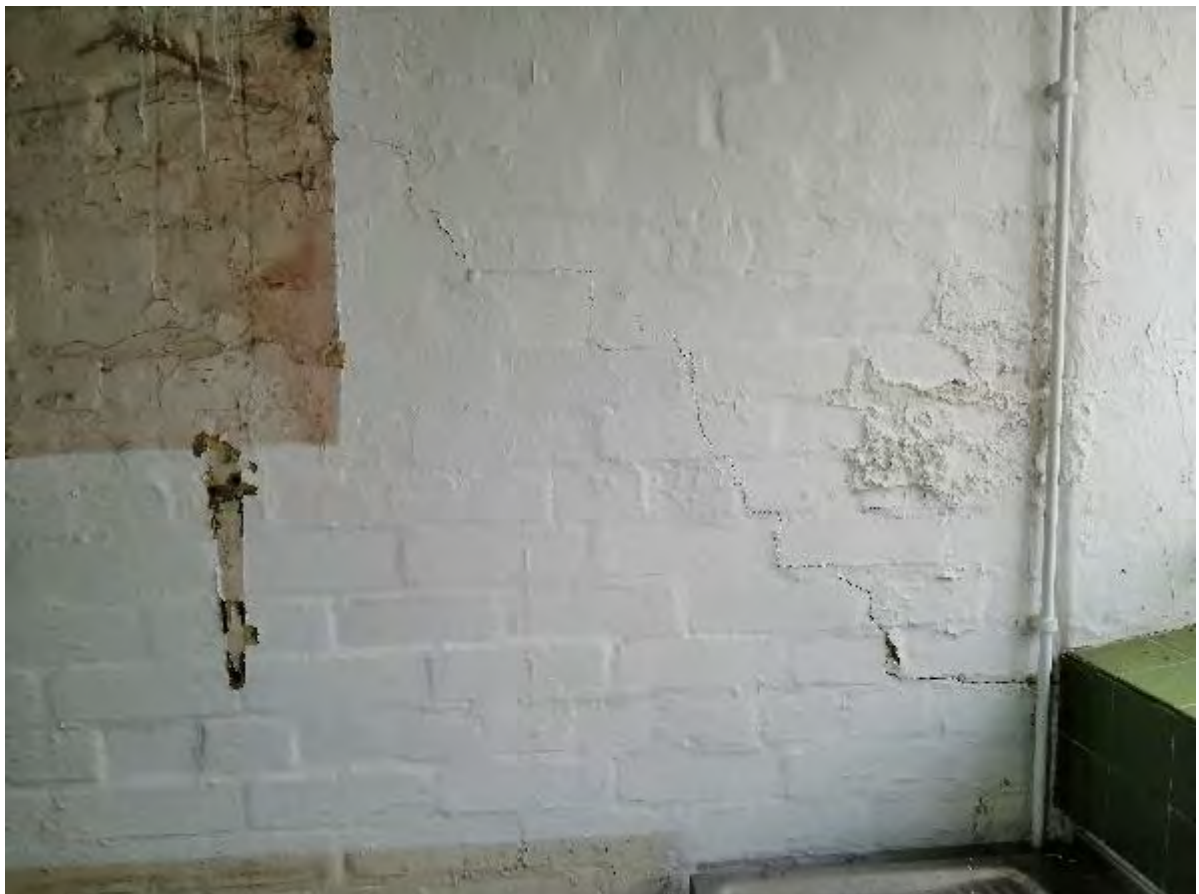
Photo 200 – Stepped Internal Wall Crack (Kitchen)

Stepped cracking (damage category 1) to the internal wall of the kitchen and utility room 2 – see photos 200-201 below. It was noted during the survey that the crack is mirrored on both sides of the wall implying that the crack has penetrated the full depth of the wall construction.

Local repairs to masonry and joints will be needed - Condition Rating **2** See Section 7.0 Recommendations for guidance on repair works required.

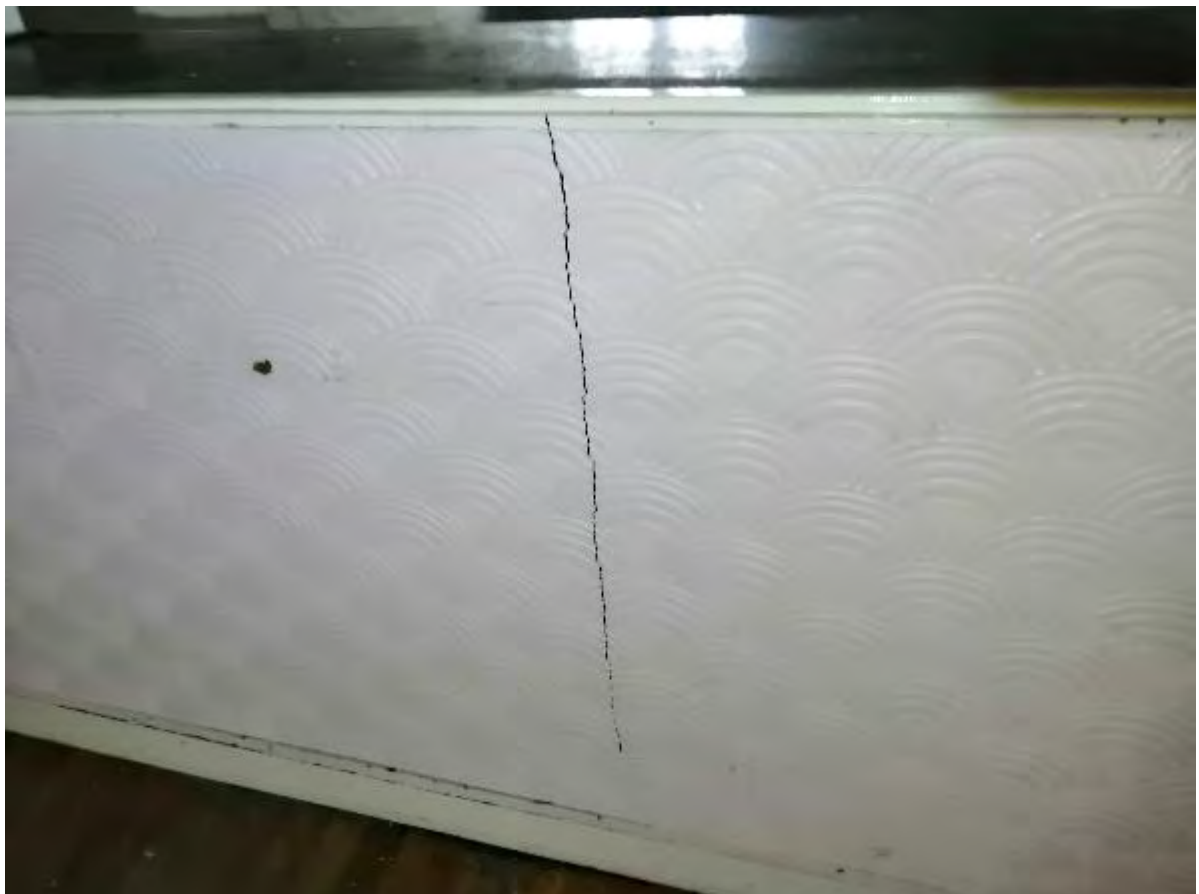
Photo 206 – Cracking to Studwork Wall (Hall)

Cracking (damage category 1) was noted to the studwork wall of the hall – see photo 206 below. This crack is not considered to be of structural concern and can be remediated through general maintenance and decoration.

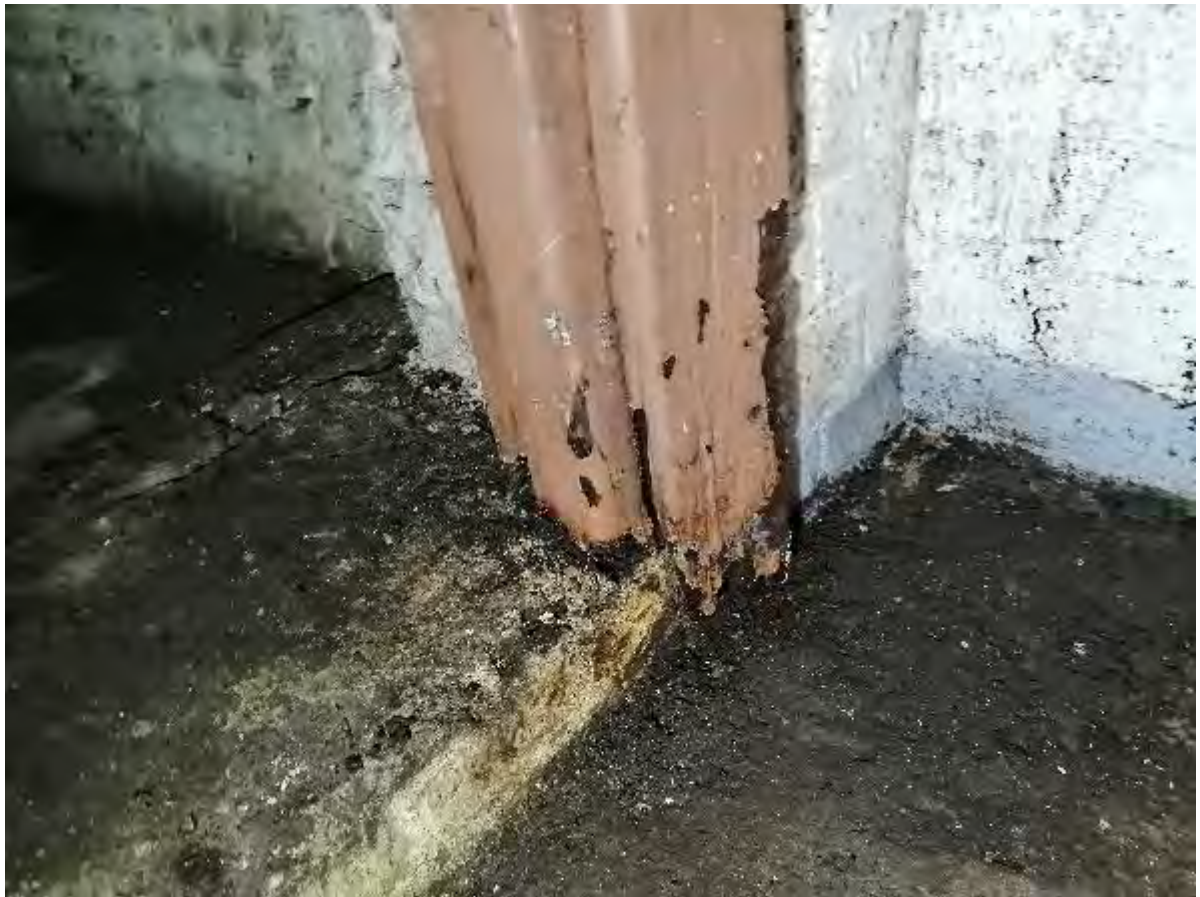
Photo 207 – Rot to Doorway Timber (Corridor 3)

Rot was noted to the base of the doorway frame to corridor 3 and the storage room – see photos 207-208 below. This rot is expected to be caused by the penetrating damp through the roof sheeting material of the rear extension. The timber doorway should be removed and replaced. There is surface damp to the concrete slab (as a consequence of the defective roof coverings) and is discussed further below - Condition Rating **2** See Section 7.0 Recommendations for guidance on repair works required.

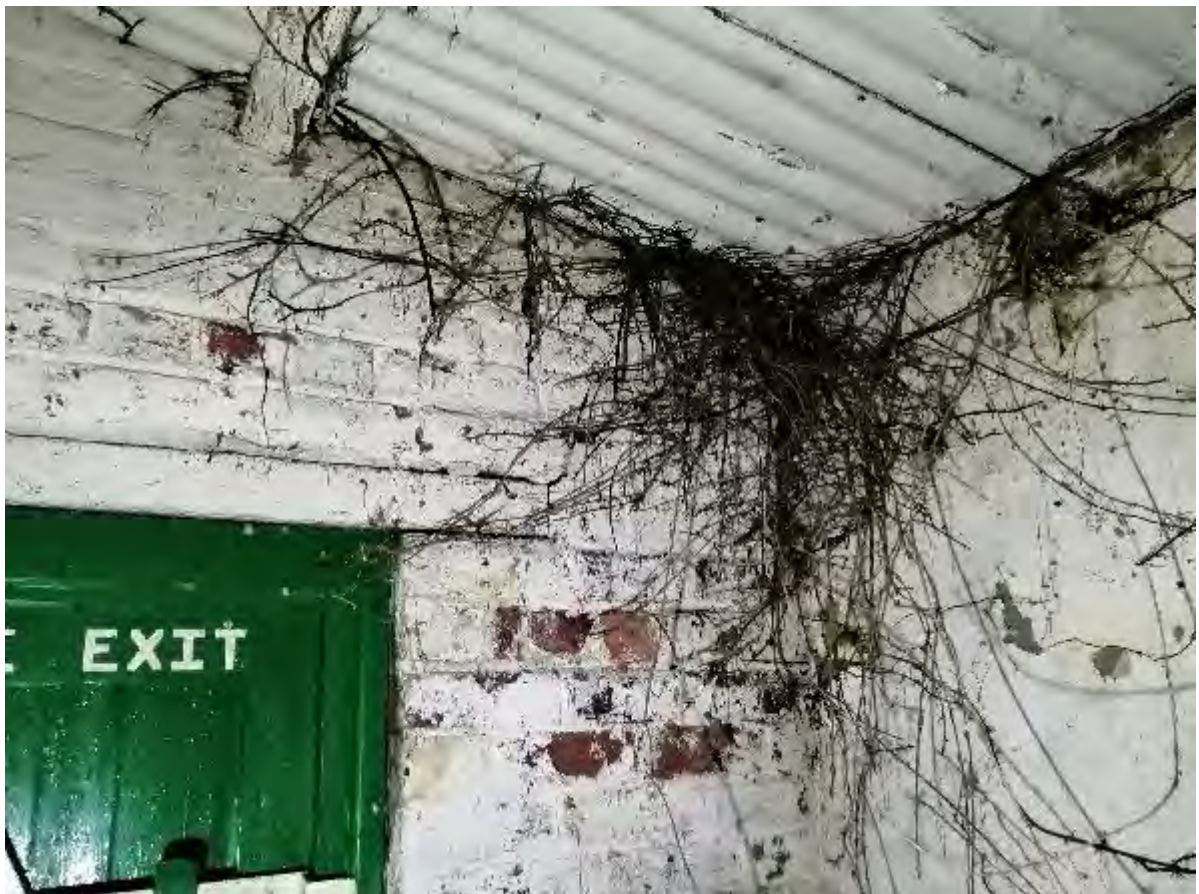
Photo 210 – Internal Vegetation Growth (Fire Exit Room)

Vegetation growth was noted the internal of the fire exit room – see photos 210-211 below. It is recommended that all the vegetation is removed to prevent further damage to the property. Condition Rating **2** See Section 7.0 Recommendations for guidance on repair works required.

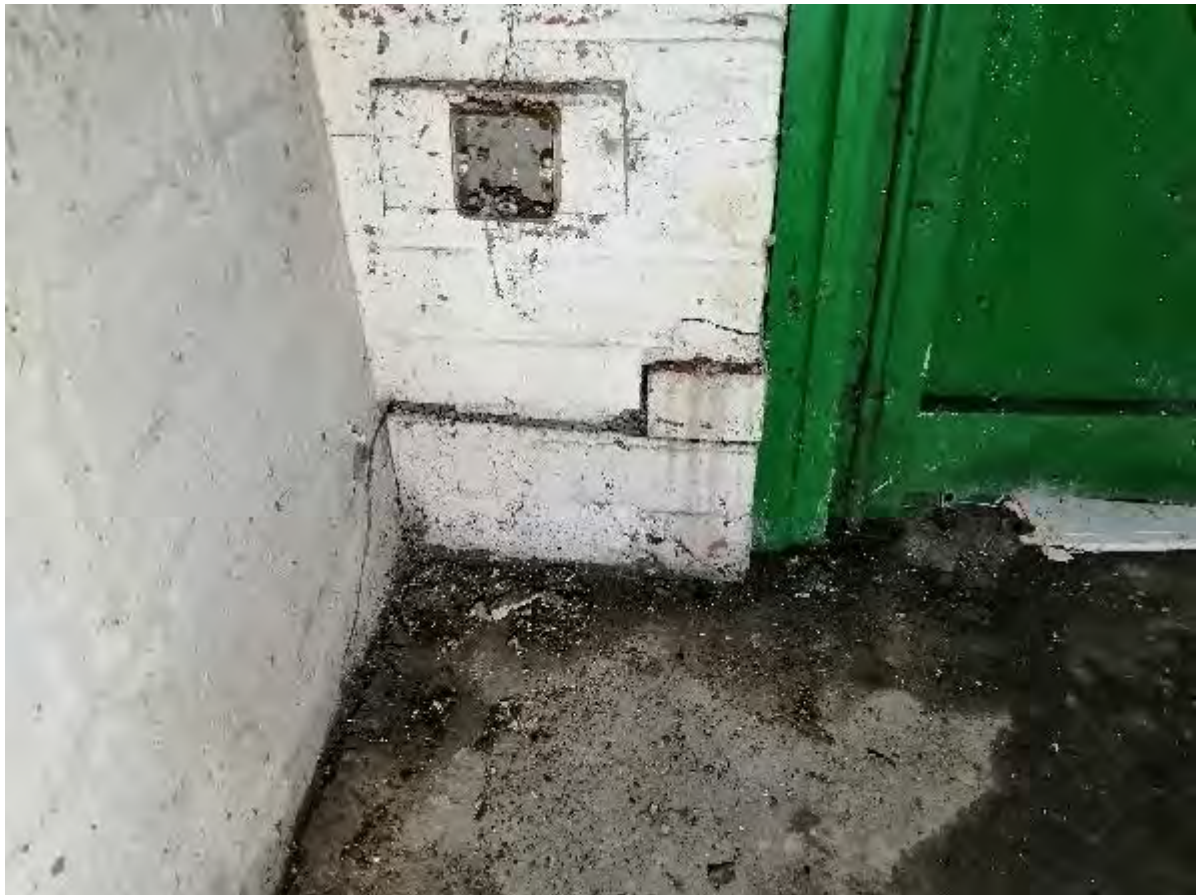
Photo 212 – Cracked and Displaced Masonry (Fire Exit Room)

Stepped cracking (damage category 2) was noted to the brickwork mortar of the in the fire exit room – see photos 212-213 below. During the survey it was noted that these cracks are mirrored on the external face of the wall suggesting that the cracks have penetrated the full depth of the wall construction. These cracks are expected to have been caused by the significant vegetation growth to the wall. Condition Rating **2** See Section 7.0 Recommendations for guidance on repair works required.

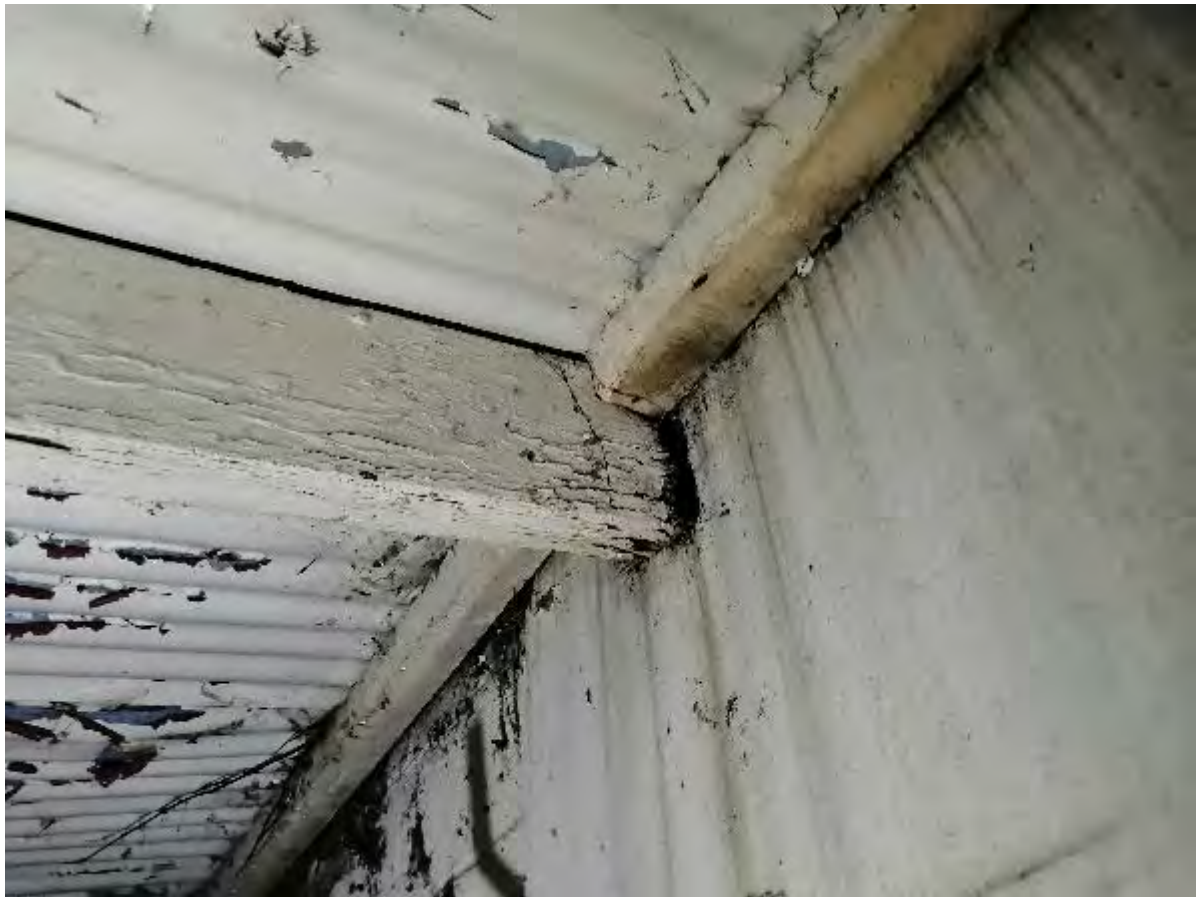
Photo 219 – Rot to Roof Purlin (Fire Exit Room)

During the survey, rot was noted to the timber purlins in the fire exit room – see photos 219-223 below. This rot is expected to be caused by the penetrating damp through the roof sheeting material. Due to the purlins condition it is recommended that the purlins are removed and replaced. Condition Rating **3** See Section 7.0 Recommendations for guidance on repair works required.

- During the survey, rot was noted to the timber purlins in the fire exit room – see photos 219-223. This rot is expected to be caused by the penetrating damp through the roof sheeting material. Due to the purlins condition it is recommended that the purlins are removed and replaced.

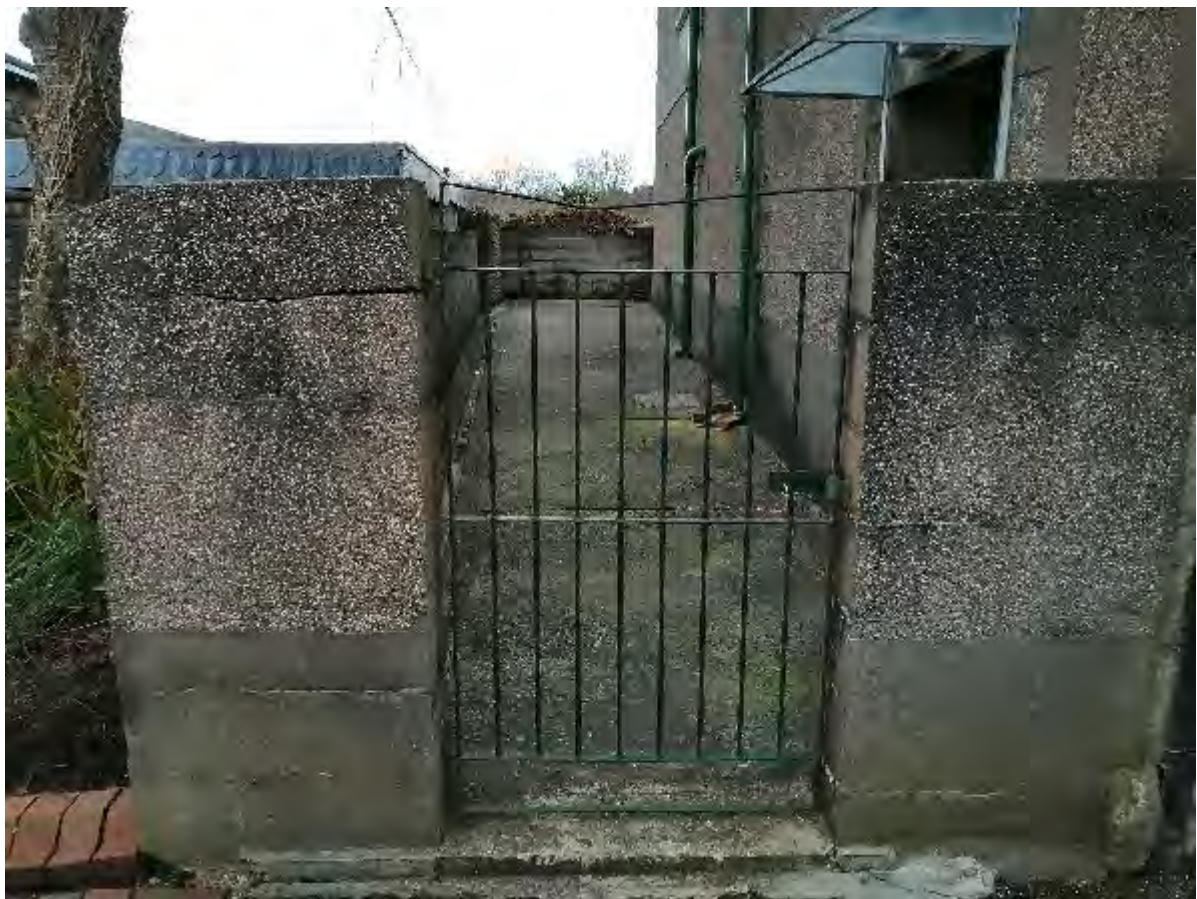
Photo 245 – Cracking to Wall Supporting Entrance Gate

Cracking (damage category 1 and 2) was noted to the boundary wall to both sides of the gate – see photo 245 below. It was noted during the survey that the cracks were mirrored on both sides of the wall implying the cracking had penetrated through the full depth of the wall construction. These cracks do not pose a structural concern for the main property building and remediation works are expected to require the demolition and reconstruction of the boundary wall at this location.

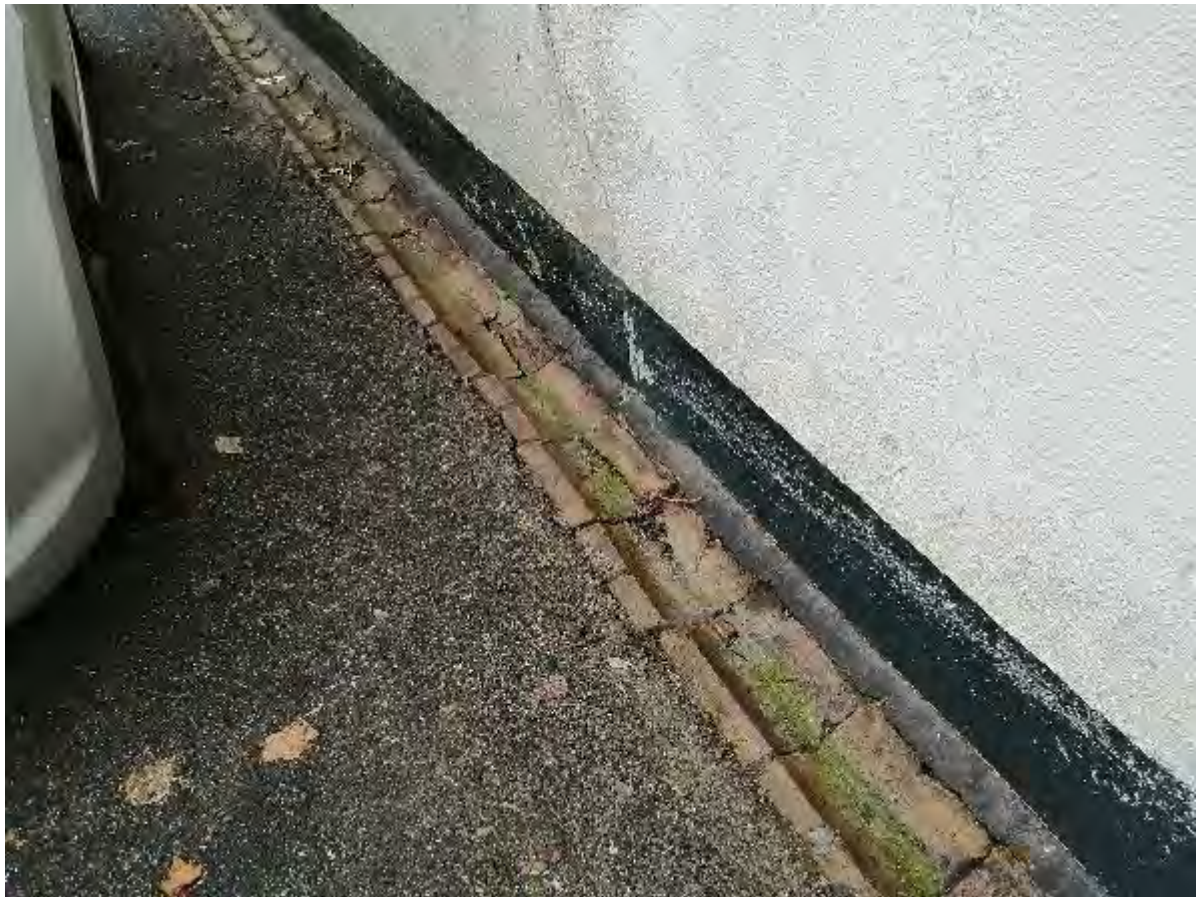
Photo 246 – Defective Drainage Chanel (Right Wall Elevation)

A defective drainage channel and lack of drainage gully to the right wall elevation were noted during the survey – see photos 246-247 below. Additionally, the rainwater down pipes to the front wall elevation discharge to the pavement without a method for removal of water away from the base of the wall – see photos 248-249 below. These defects can allow water to pond and build up against the property increasing the risk of rising and penetrating damp to the internal ground floor areas. It is recommended that the drainage arrangement to the external of the property is rationalised to remove water away from the property wall elevations. Condition Rating **2** See Section 7.0 Recommendations for guidance on repair works required.
