# ASBESTOS REFURBISHMENT SURVEY

Moose Hall, Neath SA11 3LU

1 Dec 2021

ALL100645/21/CE-1

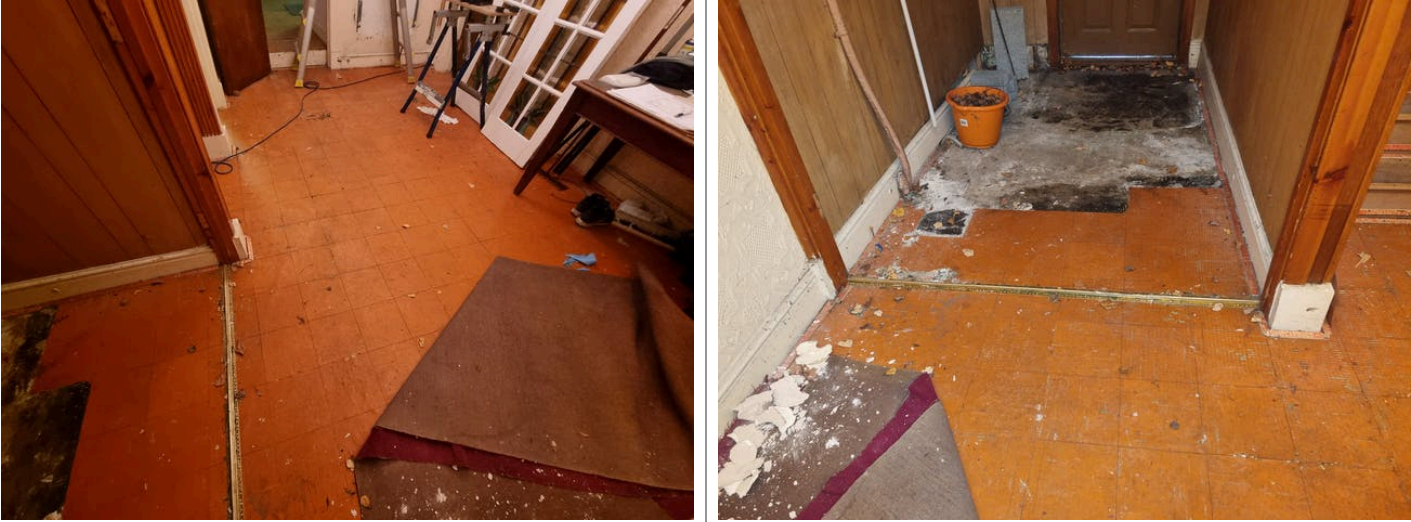
| Location | 001 - | Item | Red vinyl floor tiles |

| Material | Vinyl Tile | Extent | 10 m. sq. |
| Strategy / Sample Id | Sample / 100645/13 | Fibre Type | Chrysotile |

| Recommendation | Remove if planned works may disturb | | |

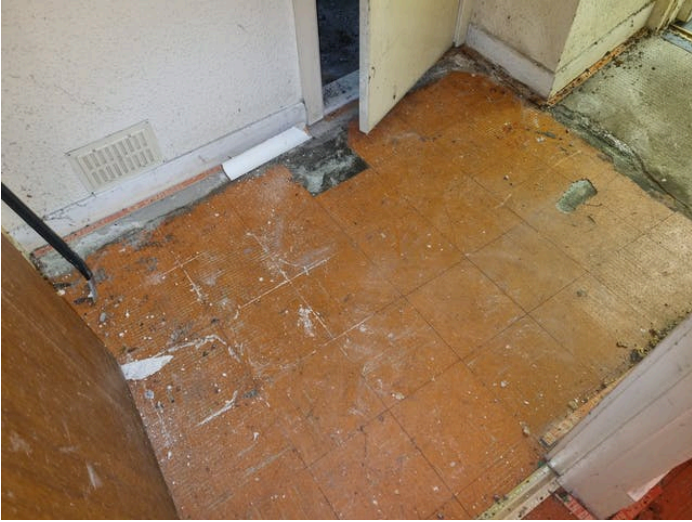
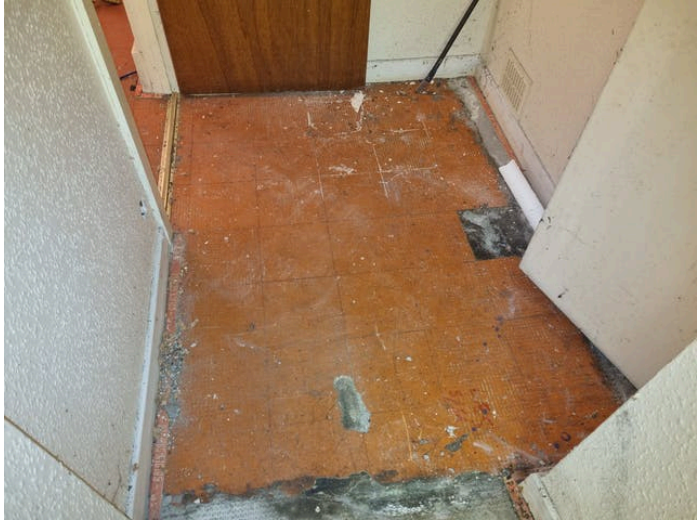
| Location | 002 - | Item | Red vinyl floor tiles |

| Material | Vinyl Tile | Extent | 2 m. sq. |
| Strategy / Sample Id | Strongly Presume / 100645/14 | Presumed Fibre Type | Chrysotile |
| General Comments | Visually similar to 100645/13 Tile missing and small amount of damaged tiles present | | |

| Recommendation | Remove if planned works may disturb | | |

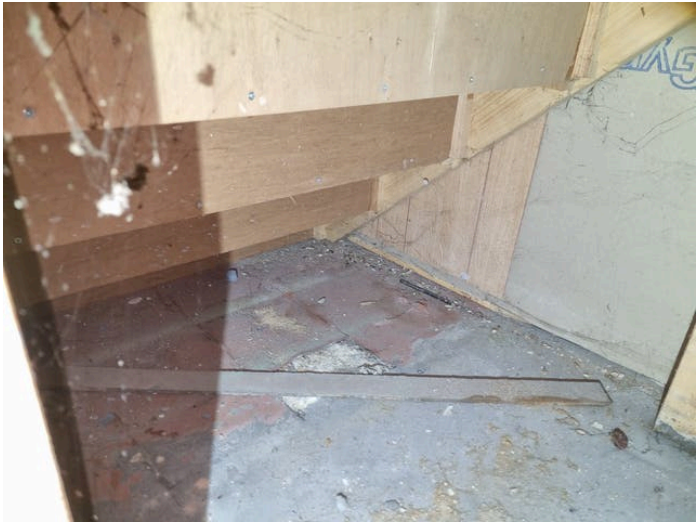
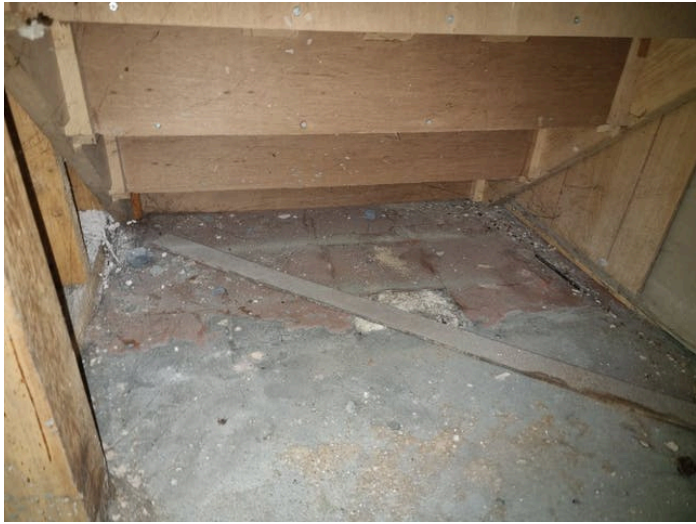
| Material | Vinyl Tile | Extent | 0.5 m. sq. |
| Strategy / Sample Id | Strongly Presume / 100645/15 | Presumed Fibre Type | Chrysotile |

| Recommendation | Remove if planned works may disturb | | |

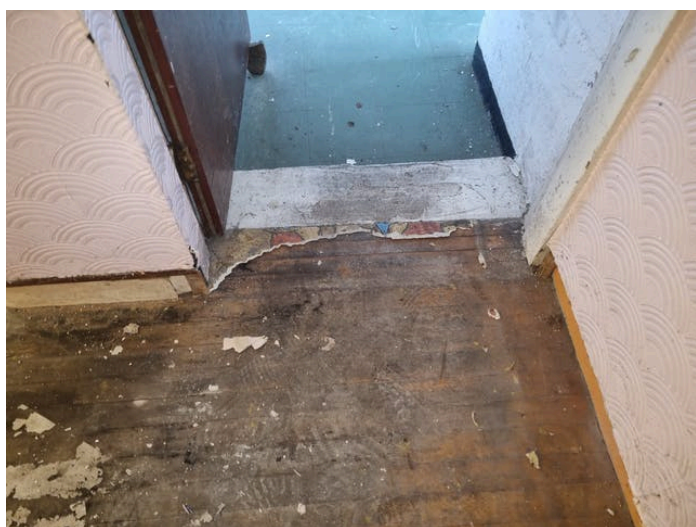
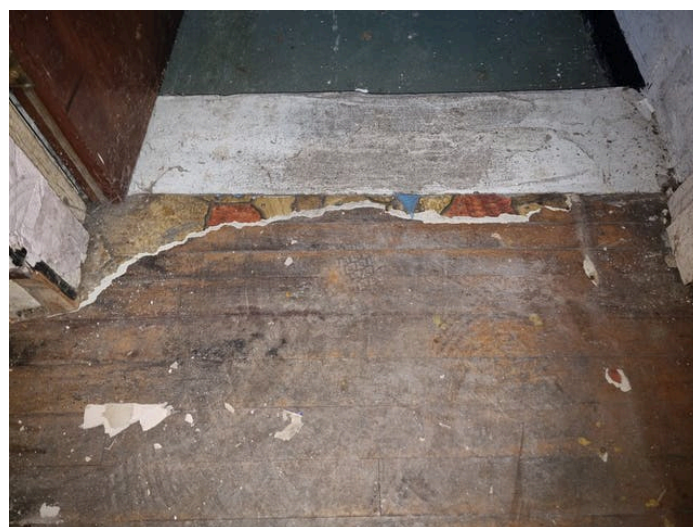
| Location | 006 - | Item | Remnants of paper backed sheet vinyl flooring at doorway leading to room 0/11 |

| Material | Paper backed sheet vinyl flooring | Extent | Small amount present |

| Strategy / Sample Id | Sample / 100645/21 | Fibre Type | Chrysotile |

| Recommendation | Remove if planned works may disturb | | |

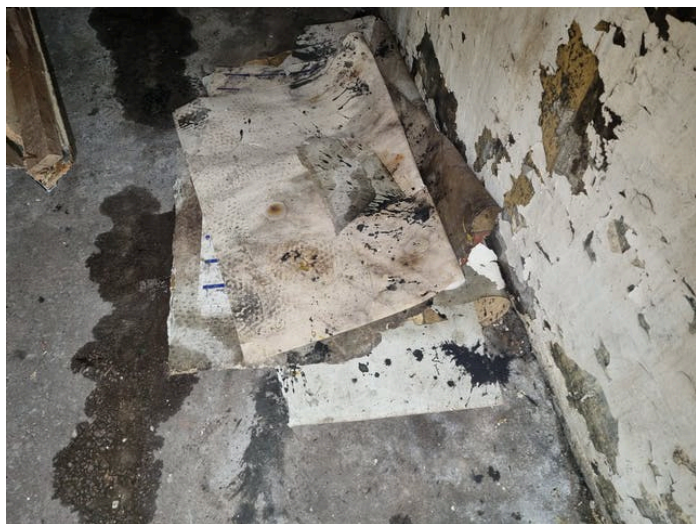
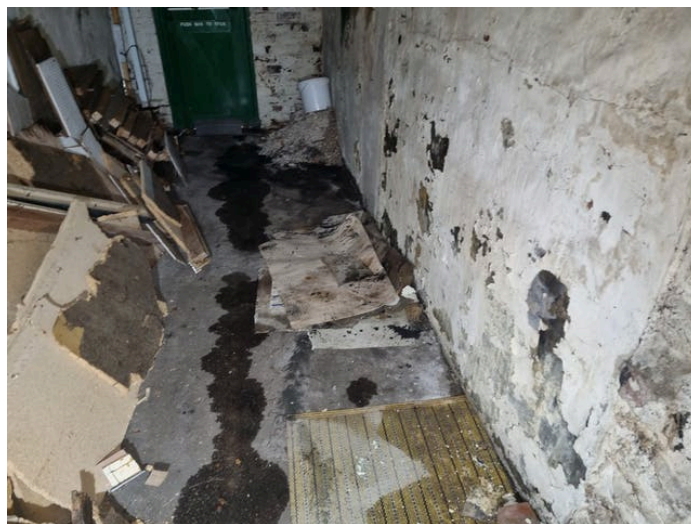
| Location | 009 - | Item | Paper backed sheet vinyl flooring stored in pile on floor |

| Material | Paper backed sheet vinyl flooring | Extent | Small amount present |

| Strategy / Sample Id | Strongly Presume / 100645/25 | Presumed Fibre Type | Chrysotile |

| Recommendation | Remove if planned works may disturb | | |

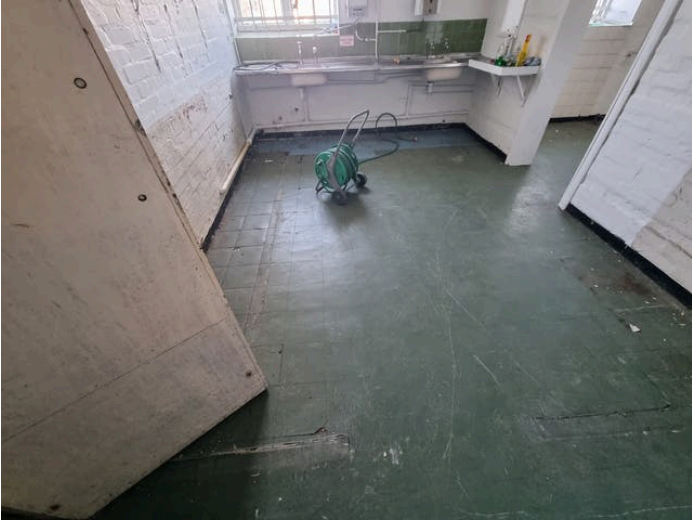
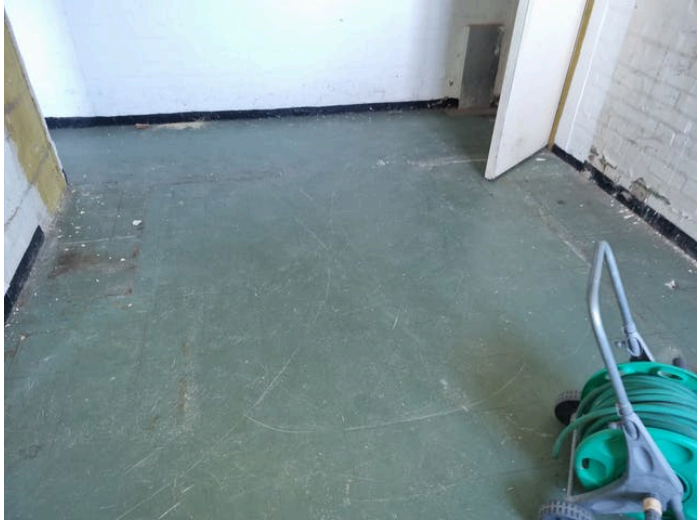
| Location | 011 - | Item | Green vinyl floor tile |

| Material | Vinyl Tile | Extent | 10 m. sq. |
| Strategy / Sample Id | Sample / 100645/22 | Fibre Type | Chrysotile |

| Recommendation | Remove if planned works may disturb | | |

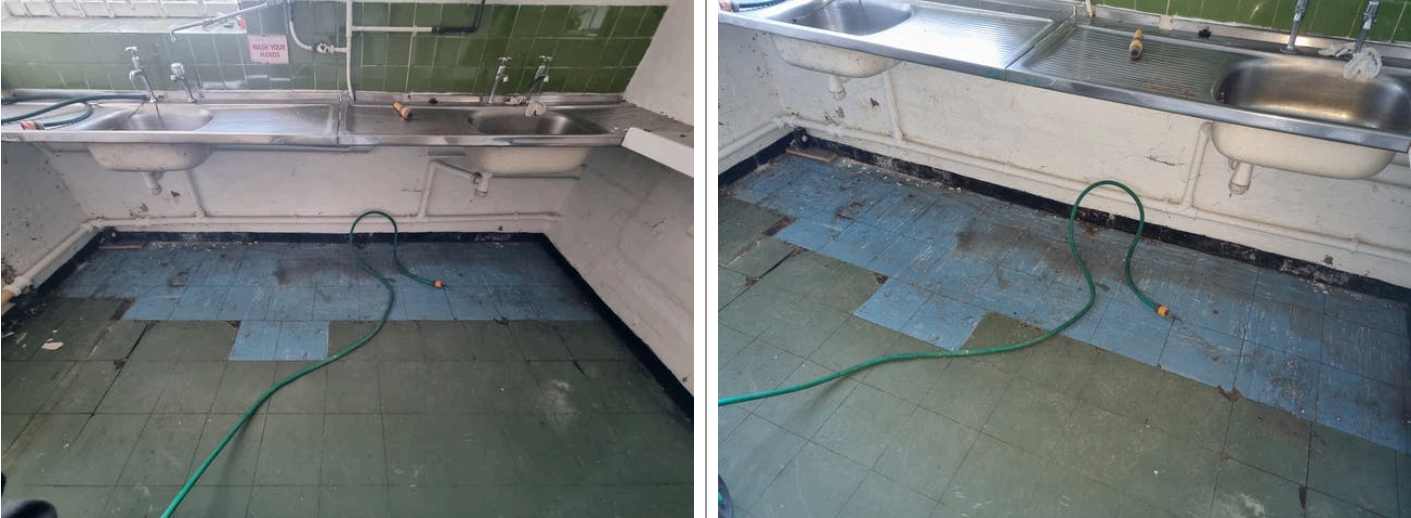
| Location | 011 - | Item | Blue vinyl floor tiles beneath sink units |

| Material | Vinyl Tile | Extent | 2 m. sq. |
| Strategy / Sample Id | Sample / 100645/23 | Fibre Type | Chrysotile |

| Recommendation | Remove if planned works may disturb | | |

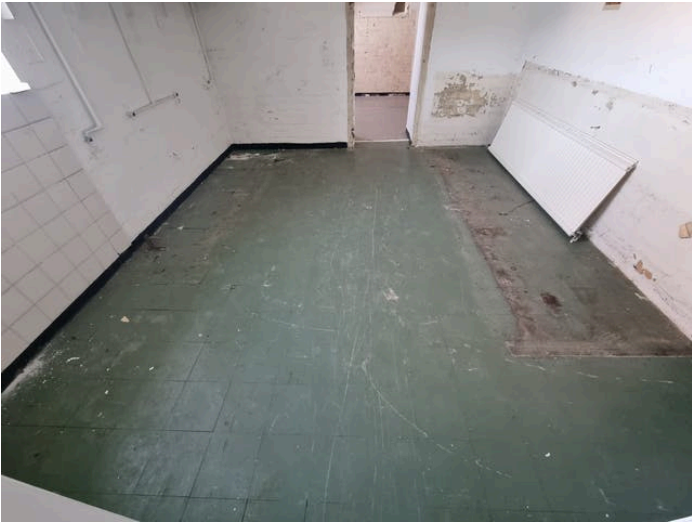
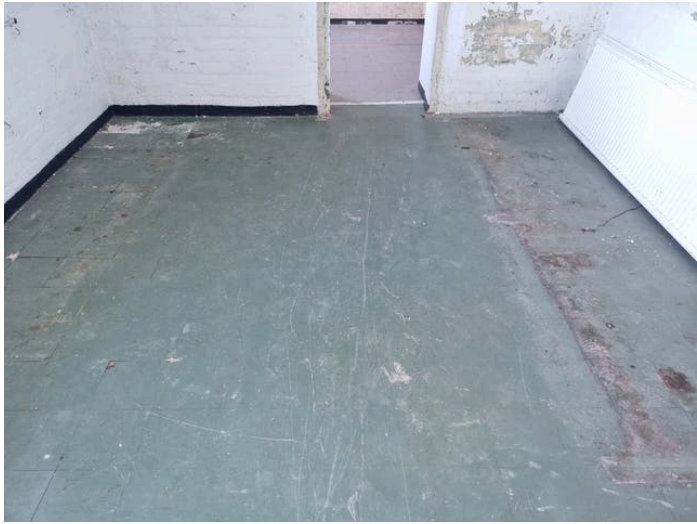
| Location | 012 - | Item | Green vinyl floor tile |

| Material | Vinyl Tile | Extent | 12 m. sq. |
| Strategy / Sample Id | Strongly Presume / 100645/24 | Presumed Fibre Type | Chrysotile |

| Recommendation | Remove if planned works may disturb | | |

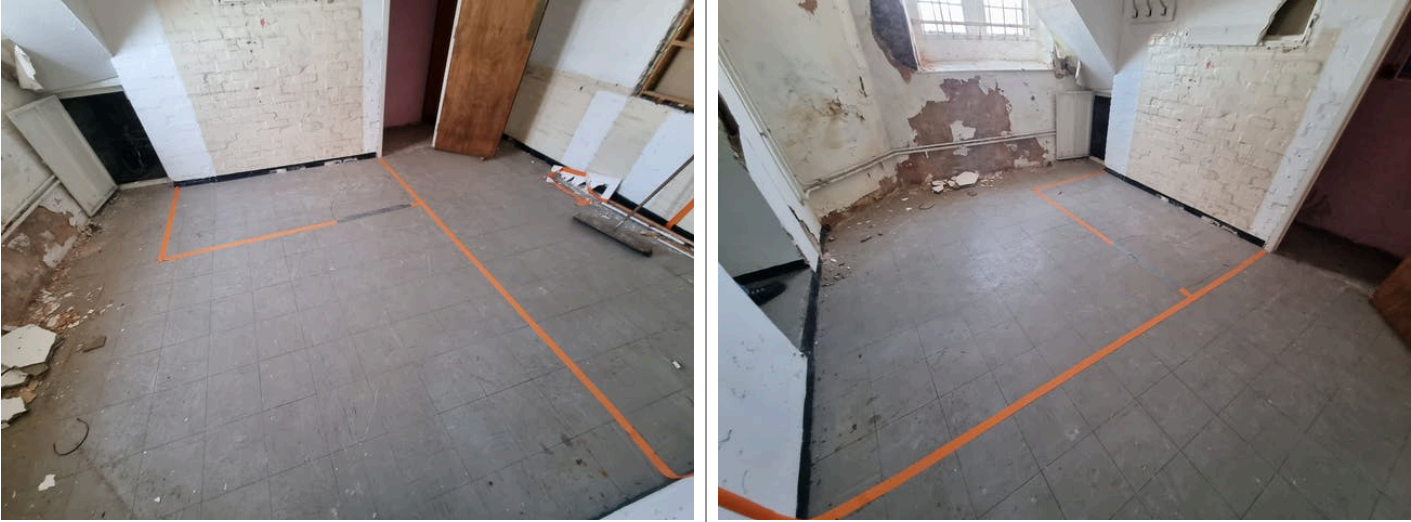
| Location | 013 - | Item | Grey vinyl floor tile |

| Material | Vinyl Tile | Extent | 10 m. sq. |
| Strategy / Sample Id | Sample / 100645/26 | Fibre Type | Chrysotile |

| Recommendation | Remove if planned works may disturb | | |

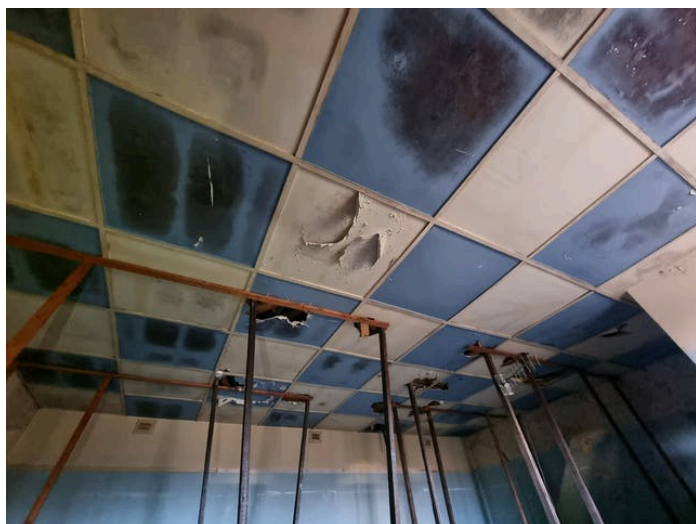
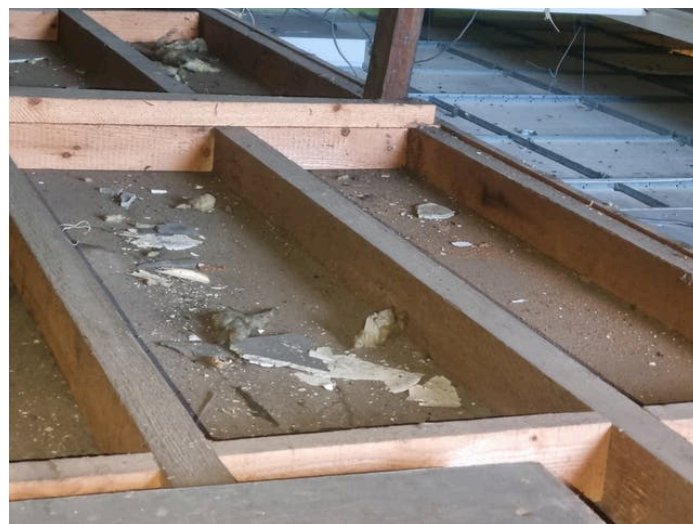
## Main Building > 0 > Suspended ceiling void above 0/06 > Cement panelling to ceiling and floor of roof void 1 above

- Badly damaged cement panelling to ceiling and floor of roof void 1 which is also located within the suspended ceiling void of room 0/006. Visible cement debris is present within both the voids. This material is non-licensed and can be removed by suitably trained personnel, however due to the amount of debris and panelling present

| Material | Cement | Extent | 60 m. sq. |

| Strategy / Sample Id | Sample / 100645/09 | Fibre Type | Chrysotile and Crocidolite |
| General Comments | <p>Debris is present throughout the void upon all surfaces including the back side of the majority of suspended ceiling tiles to the room below.</p> <p>This material is non-licensed and can be removed by suitably trained personnel, however due to the amount of debris and panelling present and the complexity of the removal work we would recommend the use of a licensed asbestos removal contractor.</p> | | |

and the complexity of the removal work we would recommend the use of a licensed asbestos removal contractor.

| Recommendation | Removal by trained operatives | | |

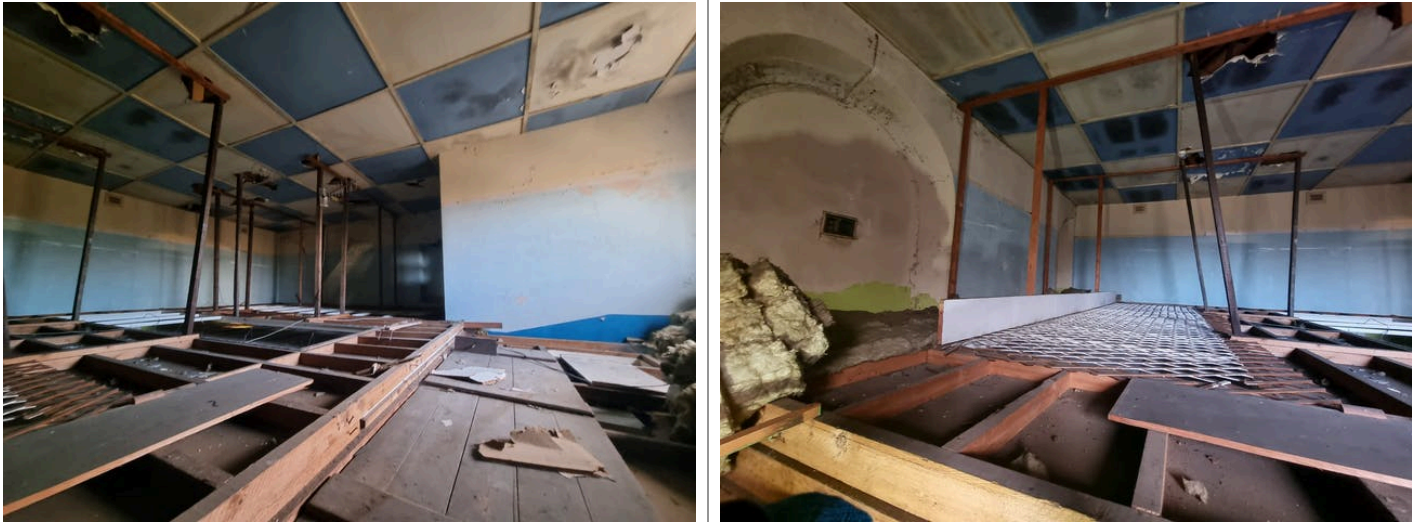
| Location Notes | Cement ceiling tiles to upper ceiling (Badly damaged with visible debris upon suspended ceiling tiles below) / Solid walls / Former arched windows have been plastered over / Compressed wood panelling to floor of void which historically formed ceiling of room below, suspended cellulosic tiles are also present beneath / Wood framed windows / MMMF insulation present in parts | | |
| Access / Notes | Limited Access / Limited access throughout void due to unsafe footing | | |

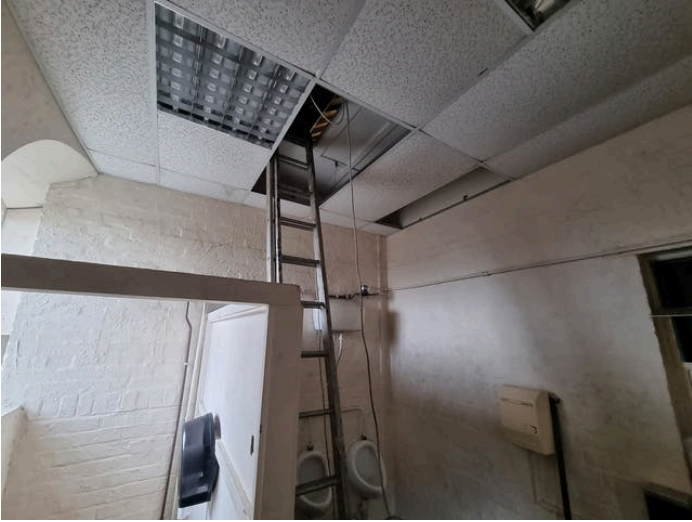
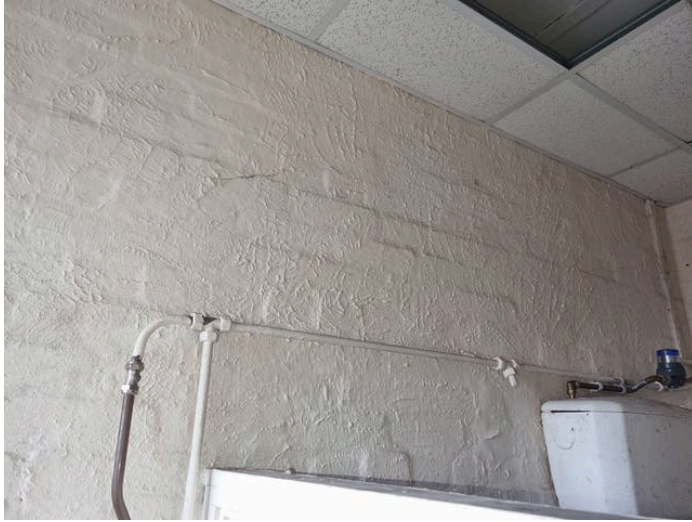
| Material | Textured Coating | Extent | 18 m. sq. |
| Strategy / Sample Id | Sample / 100645/05 | Fibre Type | Chrysotile |

| Recommendation | Remove if planned works may disturb | | |

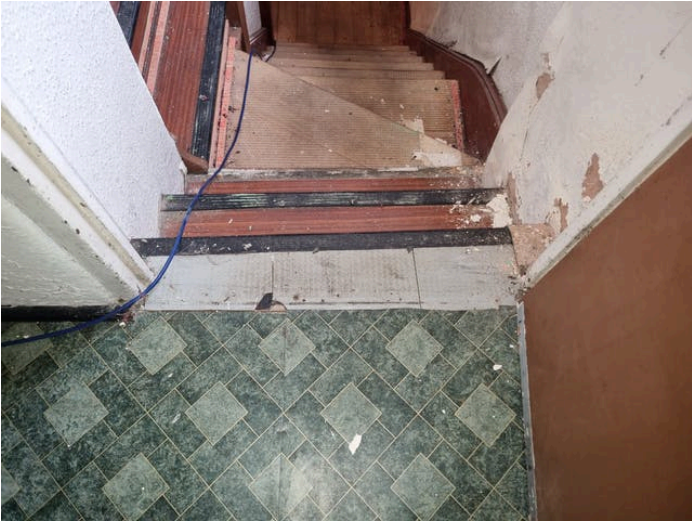
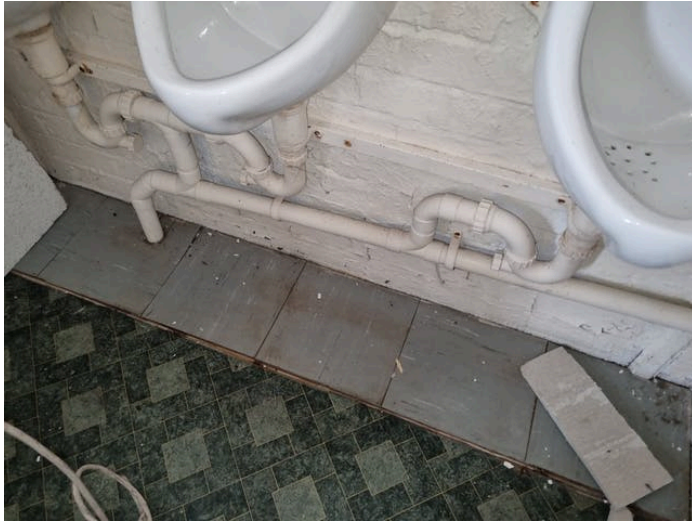
| Material | Vinyl Tile | Extent | 4 m. |
| Strategy / Sample Id | Sample / 100645/06 | Fibre Type | Chrysotile |

| Recommendation | Remove if planned works may disturb | | |

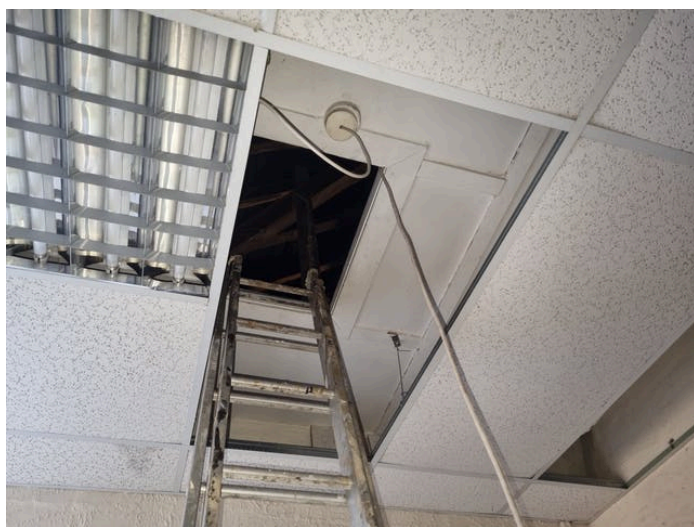
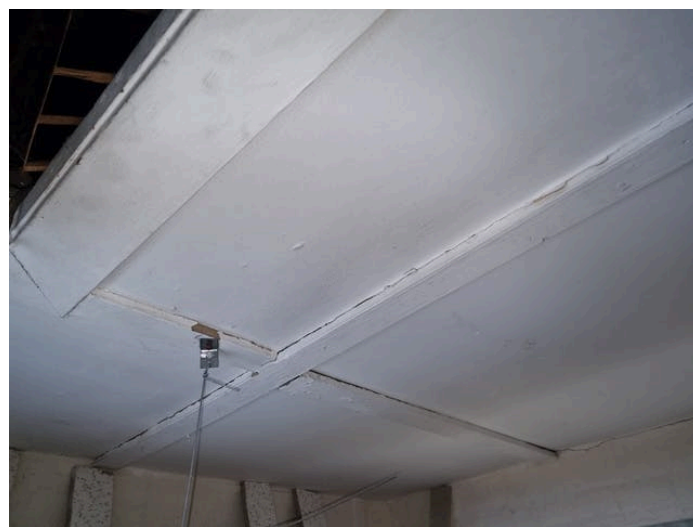
| Material | Cement | Extent | 6 m. sq. |

| Strategy / Sample Id | Strongly Presume / 100645/10 | Presumed Fibre Type | Chrysotile and Crocidolite |

| Recommendation | Remove if planned works may disturb | | |

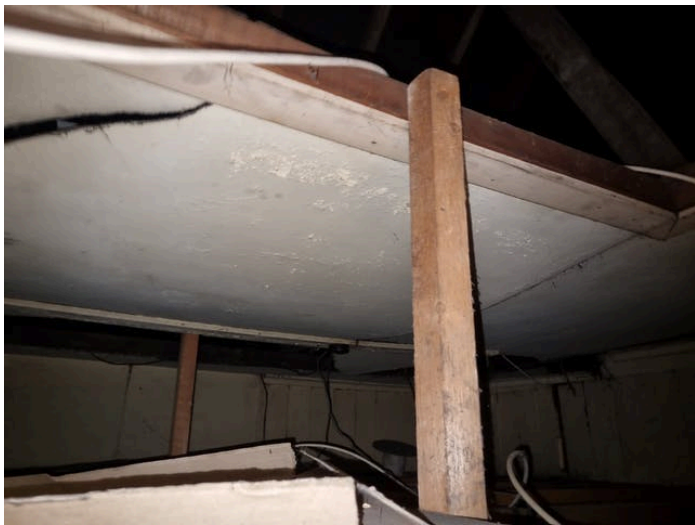
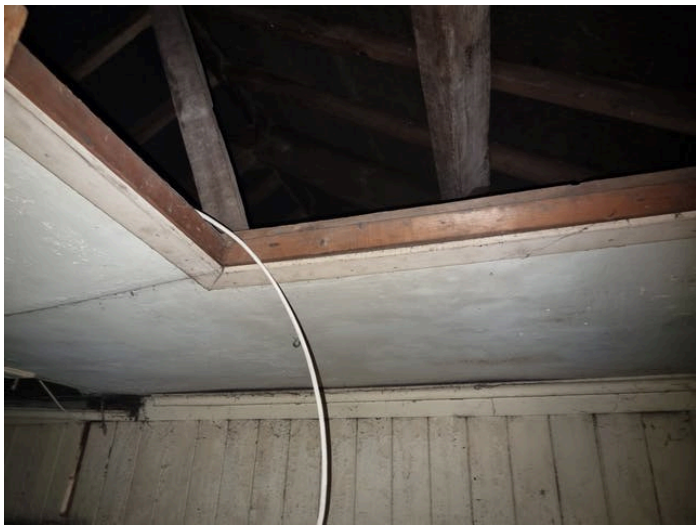
## Main Building > 1 > 003 - > Cement panelling to ceiling above suspended ceiling (Panelling to floor of roof void 2 above)

| Material | Cement | Extent | 10 m. sq. |
| Strategy / Sample Id | Strongly Presume / 100645/11 | Presumed Fibre Type | Chrysotile and Crocidolite |

| Recommendation | Remove if planned works may disturb | | |

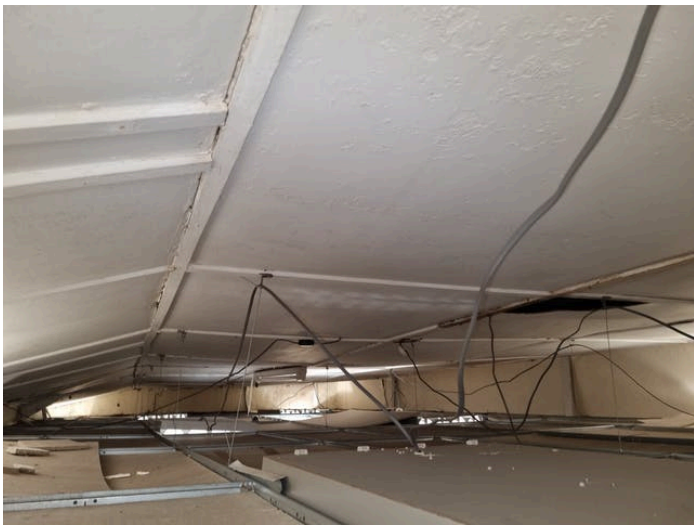
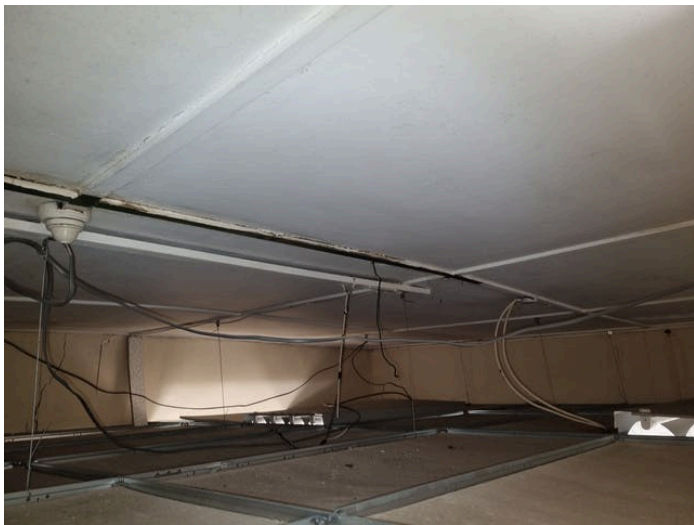
## Main Building > 1 > 004 - > Cement panelling to ceiling above suspended ceiling (Panelling to floor of roof void 2 above)

| Material | Cement | Extent | 190 m. sq. |
| Strategy / Sample Id | Strongly Presume / 100645/12 | Presumed Fibre Type | Chrysotile and Crocidolite |
| General Comments | Visually similar to 100645/03<br>Compressed wood panels present in places where repairs have been undertaken | | |

| Recommendation | Remove if planned works may disturb | | |

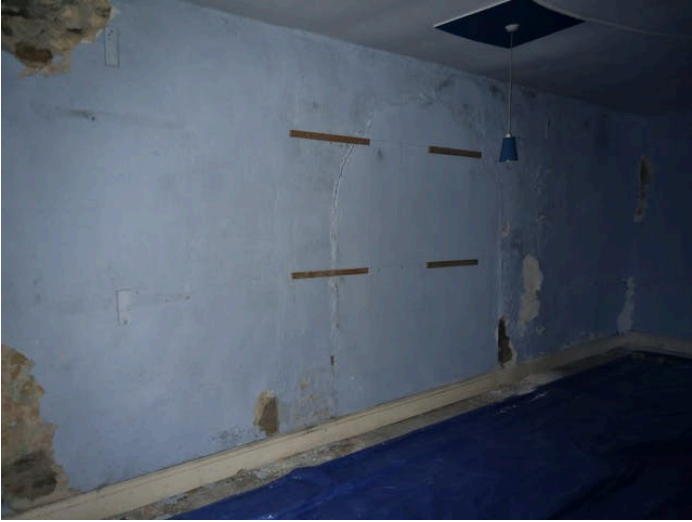
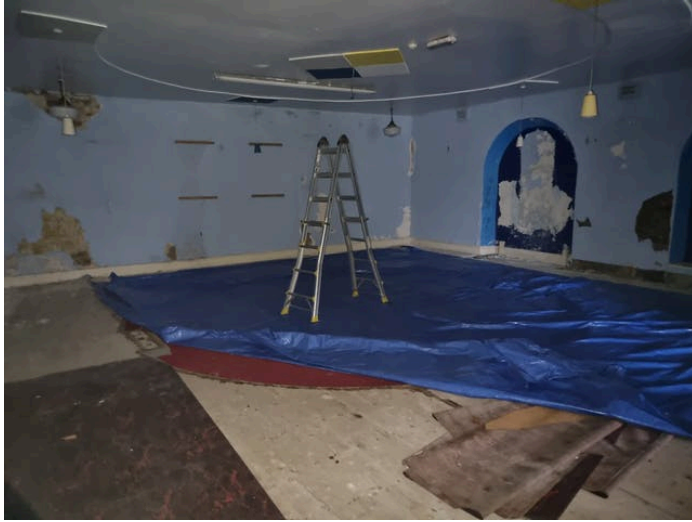
## Main Building > 1 > 005 - > Textured paint to walls

| Material | Textured Coating | Extent | Approximately 60 m2 |
| Strategy / Sample Id | Sample / 100645/07 | Fibre Type | Chrysotile |

| Recommendation | Removal by trained operatives | | |
