| | Plan Location: | | Moose Hall, Neath, SA11 3LU | | |

**Test Report ALL100645/21/CG-1**

22 Samples taken by our laboratory in accordance with our  
In-house procedure No. ANC/AS/3, from Moose Hall, Castle Street, Neath SA11 3LU

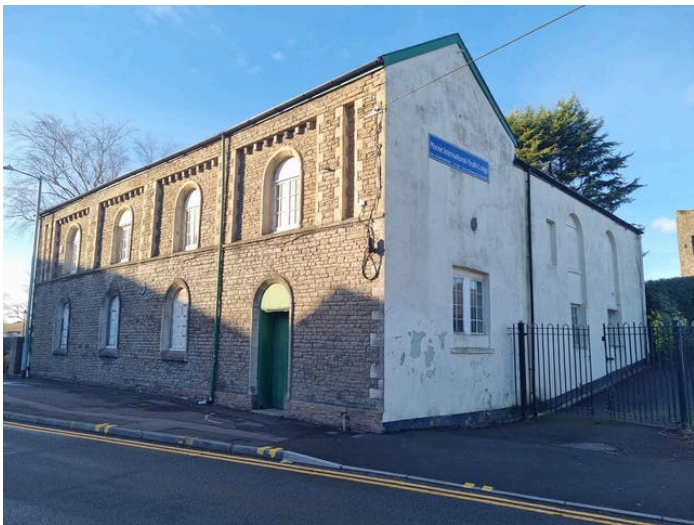
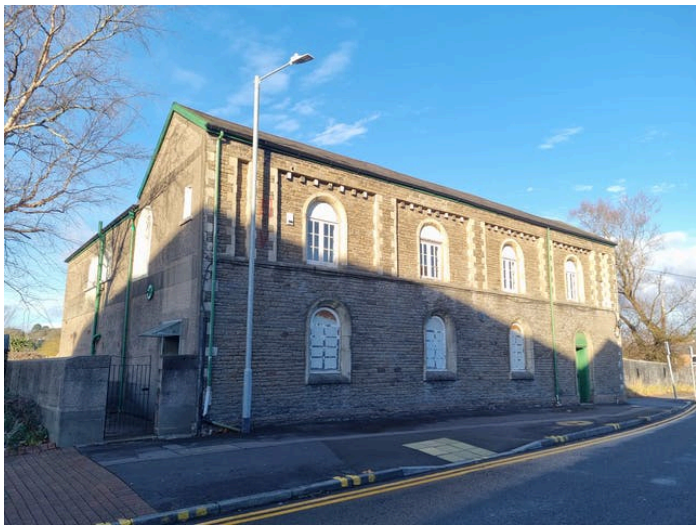
| Location Notes | Slate roof with possible composite replacement tiles / Fibreglass flat roof to rear extension/ Stone and rendered walls to main building / Brick walls to rear extension / Metal and wood window frames / Mixture of metal, PVC and cement water goods / Wood doors / No visible DPC | | |

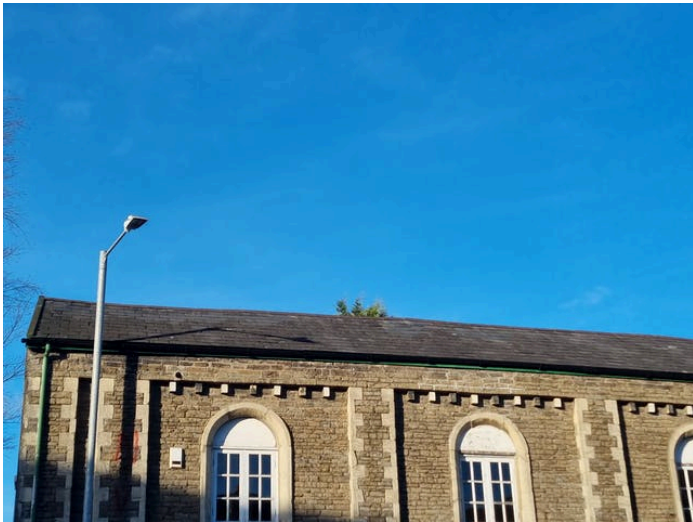
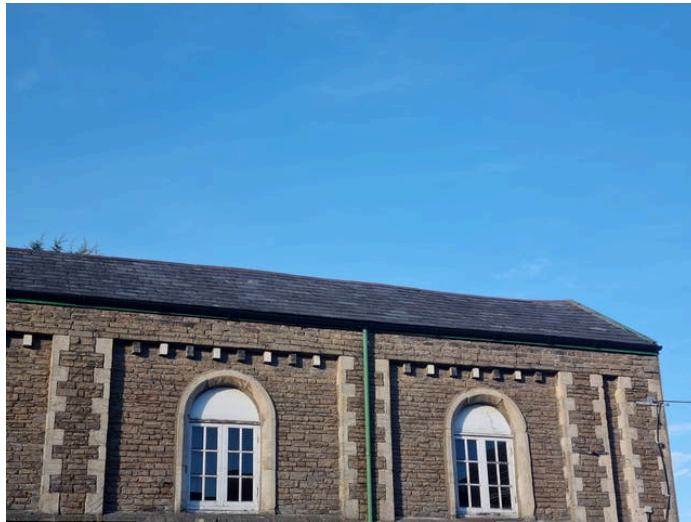
| Location | Main roof | Item | Composite replacement tiles |

| Material | Composite | Extent | Small amount of replacement tiles present |
| Strategy / Sample Id | Presume | Presumed Fibre Type | Chrysotile |

| Material Score | 3 / Very Low | | |

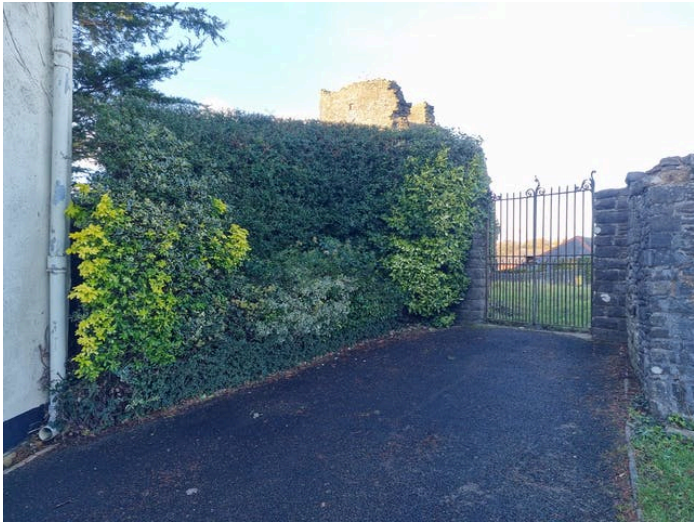
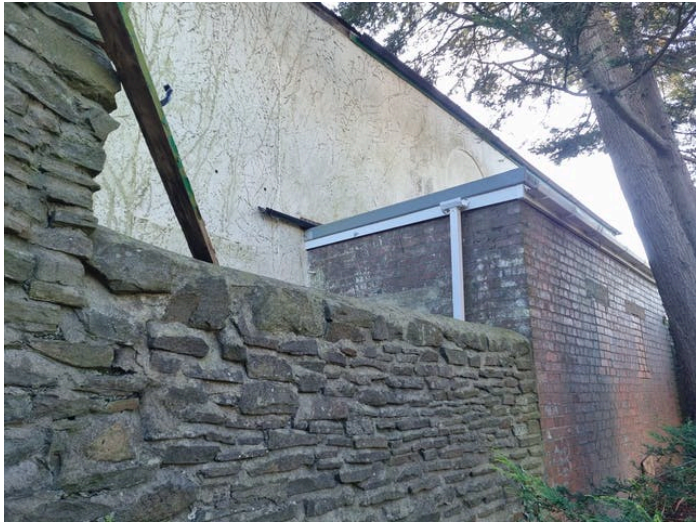
| Location Notes | Limited access due to location within adjoining castle boundary | | |

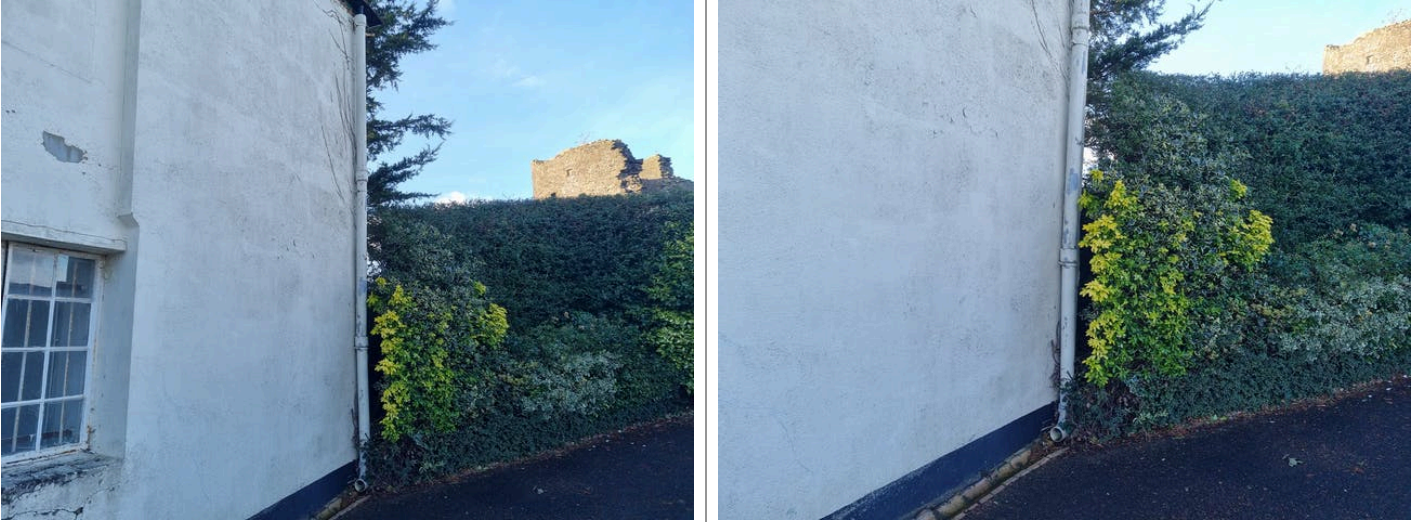
| Location | RHS rear | Item | Cement down pipe |

| Strategy / Sample Id | Sample / 100645/30 | Fibre Type | Chrysotile |

| Material Score | 3 / Very Low | | |

| Sample Reference | Sample Information | Material Type* | Test Result |
|---|---|---|---|
| 100645/30 | External, Rear RHS, Cement Down Pipe | Cement Material | Chrysotile asbestos |

| Recommendation | Removal by trained operatives | | |

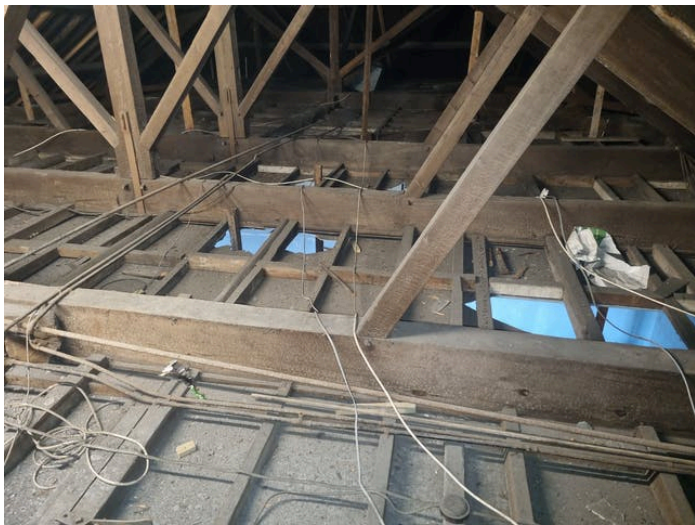
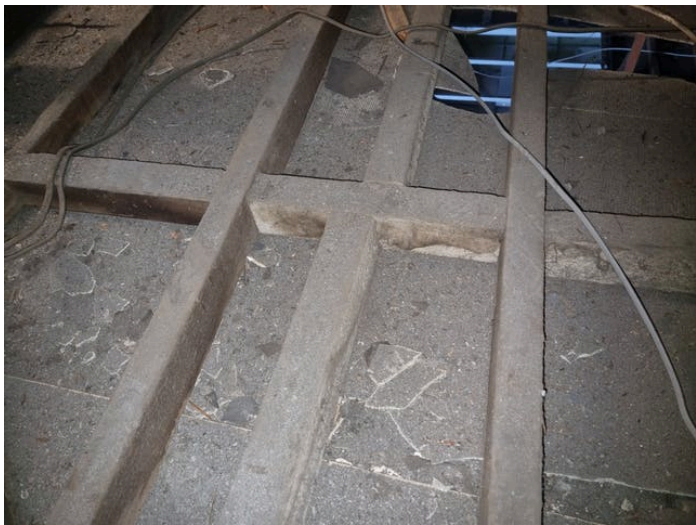
| Strategy / Sample Id | Sample / 100645/01 | Fibre Type | Chrysotile and Crocidolite |
| General Comments | Cement panelling to floor of roof void above suspended ceiling void of room 0/06 below only, Highly damaged panelling with visible debris present throughout this section of the void. The remainder of the void consists of plasterboard and plaster above room 1/05. This material is non-licensed and can be removed by suitably trained personnel, however due to the amount of debris and panelling present and the complexity of the removal work we would recommend the use of a licensed asbestos removal contractor. | | |

| Material Score | 8 / Medium | | |

| Sample Reference | Sample Information | Material Type* | Test Result |
|---|---|---|---|
| 100645/01 | Roof Void 1 - Cement Floor Panelling | Cement Material | Crocidolite and Chrysotile asbestos |

| Recommendation | Removal by trained operatives | | |

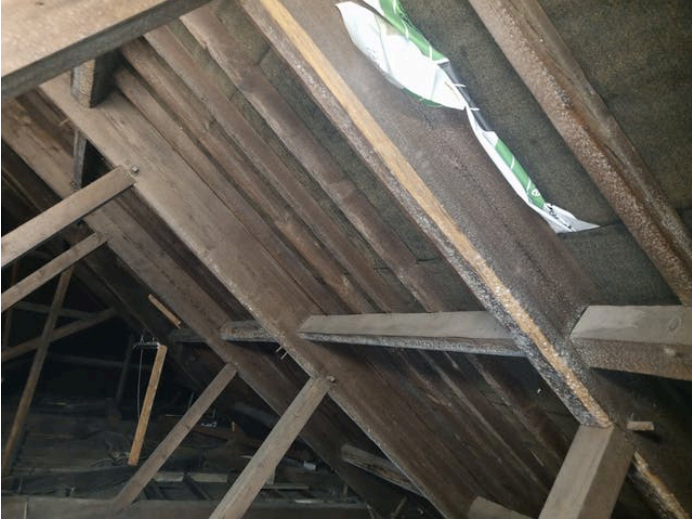
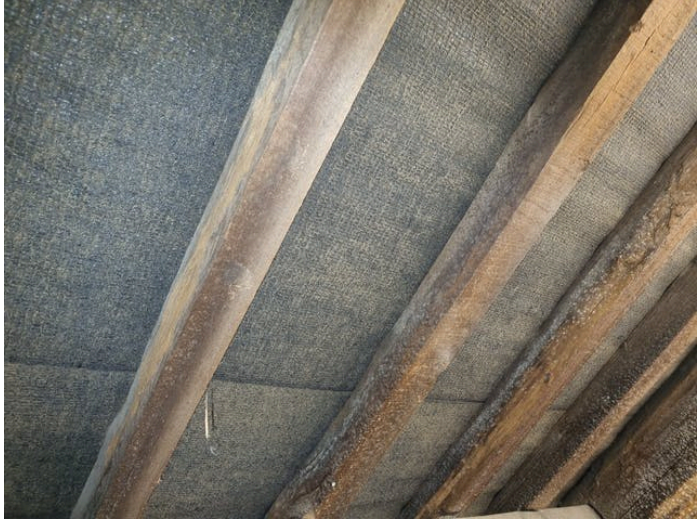
| Location | Roof void 1 | Item | Bitumen sarking felt to main roof |

| Strategy / Sample Id | Sample / 100645/02 | Fibre Type | NADIS |

| Sample Reference | Sample Information | Material Type* | Test Result |
|---|---|---|---|
| 100645/02 | Roof Void 1 - Roof Felt | Bitumen felt | Asbestos Not Detected |

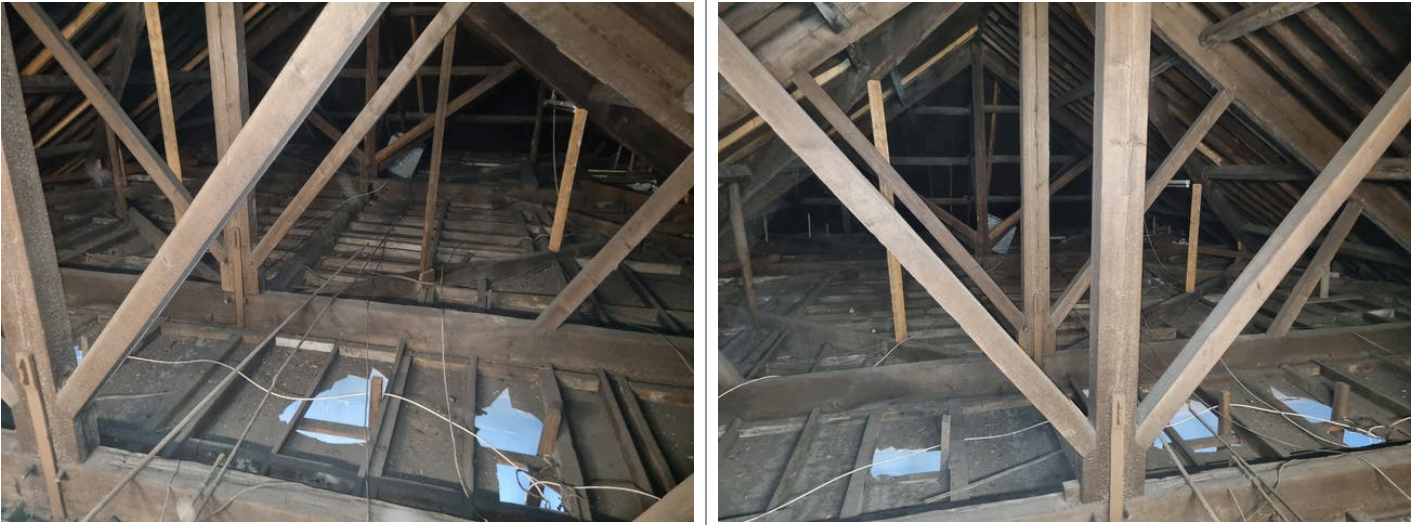
| | | <b>Location Notes</b><br>Bitumen sarking felt / Timber joists and framework / Cement panelling to floor of nearside half of the void, remaining half consists of plasterboard | |

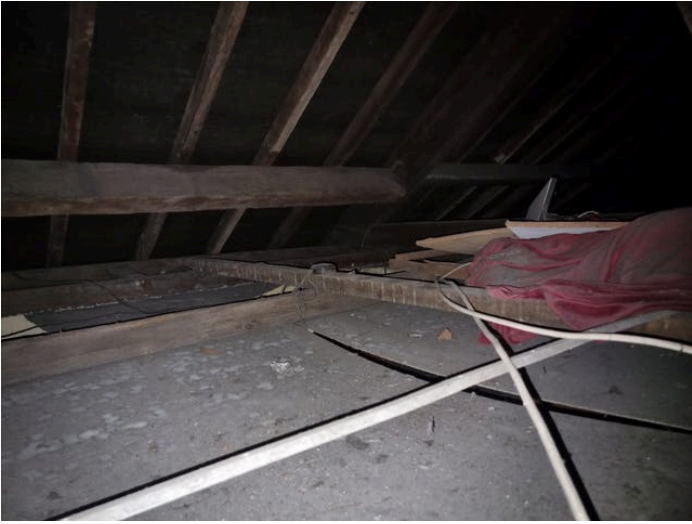
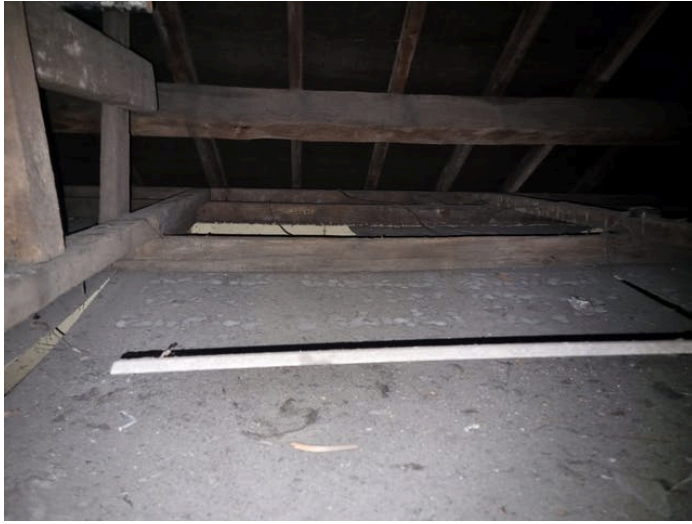
| Location | Roof void 2 | Item | Cement panelling to floor of roof void |

| Strategy / Sample Id | Sample / 100645/03 | Fibre Type | Chrysotile |

| Material Score | 4 / Very Low | | |

| Sample Reference | Sample Information | Material Type* | Test Result |
|---|---|---|---|
| 100645/03 | Roof Void 2 - Cement Floor Panel | Cement Material | Chrysotile asbestos |

| Recommendation | Remove if planned works may disturb | | |

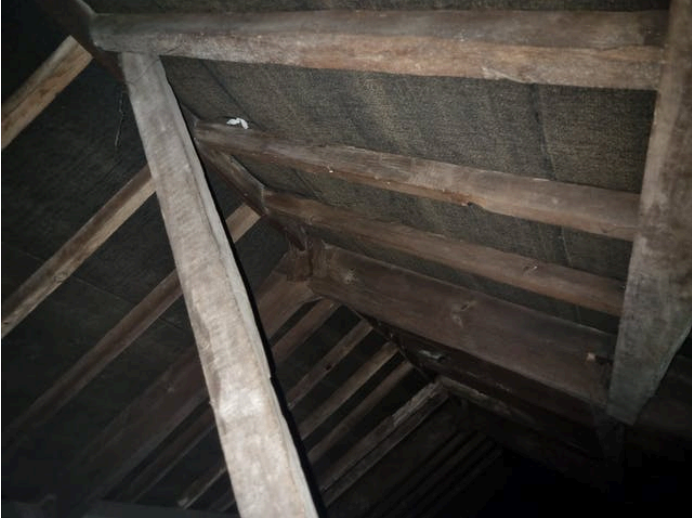
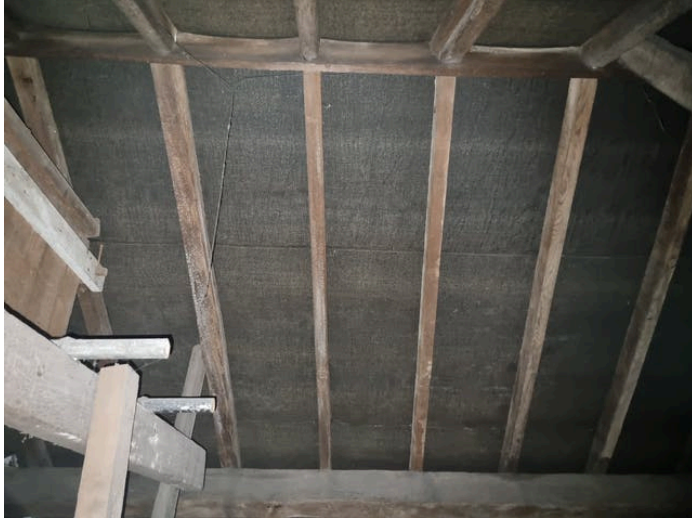
| Location | Roof void 2 | Item | Bitumen sarking felt to main roof |

| Strategy / Sample Id | Strongly Presume / 100645/04 | Presumed Fibre Type | NADIS |
| General Comments | Visually similar to 100645/02 | | |

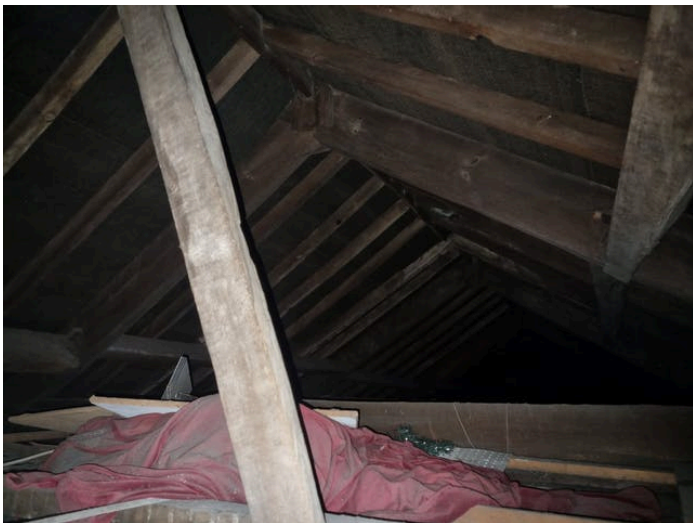
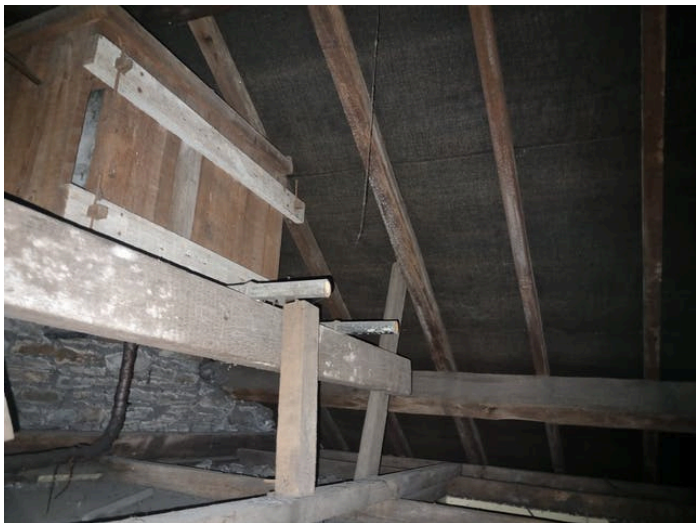
| Location Notes | Bitumen sarking felt / Timber joists and framework / Cement panelling to floor of void / lath and plaster sections present to floor of void / Wood panelling surrounding metal water tank | | |
