**MR & MRS HILL**

**MOOSE HALL, CASTLE STREET, NEATH**

**BUILDING INSPECTION REPORT (PROTECTED SPECIES)**

Document Ref: E21106701 Doc 01 – 18 JANUARY 2022

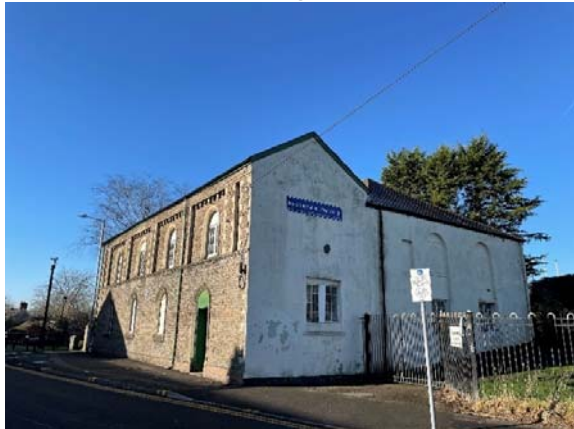
| Target Note | Description/comment |
|---|---|
| | <p><b>General:</b> Two-storey building at edge of Neath Town Centre proposed for renovation works (Grade II Listed). The frontage on Castle Street is of mortared stone with a pitched slate roof with the rear of the building, adjacent to the Castle Gardens comprising of a rendered finish with a hipped, slate roof. The building is currently vacant and is located on the edge of the town centre with limited green connections to surrounding habitat corridors – such as the canal and river to the north.</p> <p>* Room numbering in the notes follows that used in the Asbestos survey report.</p> |

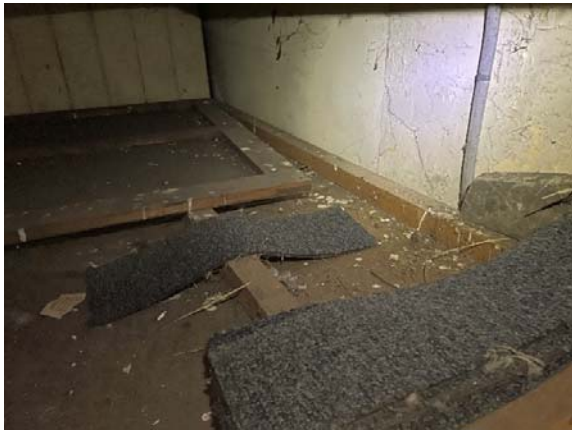
| Target Note | Description/comment |
|---|---|
| <b>Building Interior – Roof Void 2</b> | <p>Access through suspended ceiling hatch from first floor – void above suspended ceiling is partially visible. Old bird droppings and nest material visible but no obvious means of access so likely to have been blocked up (see External Notes re: broken pipe). No evidence of bats noted.</p> <p>Pitched roof with ridge height approx. 1.5 m with purlins running the length of the roof to northern and southern sides. Roof space is generally uncluttered.</p> <p>Roof felt to underside of slates is in good condition with no obvious rips or tears. No obvious light or draught ingress at eaves level. Small gaps through stone wall noted at eastern and western gable ends.</p> |

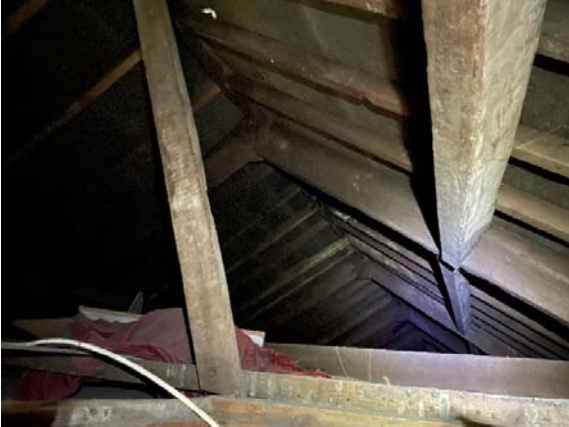
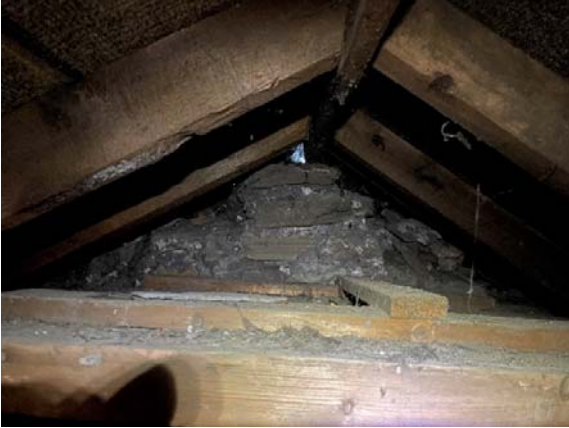
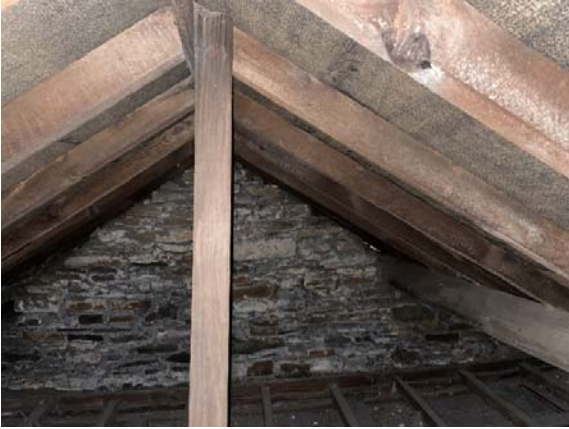
| Target Note | Description/comment |
|---|---|
| | <p data-bbox="329 688 1263 821">Covered water tank at western gable end and small gap through stone wall noted around apex of gable – no evidence of birds or bats at this location or to cover of water tank. Stone wall with rubble infill so no cavity present. Cobwebs are present around gable end and to roof timbers.</p> <p data-bbox="329 1281 1284 1381">Small gaps also noted to sides of eastern gable end with old nest material close to the purlin. No evidence to suggest current use by birds (e.g. droppings) and no evidence of bats noted on wall/floor.</p> <p data-bbox="329 1810 990 1837">No evidence of bats noted anywhere within the roof space.</p> |

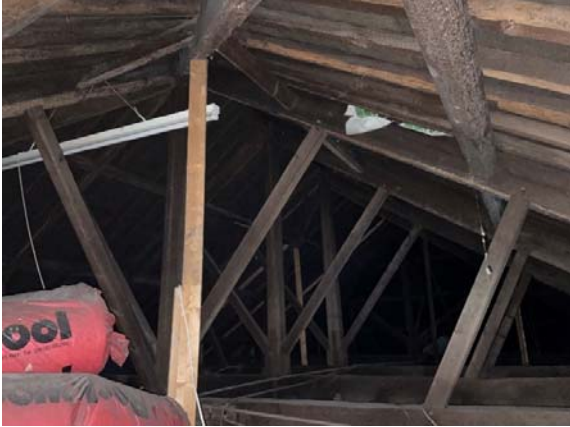
- 3.8 Roof Void 1 was not directly accessed due to the presence of asbestos although a visual check was undertaken from the loft hatch. This hipped roof is of a King post design with bitumen felt to the underside of the slates. No obvious light or draught ingress was visible from the loft hatch and the felt appeared to be in good condition with no obvious ripped or torn sections. No evidence of birds or bats was seen during the visual check.

| Target Note | Description/comment |
|---|---|
| <b>Building Interior (Roof Void 1)</b> | <p>Hipped roof above the rear (northern) part of the building – not directly access due to Medium Risk of asbestos – viewed from access hatch only. King post design with felt to underside of slates in good condition – no obvious rips or tears. No obvious light or draught ingress seen from access point and no visible evidence of birds or bats noted from this location.</p> |

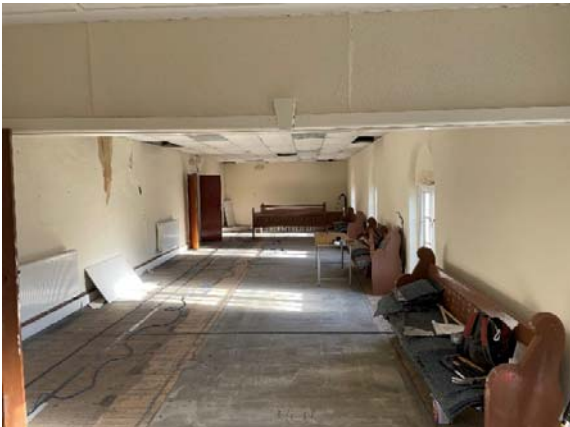
| Target Note | Description/comment |
|---|---|
| <b>First Floor – Rooms 1/04, 1/05</b> | <p>Room 1/04 is light and open with all windows sound – no evidence of use by bats or birds and no obvious means of entry. Suspended ceiling with painted wall so no features suitable for bats to use.</p> <p>Stairwell to ground floor at eastern end of room and ground floor fire exit onto Castel Street also sound – no means of entry for birds or bats and no evidence seen.</p> <p>Room 1/05 is similarly devoid of any features suitable for use by bats. Window openings have been blocked up and rendered over in the past. No obvious means of entry for birds or bats and no evidence found.</p> |

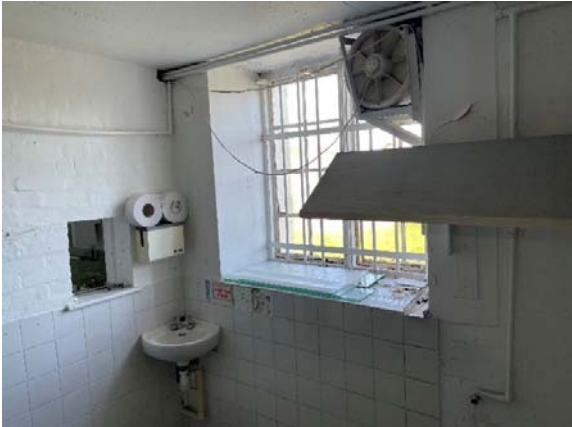
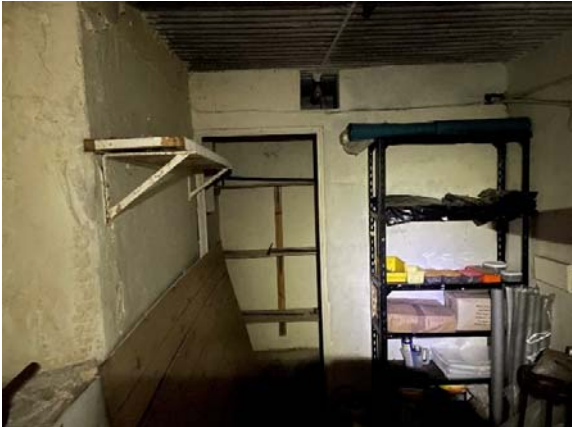
| Target Note | Description/comment |
|---|---|
| <b>Ground Floor</b> | <p data-bbox="328 695 1289 789">Rooms 0/11, 12, 13, 15, 05, 06 &amp; 01 are all relatively light and open with suspended ceiling and painted walls offering no features for bats. No obvious means of access as windows to rooms 0/11 &amp; 0/12 are all sound.</p> <p data-bbox="328 1255 1247 1314">Cellar area to rear of bar (room 0/10) is darker but no obvious means of access for birds or bats and no evidence noted.</p> |

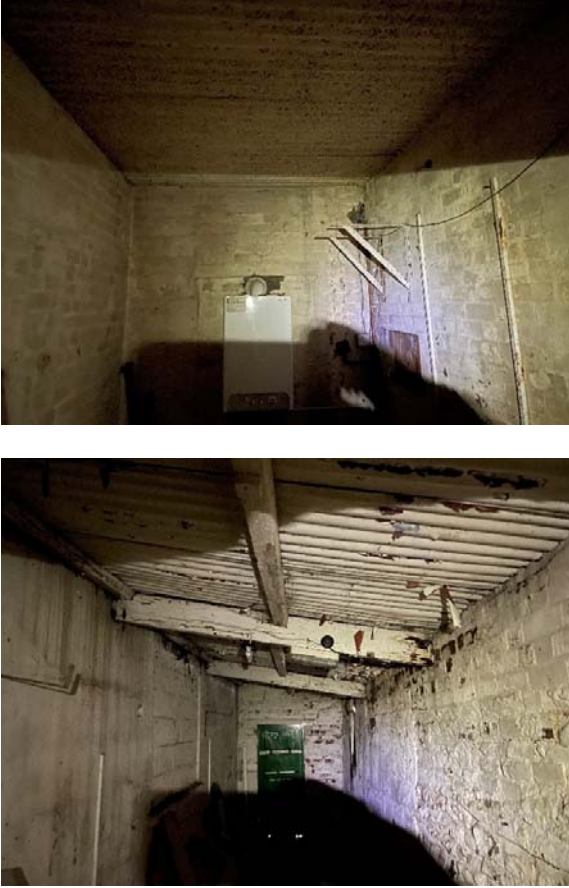
- 3.7 Rooms 0/07 – 0/09 on the northern elevation (see plans in Appendix I) were access via a locked internal fire door with an external fire escape door located at the north west corner. This external door was sound and no damage or obvious gaps were noted at the sloping corrugated metal roof which covers this space. No means of access for birds or bats or evidence of use was identified in this area.

| Target Note | Description/comment |
|---|---|
| <b>Rooms 007 - 009</b> | <p data-bbox="328 1778 1276 1871">Rear extension with combination of flat and sloping corrugated metal roof access via fire escape door next to bar. Door is kept shut. No evidence of birds or bats in any location and no obvious means of access – fire door to western end is locked and</p> |

| Target Note | Description/comment |
|---|---|
| | <p>secure. Cobwebs are prevalent to wall/roof junction.</p> |

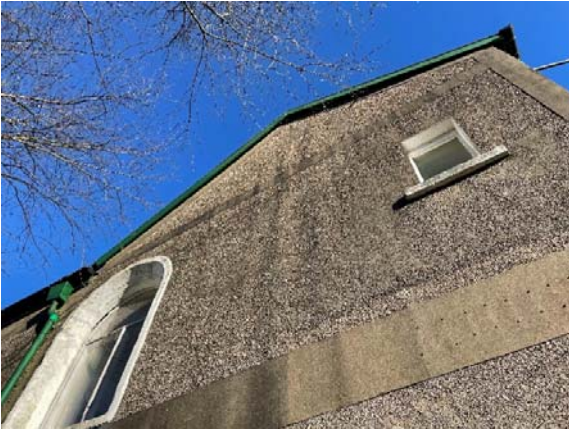
- 3.11 The external survey identified small, shallow gaps associated with the fascia and soffit in several locations (see points 1 – 5, Appendix II) with a gap also noted around the window frame on the western elevation. No external evidence of bats was noted at any location below these gaps such as on window sills, frames or rendered walls. Visible gaps at the eastern and western gable ends corresponded to the observations from inside Roof Void 1.

| Target Note | Description/comment |
|---|---|
| <b>Western elevation</b> | <p>Fascia and soffit to gable end generally sound although small gap at apex (Location 1) which corresponds to internal survey. Gap also noted to northern side of gable although no external evidence of bats on rendered finish below these points.</p> <p>Missing mortar (or putty) to window frame (2) but no external evidence of bats on glass, frame or sill below – cavity looks cluttered and shallow based on inspection from ladder. Other windows to this elevation are all sound – no external evidence of bats</p> |

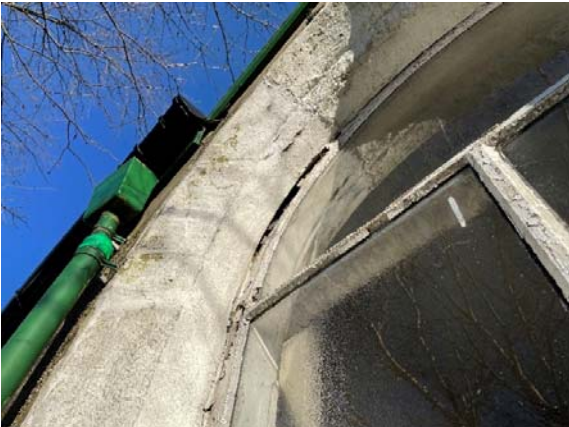
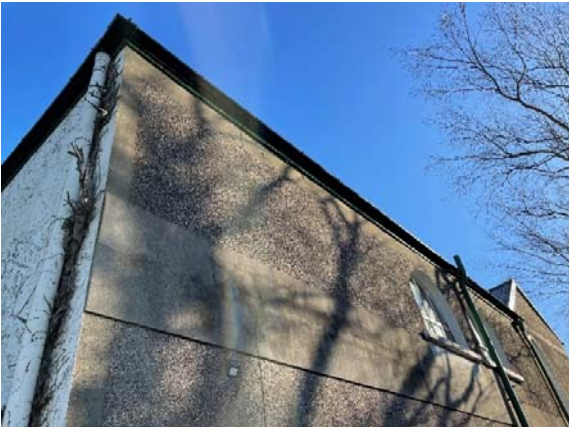
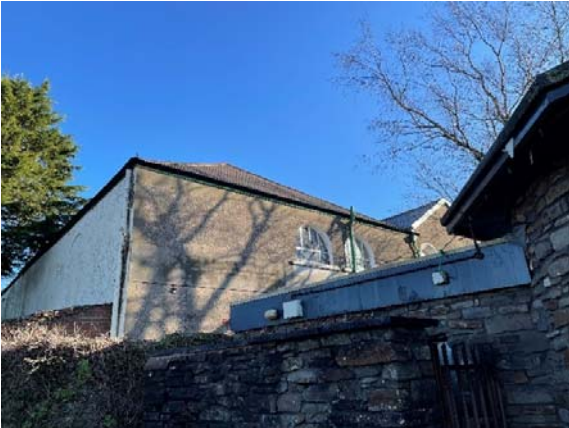
| Target Note | Description/comment |
|---|---|
| | <p data-bbox="329 235 402 260">noted.</p> <p data-bbox="329 726 1208 785">Gaps between wall and fascia also noted at southern and northern ends of this elevation but no external evidence of birds or bats noted.</p> <p data-bbox="329 1251 1276 1344">Roof slates and ridge tiles to Roof 1 &amp; 2 as viewed from Castle Gardens (with binoculars) appear sound. No missing or damaged slates or gaps to ridge. Gable and hipped end also appear sound with no missing mortar etc.</p> |

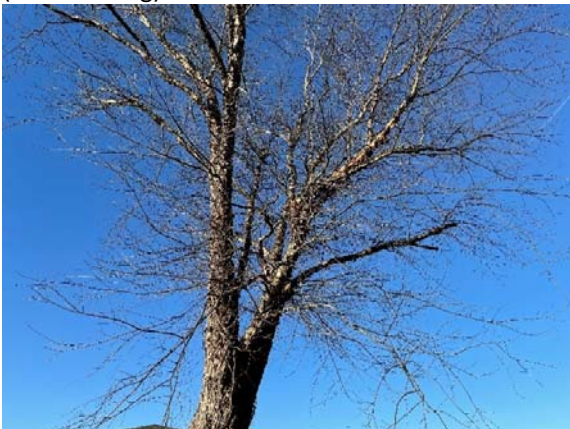
| Target Note | Description/comment |
|---|---|
| <b>Birch Tree to west</b> | Single Birch tree off-site to west. Flaking bark but no features suitable for use by roosting bats identified (Negligible potential). Could support nesting birds in season |

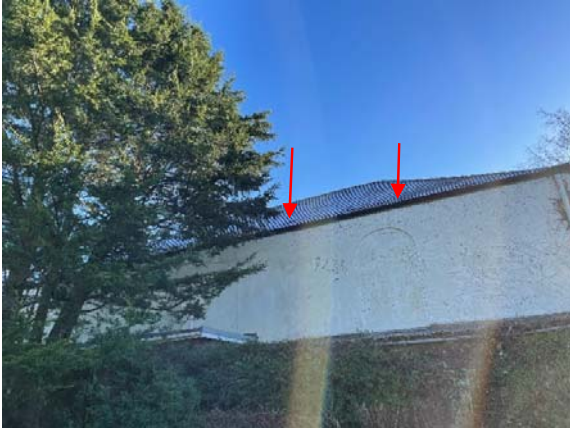
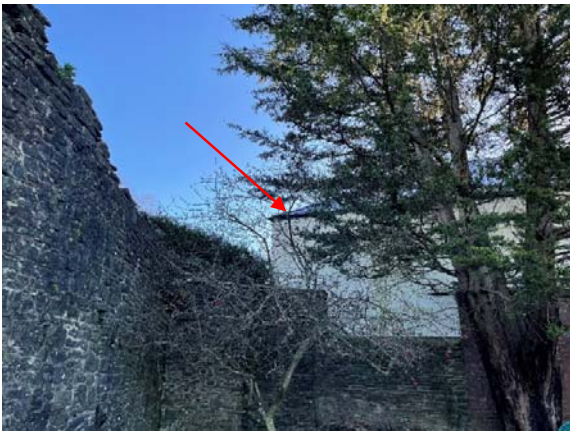
| Target Note | Description/comment |
|---|---|
| <p><b>Northern elevation</b></p> | <p>Viewed from adjacent Castle Gardens (with binoculars) and includes the flat roof and sloping metal sheet roof associated with rooms 0/07 – 0/09. Fascia is generally sound with very few gaps and dense ivy once covered this elevation – some dead stems remain around downpipe. Roof and ridge also generally sound although several raised slates to south west above eaves and raised ridge tile to north west corner.</p> <p>Cypress tree alongside boundary wall with no obvious bat potential (Negligible). Likely</p> |

| Target Note | Description/comment |
|---|---|
| | to be used by nesting birds in season along with associated ornamental shrubs in Castle Gardens. |

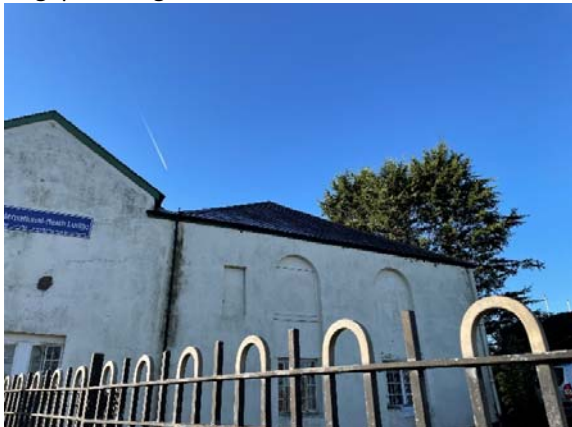
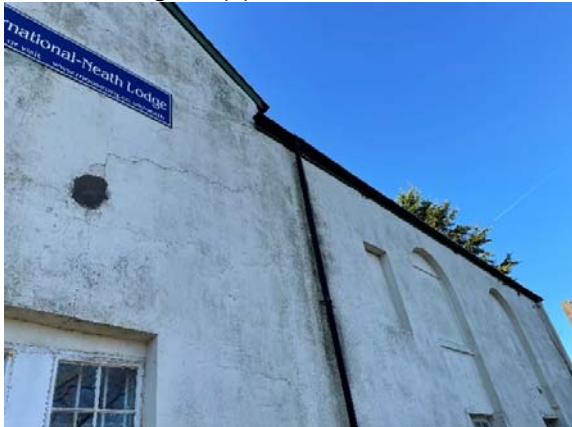
| Target Note | Description/comment |
|---|---|
| East Elevation | <p>All windows sound and Roof 1 (hipped) in good condition with no obvious raised slates or gaps to ridge.</p> <p>Fascia generally sound although gaps noted around air brick (3), downpipe (4) and to north side of gable (5). No external evidence noted on painted render.</p> |

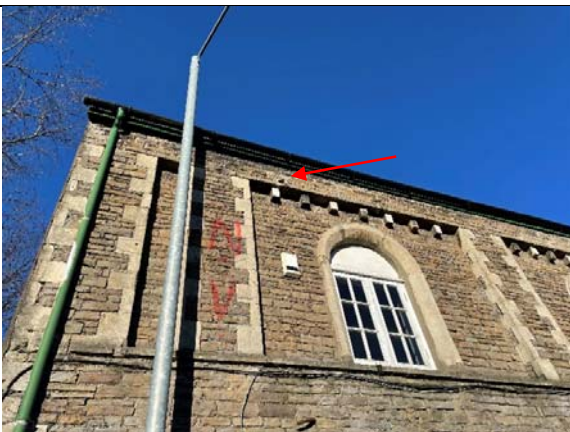
- 3.13 Two House Sparrow were seen exiting the broken flue pipe on the southern elevation and this feature is likely to be used for nesting during the season (typically March – August).

| Target Note | Description/comment |
|---|---|
| Southern elevation | <p>Roof and ridge generally sound as are all windows and fire escape door. 2no. House sparrows seen existing from broken vent pipe close to street lamp (Location 6) – this feature may once have connected to void below suspended ceiling but now blocked internally.</p> |

| Target Note | Description/comment |
|---|---|
| | <p data-bbox="328 688 1281 787">Shallow gap between fascia and wall created by uneven surface of mortared stones – gap only appears to be to height of fascia (ca. 100mm) and relatively open and exposed. No external evidence of bats or birds noted below fascia.</p> |
