## Structural Survey (Inspection)

**Moose Hall  
Castle Street  
Neath  
SA11 3LU**

Structural Surveys UK were commissioned to undertake a Full Structural Survey (Inspection) to a residential property at Moose Hall, Castle Street in Neath.

The property is detached grade 2 listed former Wesleyan Methodist Chapel which has previously been converted into a hall and has been derelict for a number of years.

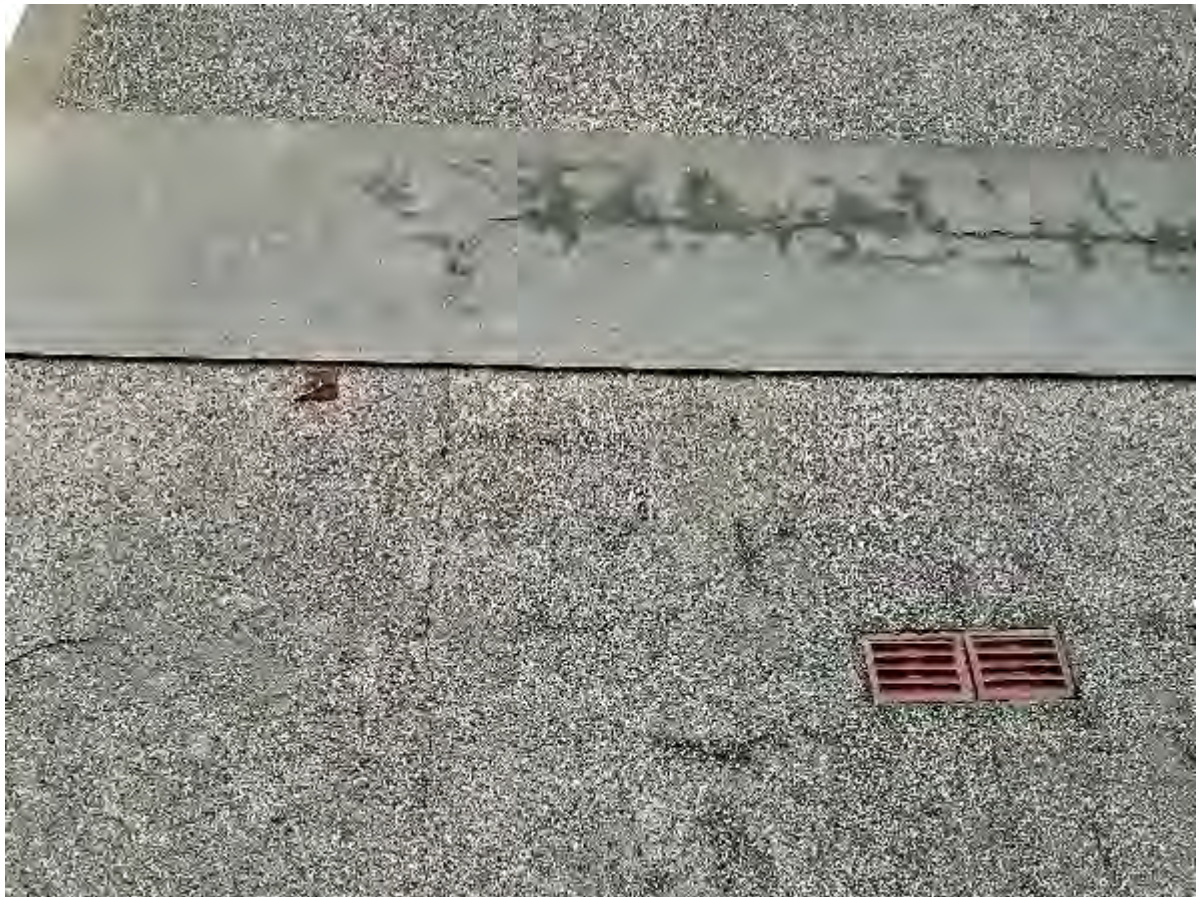
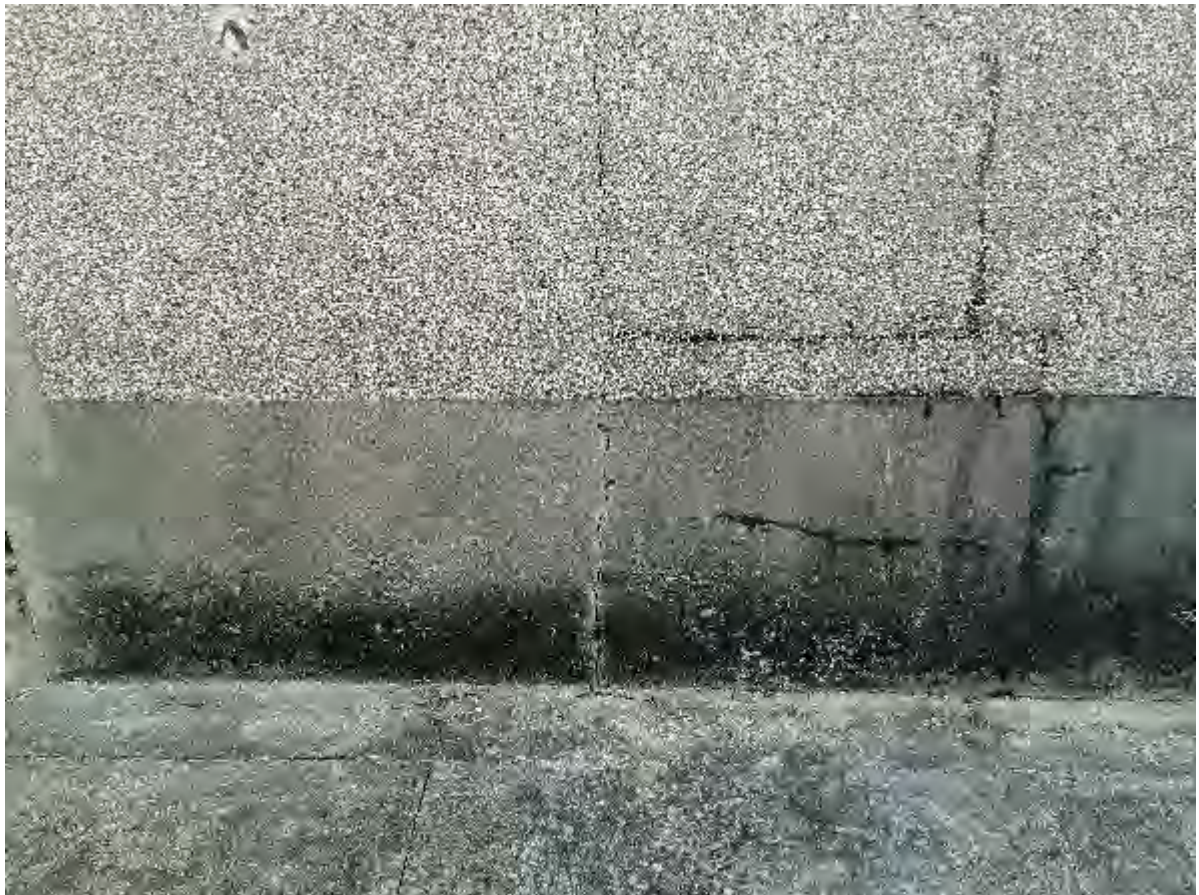
Photo 37 – Render Cracking Around Old Opening (Left Wall Elevation)

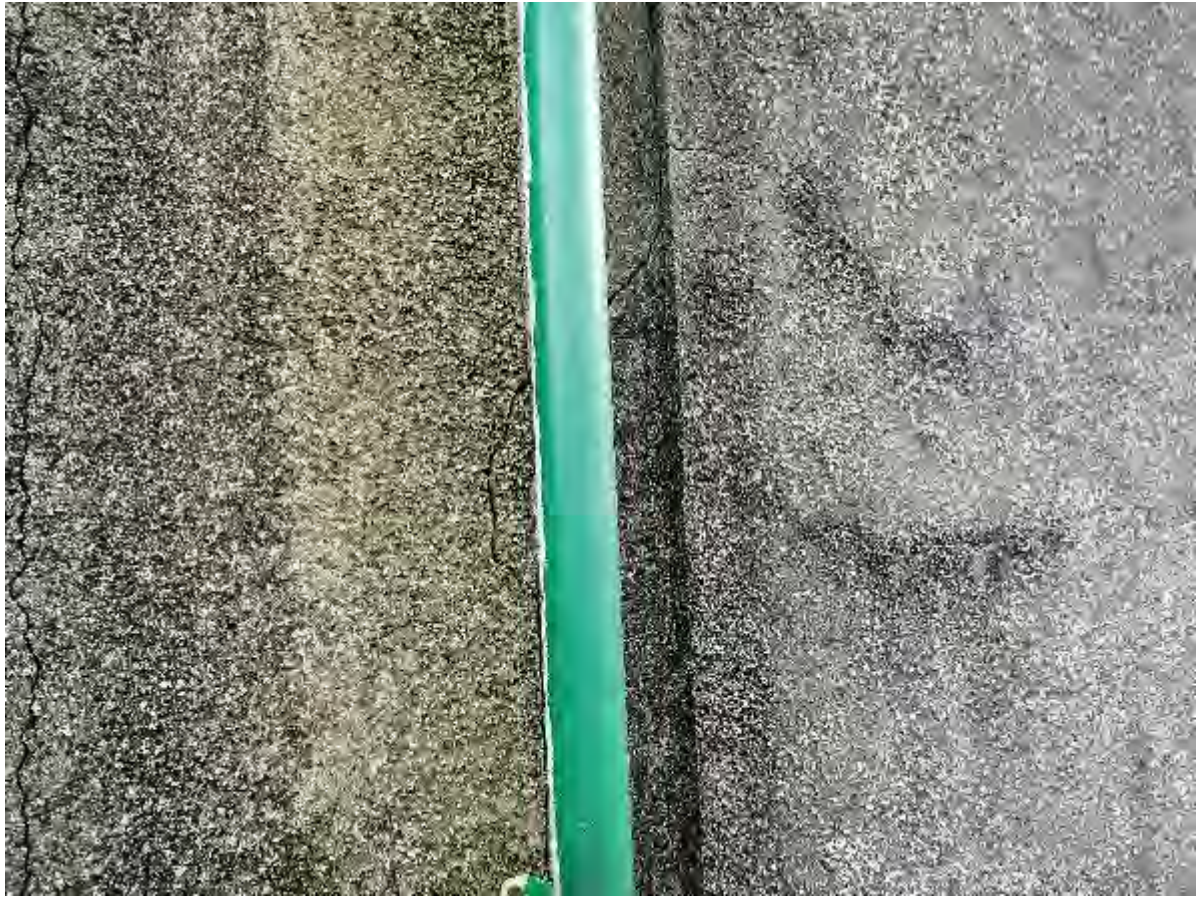
Photo 53 – Cracking Between Original Property and Front Extension (Left Wall Elevation)

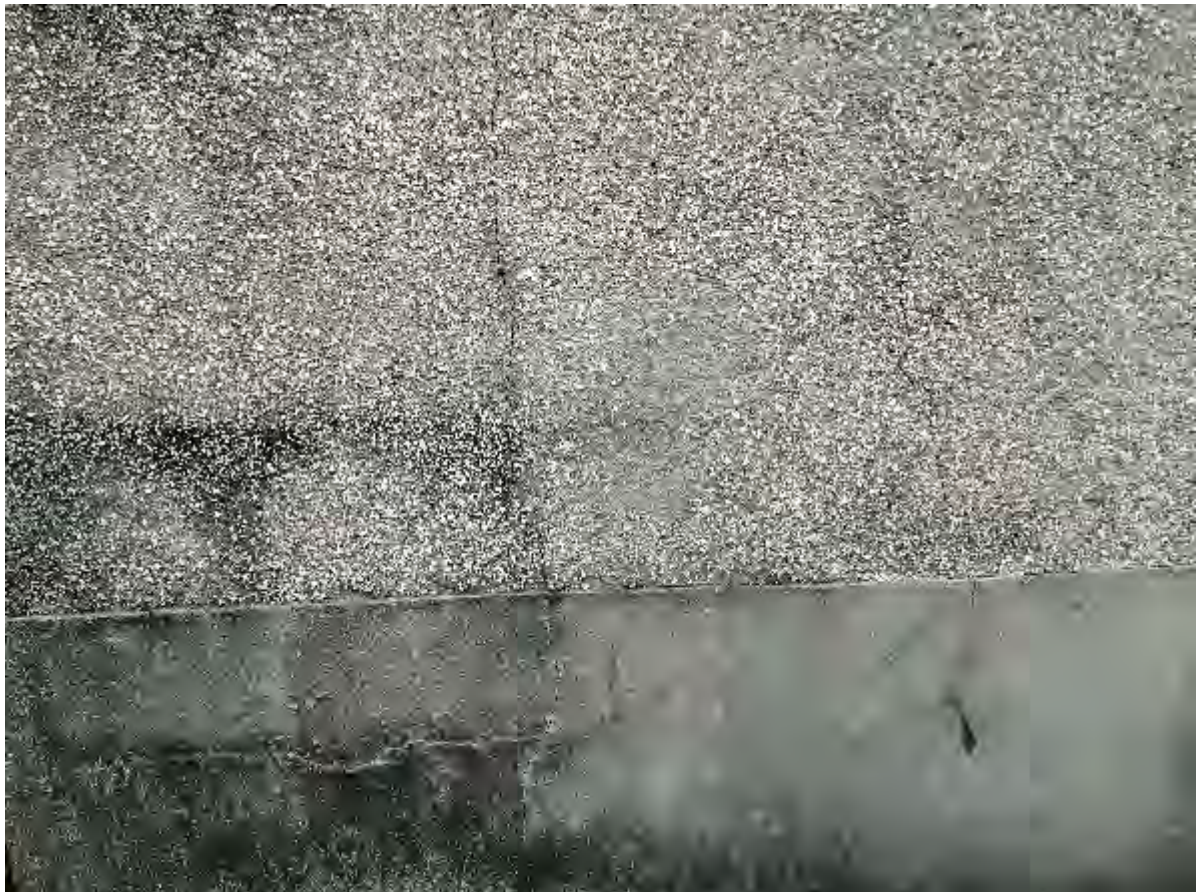
Our inspection of the external walls confirmed shrinkage cracking (damage category 1 to 2) to the left and right wall elevations – see Photos 42-51, 54, 74-83, 85 and 87 below. This cracking is considered ‘non-structural’ and has most likely developed initially during construction, i.e. due to poor preparation and mix design of the render, poor application and inadequate curing (which will have led to the render drying out prematurely and cracking over time). Moisture effects will have also exacerbated the development of these cracks through repeated wetting and drying. This cracking is low grade in nature and expected to be confined to the external render only. There is no loss of structural support or failure of the wall panel at this location. Minor local crack repair works are required. The condition of the external render is expected to be part of the cause of the majority of the penetrating damp throughout the property (discussed later in the report) - Condition Rating **2** See Section 7.0 Recommendations for guidance on repair works required.

Photo 42 – Render Shrinkage Cracking (Left Wall Elevation)

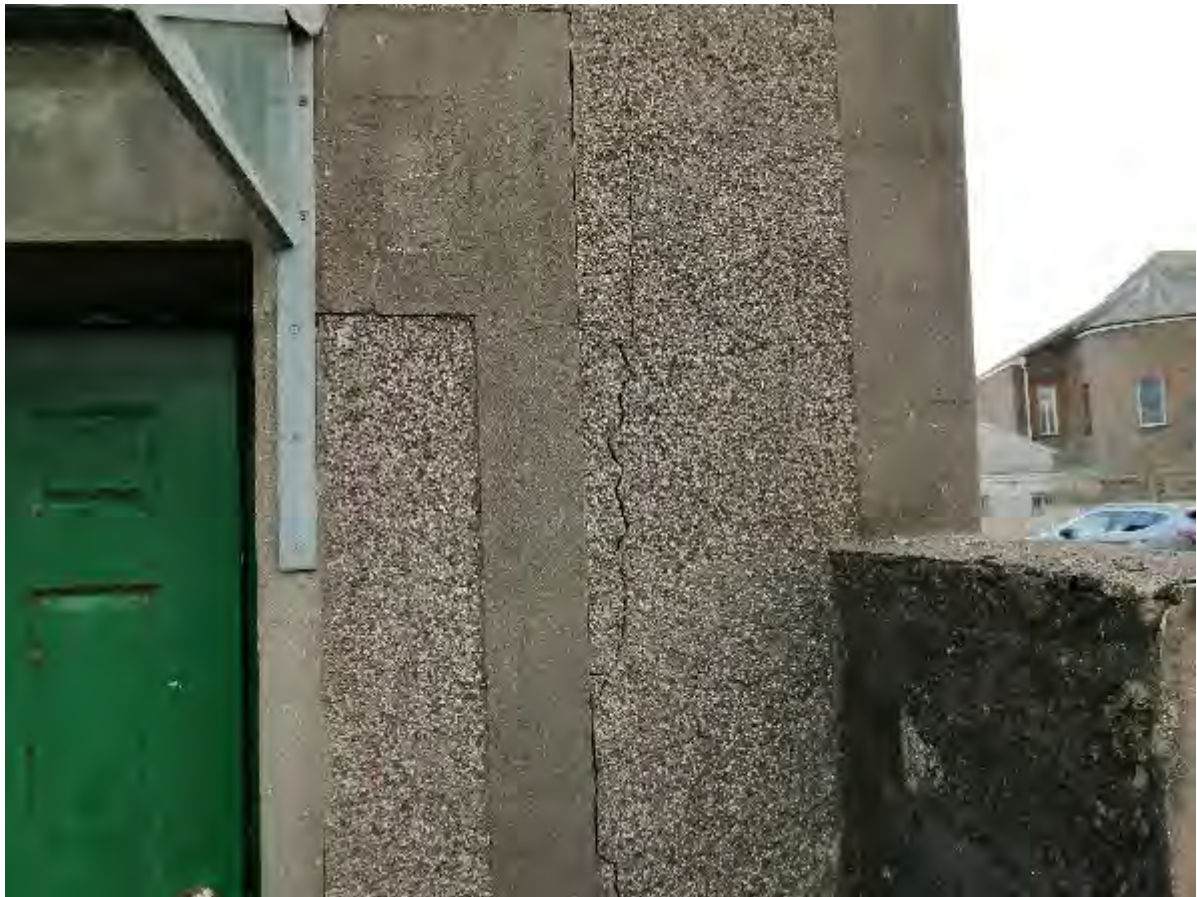
Photo 56 – Wall Crack (Left Wall Elevation)

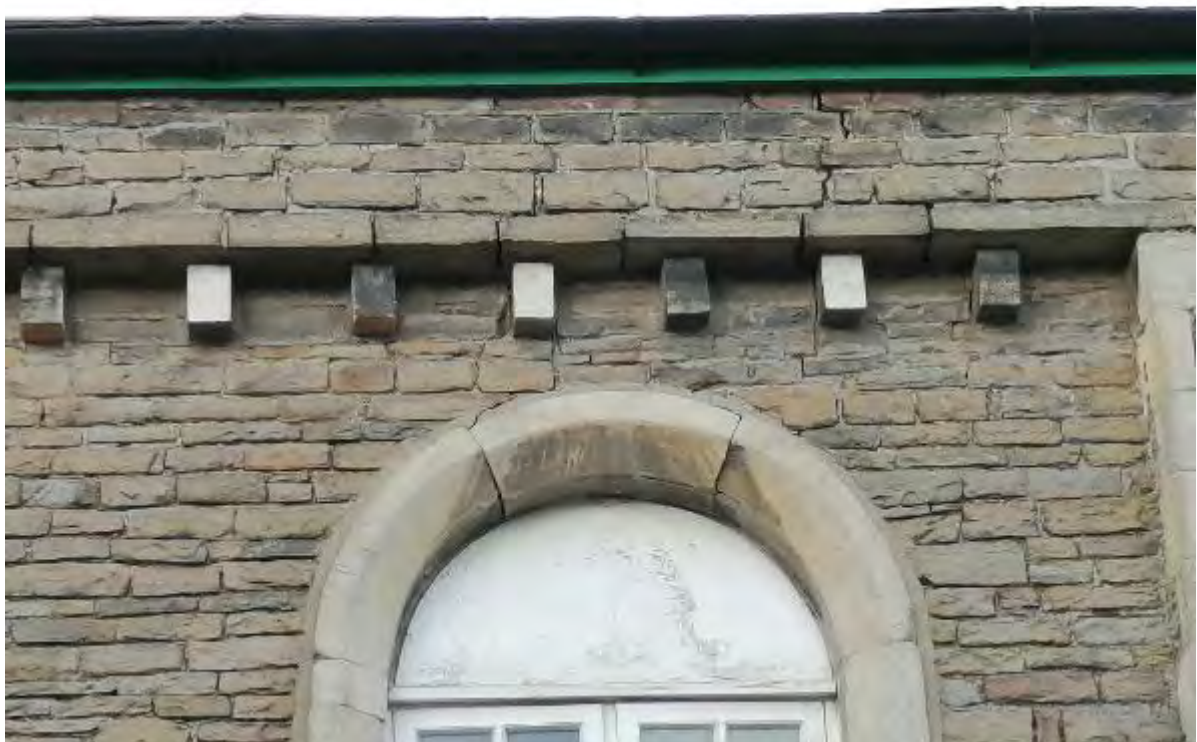
Cracking (damage category 1 to 2) and weathering was noted to the mortar of the stonework to the front wall elevation – see photos 58-60 and 65-70 below. The cracking noted above the archways are expected to be caused by minor movement within the window arches below caused by weathering of the archway mortar. Condition Rating **2** See Section 7.0 Recommendations for guidance on repair works required.

Photo 58 – Cracking to Mortar Above Archway (Front Wall Elevation)

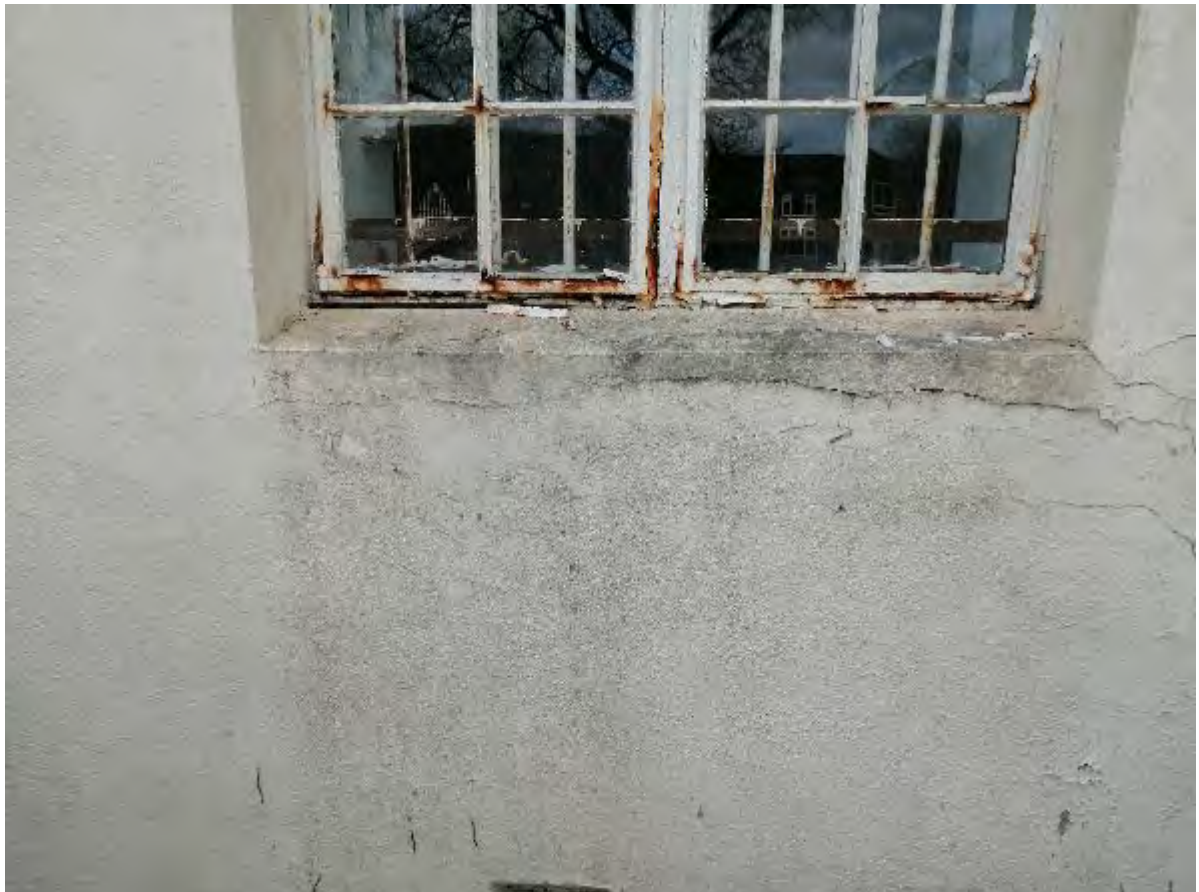
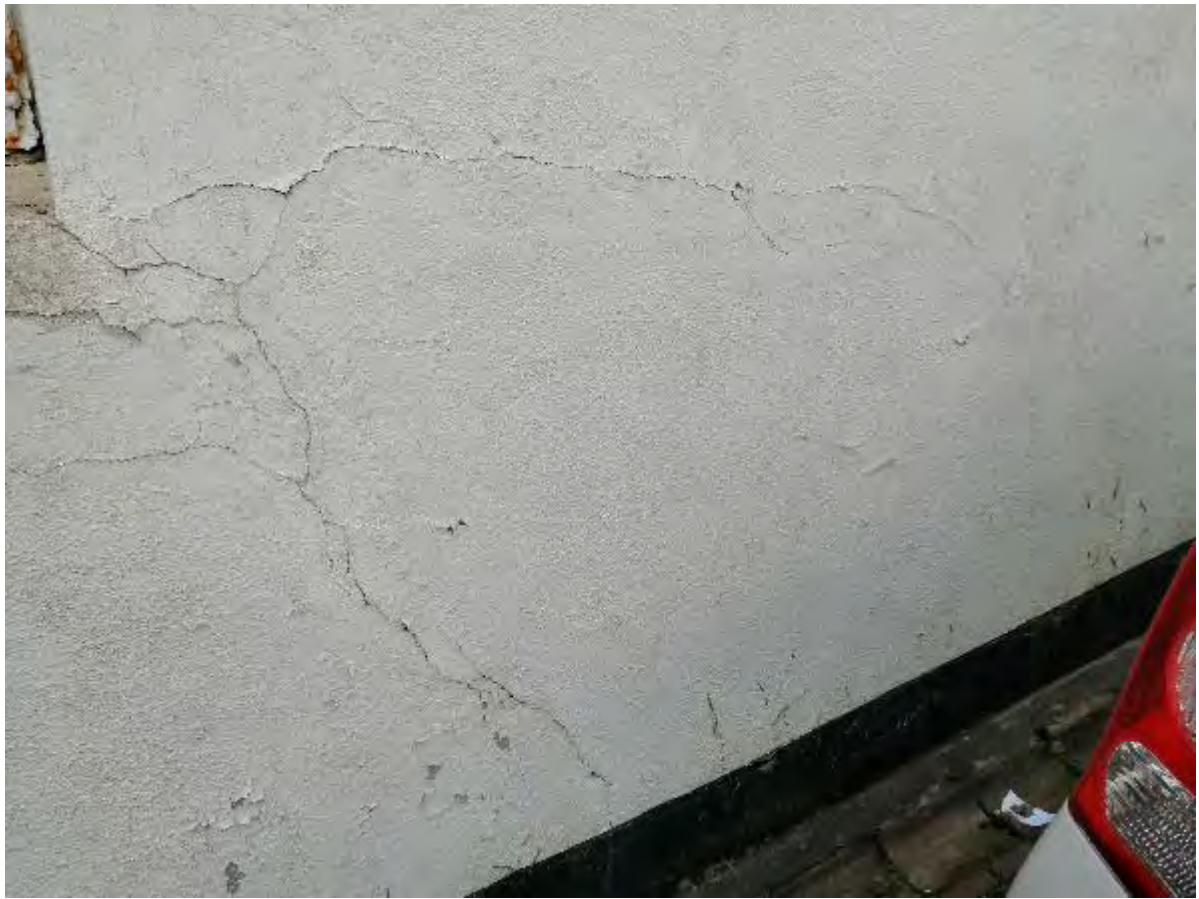
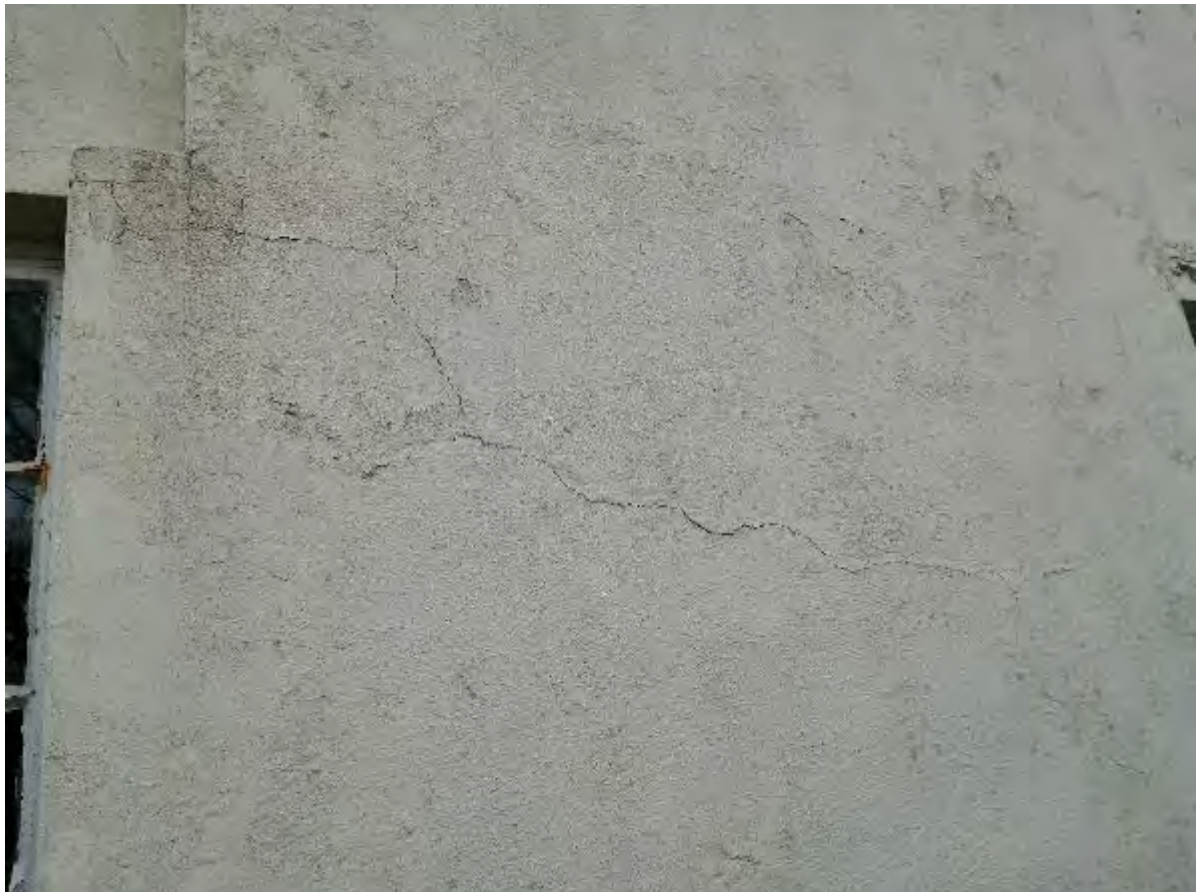
Photo 74 – Render Shrinkage Cracking (Right Wall Elevation)
