### 3.11 Hydrocarbon Seepages – Dam between East Bay and NSR

### 3.12 Potentially Contaminated Material – Eastern Boundary

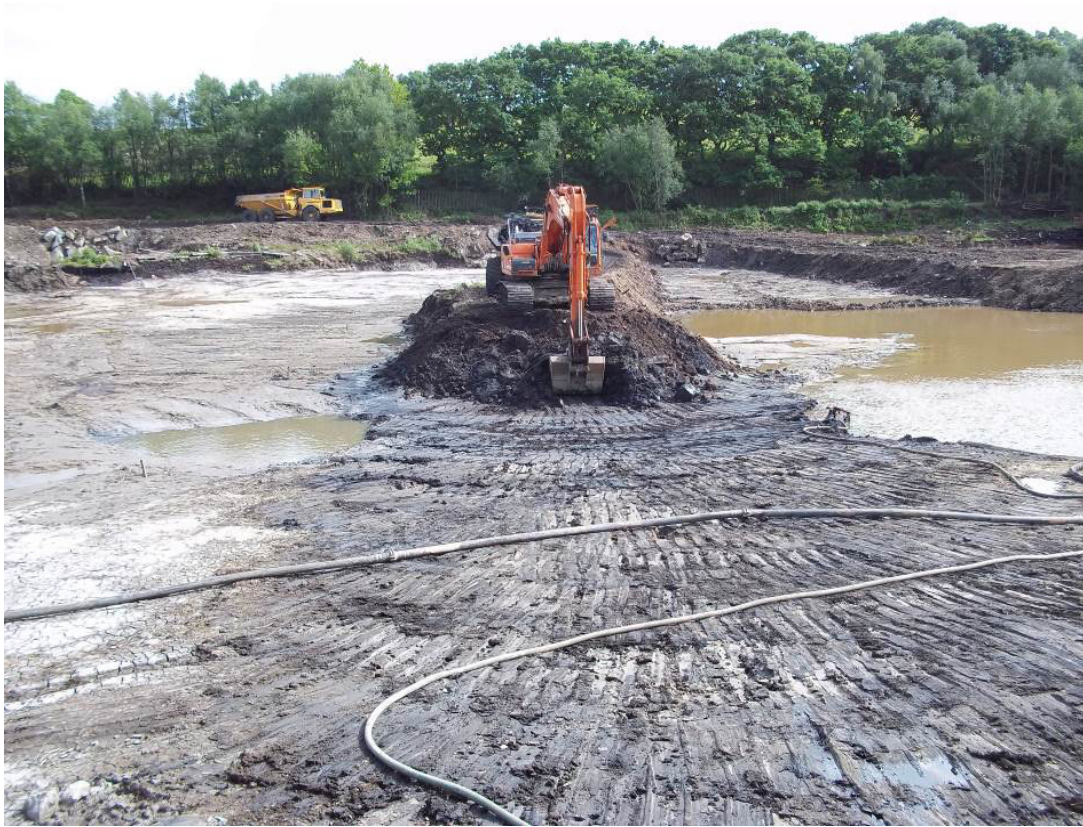
**Photograph 26 – Central pier partially removed**

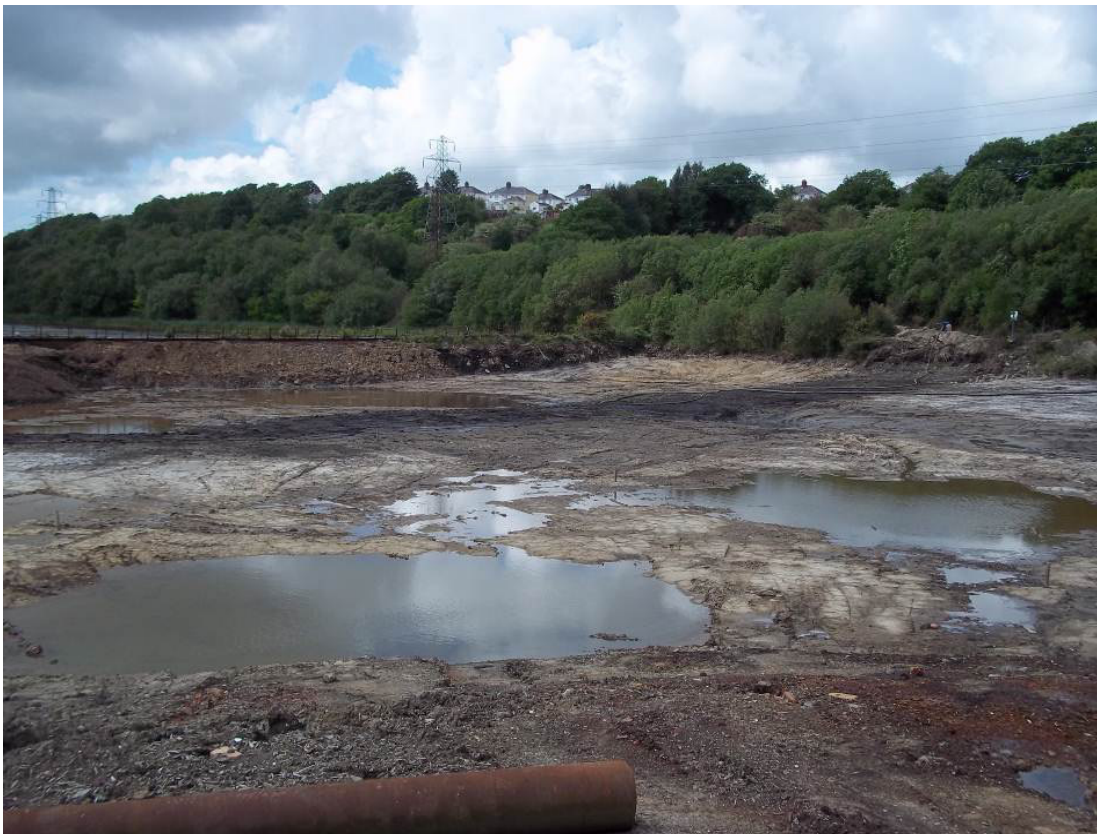
**Photograph 27 – Central pier completely removed**

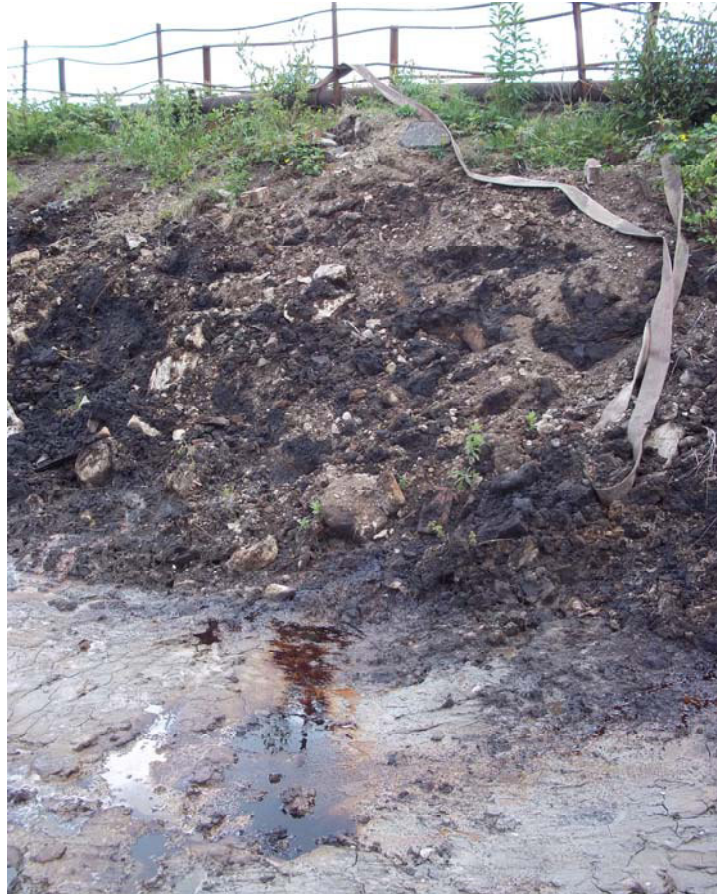
Following completion of the works in Section 1, 2 and 3 relatively minor hydrocarbon seepages were noted along the dam between East Bay and NSR (Photograph 28).

**Photograph 28** – Hydrocarbon seepage noted from dam between East Bay and NSR

This issue was discussed with Atkins (email dated 20/05/2011 – presented as Appendix E) who agreed the following methodology:

- Undertake the final verification on the clean base;
- Temporarily collect and recover any oily seepages;
- Prior to inundation use clean clay from the base of East Bay to place against the area of seepage; and
- Allow inundation to commence once verification is complete.

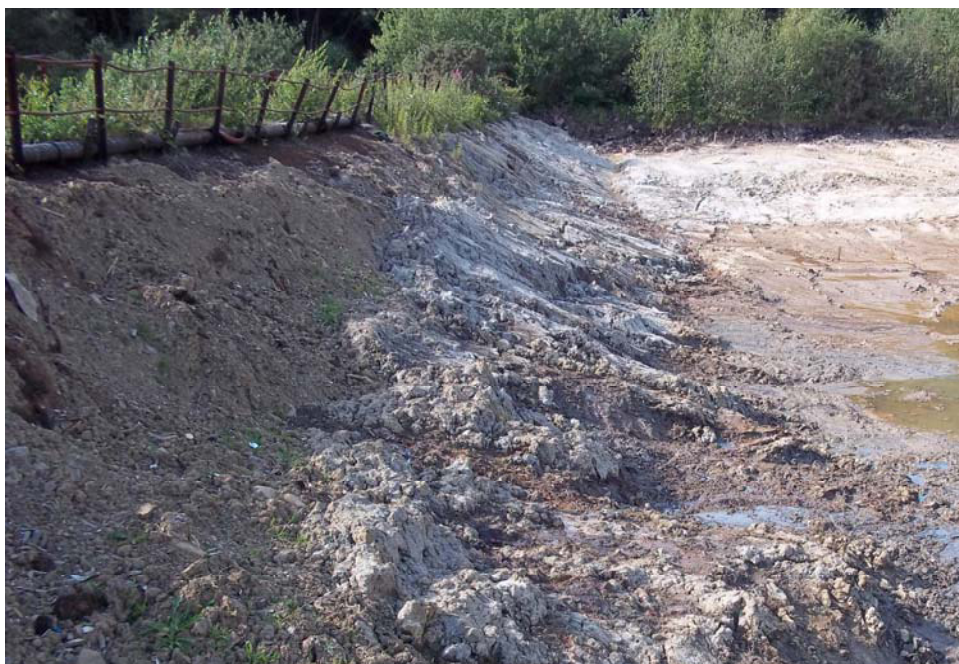
**Photograph 29** – Clay material placed against NSR Dam prior to inundation

Photograph 29 shows the dam face once the works had been undertaken. These works were inspected by an Atkins engineer on their completion.

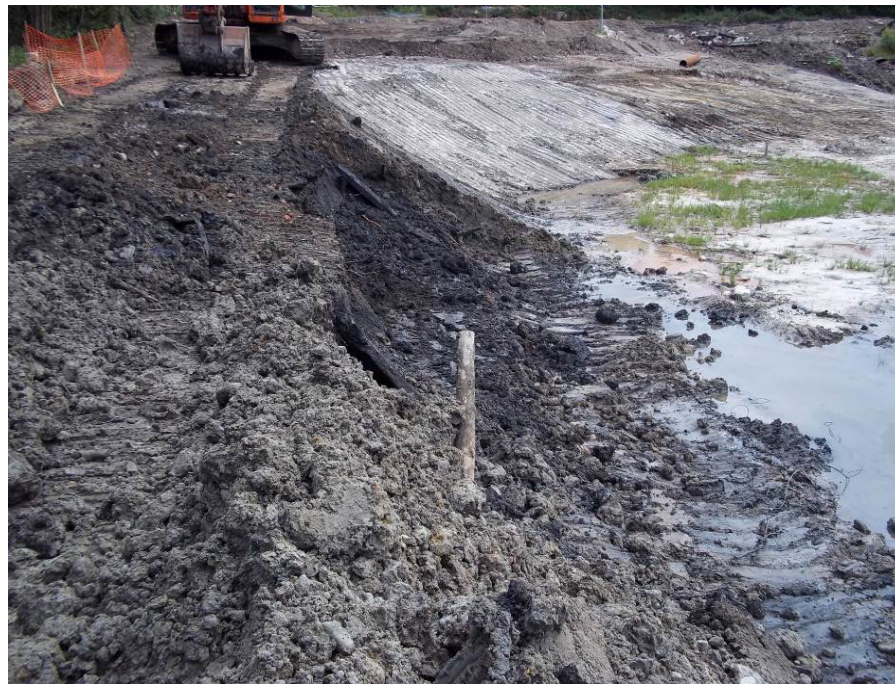
In addition to the hydrocarbon seepage discussed in Section 3.11 an area of potential hydrocarbon impacted material was noted at the eastern boundary of East Bay (Photograph 30). There were no visible seepages of hydrocarbons noted, however as precaution two samples (EBV42 and EBV43) were taken of the material for laboratory analysis. The laboratory results were assessed against the RTC for Recreational End-Use at materials to be placed <1m below surface level and 1% Soil Organic Matter.

The laboratory analysis indicated slightly elevated arsenic, cadmium, copper and Benzo(a)pyrene with all hydrocarbons being below the Section 106 RTC levels.

**Photograph 30** – Area of possible hydrocarbon impacted material at eastern boundary of East Bay

However, prior to receiving the laboratory results it was agreed with Atkins that the same methodology be adopted as with the hydrocarbon seepage noted from the NSR Dam. However, this was slightly modified with a significant proportion of the potentially hydrocarbon contaminated material being excavated and removed up to a point approximately 2 m from the site boundary (the potentially contaminated material extended beyond this point) (Photograph 30). A 0.5 to 1.0 m layer of previously validated cohesive material excavated from the base of East Bay was placed and compacted (Photograph 31) to form a re-profiled embankment.

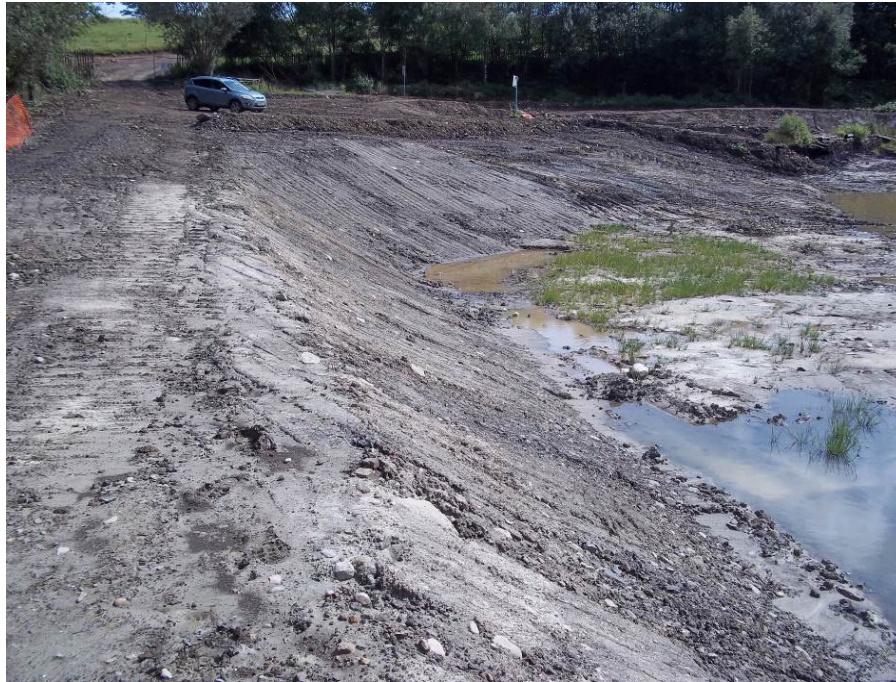
**Photograph 31** – Eastern embankment following removal of potentially hydrocarbon impacted material and re-profiling
