### 3.8 De-watering of East Bay

### 3.9 Removal of Hydrocarbon Impacted Material

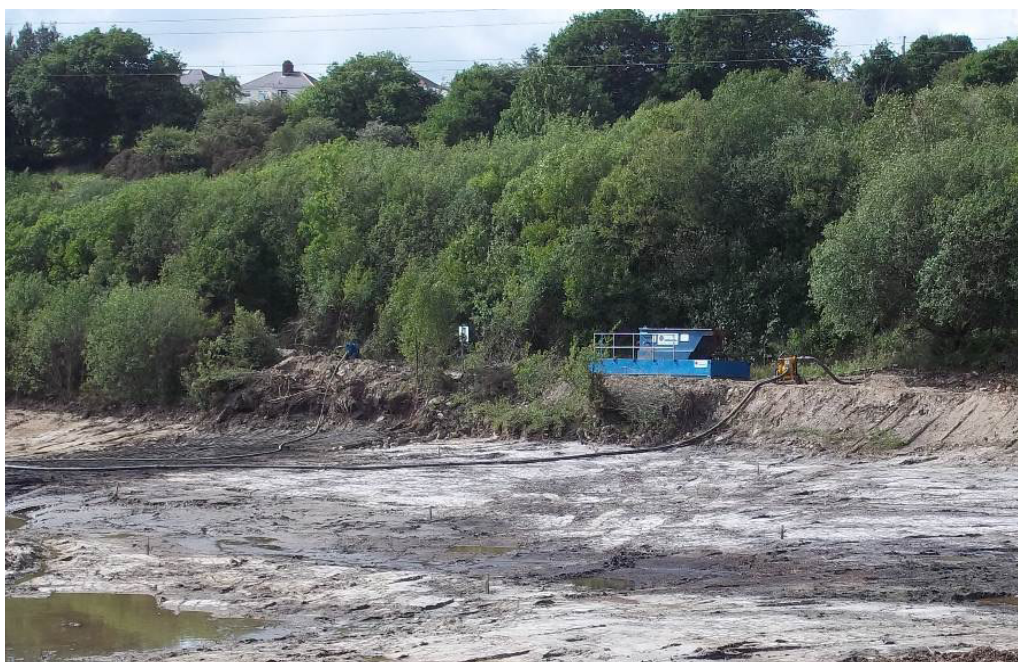
- In order to complete all sections of East Bay a short period of pumping (3 weeks in total) into NSR was required. No physical works were undertaken while this pumping was being undertaken in order to minimise agitation of the underlying sediments. The extracted water was passed through oil/ water separator and sediment trap to ensure that any contamination and/ or suspended solids were removed prior to discharge (Photograph 10).

**Photograph 10 – Water Treatment System at East Bay**

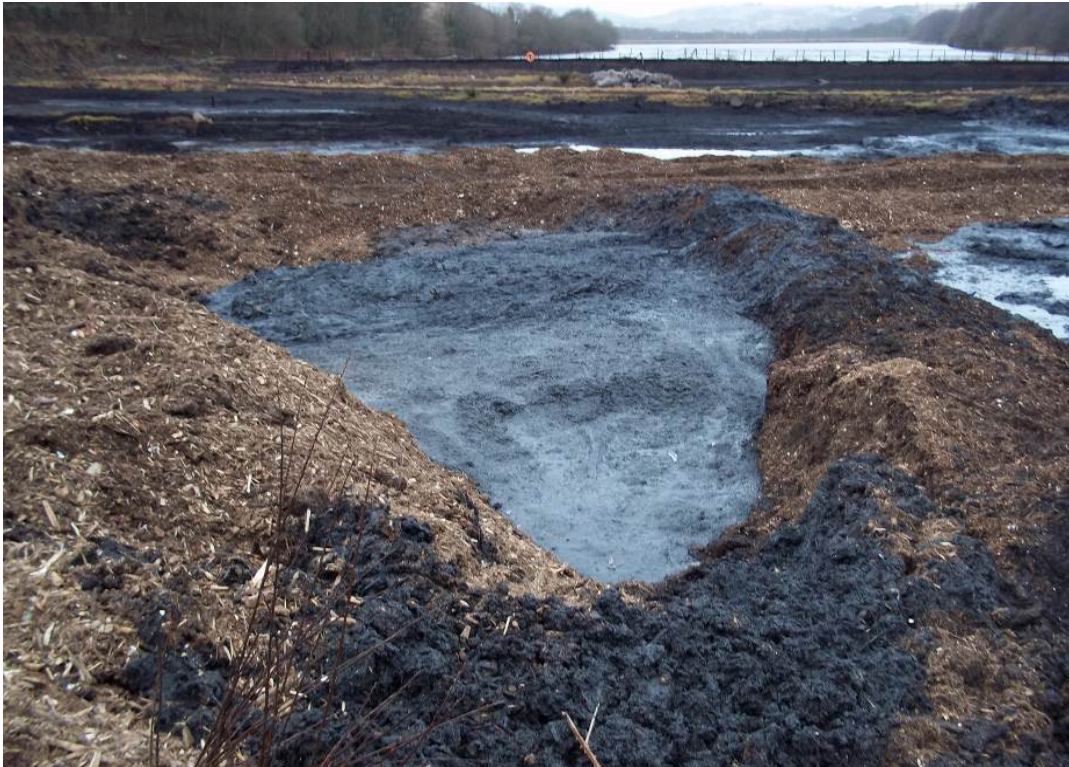
The stabilisation works were undertaken by creating a bund of wood fines that the untreated hydrocarbon impacted sediments were placed (Photograph 11). Wood fines were then slowly added and mixed to the sediment until the physical properties were sufficient to allow safe excavation and transportation to the treatment area.

**Photograph 11** – Hydrocarbon Impacted material within mixing bund at eastern section of East Bay

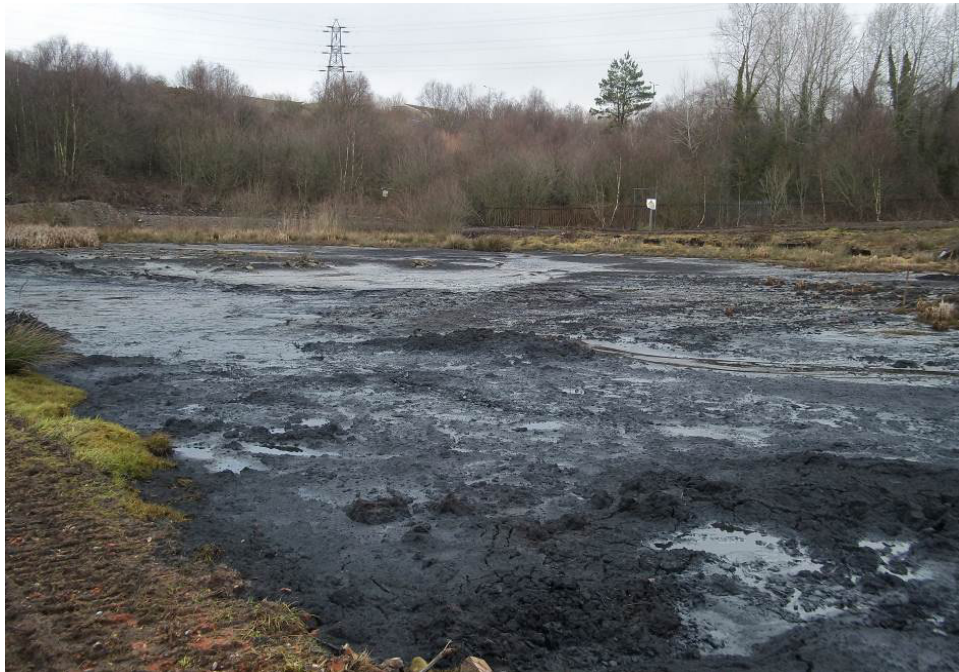
Section 1 encompassed the area to the east of the man-made pier that crossed East Bay. Following the installation of the surface water diversions the material within this area became considerably firmer with minimal standing water, negating the need for further pumping (Photograph 12).

**Photograph 12** – Section 1 of East Bay following installation of surface water diversions

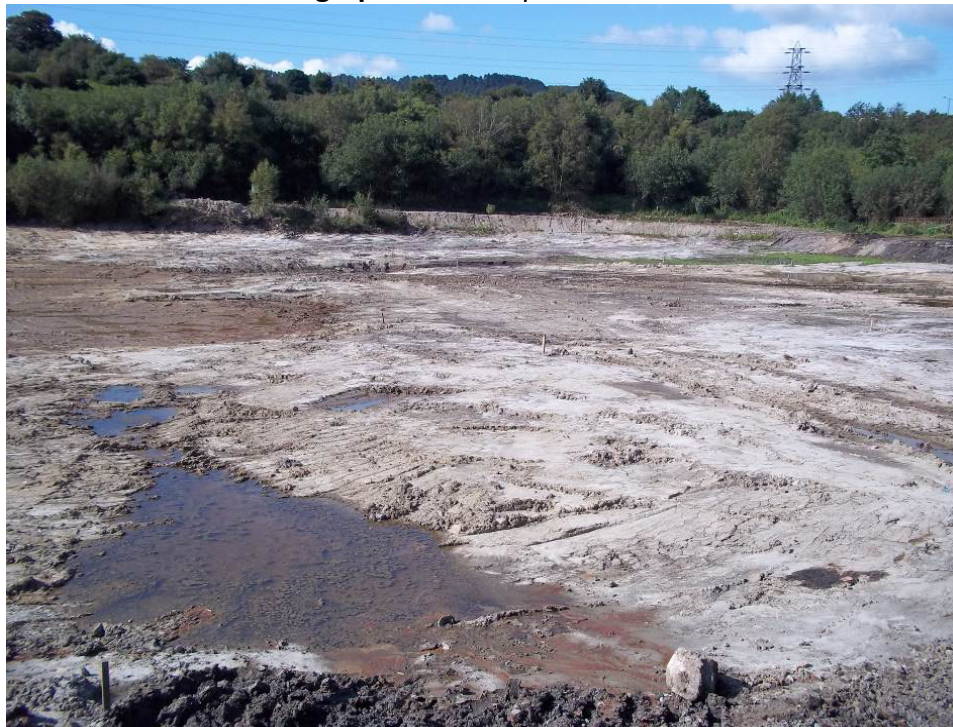
The mixing and removal of the hydrocarbon impacted sediment in Section 1 took approximately 4 weeks to complete. Water that collected during the Section 1 works was pumped directly into Section 2. The completed area is shown in Photograph 13.

**Photograph 13** – Completed Section 1

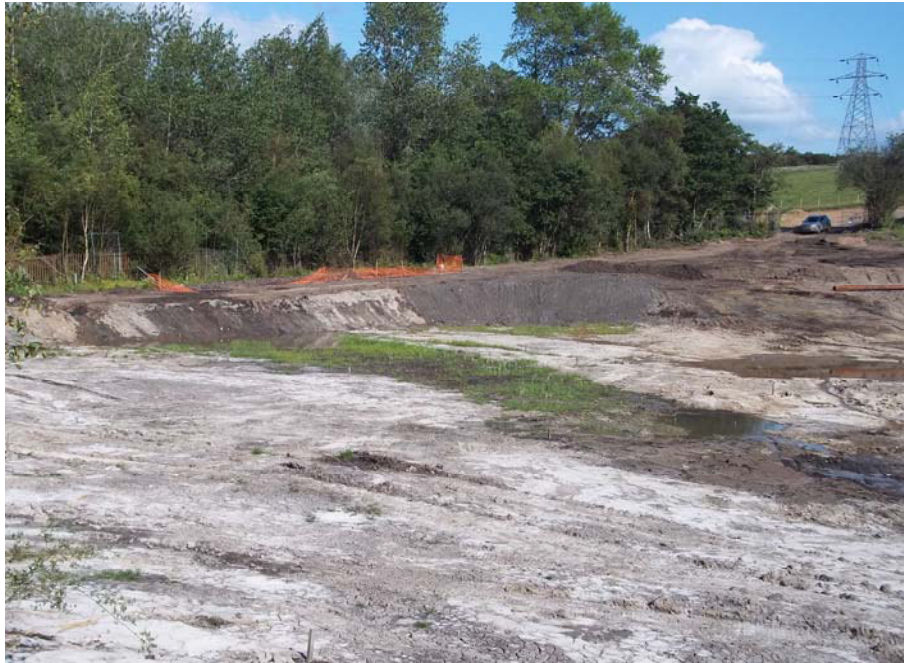
The natural base material was typically uniform comprising grey clayey silts. However, an organic band was encountered entering East Bay from the eastern boundary and crossing the central area of the base in an east to west orientation (Photograph 14). The

location of the organic band is highlighted on the post works topographic survey (Appendix A, Drawing 6).

**Photograph 14** – Band of organic material encountered at the base of East Bay (highlighted by vegetation growth)

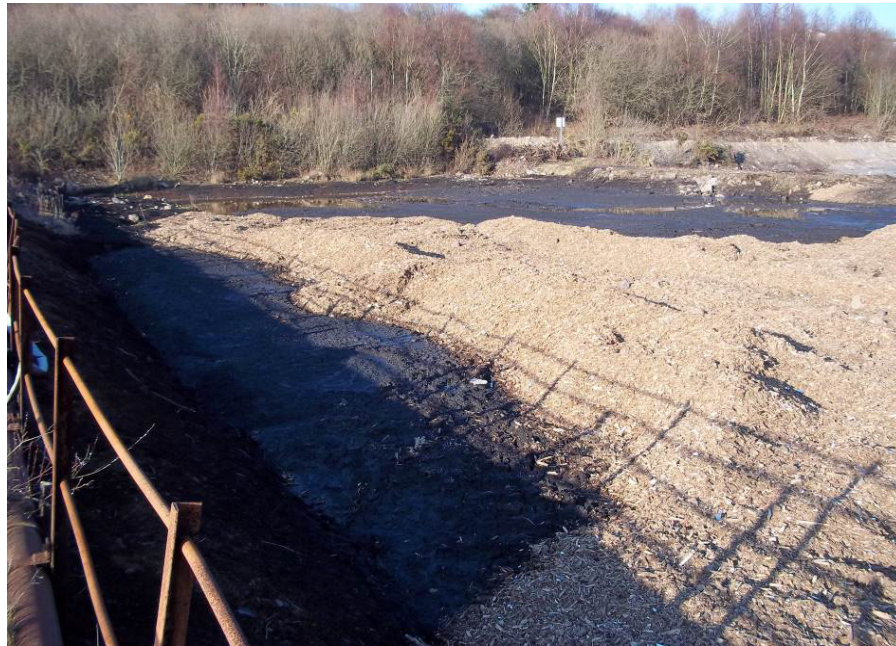
The inlets and outlets of the low level pipes were sealed using clean material excavated from East Bay. However, a significant inflow remained through the dam matrix which could not be sealed. Therefore, a large wood fines bund was created along the entire length of the dam to allow the water inflow to be adequately reduced and controlled (Photograph 15).

**Photograph 15** – Wood fines bund created along dam between NSR and East Bay

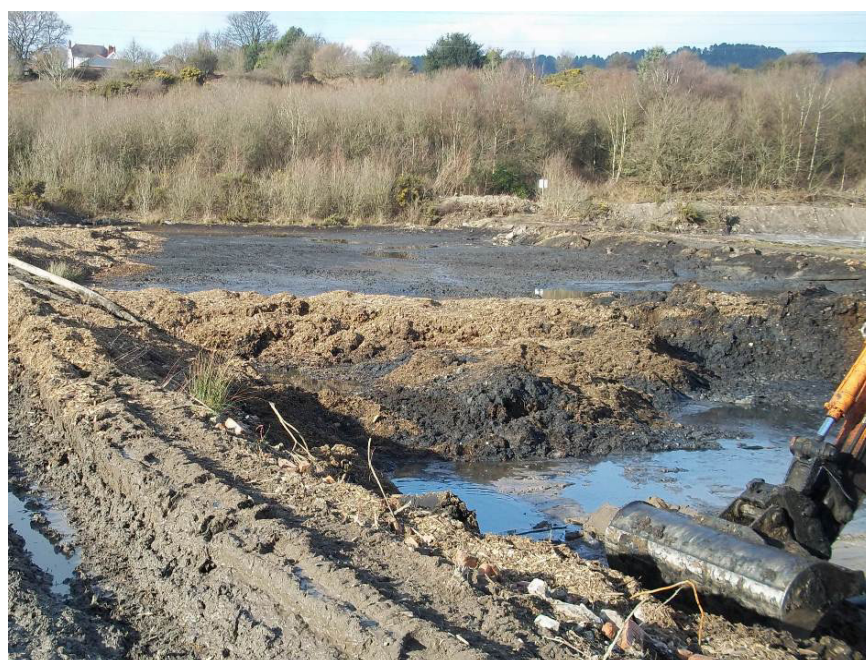
Photograph 16 shows Section 2 of East Bay immediately following de-watering and at the start of the material removal process.

**Photograph 16** – Section 2 of East Bay at start of removal process of hydrocarbon impacted material

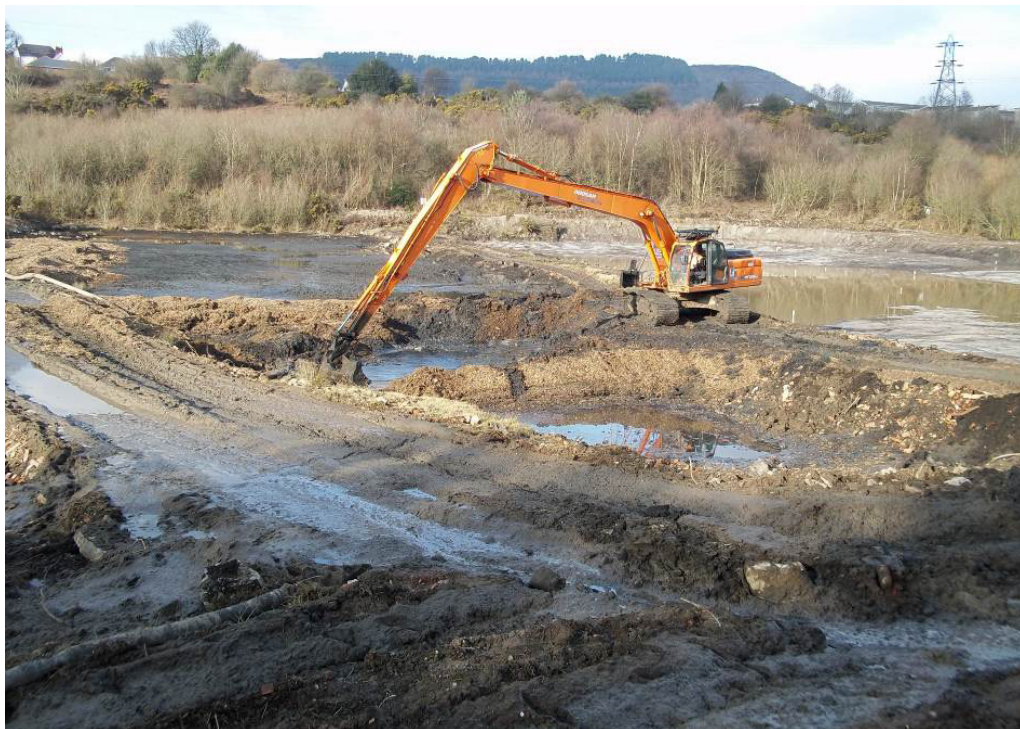
The amount of water flowing into Section 2 increased as the contaminated sediment removed and the elevation of the base of East Bay was reduced. This caused the sediment to become saturated making it difficult for mechanical excavation. As a result the methodology was modified with a large mixing lagoon being created away from the dam between NSR and East Bay using wood fines (Photograph 17). The contaminated sediment was placed into the lagoon and the relatively permeable nature of the wood fines allowed the sediment to naturally de-water. Once sufficiently de-watered the original methodology was adopted to mix and remove the material.

**Photograph 17 – Mixing lagoon within Section 2 of East Bay**

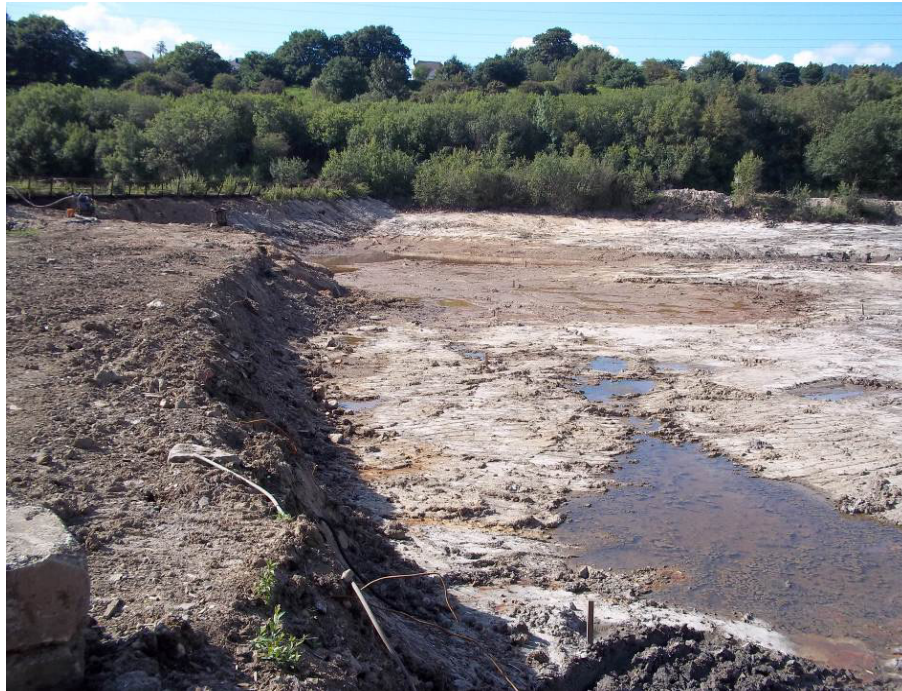
The mixing and removal of the hydrocarbon impacted material within Section 2 took approximately 6 weeks to complete. The completed profile is shown on Photograph 18.

**Photograph 18** – Section 2 following completion of the removal of hydrocarbon impacted material

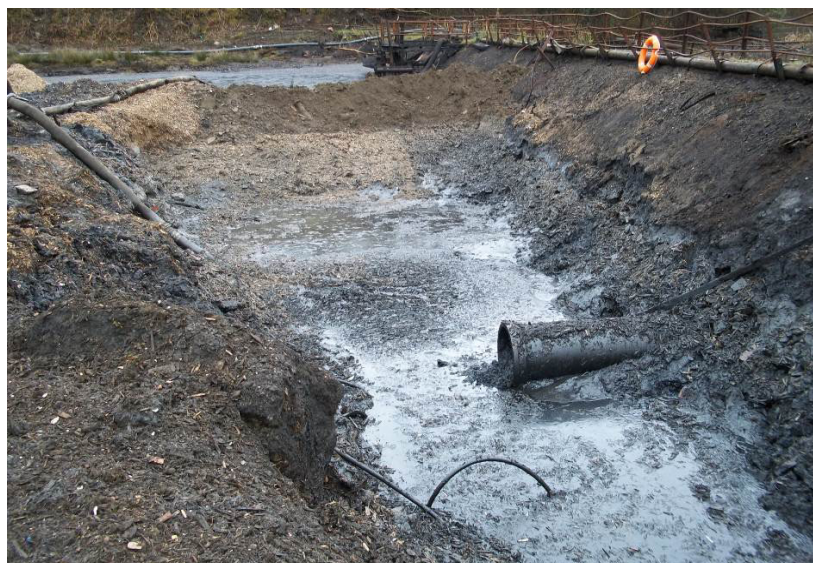
Due to the high water inflows, Section 3 was divided into two work areas by a low permeability barrier to allow each section to be pumped and completed separately (Photograph 19).

**Photograph 19** – Section 3 divided into two work areas, note connecting pipework protruding from the NSR dam

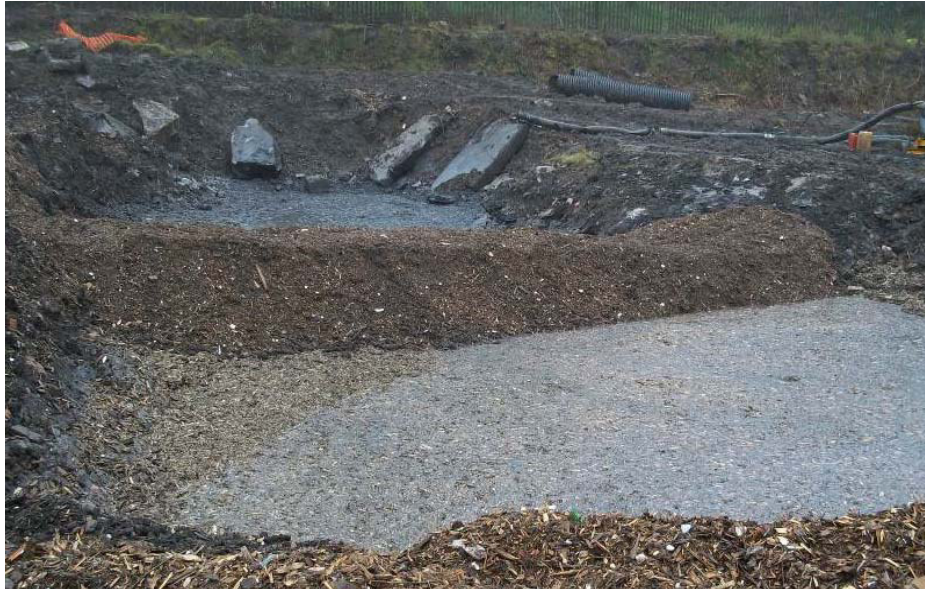
Due to the high pumping rates required to de-water these sections the OWS was not suitable. Therefore, a large lagoon was created at the southern edge of Section 2 to receive the pumped water (Photograph 20). A double bund of wood fines was created within the lagoon to provide a filtration system, preventing the recontamination of Section 2.

**Photograph 20** – Settlement lagoon created at southern edge of Section 2

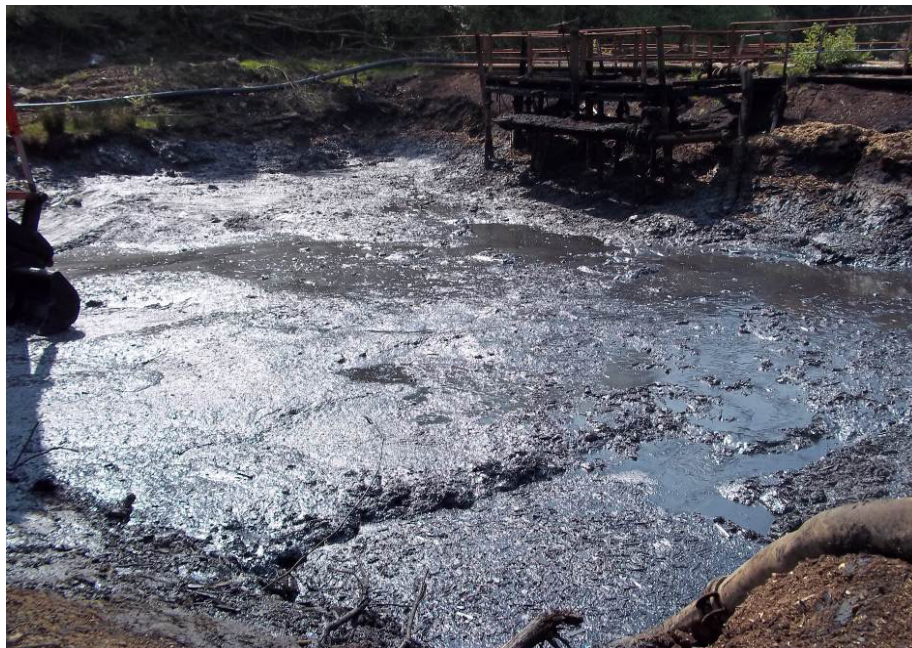
Photograph 21 shows the southern part of Section 3 following de-watering (prior to the removal of hydrocarbon impacted material).

**Photograph 21** – Southern area of Section 3 following de-watering but prior to the removal of hydrocarbon impacted material

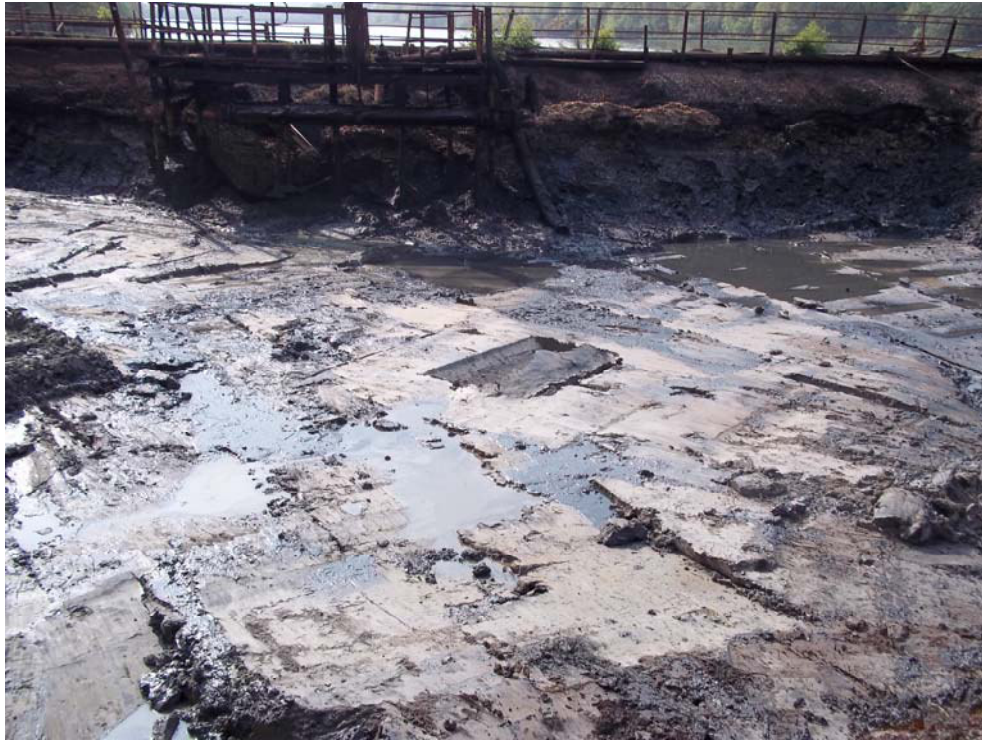
**Photograph 22** – Southern section of Section 3 after the removal of hydrocarbon impacted material

Once the water within the southern part of Section 3 was removed, the hydrocarbon impacted material was removed. However, the material remained saturated so it was placed into a settlement lagoon (Photograph 20) for it to de-water prior to mixing with wood fines. Photograph 22 shows the exposed natural base following the removal of the hydrocarbon impacted material.

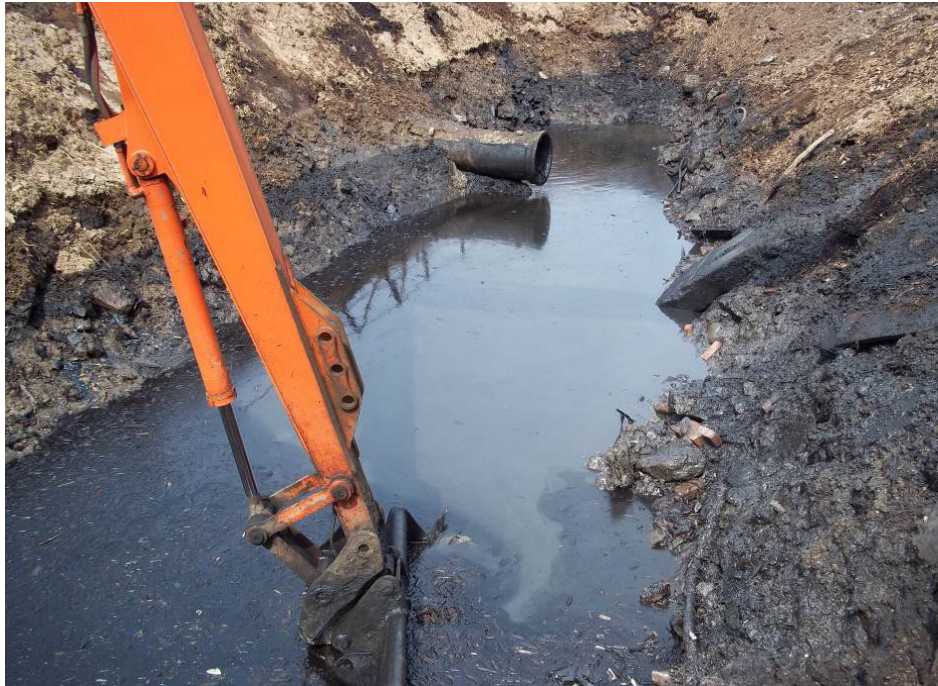
On completed of the southern part the pumps were removed and the area was allowed to re-flood. The second section was completed in using the same methodology as the first and Photographs following de-watering and the removal of hydrocarbon impacted material are presented as Photographs 23 and 24, respectively.

**Photograph 23** – Northern area of Section 3 following de-watering but prior to complete removal of hydrocarbon impacted material

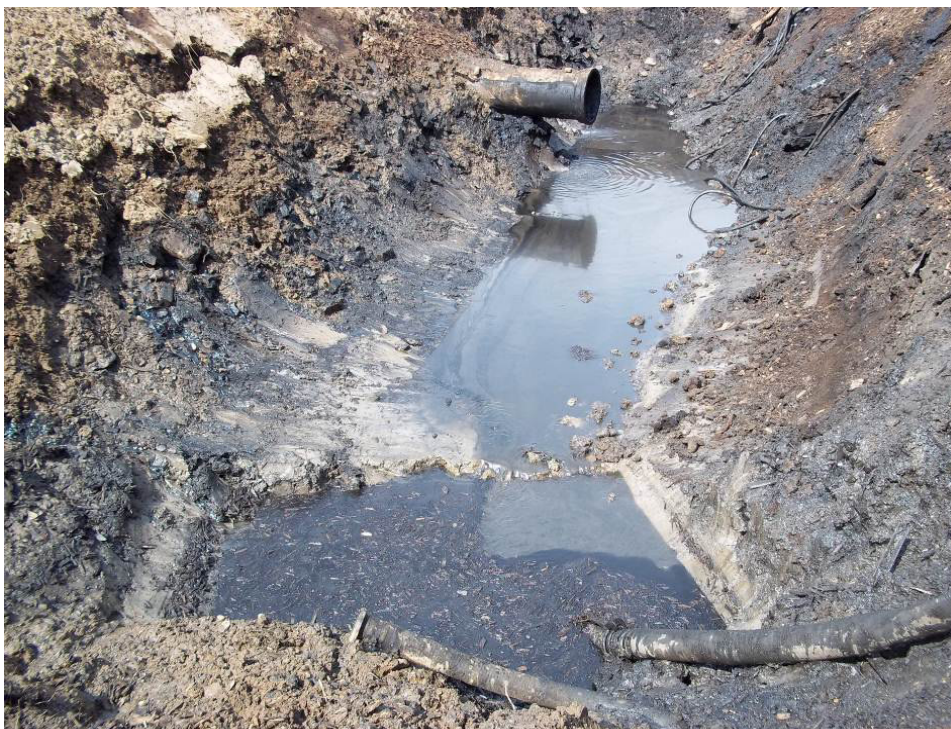
**Photograph 24** – Northern area of Section 3 the removal of hydrocarbon impacted material

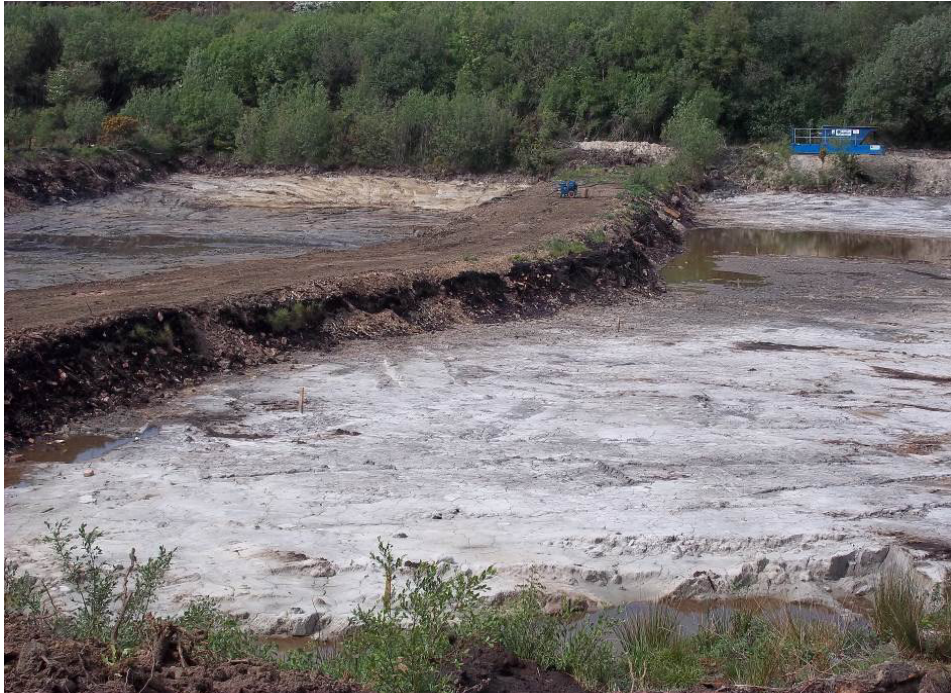
On completion of the removal of hydrocarbon impacted material Celtic undertook a visual assessment of the material contained within the central embankment/ causeway that crosses East Bay (Photograph 25).

**Photograph 25 – Central pier prior to removal**

The assessment indicated that the pier was constructed predominantly of large concrete boulders. Extensive hydrocarbon staining was present on the material within the matrix between the boulders, so the entire pier was removed in order to prevent future leaching of hydrocarbons.
