# Intrusive Coal Mining Risk Assessment Report

Site: Plot 26 and 27, Close Dewi Sant,  
Bryn

Prepared For: Ian Solomon Construction

Job No: 16483

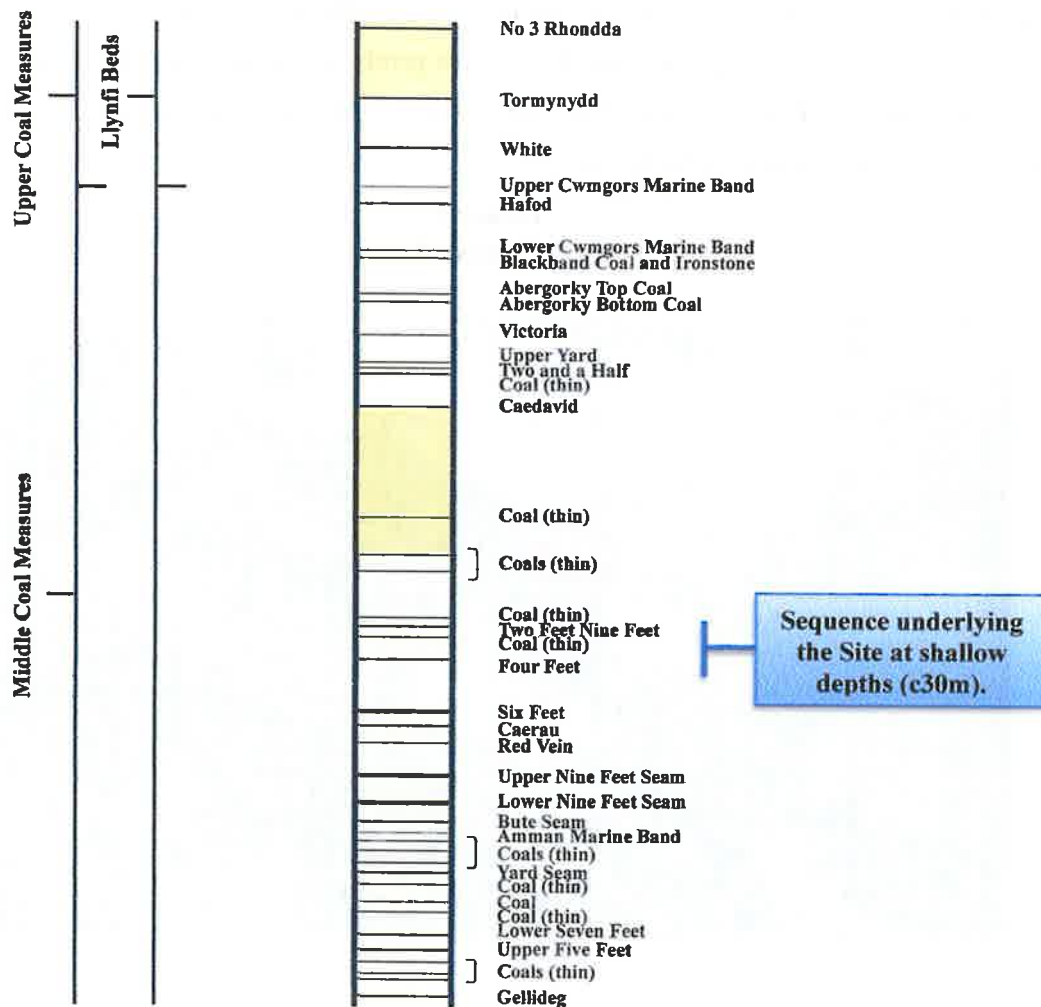
**Figure 2**  
**Indicative Stratigraphic Column.**

through the Site (see *Geology Plan, drawing no. BC/MB/07.20.06.02*). The average dip of the strata in the district is between 1 in 2 and 1 in 4 towards the north, but the rate and direction of dip of the strata is locally affected by faults and folds.

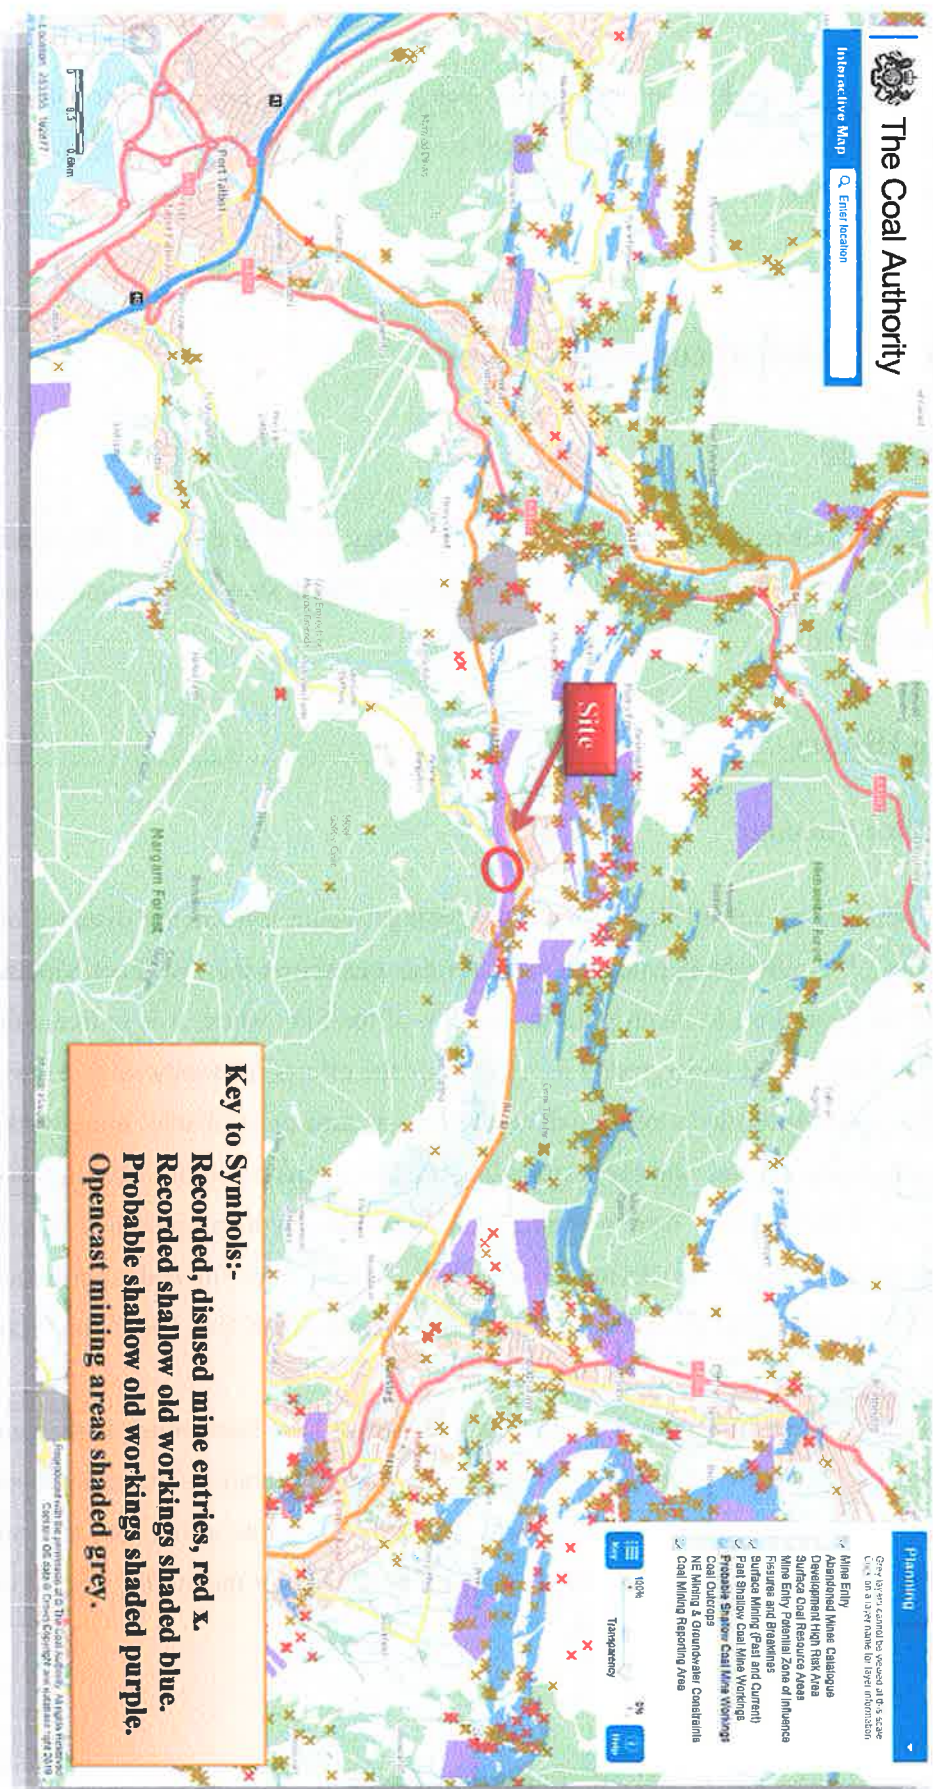
**Figure 3**  
**Print-out of The Coal Authority's Interactive Map**  
(Accessed 5<sup>th</sup> August 2020)

The general area has experienced fairly extensive underground operations for both coal and ironstone dating back to the early nineteenth century. The workings were prosecuted from a number of adits driven into the valley sides at or near the outcrops of coal seams or ironstone veins, or else from shafts sunk near the valley floor. For the greater part the past underground mining operations were prosecuted on the northern side of the Ffrwd Wyllt (see Figure 3).

The Two Feet Nine (locally known as the Fiery) and the Six Feet Seam (known locally as the Big) Seams were both mined underground in the locality of the Site. There were only very limited mining operations in the Four Feet Seam, probably because the Seam has a poor roof in the area as a result of a rider coal just above the Seam. The records of the mining operations indicate that none of the seams were mined beneath the area of the Site. Additionally, the mining records indicated that the collieries that mined the two seams had no convenient underground access that would have permitted mining operations to have taken place beneath the Site. Our searches found no record of past underground mining operations that extend beneath the Site, a situation confirmed by The Coal Authority's interactive map.
