**Re: Inspection of existing retaining wall at the proposed residential development, Margam Street, Cymmer, Port Talbot, SA13 3ED**

As per your instruction, on the 21<sup>st</sup> June 2023 I carried out a visual inspection of the highway retaining wall at the Car Service Garage, Margam Street, Cymmer. The purpose of the inspection was to advise you of the structural condition and defects of the southern boundary retaining wall.

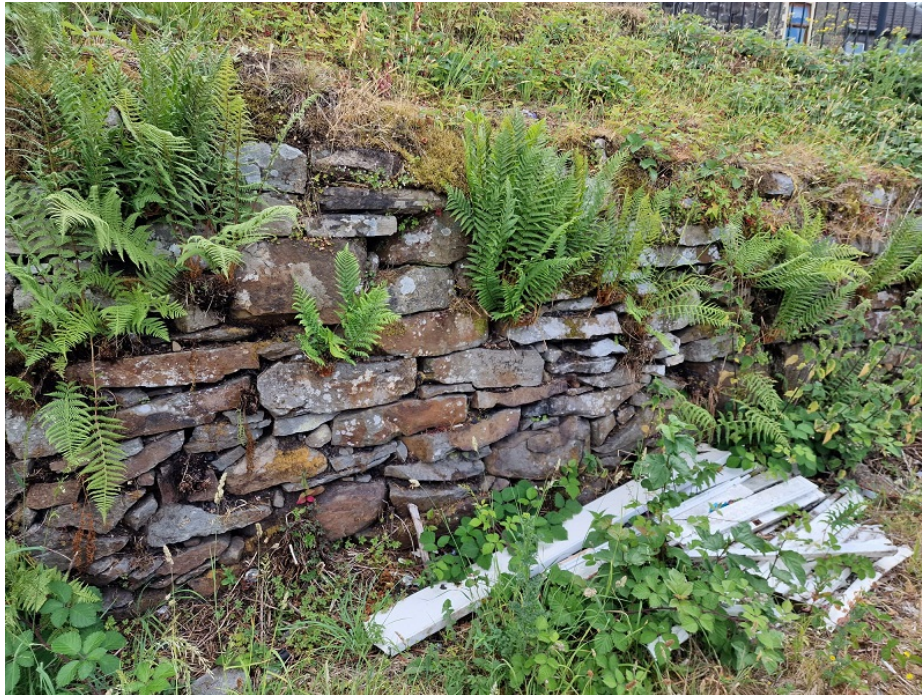
**View of wall construction**

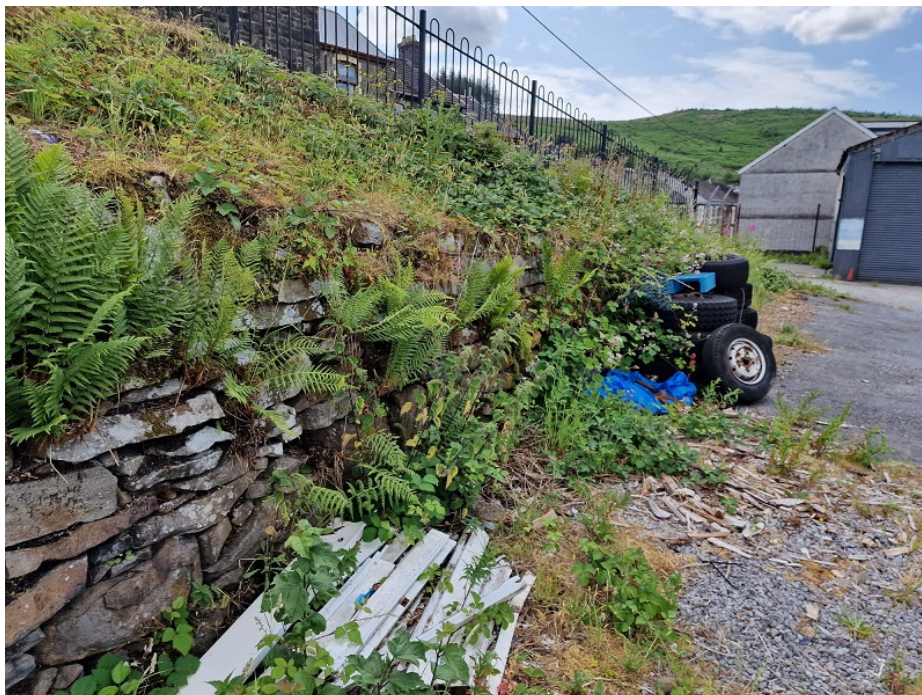
**View of lower section of wall**

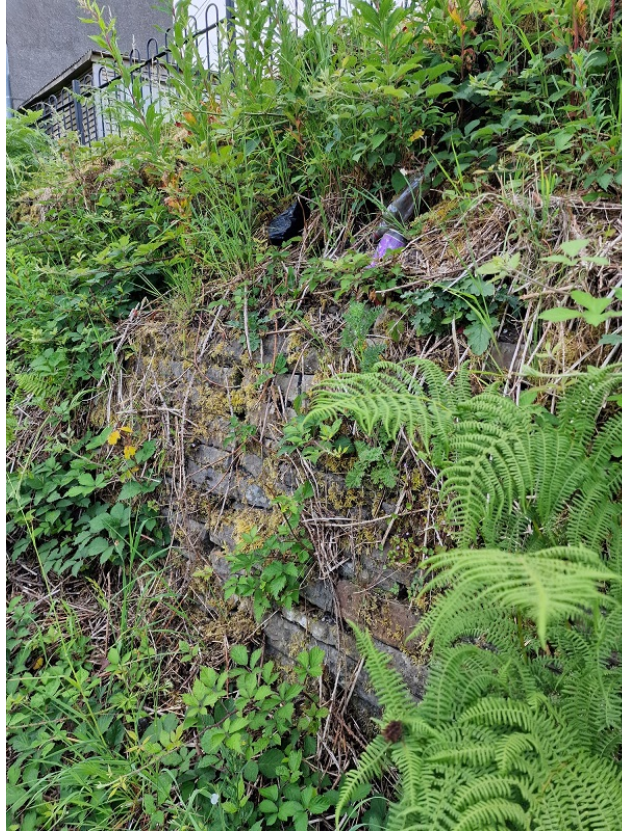
The retaining wall and banking is overgrown with vegetation. Due to the 'dry wall construction', the voids have filled with earth and soil, as a consequence of rainwater run off. Subsequently, this has allowed vegetation to take hold and grow from the wall face. Ultimately, isolated patches of stonework have become loose and dislodged.

**Overgrowth at top of wall**

In conclusion, the wall appears to be in a reasonable structural condition. However, I would advise to cut back and remove the vegetation from the joints and voids of the wall. The joints should be clean of debris. Any loose stonework should be re-laid and bedded on mortar if necessary. After this work has been carried out, I would advise another inspection to be undertaken by a suitably qualified person, when a more accurate assessment can be made.

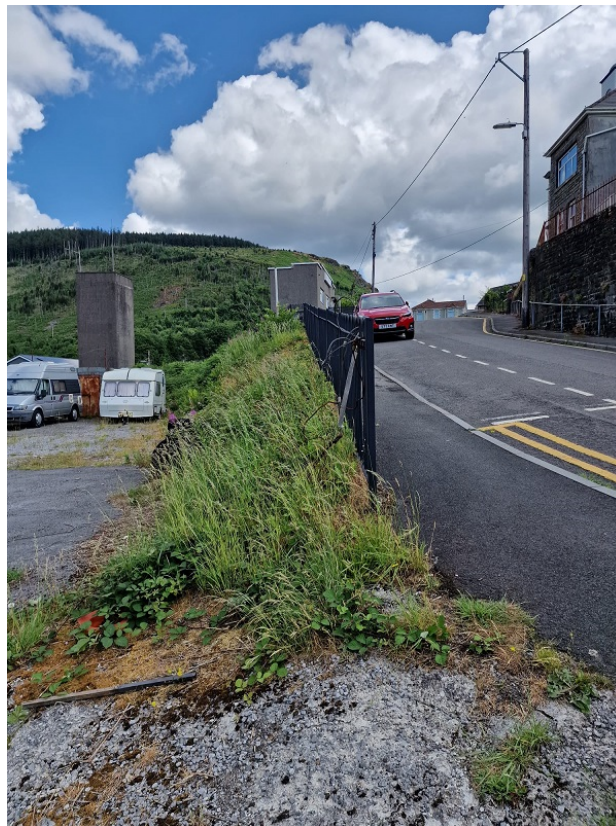
The retained path was checked for signs of subsidence. Typical signs of subsidence would present as a series of stress cracks (to the tarmac) running parallel to the retaining wall. I can confirm this type of cracking is not present.

**View of footpath to rear of wall**
