## **Ty Maes Marchog**

### **Banwen**

### **Tree Report**

3<sup>rd</sup> November 2022

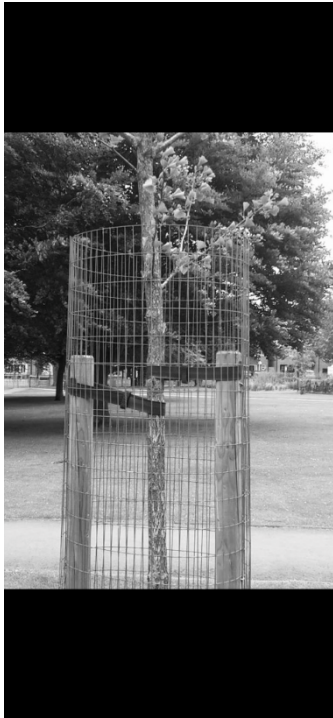
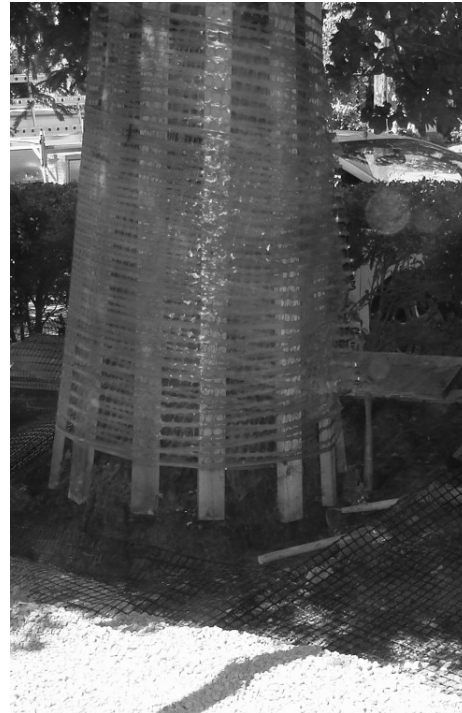
Above are a couple of examples of the kind of tree protection recommended around this tree. Either timber around the trunk of the tree with a highly visible plastic sheet wrapped around or a welded mesh tree guard around two posts. These would need to be put into the ground in a way which doesn't cause damage to the roots.

**Suggested Actions** – The installation of tree protection fencing is recommended to provide a protective barrier around the perimeter of the tree. Although because of the proximity to the road

the conventional tree protection fencing may not be suited for this particular tree, instead I'd suggest a welded mesh tree guard to go around the trunk of the tree and that it is well secured along with some signage to be cautious of the branches that will overhang the fencing.

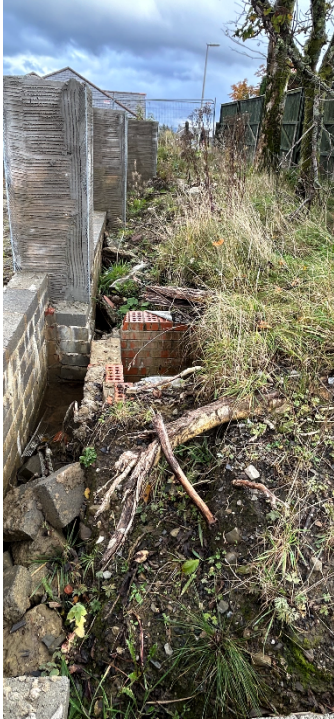
**Suggested Actions** – This Tree has had significant root damage from groundworks that have been undertaken on site, it appears an excavator has cut through half of the tree's roots on the front side which has caused the tree to die. You can see evidence of this from the dead brittle branches, flaking bark along with the lack of leaves.

**Suggested actions** – As this tree is in the same location as T13 this tree also took on root damage from the groundworks, although the root damage is not as severe, the tree is beyond healing and because of this the trees health is plummeting and beyond saving. Again, overtime and with any irregular weather conditions like high winds, this tree poses a risk to people on site and the neighbouring house. Because of this I recommend removing the tree and can be replaced at a later date if required.

Suggested actions – Same as the previous 2 trees, as they are located in the same ditch it has been damaged in the same capacity. This tree's roots took on severe damage and has caused the tree to die, which can be identified by the brittle branches through the tree and a lack of leaves. This tree needs to be removed and again be replaced at a later date if required. Once again this is a potential hazard in adverse weather.

The image below is the tree line of T13, T14 & T15. And this image shows the severe root damage that the trees have taken with what appears to be due to an excavator.

Urgent action for removal required due to trees proximity to the neighbouring garden behind the site. This could be a hazard in adverse weather conditions.

As the roots are severed, the tree is now structurally unstable. Once all groundwork is complete, a new tree can be planted to replace this one.
