Title: Gnoll House Ruins – Site Visit Report

Date: 01 Sept 2023

Project Name: Gnoll Park, Neath

2080-01-JUB-S-RP-00001-S2-P1

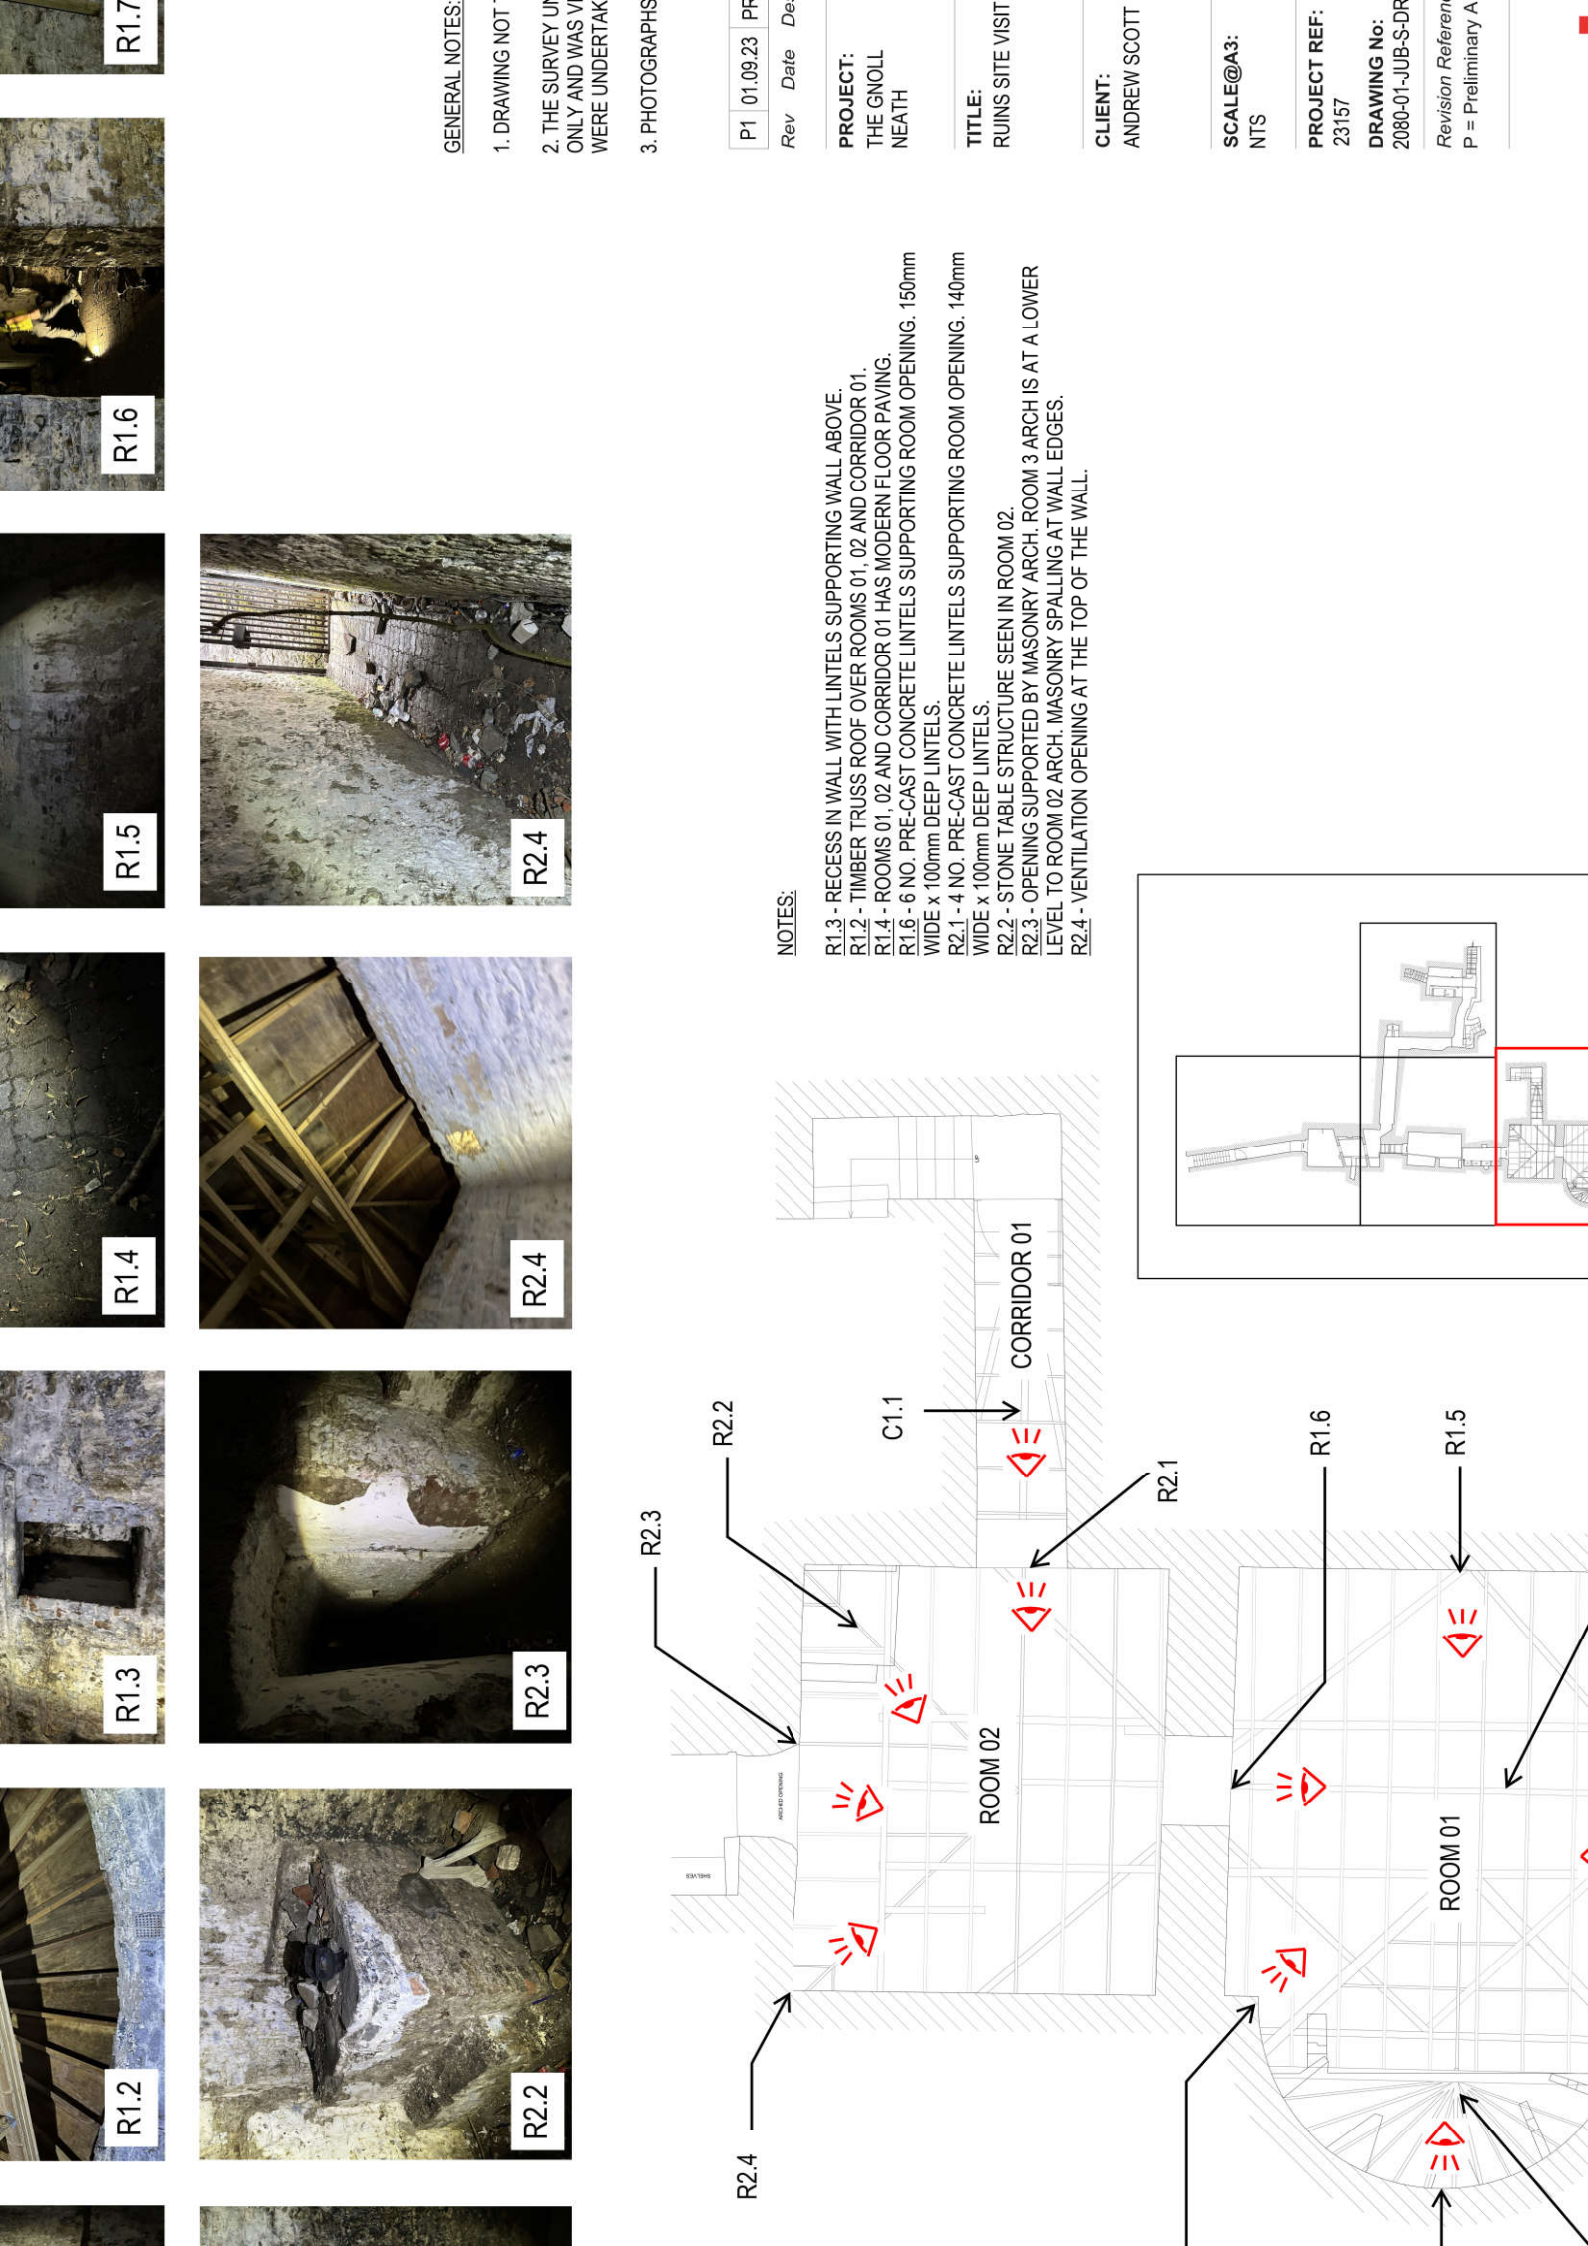
Appendix A - 2080-01-JUB-S-DR-SK001

- 4.3 Rooms 01, 02 and Corridor 01 (Refer to Appendix A) have a timber truss supporting a metal deck roof which is visible at external ground level. The rest of the basement has a combination of Arched masonry roof and a flat roof believed to be an RC slab. There are also localised areas with roof comprising of steel beams, timber joists and pre-cast concrete lintels.
