Title: Kitchen Garden – Stone wall condition summary

Date: 24<sup>th</sup> August 2023

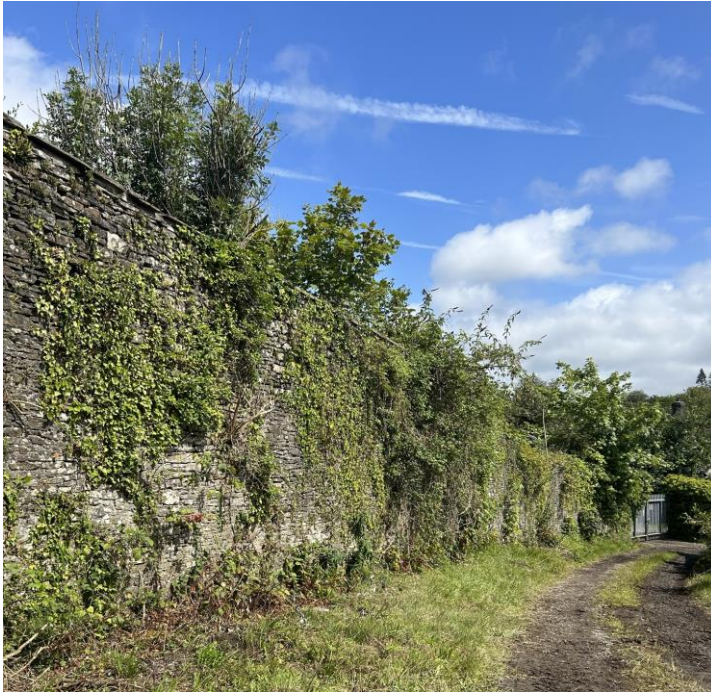
The north wall appears to be approx. 600mm thick with 800mm thick piers at the kitchen garden gates. At the time of this visit some clearance of vegetation along the south elevation had been carried out, this provided an opportunity to review the south elevation of the wall, heavy vegetation still existed on the north elevation of the wall.

The northern wall appears to be in reasonable condition. The wall looks visually plumb but this will need to be confirmed by a plumb survey.

Portions of the wall coping appears to be damaged and missing along the wall length.

Figure 4.1: Overall extents of the north wall (First visit prior to vegetation removal)

Overall, the north wall appears to be in reasonable condition, a plumb survey is required to confirm and review stability of the wall. Ideally both north and south elevations.

No access was available to inspect the top of the wall, but based on the basic walk along the wall it was apparent that several coping stones were missing, and replacement and reinstatement of stones will be required along the length of the wall.

Where the existing pointing has eroded over years this will require reinstatement and areas that have previously had cement pointing applied, this will require removal and lime mortar pointing reapplied in its place. Also, some consolidation of masonry will also be required if stone pieces have fallen from the wall.

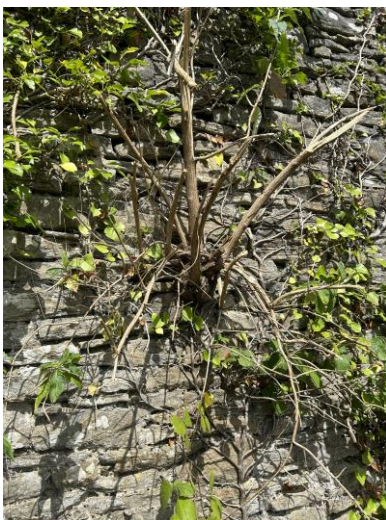
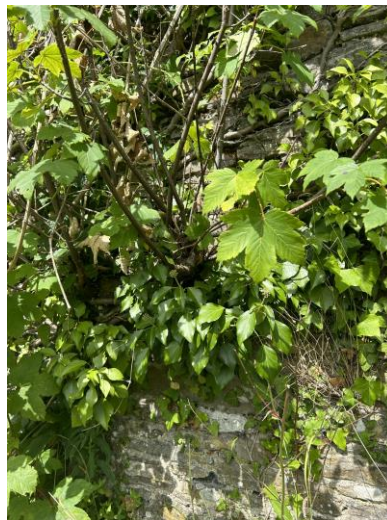
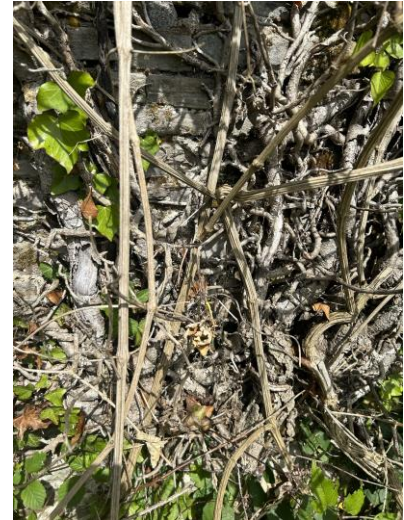
Instances of vegetation penetration within the wall have been observed; however, the resulting damage appears to be localized and not extensive. Refer to Figure 4.1 for an overall view of the wall and figure 4.2 for the vegetation penetrations through the wall in the Appendices.

Figure 4.2: Vegetation seen penetrating through the north wall.

Localised removal of large vegetation is required as part of the repair works, a temporary works approach will be developed with Andrew Scott to ensure as much of the wall remains in place, with any rebuild sections following the best practice repairs summary (Jubb document 2080-04-JUB-S-RP-00001-S2-P2).

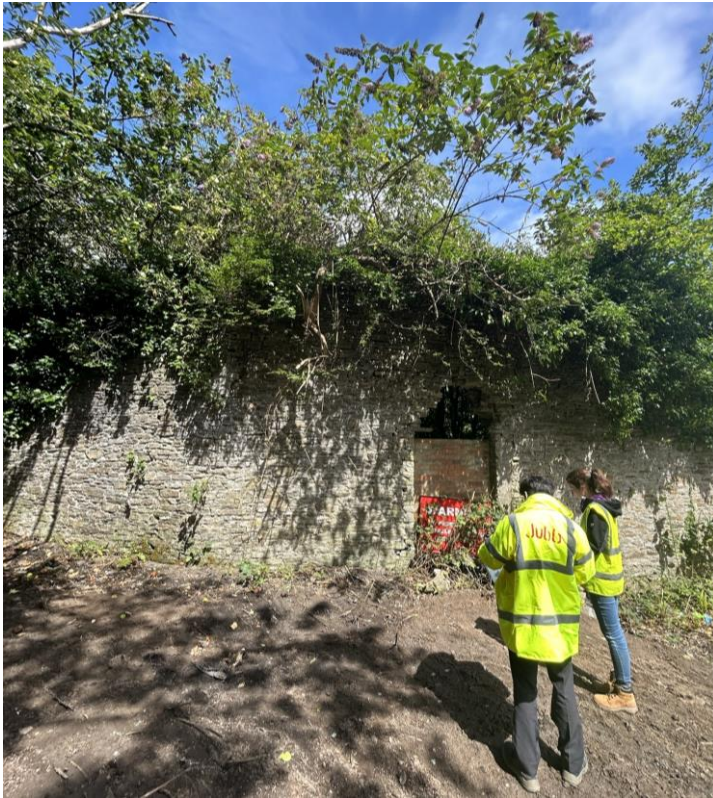
The north-west wall is in poor condition. The wall is visibly out of plumb and leaning in a significant section (approx 7-10m length from the west corner), in the same area there appears to be an existing opening in the wall that seems to have partially collapsed. This location also appears to have large vegetation located at the top of the wall. Instances of vegetation penetrating along the rest of the wall have also been observed along with cracks in the wall.

It is anticipated that the coping of the wall is significantly damaged along this wall line due to the presence of thick root and ivy growth located at the top, over the full length. Refer to Figure 4.3 to 4.6 in the Appendices showing the overall extents of the walls, vegetation penetration through the wall, cracks and partial collapse of the opening.

Figure 4.3: Overall extents of the north-west wall (second visit, following removal of some vegetation)

Overall, the north-west wall appears to be in poor condition. A large section of the wall is significantly out of plumb for approx. 5-8m length, at the west end of the wall. A plumb survey of the wall would be beneficial as a record and for discussions with Cadw and the local authority when discussing the extents of the rebuild due to instability concerns. There is also large vegetation growth at the top of the wall contributing to the deterioration which will require removal and an existing opening to the wall appears to have suffered some collapse. All these contributing factors result in our recommendation to rebuild the top section of the wall, approx 2m height (ideally to the location where the wall is plumb). Figures 4.4 and 4.6 show the area discussed above, the large vegetation and existing opening. Repairs done to these walls should be sympathetic with historic considerations and methods agreed before work commences, see Jubb report 2080-04-JUB-S-RP-00001-S2-P2 for more detail.

No access was available to inspect the top of the wall, but based on the basic walk along the wall it was apparent that several coping stones were missing, and replacement and reinstatement of stones will be required along the length of the wall.

Similar to the North wall, any repointing works required will need to be reinstated and removal of historic cement pointing replaced with lime based mortar.

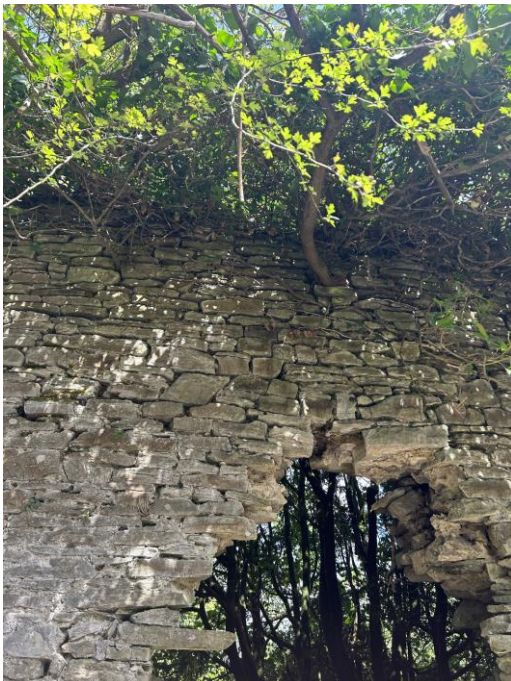
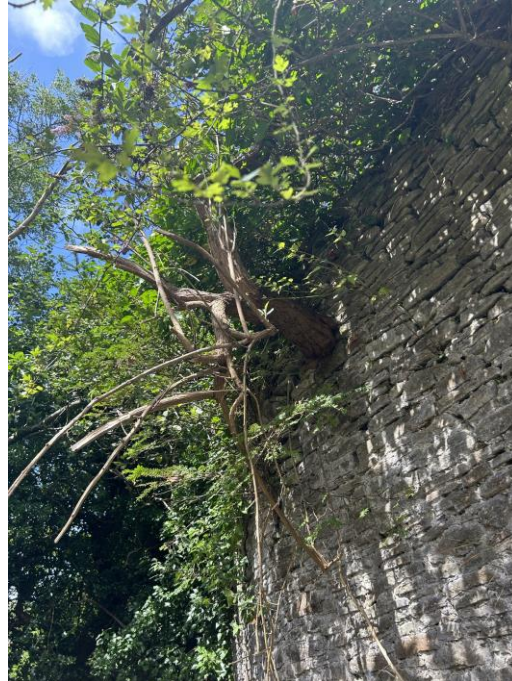
Figure 4.4: Vegetation seen penetrating through the north-west wall.

Removal of vegetation across the rest of the wall (not area of rebuild) would be required, consolidation and repointing to suit and repair wall in these areas.

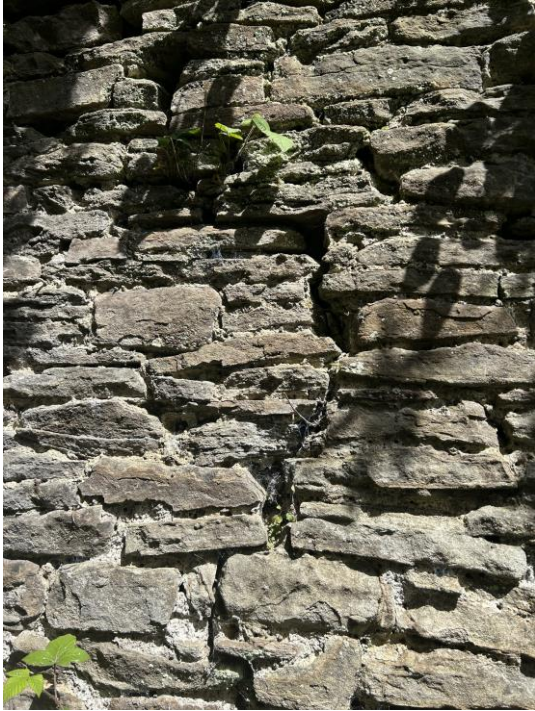
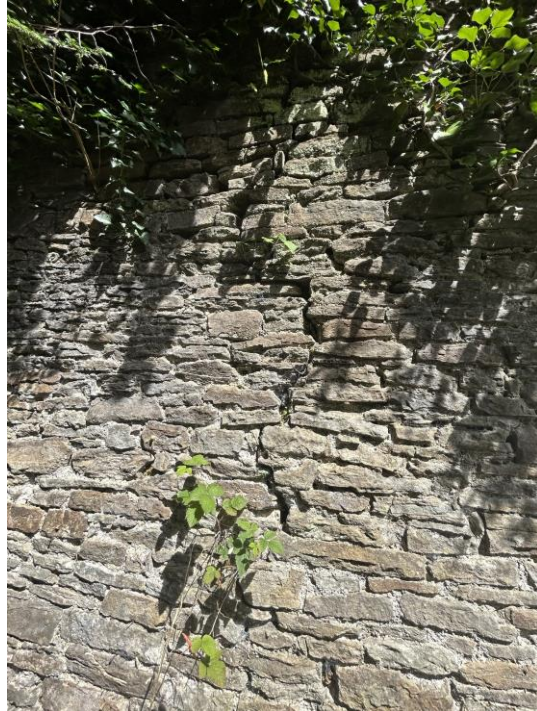
Figure 4.5: Crack seen along the north-west wall.

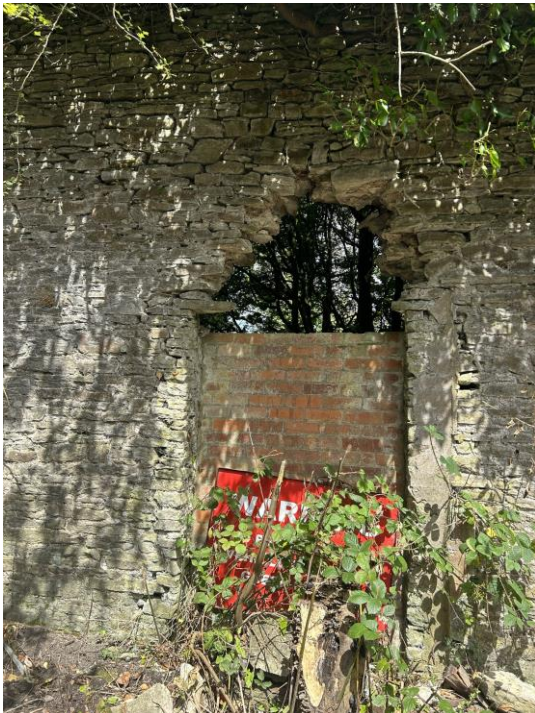
Figure 4.6: Partially collapsed opening along the north-west wall.

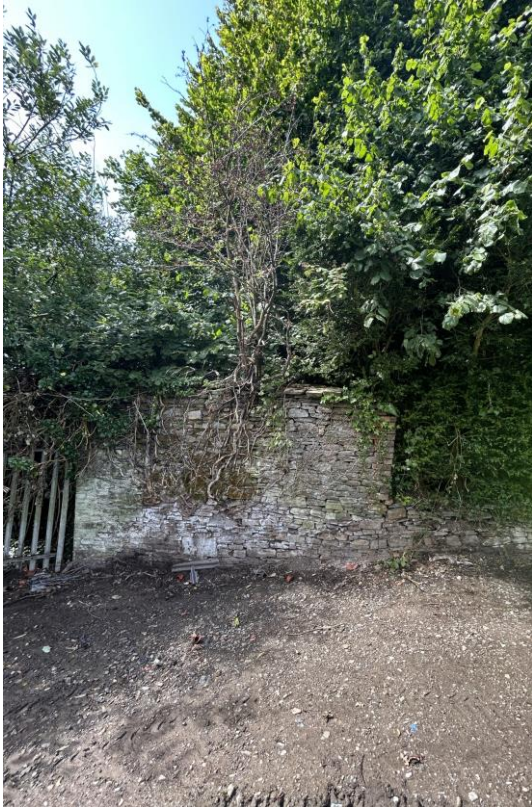
During our site visit, this section of wall was highlighted to be included as part of the initial review by Andrew Scott. This wall is located towards the south of the site, perpendicular to the existing boundary retaining wall at high level. This section of wall is approx. 3-4m length of wall, approx. 2m high, to the south is a palisade fence and to the north the wall continues at a shorter height of approx. 600-800mm high.

Figure 4.7: Wall A – Elevation

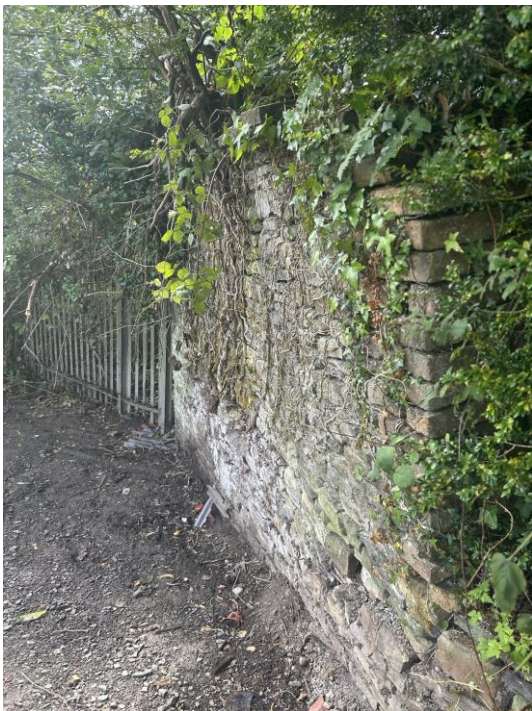
Based on a visual inspection on site, it appears that approx. 2m length of wall is significantly out of plumb, beyond what would be considered acceptable for a masonry wall, it would be good to carry out a plumb survey for discussions with Cadw and local authority.

At the top of the wall there is large vegetation growing from the top, this is likely causing damage and detriment to the wall.

Figure 4.8: Wall A – Side view, providing some indication of the section out of plumb and the large vegetation on top of the wall.

Based on the initial visual inspection we would recommend rebuilding the section of wall out of plumb, but also carrying out further inspections behind the wall to determine if any vegetation or other effect has had an impact on the wall to reduce the chance of the wall deteriorating in the same manner in the future.

Removal of vegetation would be required with consolidation of the masonry surrounding these areas, and a review of any existing coping to be reinstated or new coping laid on top.

For Wall A, an allowance should be made to rebuild a 2m long, 1.5m high section of wall, with works to regrade the ground behind the wall and remove some localised vegetation if possible. Some allowance for repointing in the remaining length of the wall would also be sensible at this stage. These allowances are restricted to the short section of wall inspected on site, a full survey of the wall will be carried out.
