## 4.1 Photographic Record - First Floor

SECOND FLOOR PHOTOGRAPHS

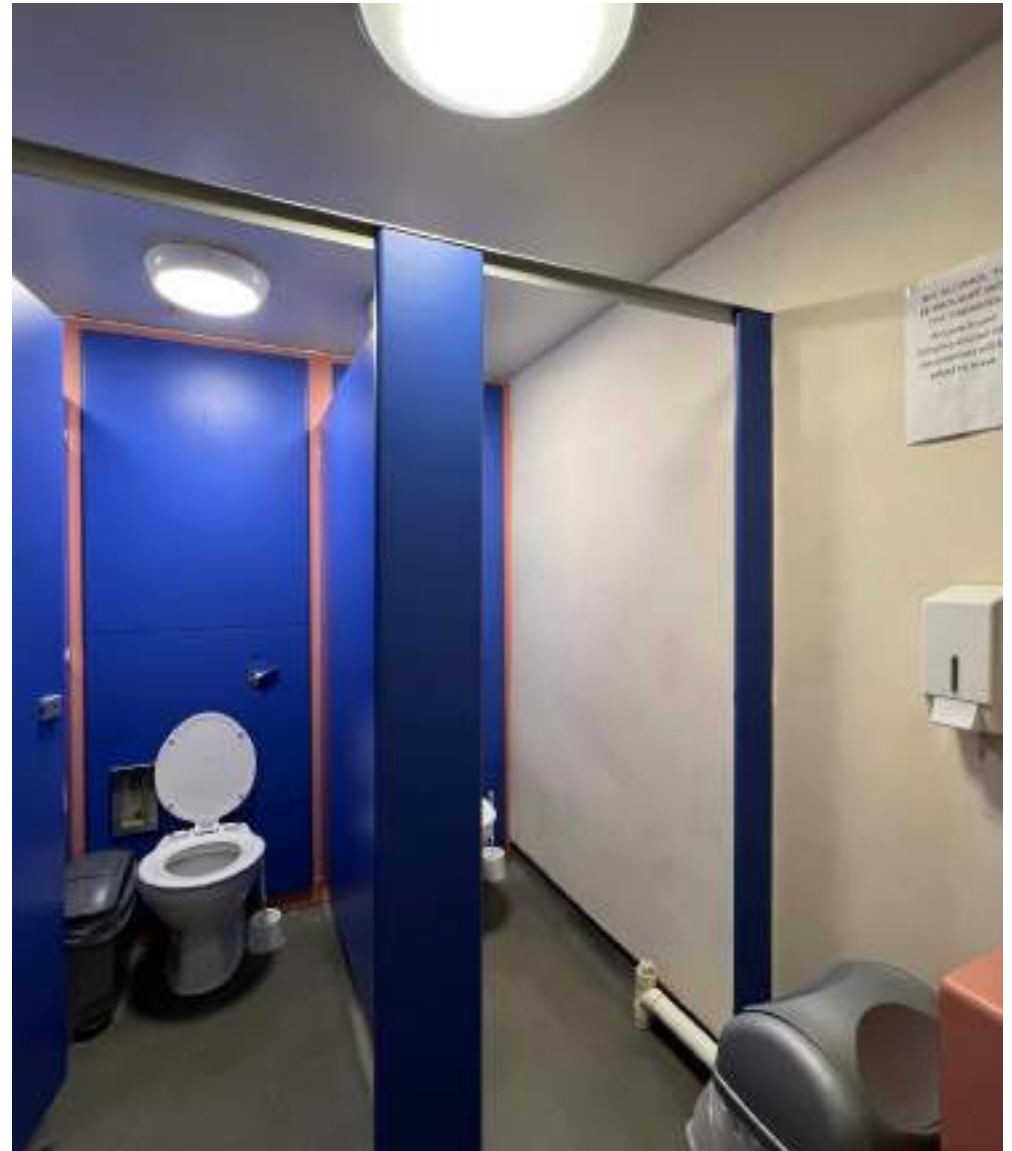
Generally, the first floor female WCs contain no features of historical merit. The internal toilet cubicles, light fittings, floor finishes and sanitaryware all appear to be modern installations.

Photograph 82: Modern toilet cubicle system and finishes

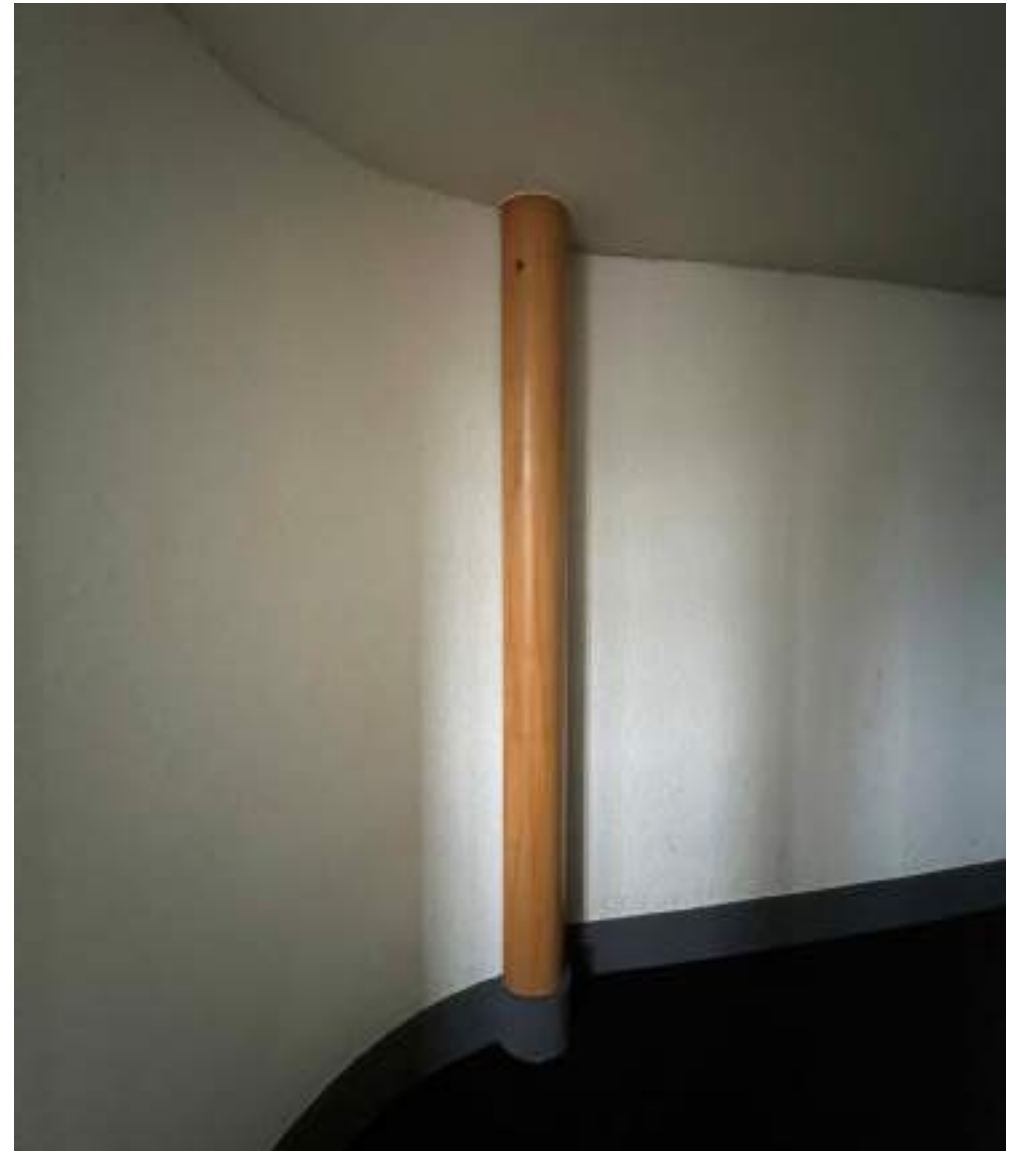
The existing interconnected corridor space contains no visible historic features, with the column within the space appearing to have been built during the 1990s.

Photograph 83: Modern finishes and veneered timber column casing

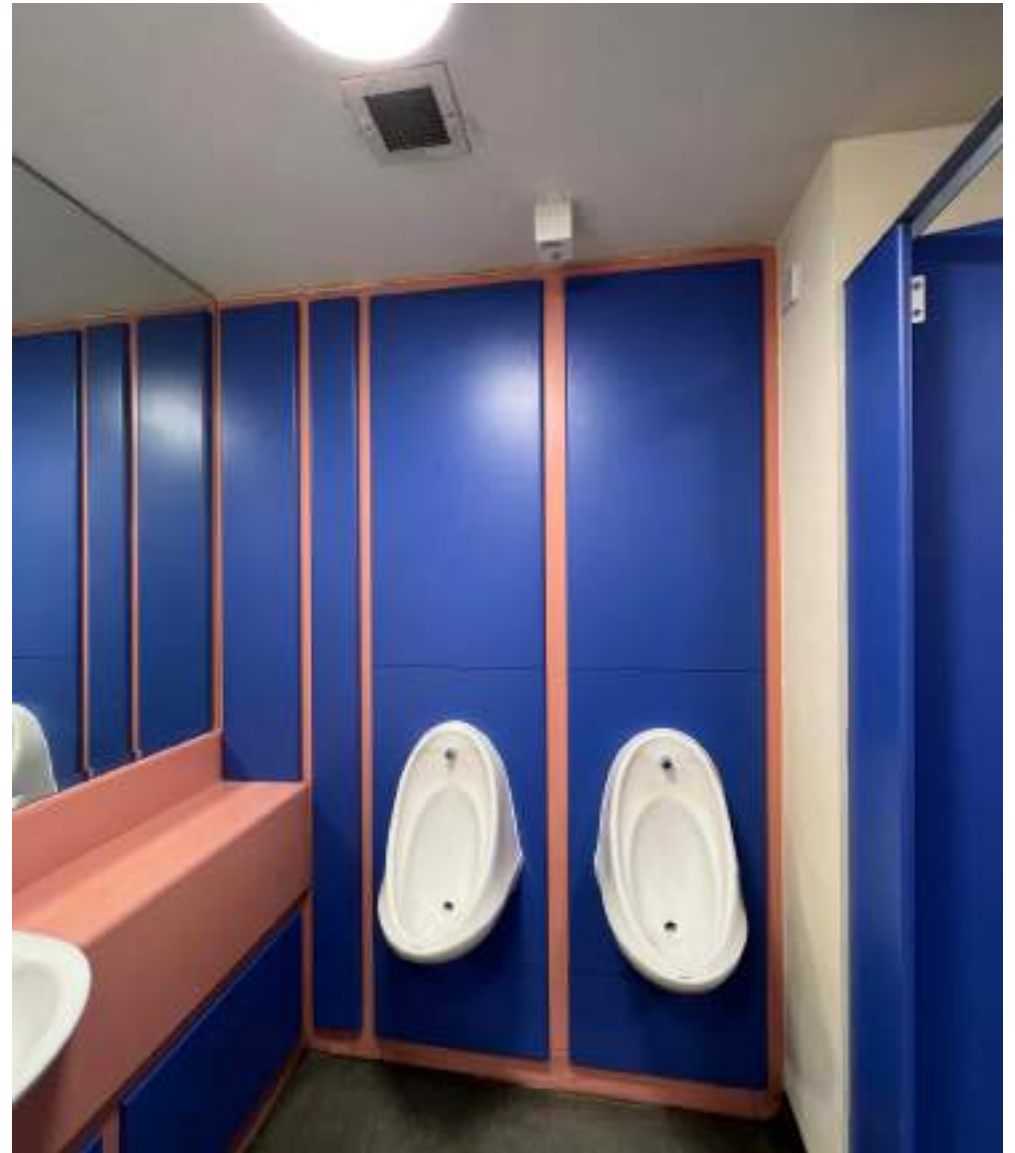
Generally, the first floor male WCs contain no features of historical merit. The internal toilet cubicles, light fittings, floor finishes and sanitaryware all appear to be modern installations.

Photograph 84: Modern toilet cubicle system and finishes

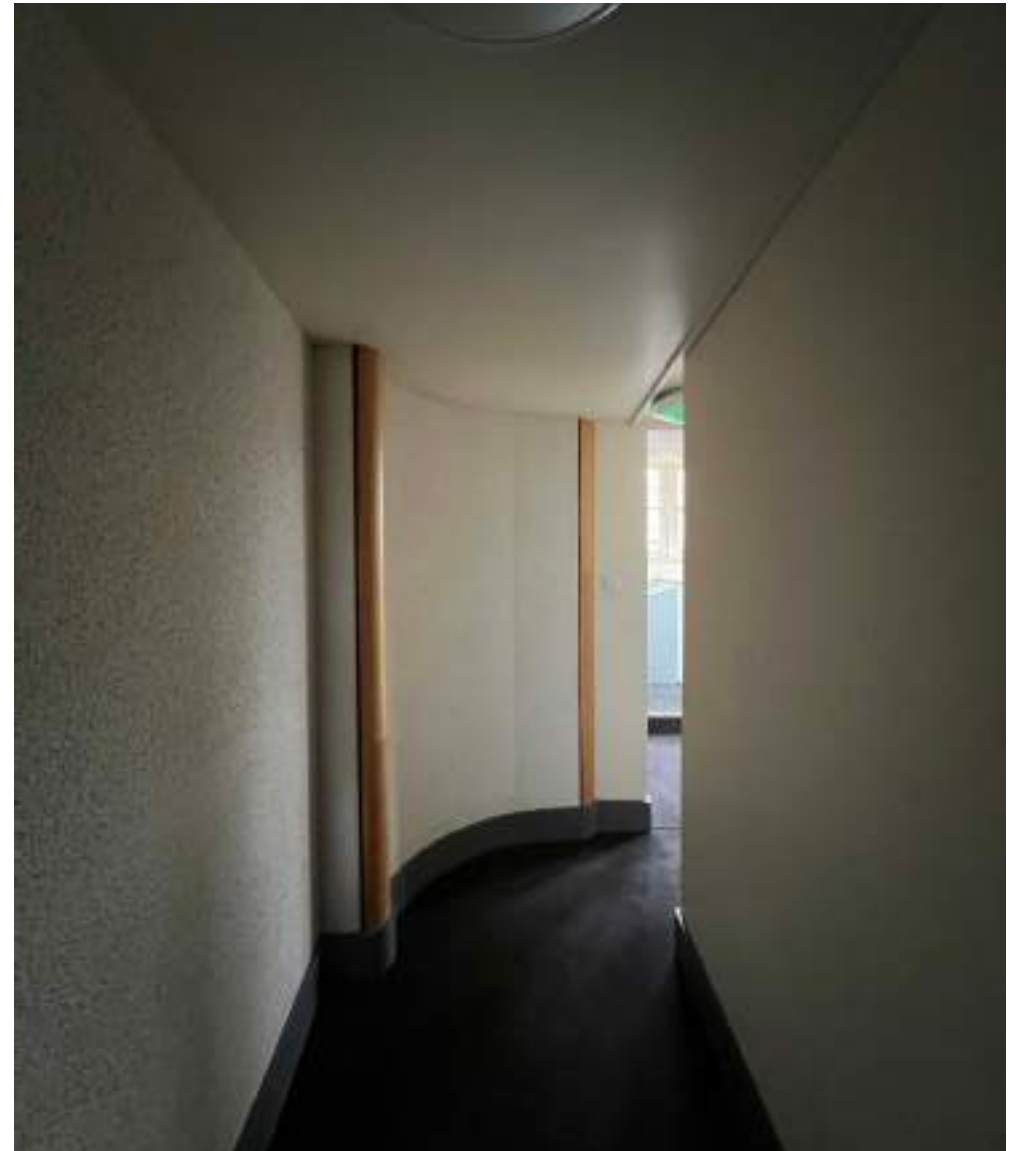
The existing interconnected corridor space contains no visible historic features, with the curved columns within the space appearing to have been built during the 1990s.

Photograph 85: Modern finishes and veneered timber column casing

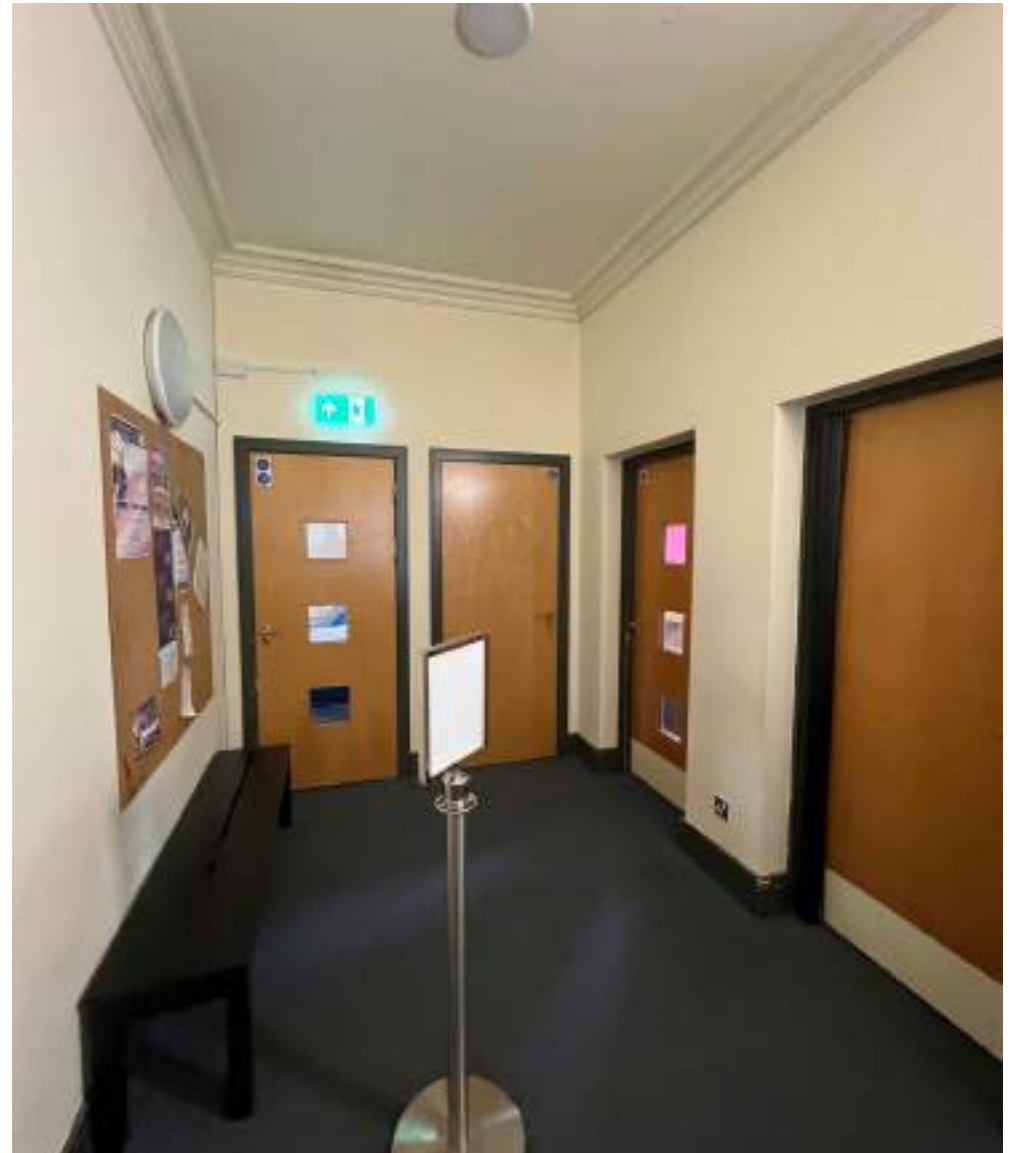
The internal corridor / lobby space on the first floor has very little in the way of historic features, with the exception of the plaster cornice that runs around the perimeter of the room. All other features and finishes appear to be modern in nature.

Photograph 86: Modern finishes and doors with historic cornice

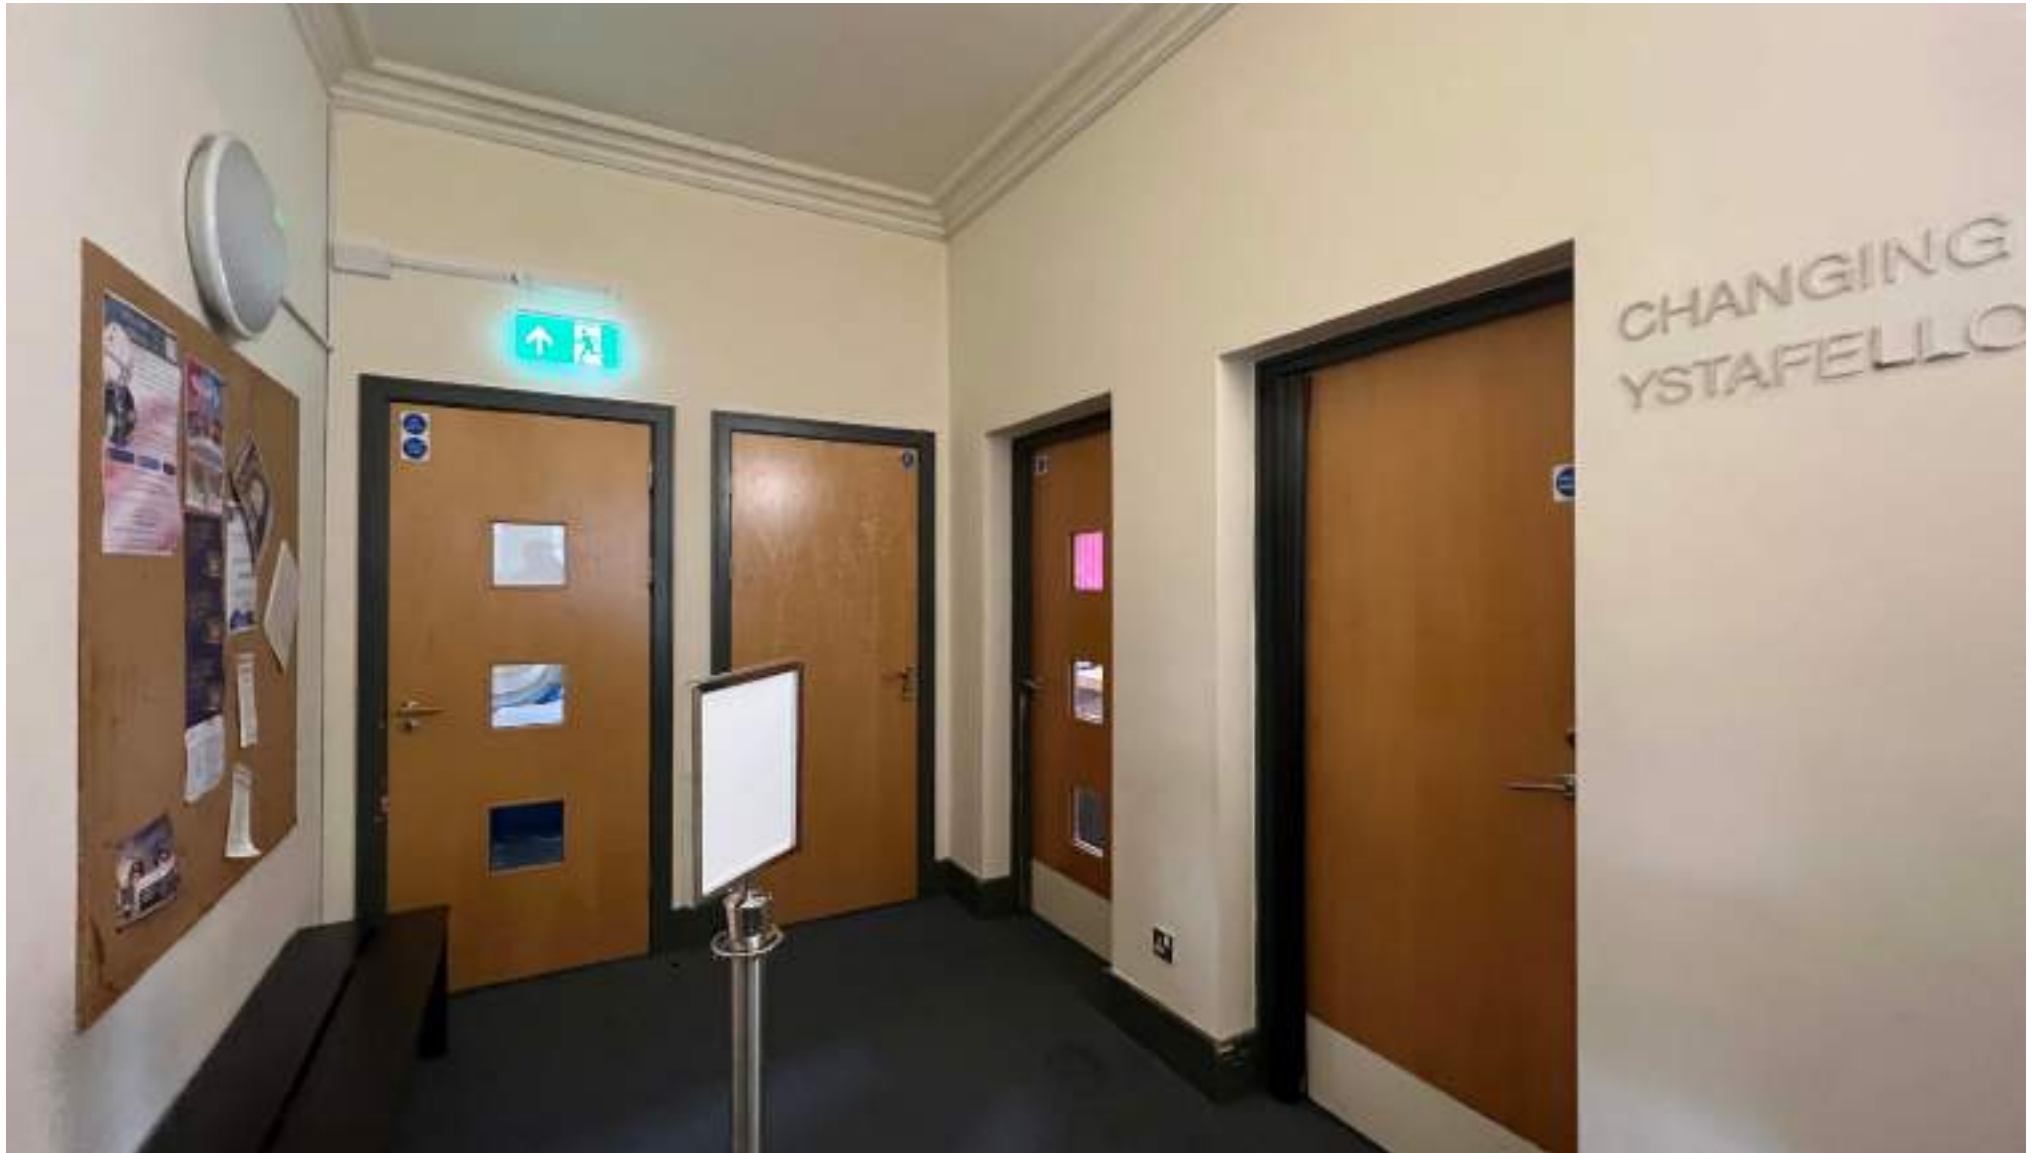
Photograph 87: Modern finishes and doors with historic cornice

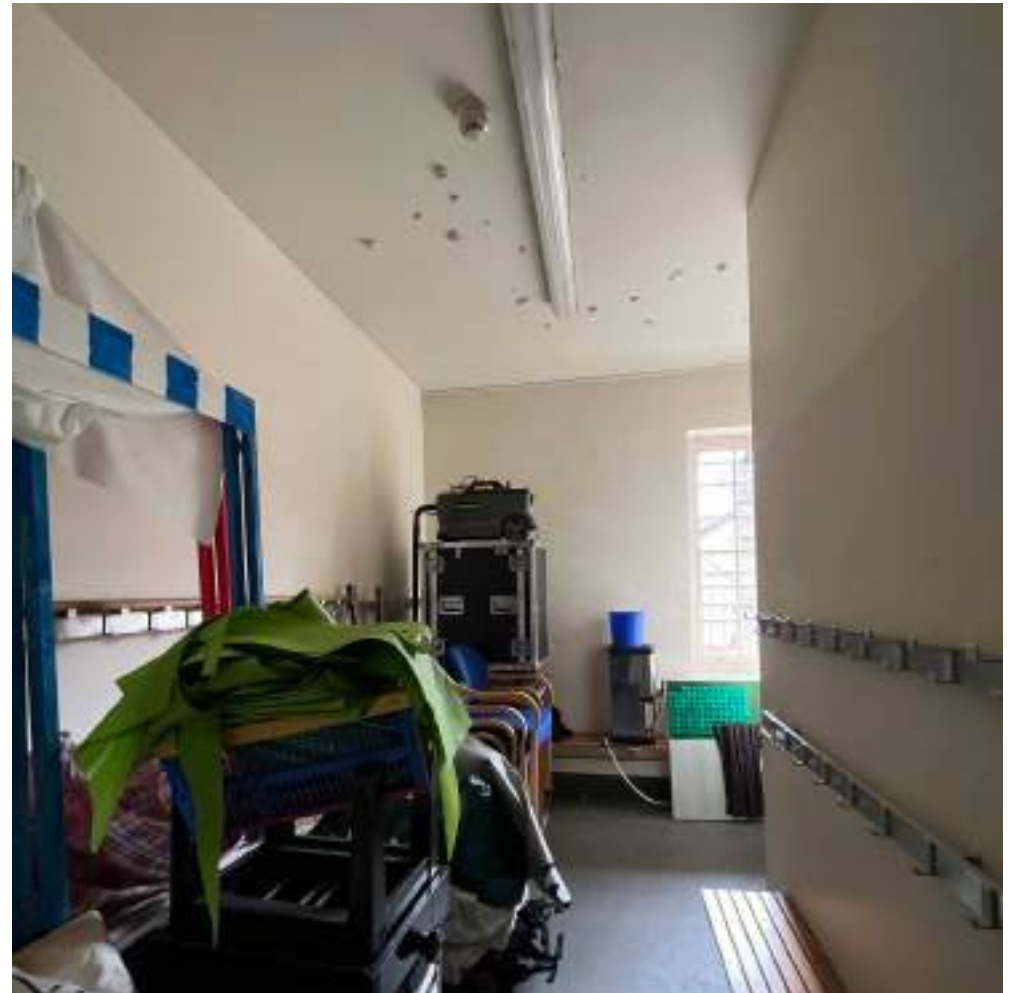
In general, the first floor changing rooms contains very little historic fabric. The wall finishes, floor finishes, internal doors, light fittings, and fixed furniture all appear to be modern insertions. The only notable historic fabric is the timber sash window.

Additionally the space appears to have been subdivided with a partition to create the shower area and toilet

Photograph 88: Modern finishes and separating partition for shower

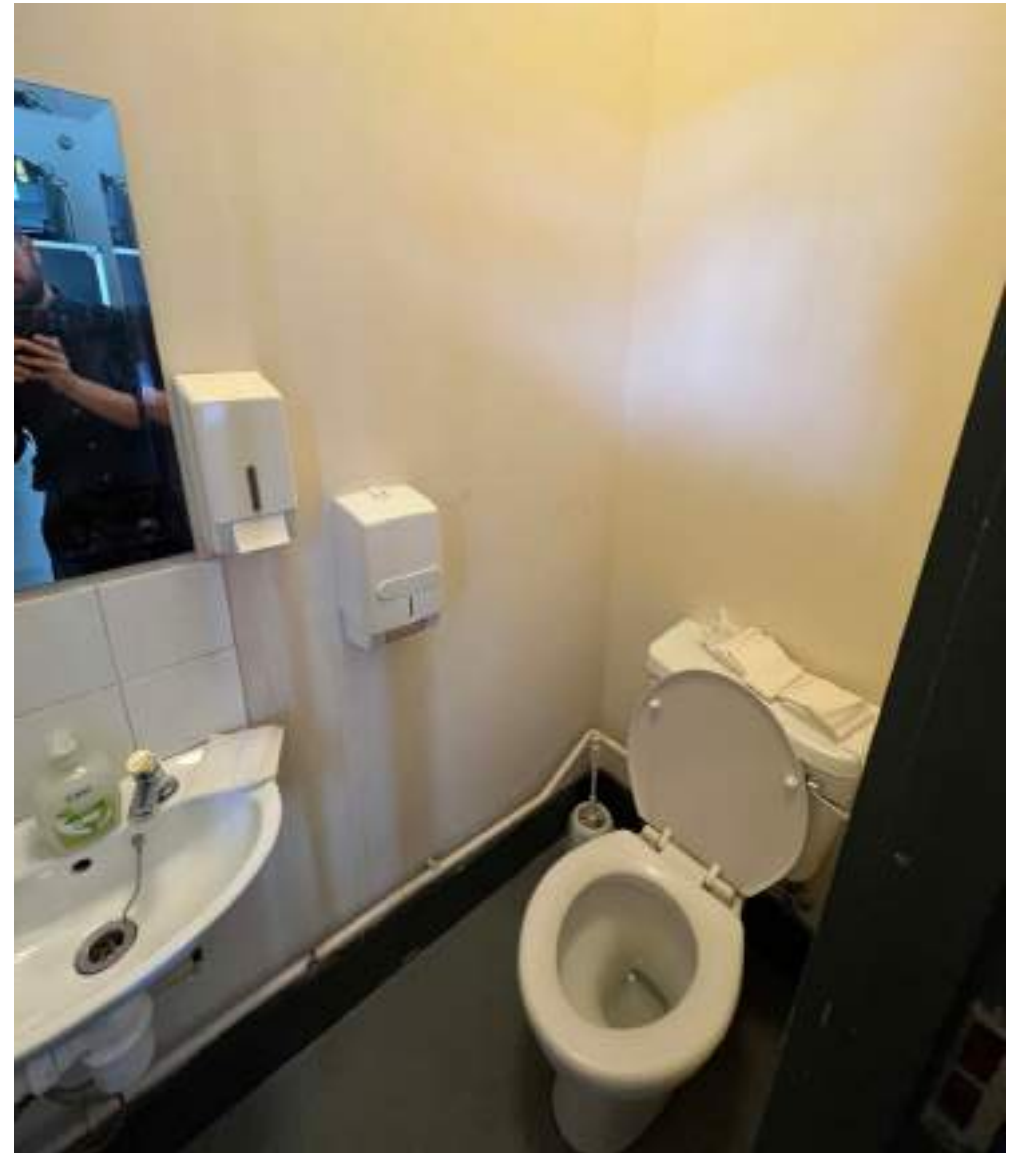
Accessed off the changing room is a WC. The WC contains no fabric of historic value with all finishes and sanitaryware fittings being modern insertions.

Photograph 89: Modern finishes and sanitaryware

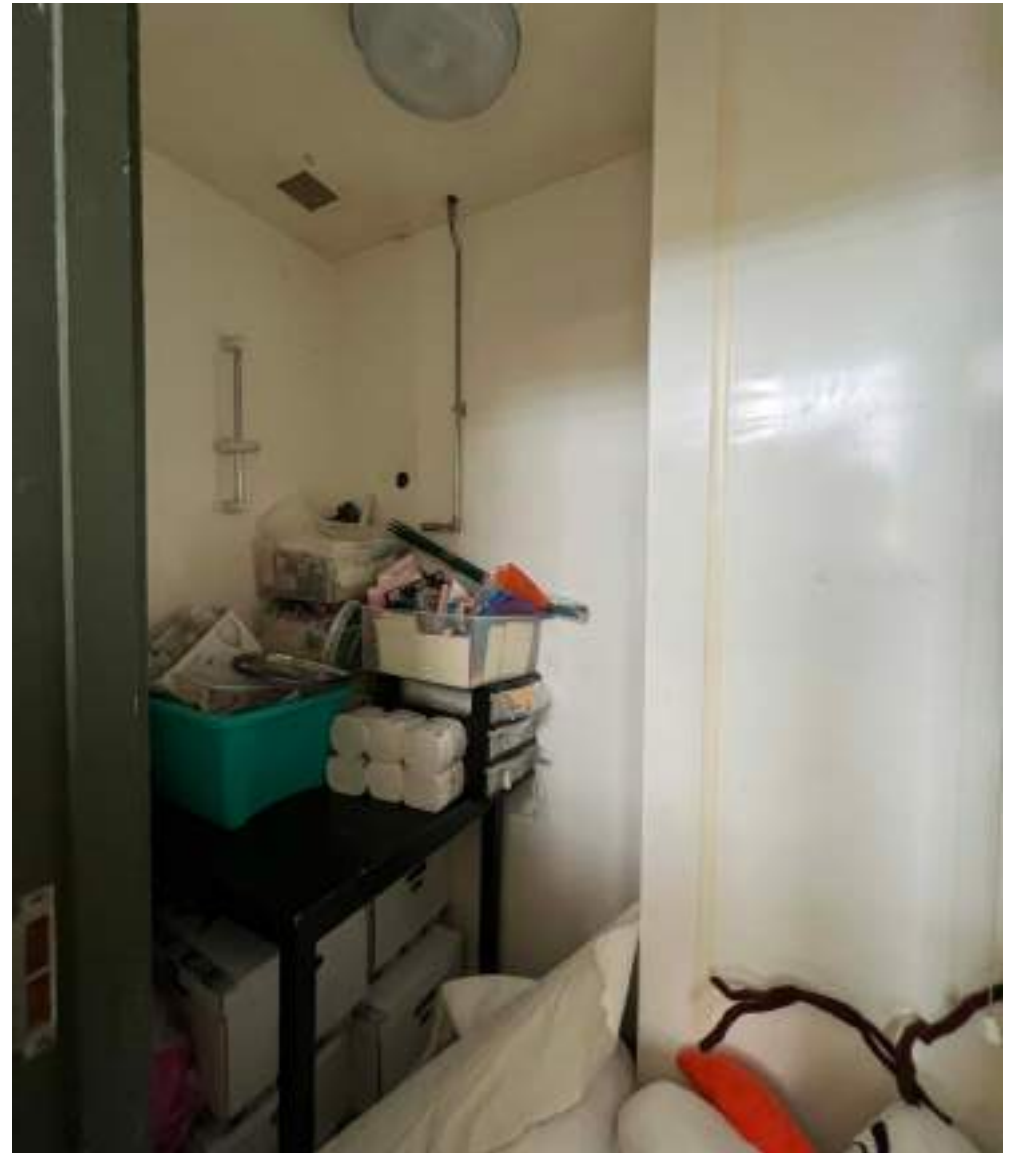
Accessed off the changing room is a shower cubicle, currently used as a storage room. The existing finishes and fittings all appear to be modern interventions with there being no visible historic fabric within.

Photograph 90: Modern finishes and sanitaryware

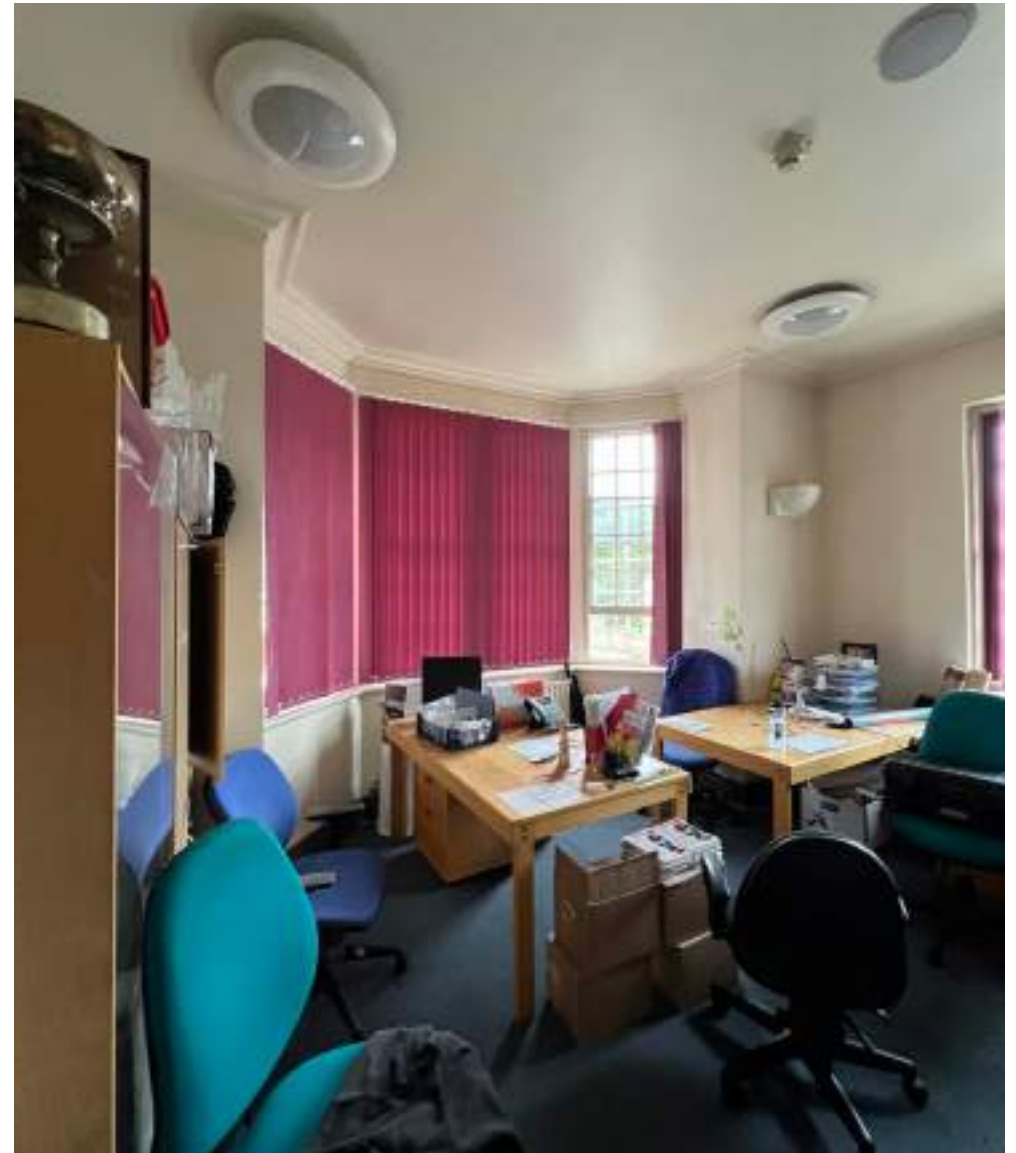
The existing meeting room is characterised by its bay window, which is presumed to be original fabric. Modern interventions within the room include: lighting fixtures and floor finishes. The most prominent historical features within the space include: the timber sash windows and cornicing to the perimeter of the room.

Photograph 91: Modern finishes and with original timber sash windows in bay

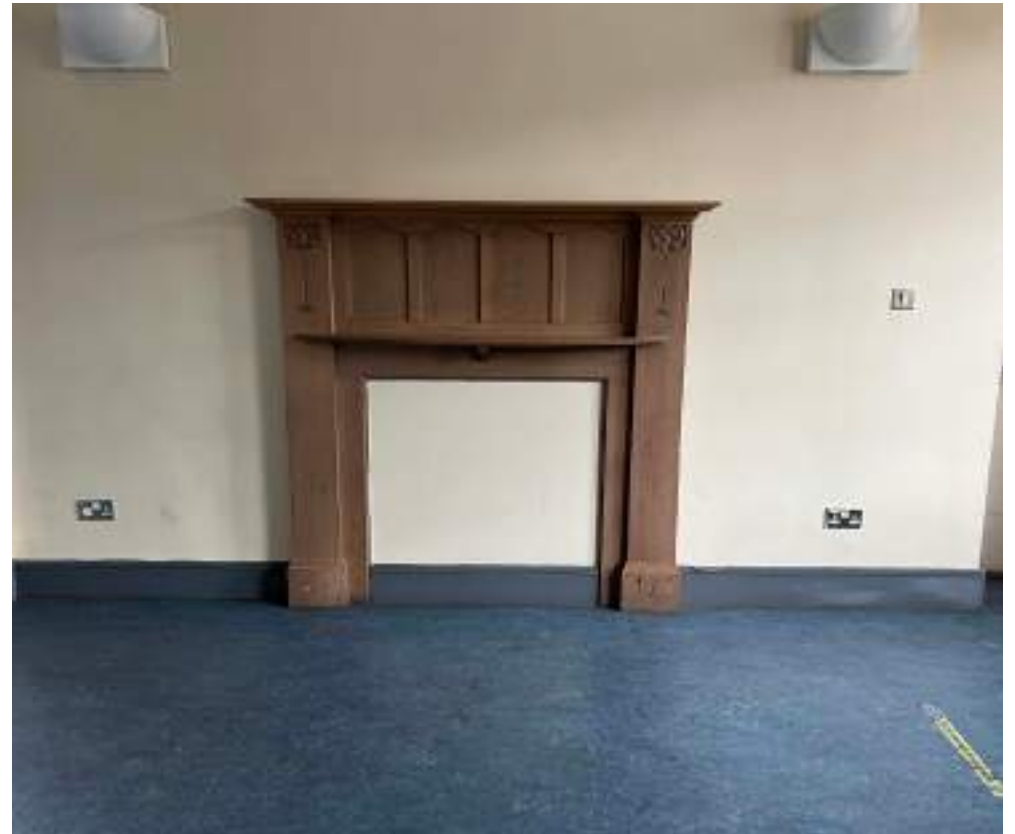
The multi-purpose room contains a few historical features, mainly the 2 No. fireplaces, cornicing around the perimeter of the room, and the 4 No. timber sash windows. Modern insertions in the space include: light fittings and wall finishes.

Photograph 92: Modern finishes generally with original fireplaces

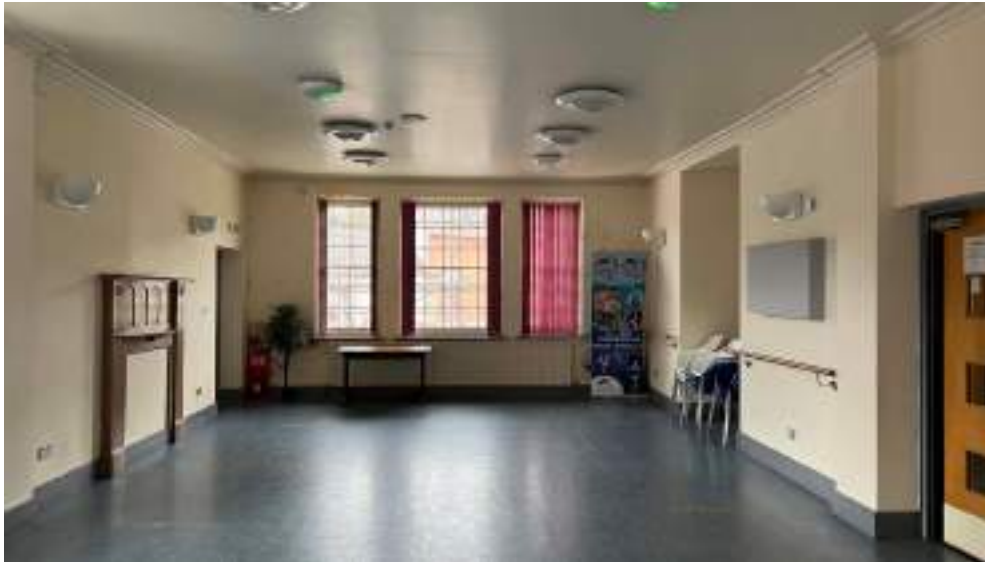
Photograph 93: Timber sash windows, fireplaces and cornice with modern doors

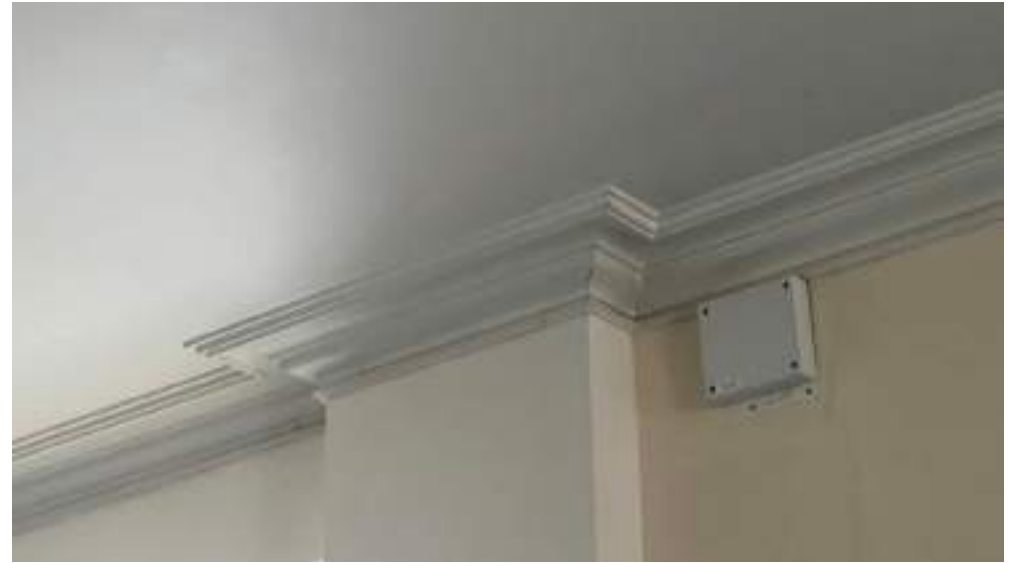
Photograph 94: Original plaster cornice

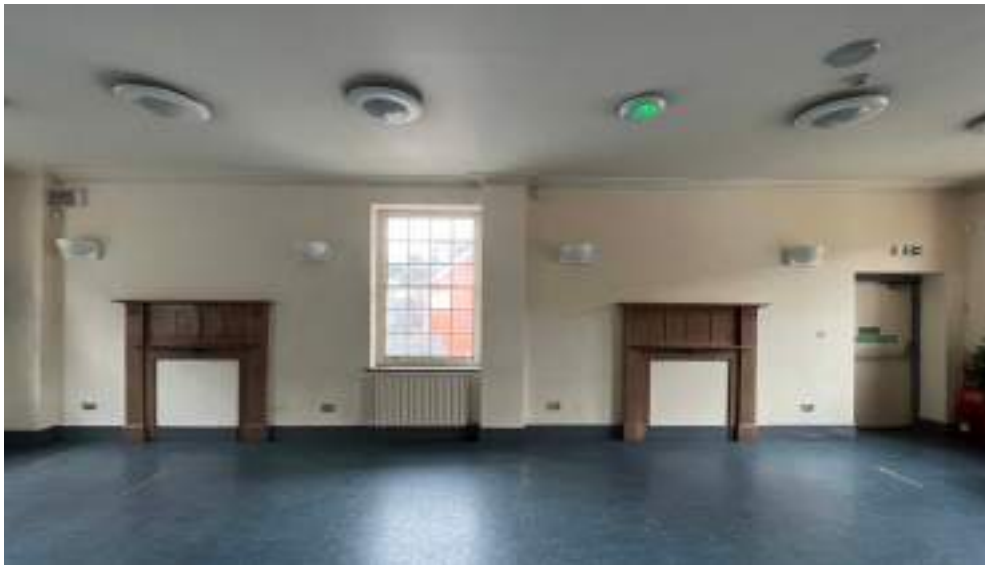
Photograph 95: Timber sash window and original fireplaces

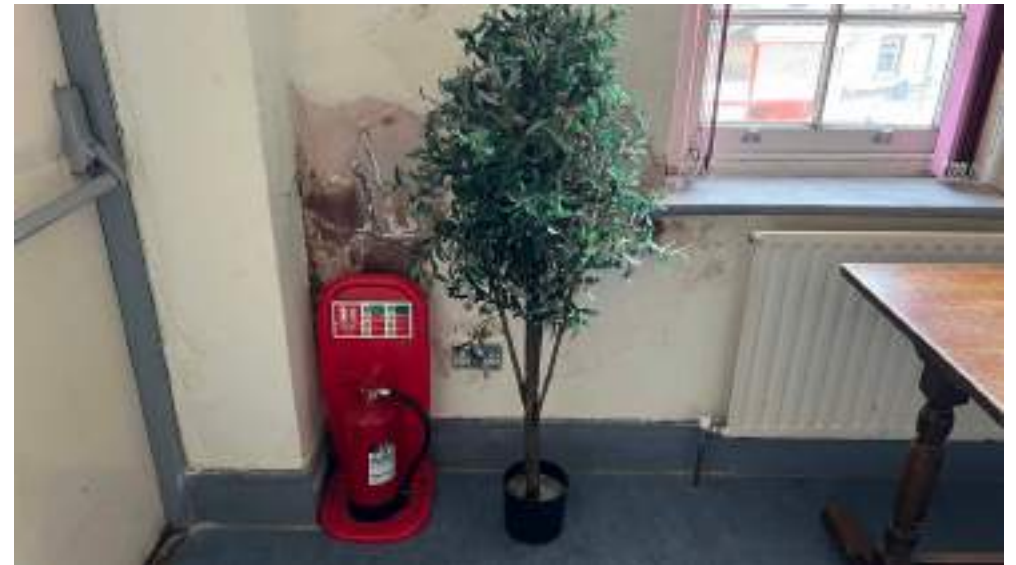
Photograph 96: Signs of significant water ingress from west facade

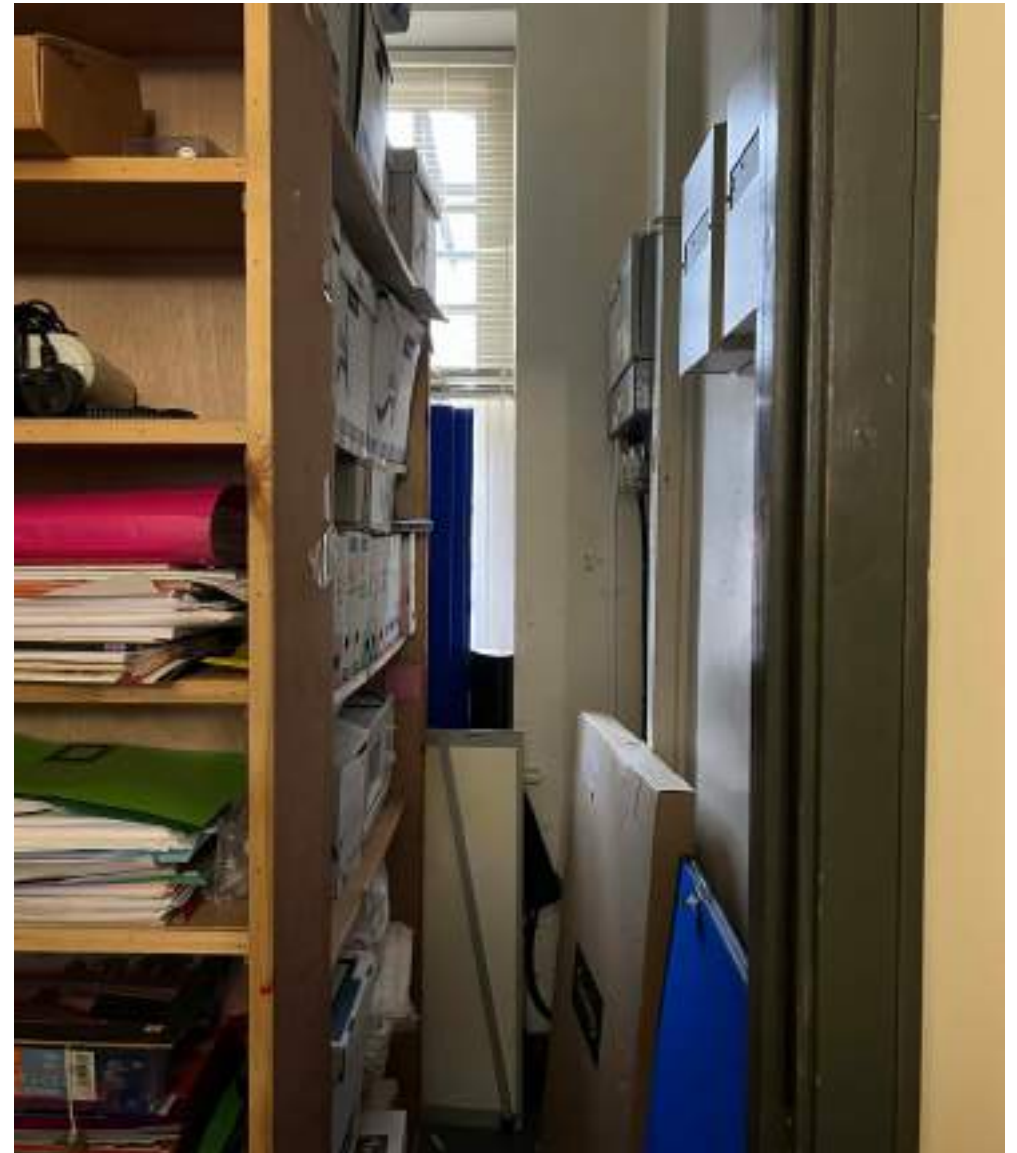
Located adjacent to the office space is a store room. Due to the fixed shelves constructed within the room it is hard to fully determine if there are any historical features within the room, although from inspection it appears to contain no historic fabric.

Photograph 97: Modern shelving with sash window behind

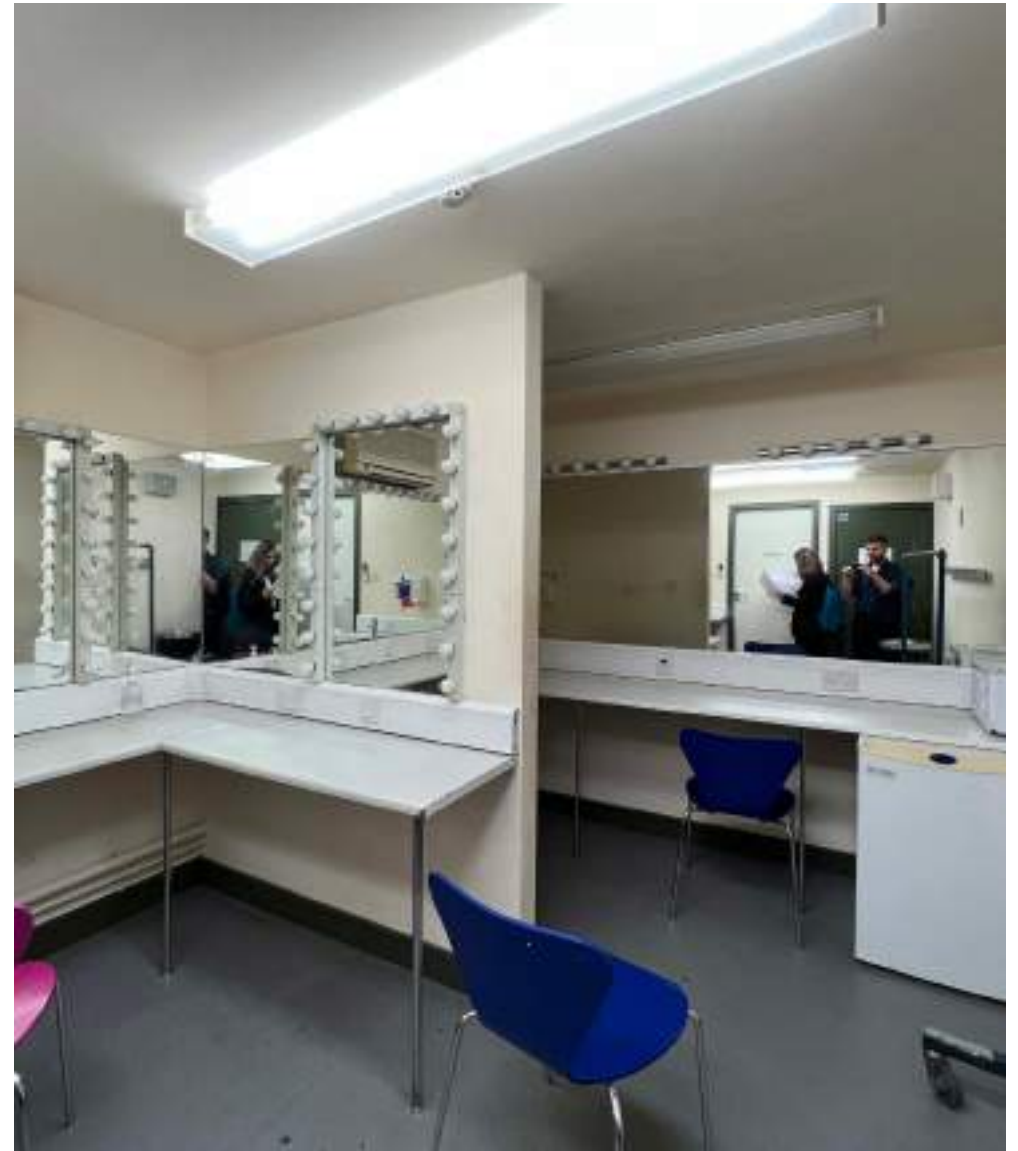
Generally, the first floor dressing room contains no historic features with all light fittings floor finishes, wall finishes and fixed furniture being modern insertions.

Photograph 98: Modern fixtures and fittings throughout

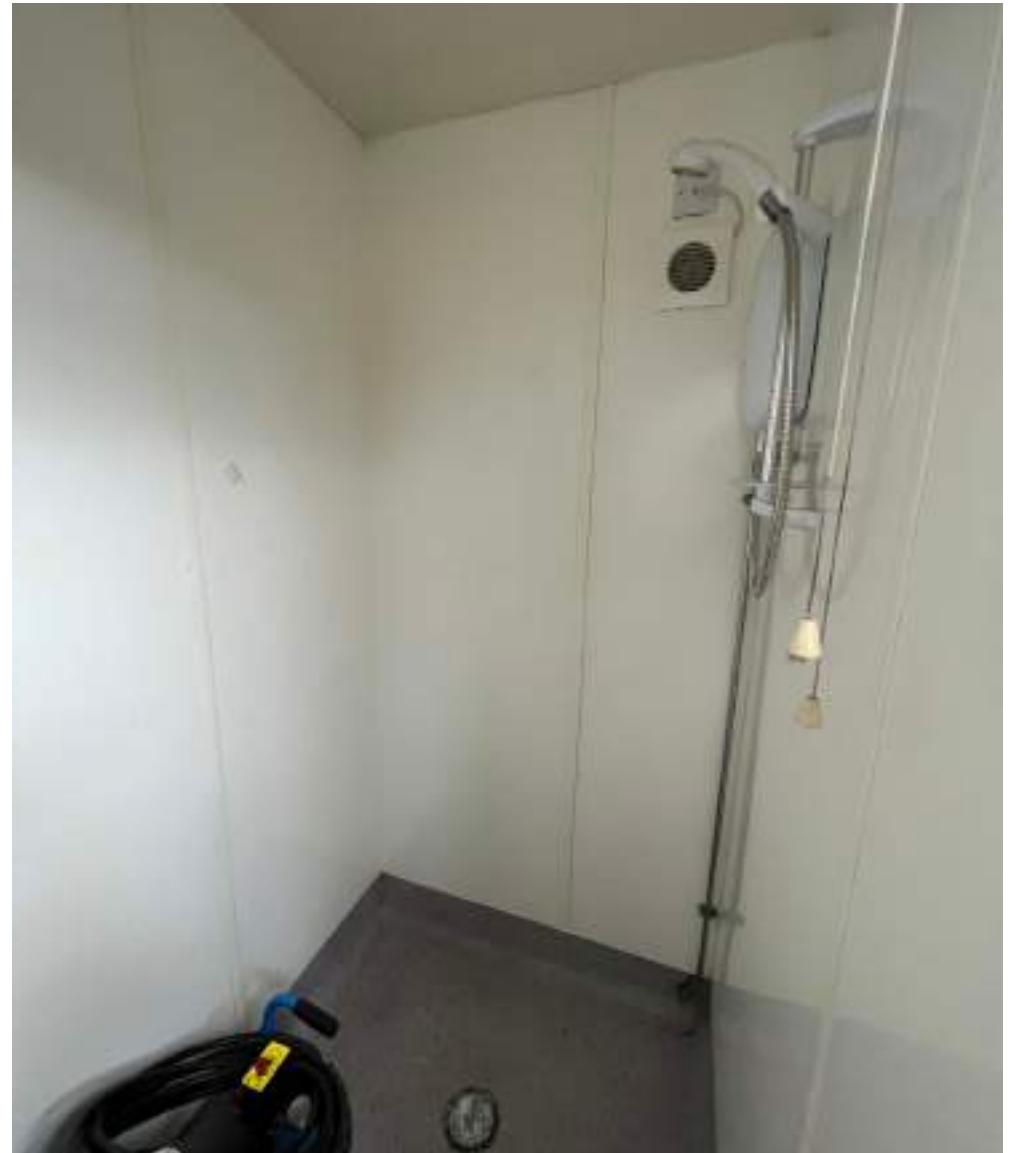
In close proximity to the first floor dressing room is a shower cubicle. Much like the changing room there is no visible evidence of any historic fabric. All floor finishes, wall finishes and fixtures within the room appear to be modern interventions.

Photograph 99: Modern finishes and sanitaryware

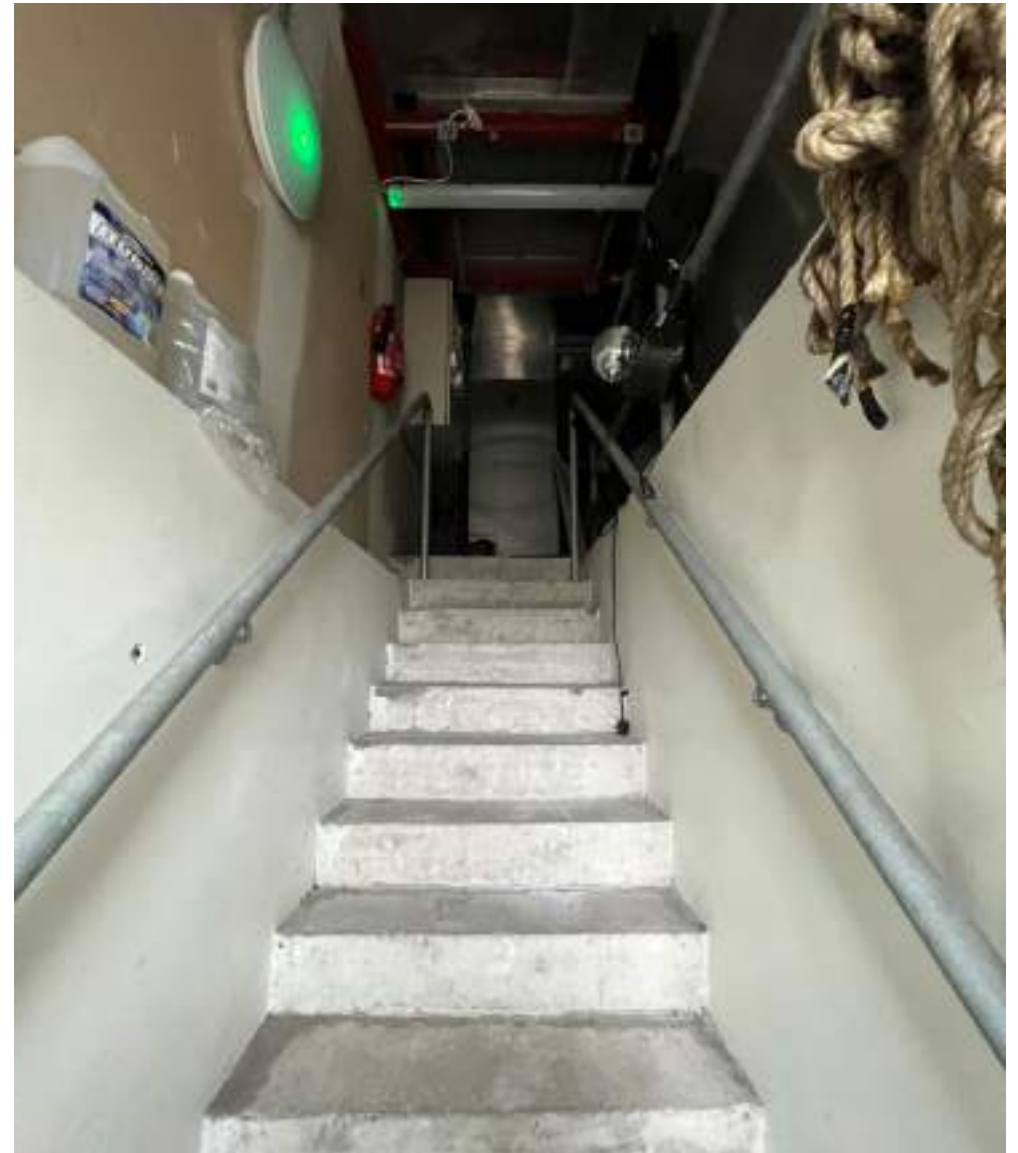
Leading up to the plant room is an existing modern staircase. There is no visible historic fabric within this area.

Photograph 100: Modern staircase

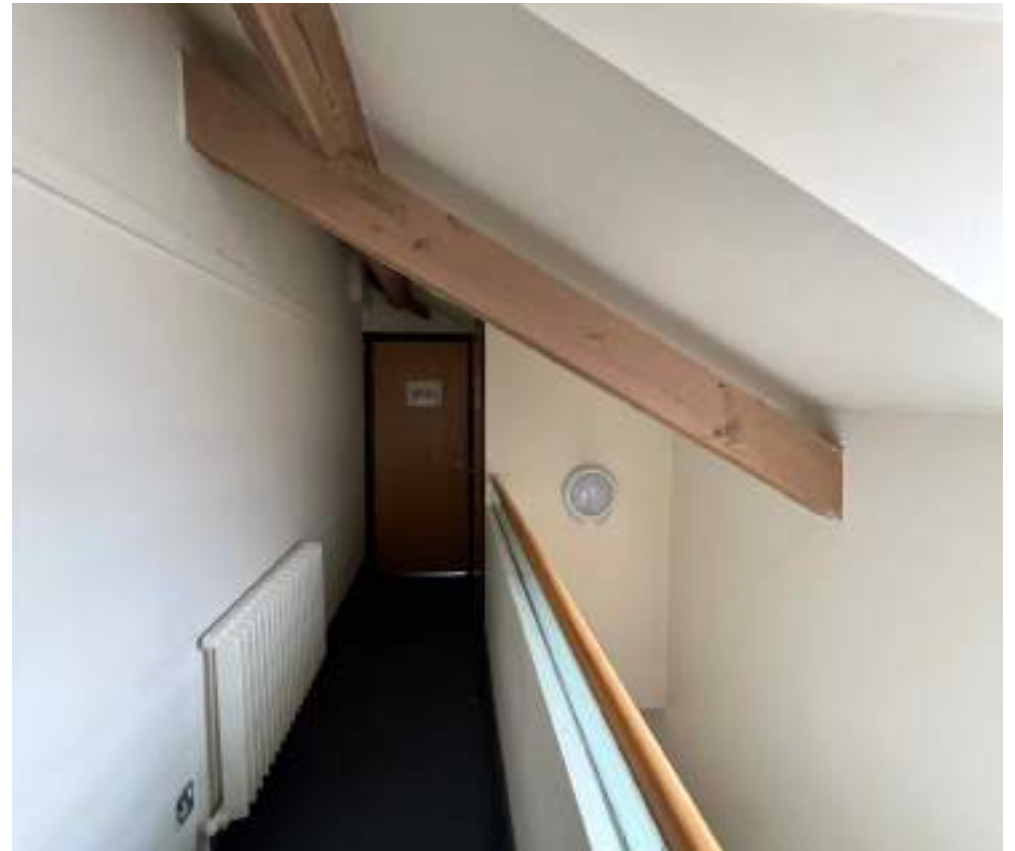
On the second floor landing there are only a couple of historical features, including: the timber sash window and visible supporting timber roof beams.

It is not clear whether the current stair is a replacement of the original stair or whether the original stair was in another location but the everything that is currently within this stair core is 1990's in age.

Photograph 101: Modern stair case with original timber roof structure exposed
