## 4.1 Photographic Record - First Floor

SECOND FLOOR PHOTOGRAPHS

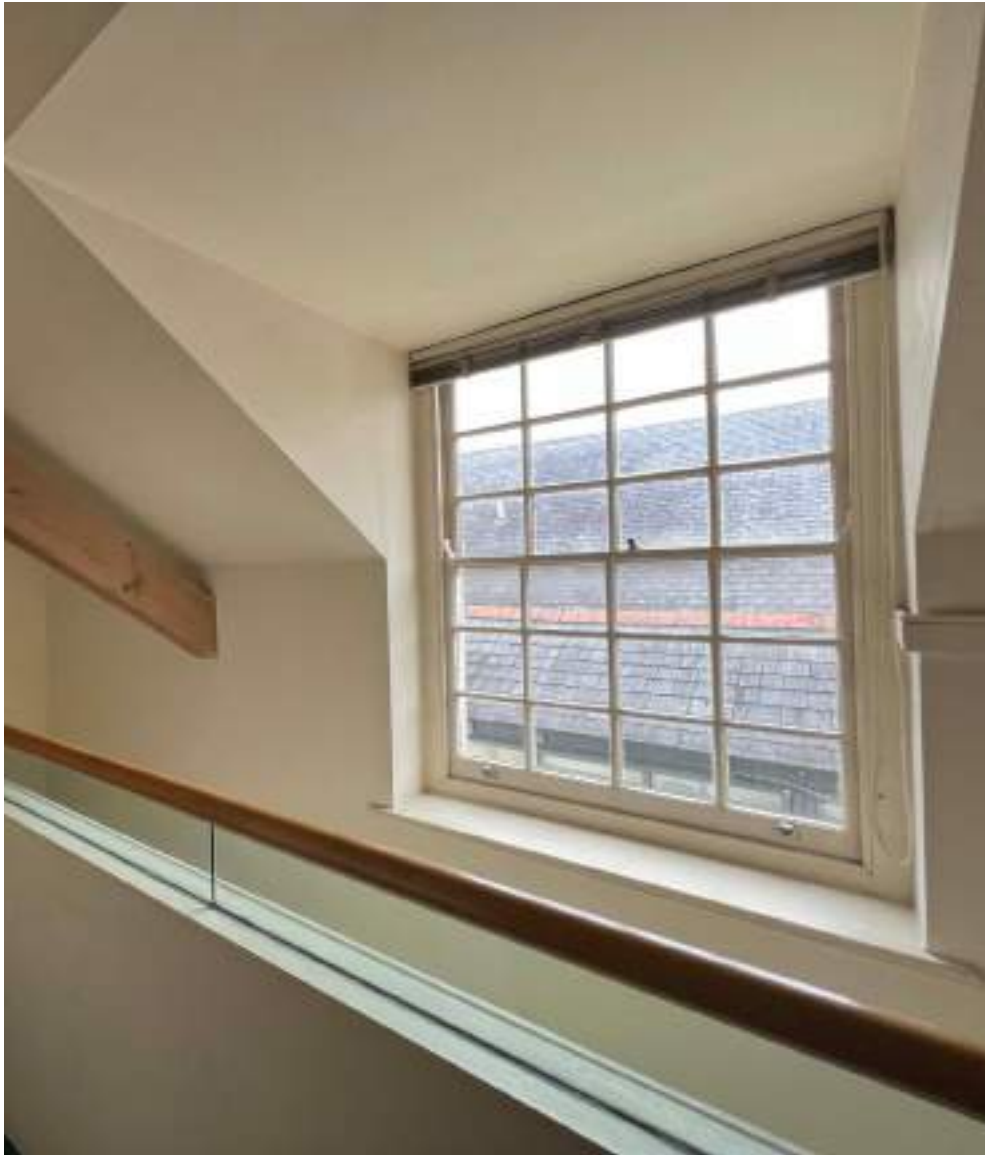
Photograph 102: Original timber sash window

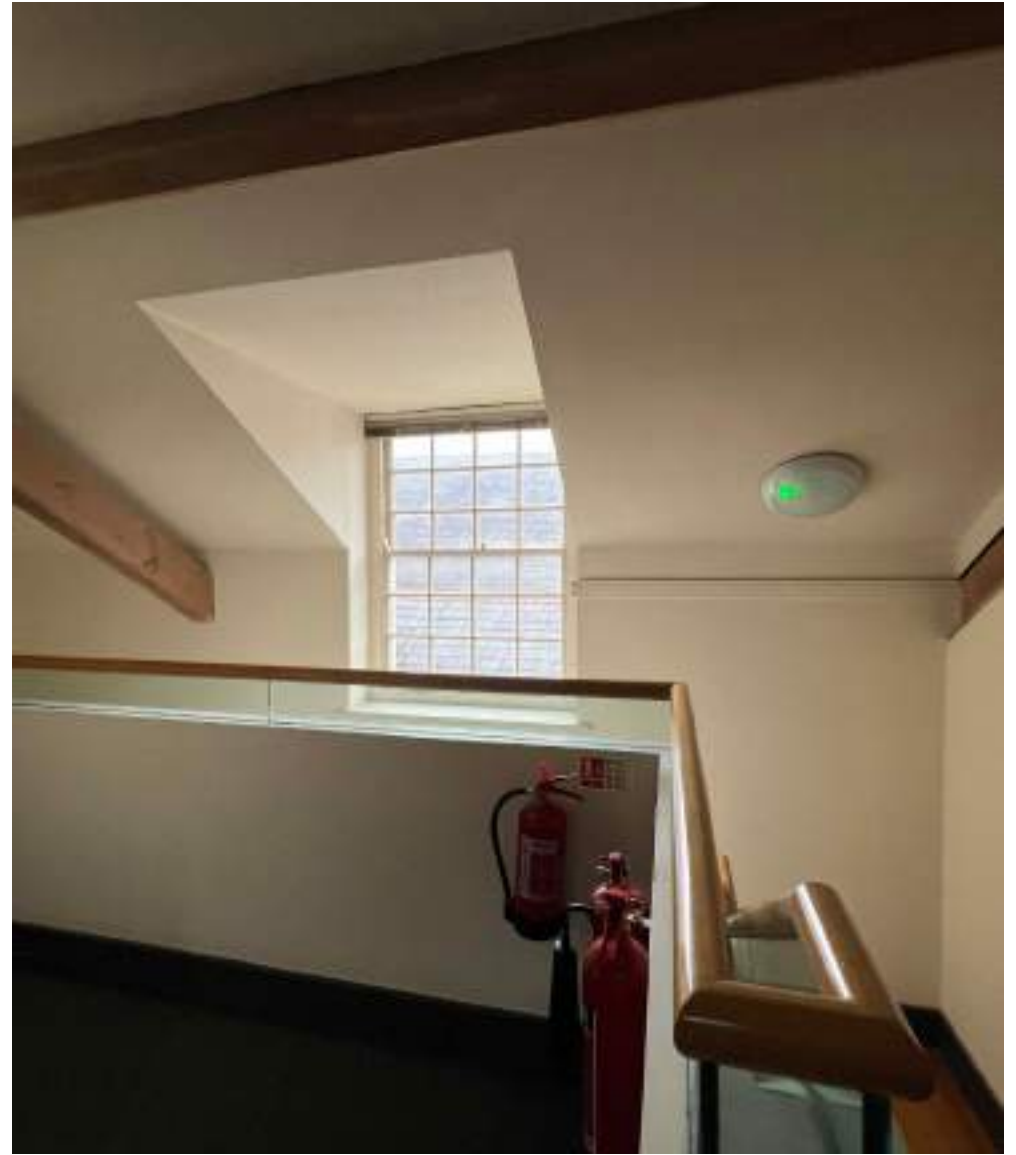
Photograph 103: Original timber sash window

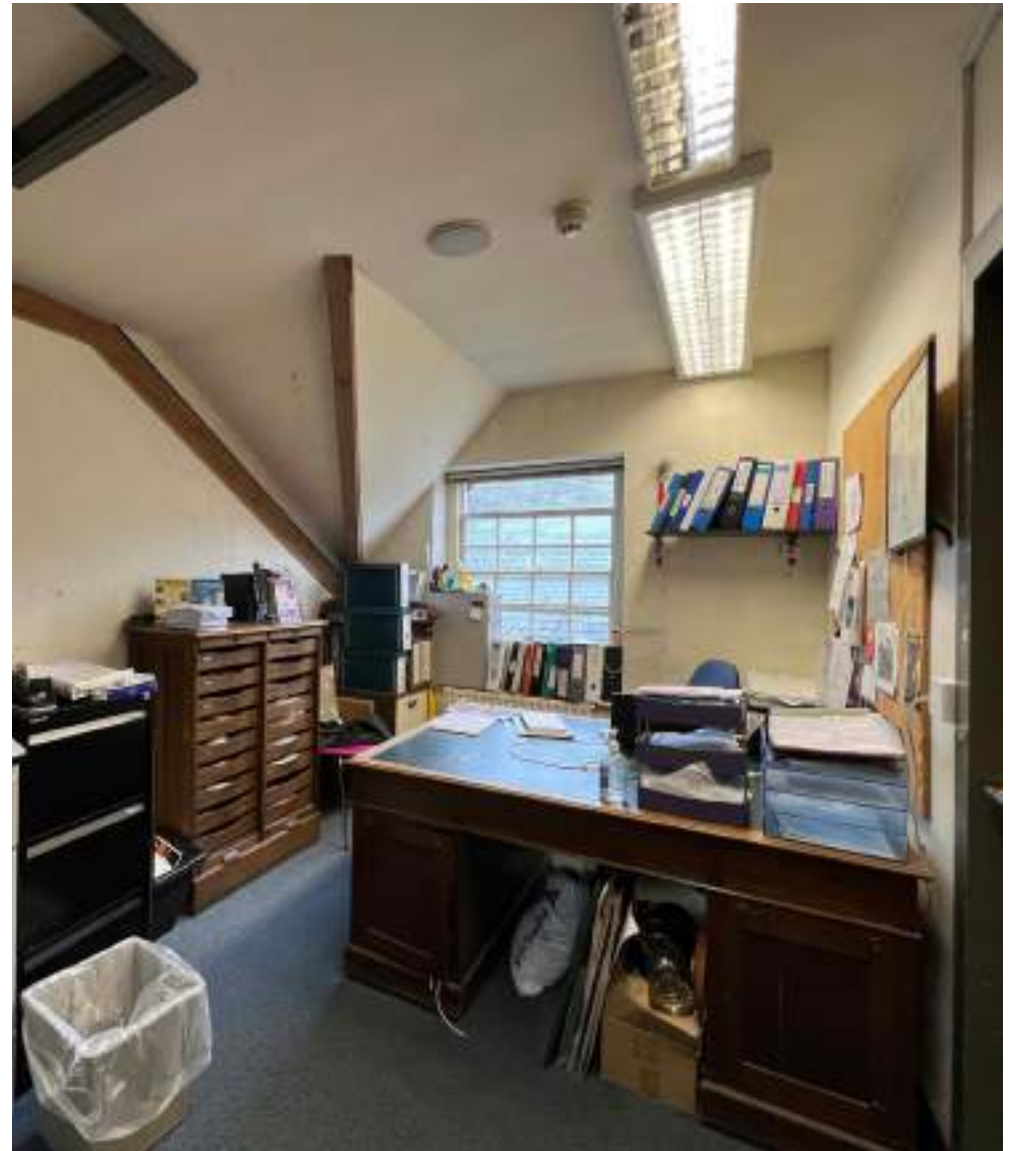
The office space is characterised by the roof form above, with the chamfered corner and expressed timber beams appearing to be original features. The existing timber sash window also appears to be an original feature. Other finishes and fittings within the space are likely more modern insertions.

Photograph 104: Timber sash and exposed roof structure

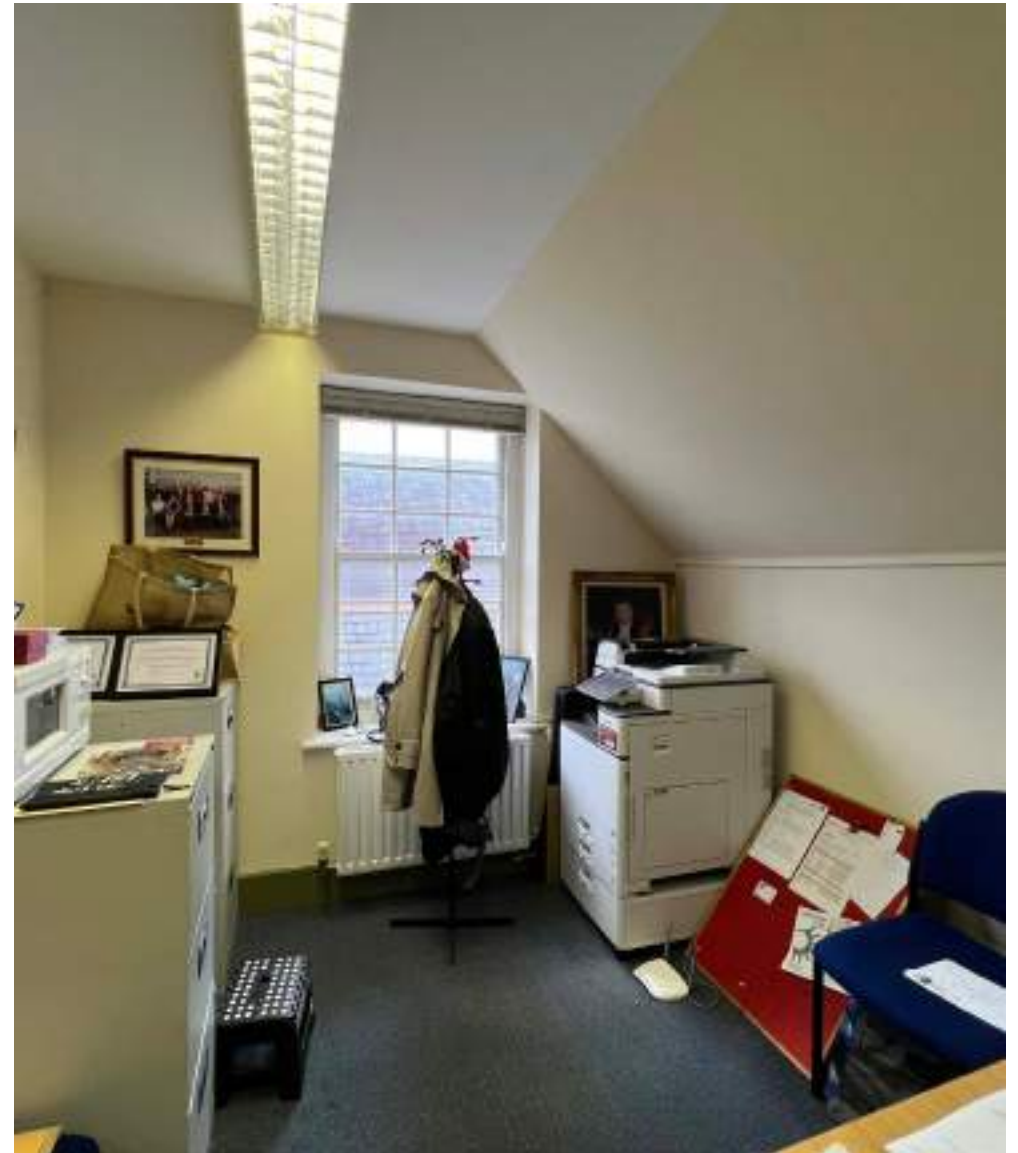
The smaller office space contains little historic fabric, with only the timber sash window appearing to be original.

Photograph 105: Timber sash window with modern finishes

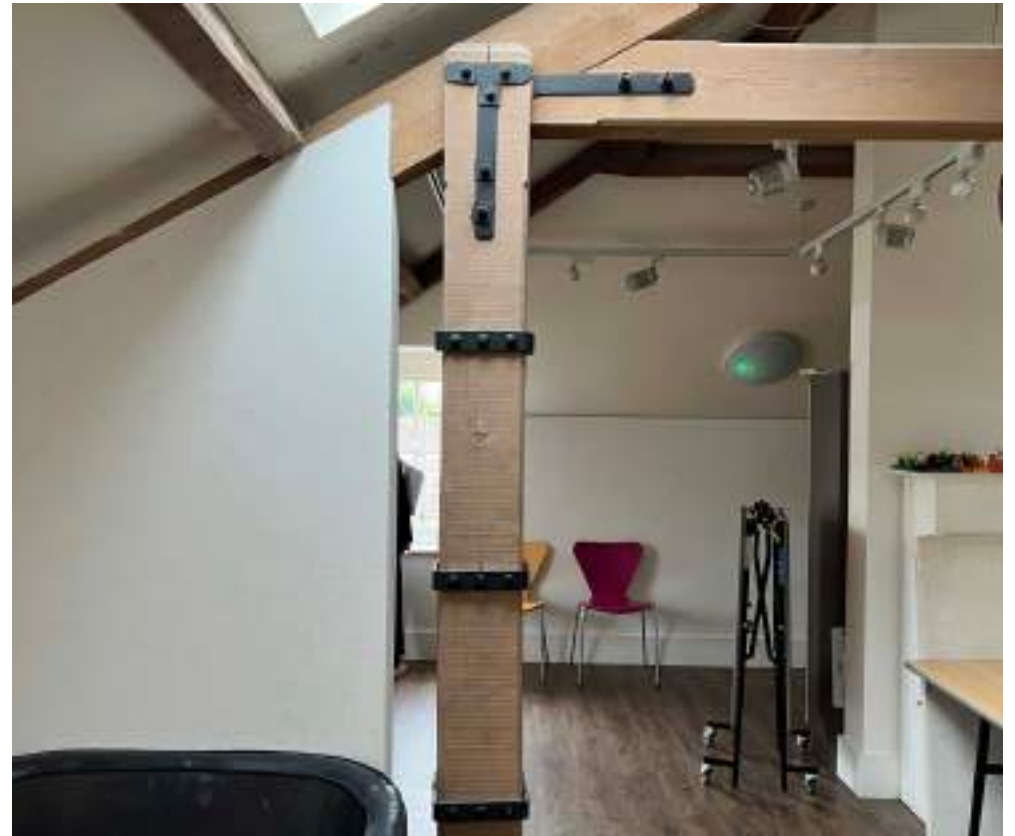
The gallery space on the second floor contains a few notable items of historic fabric. These include: the A-framed timber roof beams, supporting timber columns, and timber sash windows. The rooflights, lighting, flooring and glazed internal walls appear to have been modern interventions.

Photograph 106: A-framed timber roof trusses with black metal bolted straps

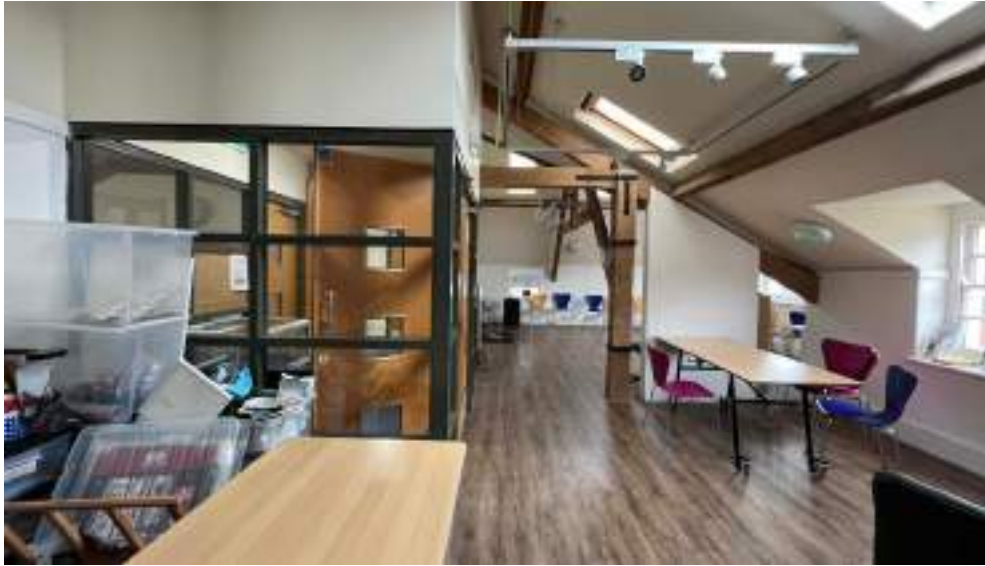
Photograph 107: Modern finishes with timber framed internal glazing

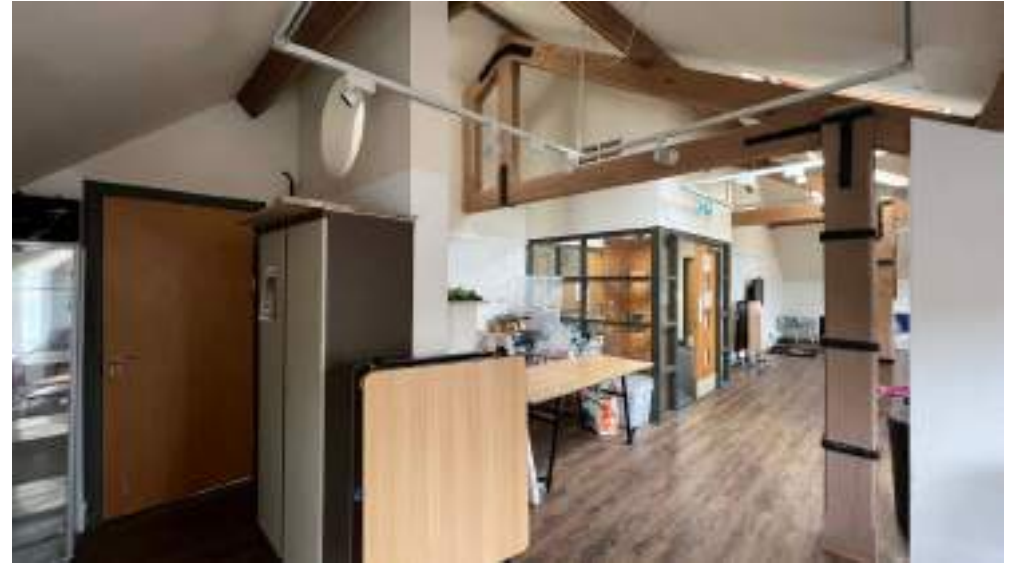
Photograph 108: A-framed timber roof trusses and modern stud partitions

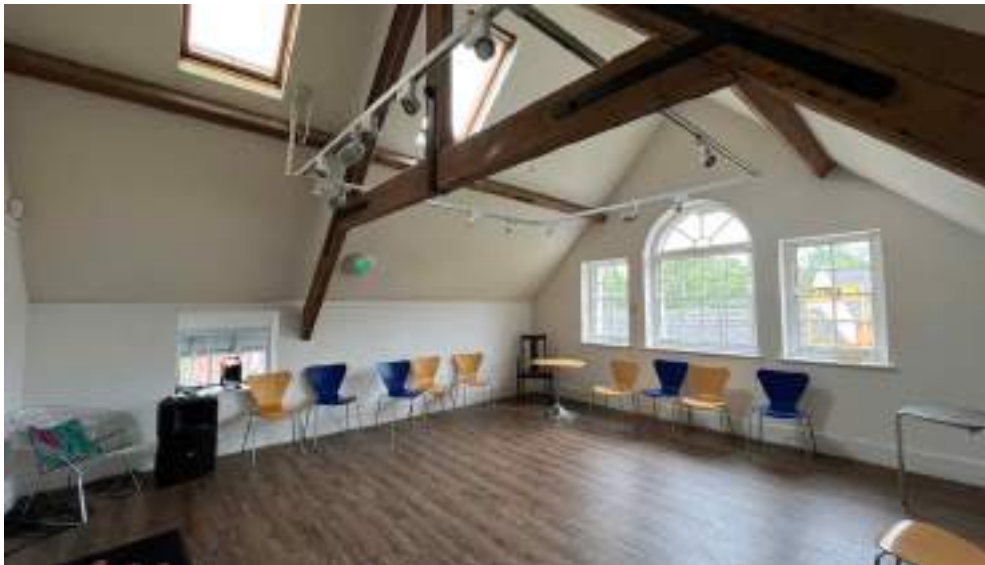
Photograph 109: Original timber sash windows and central arched window

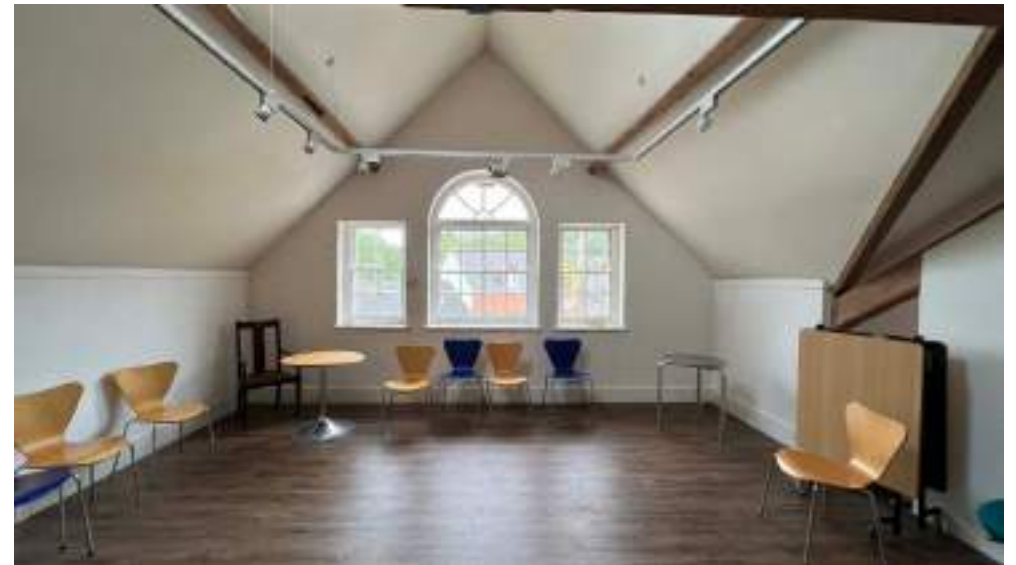
Photograph 110: Original timber sash windows and central arched window

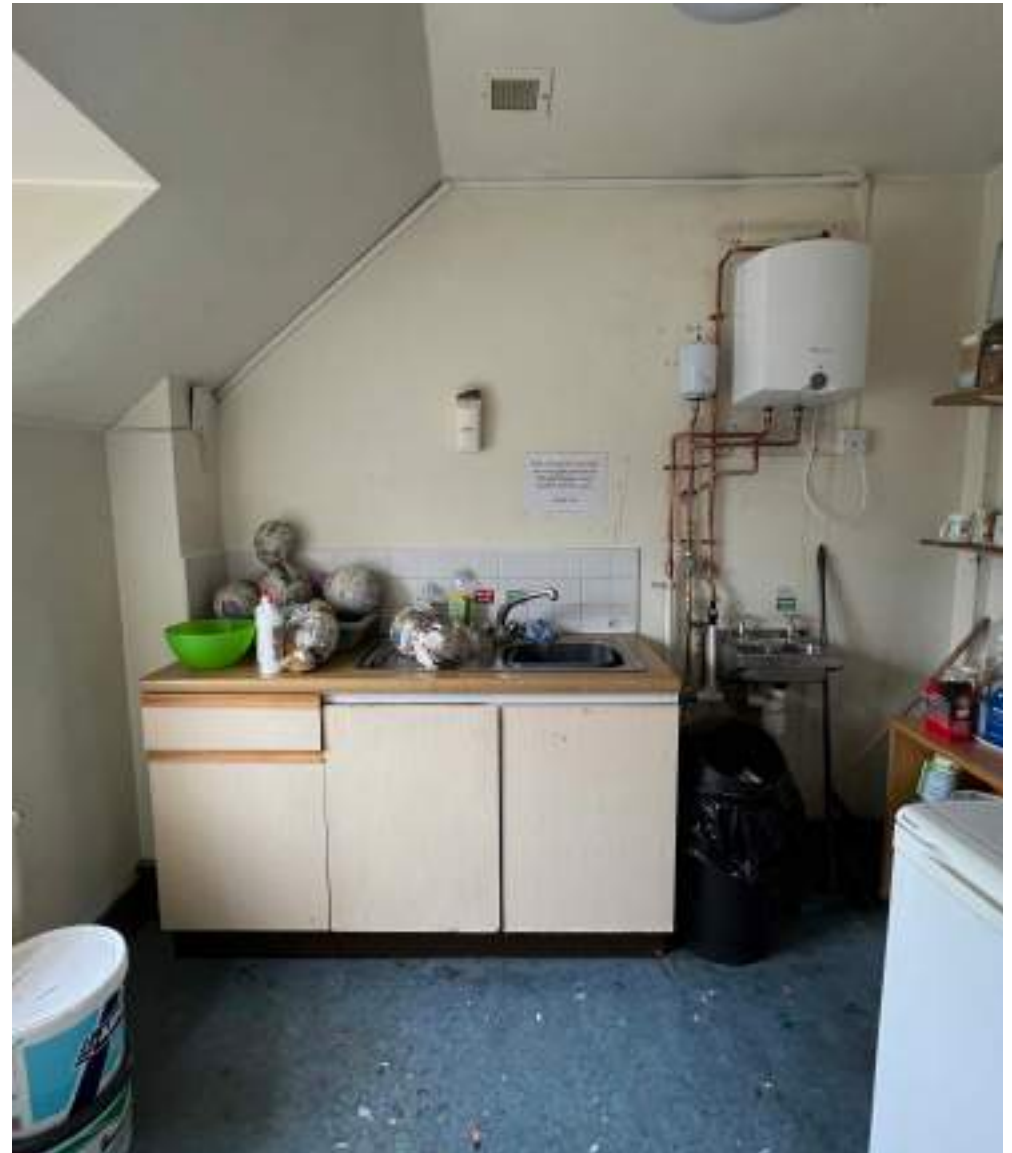
Access off the second floor gallery is the second floor kitchenette. Within this space there are limited historical features, with the flooring, wall finishes and kitchen furniture all appearing to be modern installations that pre-date the 1996 conversion.

Photograph 111: Mid-20th century kitchen fittings

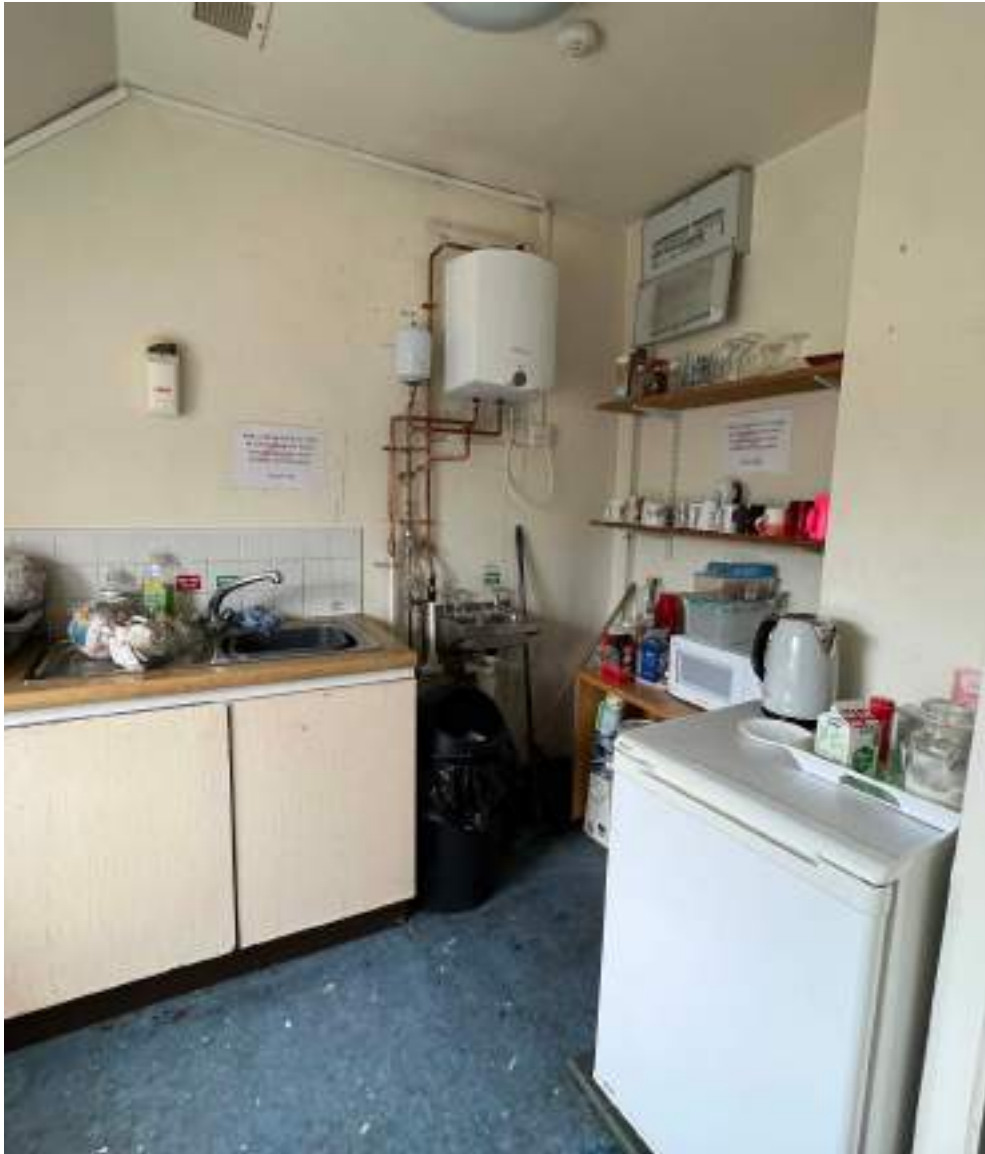
Photograph 112: Mid-20th century kitchen fittings

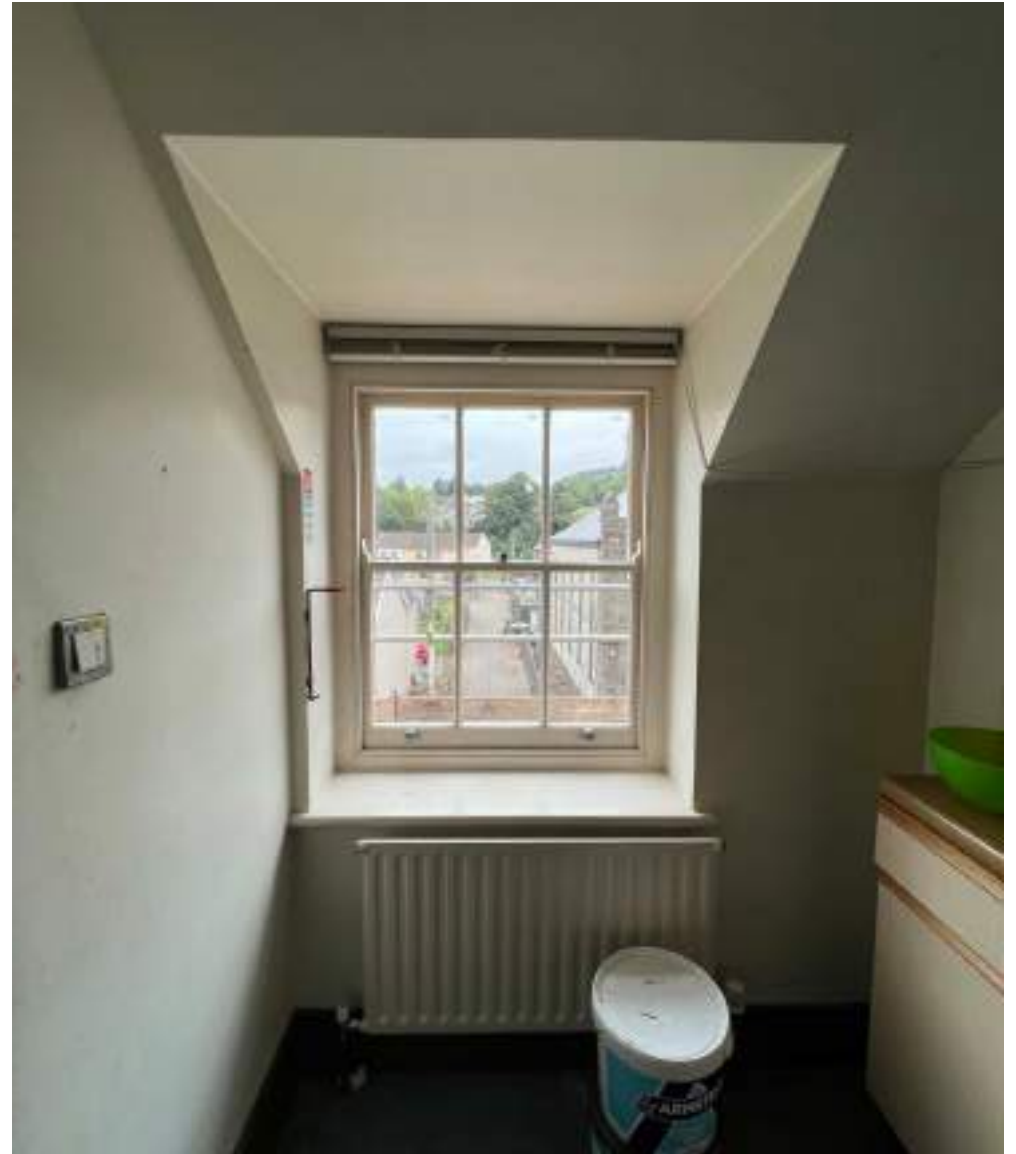
Photograph 113: Timber sash window

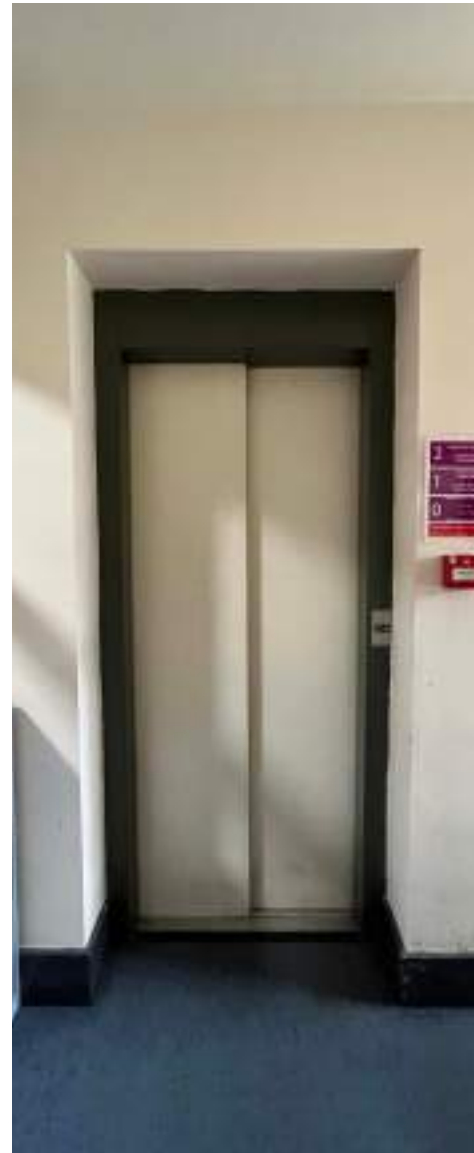
Connecting the ground floor, first floor and second floor is an existing lift. A provision for a lift would not have been viable within the original building proposals, therefore it is safe to assume that it is a modern insertion, containing no historic fabric.

Photograph 114: 20th century lift

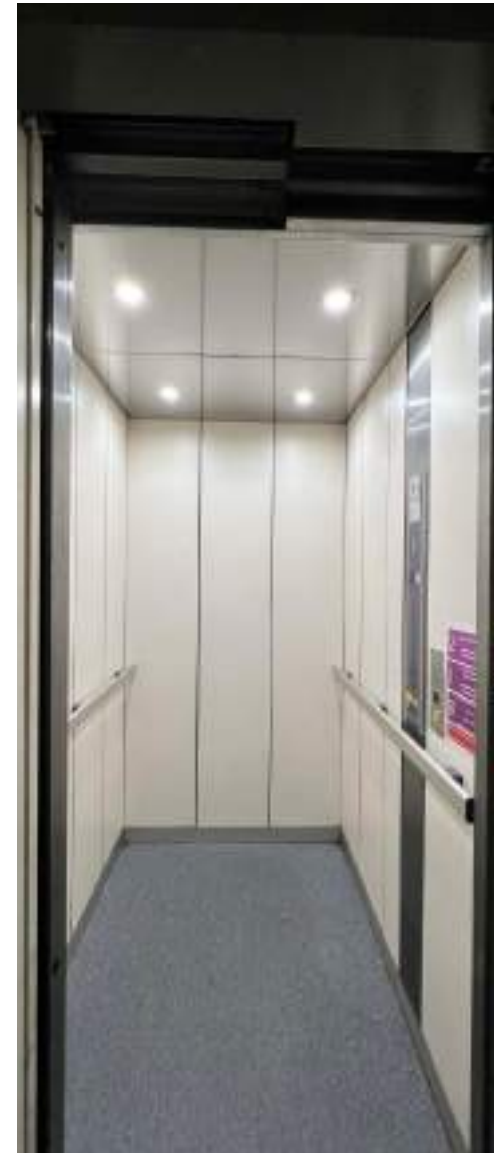
Photograph 114: 20th century lift - interior

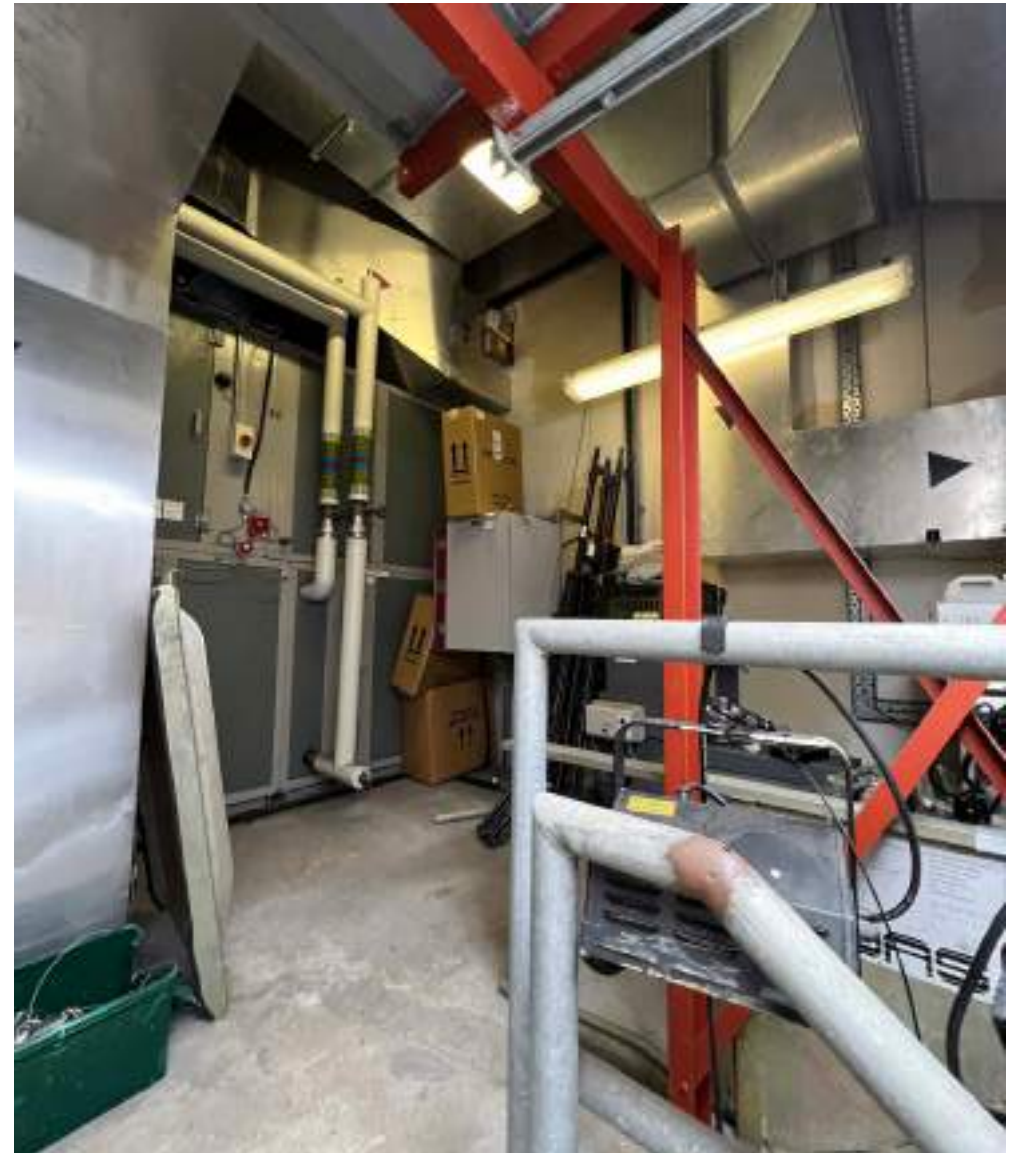
The existing plant space shows no visible evidence of any historic fabric.

Photograph 115: Modern plant installation
