Our Reference: 15857 / 70434

### **RE: Beech Tree on Rear Garden Boundary.**

Photograph Appendices: 1 St Catherines Court, Baglan.

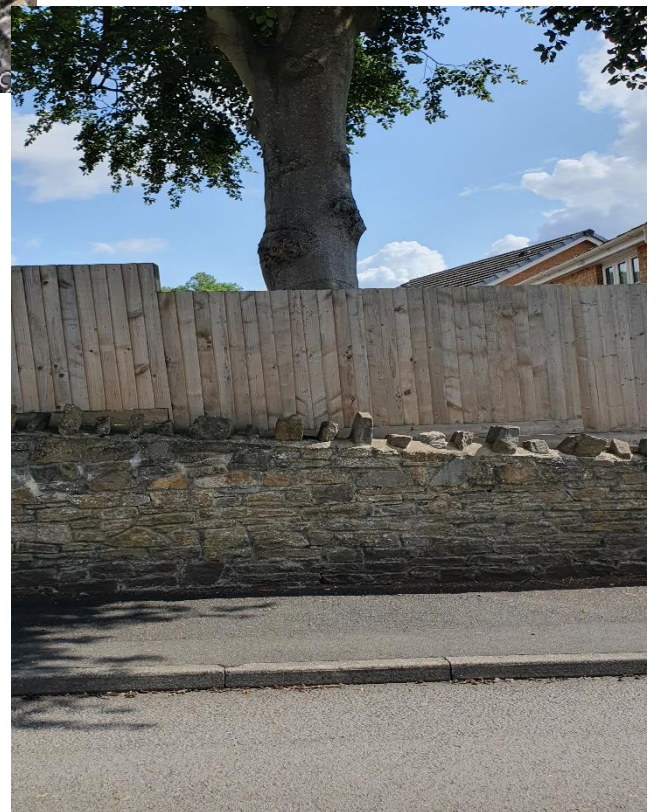
The tree is situated in an elevated position on the western boundary with an historic and substantial retaining wall to the west which is showing evidence of cracking and bulging immediately adjacent to the tree. A close board fence has been installed on top of the wall to provide private rear garden space to the property (Photograph 2).

Photograph 2. Boundary wall and Fence

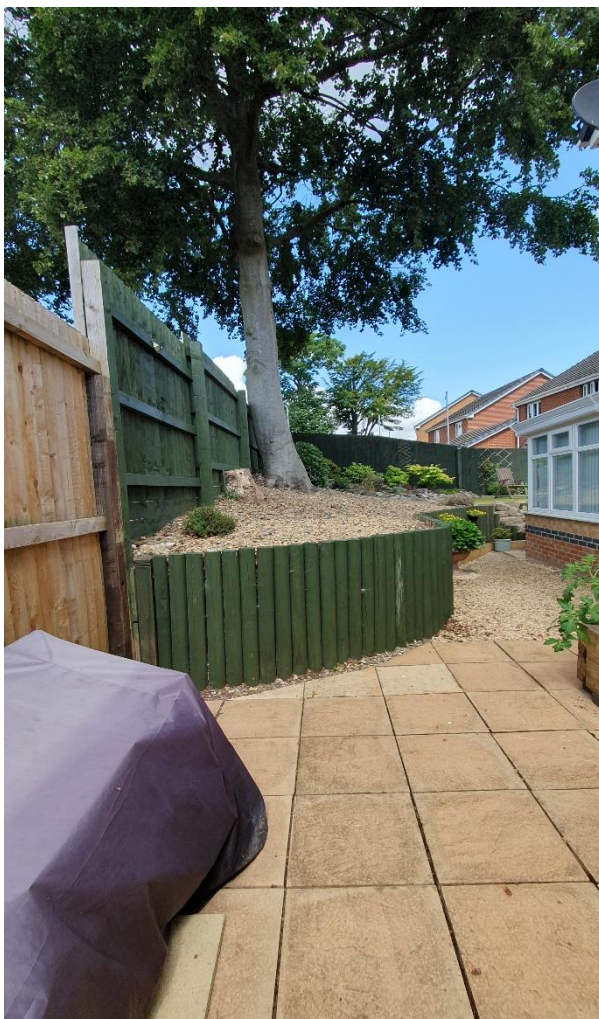
The area around the tree is covered in gravel and you stated that nothing appears to grow, with new, healthy plants dying within a few months of installation despite you providing suitable care (photograph 3).

Photograph 3. Raised gravel area around tree.

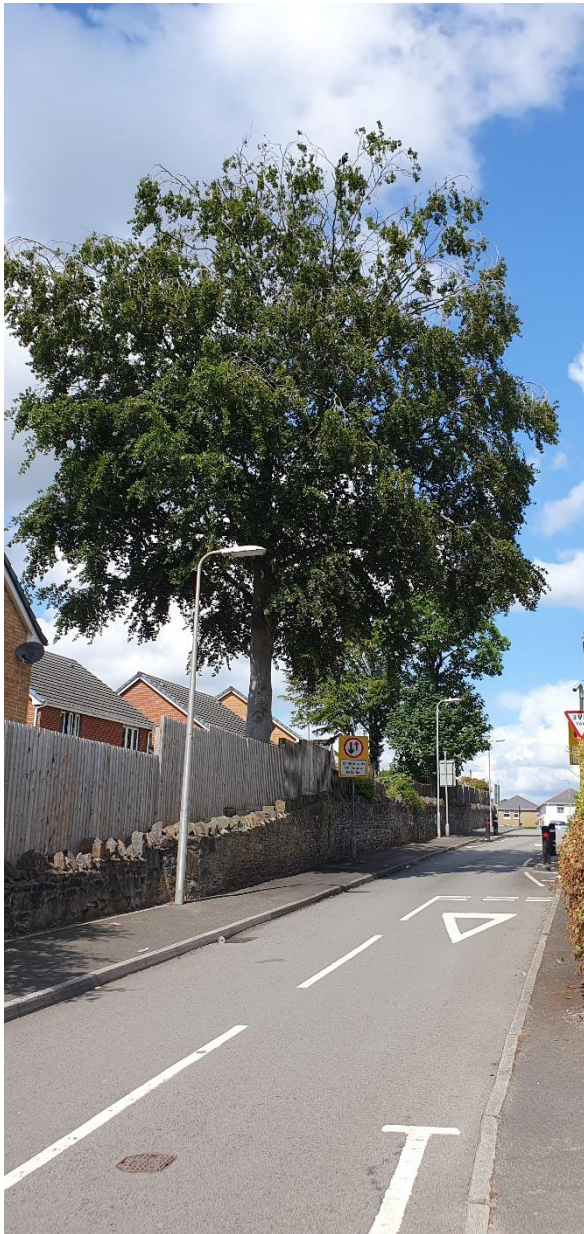
The tree's Physiological Condition is fair but declining, as the upper crown is thin with a secondary crown forming 3-4 metres below the outer edge. The distance between leaves (internodal distance) is reduced and clumps at the branch ends have upturned growing points often associated with declining vitality and infection by *Necteria*, sp. which results in the death of small twigs (Photograph 4). Leaf size and colour remain good, but you confirmed that the tree is shedding a fairly continuous stream of small twigs and deadwood.

It is clear that the tree is of deteriorating condition and vitality. Continuous twig shedding, slow wound closure, reduced internodal distance, increased seed production and upturned growing points all support this.

Photograph 4. Tree with declining crown condition (Viewed from north)

Fell tree to ground level. Install suitable replacement/s no closer than 1.5 metres from the boundary wall.

The tree should be removed within 12 months.

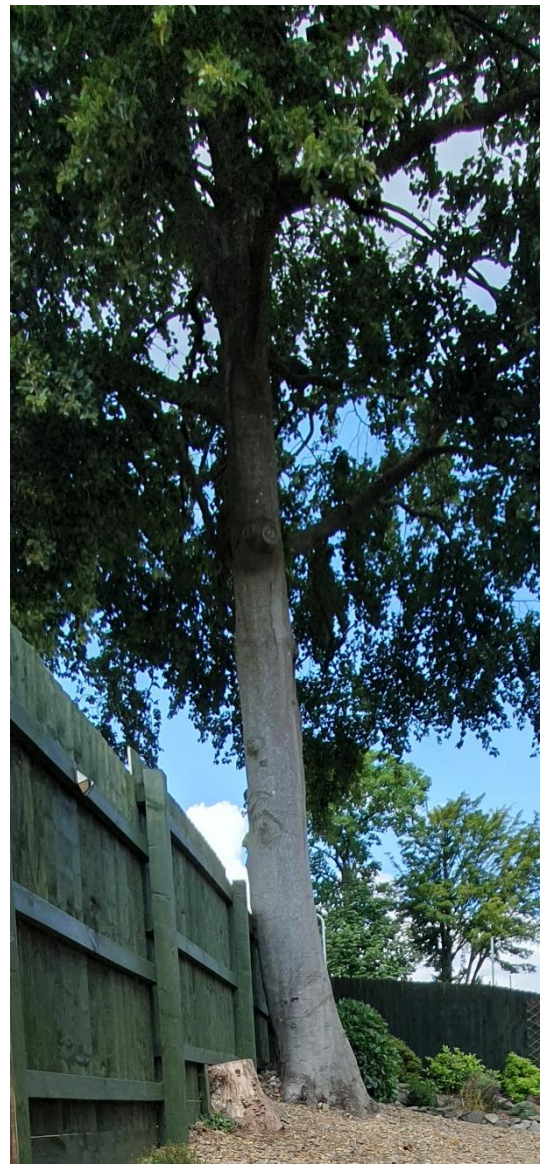
The trunk leans gently to the west and contains a number of fully occluded old pruning wounds low down on the trunk. A larger and more recent pruning work slightly higher up is again showing evidence of slow wound closure and early stages of decay which does not appear significant to safety at this time. The uniform taper of the trunk starts to flair at around 1.2 metres and broadening towards the base (Photograph 5).

Photograph 5. Trunk with decaying pruning wound and slow wound closure.

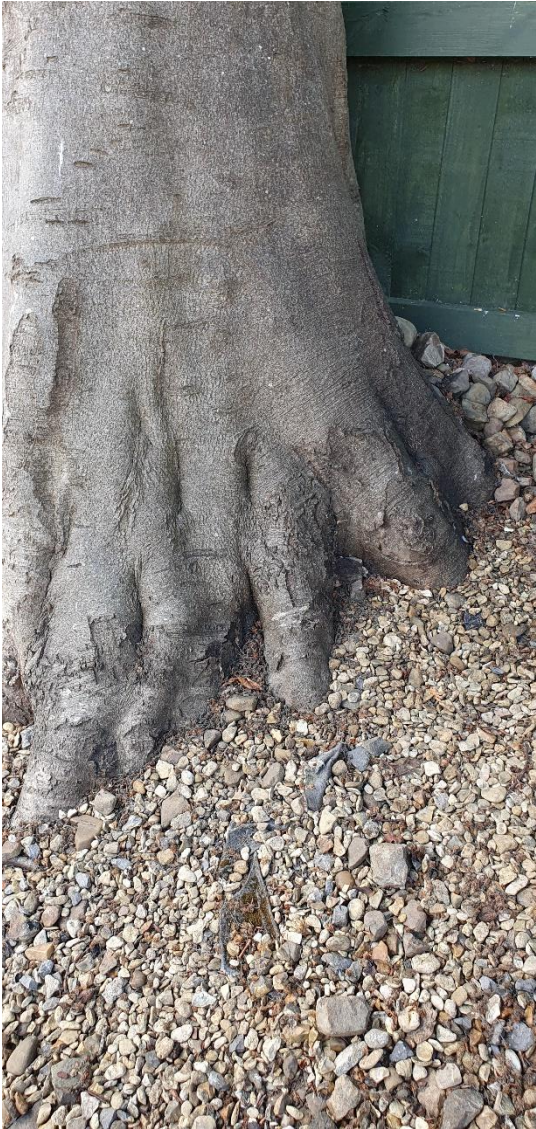
Although there are larger buttress roots at the base of the tree these are not well defined, with reaction growth developing between the natural buttress roots (Photograph 6). An area of dead bark was located at ground level on the south side which, when removed, indicated a white fungal mycelium and soft, wet white rot which extends around 150mm. No fungal fruiting bodies were present but the type and position of decay would be consistent with the tree being colonised with Honey Fungus (*Armillaria*, sp.) (Photograph 7).

As indicated above, the Beech has already been colonised in its south side at ground level with dead bark and initial stage of decay being present. Given the production of reaction wood between the buttress roots, it is likely that the decay is more advanced than seen at the time of the survey possibly occupying a larger proportion of the trunk's cross section at ground level.

Photograph 6. Buttress roots with reaction growth (North east side)

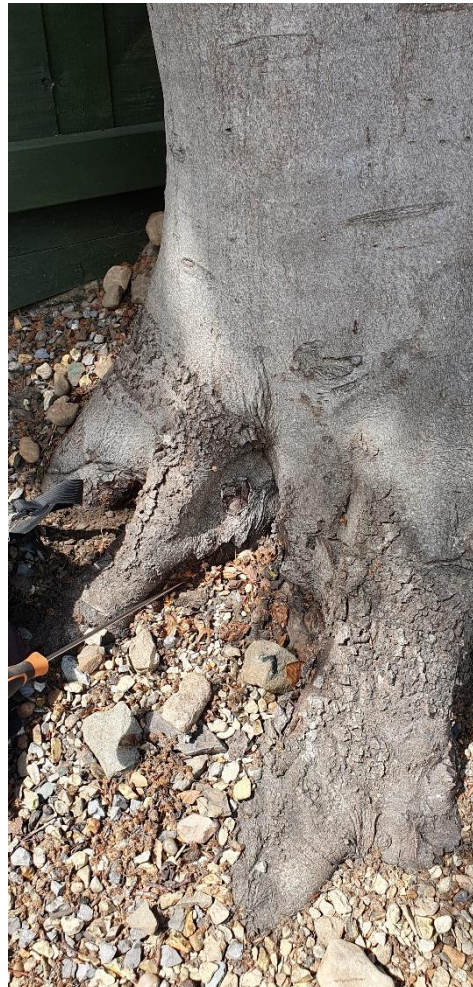
Honey Fungus, which has the capacity to be actively parthenogenic (being able to enter a living tree through its own volition). It is a pathogen which causes a simultaneous white rot of the roots and lower trunk, it actively kills live tissue and results in reduced vitality and eventual death and/or windthrow of the tree.

Photograph 7 Dead bark and basal decay on south side.
