**LanzaTech UK Limited**

**Project Dragon – Sustainable Aviation Fuel  
(SAF) Production Facility:  
Temporary Construction Area at Margam  
Wharf**

**Ground Investigation Report**

| ISSUE RECORD | | | | | |
|---|---|---|---|---|---|
| Report Reference: 2111006.006.02 | | | | | |

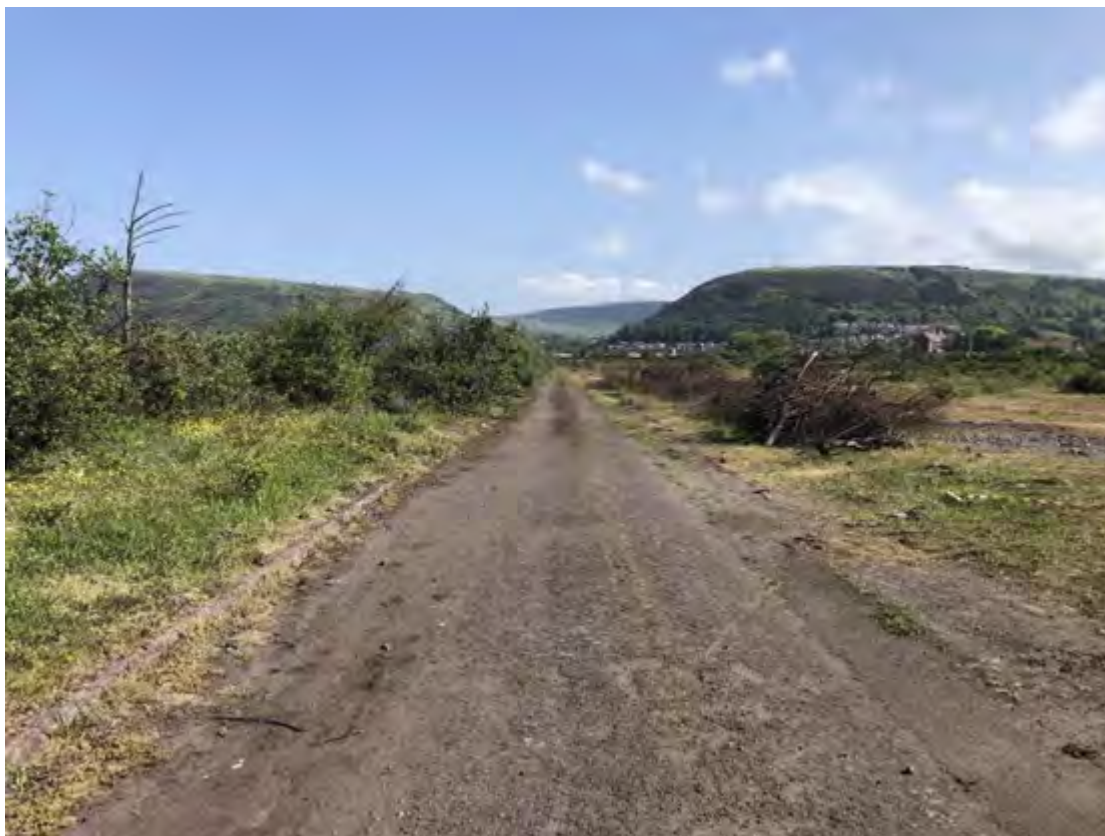
Photograph 1: View across site, facing north.

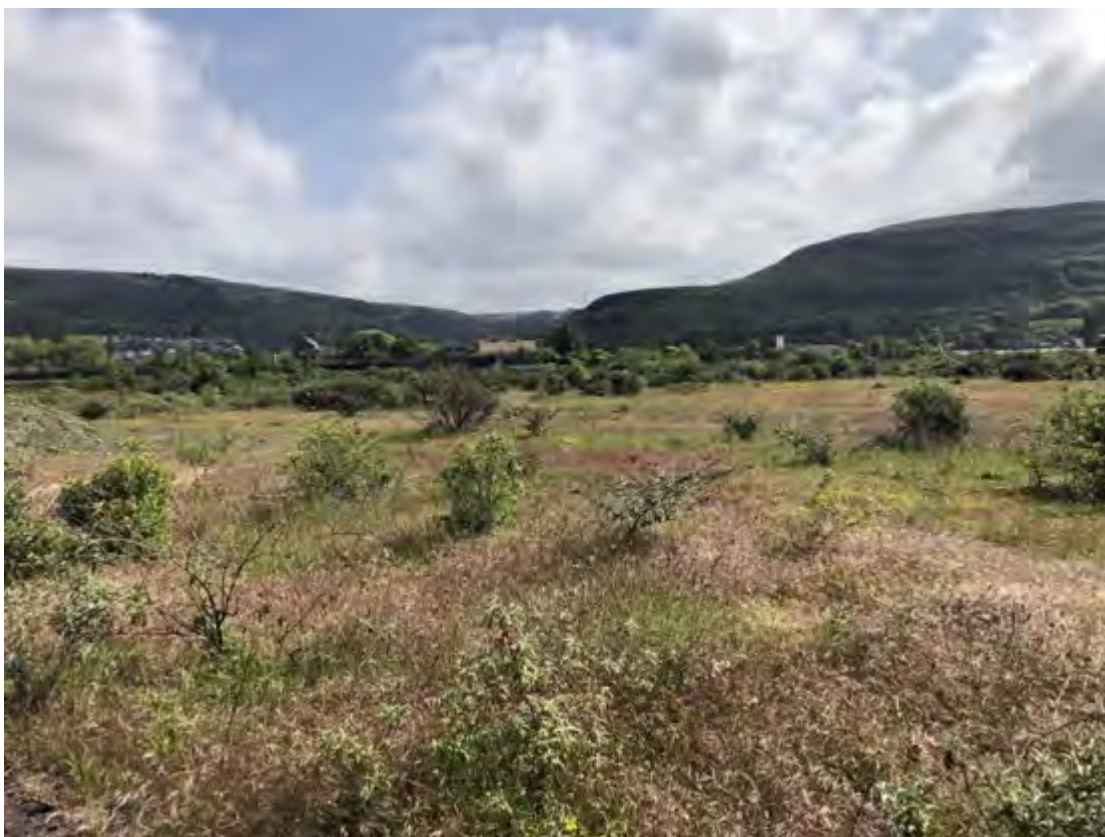
Photograph 2: View across site, facing north-east.

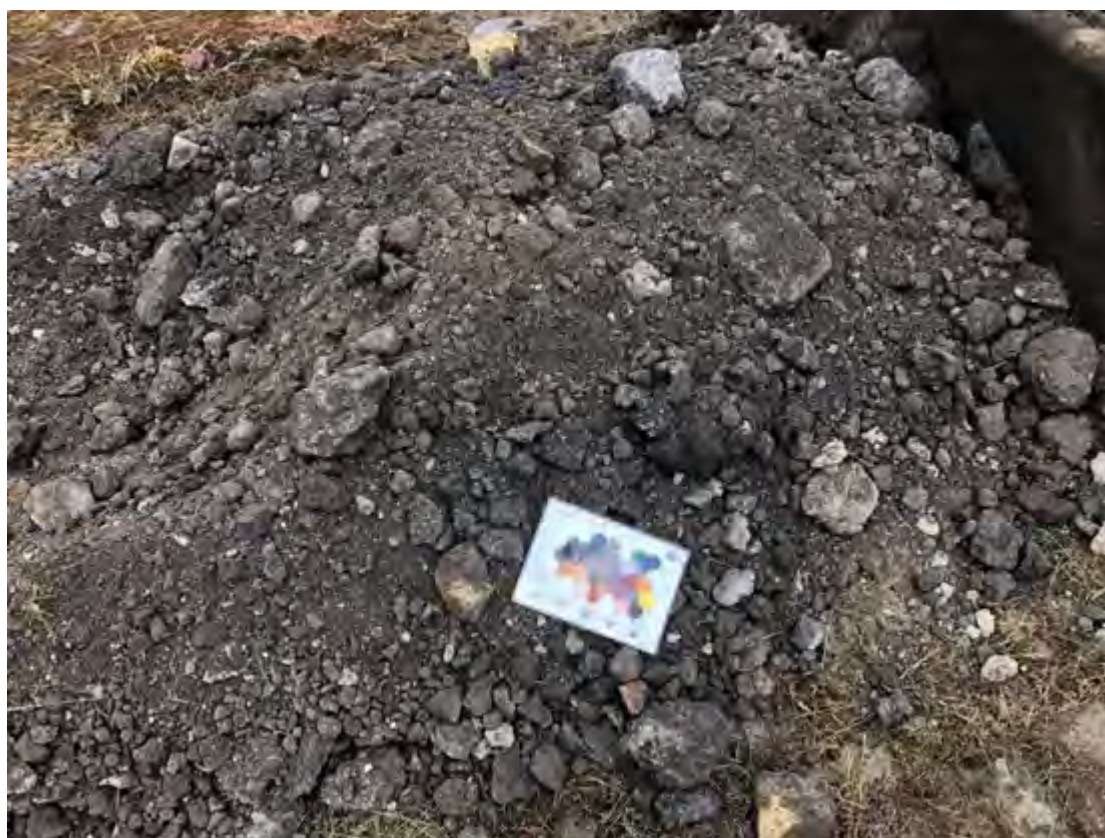
- 4.1.5 Concrete slabs were observed in numerous locations across the site. 5No. exploratory locations (BH201, BH201A, BH202, BH202A, TP208 and TP216) recorded concrete slabs below ground level between depths of 0.2mbgl (7.4mAOD) and 0.45mbgl (7.15mAOD).

| Exploratory Location | Depth (mbgl) | Asbestos Identification |
|---|---|---|
| TP208 | 0.3 | Amosite – loose fibrous debris |

Photograph 8: Encountered ground conditions within trial pit, TP208.

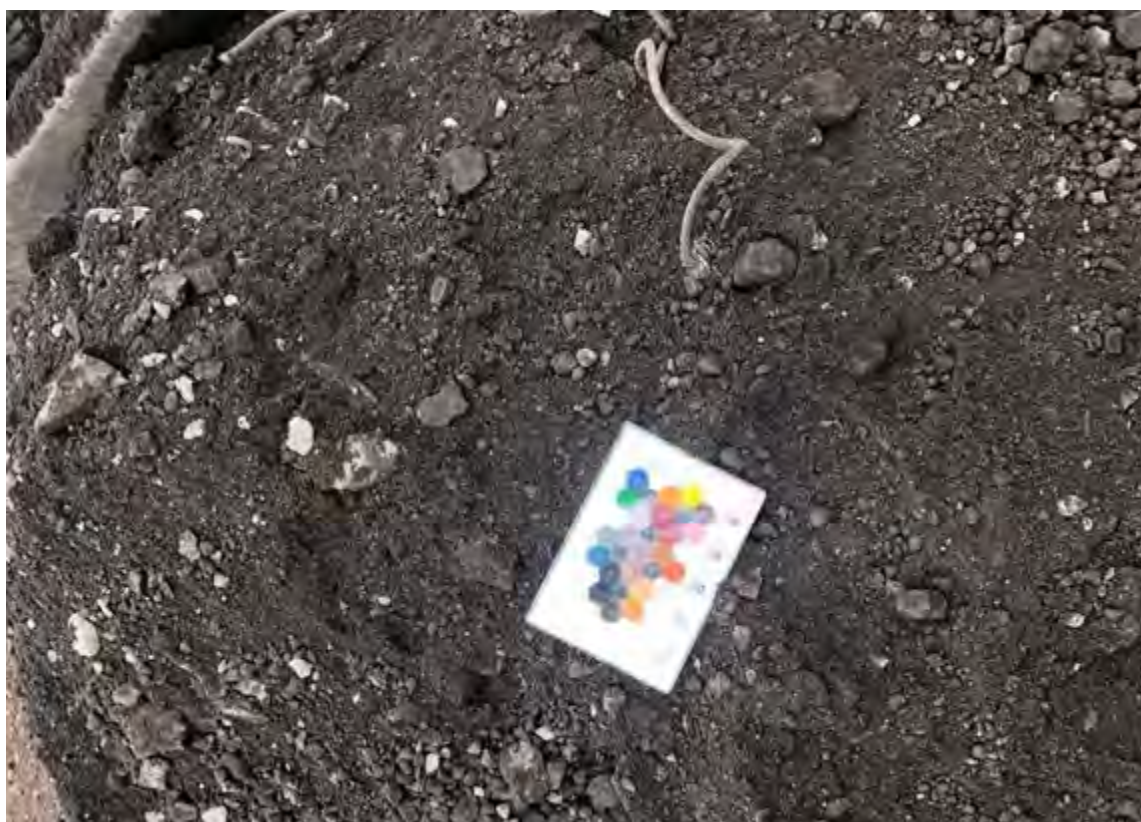
| Exploratory Location | Depth (mbgl) | Asbestos Identification |
|---|---|---|
| TP211 | 0.4 | Amosite – loose fibres |
| TP211 | 1.3 | Chrysotile – loose fibres |

Photograph 14: Encountered ground conditions within trial pit, TP211.

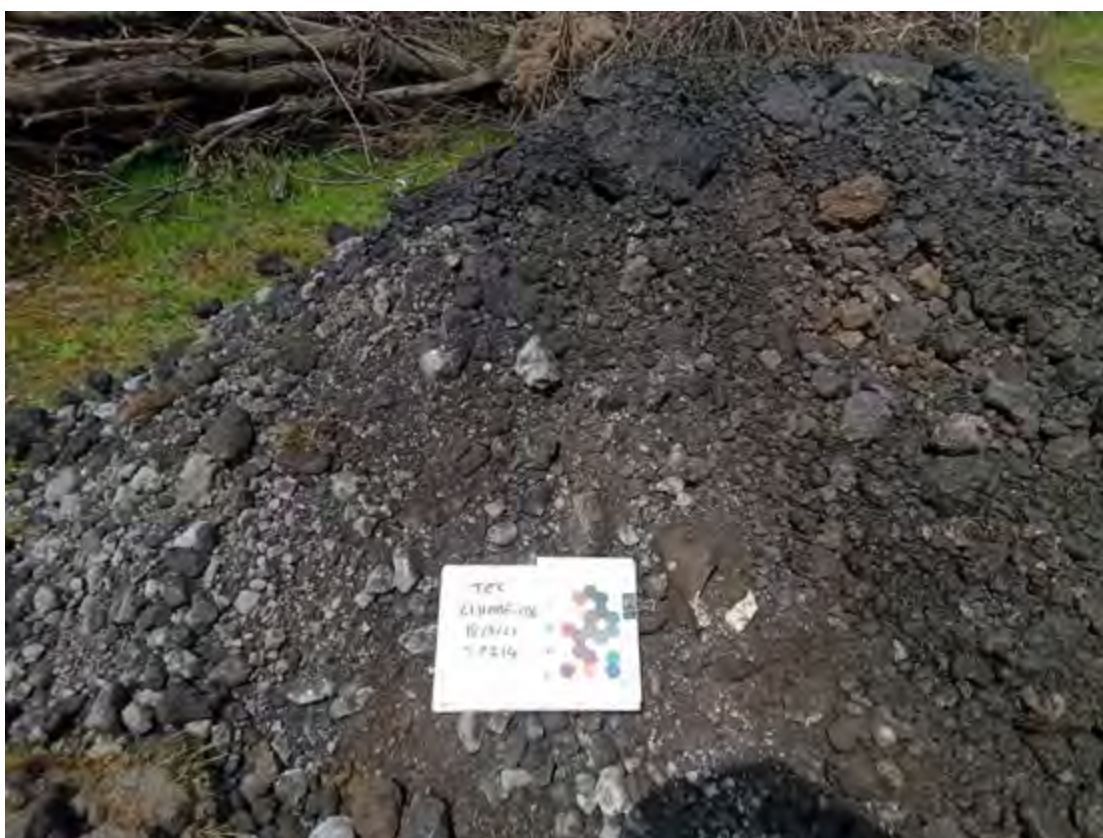
- 4.2.1 Perched water was encountered within two exploratory locations (BH202B and TP214). Within BH202B, perched water was recorded at 3.1mbgl, with a resting level of 1.7mbgl after a period of 20minutes. Within TP214, the perched water was encountered at 2.1mbgl, with a resting level of 2.0mbgl after a period of 15minutes. Water strikes/ observations are also shown on the exploratory hole logs in Appendix D.
- 4.2.2 It should be noted that groundwater conditions recorded during the investigation may not be representative of long-term conditions and that groundwater levels may vary in response to meteorological/ seasonal changes.

Photograph 18: Encountered ground conditions within trial pit, TP214.

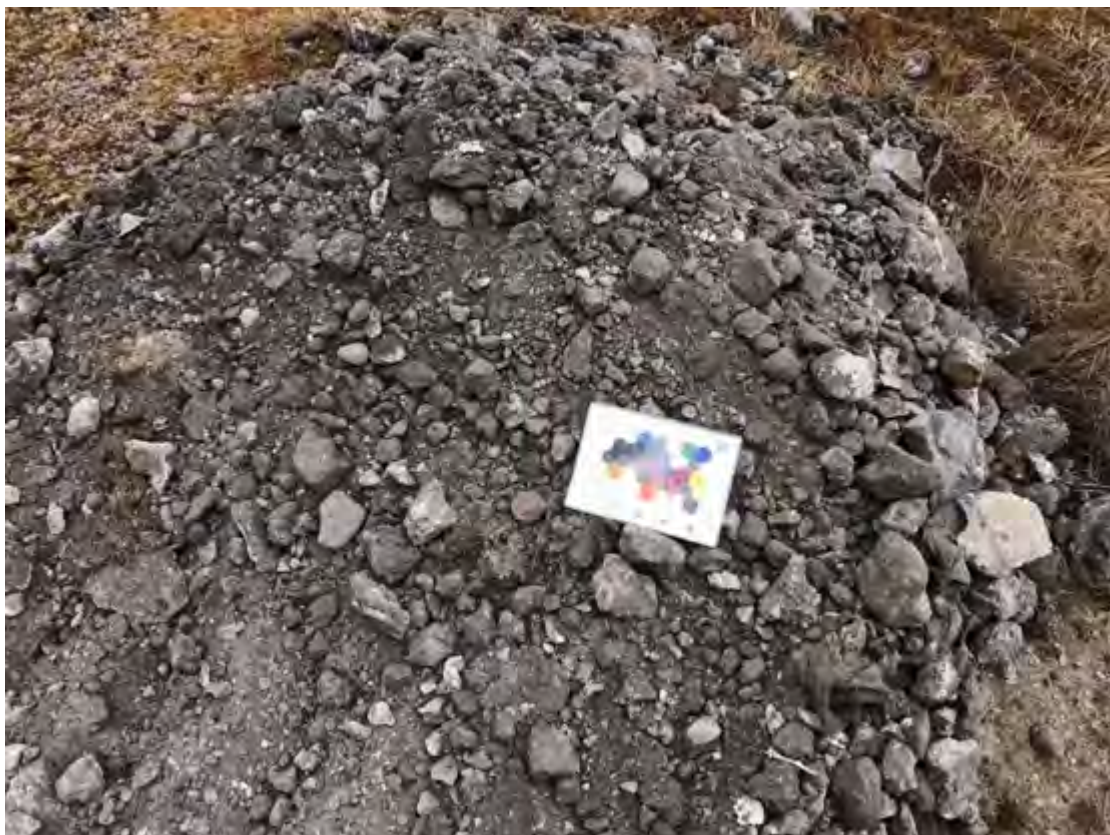
Photograph 22: Encountered ground conditions within trial pit, TP216.
