# Y Bryn Wind Farm

## Appendix 10.5

### Access Route - Geotechnical Assessment

**Y Bryn Wind Farm Ltd.**

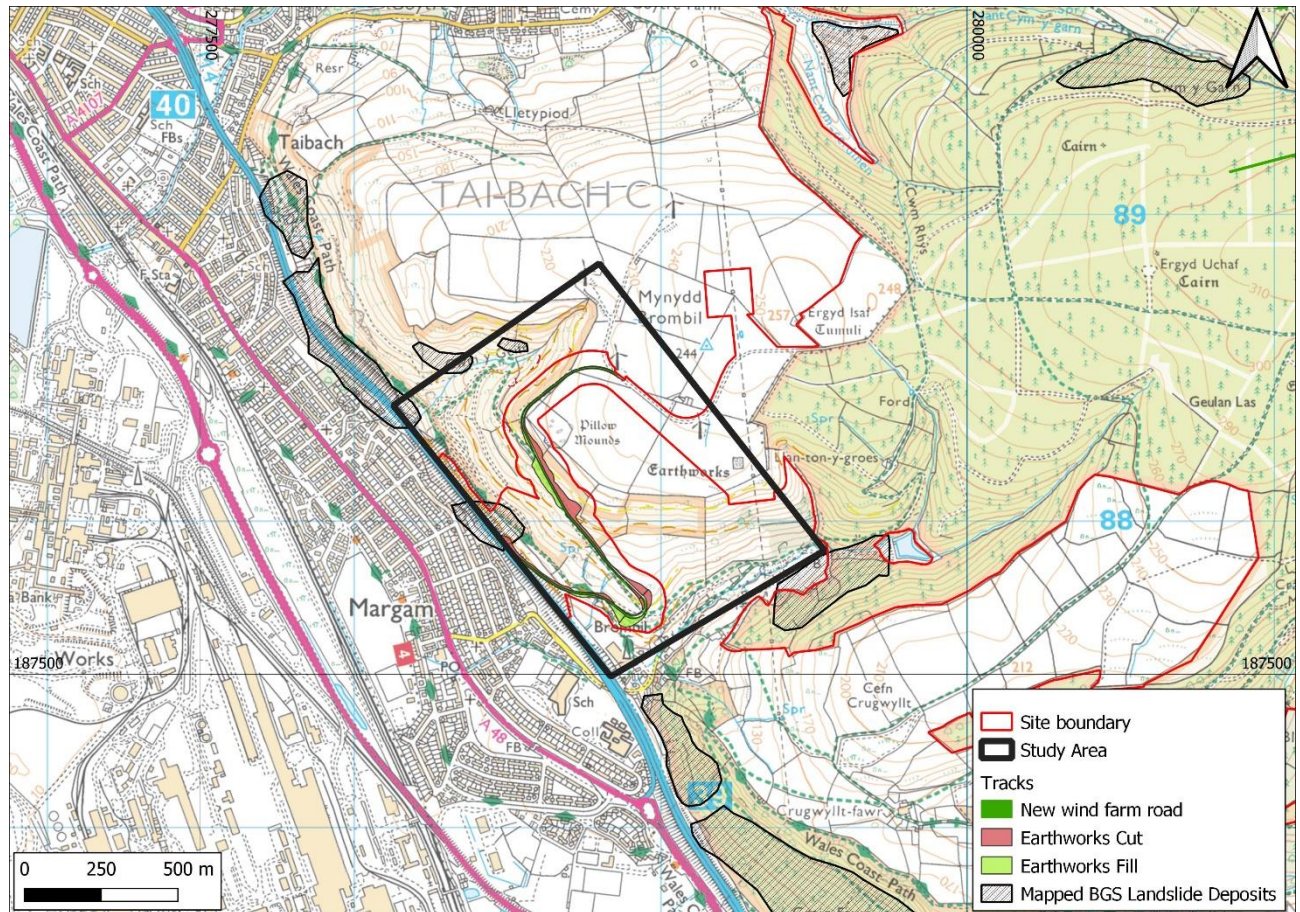
Figure 2.5: BGS-mapped Landslide Deposits on and near to the Site

The BGS maps show Landslide Deposits near the Site access track and in the surrounding area. Available literature records (Waters et al., 2006) provides additional information on these deposits near to Port Talbot and Margam –

“Following deglaciation, valley sides over steepened by glacial erosion were widely subject to landslide in the region...all are shallow translational slide/debris flows (Conway et al., 1980) and are in argillaceous horizons and/or superficial deposits, with failure caused by seepages at the bases of Pennant Sandstone scarps, or along fault planes”.

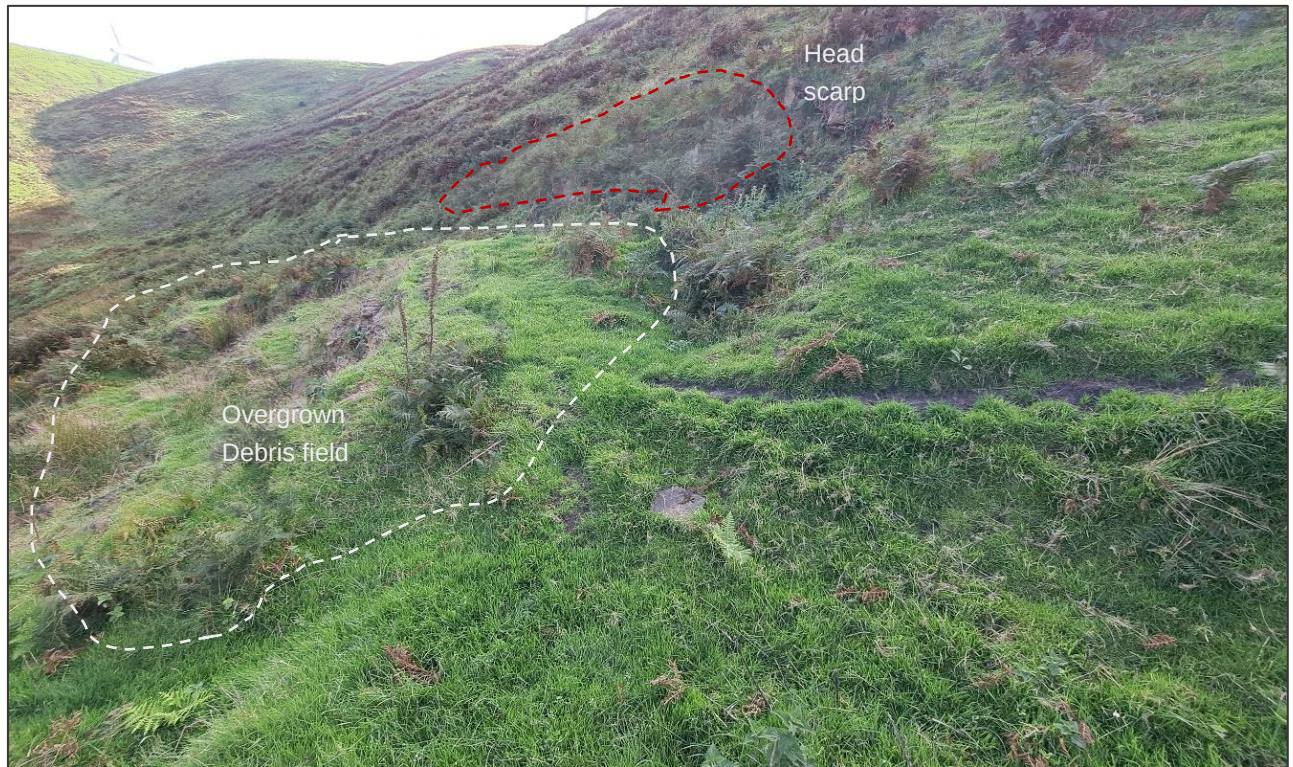
Figure A1: A small-scale translational landslide deposit (annotated) now covered in vegetation located on the eastern side of the Cwm y Geifr valley (west of the hill on which the access track runs).

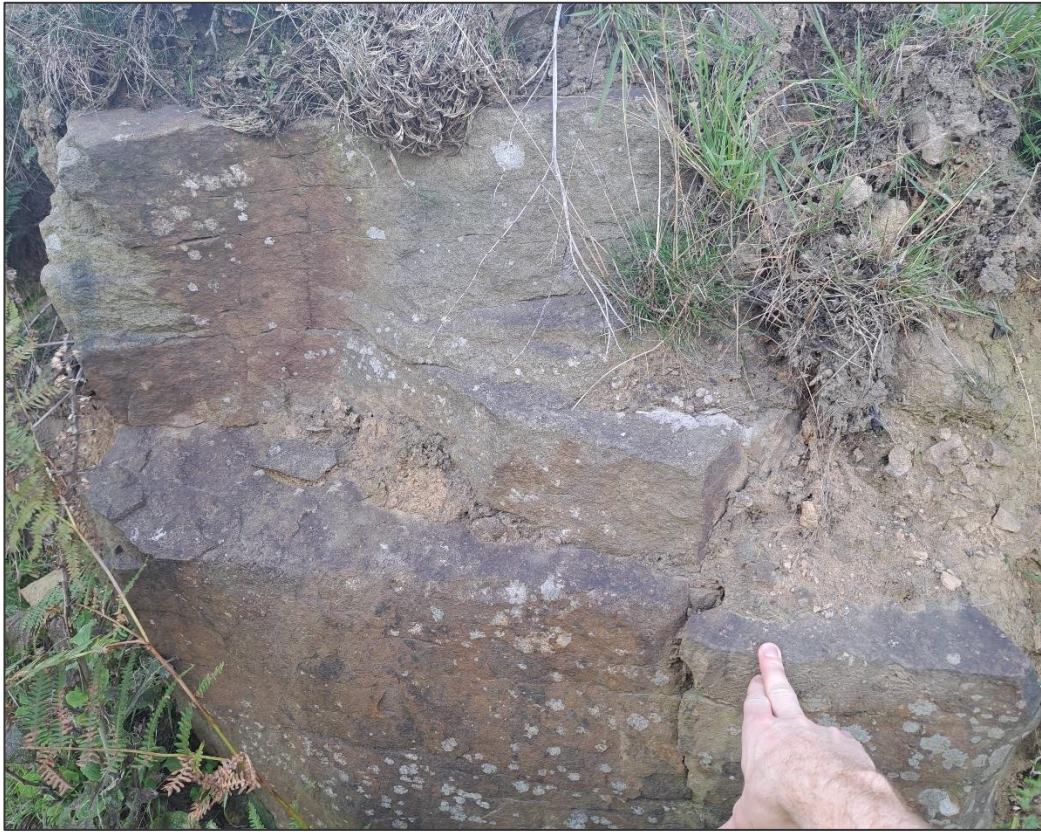
Figure A2: Sandstone (Rhondda Member) block part of a landslide deposit found west of access track alignment.

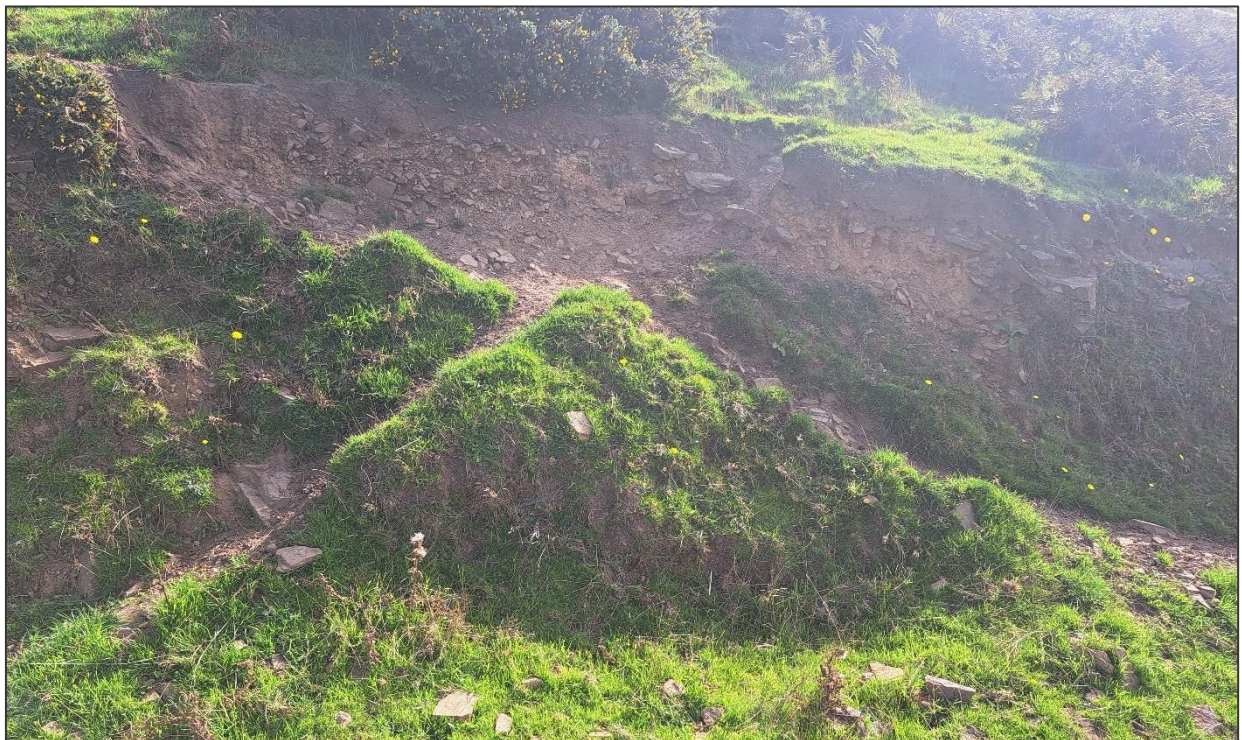
Figure A3: Signs of ground instability (soil slippage & active erosion) along the side of the current access track towards crest slope system

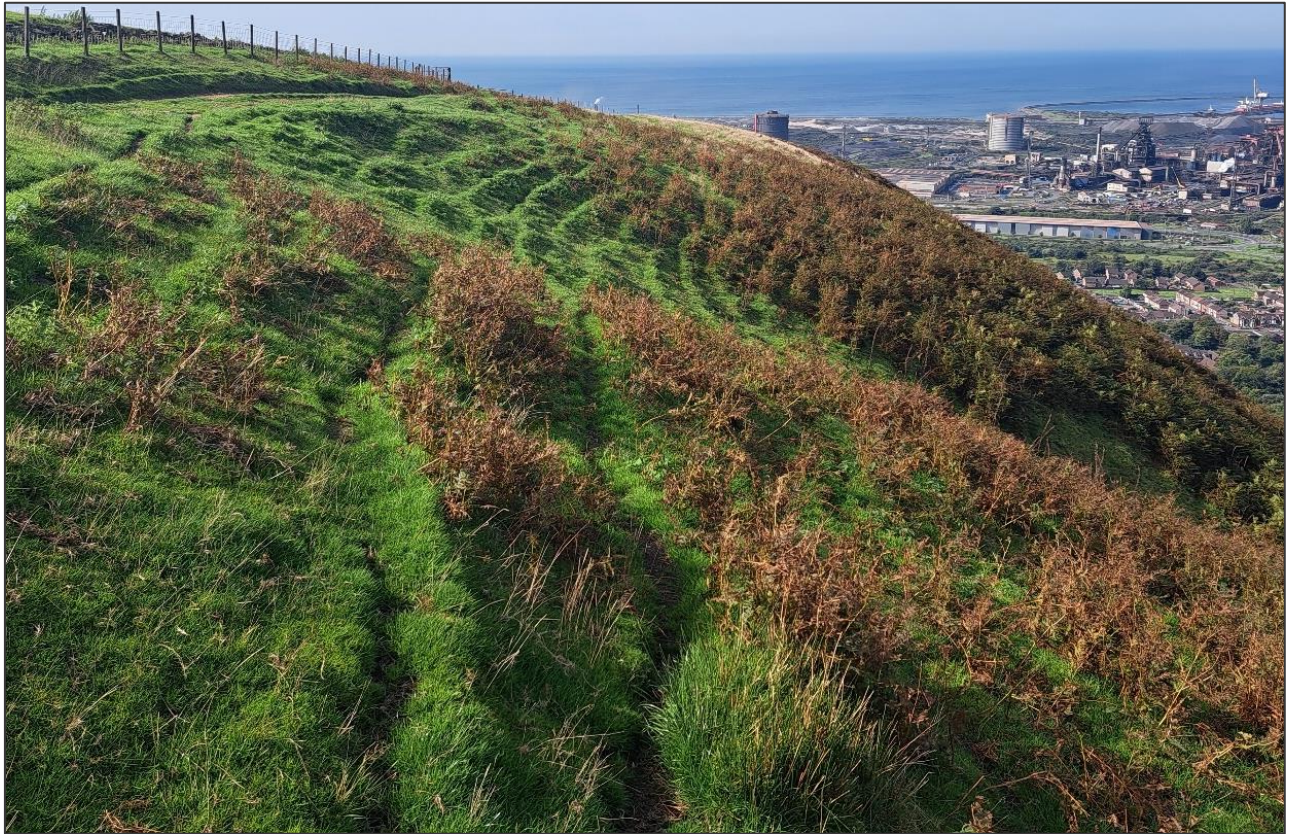
Figure A4: View southeast: Natural terracing of the slope above the access track at higher elevations above Brombil Farm. This land feature may be accentuated by grazing sheep and the lack of high-growing vegetation.

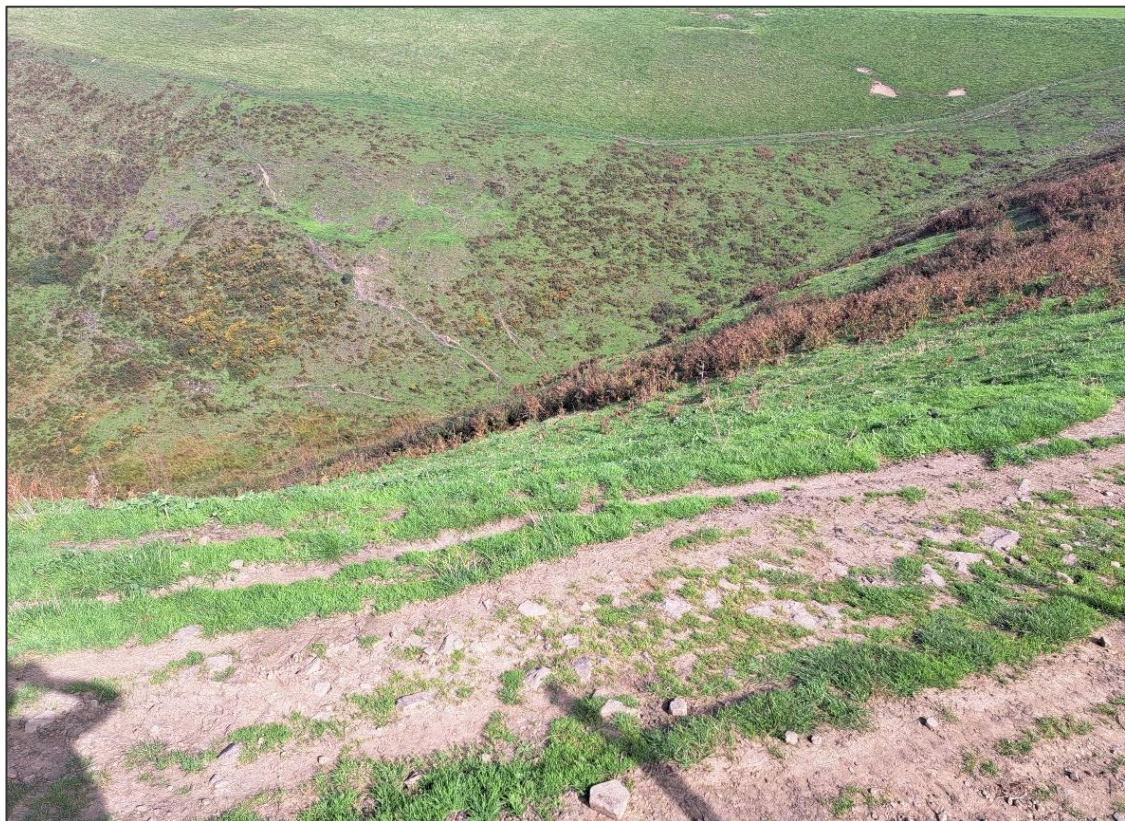
Figure A5: Steep exposed terrain directly adjacent to the current access track alignment, looking northwest across the Cwm y Geifr valley

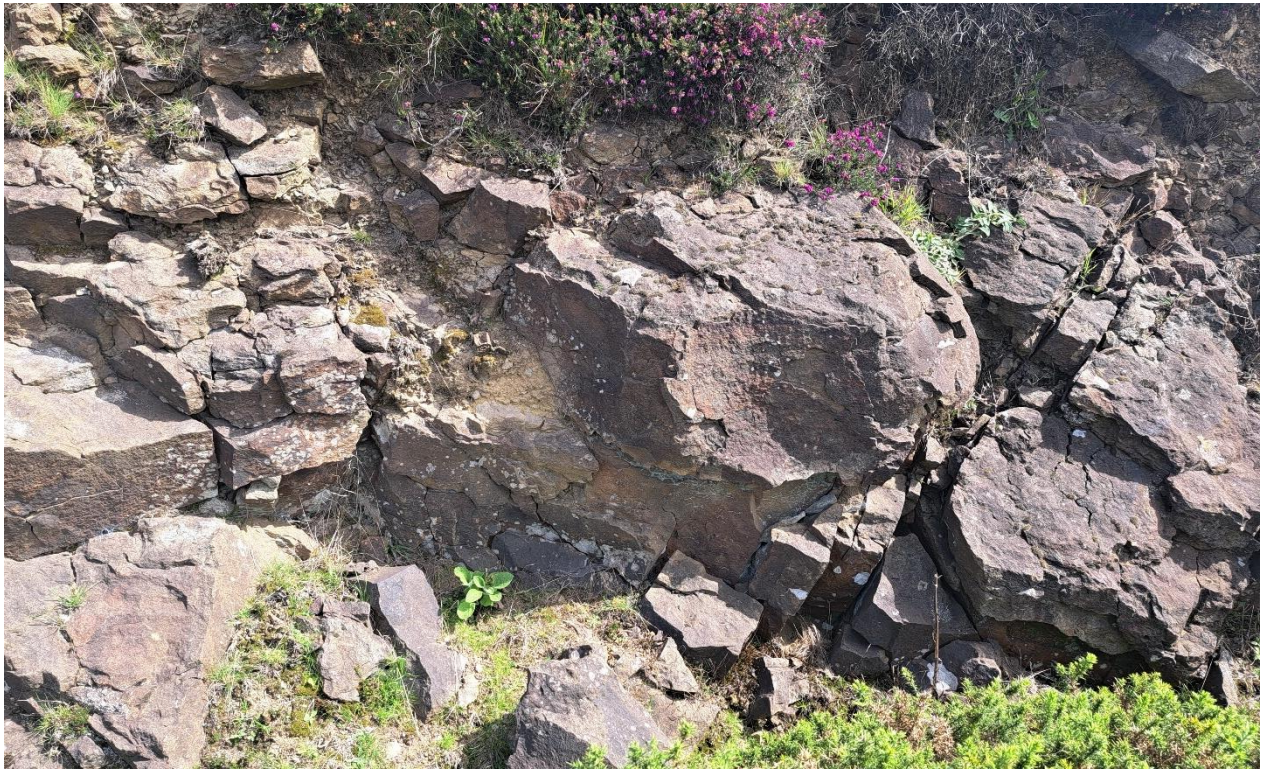
**Figure A6:** Sandstone (Rhondda Member) outcrop along the access track (278583E, 188196N) exhibiting an approximately 45-degree fracture plane (dotted yellow line). This outcrop is located on shallower-dipping ground along the current track compared to where the landslide deposits were observed which may explain why there hasn't been clear rock sliding/ground movement here

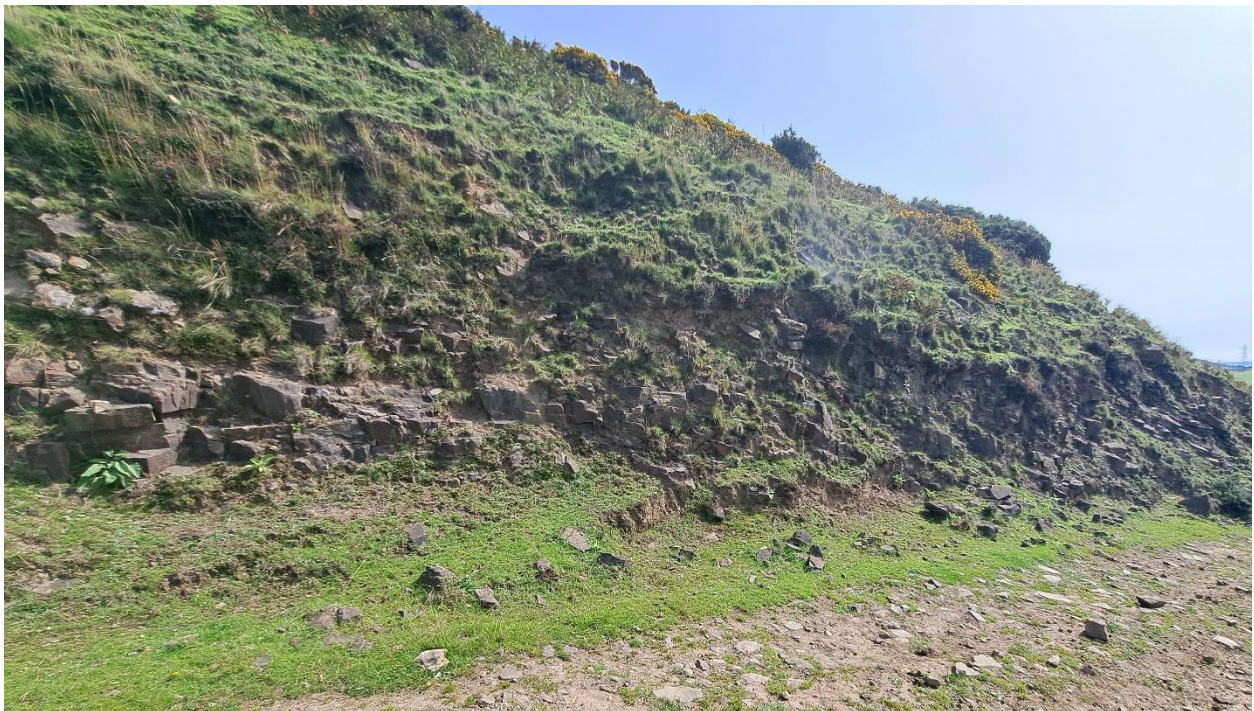
**Figure A7:** Sandstone (Rhondda Member) outcropping steeply beside the access track running northwest-southeast.

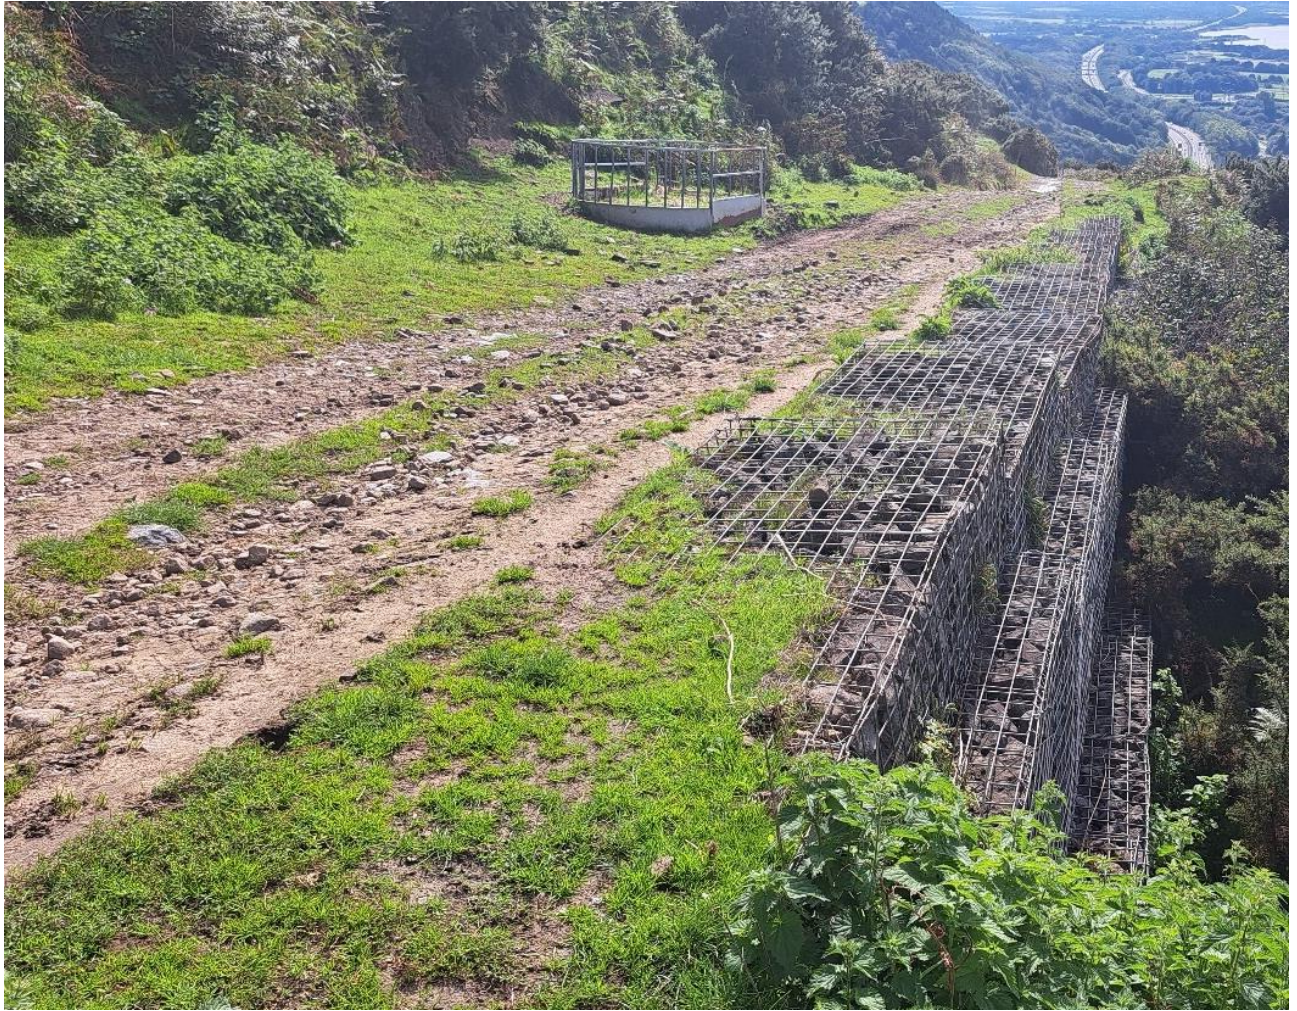
**Figure A8: A pre-existing construction install to increase slope stability beside the access track (gabion baskets) located on the lower slopes of the current access track (278672E, 188030N)**

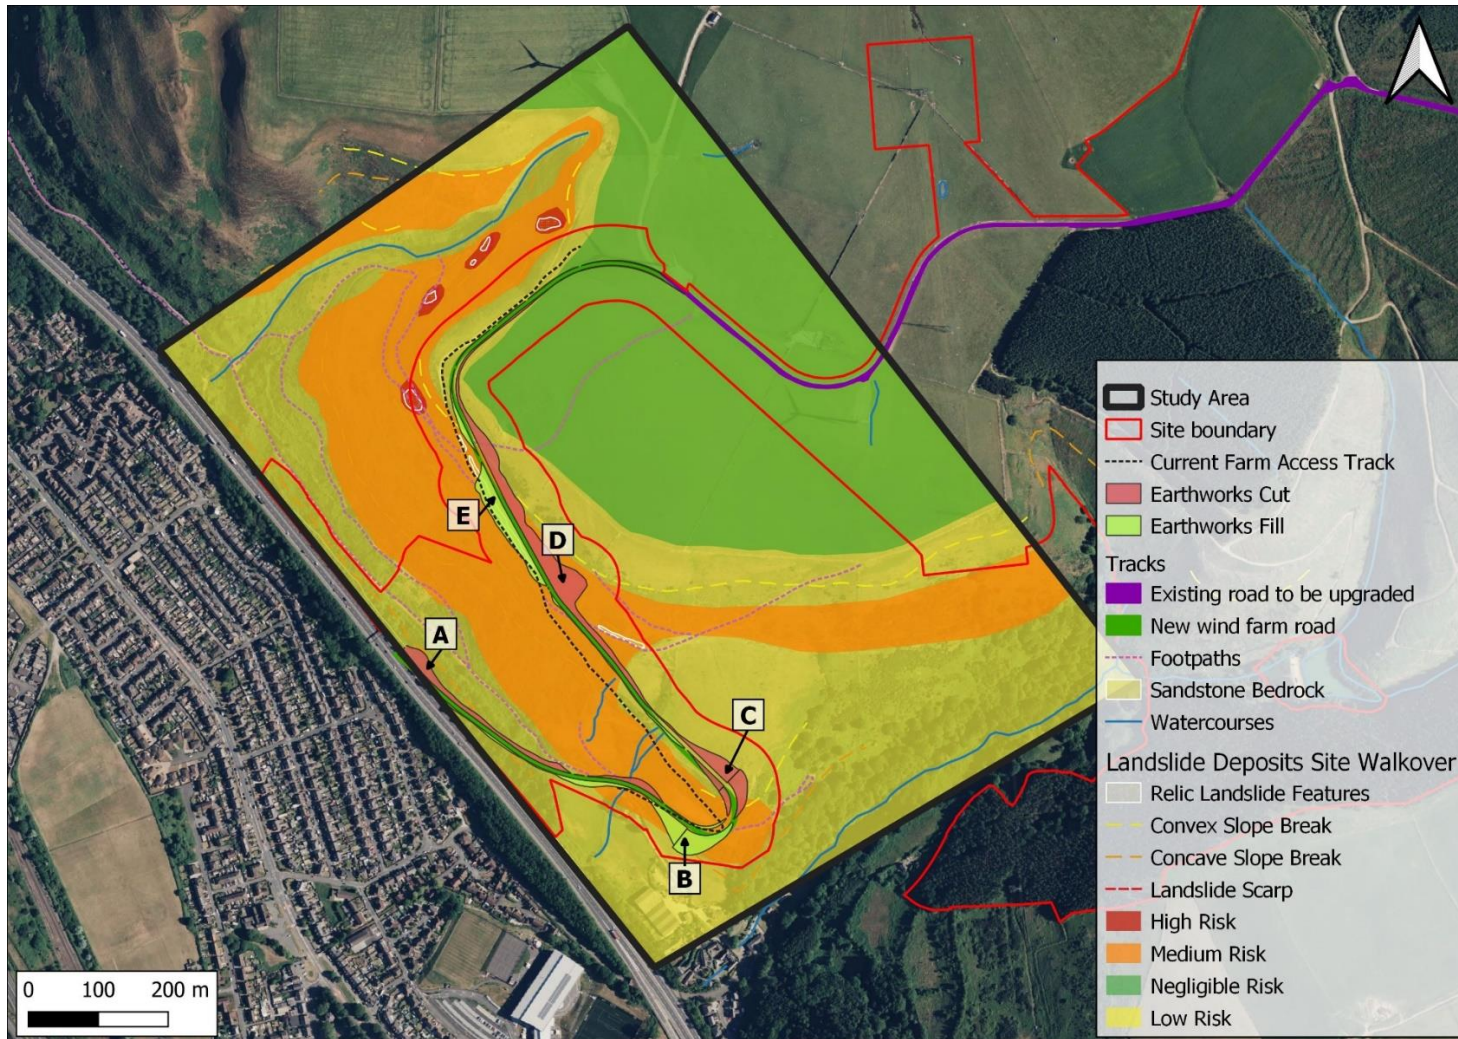
## C. Landslide Risk Ranking Map – Figure C1

| <b>Risk Map<br/>(Figure C1<br/>and F1)<br/>Reference</b> | <b>Hazard</b> | <b>Risk Rank<br/>Before Mitigation</b> | <b>Mitigation</b> | <b>Residual<br/>Risk</b> |
|---|---|---|---|---|
| <b>A (CH20-80m**)</b> | Cutting into steep (15 – 18°) slope* where landslide deposits are mapped, possibility for destabilisation of slope with rock & soil debris near to live motorway | <b>Low</b> | Removal of any loose debris, re-compaction of slope to increase ground stabilisation. Consider catch netting at base of slope. | <b>Low</b> |
| <b>C (CH560-700m)</b> | Cutting into steep (15 – 20°) ground* where convex break in slope exists, slope destabilisation | <b>Medium</b> | Flattening of the overburden slope to reduce the gradient and likelihood of future failure, use of berms and/or benching to increase base of slope stability. | <b>Low</b> |

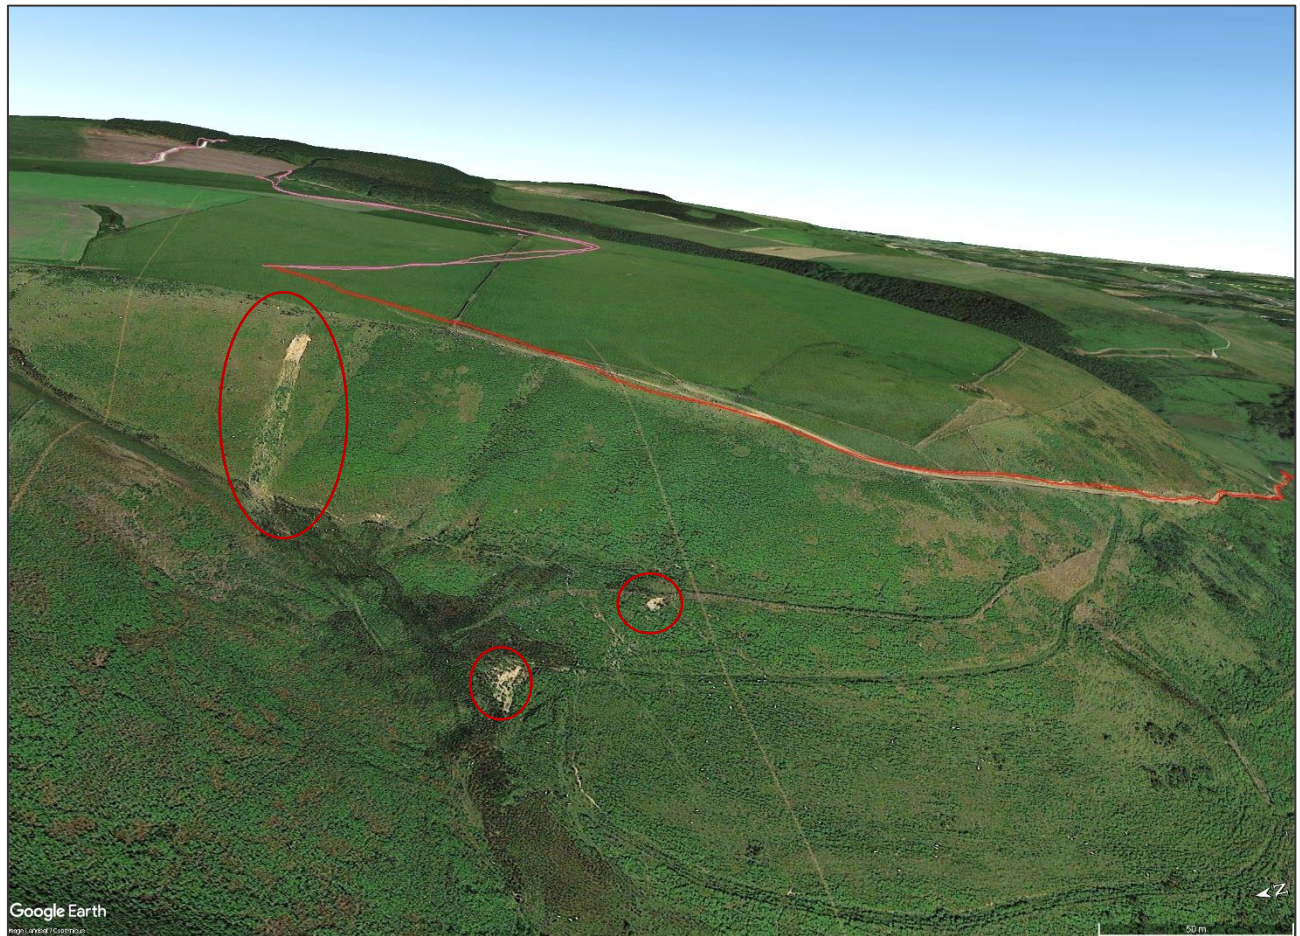
The BGS mapped landslide deposits along the interface with the M4 motorway were not clearly identifiable on the Site during the walkover due to dense vegetation cover. However, a significant relic landslide feature with a horizontal extent of about 180 m can be observed from Google Earth Imagery (2021) approximately 600m southwest of the access route (277993E, 188669N, Figure E2 in Appendix E). In closer proximity to the access track, a localised landslide feature was identified (Figure B1 in Appendix B) on the western side of the current access track. The landslide head scarps typically measure 5 to 10 m in width, and the debris was found between 2 to 20 m below this. A clear example of a previous slide, along the western side of the access track/eastern flank of the Cwm y Geifr valley) can be seen using historic satellite imagery from 2013 (Figure E1, Appendix E).

**E1: Google Earth Satellite Imagery (2013) with relic landslides circled in red. Image is facing the west side of the existing farm track on the eastern side of the Cwm y Geifr valley.**

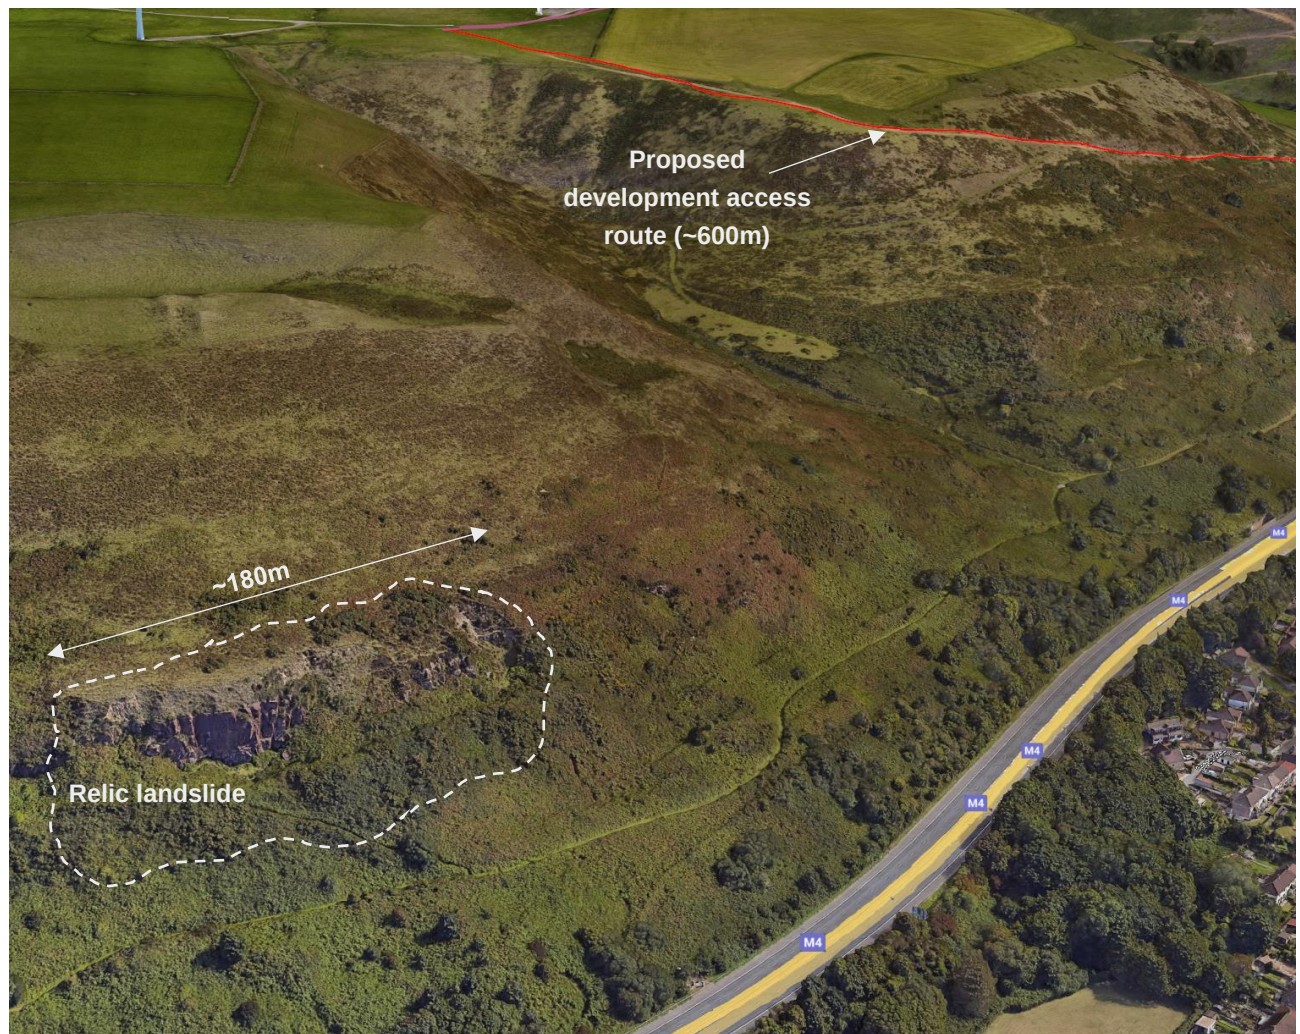
**E2: Historic landslide southwest of the proposed development's access route. Google Earth Satellite imagery from 2021**
