# Appendix 10

## Hydrology, Geology and Hydrogeological Assessment

## A10.1 WATERCOURSE CROSSING ASSESSMENT

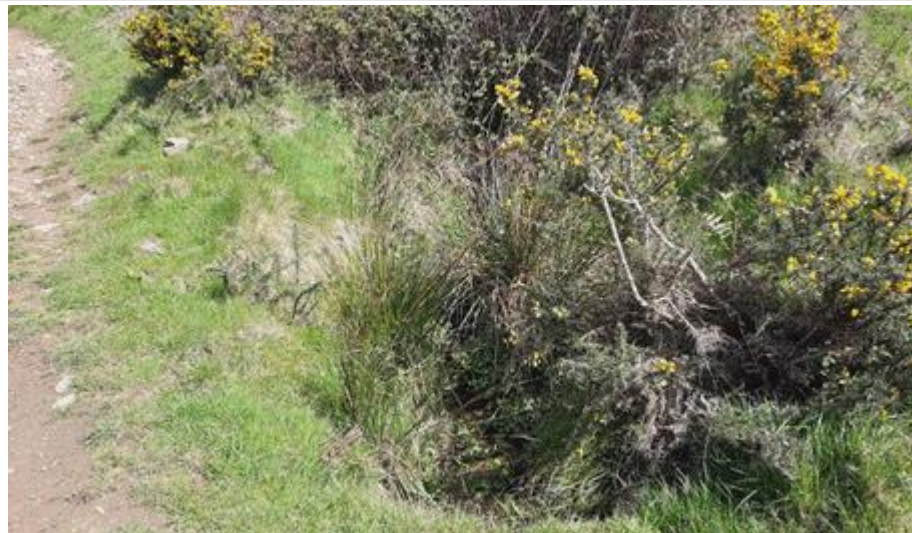
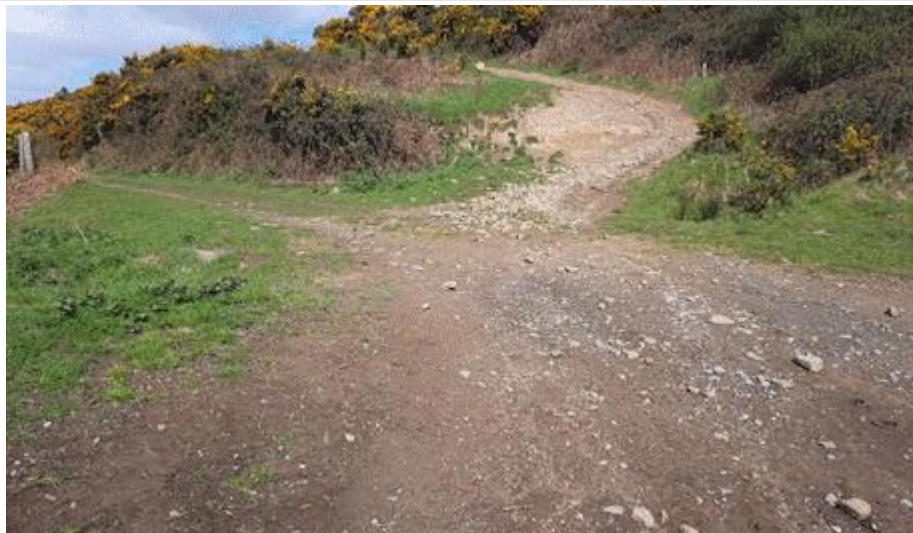
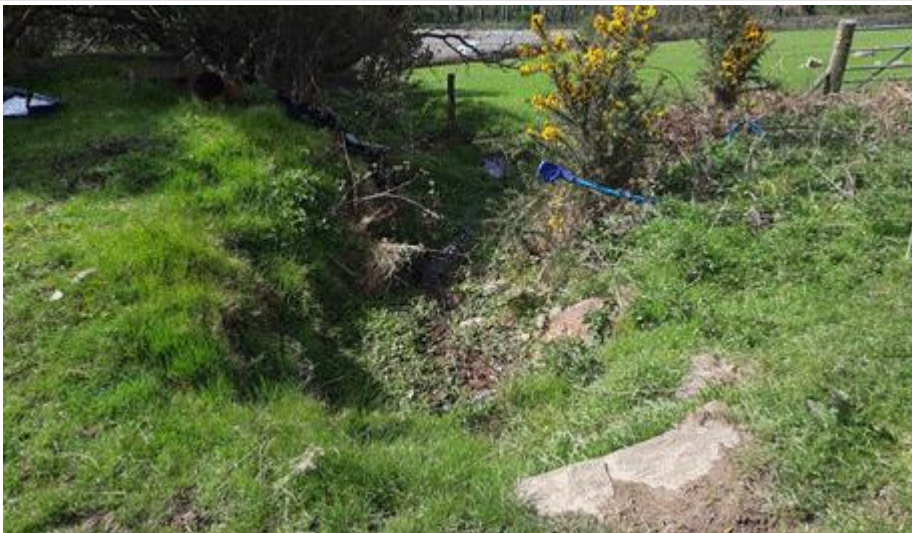
Table A10.2: Crossing WX1

| WX1 (281396, 189361) | | |
|---|---|---|
| | <ul style="list-style-type: none"><li>Existing Crossing: Yes</li><li>Crossing Type (existing): Circular Culvert</li><li>Crossing Material (existing): Plastic</li><li>Crossing Condition (existing): Average</li><li>Channel Type: Incised</li><li>Gradient: Moderate</li><li>Valley form: Shallow vee</li><li>Bank condition: Stable</li><li>Bed material: Fine sand/silt, Coarse gravel, Boulders</li><li>Riparian corridor: Heavily Vegetated (e.g., gorse, bramble), Agricultural Grazing</li><li>Flow condition: Slow</li></ul> <ul style="list-style-type: none"><li><b>Culvert Dimensions (m):</b> 0.45</li><li><b>Water width (m):</b> 0.5</li><li><b>Water depth (m):</b> 0.05-0.1</li><li><b>Bankfull width (m):</b> 1</li><li><b>Bankfull height (m):</b> 0.5</li></ul> <p><b>Note:</b> Plastic culvert on upstream of track is at least half full of silt. Heavily vegetated upstream with brambles, gorse and willow. Sparse gorse, bramble, nettles and bracken on downstream side of track.</p> | |

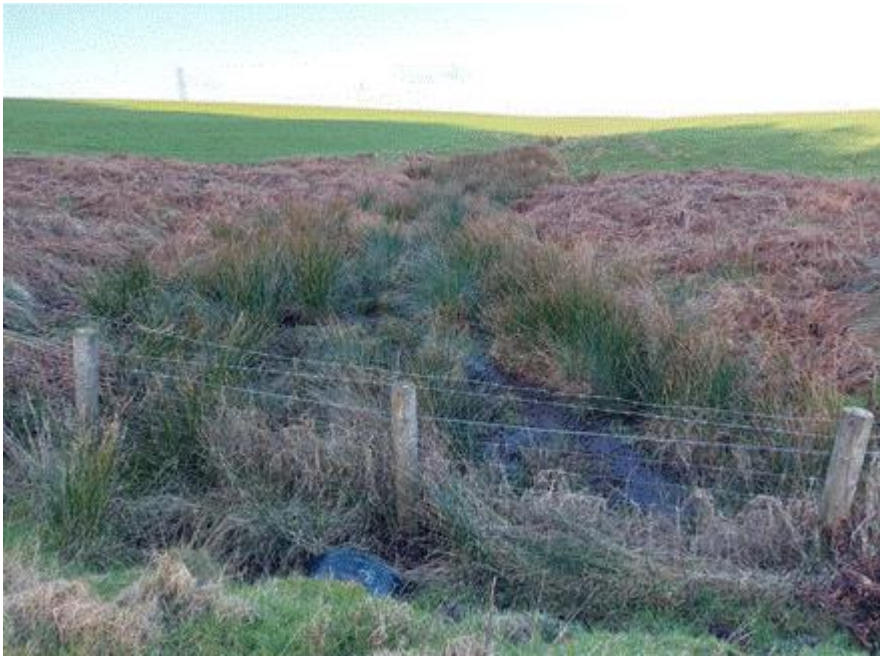
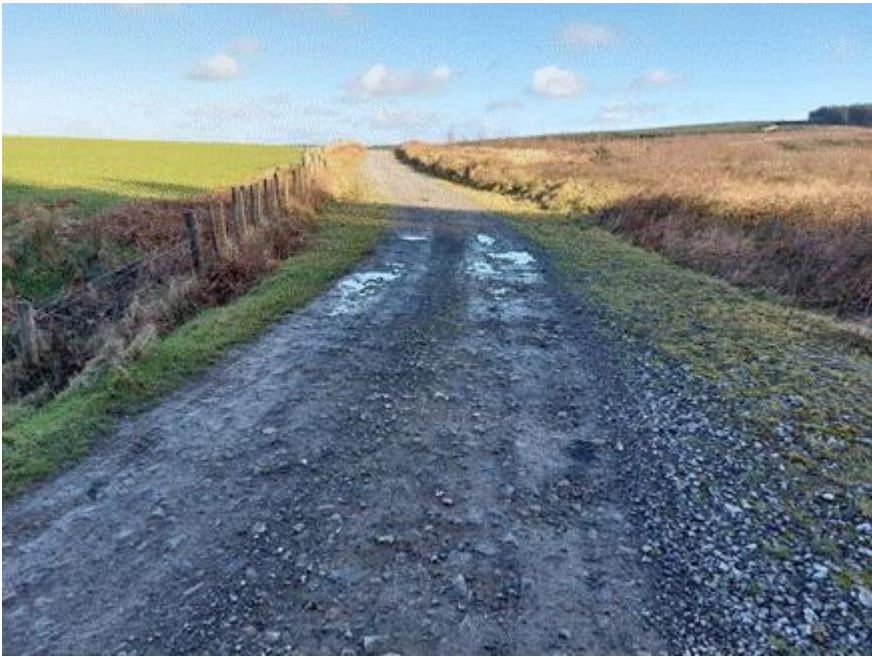
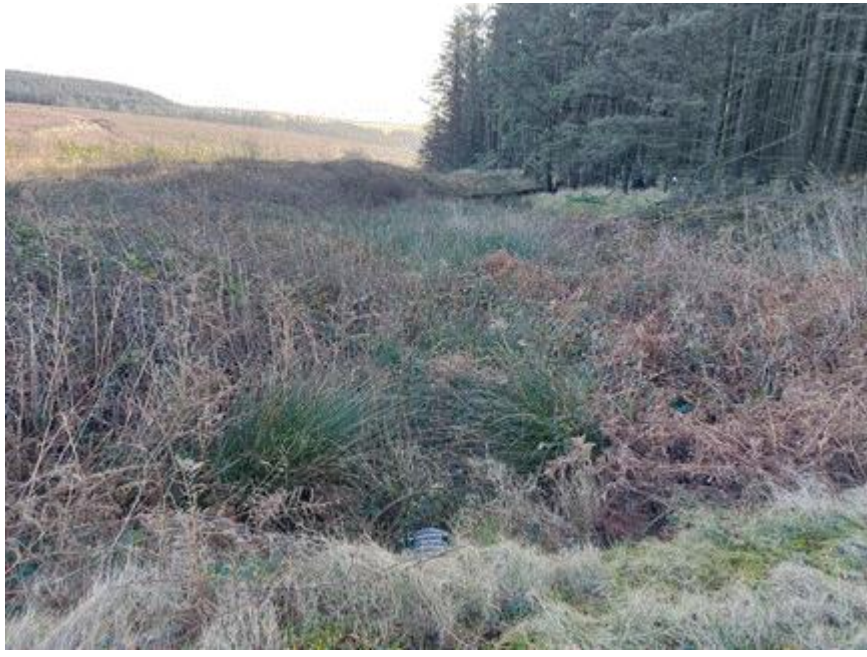
Table A10.3: Crossing WX2

| WX2 (279674, 188596) | | |
|---|---|--|
| | <ul style="list-style-type: none"><li>Existing Crossing: Yes</li><li>Crossing Type (existing): Circular Culvert</li><li>Crossing Material (existing): Plastic</li><li>Crossing Condition (existing): Excellent</li><li>Channel Type: Poorly defined</li><li>Gradient: Gentle</li><li>Valley form: Shallow vee</li><li>Bank condition: Stable</li><li>Bed material: Vegetation, Soil, Peat</li><li>Riparian corridor: Heavily Vegetated (e.g., gorse, bramble), Agricultural Grazing, Productive Forestry</li><li>Flow condition: Dry</li></ul> <ul style="list-style-type: none"><li><b>Culvert Dimensions (m):</b> 0.62</li><li><b>Water width (m):</b> 0.3</li><li><b>Water depth (m):</b> 0</li><li><b>Bankfull width (m):</b> 4.0</li><li><b>Bankfull height (m):</b> 0.5</li></ul> <p><b>Note:</b> Up to 6 m wide upstream in field, likely braided and more of a marsh than a channel. More defined channel downstream.</p> | |

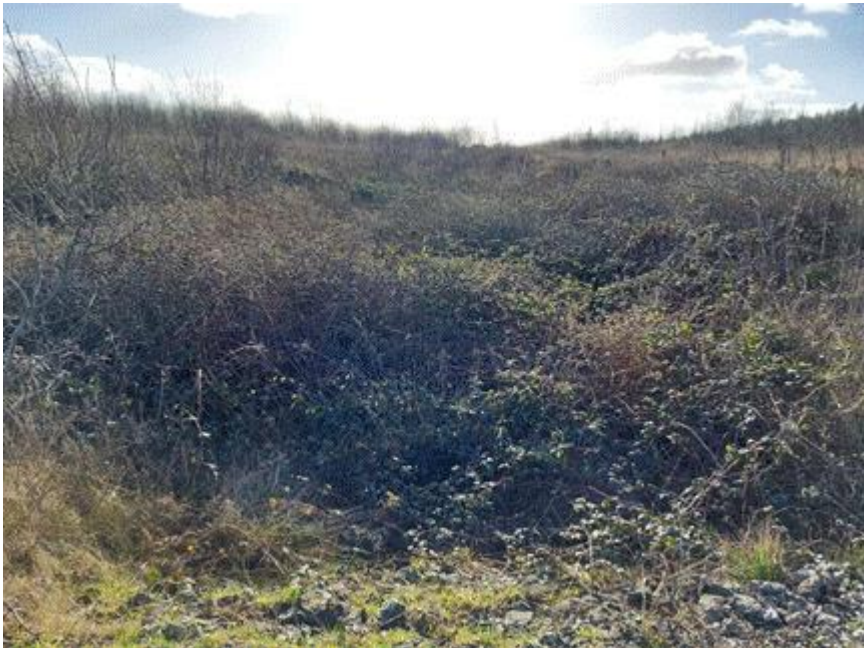
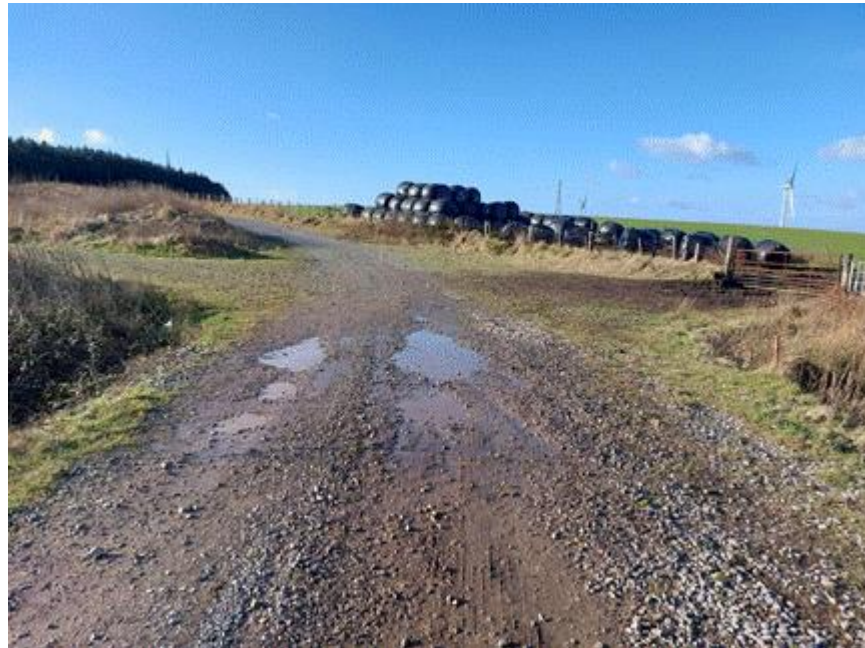
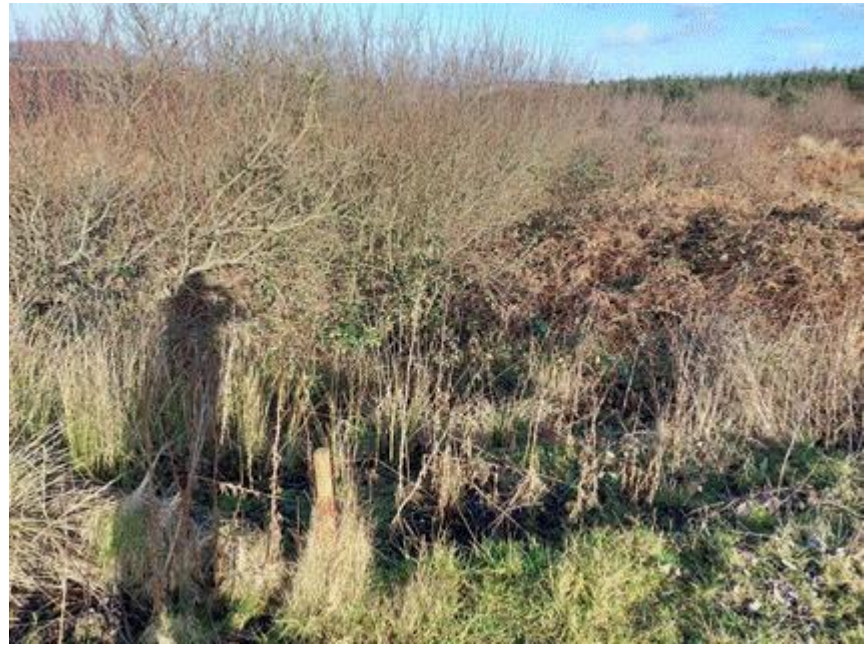
Table A10.4: Crossing WX3

| WX3 (279821, 188758) | | |
|---|---|---|
| <p>© Crown Copyright 2023. All rights reserved. Ordnance Survey Licence 0100031673.</p> | <ul style="list-style-type: none"><li>Existing Crossing: Yes</li><li>Crossing Type (existing): Circular Culvert</li><li>Crossing Material (existing): Plastic</li><li>Crossing Condition (existing): Good</li><li>Channel Type: Incised</li><li>Gradient: Moderate</li><li>Valley form: Deep vee, Shallow vee</li><li>Bank condition: Stable</li><li>Bed material: Vegetation, Fine sand/silt</li><li>Riparian corridor: Heavily Vegetated (e.g., gorse, bramble), Agricultural Grazing, Productive Forestry</li><li>Flow condition: Stagnant</li></ul> <ul style="list-style-type: none"><li><b>Culvert Dimensions (m):</b> 0.8</li><li><b>Water width (m):</b> 1.0</li><li><b>Water depth (m):</b> 0</li><li><b>Bankfull width (m):</b> 2.0</li><li><b>Bankfull height (m):</b> 0.5</li></ul> <p><b>Note:</b> very close to watershed. Too heavily vegetated by brambles for accurate channel measurements.</p> | |

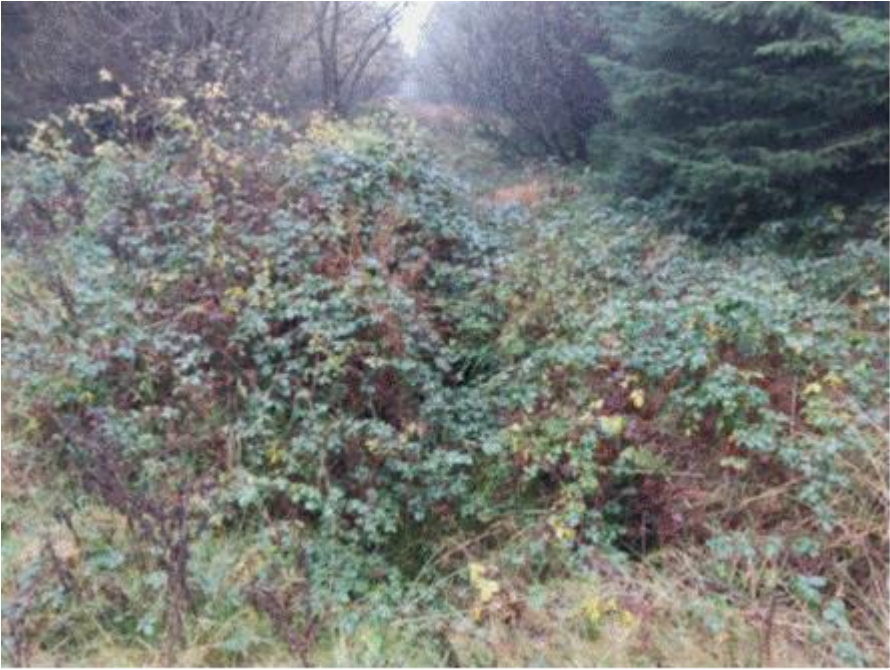
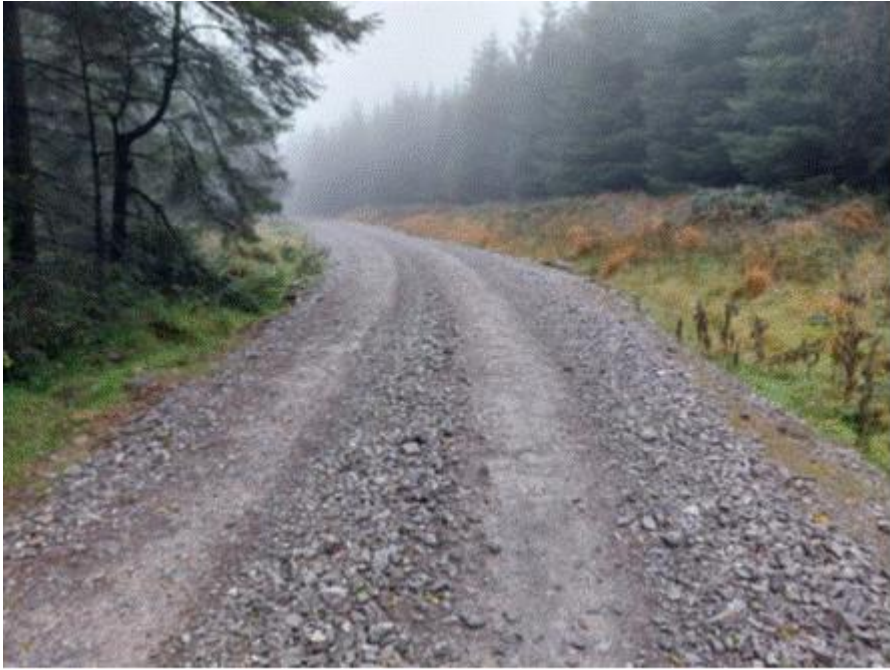
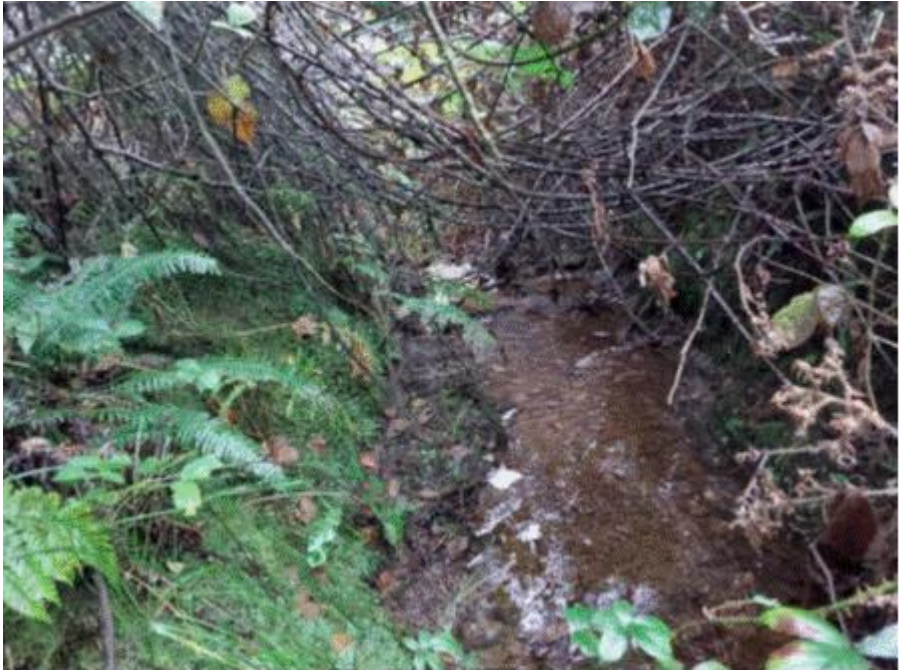
Table A10.5: Crossing WX4

| WX4 (281396, 189361) | | |
|---|---|--|
| | <ul style="list-style-type: none"><li>Existing Crossing: Yes</li><li>Crossing Type (existing): Circular Culvert</li><li>Crossing Material (existing): Concrete</li><li>Crossing Condition (existing): Good</li><li>Channel Type: Incised</li><li>Gradient: Gentle</li><li>Valley form: No obvious valley sides</li><li>Bank condition: Stable</li><li>Bed material: Fine sand/silt, Coarse gravel, Boulders</li><li>Riparian corridor: Heavily Vegetated (e.g., gorse, bramble), Productive Forestry, Natural Woodland</li><li>Flow condition: Slow</li></ul> <ul style="list-style-type: none"><li><b>Culvert Dimensions (m):</b> 0.4</li><li><b>Water width (m):</b> 0.2 - 0.4</li><li><b>Water depth (m):</b> 0.05</li><li><b>Bankfull width (m):</b> 2.0</li><li><b>Bankfull height (m):</b> 1.2</li></ul> <p><b>Note:</b> Upper reaches of watercourse, lots of brambles and vegetation around watercourse at crossing. Existing crossing in good condition in such that there appears to be no restriction to flow and or obvious degradation to the structure.</p> | |

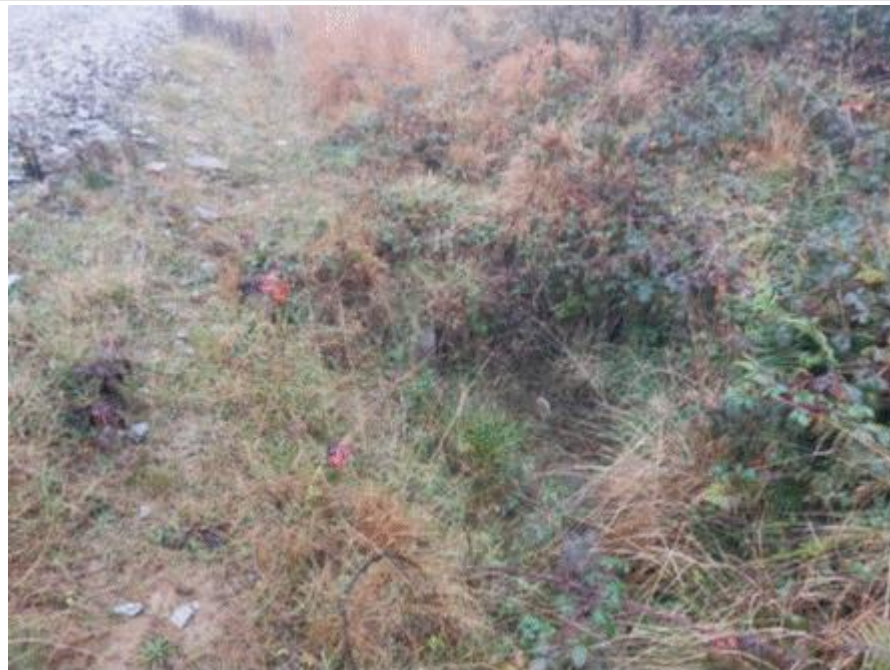
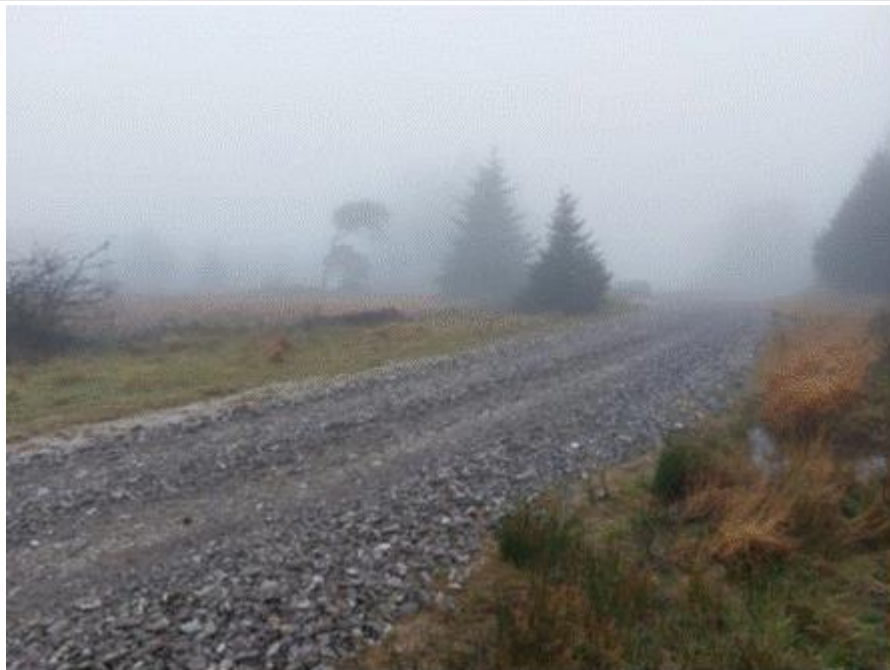
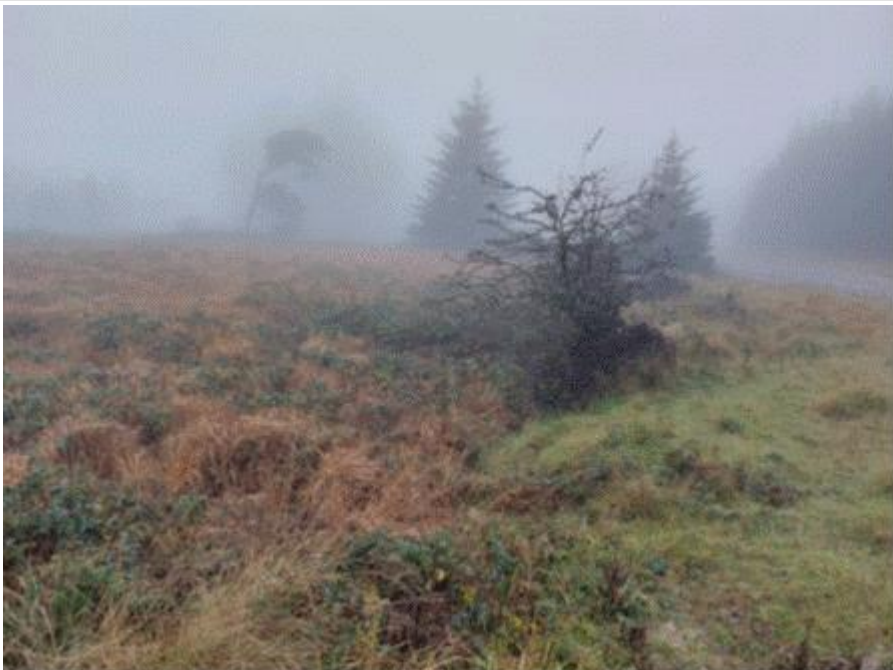
Table A10.6: Crossing WX5

| WX5 (281480, 189267) | | |
|---|---|---|
| | <ul style="list-style-type: none"><li>• <b>Existing Crossing:</b> Yes</li><li>• <b>Crossing Type (existing):</b> Circular Culvert</li><li>• <b>Crossing Material (existing):</b> Concrete</li><li>• <b>Crossing Condition (existing):</b> Good</li><li>• <b>Channel Type:</b> Artificial drainage channel</li><li>• <b>Gradient:</b> Gentle</li><li>• <b>Valley form:</b> No obvious valley sides</li><li>• <b>Bank condition:</b> Stable</li><li>• <b>Bed material:</b> Vegetation</li><li>• <b>Riparian corridor:</b> Productive Forestry, Moorland, Heavily Vegetated (e.g., gorse, bramble)</li><li>• <b>Flow condition:</b> Stagnant</li></ul> <ul style="list-style-type: none"><li>• <b>Culvert Dimensions (m):</b> 0.4 m</li><li>• <b>Water width (m):</b> N/A</li><li>• <b>Water depth (m):</b> N/A</li><li>• <b>Bankfull width (m):</b> N/A</li><li>• <b>Bankfull height (m):</b> N/A</li></ul> <p><b>Note:</b> This does not exist as a natural water crossing with the watercourse starting downstream of the track. Presumably to allow the upstream catchment to drain now there is a track in place an artificial roadside ditch and culvert have been put in place. Road is in very good condition and wide.</p> | |

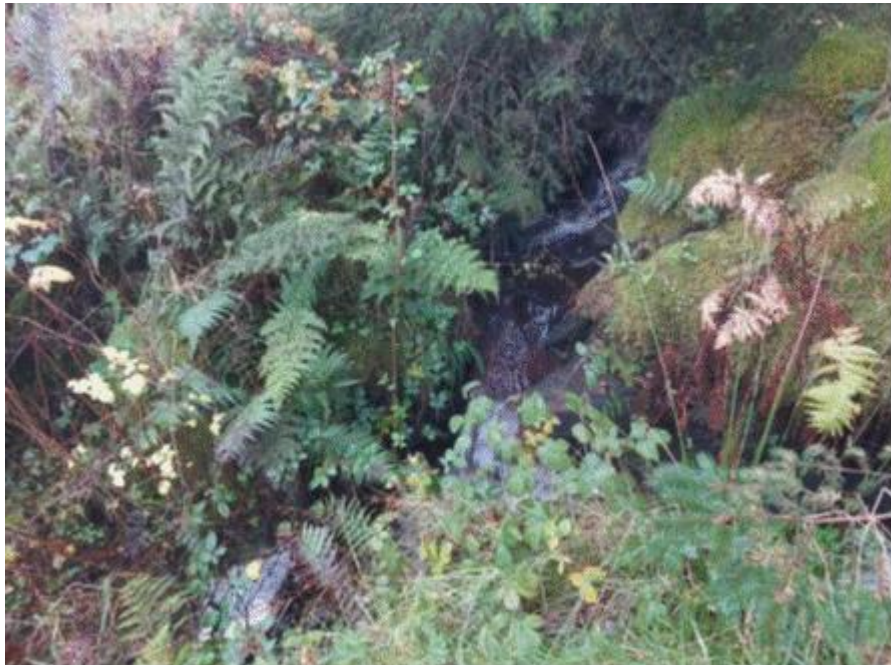
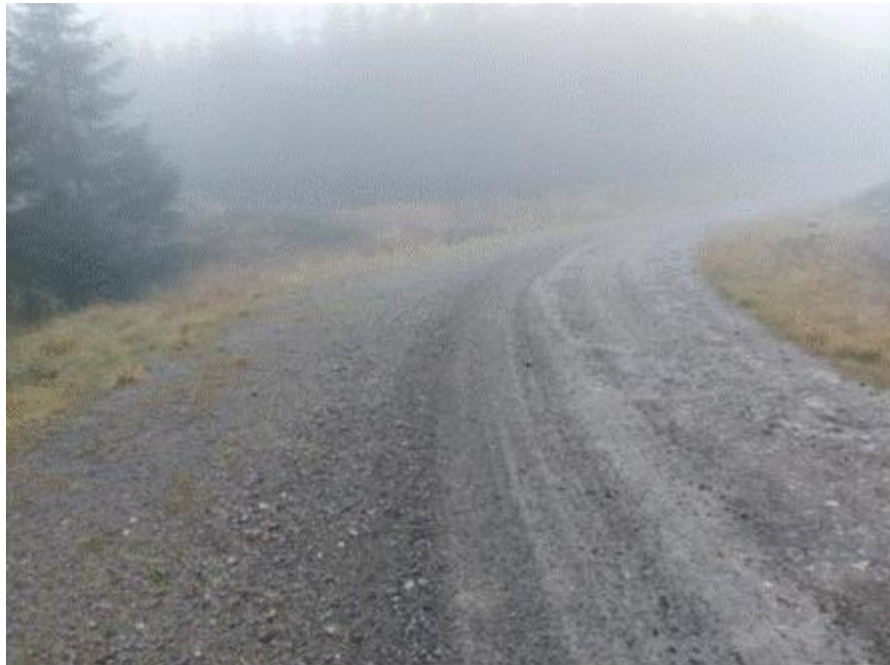
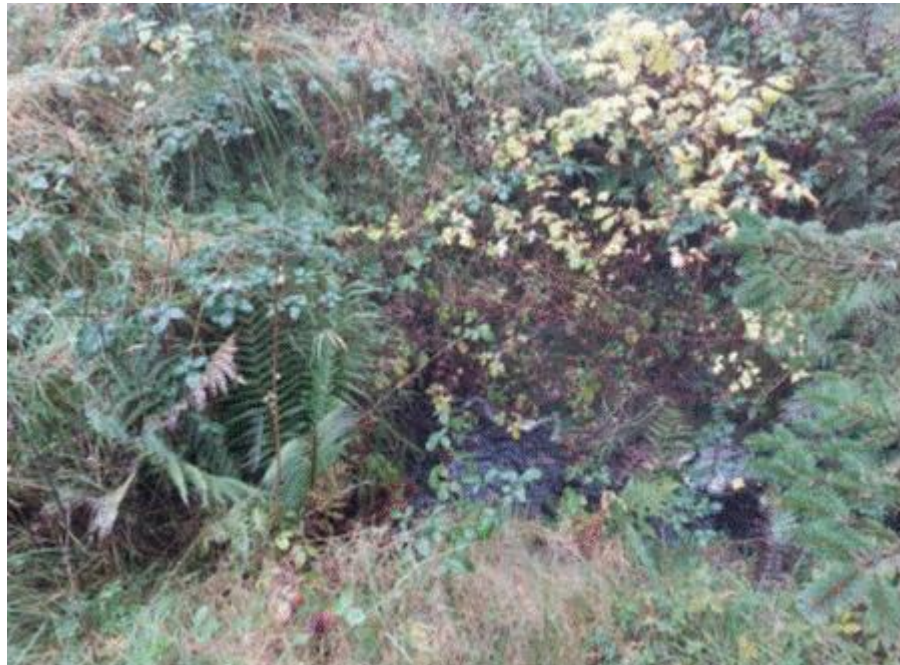
Table A10.7: Crossing WX6

| WX6 (282325, 189025) | | |
|---|---|---|
| <div></div> <p>© Crown Copyright 2023. All rights reserved. Ordnance Survey Licence 0100031673.</p> | <ul style="list-style-type: none"><li>• <b>Existing Crossing:</b> Yes</li><li>• <b>Crossing Type (existing):</b> Circular Culvert</li><li>• <b>Crossing Material (existing):</b> Concrete</li><li>• <b>Crossing Condition (existing):</b> Good</li><li>• <b>Channel Type:</b> Incised</li><li>• <b>Gradient:</b> Moderate</li><li>• <b>Valley form:</b> Shallow vee, Asymmetrical</li><li>• <b>Bank condition:</b> Stable</li><li>• <b>Bed material:</b> Fine sand/silt, Coarse gravel, Boulders</li><li>• <b>Riparian corridor:</b> Heavily Vegetated (e.g., gorse, bramble), Productive Forestry, Natural Woodland</li><li>• <b>Flow condition:</b> Moderate</li></ul> <ul style="list-style-type: none"><li>• <b>Culvert Dimensions (m):</b> 0.9 m</li><li>• <b>Water width (m):</b> 0.3 - 0.8</li><li>• <b>Water depth (m):</b> 0.05 - 0.1</li><li>• <b>Bankfull width (m):</b> 4.0</li><li>• <b>Bankfull height (m):</b> 1.0 - 1.5</li><li>• <b>Flooded Bankfull width (m):</b> 4.0</li></ul> <p><b>Note:</b> Existing wide crossing in what appears to be good condition. Channel deeper and narrower upstream of crossing.</p> | |

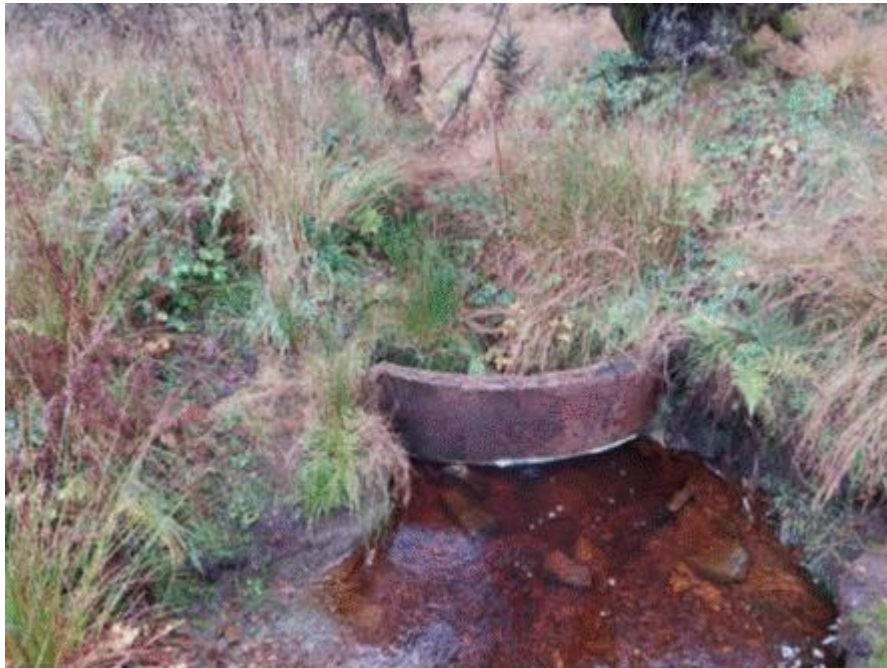
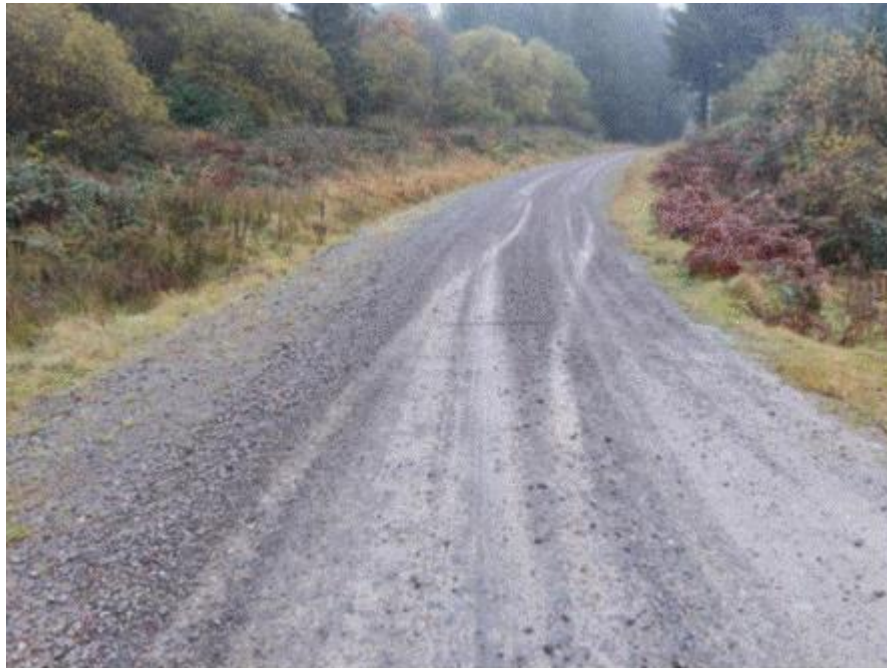
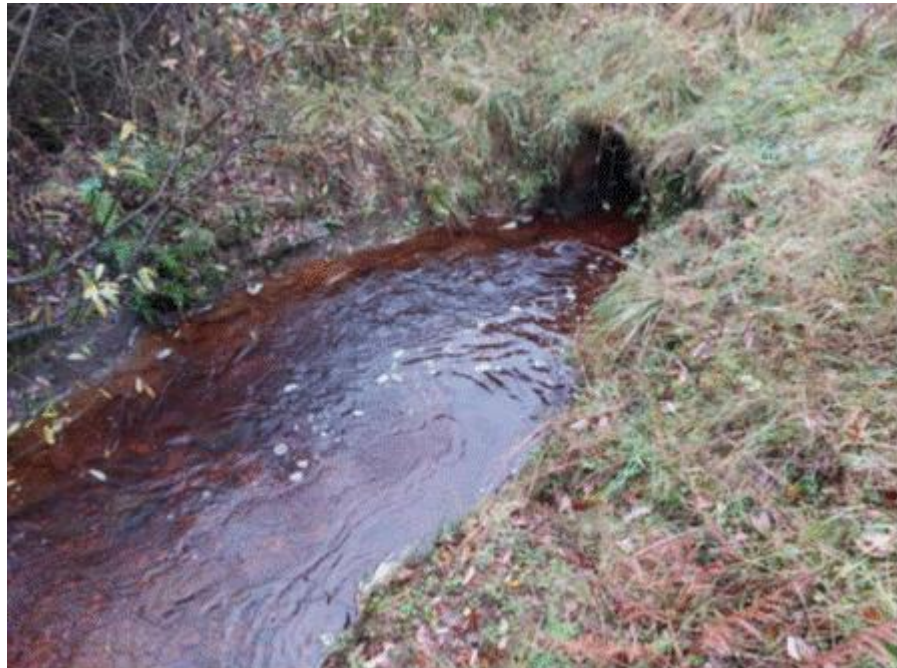
Table A10.8: Crossing WX7

| WX7 (282739, 189822) | | |
|---|---|---|
| <div></div> <p>© Crown Copyright 2023. All rights reserved. Ordnance Survey Licence 0100031673.</p> | <ul style="list-style-type: none"><li>Existing Crossing: Yes</li><li>Crossing Type (existing): Circular Culvert</li><li>Crossing Material (existing): Concrete</li><li>Crossing Condition (existing): Good</li><li>Channel Type: Incised</li><li>Gradient: Moderate</li><li>Valley form: Shallow vee</li><li>Bank condition: Stable</li><li>Bed material: Fine sand/silt, Coarse gravel, Boulders</li><li>Riparian corridor: Natural Woodland, Productive Forestry</li><li>Flow condition: Moderate</li></ul> <ul style="list-style-type: none"><li>Culvert Dimensions (m): 0.9 m</li><li>Water width (m): 1.5 - 2.0</li><li>Water depth (m): 0.05 - 0.4</li><li>Bankfull width (m): 2.2</li><li>Bankfull height (m): 1.0</li></ul> <p><b>Note:</b> Although not so close to the break in slope, this crossing is similar to WX7 near the edge of the plateau. Older concrete culvert but in good condition with well-maintained wide road in place. Old, engineered dam to slow flow before culvert entrance.</p> | |

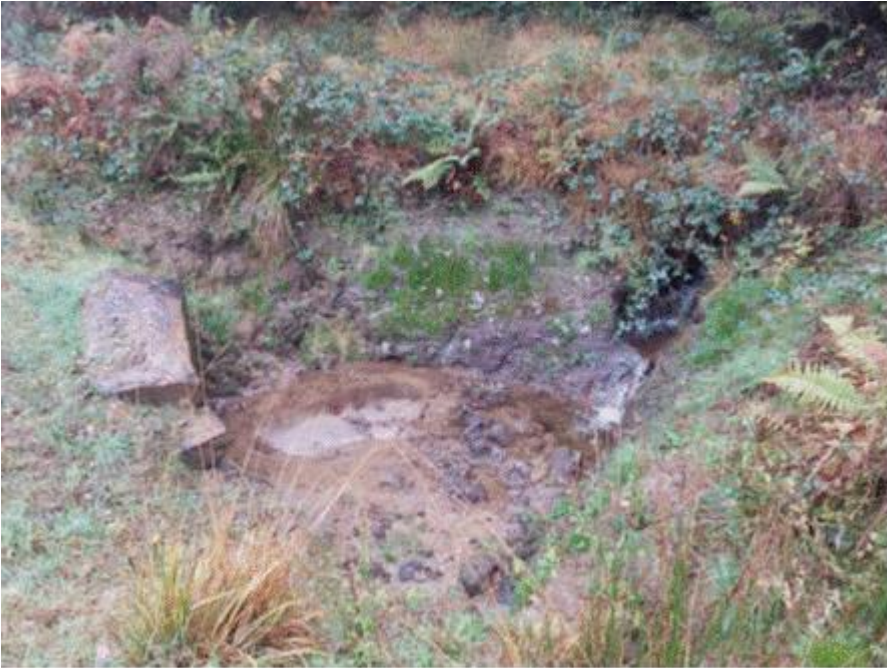
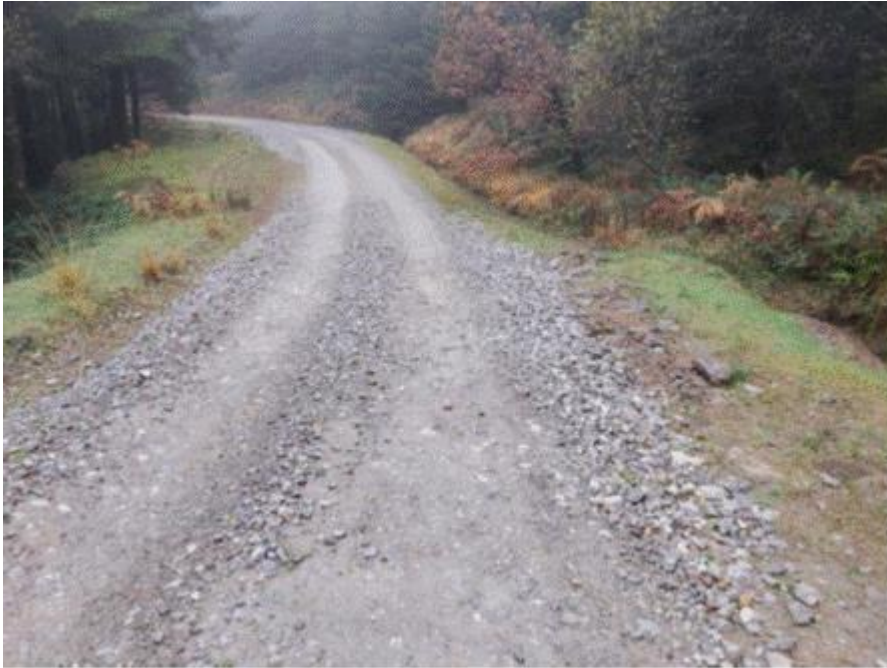
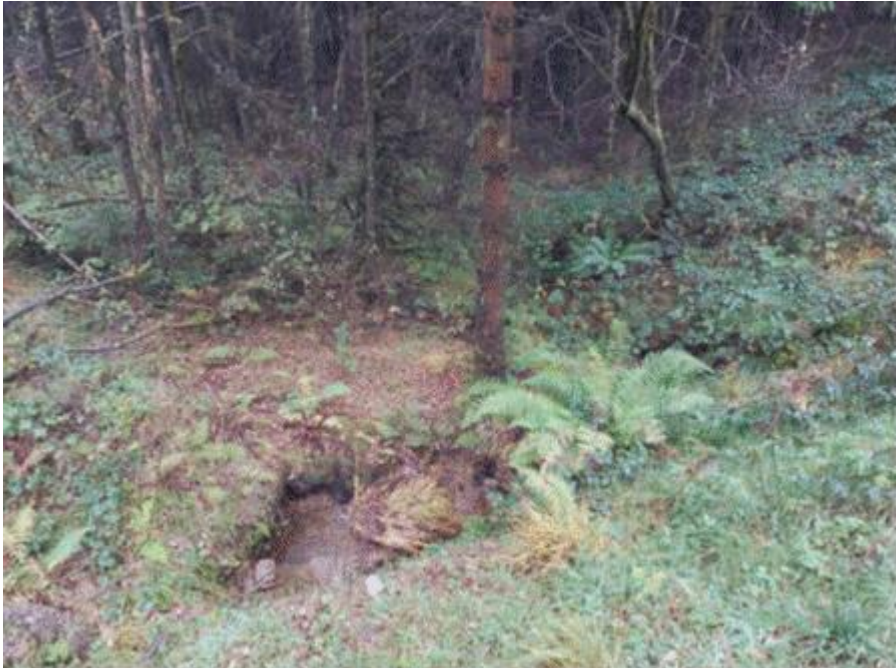
Table A10.9: Crossing WX8

| WX8 (282582, 190547) | | |
|---|---|--|
| | <ul style="list-style-type: none"><li>• <b>Existing Crossing:</b> Yes</li><li>• <b>Crossing Type (existing):</b> Circular Culvert</li><li>• <b>Crossing Material (existing):</b> Plastic</li><li>• <b>Crossing Condition (existing):</b> Good</li><li>• <b>Channel Type:</b> Incised</li><li>• <b>Gradient:</b> Moderate</li><li>• <b>Valley form:</b> Shallow vee</li><li>• <b>Bank condition:</b> Stable</li><li>• <b>Bed material:</b> Fine sand/silt, Coarse gravel, Boulders</li><li>• <b>Riparian corridor:</b> Productive Forestry</li><li>• <b>Flow condition:</b> Moderate</li></ul> | |
| | <ul style="list-style-type: none"><li>• <b>Culvert Dimensions (m):</b> 0.6</li><li>• <b>Water width (m):</b> 0.3 - 2.7</li><li>• <b>Water depth (m):</b> 0.05 - 0.2</li><li>• <b>Bankfull width (m):</b> 1.4 - 4.0</li><li>• <b>Bankfull height (m):</b> 1.0 - 1.7</li></ul> <p><b>Note:</b> Water crossing in good condition in place with evidence of recent upgrading and engineering (old, discarded culverts, unvegetated verges). Wide road in good condition. Larger channel widths and depths are from dug out pool area at entrance to culvert. Generally, 0.05 m depth, 0.4 m width. Note that WX9 is an almost identical crossing, ~30 m west.</p> | |

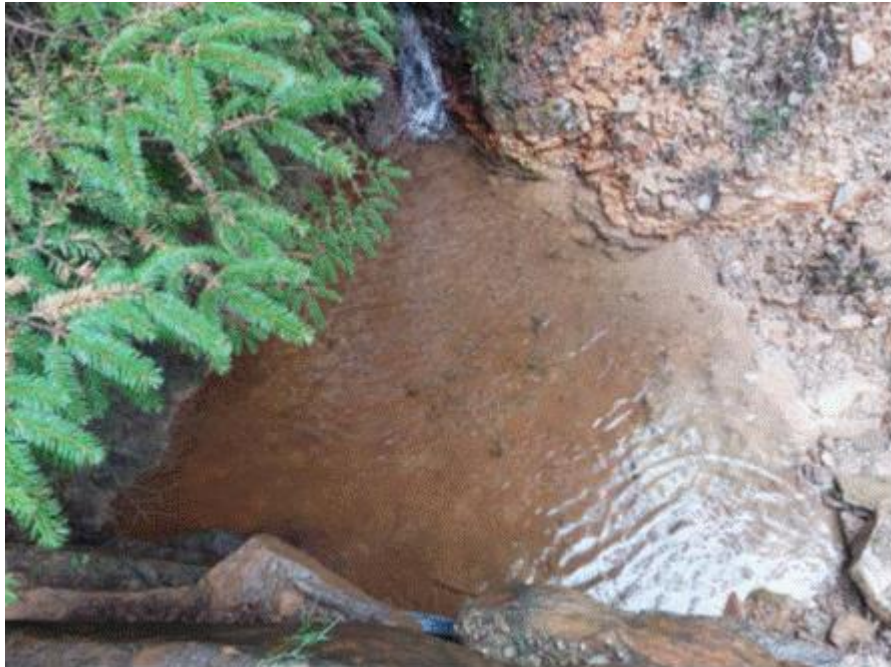
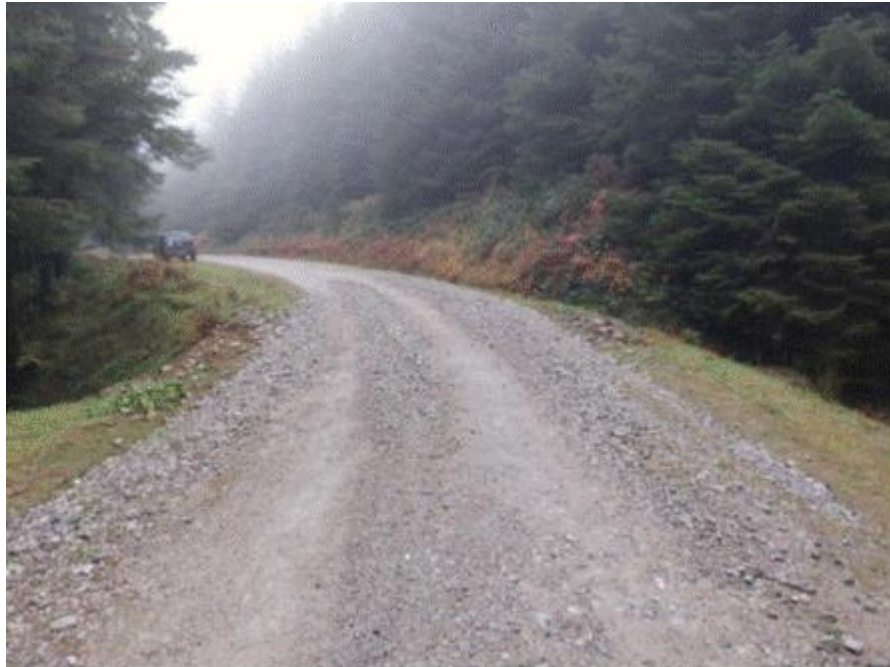
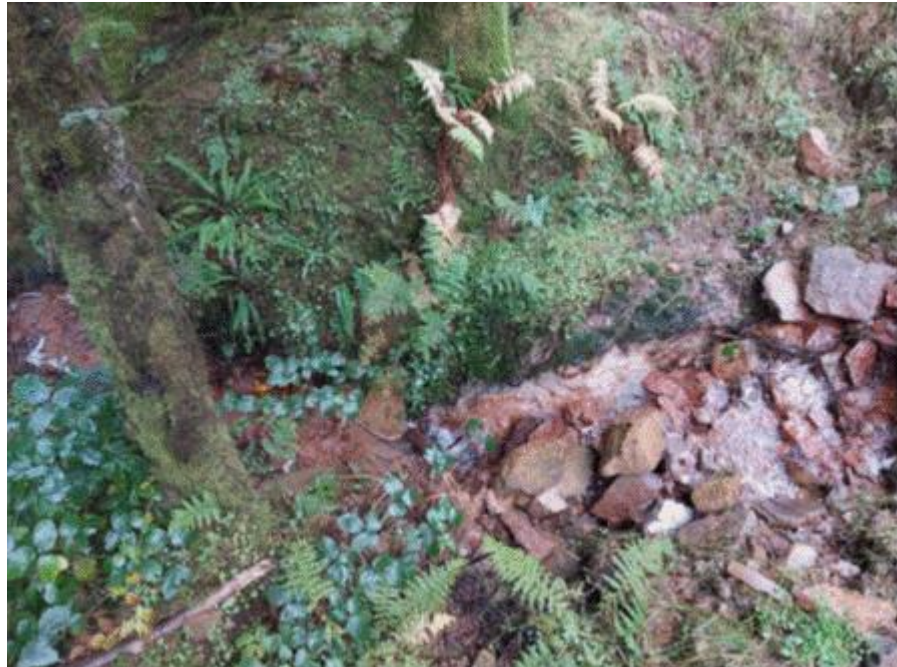
Table A10.10: Crossing WX9

| WX9 (282540, 190541) | | |
|---|---|---|
| | <ul style="list-style-type: none"><li>• <b>Existing Crossing:</b> Yes</li><li>• <b>Crossing Type (existing):</b> Circular Culvert</li><li>• <b>Crossing Material (existing):</b> Plastic</li><li>• <b>Crossing Condition (existing):</b> Good</li><li>• <b>Channel Type:</b> Incised</li><li>• <b>Gradient:</b> Moderate</li><li>• <b>Valley form:</b> Shallow vee</li><li>• <b>Bank condition:</b> Stable</li><li>• <b>Bed material:</b> Fine sand/silt, Coarse gravel, Boulders</li><li>• <b>Riparian corridor:</b> Productive Forestry</li><li>• <b>Flow condition:</b> Moderate</li></ul> <ul style="list-style-type: none"><li>• <b>Culvert Dimensions (m):</b> 0.6 m</li><li>• <b>Water width (m):</b> 0.3 - 2.7</li><li>• <b>Water depth (m):</b> 0.05 - 0.45</li><li>• <b>Bankfull width (m):</b> 1.4 - 4.0</li><li>• <b>Bankfull height (m):</b> 1.0 - 1.7</li></ul> <p><b>Note:</b> Water crossing in good condition in place with evidence of recent upgrading and engineering (old, discarded culverts, unvegetated verges). Wide road in good condition. Larger channel widths and depths are from dug out pool area at entrance to culvert. Generally, 0.05 m depth, 0.4 m width. Note that WX8 is an almost identical crossing, ~30 m east.</p> | |

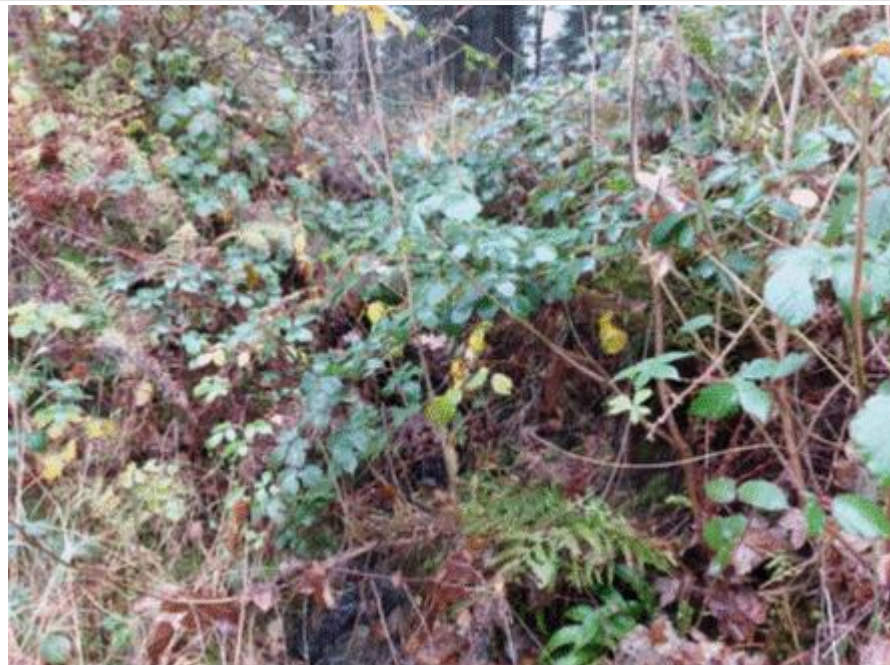
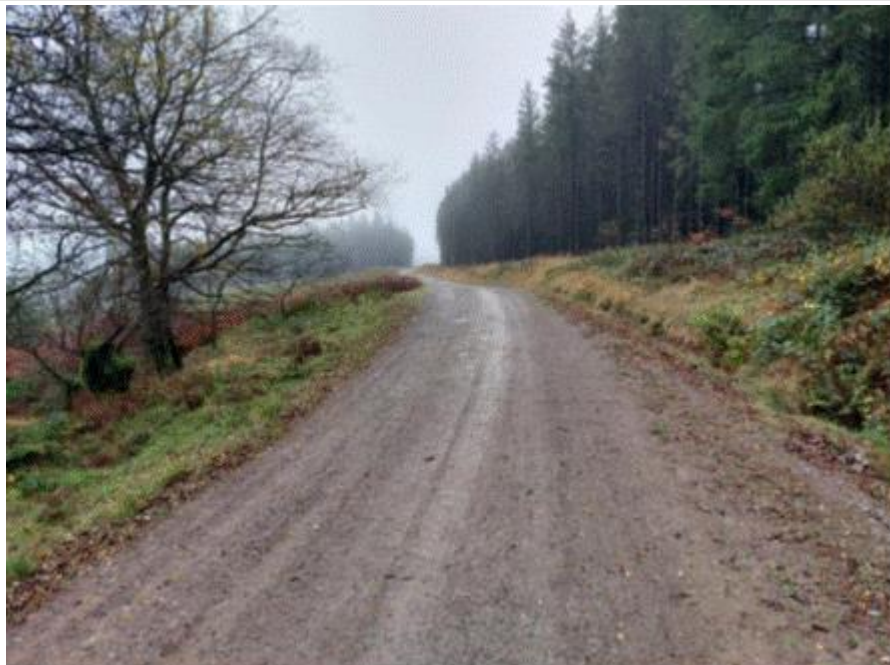
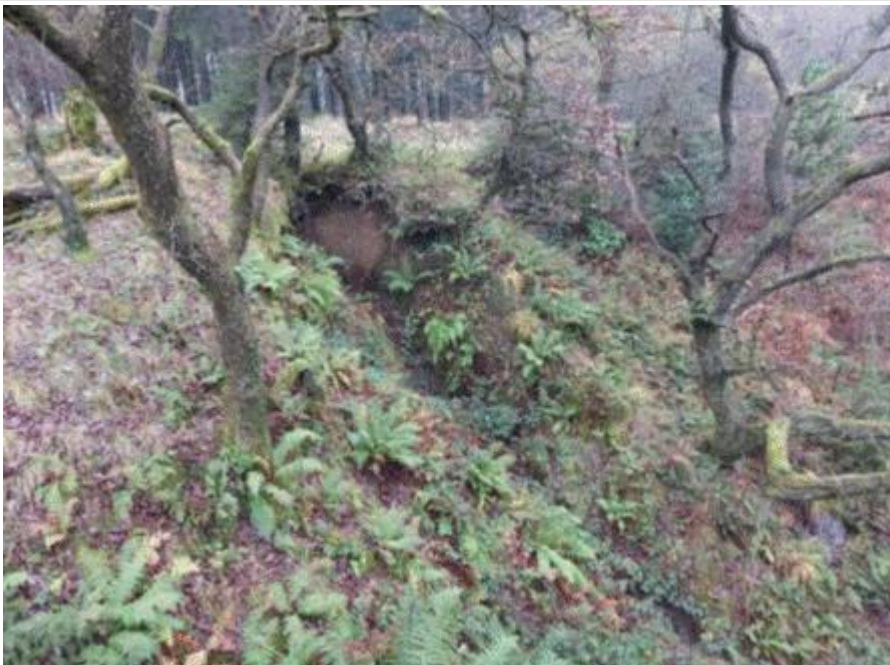
Table A10.11: Crossing WX10

| WX10 (282946, 190704) | | | | |
|---|---|---|--|--|
| | <ul style="list-style-type: none"><li>• <b>Existing Crossing:</b> Yes</li><li>• <b>Crossing Type (existing):</b> Circular Culvert</li><li>• <b>Crossing Material (existing):</b> Plastic</li><li>• <b>Crossing Condition (existing):</b> Good</li><li>• <b>Channel Type:</b> Incised</li><li>• <b>Gradient:</b> Gentle</li><li>• <b>Valley form:</b> No obvious valley sides (upstream), Deep vee (downstream), Gorge (downstream)</li><li>• <b>Bank condition:</b> Stable</li><li>• <b>Bed material:</b> Fine sand/silt, Coarse gravel, Boulders</li><li>• <b>Riparian corridor:</b> Natural Woodland, Productive Forestry</li><li>• <b>Flow condition:</b> Slow</li></ul> | | | |
| <ul style="list-style-type: none"><li>• <b>Culvert Dimensions (m):</b> 0.45</li><li>• <b>Water width (m):</b> 0.3 - 0.8</li><li>• <b>Water depth (m):</b> 0.15</li><li>• <b>Bankfull width (m):</b> 1.7</li><li>• <b>Bankfull height (m):</b> 1.0</li></ul> <p><b>Note:</b> Wide track in good condition at existing crossing. Crossing sits at the edge of the sedimentary plateau, so is very flat upstream, and within 3 m downstream drops into a very steep sided vee valley or gorge. Note that WX11 is a very similar crossing, ~50 m north.</p> | | | | |

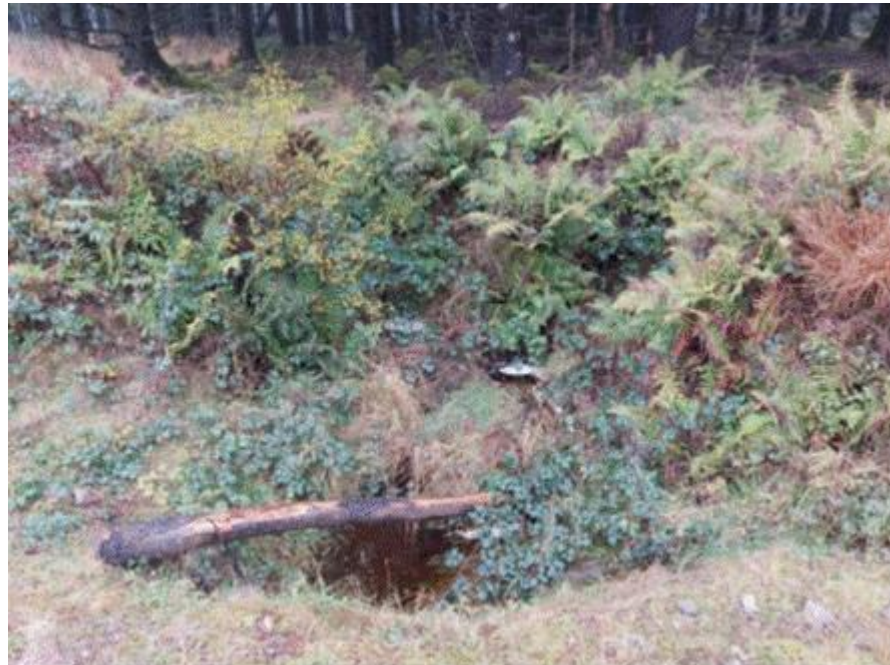
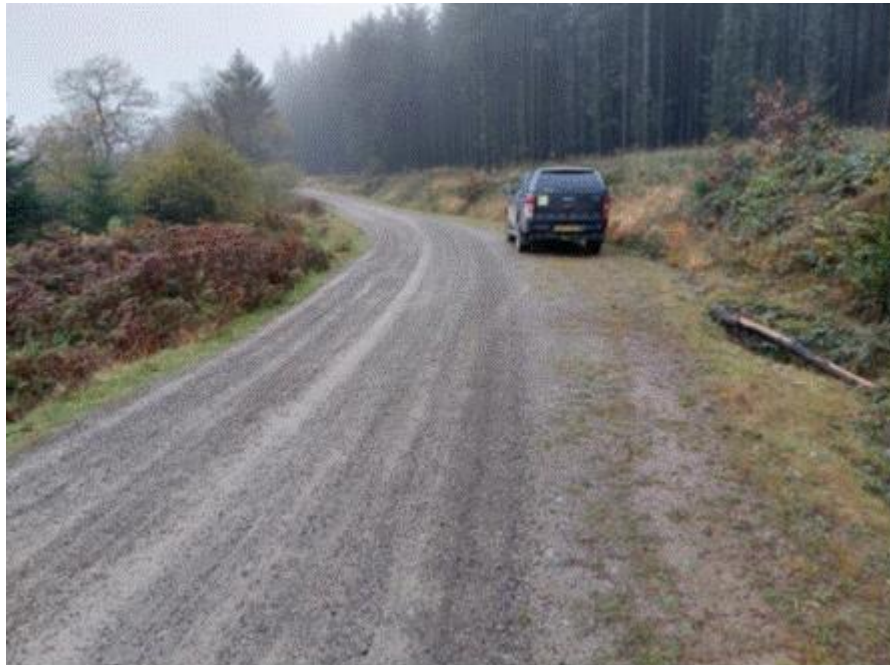
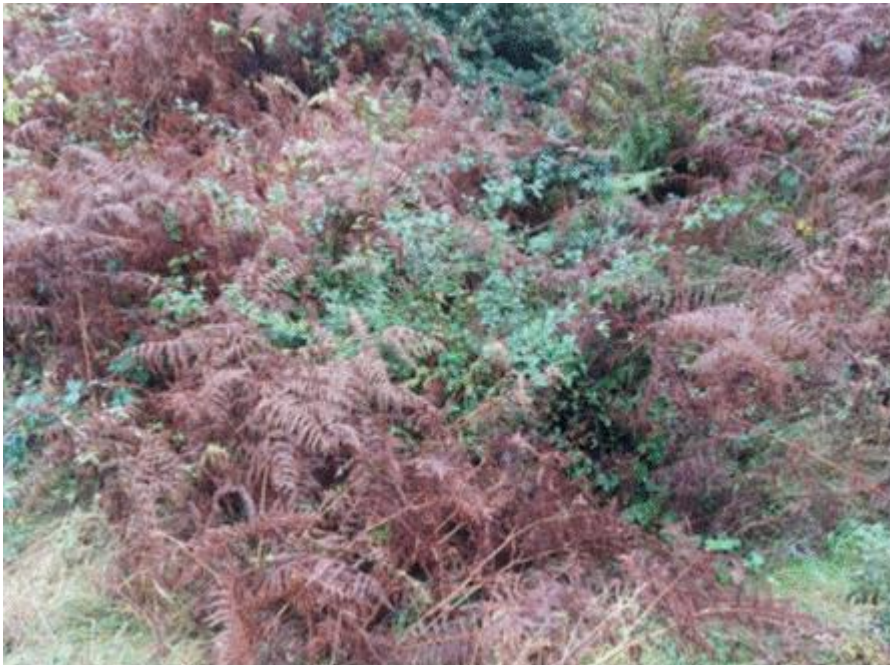
Table A10.12: Crossing WX11

| WX11 (282977, 190771) | | |
|---|---|---|
| <div></div> <p>© Crown Copyright 2023. All rights reserved. Ordnance Survey Licence 0100031673.</p> | <ul style="list-style-type: none"><li>Existing Crossing: Yes</li><li>Crossing Type (existing): Circular Culvert</li><li>Crossing Material (existing): Plastic</li><li>Crossing Condition (existing): Good</li><li>Channel Type: Incised</li><li>Gradient: Gentle</li><li>Valley form: No obvious valley sides (upstream), Deep vee (downstream), Gorge (downstream)</li><li>Bank condition: Stable</li><li>Bed material: Fine sand/silt, Coarse gravel, Boulders</li><li>Riparian corridor: Natural Woodland, Productive Forestry</li><li>Flow condition: Slow</li></ul> <ul style="list-style-type: none"><li>Culvert Dimensions (m): 0.45</li><li>Water width (m): 0.3 - 0.8</li><li>Water depth (m): 0.15</li><li>Bankfull width (m): 1.7</li><li>Bankfull height (m): 1.0</li></ul> <p><b>Note:</b> Wide track in good condition at existing crossing. Crossing sits at the edge of the sedimentary plateau, so is very flat upstream, and within 3 m downstream drops into a very steep sided vee valley or gorge. Note that WX10 is a very similar crossing, ~50 m south.</p> | |
